Our Reference  
**09.283**  
Computer File

## **Structural Assessment Report**

**Project - Refurbishment Glenmore Hotel,  
96 Cumberland Street, The Rocks**

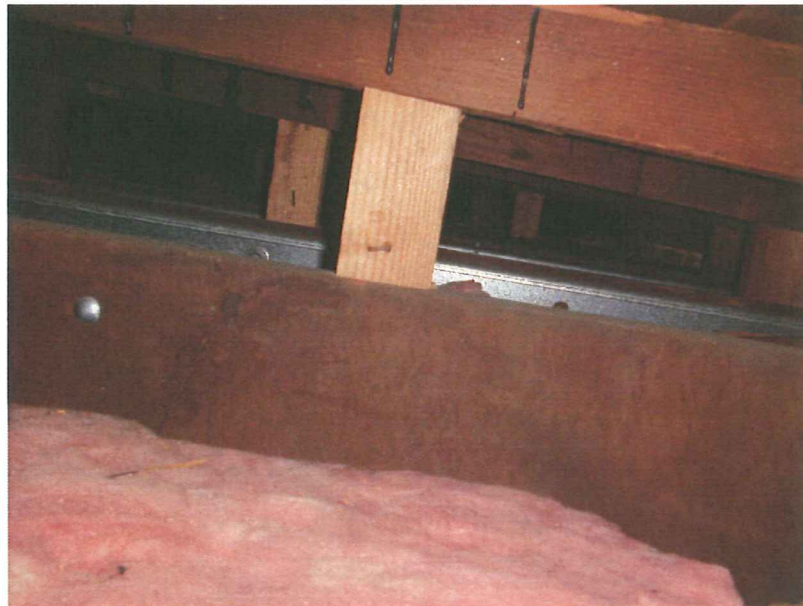
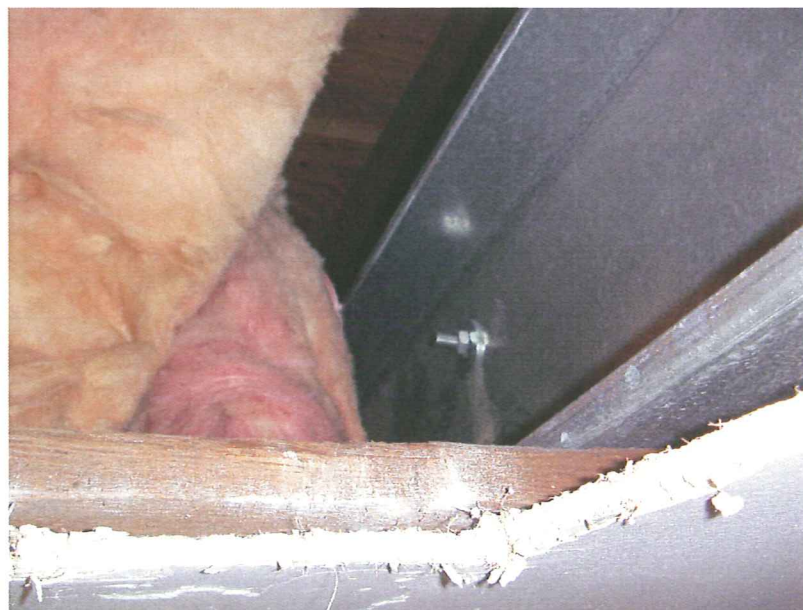
Ashby Doble Pty Limited completed a preliminary review of the existing roof structure of the Glenmore Hotel in 2005. A follow-up inspection was completed in November 2009 to confirm that the configuration of the roof structure remained the same. The existing roof structure is a combination of timber rafters with steel C-purlins bolted to the sides of the rafters. Refer to photograph and sketch below.

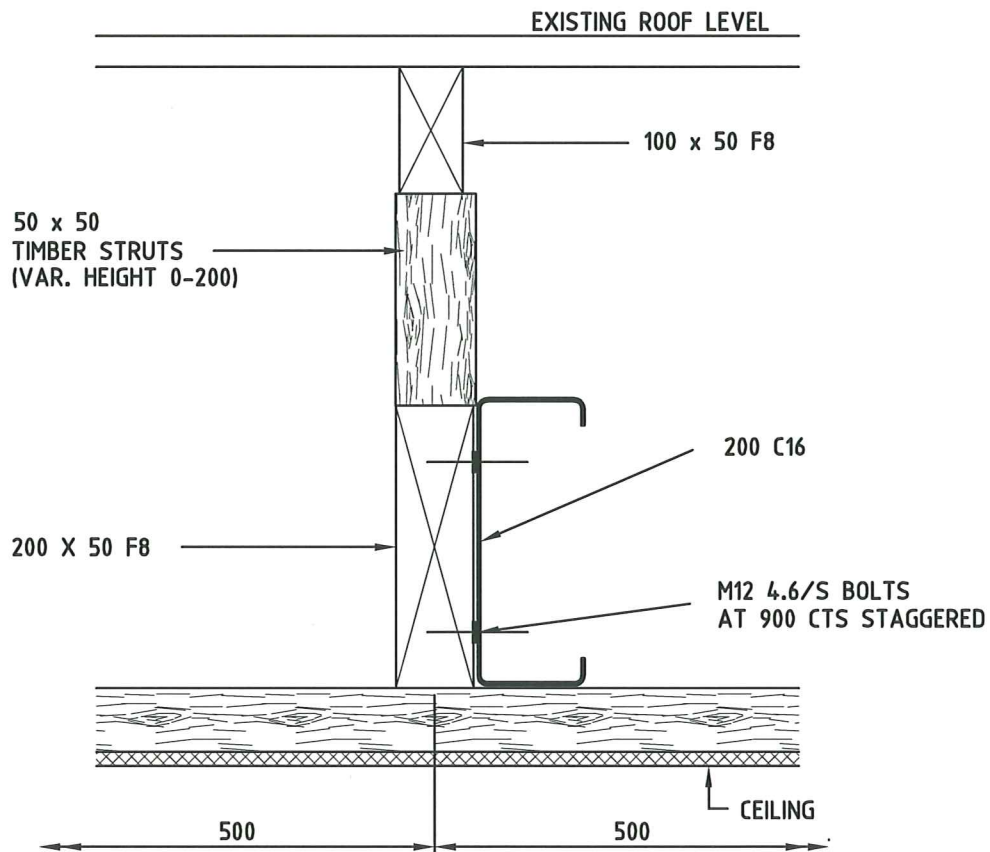
STRUCTURAL CONFIGURATION  
OF EXISTING ROOF FRAMING

In review of the heritage information provided in the Conservation Management Plan document, we note that there have been ongoing issues associated with waterproofing to the roof and parapet structure over the life of the building, with leaking of the roof structure and cracking in the parapet first noted as far back as 1933. Ongoing repairs and maintenance of the roof structure have been completed continuously over the life of the building, with a reinforced concrete collar beam being installed to restrain the tops of the parapet walls in the 1970's.

We have also been instructed by the architects that it is proposed to create the roof structure as thin as possible, to ensure that the SHFA request, which is to provide for the roof floor level to be lowered as much as possible, to be accommodated. Bearing these items in mind, we believe that the rooftop floor should be a reinforced concrete deck, and make these recommendations for the following reasons:

- The reinforced concrete deck will provide a better quality of tie-in to the existing walls, to ensure no spreading of the upper level walls and ongoing cracking of the parapet structure.
