Our Ref: 81604:SA0413
AMP Preliminary Site OHS & Environmental Inspection Apr 10

Re: Preliminary Site OHS and Environmental Inspection

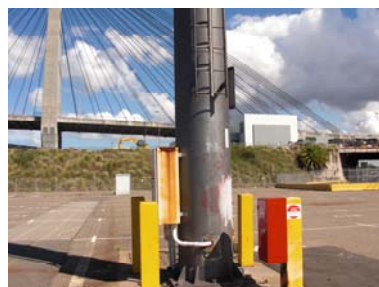
- The lighting rigs are fitted with ladders extending their full height from approximately 2.5 metres above the ground surface. NAA was advised by the site contact that numerous ladders are structurally unsafe and have been condemned. Access to the ladders should be prevented by either their removal or enclosure of the rig footing area.

Lighting rig ladders
