10 December 2013

**RE: ASBESTOS MATERIAL INSPECTION OF SOIL STOCKPILE  
YENNORA DISTRIBUTION CENTRE, DENNISTOUN AVENUE, YENNORA NSW**

PCA3834-2013\_LET01\_10Dec13

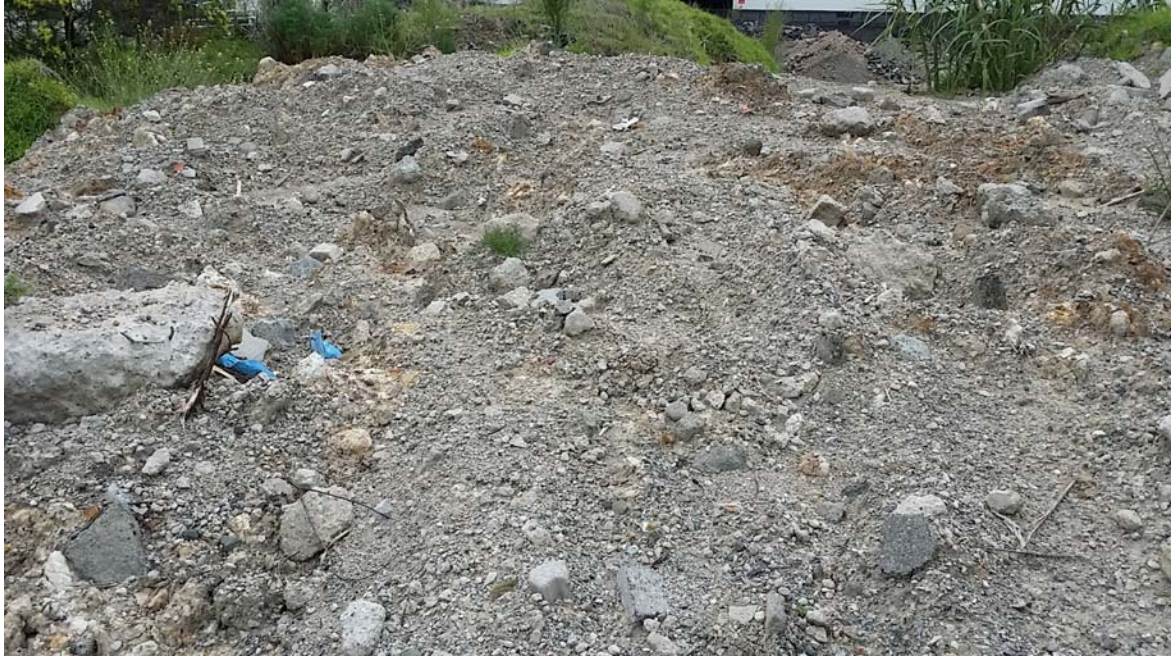
**Photograph No. 1: Grey coloured sandy soil in eastern area of the stockpile.**

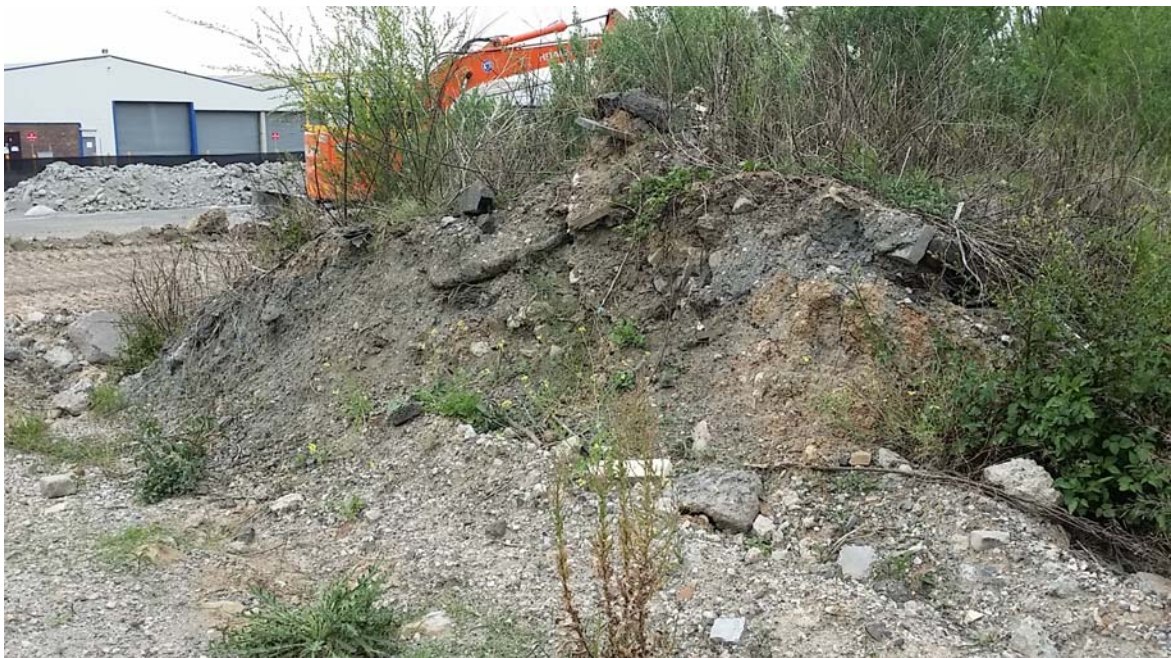
**Photograph No. 2: Grey coloured sandy soil in eastern area of the stockpile.**

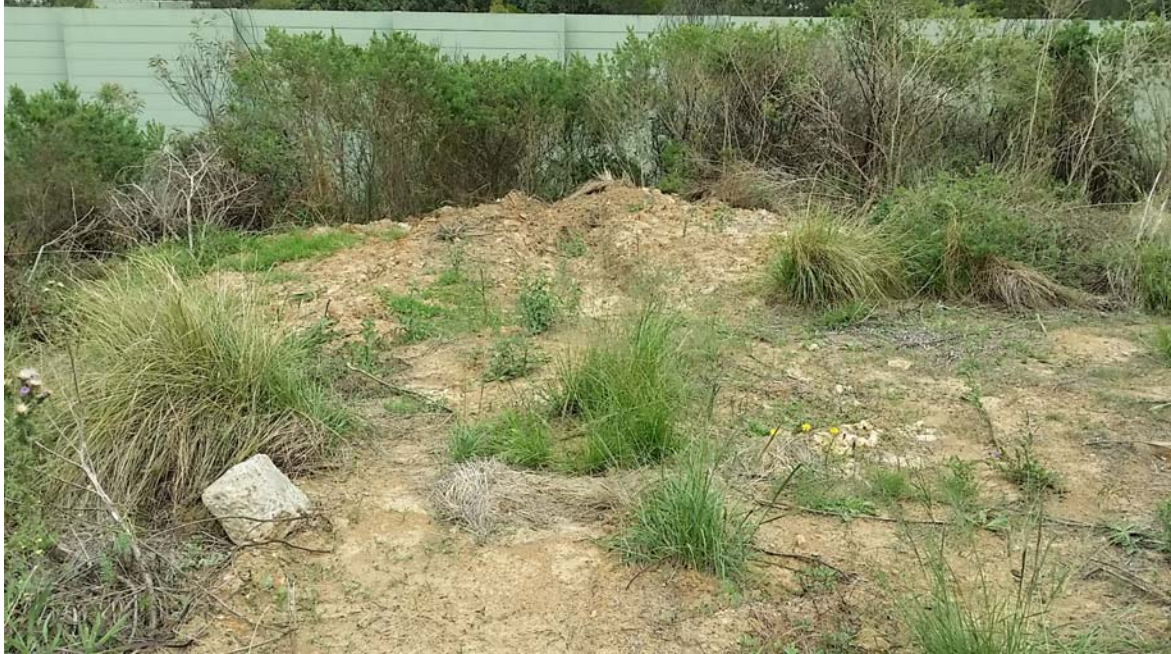
**Photograph No. 3: Orange coloured clay soil in north west area of the site**

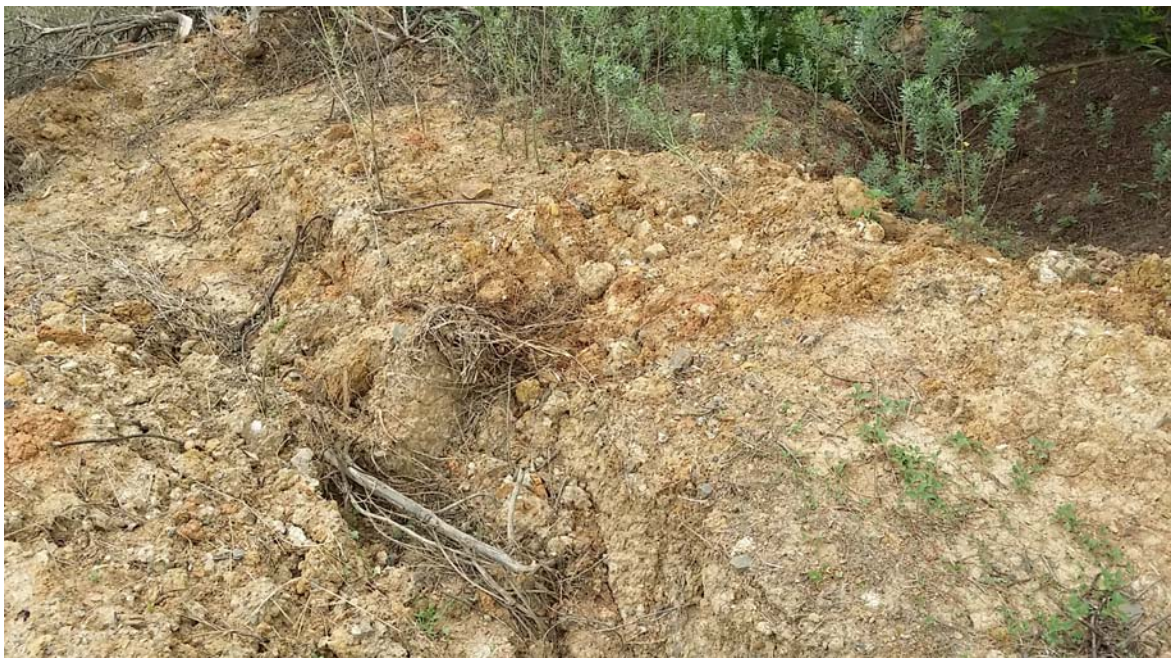
**Photograph No. 4: Orange coloured clay soil in northern area of the site**

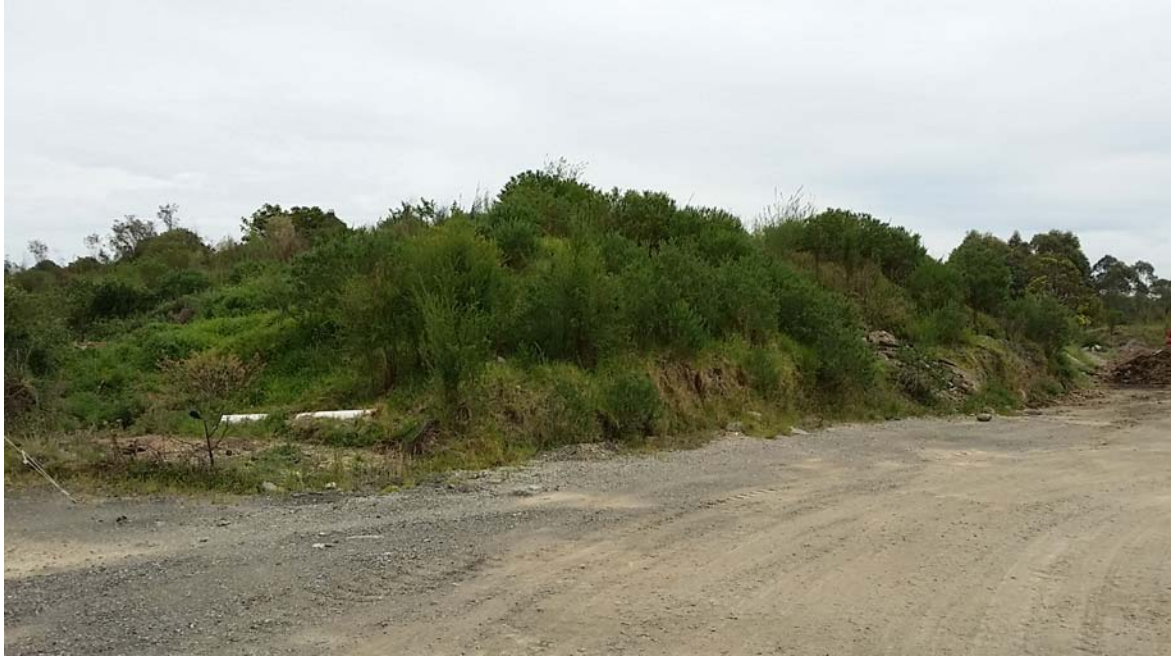
- Along the eastern side of the stockpile there are numerous locations where the soil and debris within the stockpile is exposed. In these locations the soil consists mostly of grey coloured sandy soil and road base / crushed concrete debris with building rubble including ceramic tiles, concrete pavers, timber and metal. See photograph Nos. 1 and 2.
- Across the northern side of the stockpile there soil consists of orange and light brown coloured clay in which there are only a small number of randomly located pieces of building debris. See photograph Nos. 3 and 4.
- In the southern area the soil consists if grey and brown coloured soil containing and range of different types of building debris. In the south west area there are a number of piles of bitumen debris. See photograph Nos. 5 and 6.

**Photograph No. 5: South eastern area of the stockpile**

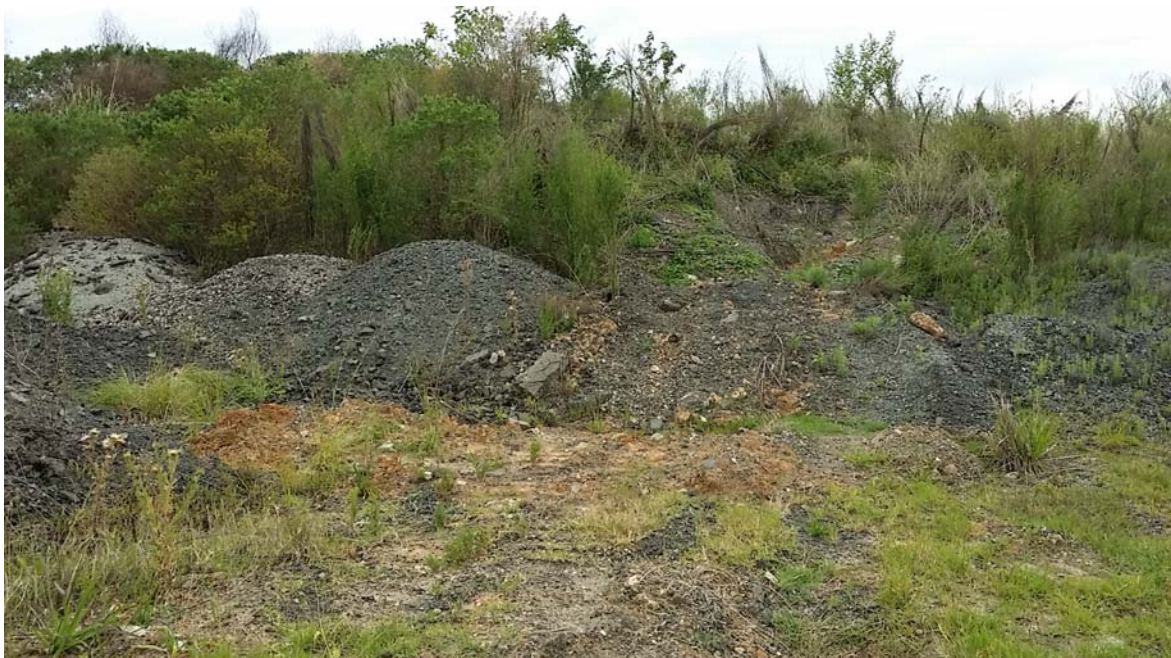
**Photograph No. 6: Southern area of stockpile**

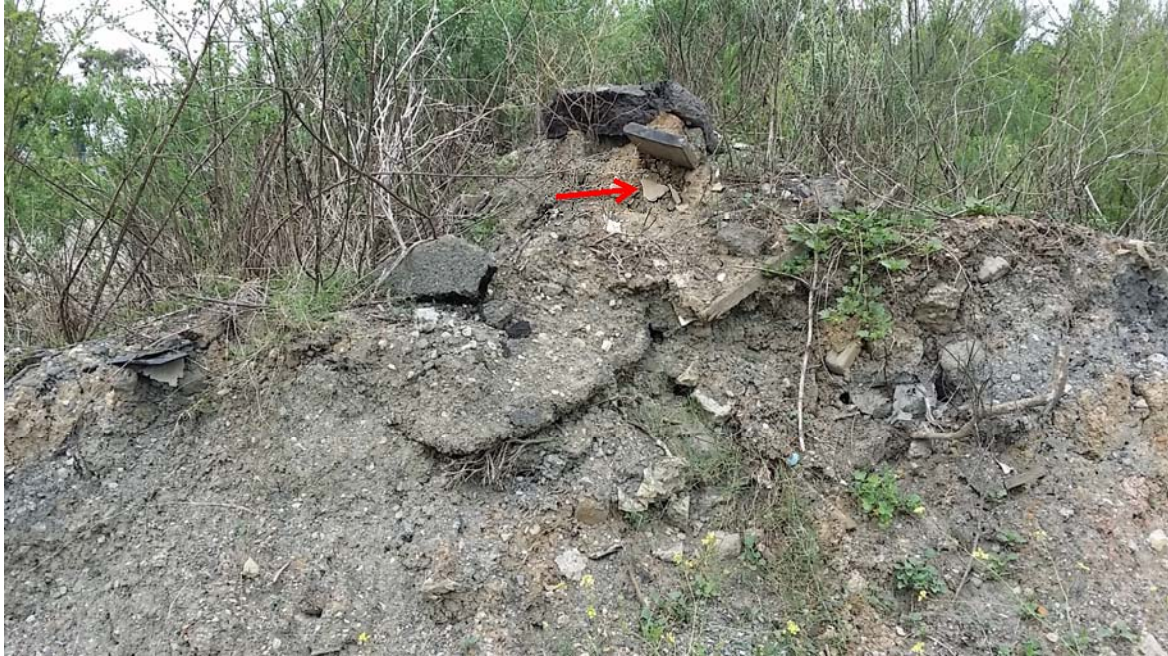
During the site inspection we observed a small number of randomly scattered fragments of asbestos cement sheet debris. These were located in the north eastern and south eastern areas of the stockpile on the surface of light or dark grey sandy soil. See photograph Nos. 7 and 8. The loose soil in each of these locations was spread and no further fragments of asbestos cement sheet were identified.

The fragments of asbestos cement sheet material that were found during the site inspection were broken but not weathered or degraded to a degree that asbestos fibres could be removed by hand pressure. Accordingly these pieces of material are classified as non-friable asbestos containing material.

**Photograph No. 7: Fragment of asbestos cement sheet that was removed from the soil in the north east area of the stockpile**

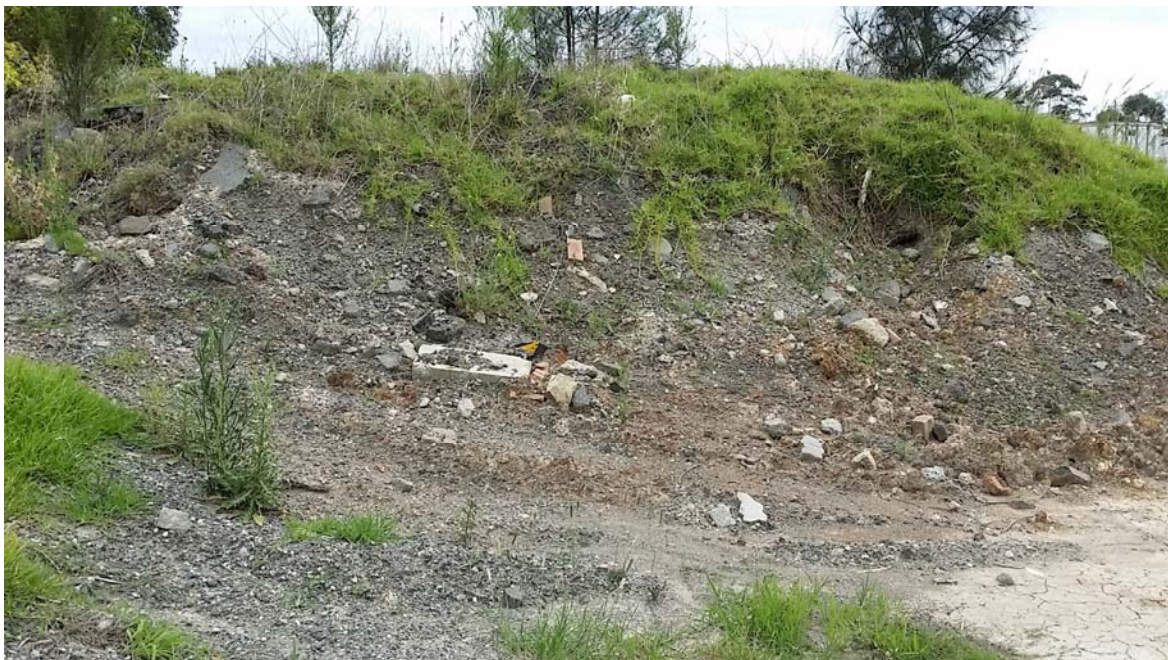
**Photograph No. 9: South eastern area of stockpile from which one fragment of asbestos cement sheet debris was removed.**

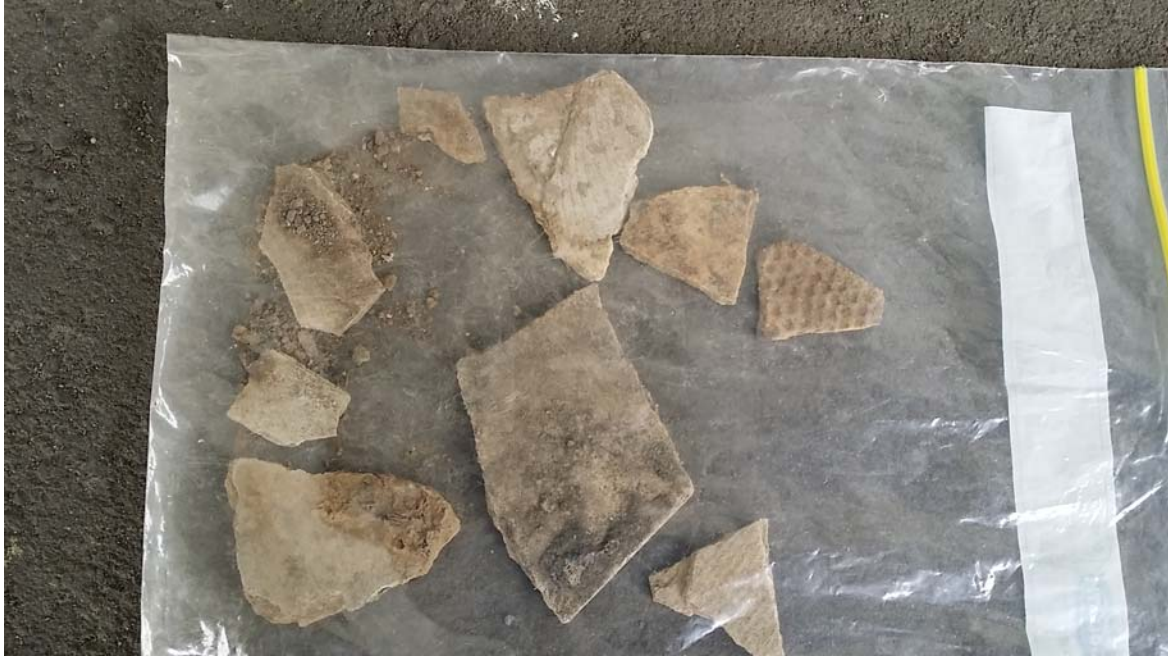
A total of nine fragments of asbestos cement sheet debris were sighted and removed from the stockpile. See photograph No. 9. These fragments were placed into a resealable plastic bag and will be delivered to a licenced asbestos removal contractor for disposal as asbestos contaminated waste at a NSW EPA licenced landfill facility. No large pieces of asbestos containing material were found to be present on accessible areas of the stockpile.

**Photograph No. 9: Fragments of asbestos cement sheet debris collected on 9 December 2013 from the soil stockpile in the north western area of the Yennora Distribution Centre**

We recommend that regular inspections (annually or following soil disturbance) be carried out of the exposed soil areas on the stockpile to confirm that these areas remain free of asbestos containing material and that no human health risk is posed to persons working in areas adjacent to the stockpile.
