Highland Pine Products

***Independent Audit Report:
Planning & Environmental Compliance
Oberon NSW, June 2019***

Highland Pine Products Pty Ltd

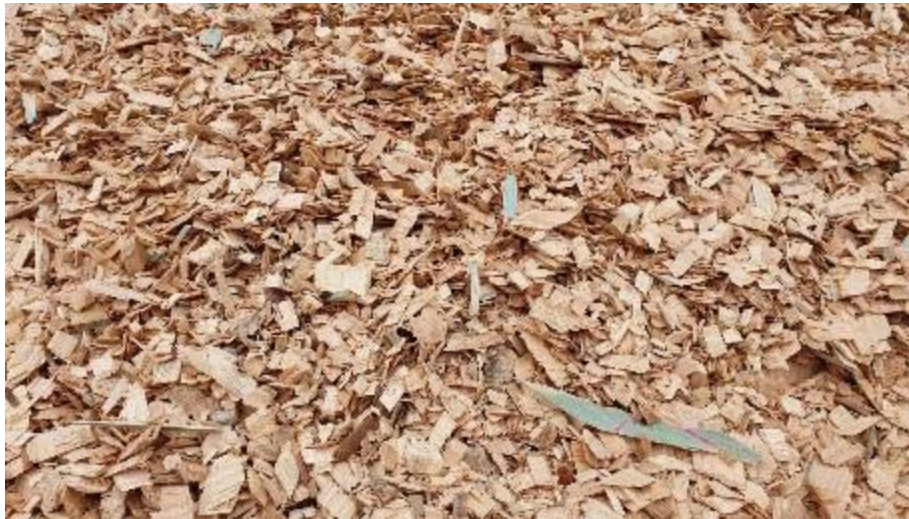
- Timber chip stockpiles intended for use as boiler fuel were noted to contain sporadic blue coloured timber. This was considered to indicate the presence of chipped bifenthrin treatment timber pieces. Such timbers should not be burned without EPA approval and require segregation from the boiler fuel timbers as per procedures specified in the current EMP. A beneficial re-use review of this waste stream is recommended.

Photo 1: Chip contains small amounts of treated timber content (Blue frame pieces). Destined for boiler fuel.

DC:19-5	Prior to purchasing timber chip for boiler fuel, have the Environmental Advisor sign off it is fit for purpose and contains no hazardous materials e.g. treated painted or engineered timber, impurities (metals, plastics), etc.	High
DC:19-6	Seek DPE approval of the current version of the Waste Management Plan.	Medium
DC:19-7	Prepare a Landscape Management Plan and provide to the D-G for approval.	High
DC:19-8	Add compliance assessment & reporting timeframes with reminders into the Risk Manager (or equivalent) scheduler as a means to mitigate the risk of future consent action item non-compliances.	High
DC:19-9	HPP consider aligning the AEMR and EPA Licence Annual Return to avert the doubling reproduction of some data.	Low
	<i>EPL 11229 Conditions</i>	
EPL:19-1	Develop a system for management and control of H2 waste including operator training to ensure treated Bifenthrin timbers do not enter the boiler fuel waste re-use stream. (This may alter if permission is granted by EPA to burn bifenthrin treated timber following a proof of destruction testing program). There may be options to re-use these residues as a beneficial re-use, e.g. fuel, MDF.	High

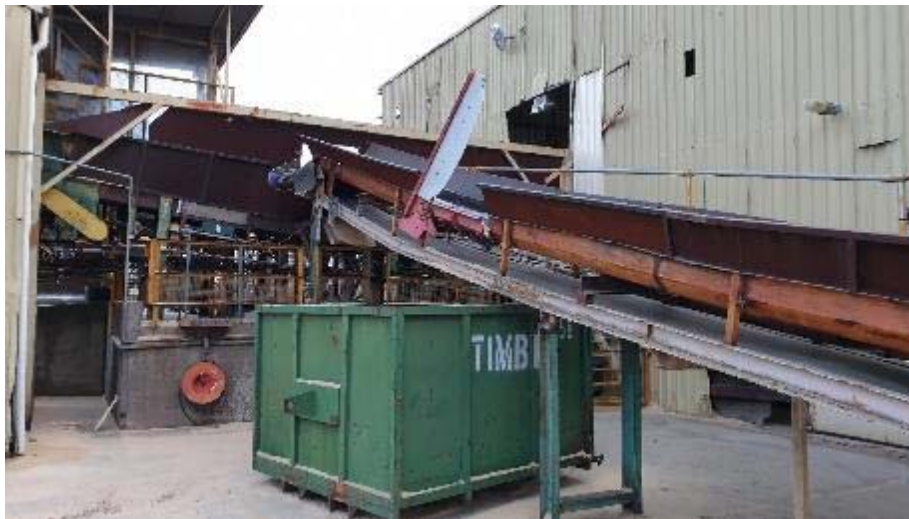
Photo 2a: Docking of Holtec treated timbers can feed into timber bin destined for chipping and boiler fuel.

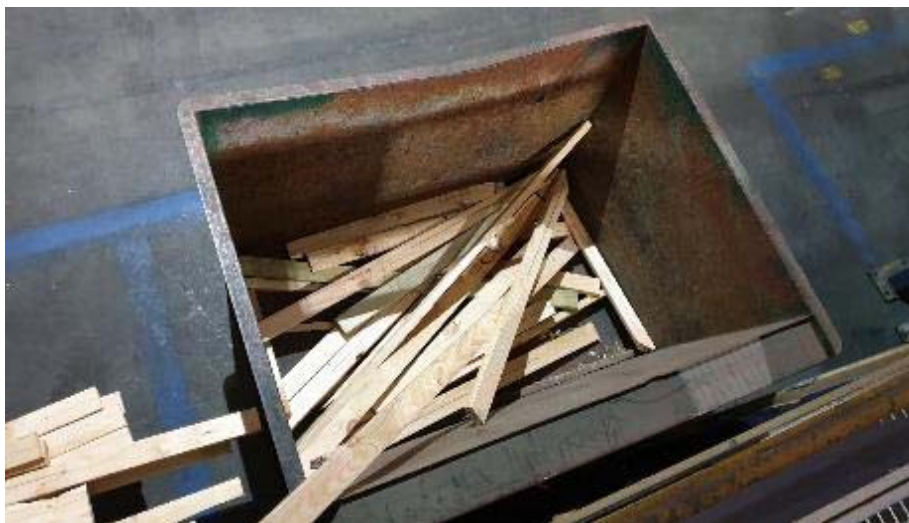
Photo 2b: Blue frame rejects (at application area Dry Mill) found in wood chip bin destined for boiler fuel.

Rec. Update SOP and train operators on segregation practices. Investigate beneficial re-use opportunities for the treated timber residues.

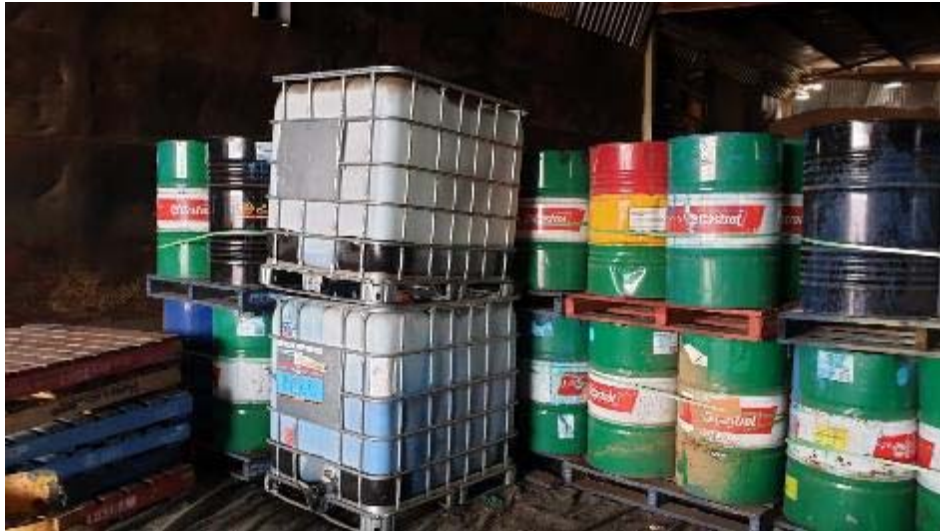
- Blue timber framing H2 Bifenthrin liquid preservative waste was noted stored within a bunded location away from the treatment plant area (Site 1). A storage, wash-out and labelling procedure update is required prior to relocating containers that are considered 'empty'.
- The timber preservation area at the dry mill was assessed against specifications within the Australia Standards for Timber Preservation Plants. Improvements were identified in order to demonstrate compliance with pipe labelling, pipe and hose drip control within a bunded area, backflow protection device location and groundwater monitoring.

Photo 3: Containers with H2 preservative content in shed with empty 200L drums; outside treatment area.

Rec. Update SOP and train operators in correct storage and handling practices.

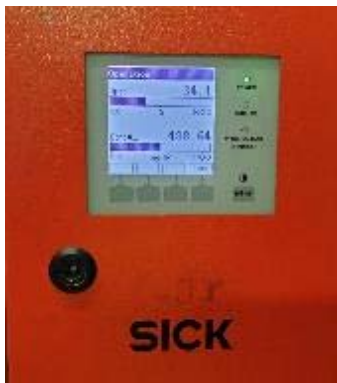
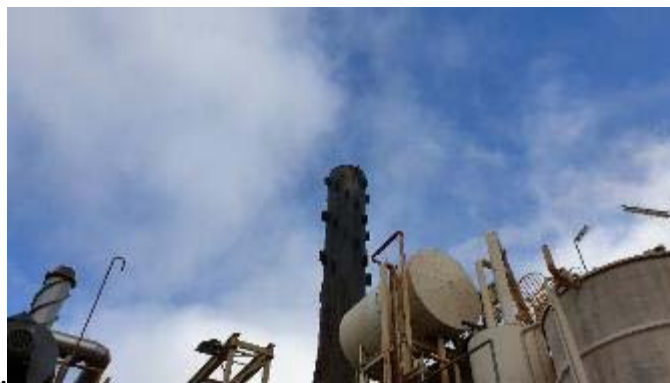
- The opacity of the boiler is reading up to 50%. Whilst the most recent stack tests (Ektimo 2017, 2018) reveal compliance against the 250mg/m³ particulate limit, a 30-50% real-time opacity meter reading observed during the audit suggests calibration issues with the SICK monitor, or potential excursions over the Clean Air Regulations 20% limit.

Photo 4: Boiler emissions opacity monitor reading 30-50%; minimal smoke evidence at 34.1%.

Monitoring records in recent tests therefore reveal compliance with the 250mg/m³ limit. Observations of the boiler stack during the audit period indicated largely only a heat haze. Some white smoke was observed when the opacity meter coincided with a reading above 40%. This appears to be in excess of the stated 20% trigger within the EMP (and in excess of Group 4, 20% opacity requirements Schedule 4 of the

Furthermore, interviews with the operators identified no system to immediately implement steps to rectify a high opacity reading. A Standard Operating Procedure would assist with this compliance control deficiency and has been recommended.

EPL:19-5	Ensure a program to calibrate the SICK opacity meter is undertaken during the next scheduled particulate and NOx stack emission compliance test.	High
EPL:19-6	Continue to assess trends in groundwater to evaluate impact; particularly the nitrate concentration. If the trend continues upwards, undertake a risk assessment of likely impact to off- site receptors.	Low
EPL:19-7	Investigate the reason for weather monitoring station data drop-outs; in particular check battery condition.	Medium
EPL:19-8	Add the regulatory notification process into HPPs Risk Manager program so that a record is captured and readily accessible.	Low
	Environmental system and plan specifications	
EMS:19-1	Develop a new SOP capturing control over treated timber required including movement of liquid residues and empty container labelling and storage. Train all relevant operators in the SOP.	High
EMS:19-2	Add to MEX an inspection process for the floor and sumps of the H2 application and mix areas and any sump level controls calibration.	Medium

Rec. Calibration required and operator SOP to use data to better regulate fuel/air mix/ overfire air as compliance control tool.

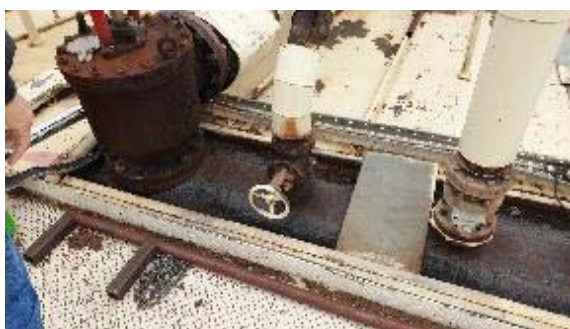
**Photo 5a: Boiler top not insulated leading to inefficiencies & additional fuel requirements.
Rec. Insulate the boiler top and valve stems.**

The top of the boiler was noted to not be insulated with rockwool lagging. This would result in unnecessary heat loss wasting energy and resulting in the need for additional fuel requirements.

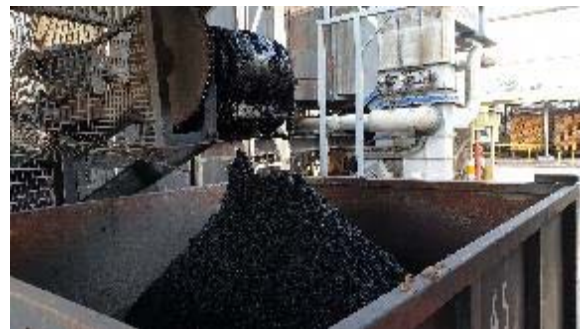
Photo 5b: The boiler furnace ash exhibits large pieces indicative of incomplete combustion.

- The fire within the furnace is burning too actively on the grates which produces elevated temperature towards the base of the furnace.
- Ash appearance confirms incomplete combustion i.e. largish unburnt particles were observed (refer Pictorial Summary).

1. Damage to grates requiring Increased replacement cost and boiler down time.
2. Carry over of particulate matter as the combustion is not held in a quiet zone but gets swept up with overfire air and carried into then generating tubes section from which it is then discharged. This can result in premature coating of the generator section and build up within the multi-clones.

Rec. Progress review to negate 'grate burning' to improve combustion and mitigate particle overcarry thereby mitigating the risk of non-compliance with Opacity and particulate limits. Assess re-use options.

1. Review the existing Citec control system with a view to making it easier for operators to understand and respond to combustion improvement using currently available monitoring information.
2. Optimise the screens to enable ready interpretation of data.
3. Provide ability to adjust mix of under-fire and over-fire air in relation to percentage of feed the rate.
4. Optimise the overfire air burning zone closer to the furnace bed.
5. Investigate feasibility of bark hammer mill with payback against fuel purchase, grate replacement, downtime and sale of existing dry material (chip).
6. Insulation required over valve bodies and the currently exposed top of the boiler.
7. Review beneficial waste re-use opportunities for boiler ash as opposed to landfill.

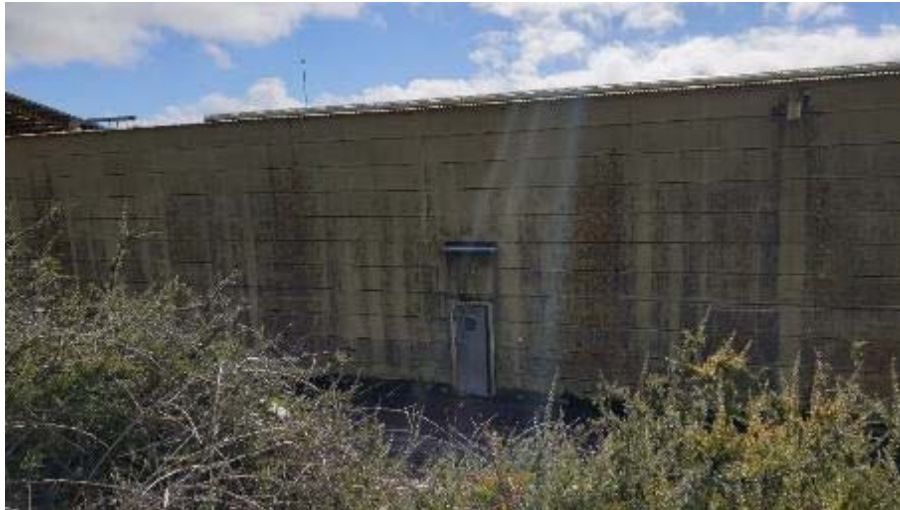
Photo 6: Southern door ajar represents a pathway for noise escape during night.

A door along the southern wall of the dry mill was observed open. It was in an area of limited employee access and possibly was left open following maintenance works. Doors along the south aspect should be closed during night period and this has been captured in a recommendation.

Rec. Operator training required to ensure southern doors remain closed.

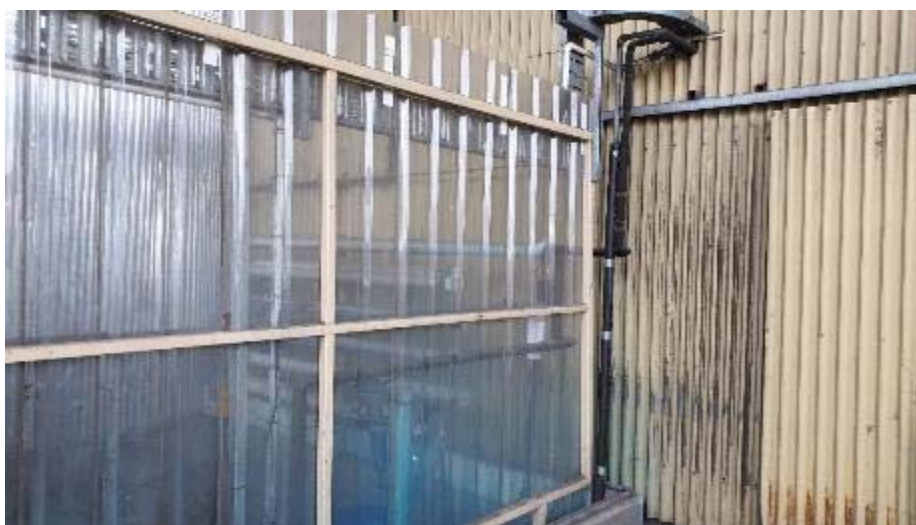
Photo 8: Pipe identification not present and pipes extend outside bund.

Reference	Recommendation	Priority%
EPL:19-4	<p>Improve Bifenthrin treatment plant design compliance with the ANZS 2843.1 Standard including:</p> <p>a) Part 1, Section 1.6. Labels. Colour code pipe runs and include transfer runs in a schematic plan.</p> <p>b) Part 1 Section 2.4 Water Bodies: Install a groundwater monitoring bore downgradient outside the treatment plant bunded area to support no loss of containment through the floor and sumps.</p> <p>c) Part 1, Sect 3.8 & Part 2 2.1 Emergency Plans & 2.8 Signs; Access & Signage: Re-label the Emergency Exit sign leading into the H2 Preservative mix area given it is a locked area and provides no escape.</p> <p>d) Part 1, Sect 4.7.2 Backflow Precautions: Review whether the backflow protection device is positioned correctly and is upstream from all flow lines to protect potable water supply.</p> <p>e) Part 1 Sect 4.7.3 - Auto Shut off and containment: Confirm that the level device and alarm in the water sump is included in the preventative maintenance MEX checking system.</p> <p>f) Part 1 Sect 3.5: Containment: add a double skin (extra pipe) around the pipes that run outside the building from the bifenthrin mixing area to the bunded application area so that line leakage would drain back into the bunded area (e.g. secondary pipe control).</p> <p>g) Part 1 Sect 3.5 Containment: relocate the dripping hoses from the wall potentially outside the bunded area back into the bunded areas.</p>	Medium

Rec. Label and colour code piping. Provide a secondary pipe to drain line back into bund should leak occur.

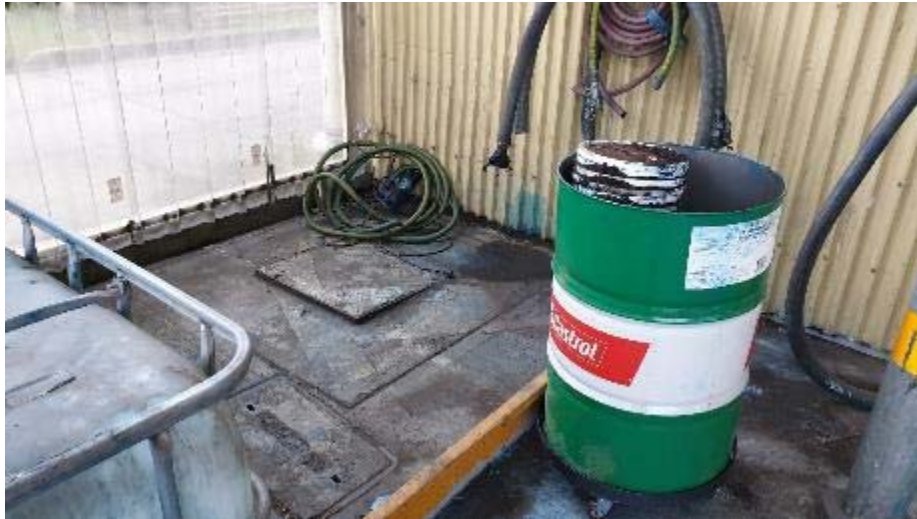
Photo 9: Hose hook up area is outside bund and can drain to below ground services.

Recs. Re-location required so as within bund. Install a groundwater bore down hydraulic gradient. Ensure pump sump alarm is on PM check

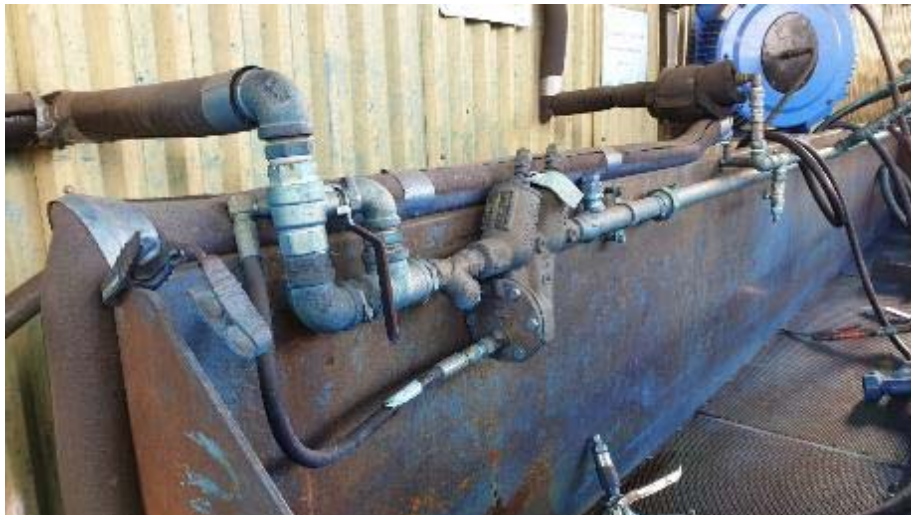
Photo 10: Backflow prevention may not be on in-feed line. Rec. Check location of backflow control.

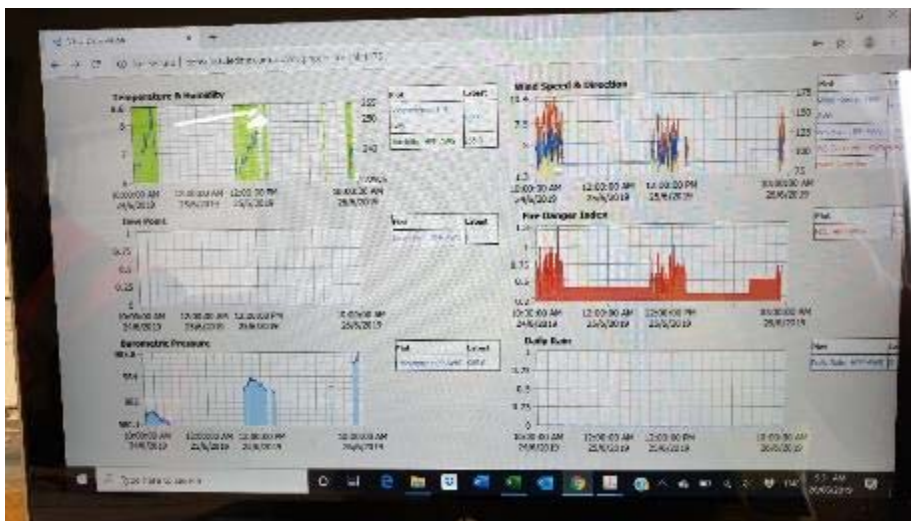
Photo 11: Weather monitoring station ramps off.

Rec. Battery or settings check required to capture 24hrs.

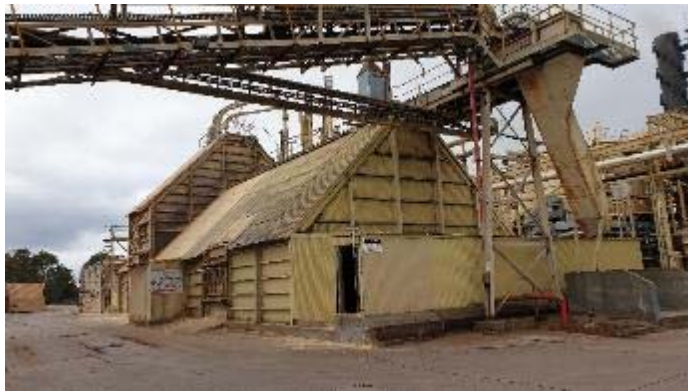
Boiler shed managed to minimise dust

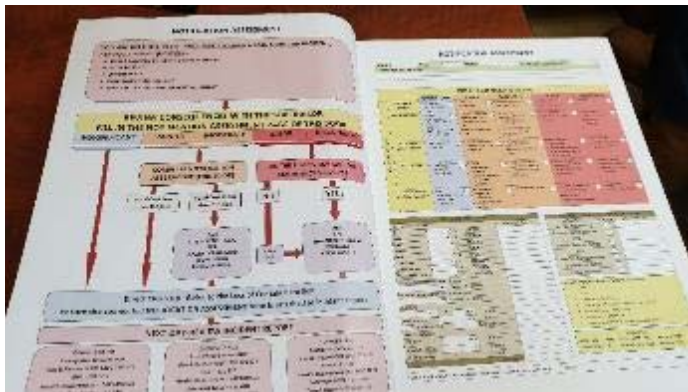
Incident notification clear and utilised.

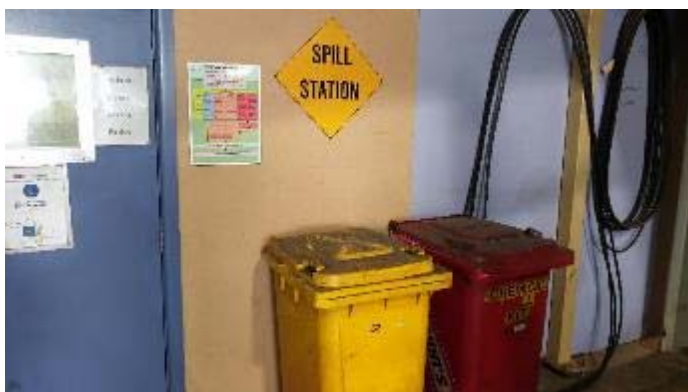
Spill response kits well maintained

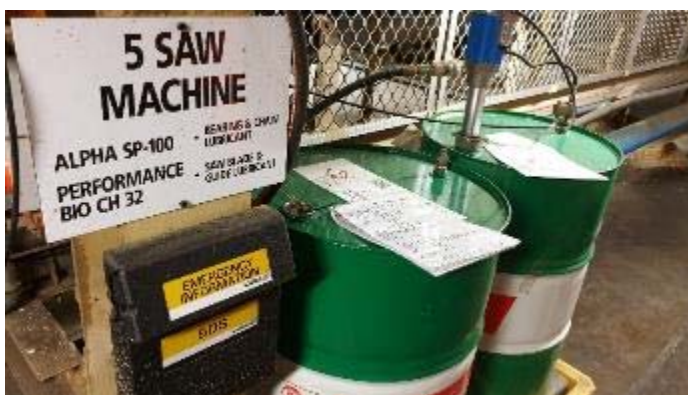
Oils and chemicals bunded with emergency information readily available.

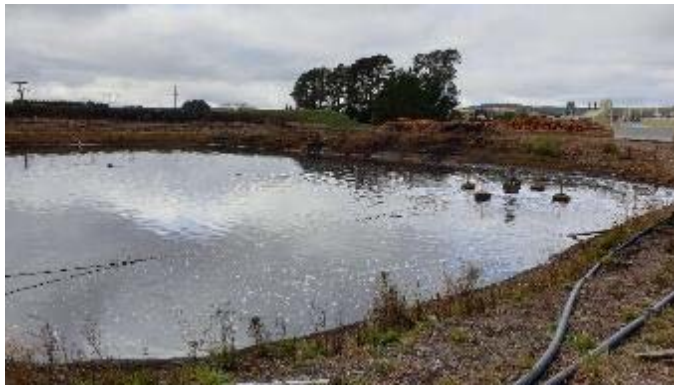
Log yard run off controlled, aerated to reduce odour and sent to Borg (neighbouring site) under contract for re-use.

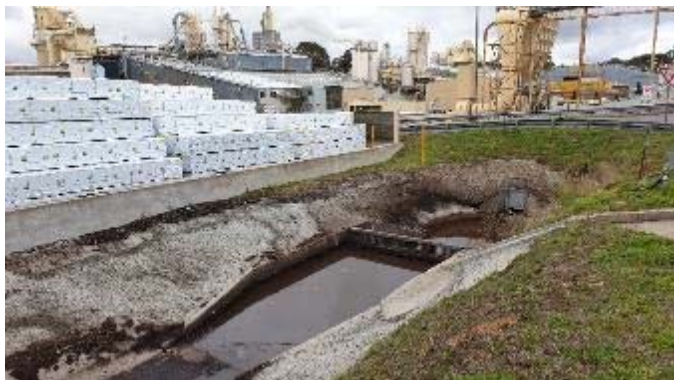
Interceptors in stormwater drains provide capability to respond to spills.

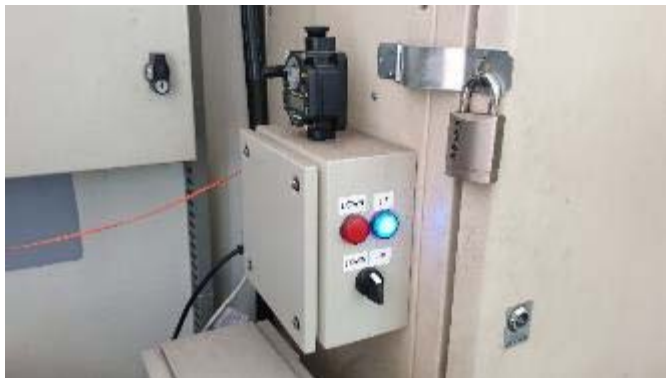
Final stormwater channel has isolation gate ability to contain spillage incidents

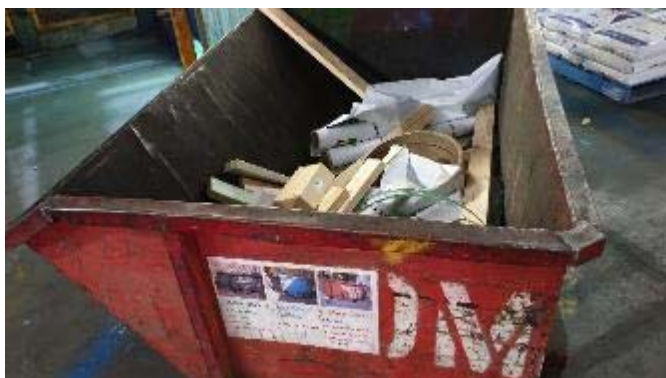
Colour coded waste bins available to facilitate correct waste management (albeit further training required).

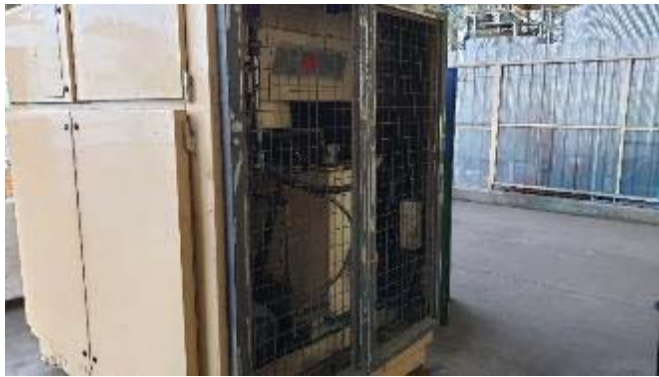
Noise enclosures progressively actioned.

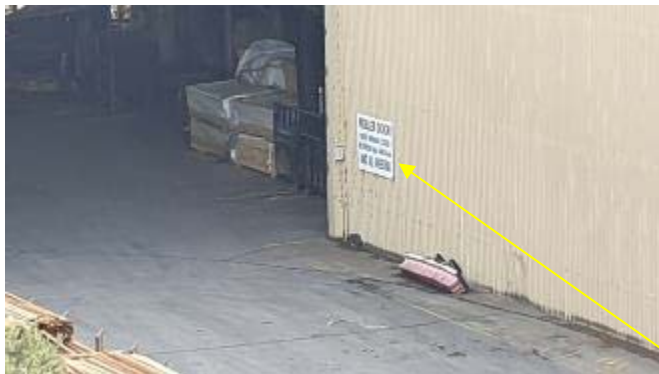
Signage on entry doors to remind operators to close during night period to minimise noise in community.

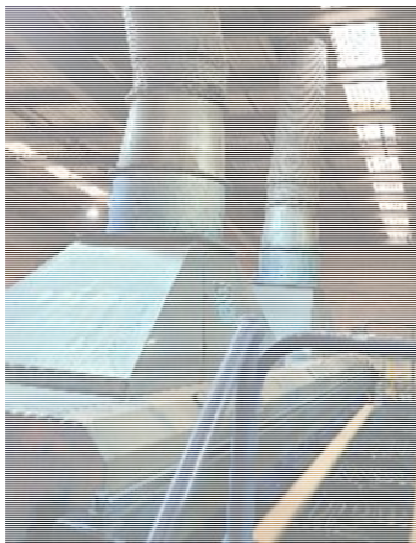
Filters on Blue frame H2 preservative application area are on preventative maintenance to avert overspray discharge.

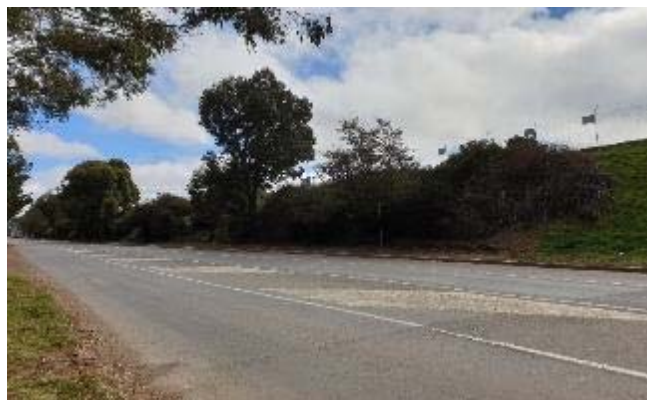
Noise wall & landscaping at south boundary. Roads regularly swept by contract sweeper to control road dust.
