Schedule 3, Condition 16 of the Dendrobium Area 3C (DA3C), Longwall 22 and 23 SMP Approval, granted 20 December 2022 which states:

Extraction of Longwall 22 commenced on 11 August 2024 and is currently being extracted.

# 1. Monitoring Results (1 June – 30th September 2025)

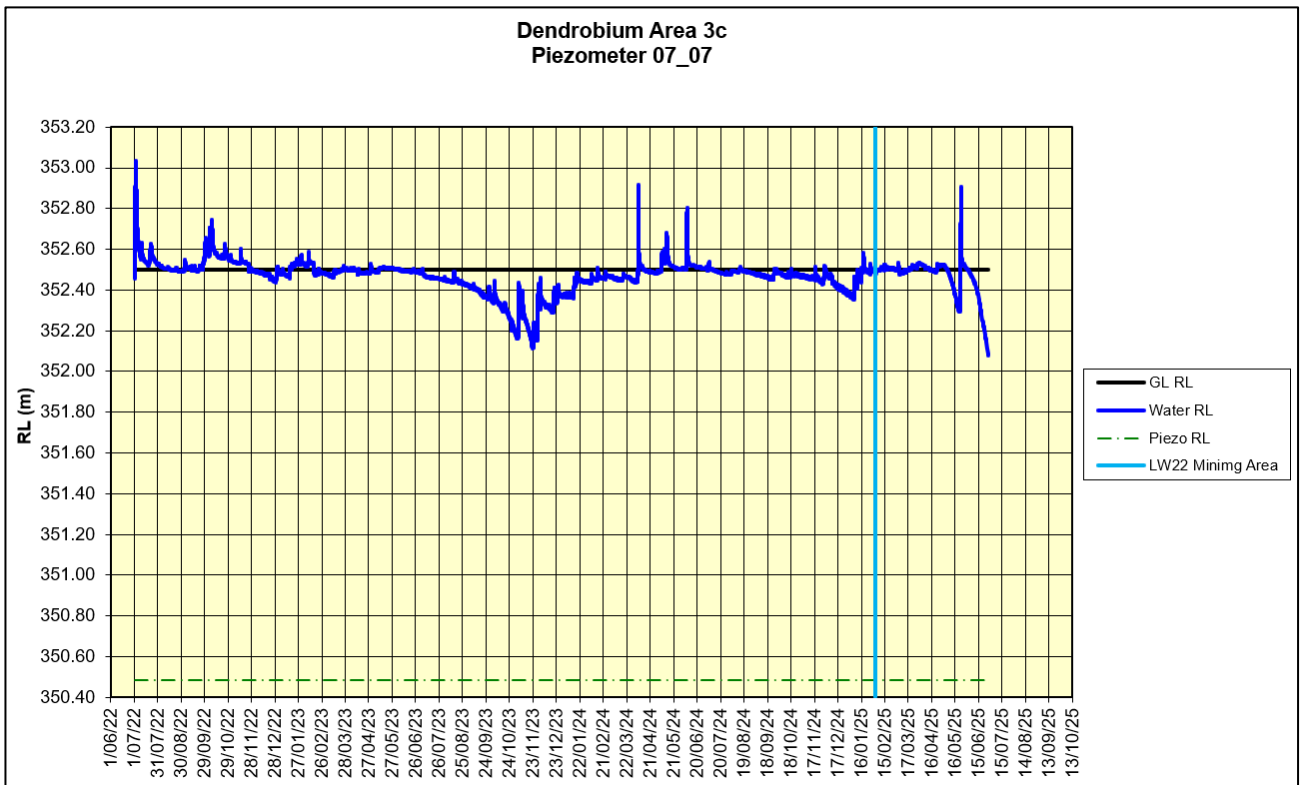
Piezometer 07\_07 is located 65m north of Longwall 22, measured at the closest point (Figure 1). Monitoring at site 07\_07 commenced in July 2022, the site entered the Longwall 22 mining area on 3 February 2025 and was outside the mining area from 16 June 2025. Recent analysis of Swamp 7 groundwater data identified that water level at the piezometer dropped below the lowest level recorded in the baseline period (Graph 1) and the rate of water level recession at the site exceeded the baseline rate by 32.1% (Graph 2). This observation constitutes a Level 2 trigger according to the Longwalls 22 and 23 SIMMCP (Table 7), specifically:

Graph 1: Groundwater records at 07\_07, logged hourly. Date range: 01/07/2022 to 27/06/2025.

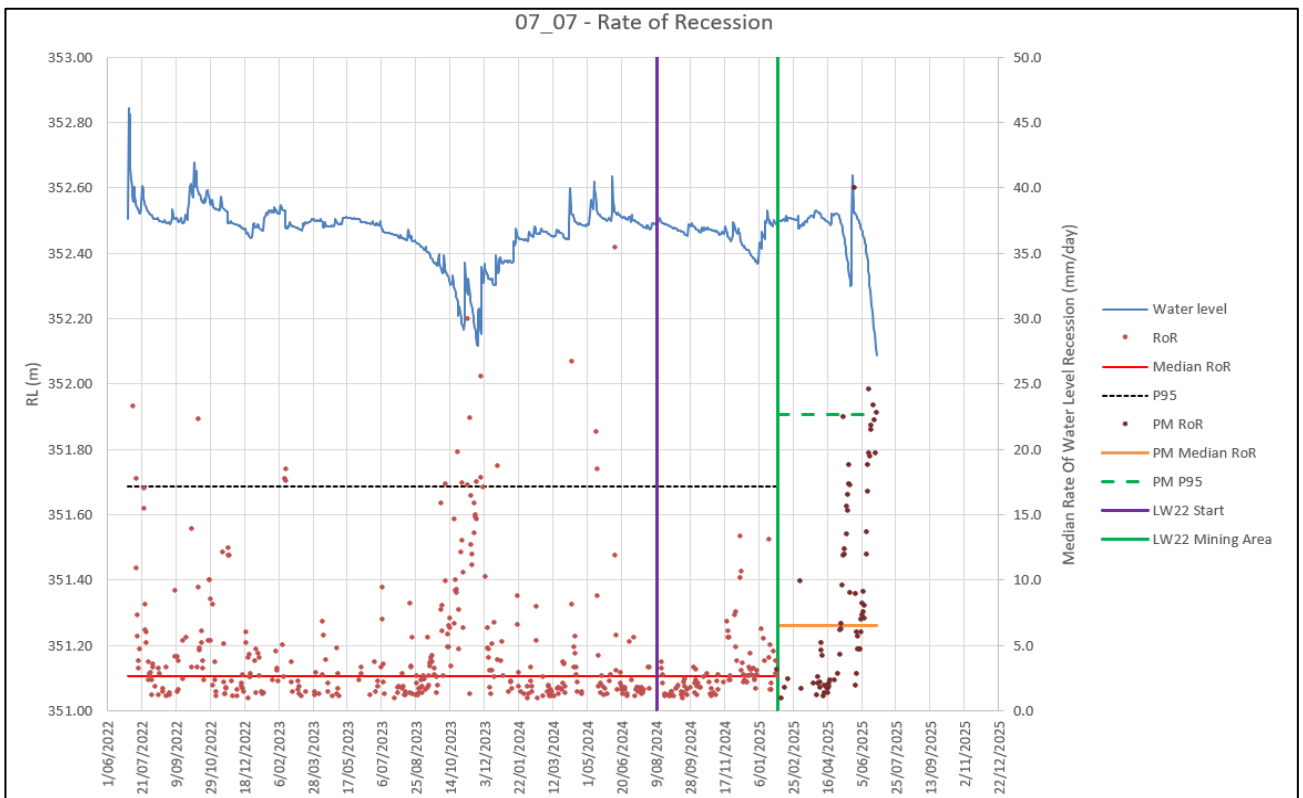
Graph 2: Rate of Recession records at 07\_07. Date range: 01/07/2022 to 27/06/2025.

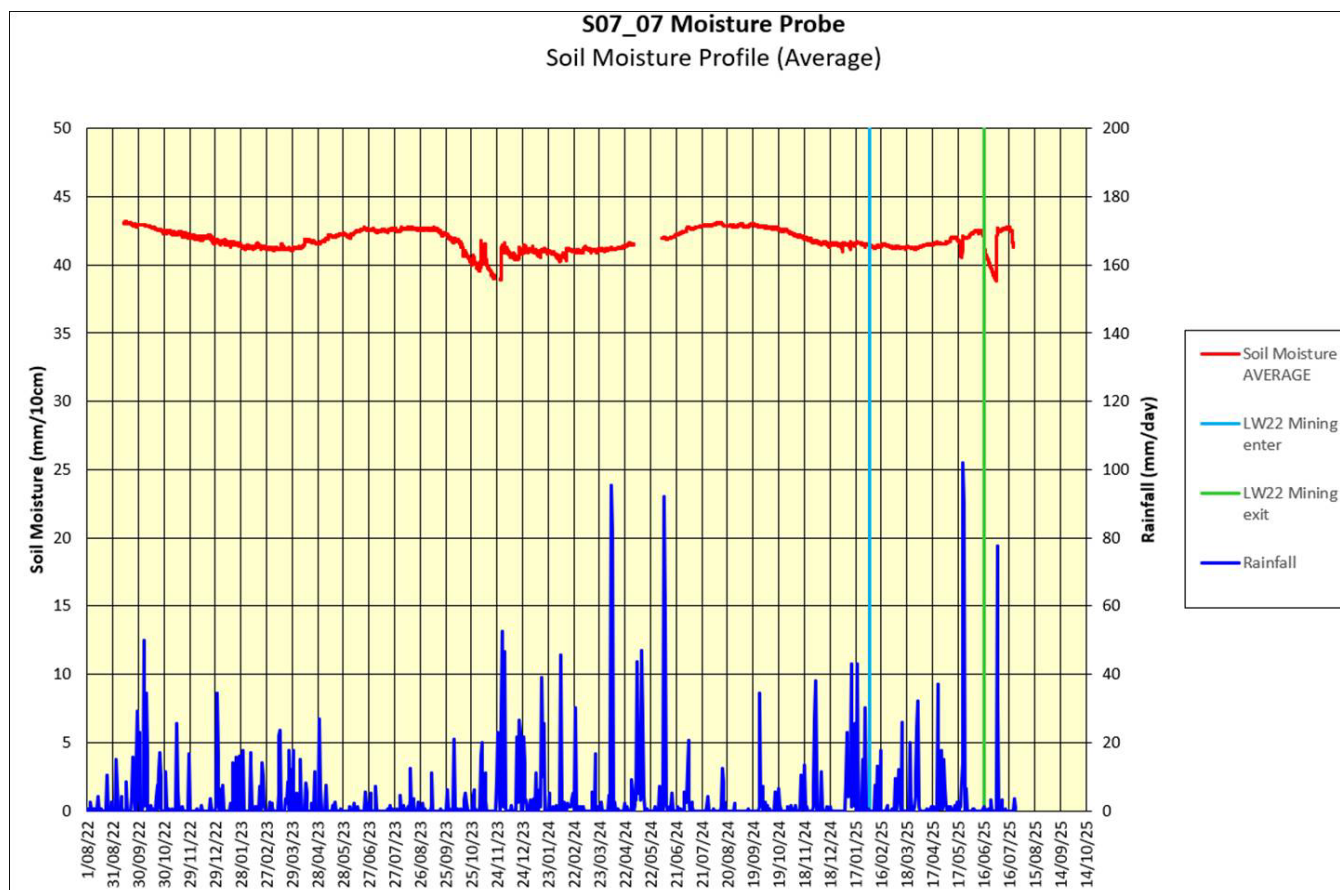
Soil moisture monitoring site S07\_07 is located approximately 70 m north of Longwall 22 and was passed by the longwall on 6 April 2025. The site entered the Longwall 22, 400m mining area on 3 February 2025 and exited the area on 16 June 2025. Recent analysis of soil moisture data identified that the average soil moisture at the site dropped below the lowest level recorded during the baseline period (Graph 3), thus contributing to Level 2 trigger as per the Longwalls 22 and 23 Swamp Impact, Monitoring, Management and Contingency Plan (SIMMCP) (Table 7), specifically:

Level 2: Groundwater or soil moisture level lower than baseline level at any monitoring site within the swamp.

The soil moisture records recovered to above the baseline lowest levels following a rainfall event on 2 and 3 July 2025.

Graph 3: Soil moisture records at S07\_07, logged hourly. Date range: 13/09/2022 to 21/07/2025.

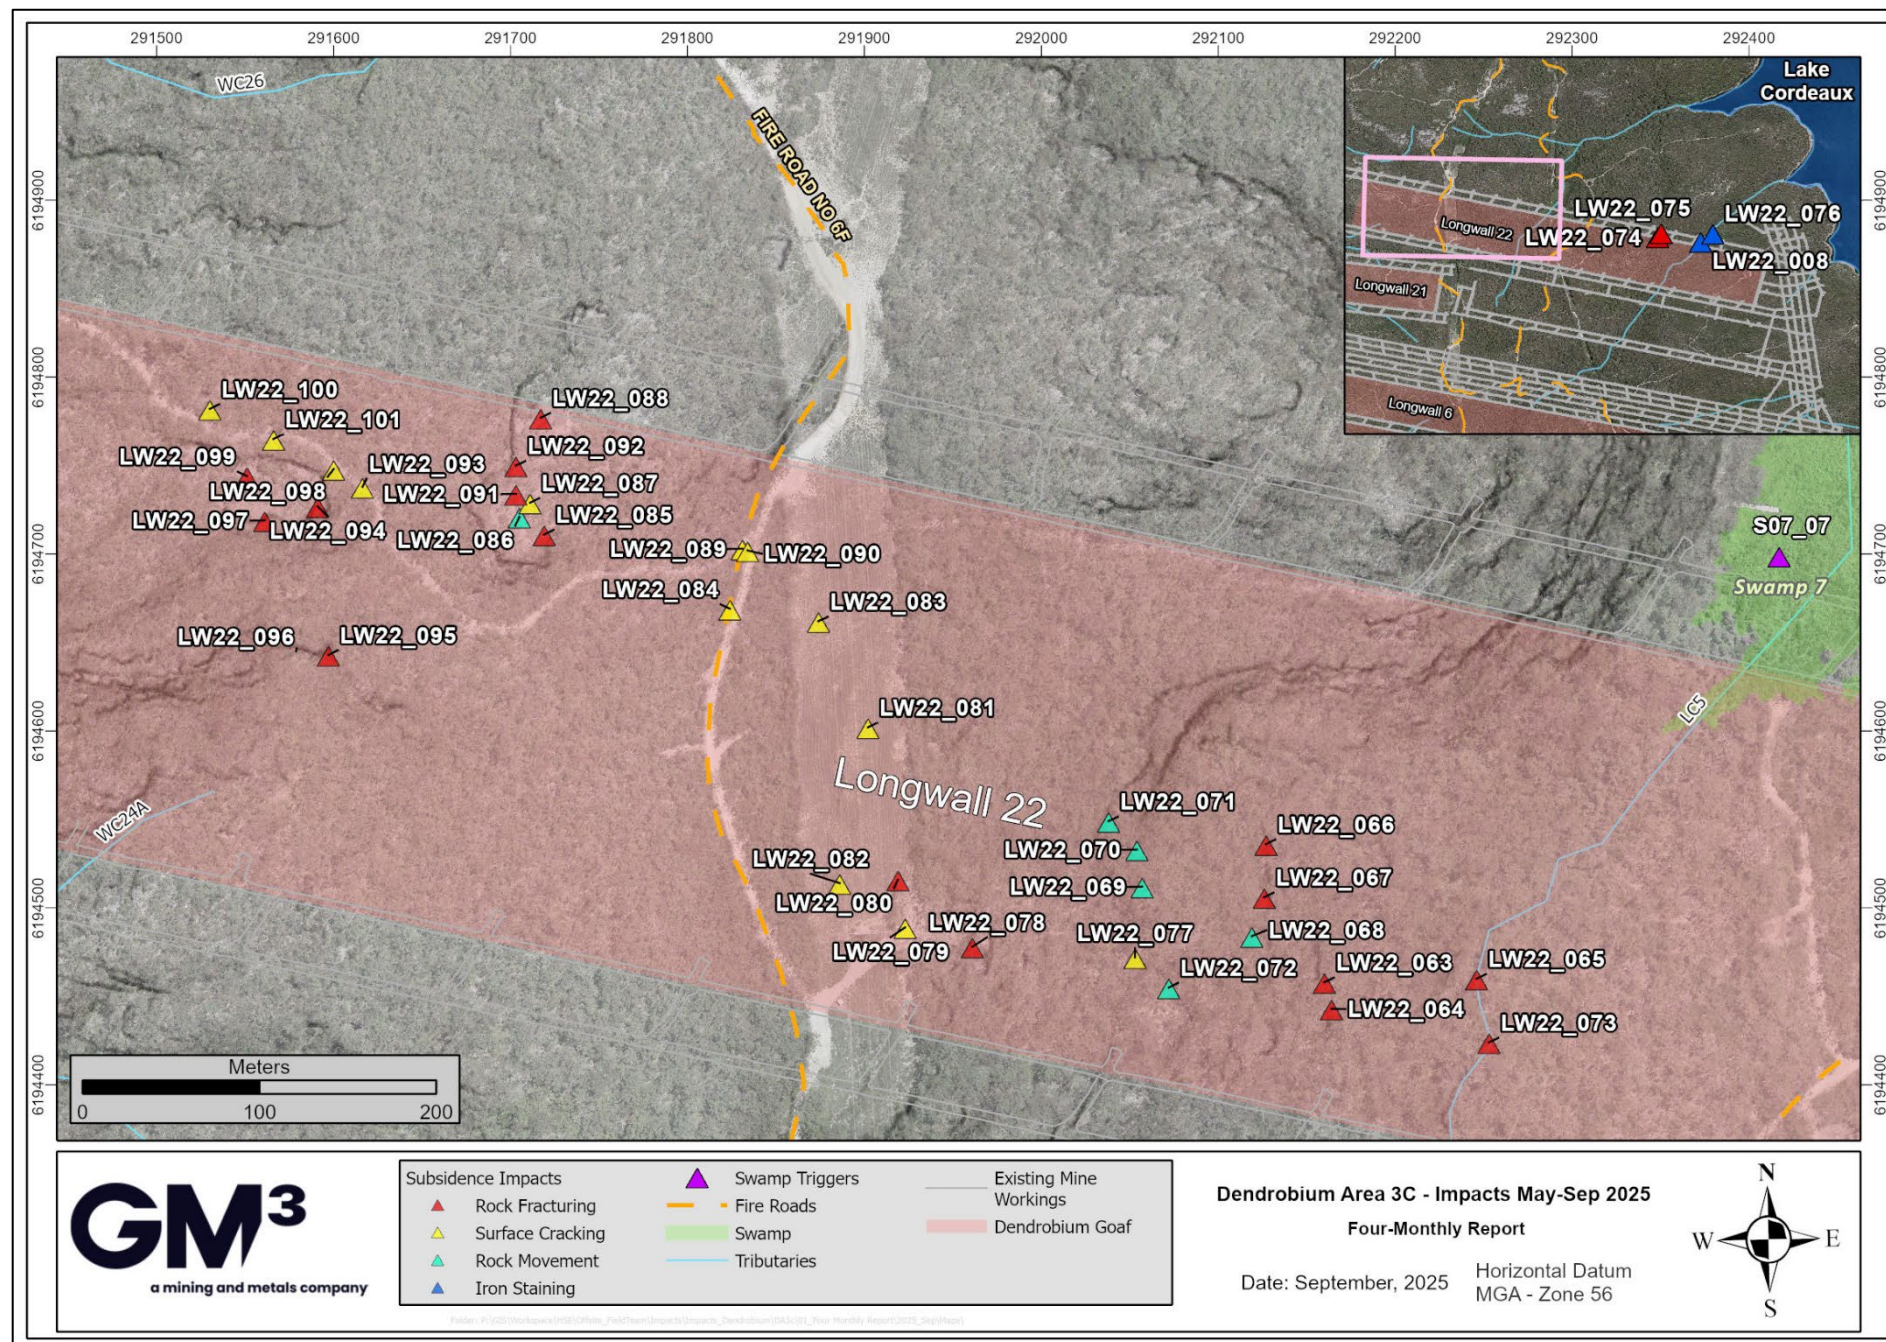
Figure 1: DA3C Longwall subsidence impacts and triggers recorded during the reporting period.

Impact *DA3C\_LW22\_063* consists of rock fracturing to a rock outcrop situated in bushland over Longwall 22 (Figure 1). The continuous and discontinuous length of rock fracturing is the same which was measured as 0.55m in length, with a maximum width of 0.01m and a maximum measurable depth of 0.125m.

Impact *DA3C\_LW22\_064* consists of rock fracturing and fragmentation to a rock outcrop situated in bushland over Longwall 22 (Figure 1). The continuous and discontinuous length of rock fracturing is the same which was measured as 1.07m in length, with a maximum width of 0.011m and a maximum measurable depth of 0.6m.

Impact *DA3C\_LW22\_065* consists of rock fracturing along LC5\_Rockbar 11, located directly above Longwall 22 (Figure 1). The continuous and discontinuous length of rock fracturing is the same

which was measured as 1.96m in length, with a maximum width of 0.01m and a maximum measurable depth of 0.135m. The fracture runs across the main flow path of the tributary, and some flow diversion was observed. Water level monitoring data from LC5\_Rockbar 11 shows a reduction in water level at the site.

Impact *DA3C\_LW22\_066* consists of rock fracturing, rock movement and soil cracking in bushland over Longwall 22 (Figure 1). The impact has a continuous length of 2.1m, a discontinuous length of 14.2m, a maximum width of 0.035m and a maximum measurable depth of 0.9m.

Impact *DA3C\_LW22\_067* consists of a rock fracture along a rock outcrop over Longwall 22 (Figure 1). The fracture transitions into soil cracking towards the middle of the fracture, before it continues to a fracture. Vertical displacement of 0.065m was displayed. The impact has a continuous and discontinuous length of 14.5m in length, a maximum width of 0.105m and a maximum measurable depth of 3.27m.

Impact *DA3C\_LW22\_084* is located on Fire Road 6F and consists of multiple soil cracks in an area of approximately 70m x 6m over Longwall 22 (Figure 1). The soil cracking has a maximum continuous length of 18.9m, a maximum width of 0.105m and a maximum measurable depth of 1.4m. There are some smaller associated cracks in the same area. The impacts do not currently impede vehicle or pedestrian access however, increased rainfall or vehicle movements could result in erosion of the soil cracks, Fire Road 6F will continue to be monitored for any changes. Traffic cones and safety signage have been erected in the area to alert oncoming traffic, and remediation of the impacts will be scheduled as soon as weather permits.
