Structural Inspection Report

Hotham House

65 Hotham Road, Kirrawee, NSW 2232

Report Number: DN190017.R2

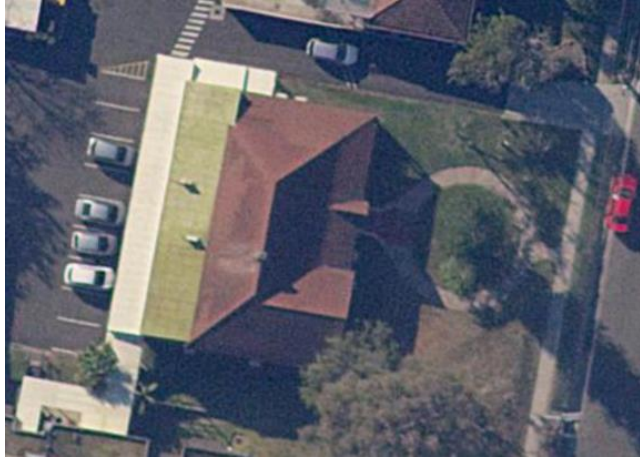
N/A
1	General view of the gymnasium roof valley	At roof valley there is excessive roof water penetration through joints in the roof sheeting	Repair/ replace sheeting, as may be required to stop timber rotting. Continue with the ongoing programmed maintenance regime	2

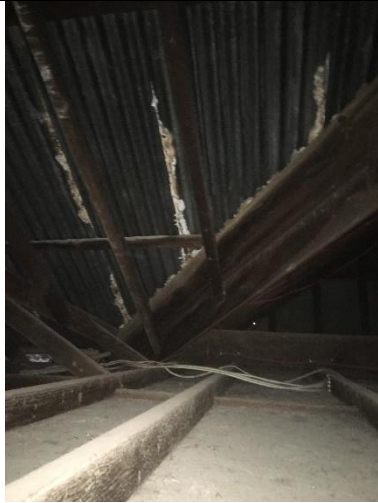
Item No.	Component	Observation Assessment	Recommended Work Upgrade	Photo No.	Photographic Observation	Condition Grade
2	General view of the gymnasium roof, ridge framework	Excessive roof water penetration through joints in roof sheeting. It appears that remedial structural repairs were undertaken to strengthen the damage timber, this critical connection is to be investigated to ensure its integrity is maintained	Repair/ replace sheeting, as may be required to stop further timber rotting. Continue with the ongoing programmed maintenance regime	3

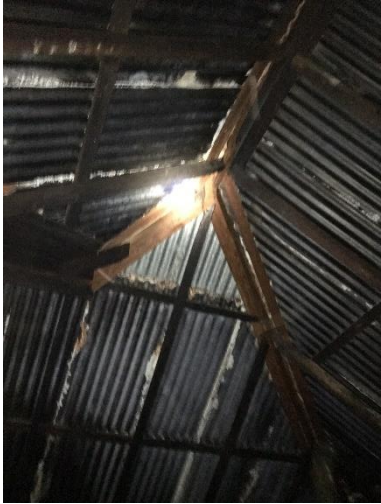
Type 2
3	General view of the gymnasium roof, ridge framework	Refer to item 2 above	Refer to item 2 above	4

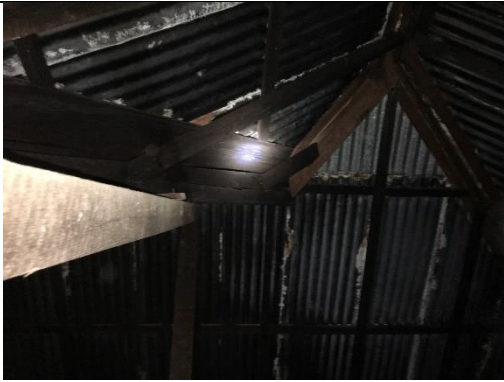
Item No.	Component	Observation Assessment	Recommended Work Upgrade	Photo No.	Photographic Observation	Condition Grade
4	General view of the damaged gymnasium roof sheeting	Excessive roof water penetration through joints in roof sheeting	Repair/ replace sheeting, as may be required to stop timber rotting. Continue with the ongoing programmed maintenance regime	5

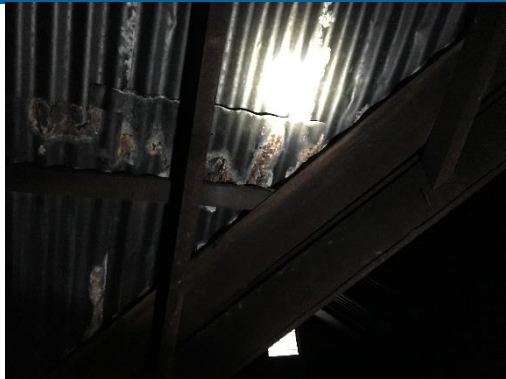
Type 2
5	General view of the gymnasium damaged condition of the roof sheeting	Refer to item 2 above	Refer to item 2 above	6

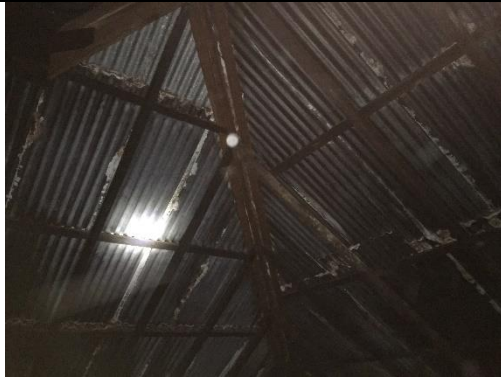
Type 2
6	General view of the gymnasium ceiling, showing the main centre post roof support	Under the post the ceiling timber support beam has deflected excessively	Ceiling timber beam will require strengthening	7

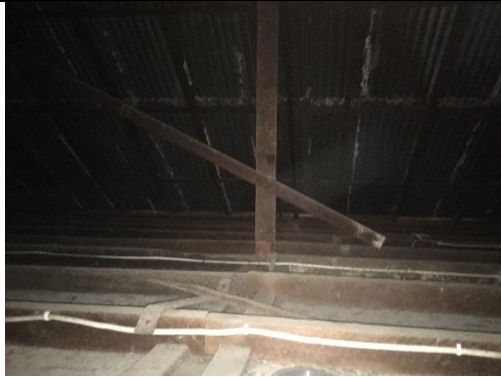
Item No.	Component	Observation Assessment	Recommended Work Upgrade	Photo No.	Photographic Observation	Condition Grade
7	Ceiling manhole to the gymnasium roof void	Detail of the removed manhole panel	A specialist company should be engaged to undertake sampling, testing for asbestos fibres	8

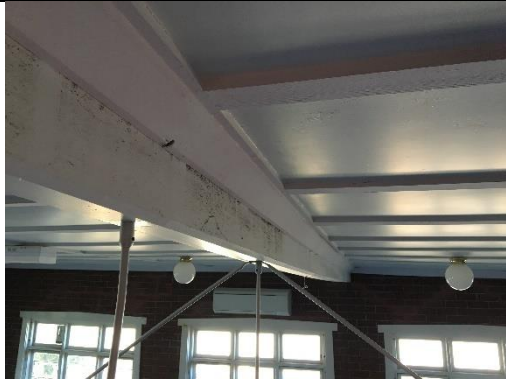
Item No.	Component	Observation Assessment	Recommended Work Upgrade	Photo No.	Photographic Observation	Condition Grade
10	Close-up view of the gymnasium ceiling construction. Strips correspond to the joints in the sheet	Ceiling is sagging	Continue with the programmed maintenance regime.	11

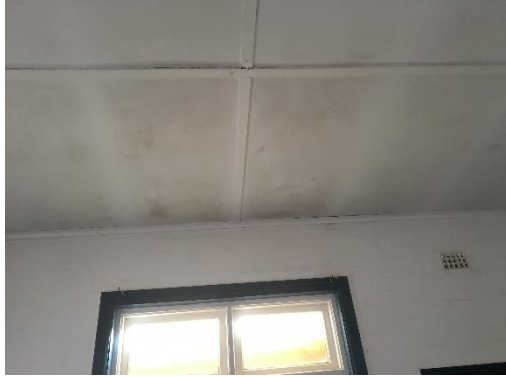
- i. There is evidence of extensive water stains at the junction of the ceiling and western wall, most likely caused by failure of the roof sheeting and/ or roof flashing in this area. *Refer to Photos 12 & 13*
- ii. It is reported that Item (i) above is well known to the occupants as the water stains keep reappearing after each general maintenance period.

Type 2
12	Ceiling to the Dirty Utility Room	Refer to item 11 above	Refer to item 11 above	13

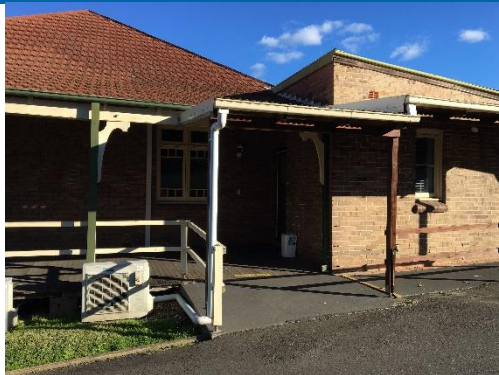
Type 2
14	View of the north-East corner of the house	The general condition of the verandah floor was not thoroughly check due to lack of clearance space.	A specialist company should be engaged to undertake a detailed condition assessment of the "Pressed Metal Roof Tiles".	15

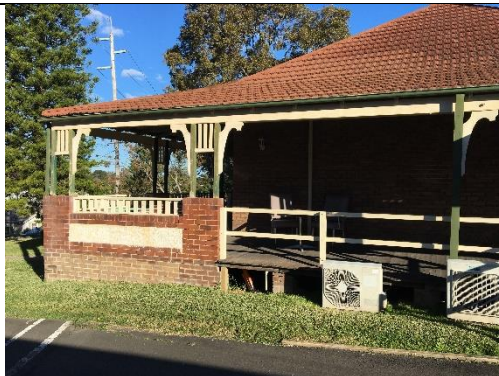
Type 2
15	View of the North-West corner of the house	Surface water runoff is generally directed towards the house.	Check effectiveness of the stepped roof flashing where abutting brickwork Review and upgrade surface site drainage system	16

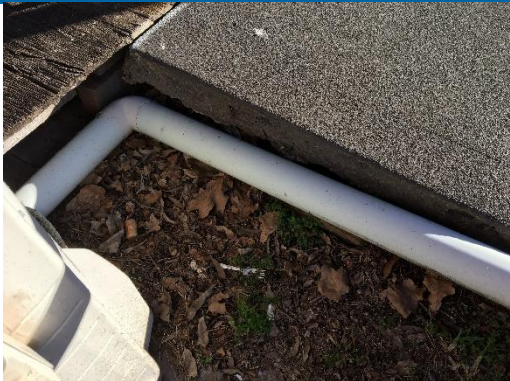
- ii. To the north, the concrete ramp that joins the existing timber verandah has moved and settled unevenly, causing a tripping hazard. Poor surface drainage provisions in this area have eroded the soil under the ramp, where soil has been washed away forming a large cavity under the ramp. *Refer to Photos 20 & 21.*

Type 2
20	Corner of the concrete access ramp	Erosion of soil and slab settling will continue to occur and eventually will become a serious trip hazard.	Refer to item 17 above	21

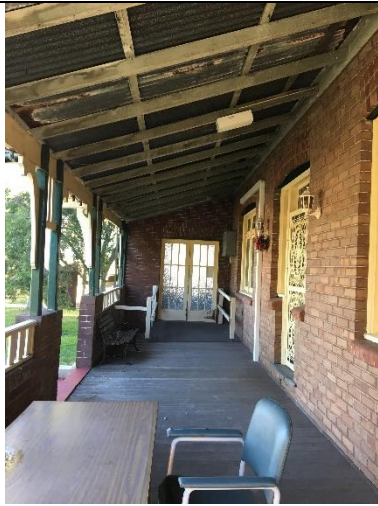
Item No.	Component	Observation Assessment	Recommended Work Upgrade	Photo No.	Photographic Observation	Condition Grade
23	The Northern wall elevation, of the house under the verandah	Roof sheeting and timber is water damaged. Remediated brick crack above the window.	Remove and replace roof sheeting and flashing as necessary and make good to resolve present roof water issues	24

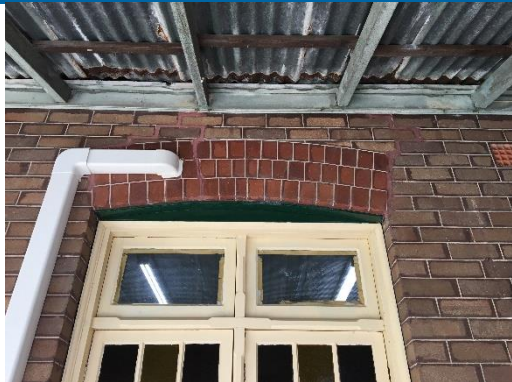
- iv. The verandah roof where it attaches to brick wall is in poor condition and needs attention and remediation. In this location the roof sheeting is severely rusted and the roof flashing is missing or not working as it should as it is affected by the severe rust causing the deterioration of the roof sheeting. The timber wall plate supporting the roof is fixed by a masonry anchor to the wall which appears severely rusted. All the anchors along this wall need to be checked to ensure they have structural capacity to deal with all imposed service loads. *Refer to Photos 24 & 25.*

Type 2
24	The Northern wall elevation, of the house under the verandah	Refer to Item 23 above.	Carefully examine all the masonry bolt fixings supporting the roof structure above for rust, treat and paint as required to maintain the structural integrity of the roof against wind uplift.	25

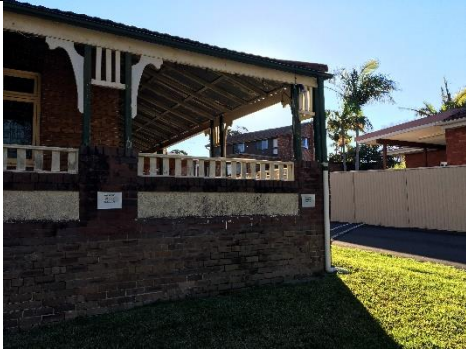
Item No.	Component	Observation Assessment	Recommended Work Upgrade	Photo No.	Photographic Observation	Condition Grade
29	View of the South-East corner of the house	Extensive brick damage remediation undertaken. Brick efflorescence an indication of raising damp, the presence of excessive ground moisture	Review and remediate the site drainage, collect and affectively connect and discharge into the existing piped drainage system	30

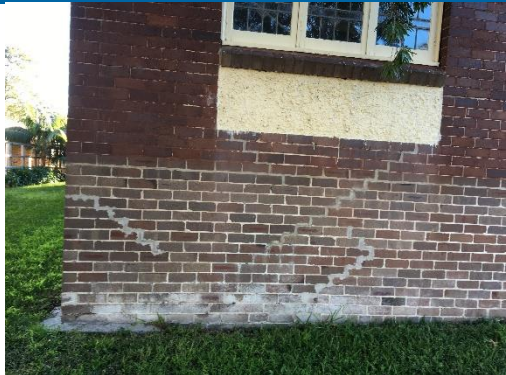
Type 2
30	View of the Eastern elevation the house	Brick efflorescence an indication of raising damp, the presence of excessive ground moisture The remains of tree root beneath the footing and movement and associated stepped brick cracking	Refer to Item 29 above	31

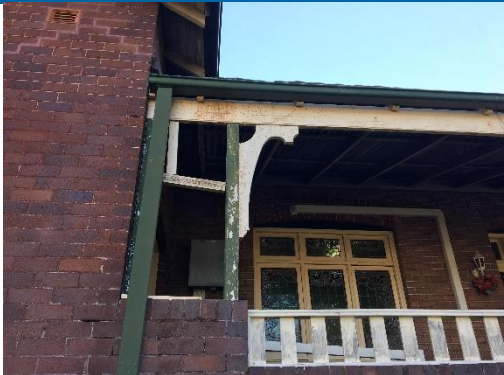
Type 2
35	Looking West, the front verandah	There is footing movement and associated stepped brick cracking. Brick cracking is in the order of < 5.0 mm. With reference to AS2870 Classification of damage with reference to walls, fall is the category of slight	Review and remediate the site drainage, collect and affectively connect and discharge into the existing piped drainage system prior to brick remediation	34

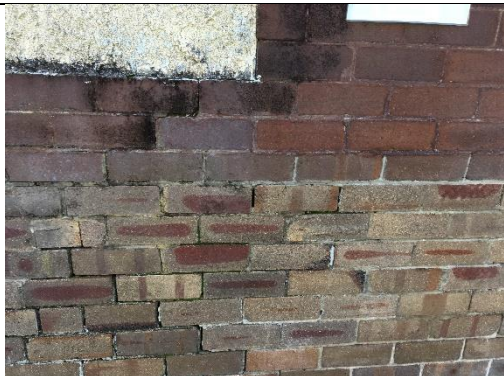
Type 2
38	View of the North-East corner of the house	Footing settlement/movement with associated stepped brick cracking	Review and remediate the site drainage, collect and affectively connect and discharge into the existing piped drainage system Check connection to DP below ground	37

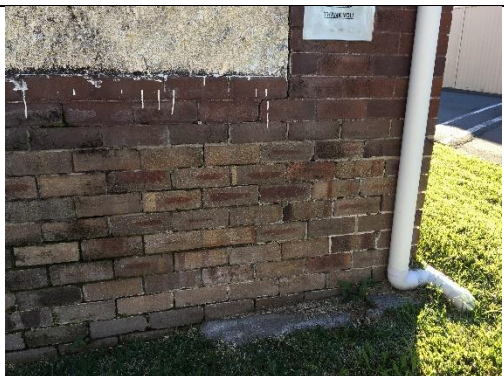
Item No.	Component	Observation Assessment	Recommended Work Upgrade	Photo No.	Photographic Observation	Condition Grade
39	View of the South-East corner of the house	<p>Extensive brick damage remediation undertaken.</p> <p>Mature tall tree located within close proximate of the damaged corner, extent of tree root system matches canopy area</p>	Investigate and consult a tree arborist and establish the need for the installation of tree root barriers to stop footing damage	38

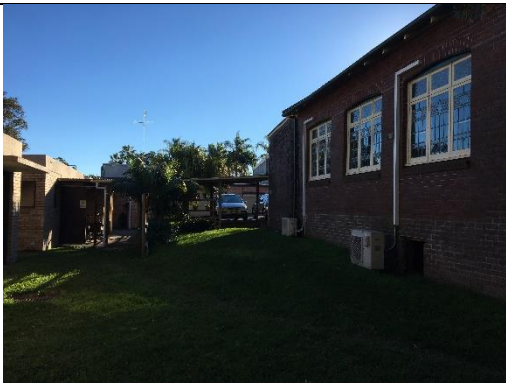
Item No.	Component	Observation Assessment	Recommended Work Upgrade	Photo No.	Photographic Observation	Condition Grade
41	South -West corner of the house	<p>The roof drainage in this location is in disrepair and not working properly.</p> <p>It appears that there is mold growth on the wall, an indication that the roof drainage problem has existed for some time</p>	Investigate the cause of the problem and make good as required, the fascia board needs replacing	40

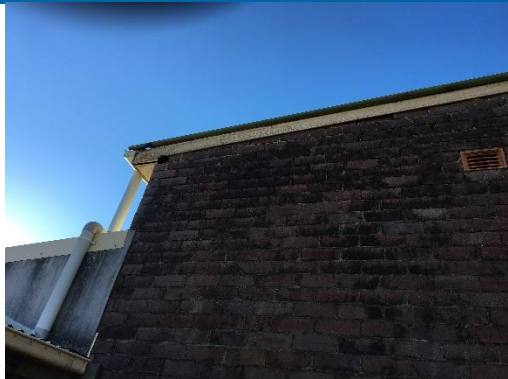
Type 2
42	Southern elevation of the house, where the gymnasium roof meets the Dirty Utility room roof	<p>Evidence that the previously brick repairs have not worked, and new stepped cracks have opened in the same location, emanating from the corner of the window.</p> <p>The steel lintel bar has rusted</p>	Review and remediate the site drainage, collect and affectively connect and discharge into the existing piped drainage system prior to brick remediation. Wire brush the lintel clean treat and paint and protect against rust	41

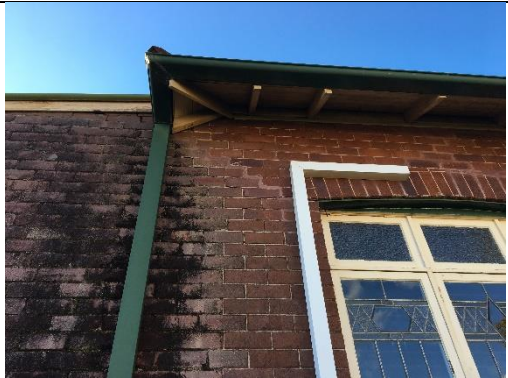
Item No.	Component	Observation Assessment	Recommended Work Upgrade	Photo No.	Photographic Observation	Condition Grade
43	Southern elevation of the house, below gymnasium window	Refer to item 42 above	Review and remediate the site drainage, collect and affectively connect and discharge into the existing piped drainage system prior to brick remediation.	42

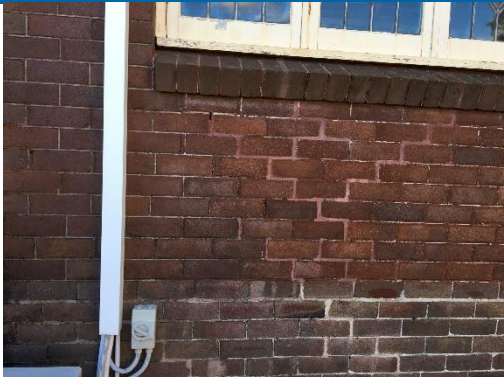
Type 2
44	Southern elevation of the house	Access manhole located below the Dirty Utility room	Check the DP's connection below the ground	43

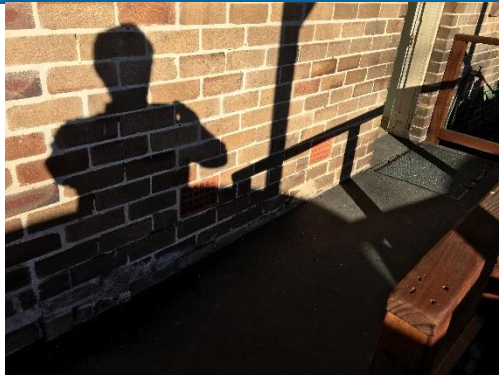
Type 2
47	Western wall, end of the access ramp	A/C Unit pipe discharge water in the garden bed	Pipe and discharge water away form house footings	46

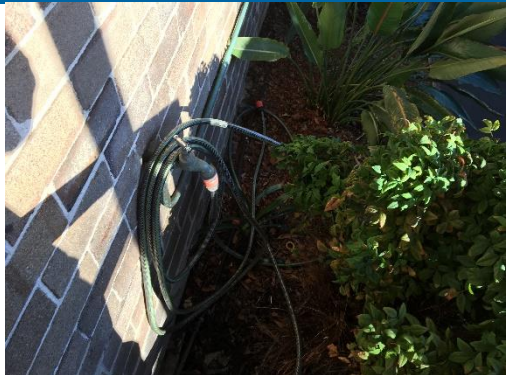
Type 2
49	Western wall	An established garden bed exists against the wall. Not recommended by good building practices.	Review the need for this garden. It is evident that in the subfloor area behind this wall the ground is saturated, disturbing the soil moisture conditions to the structural detriment of the footings	48

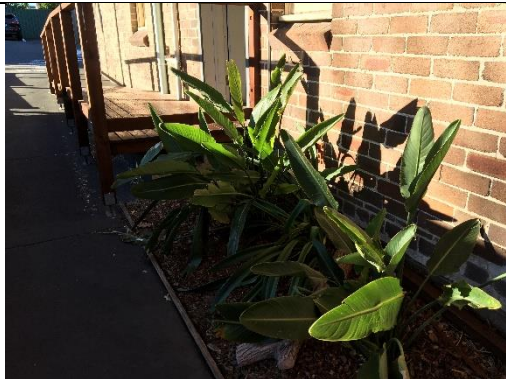
Type 2
50	Subfloor area below the raised garden bed	The brick wall is wet, and the soil is saturated.	Refer to Item 49. above	49

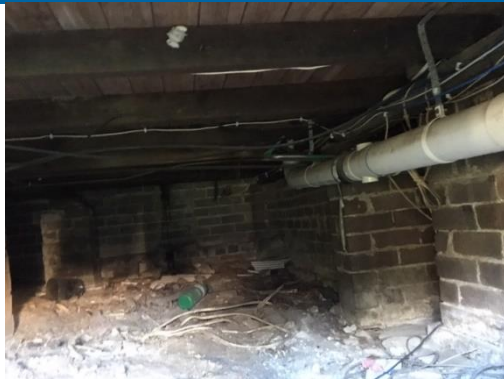
Type 2
52	Subfloor area below the South-east corner of the gymnasium floor	In times of heavy rain this portion of the subfloor area collects all the runoff from the uphill side of the property. It would mostly explain the extensive brick damage done to the corner of the house.	Review and remediate the site drainage, collect and affectively connect and discharge into the existing piped drainage system	51

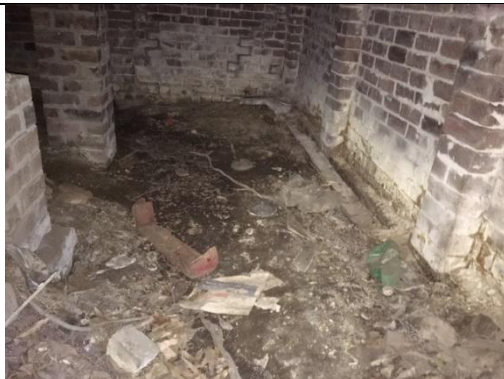
Type 2
53	Subfloor isolated brick piers supporting the gymnasium floor	Soil erosion caused by stormwater runoff under the subfloor area has caused instability to the isolated piers. Some piers are out of vertical while others have settled.	Refer to item 55 above, and thoroughly investigate the condition of all isolated piers and make good to affectively support the gymnasium timber floor	52

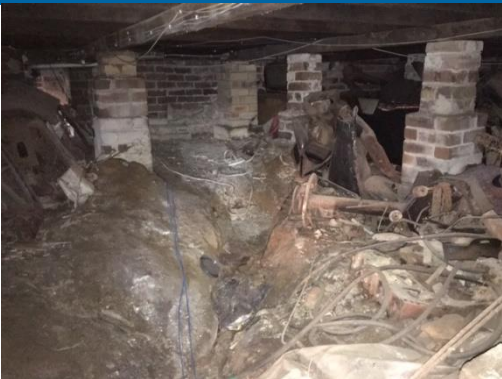
Type 1
55	Subfloor isolated brick piers supporting the gymnasium floor	General soil erosion under stormwater channel flow conditions, has caused settlement and movement to the isolated brick piers. We note that white ant capping is missing throughout the subfloor area, this is not acceptable practice.	Check all displaced isolated pier to ensure bearers are full supported, use timber hardwood wedges to fill gaps between the underside of the timber bearer and top of the brick pier. Retrofit white ant capping	54

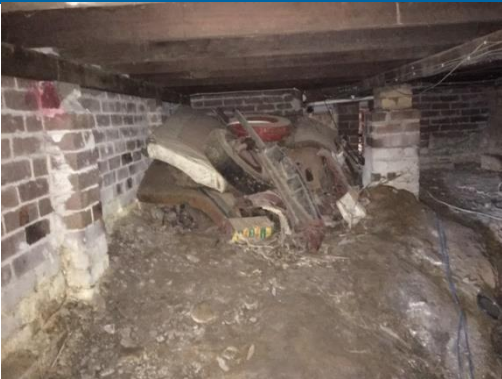
Type 2
57	Subfloor stormwater channel directs flow from under the norther office areas	There appears to be a system of stormwater channels und the house. Generally, channels sizes vary in dimension, but approximately they are in the order of 0.5 x 0.3 deep	Review and remediate the site drainage, collect and affectively connect and discharge into the existing piped drainage system	56

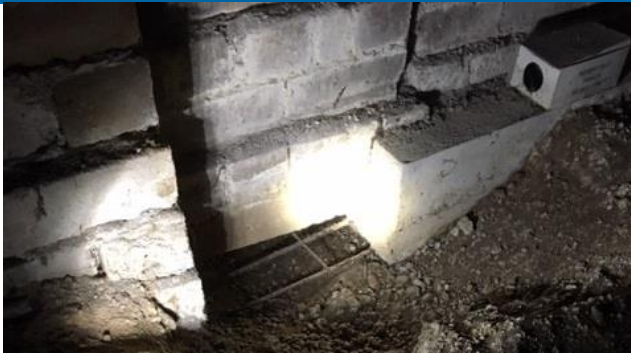
Type 3
63	Subfloor view under the office rooms	The timber floor construction appears of similar construction to the rest of the house.	Adequate cross air ventilation will not satisfy current code requirements and needs further investigation.	58
