Inspection report / Inspection: 1

Date: 31/03/2020	Asset owner's job ref.:	Project Name: 203302	Operator : CRAIG PICKUP	Section number: 1	Pipe Asset Id:
Method of inspection:	Cleaned: No	Criticality:

Suburb: KIRRAWEE	Purpose: Structural Condition Inspection	U/S MH: A
Street: BIDURGAL	Asset Owner:	D/S MH: B
Site:	dvd no.:	Section length : 99.66 m
Location type: Light road	Cleaned No	Survey Dir : downstream
Shape Of Pipe : Circular	Width :	
Use of pipe: Drain	Dia/Height: 1200 mm	
Type of pipe: Stormwater	Depth: 0	
Weather: Dry	Pipe Material: Reinforced concrete

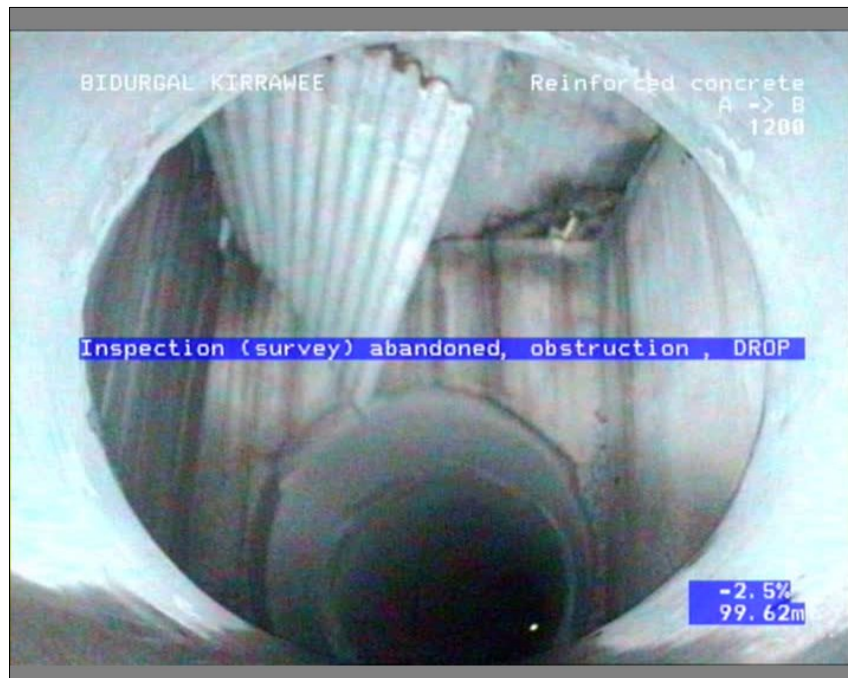
Photo: 1_1_7_A.JPG, Media No.: 20A BIDU_0, 00:08:08 99.66m,
Inspection (survey) abandoned, obstruction , DROP / DROP
