CUSTOMER JOB NO. 203302 - 3911 - Sean Ramsay CCTV - Tractor Cam

Project Name Option 2 - CCTV, Locate & Survey
 from Bidurgal Lane

Date Created 27/03/2020

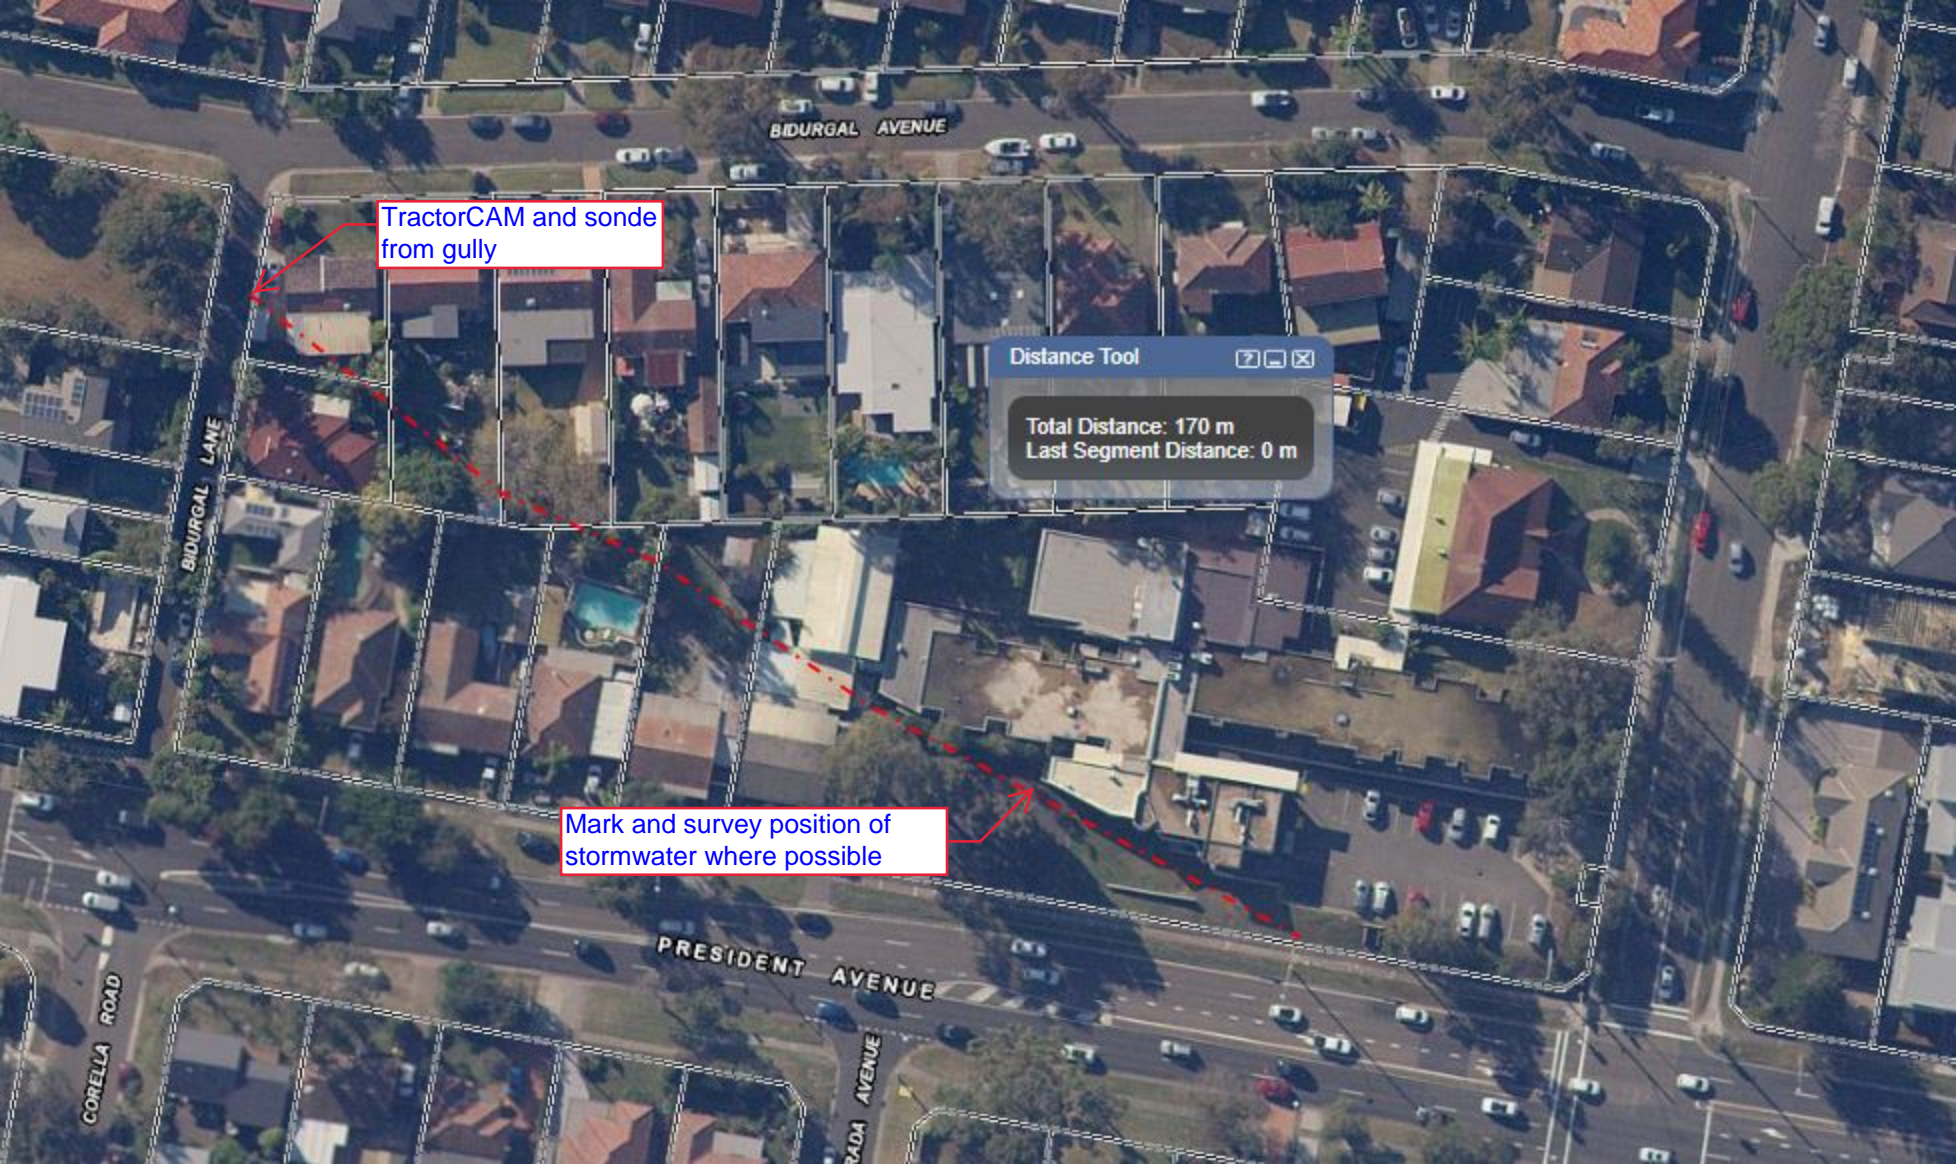
Craig got as far as chamber outside of outpatient building/cafe, copped fumes from exhaust or such and didn't feel safe. Change of direction to left 63m from lane, pipe changes size 75m from lane to approx 900mm. Change of direction to right at chamber, 85m from lane pipe changes to approx 1050mm to next pit, unable to get passed drop into chamber. Light visible at end of pipe seen in chamber

TractorCAM and sonde
from gully

Total Distance: 170 m
Last Segment Distance: 0 m

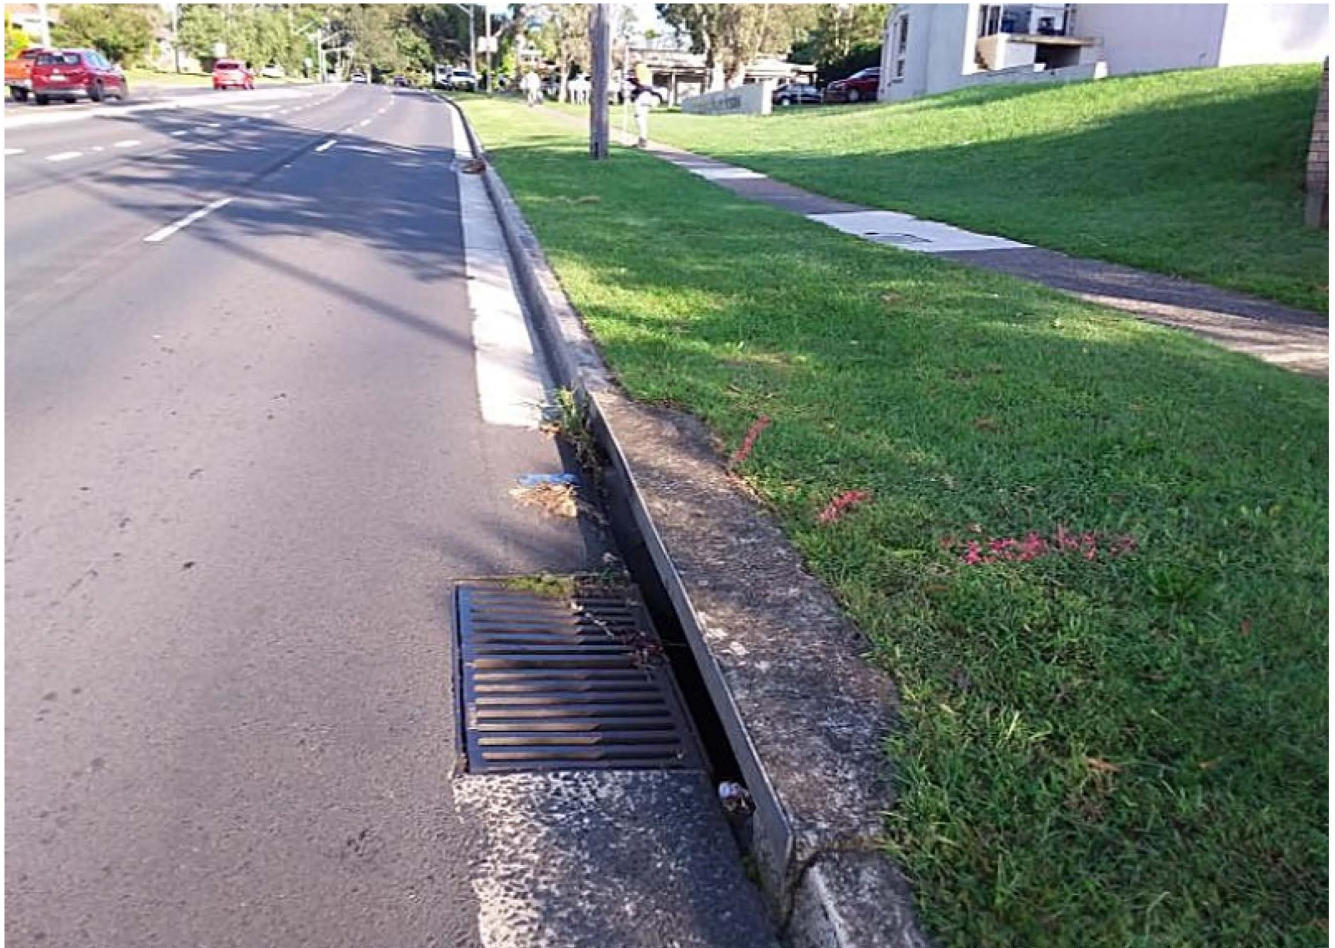
Pit in President Av, 2040mm invert from grate, appears to run straight to pit near cafe

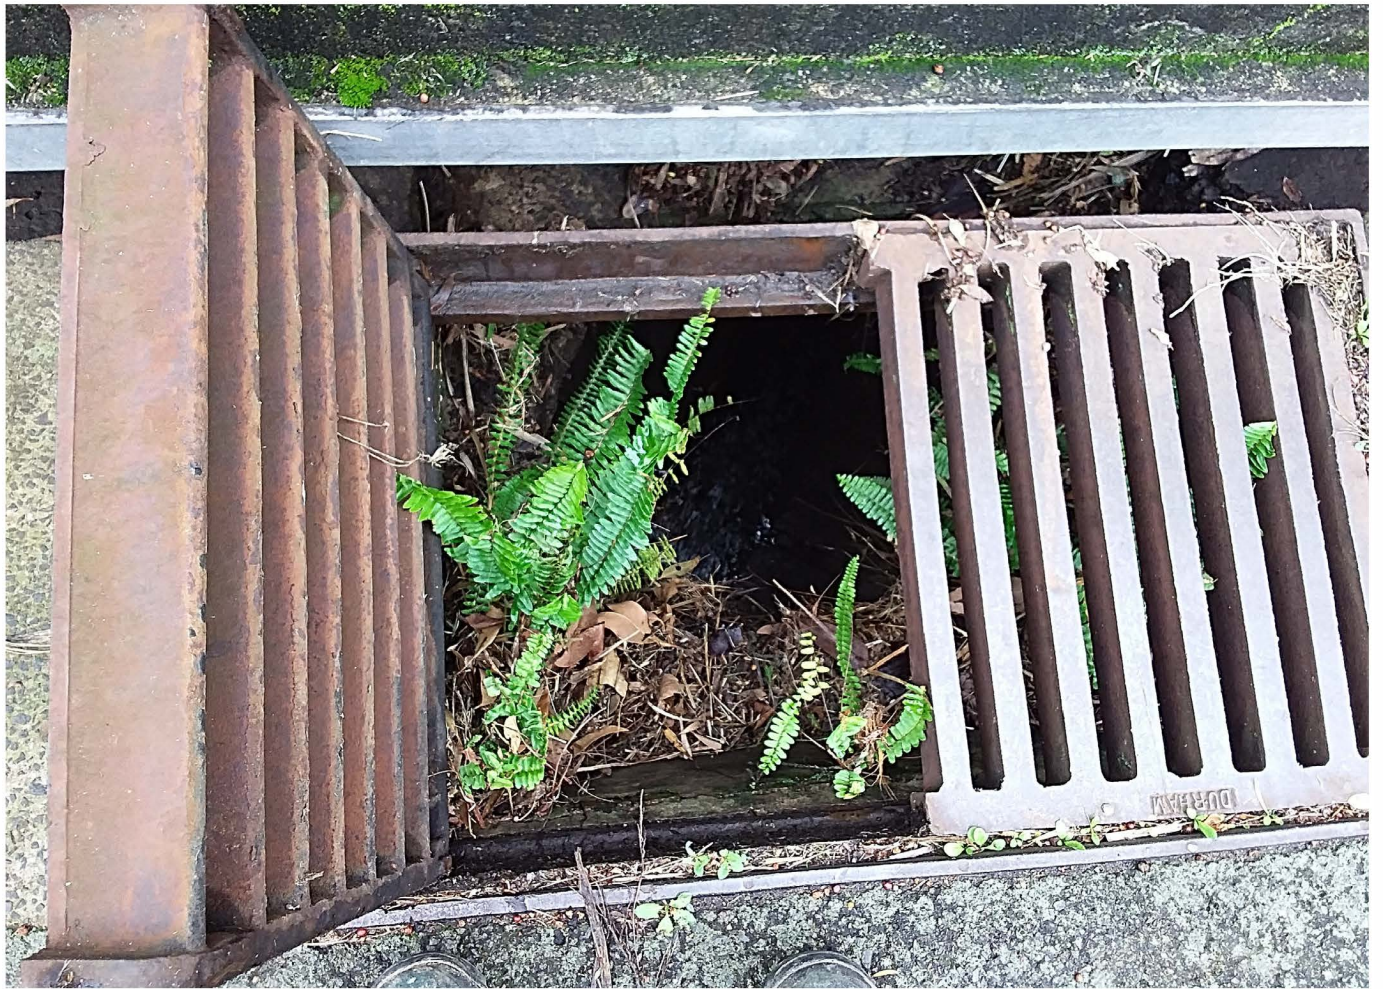
Pit in Biduragal Lane, 1740mm invert
