Health Infrastructure
NMH Health Infrastructure
Part Lot 401
Site Investigation

September 2019

Table 5-1 Part Lot 401 site inspection observations and photographic log

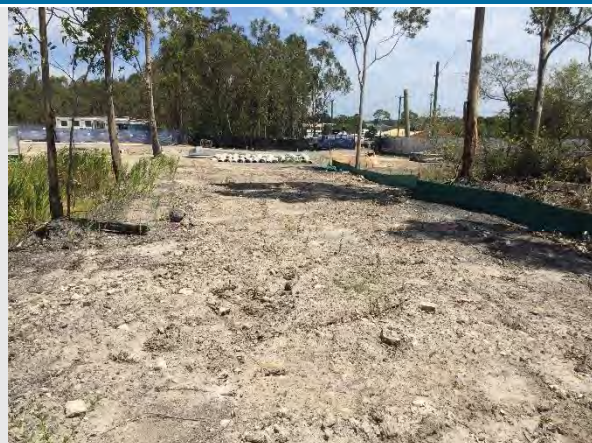
Photograph 1 Western corner of Part Lot 401, access track to Metford Road gate (for access to Lot 7314). Reed-lined channel on left (east of access track). View southwest.

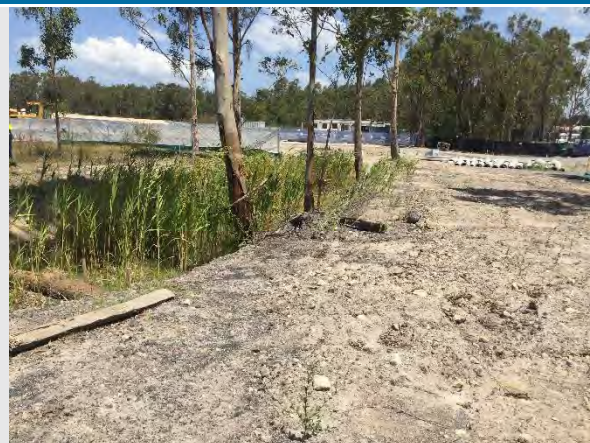
Photograph 2 Reed-lined channel east of the access track. Lot 7314 site compound in background. View south.

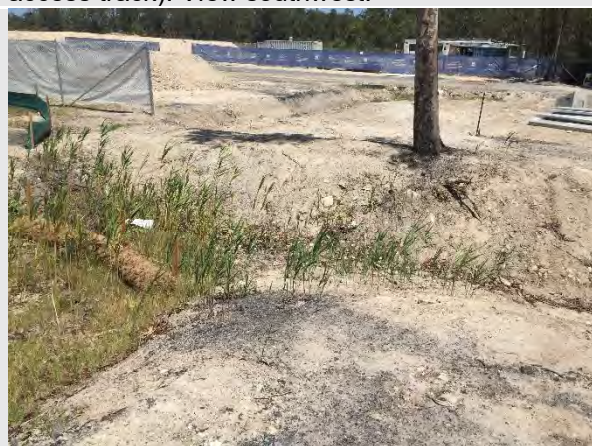
Photograph 3 Southern end of the reed-lined channel, continuing into (downgradient) unlined channel [now grass lined]. Lot 7314 site compound in background. View south.

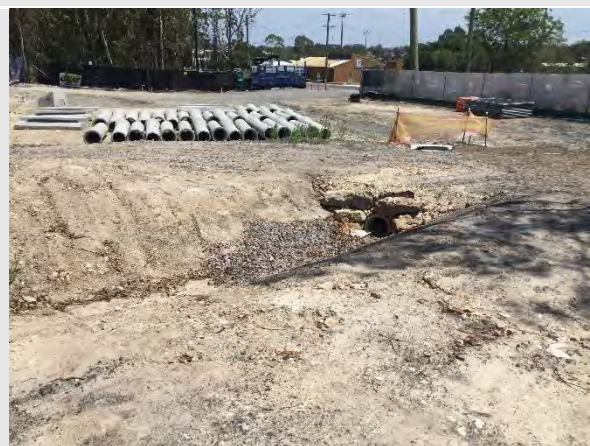
Photograph 4 Unlined channel [now grass lined] and concrete pipe culvert under access track. Metford Road gate in background. View southwest.

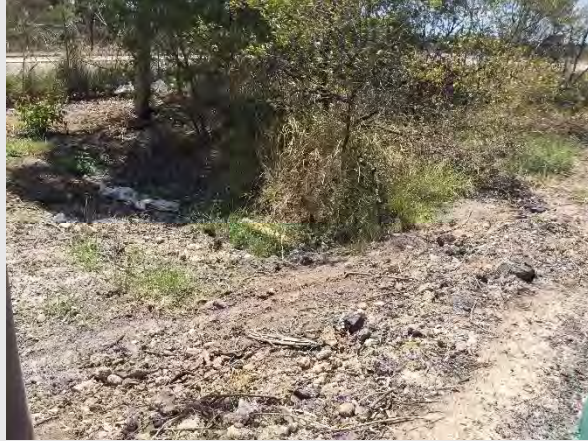
Photograph 5 Plastic pipe culvert under access track, small collection area to west of access track. View north.

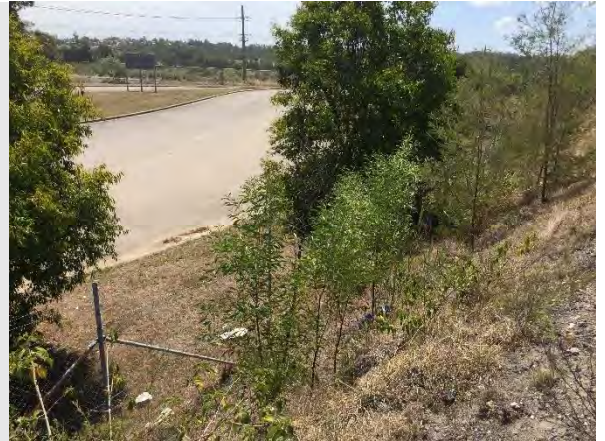
Photograph 6 Former CSR access road, now main access to Lot 401 (northern corner), viewed from the fill mound/berm in northern corner of Part Lot 401 (berm continues northeast along northwestern boundary of Lot 401) [berm no longer present]. View north.

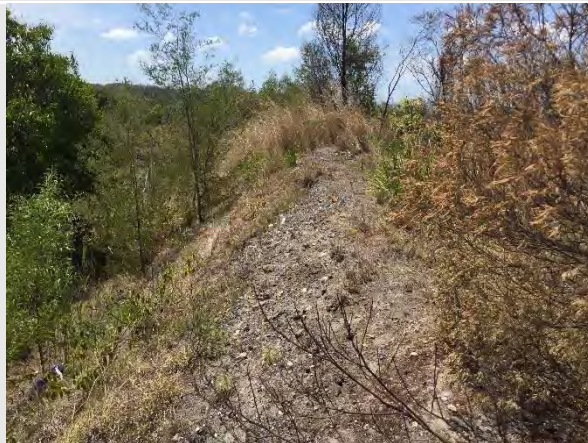
Photograph 7 Fill mound/berm running along northwestern boundary of Lot 401 [no longer present]. Surface predominantly soil with brick fragments. View northeast.

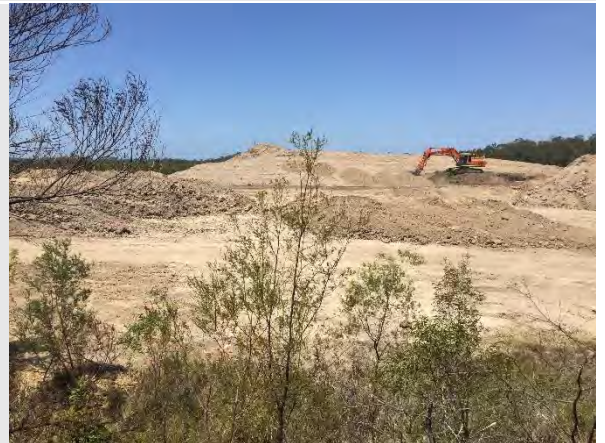
Photograph 8 Central portion of Part Lot 401 viewed from the fill mound/berm [no longer present]. Various stockpiles from Lot 401 remediation, predominantly fill material awaiting screening [no longer present]. View southeast.

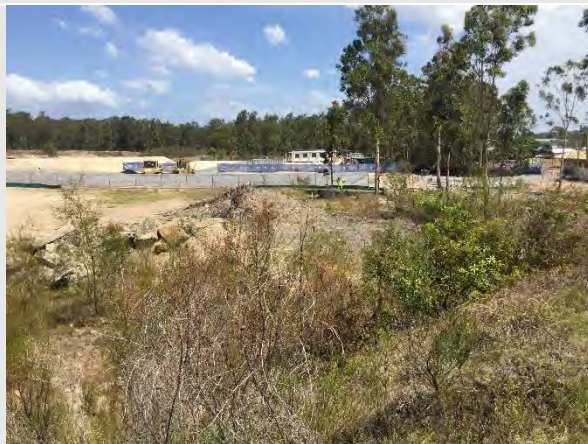
Photograph 9 Western portion of Part Lot 401 viewed from the fill mound/berm [no longer present]. Various waste stockpiles, including vegetation (from clearing), soil and concrete [no longer present]. Lot 7314 site compound in background. View southwest.

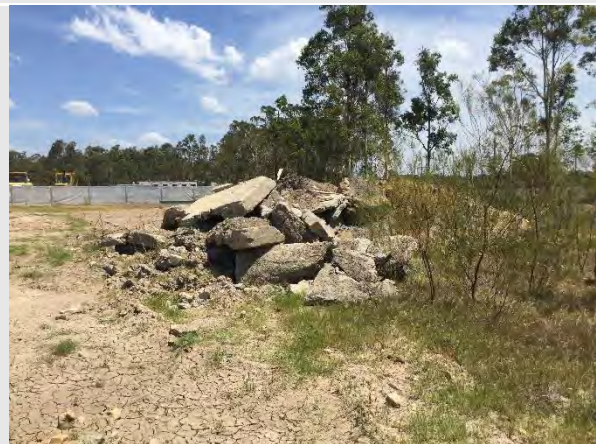
Photograph 10 Concrete waste stockpile in western portion (northern corner) of Part Lot 401 [no longer present]. View southwest.

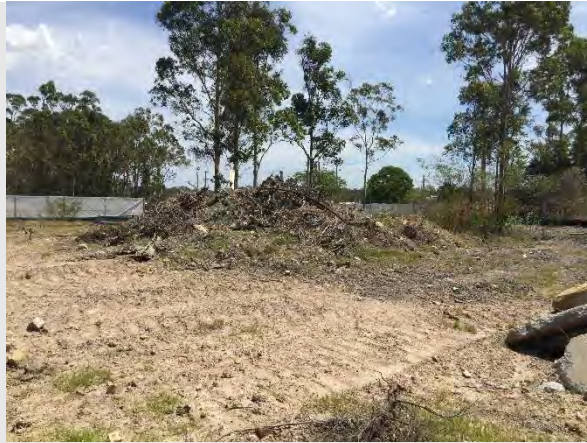
Photograph 11 Soil and vegetation waste stockpiles in western portion of Part Lot 401 **[no longer present]**. View west.

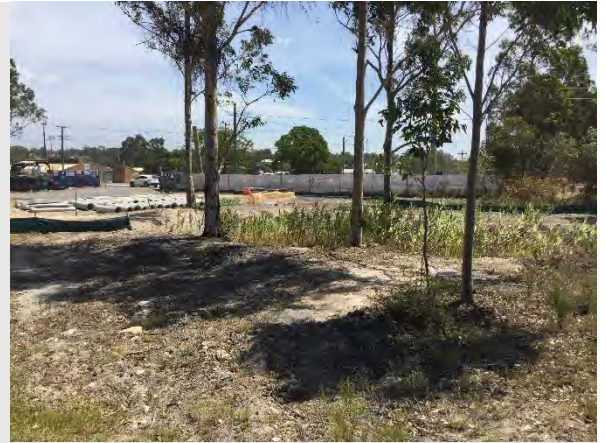
Photograph 12 Reed-lined channel and access track. Metford Road gate in background. View west.

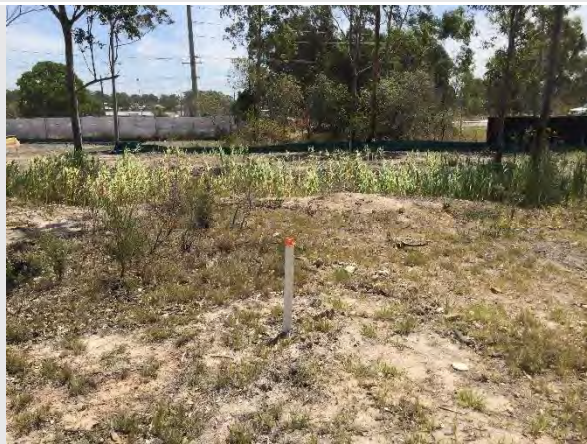
Photograph 13 Groundwater monitoring well MW62 (see DLA Figure 1 “Groundwater Monitoring Well Locations” 10/12/2015), adjacent (east of) the reed-lined channel. View west.

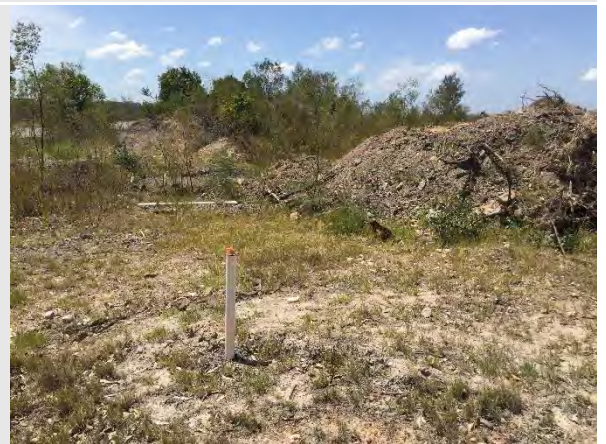
Photograph 14 MW62. Soil and vegetation waste stockpiles **[no longer present]**. Fill mound/berm in background **[no longer present]**. View north.

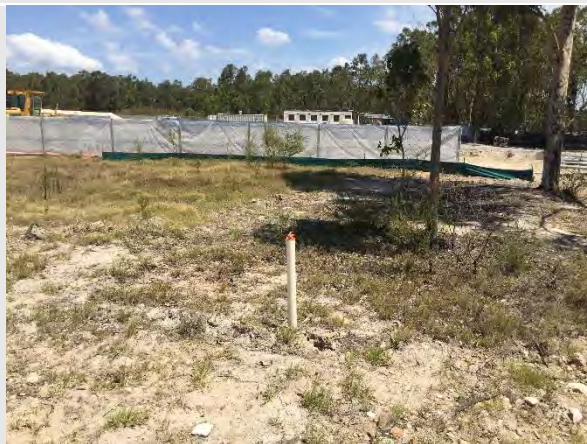
Photograph 15 MW62. Reed-lined channel to right of frame. Security fence along southwest boundary of Part Lot 401 and northeastern boundary (western portion) of Lot 7314. Lot 7314 site compound in background. View southwest.

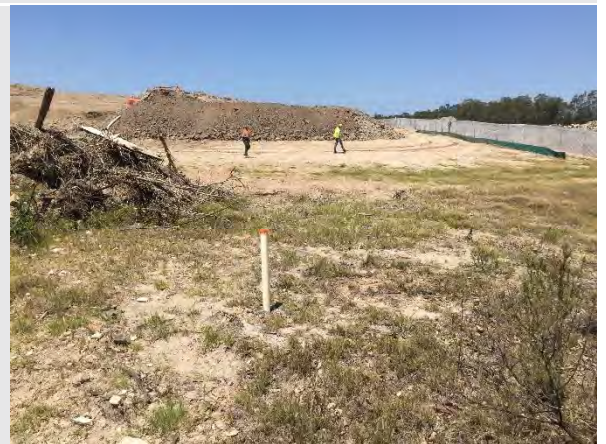
Photograph 16 MW62. Waste soil and vegetation stockpiles on left **[no longer present]**, fill material stockpiles from Lot 401 remediation in background **[no longer present]**. Security fence continuing along southwest boundary of Part Lot 401 and northeastern boundary (western portion) of Lot 7314. View southeast.

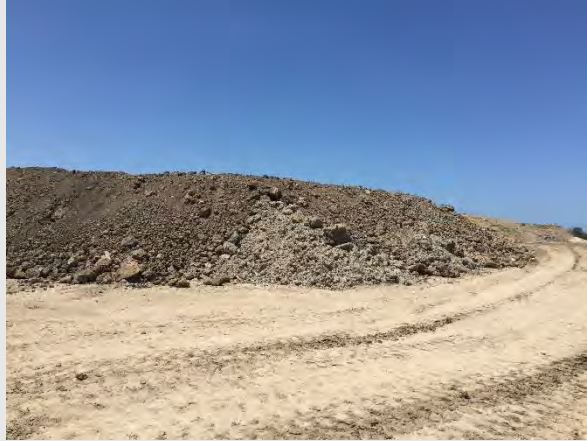
Photograph 17 Fill material stockpile from Lot 401 remediation **[no longer present]**. View southeast.

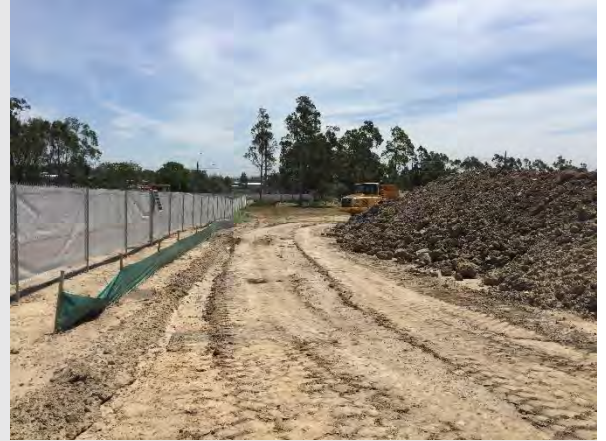
Photograph 18 Southwestern boundary (fence) of Part Lot 401. Fill material stockpiles from Lot 401 remediation on right **[no longer present]**. Metford Road in background. View northeast.

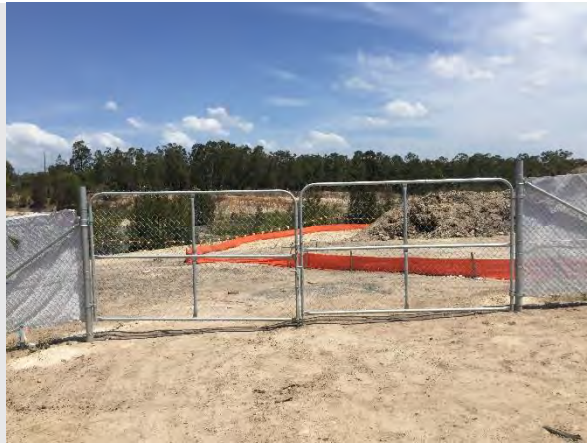
Photograph 19 'Top gate' in boundary fence between Part Lot 401 and Lot 7314. Soil and vegetation waste stockpile (from clearing) on Lot 7314 in background **[no longer present]**.

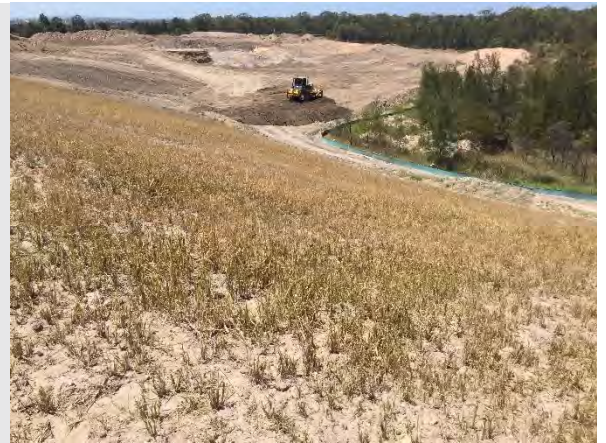
Photograph 20 Embankment in eastern portion of Part Lot 401, recently excavated to rock, top-soiled and seeded **[now well established]**. View northeast.

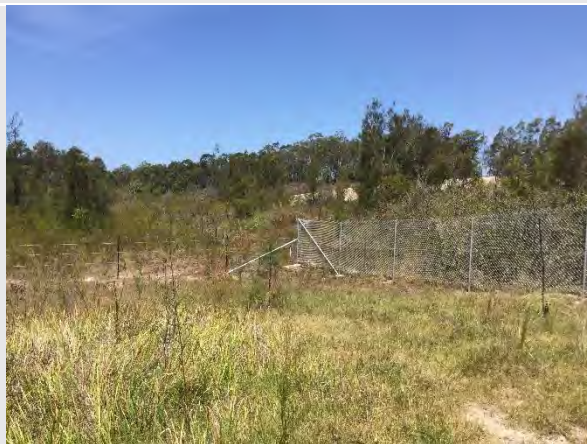
Photograph 21 Southern corner of Part Lot 401. Extent of security fence along the southwestern boundary of Part Lot 401. Continues to northeast as post-wire fence **[now security fence]**. View south (into Lot 7314).

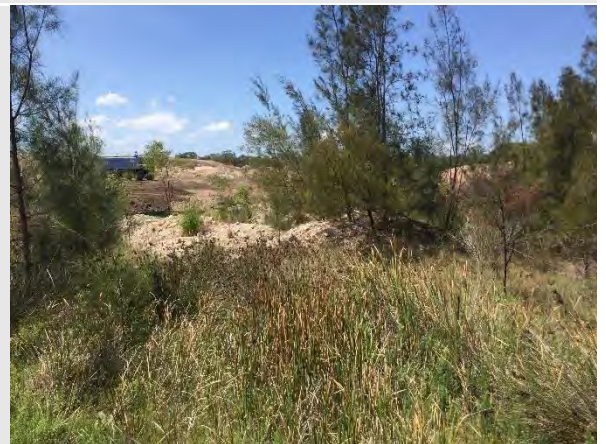
Photograph 22 Fill stockpiles in eastern portion of Part Lot 401, believed to be from previous site works (not specifically associated with Lot 401 remediation) **[no longer present]**. View northeast.

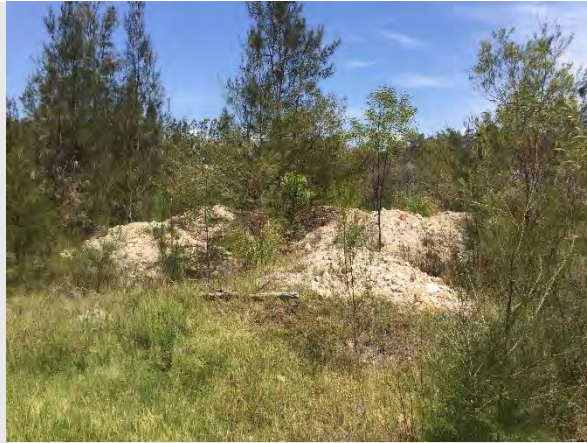
Photograph 23 Fill stockpiles in eastern portion of Part Lot 401 **[no longer present]**. Lot 7314 in background. View southeast.

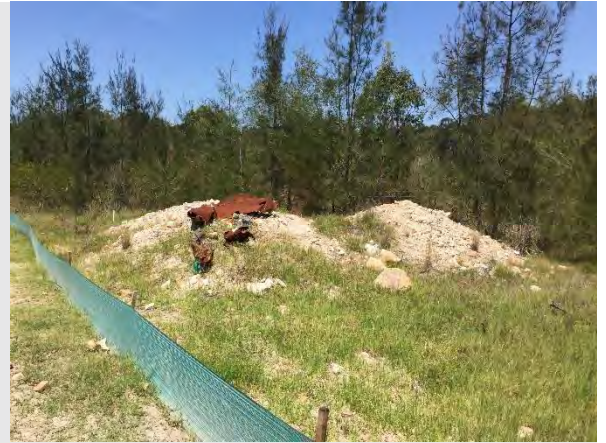
Photograph 24 Fill stockpiles in eastern portion of Part Lot 401 **[no longer present]**. Scrap metal on surface. Lot 7314 in background. View southeast.

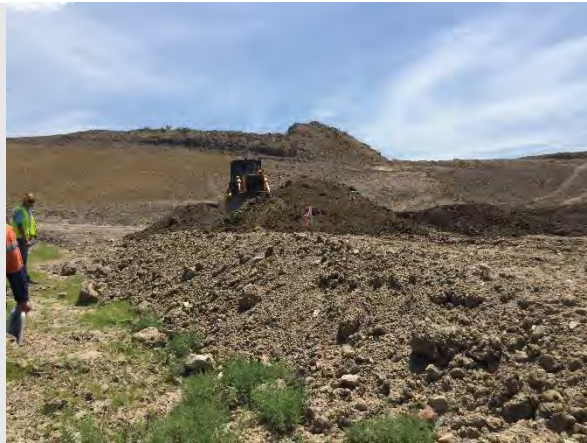
Photograph 25 Eastern corner of Part Lot 401 viewing along estimated northeastern boundary. Seeded embankment **[now well established]** and fill material stockpiles (from Lot 401 remediation) **[no longer present]** in background. View northwest.

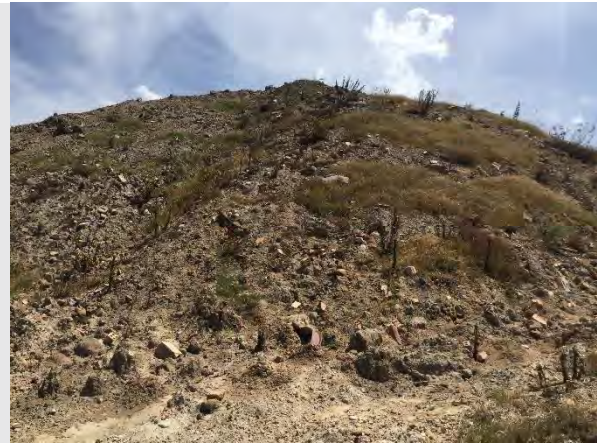
Photograph 26 Fill material from Lot 401 remediation, awaiting processing **[no longer present]**. View west.

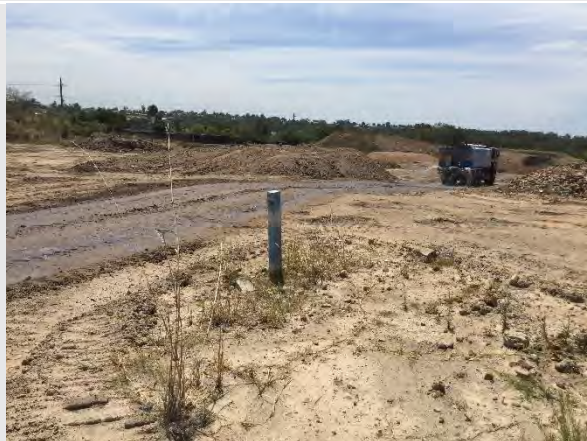
Photograph 27 Groundwater monitoring well MW61 (see DLA Figure 1 “Groundwater Monitoring Well Locations” 10/12/2015). Remainder of Lot 401 in background. View north.

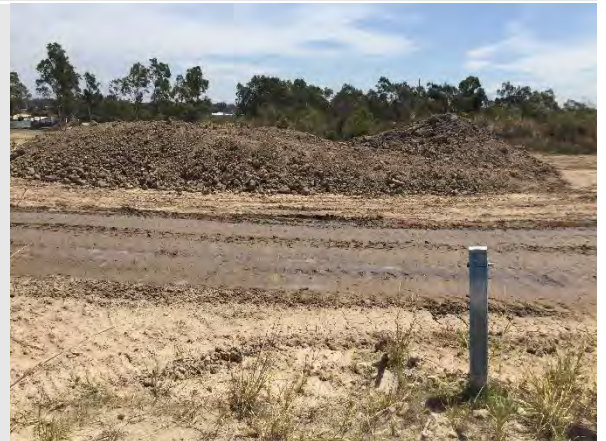
Photograph 28 MW61, viewing approximately along northeastern boundary of Part Lot 401 (no survey markers at time of inspection). Fill material stockpiles from Lot 401 remediation in background **[no longer present]**. View northwest.

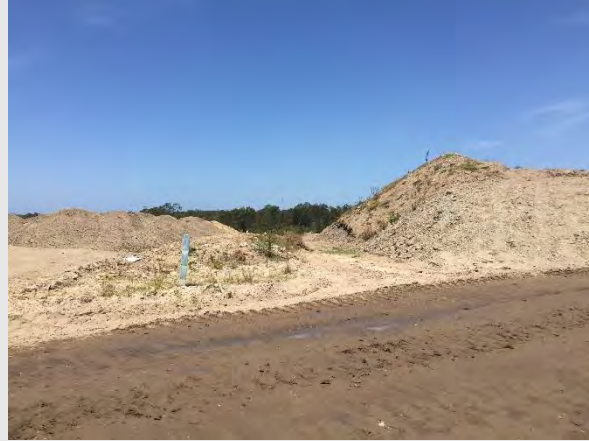
Photograph 29 MW61 (on left). Fill material stockpiled above the seeded embankment (as noted in Photograph 25 and Photograph 26) **[no longer present]**. View south.

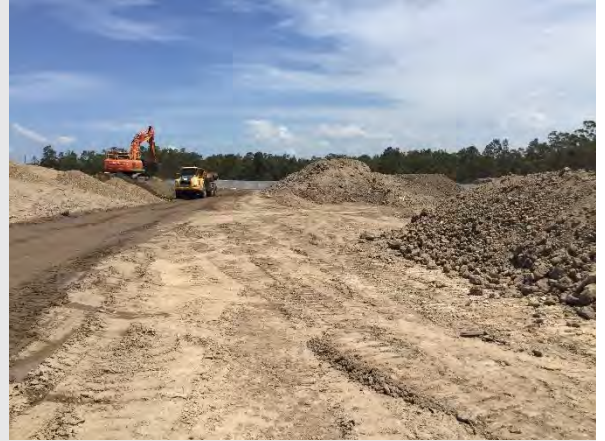
Photograph 30 Central portion of Part Lot 401. Fill material stockpiles from Lot 401 remediation **[no longer present]**. Southwestern boundary security fence in background. View southwest.
