7 February 2022
E24724.G11.01

Groundwater Monitoring Report No. 1 Proposed Mixed-Use Development 2 Mandala Parade, Castle Hill NSW

El Australia (El) has been engaged to prepare this factual letter report to provide the groundwater monitoring results at the above site. The monitoring period is from Monday 11 October 2021 to Tuesday 11 January 2022.

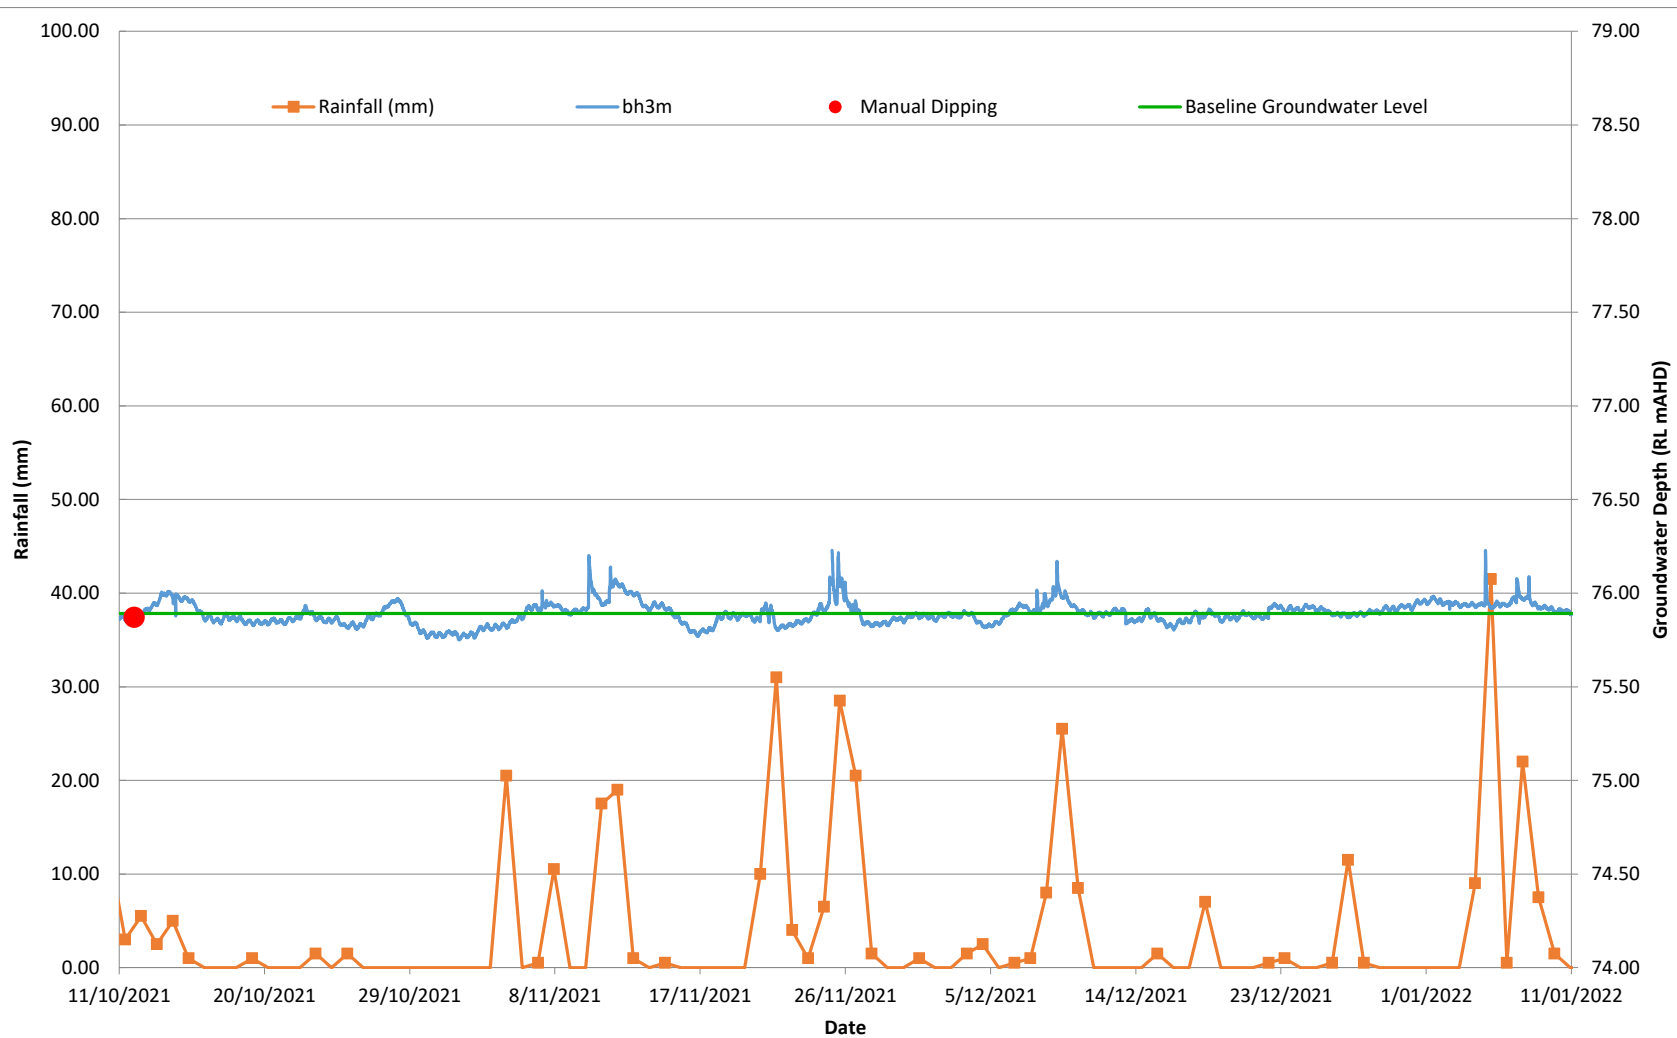
2

Units	Baseline Groundwater Level ¹	Lowest Groundwater Level Recorded	Highest Groundwater Level Recorded
	RL m AHD	RL m AHD	RL m AHD
BH3M	75.89	75.75	76.23
BH4M	78.14	77.85	78.40

Please find attached figures for the groundwater monitoring results. The groundwater levels observed during the current monitoring period ranged from RL 75.75m to RL 78.4m across the site.

BH3M

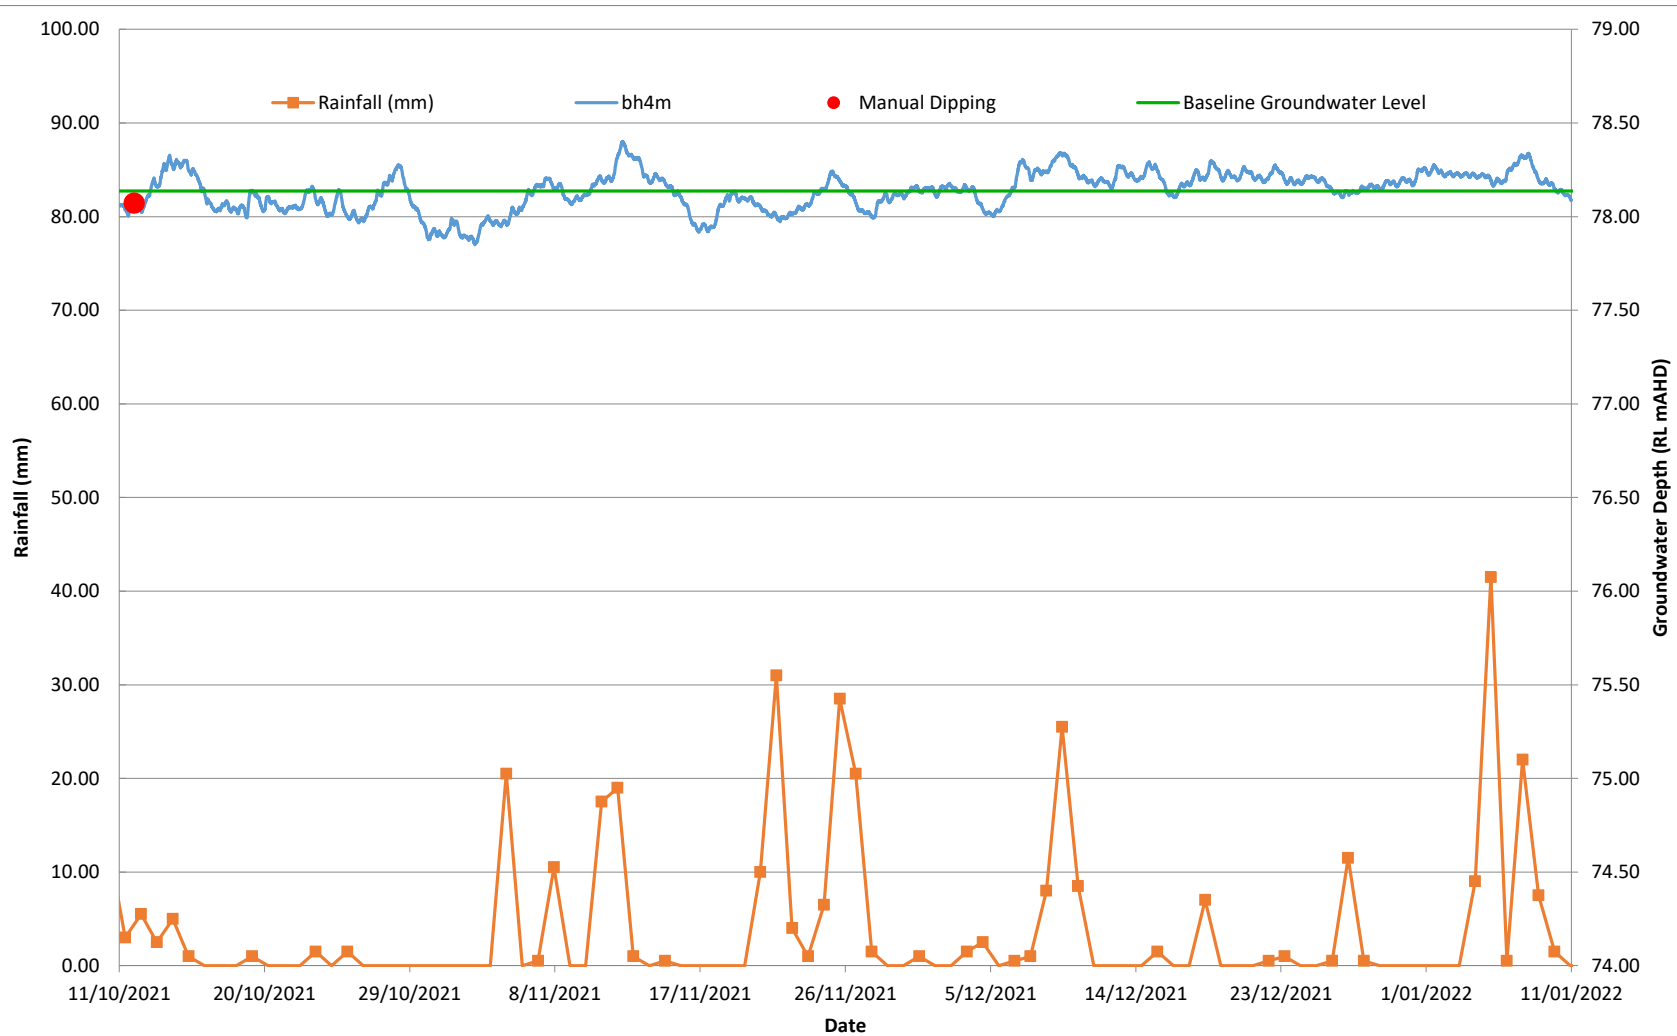
3

BH4M
