**ARBORIST REPORT  
for  
GOSFORD KIBBLEPLEX DEVELOPMENT**

***LOT 6 in DP 598833  
and  
LOT 1 in DP 540292***

***Henry Parry Drive  
GOSFORD***

***PREPARED BY  
TATTERSALL LANDER  
PTY LTD  
DEVELOPMENT CONSULTANTS  
February 2020***

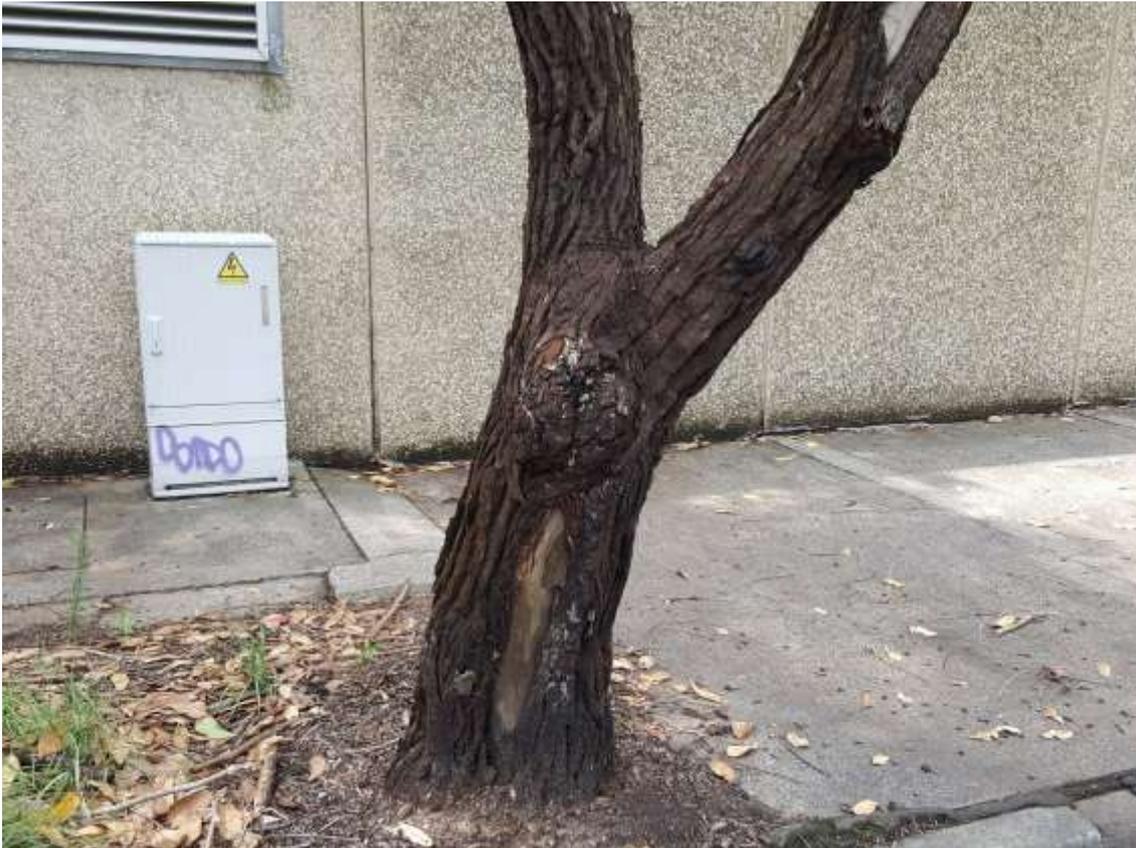
Tree	Comment
1	Mature. Damage to trunk and branch, assumed mechanical from maintenance equipment and vehicles. Poor form. Asymmetrical. Average vigour. Slight lean.
2	Mature. Good Vigour. Slight root girdling. Damage to gutter.
3	Semi mature. Average vigour. Asymmetrical. Poor form. Damage to path.
4	Semi mature. Average vigour. Very slight lean. Small deadwood. Damage to path suspected from tree roots.
5	Mature. Average vigour. Significant small deadwood. Slight lean over road. Asymmetrical.
6	Mature. Poor vigour. Damage to path. Root girdling. Significant small deadwood. One medium break. Significant epicormic growth.
7	Mature. Excellent vigour. Slight root girdling. Significant damage to path and kerb and gutter.
8	Semi mature. Asymmetrical. Very slight lean. Good vigour. Slight root girdling.
9	Mature. Excellent vigour. Damage to path, not conclusive that tree roots are the cause.

Photograph 1 – Tree 1 (damage/scarring at base)

Tree	Remove/Retain	Reason
1	Remove	Works will be within the SRZ and the TPZ. Additionally, the tree has relatively significant damage to the trunk and the location of the tree is such that it is likely that such damage may be reoccurring. The location of the tree is such that it is highly constrained and will undoubtedly damage the adjacent kerb and gutter as it increases in size should it remain.
2	Remove	Works will be within the SRZ and the TPZ. The location of the tree is such that it is highly constrained and will undoubtedly damage the adjacent kerb and gutter (further to which it has already) as it increases in size should it remain.
3	Remove	Works will be within the SRZ and the TPZ. The location of the tree is such that it is highly constrained and will undoubtedly damage the adjacent kerb and gutter (further to which it has already) as it increases in size should it remain.
4	Remove	Works will be within the SRZ and the TPZ. The location of the tree is such that it is highly constrained and will undoubtedly damage the adjacent kerb and gutter (further to which it has already) as it increases in size should it remain.

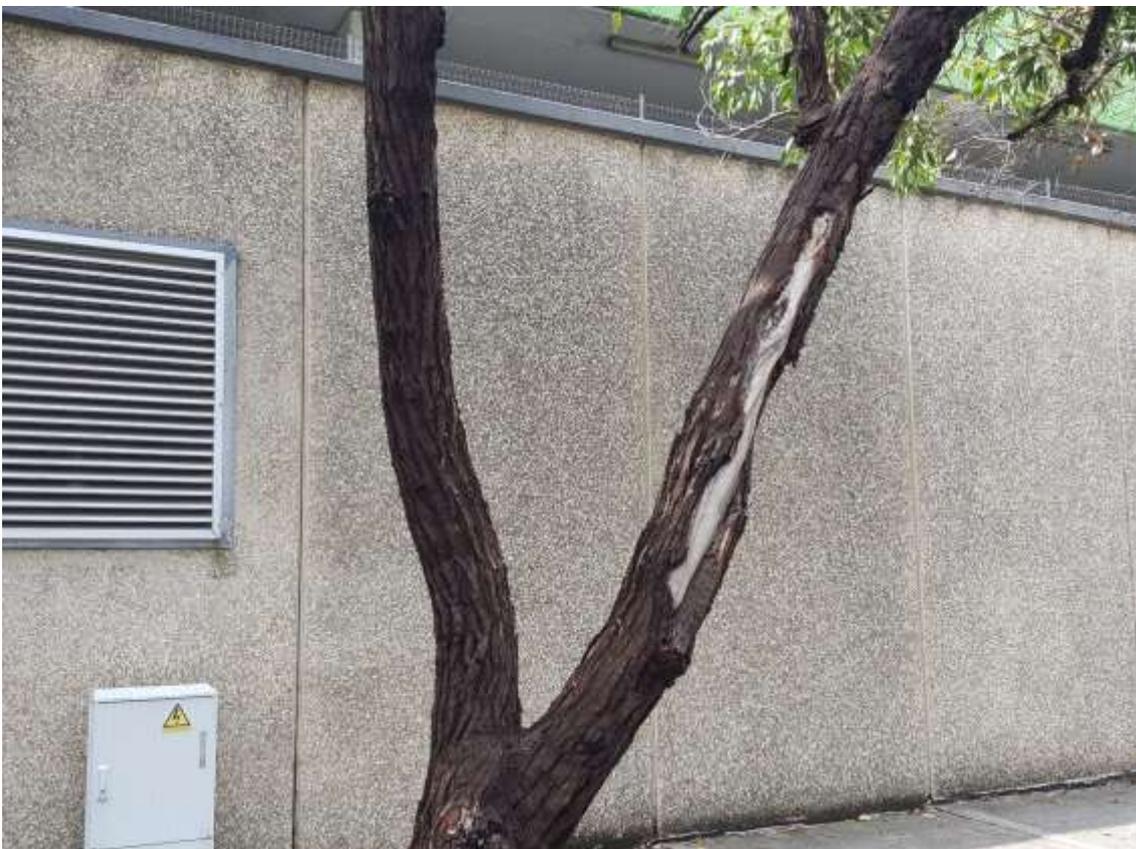
Photograph 2 – Tree 1 (damage/scarring)

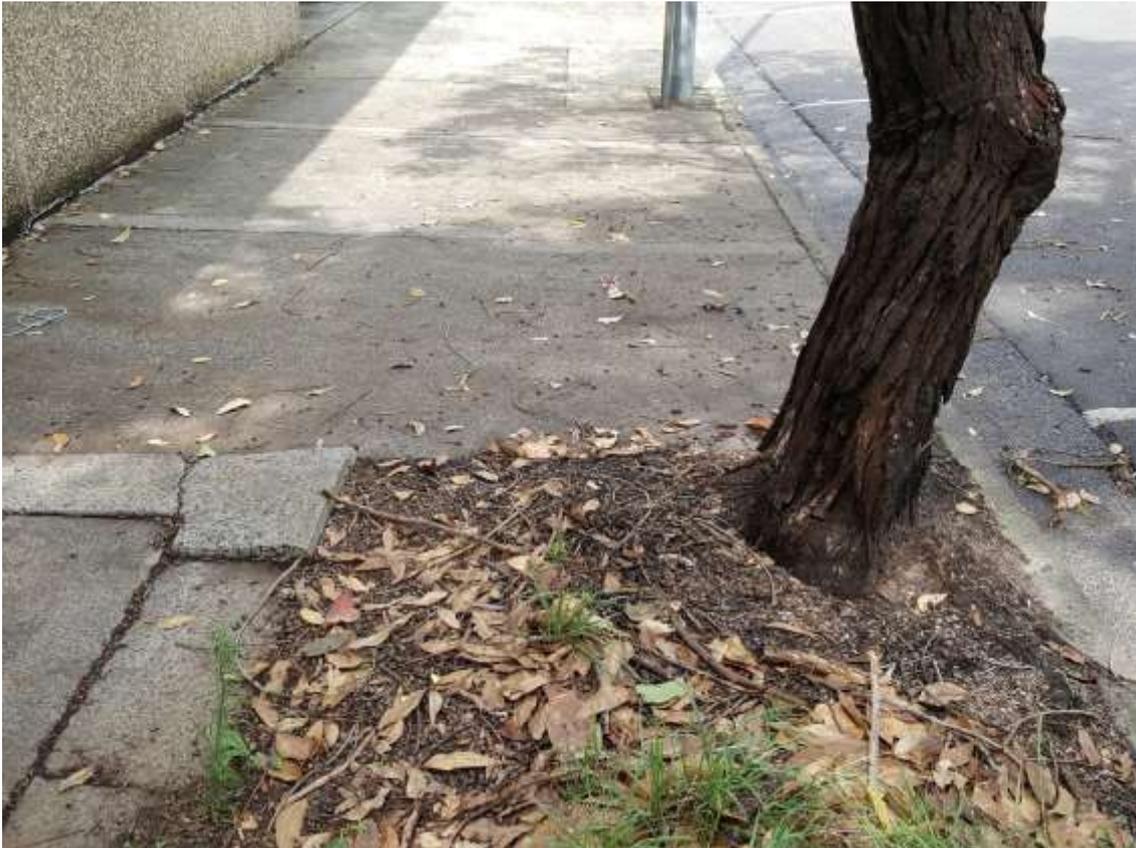
**Photograph 3 – Tree 1 and adjacent damage to path**

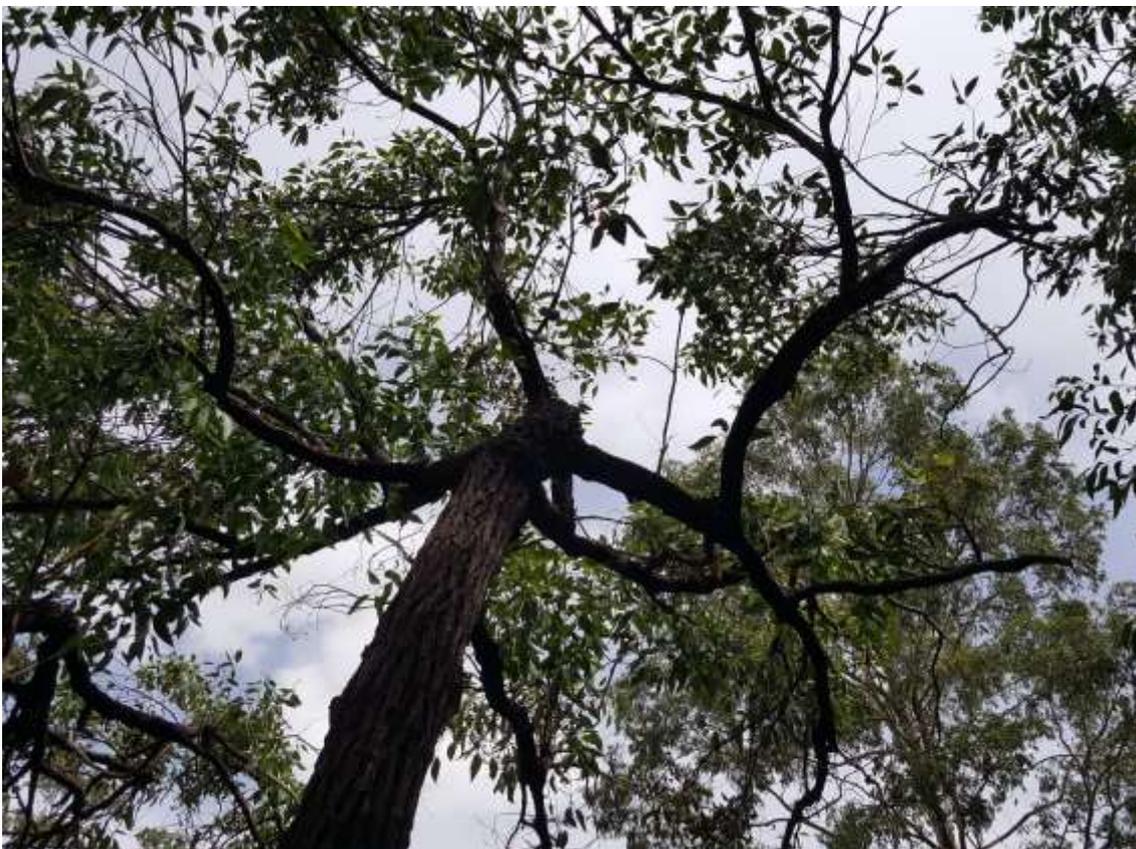
**Photograph 4 – Tree 1 canopy**

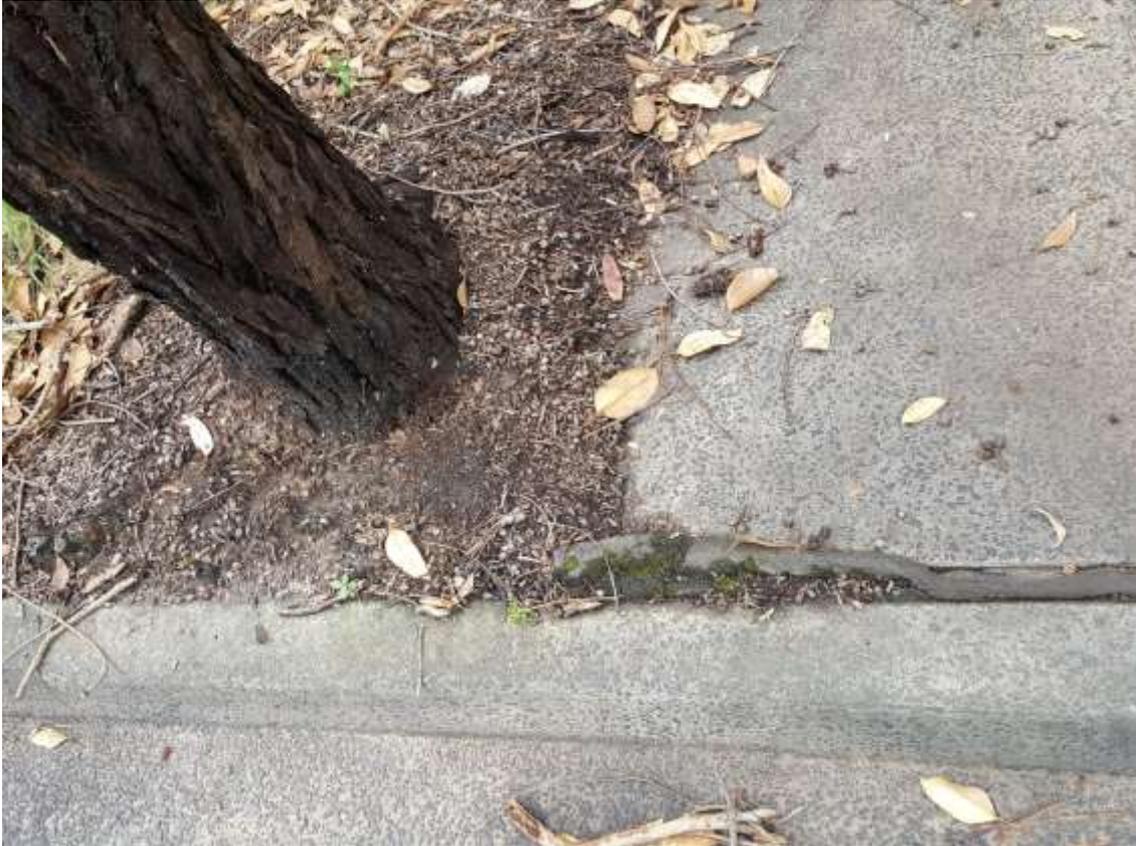
**Photograph 5 – Tree 1 root between path and kerb**

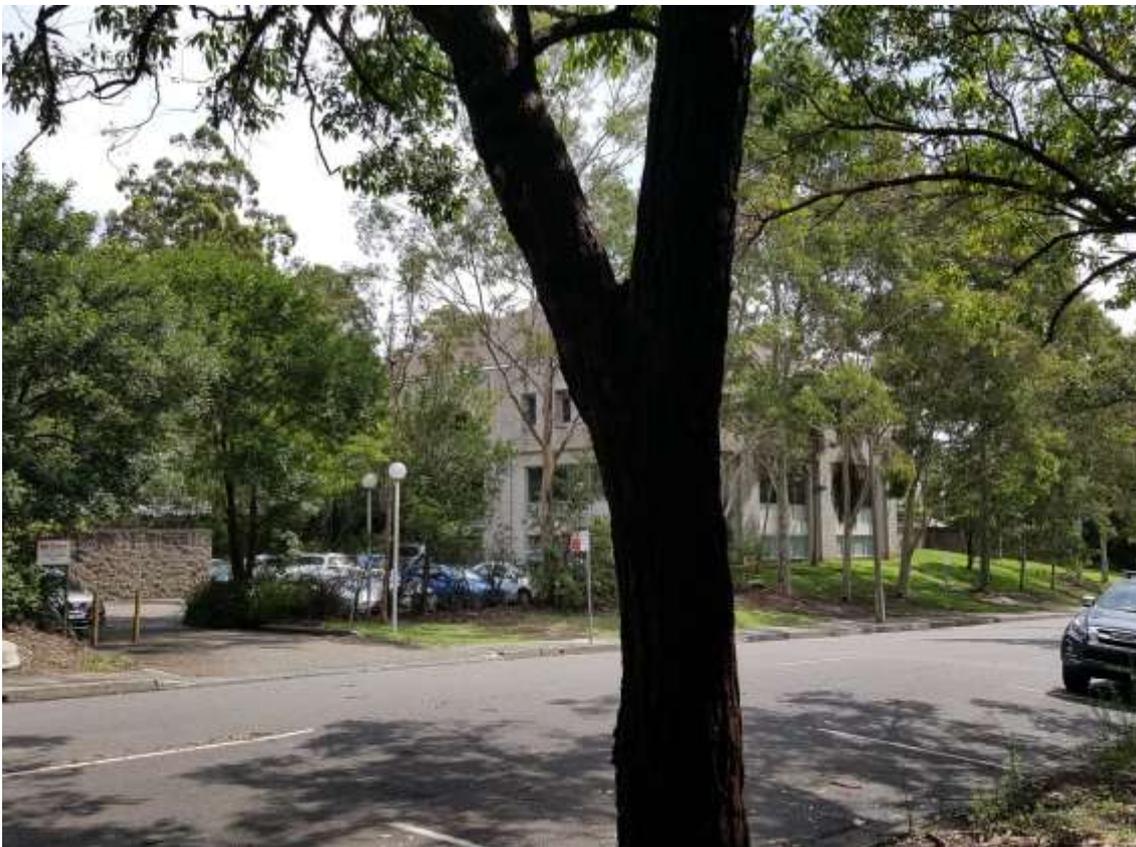
**Photograph 6 – Tree 2**

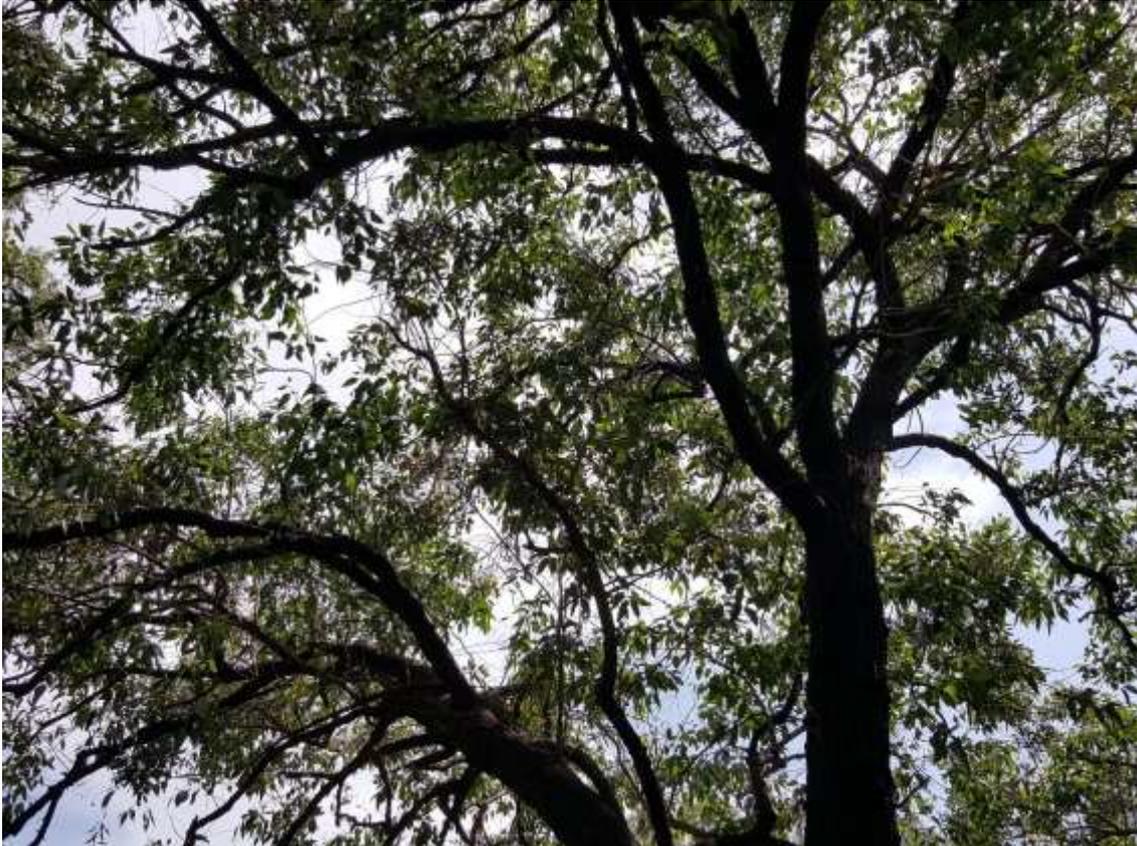
**Photograph 7 – Tree 2 canopy**

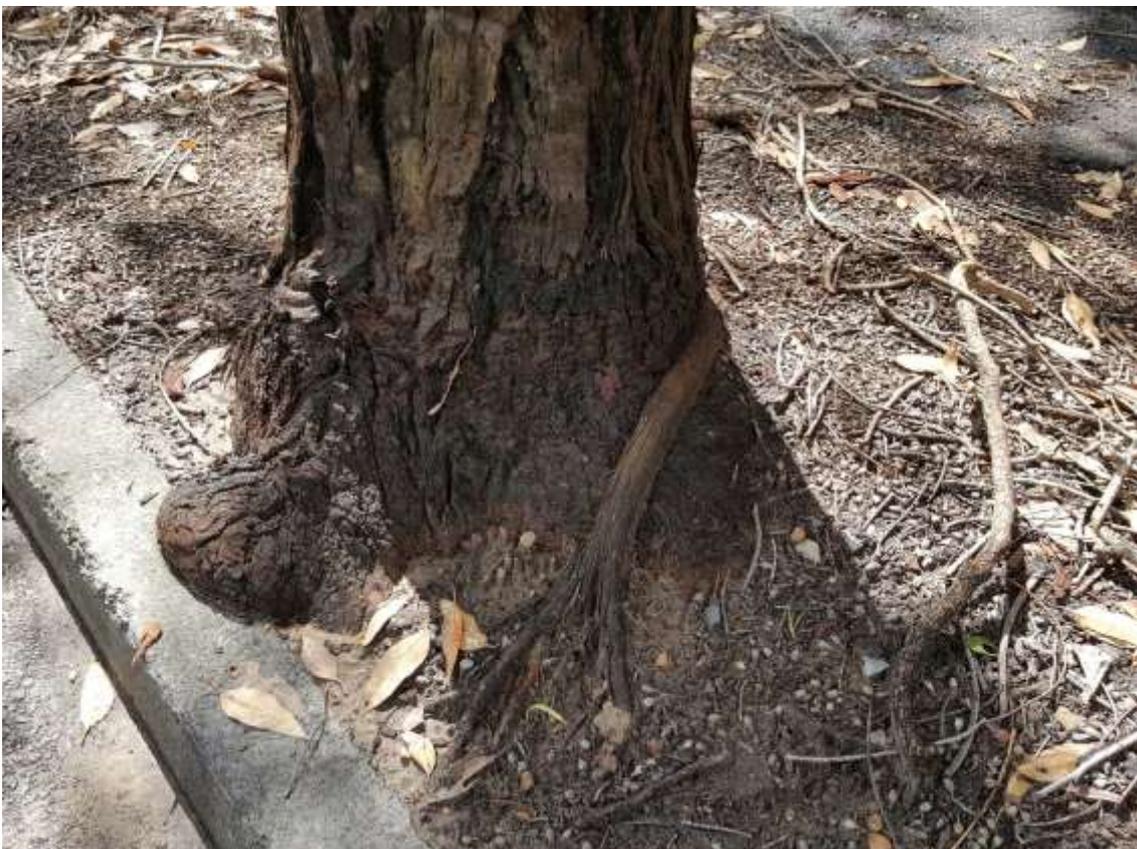
**Photograph 8 – Tree 2 slight root girdling**

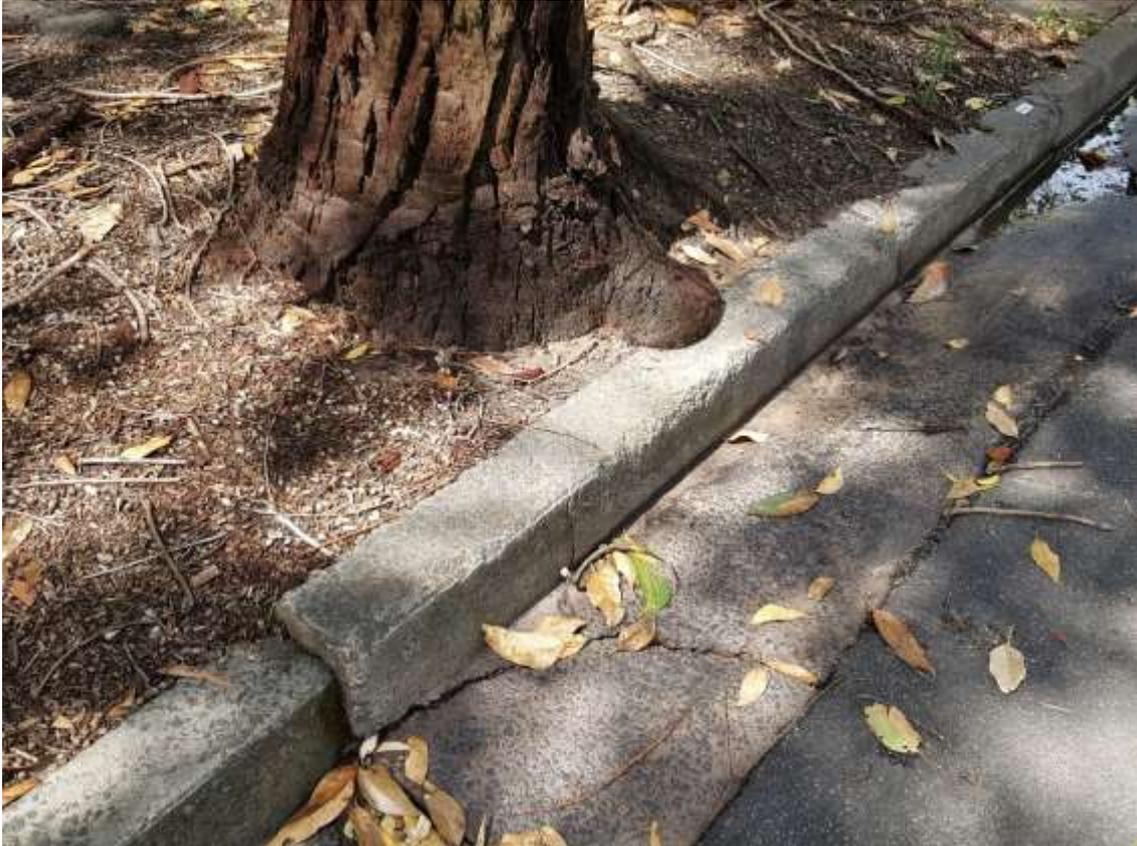
**Photograph 9 – Tree 2 damage to kerb and gutter**

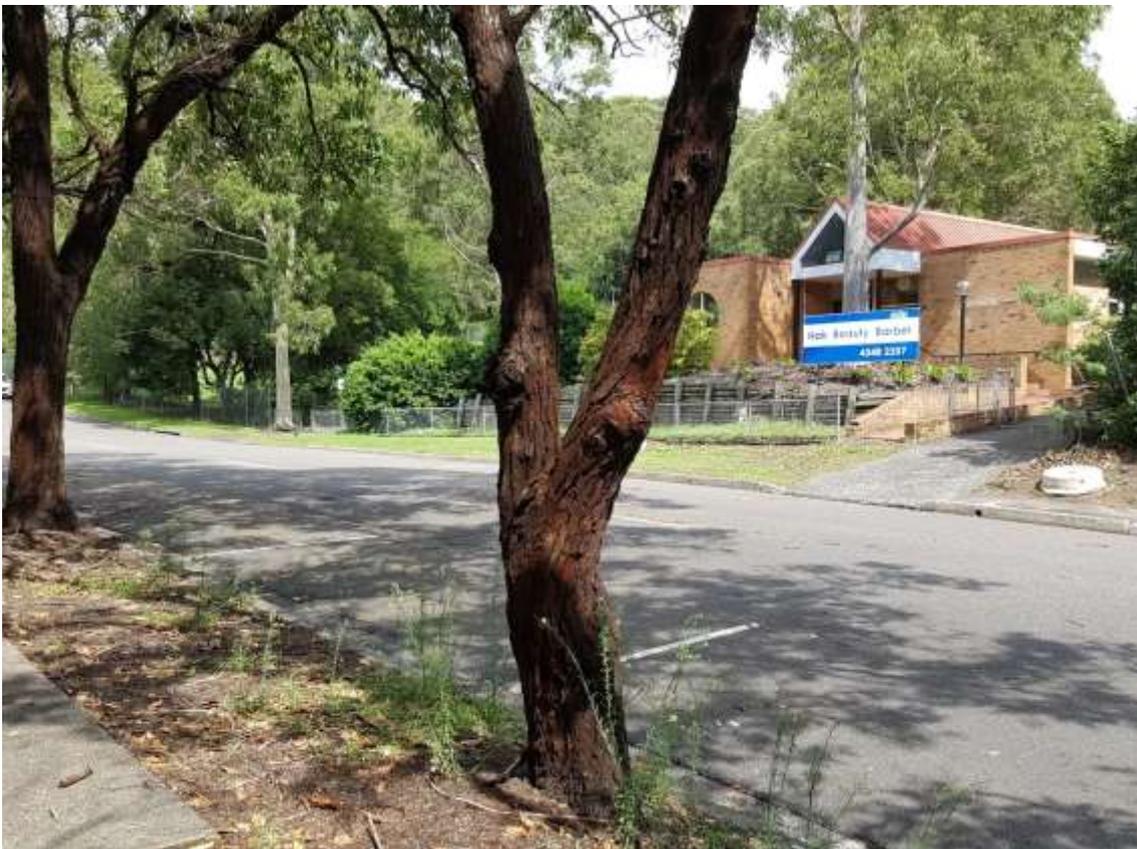
**Photograph 10 – Tree 3**

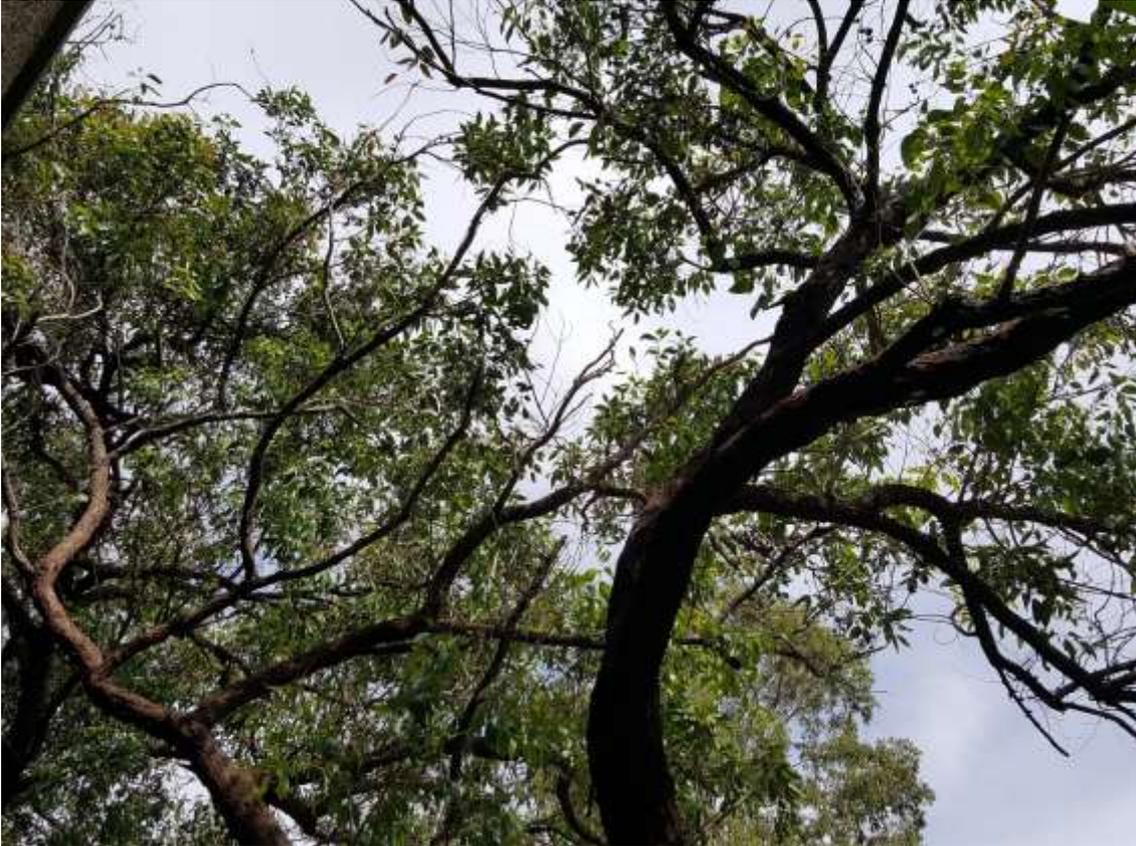
**Photograph 11 – Tree 3 canopy**

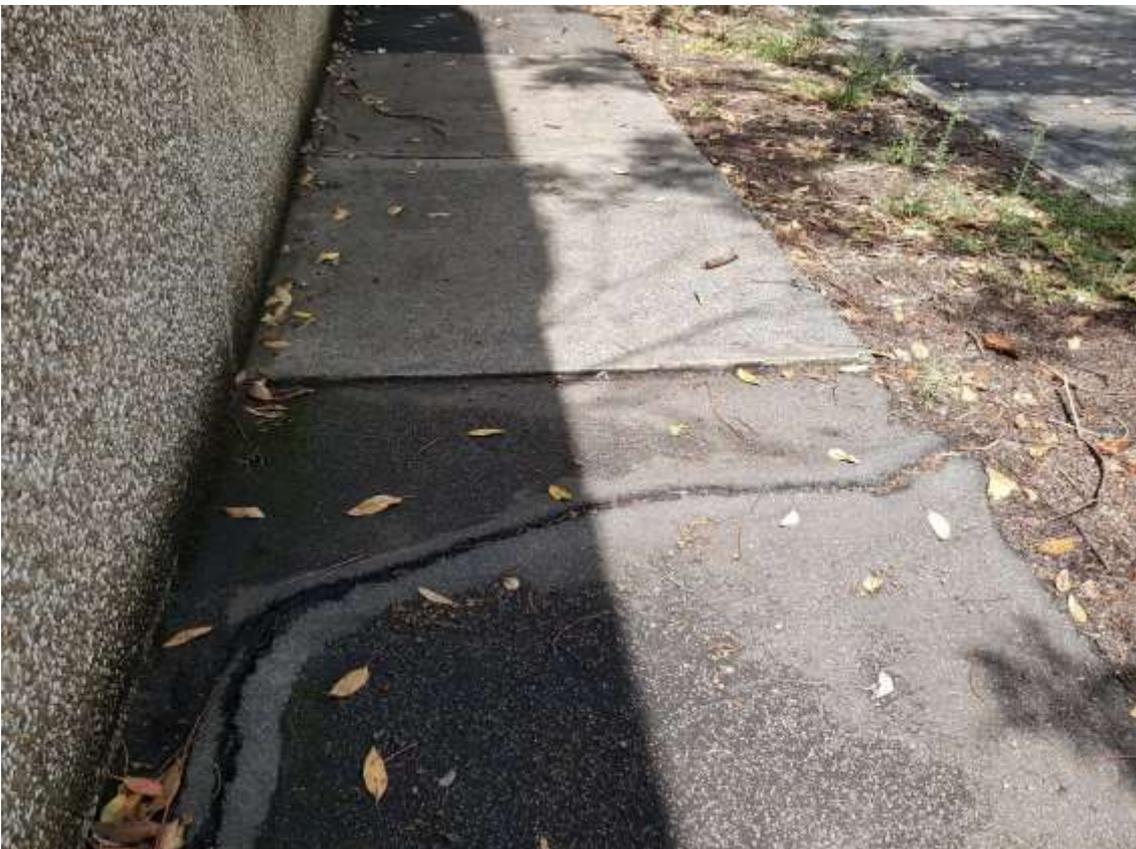
**Photograph 12 – Tree 3 damage to path adjacent**

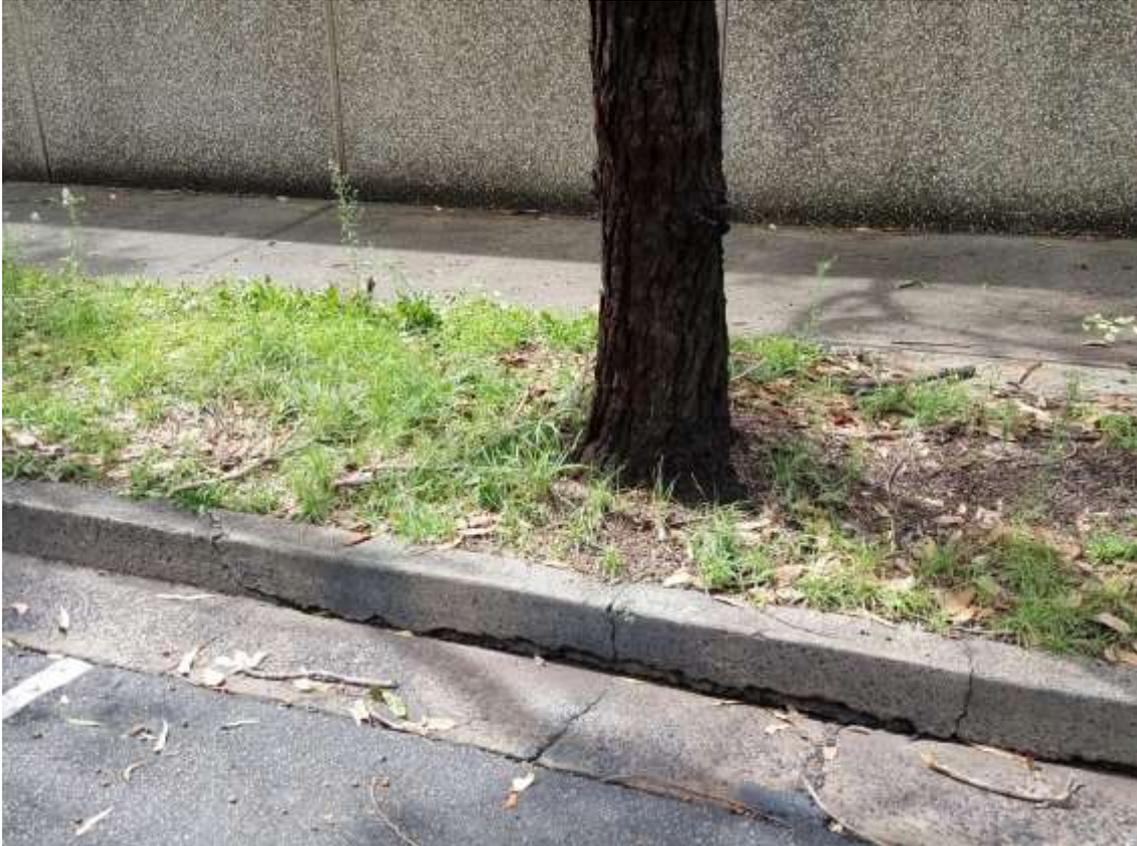
**Photograph 13 – Tree 4 damage to kerb and gutter**

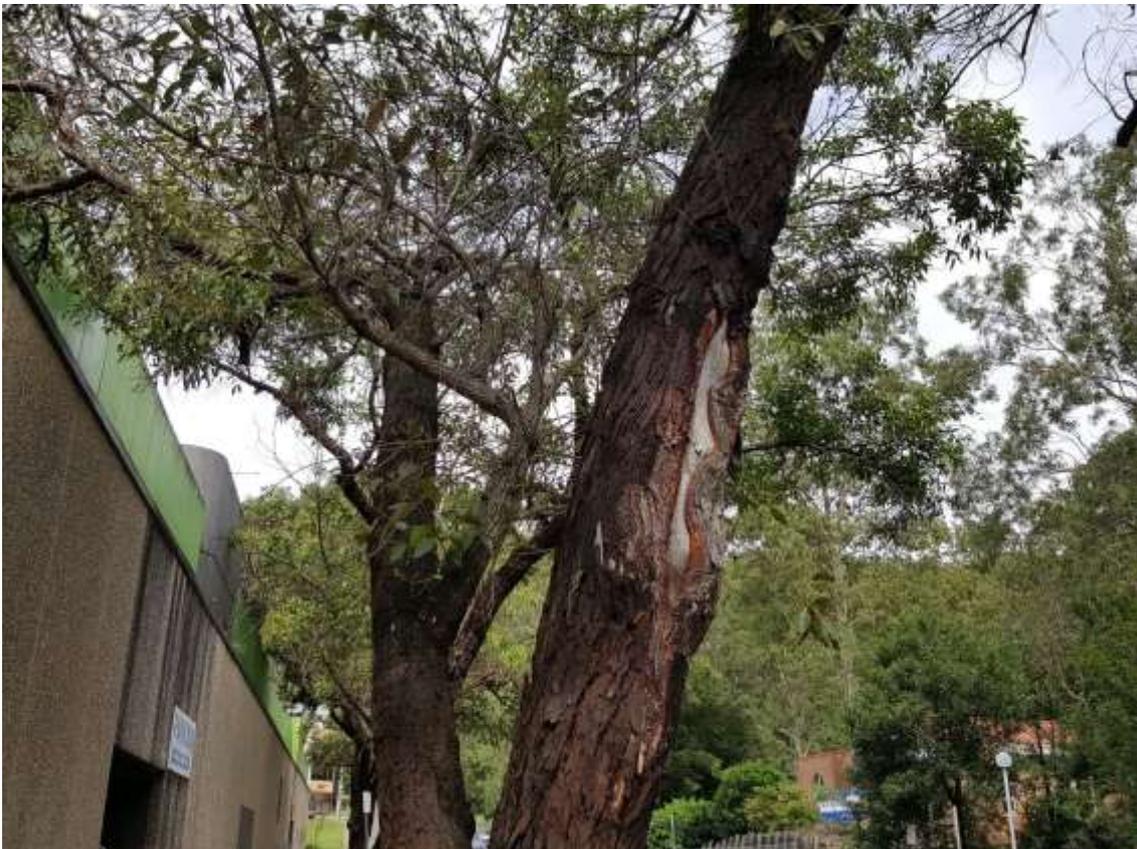
**Photograph 14 – Tree 5 damage/scarring**

5	Remove	Works will be within the SRZ and the TPZ. The location of the tree is such that it is highly constrained and will undoubtedly damage the adjacent kerb and gutter as it increases in size should it remain.
6	Remove	Works will be within the SRZ and the TPZ. The location of the tree is such that it is highly constrained and will undoubtedly damage the adjacent kerb and gutter (further to which it has already) as it increases in size should it remain.
7	Remove	Works will be within the SRZ and the TPZ. The location of the tree is such that it is highly constrained and will undoubtedly damage the adjacent kerb and gutter (further to which it has already) as it increases in size should it remain.
8	Remove	Works will be within the SRZ and the TPZ. The tree is easily replaceable in the short to medium term.
9	Remove	Works will be within the SRZ and the TPZ. The tree is easily replaceable in the short to medium term.

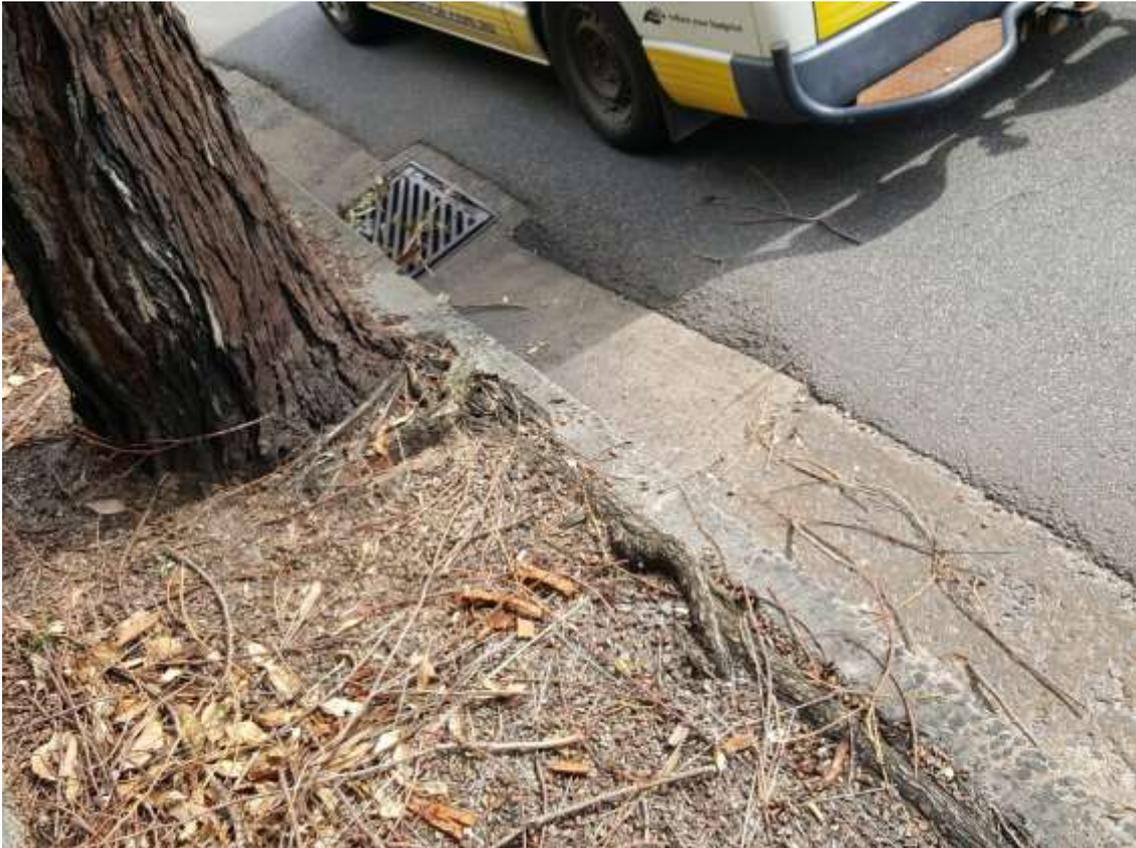
**Photograph 15 – Tree 6 roots behind kerb**

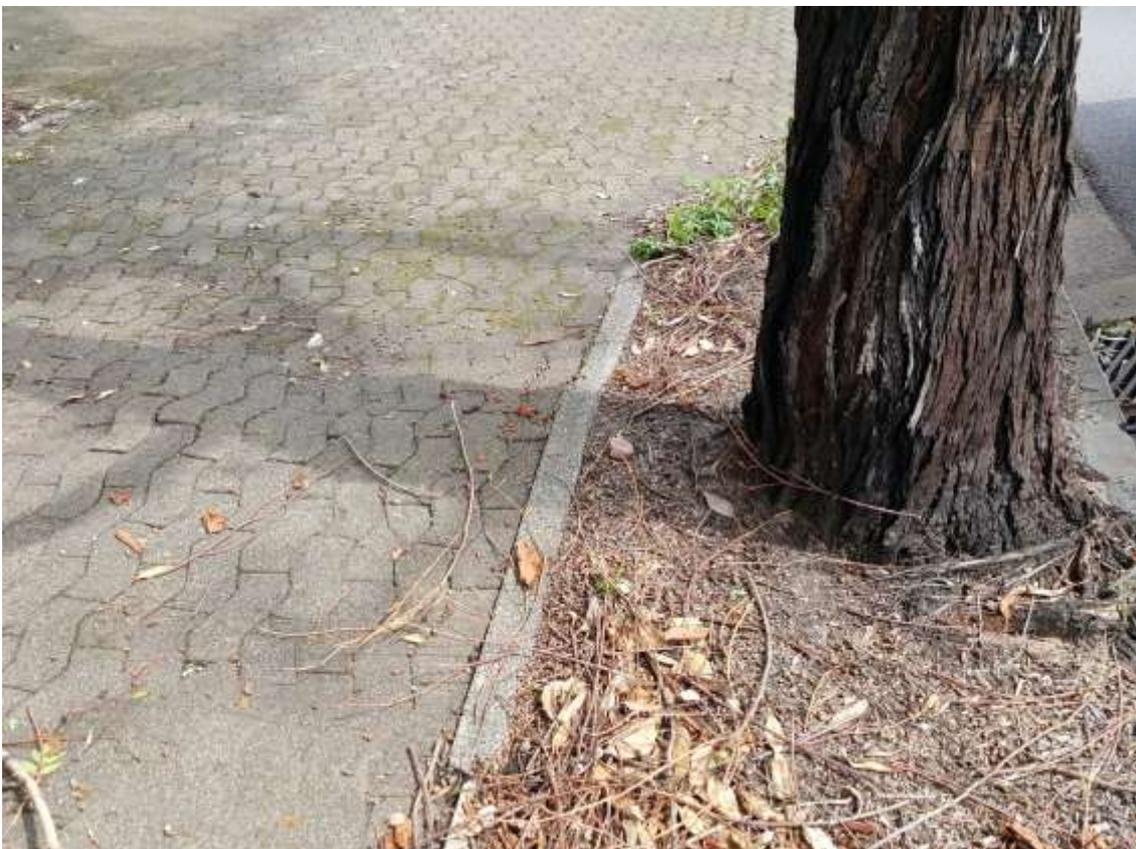
**Photograph 16 – Tree 6 lifting of paved path**

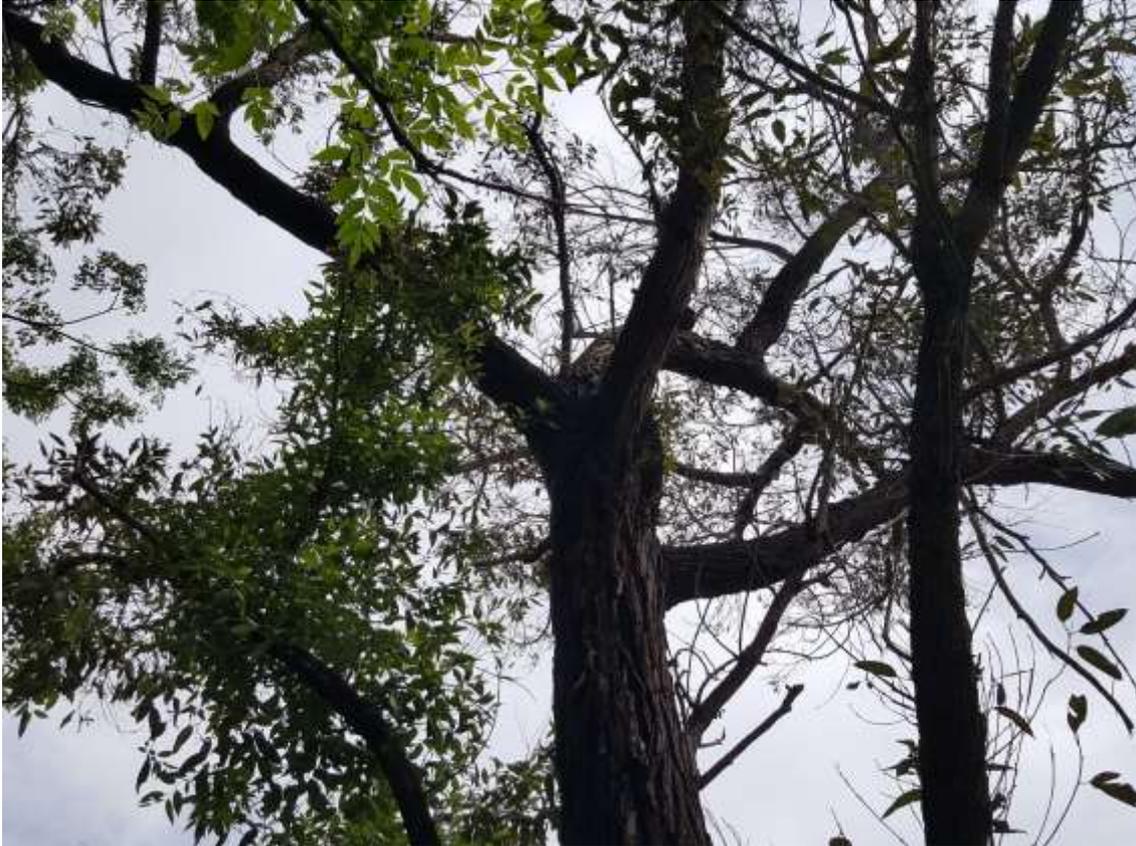
**Photograph 17 – Tree 6 canopy and epicormic growth**

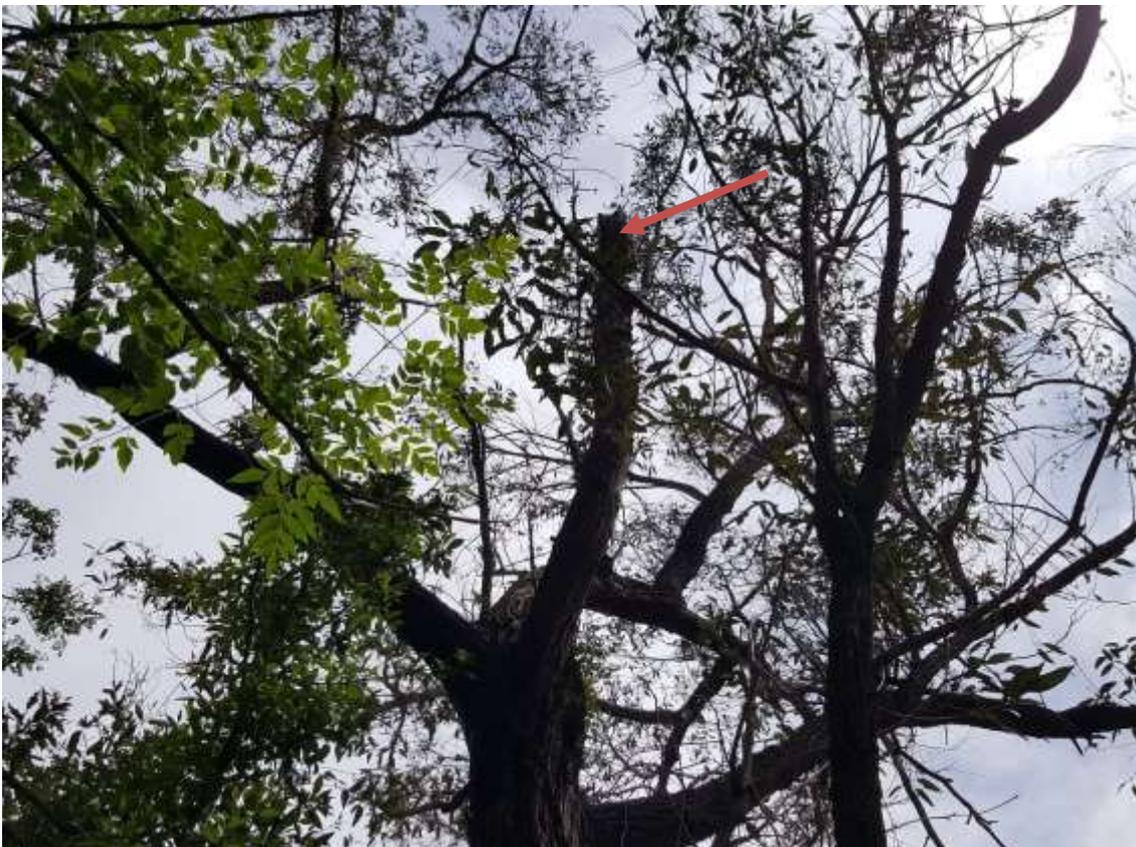
**Photograph 18 – Tree 6 medium break**

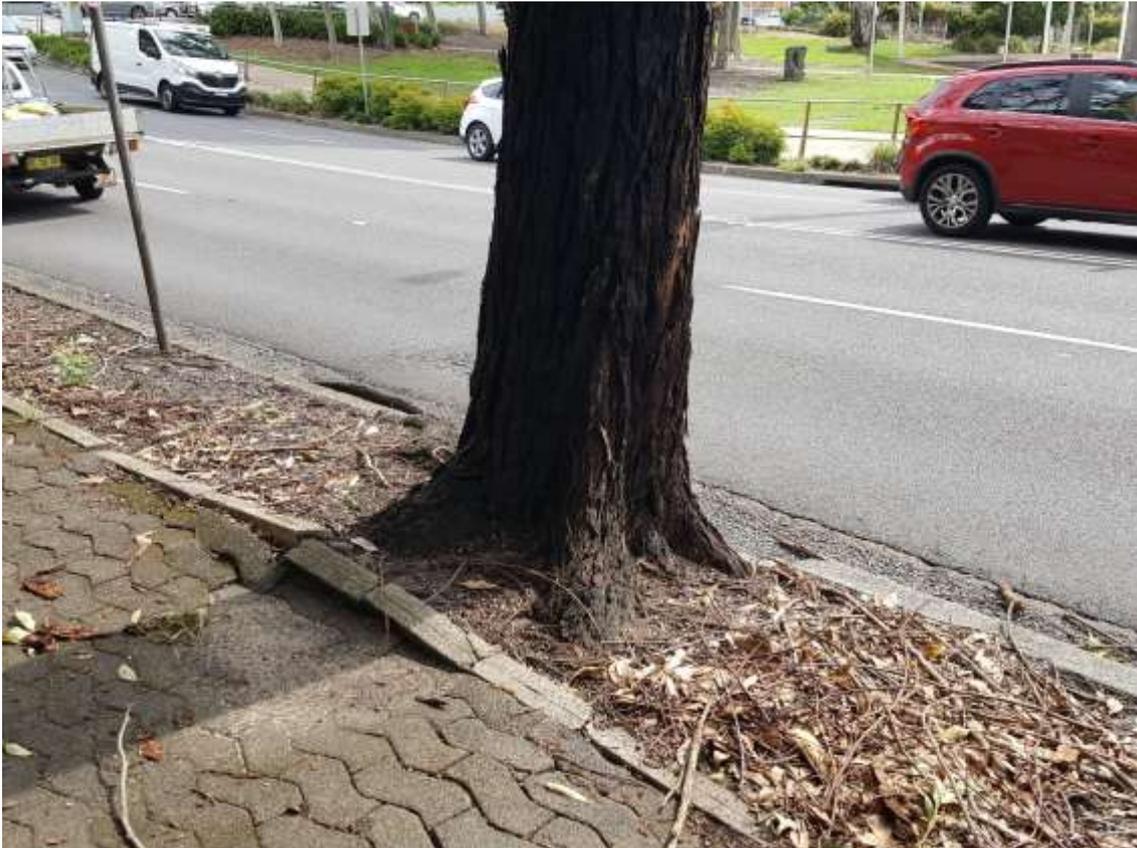
**Photograph 19 – Tree 7 damage to pavement**

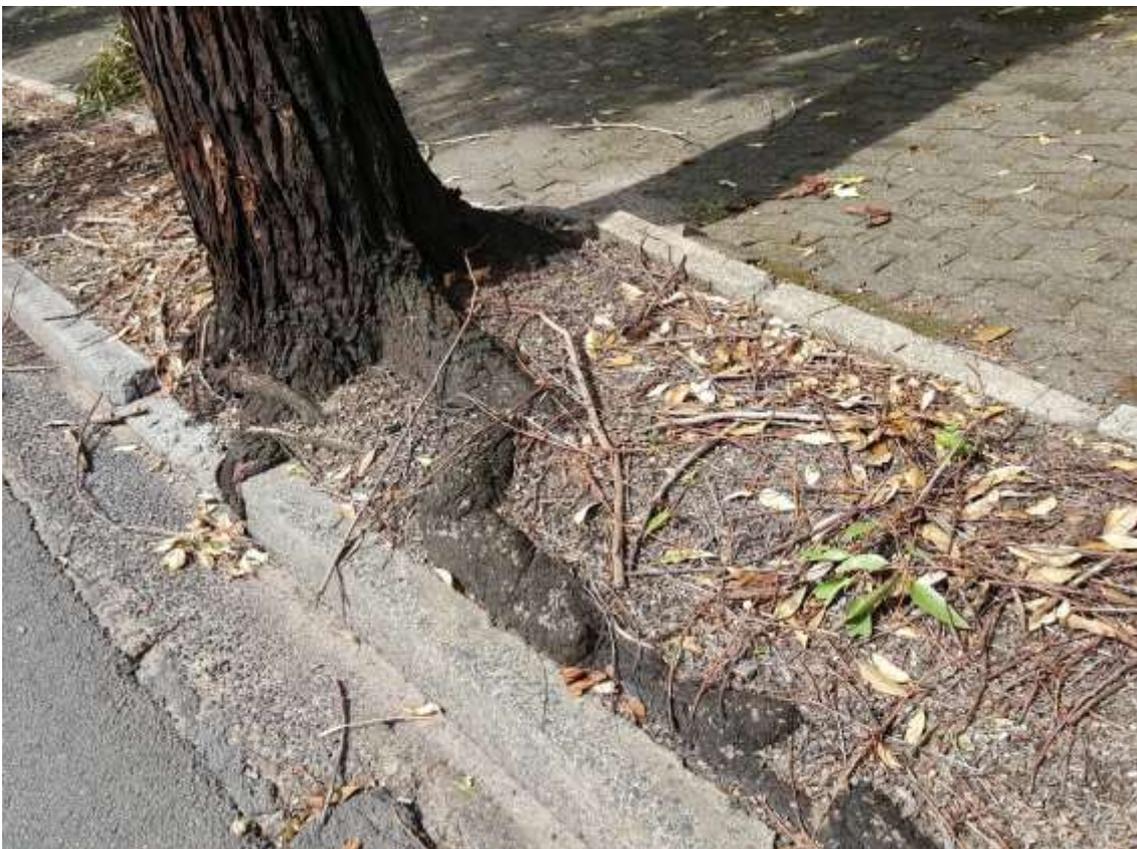
**Photograph 20 – Tree 7 damage to kerb and gutter**

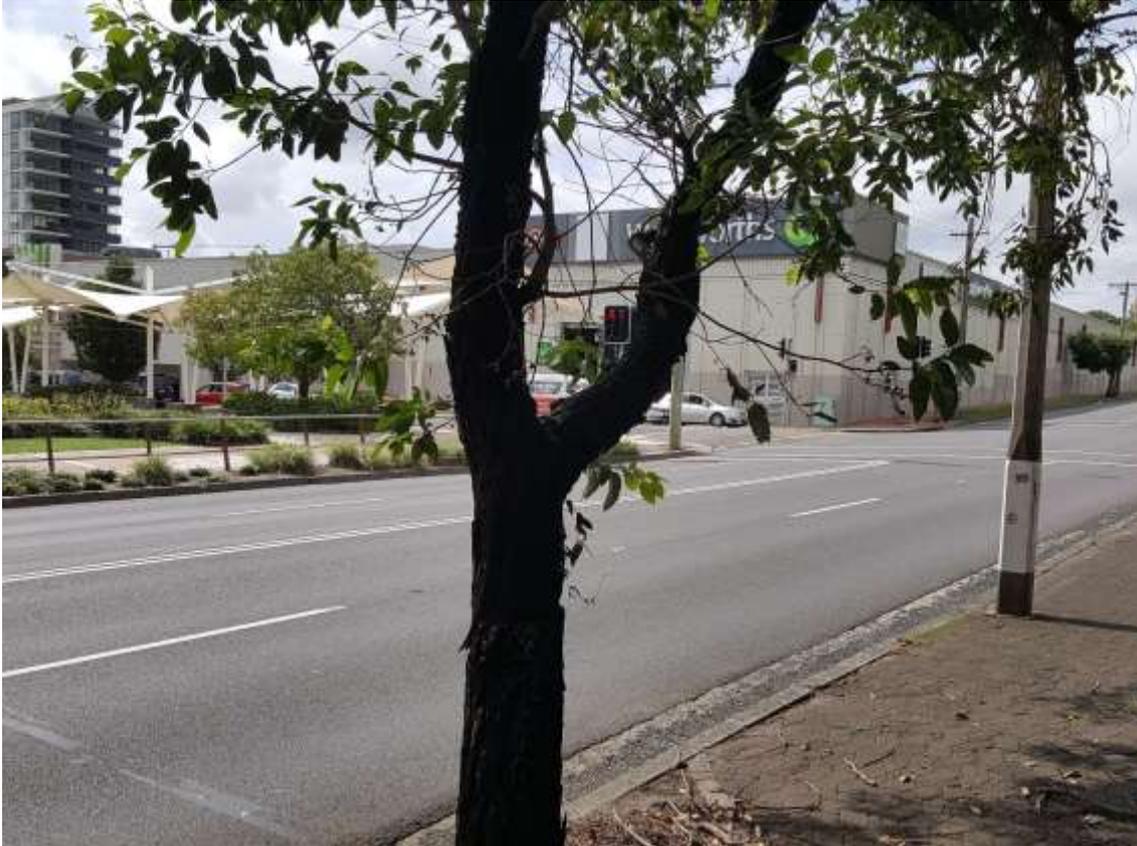
**Photograph 21 – Tree 8**

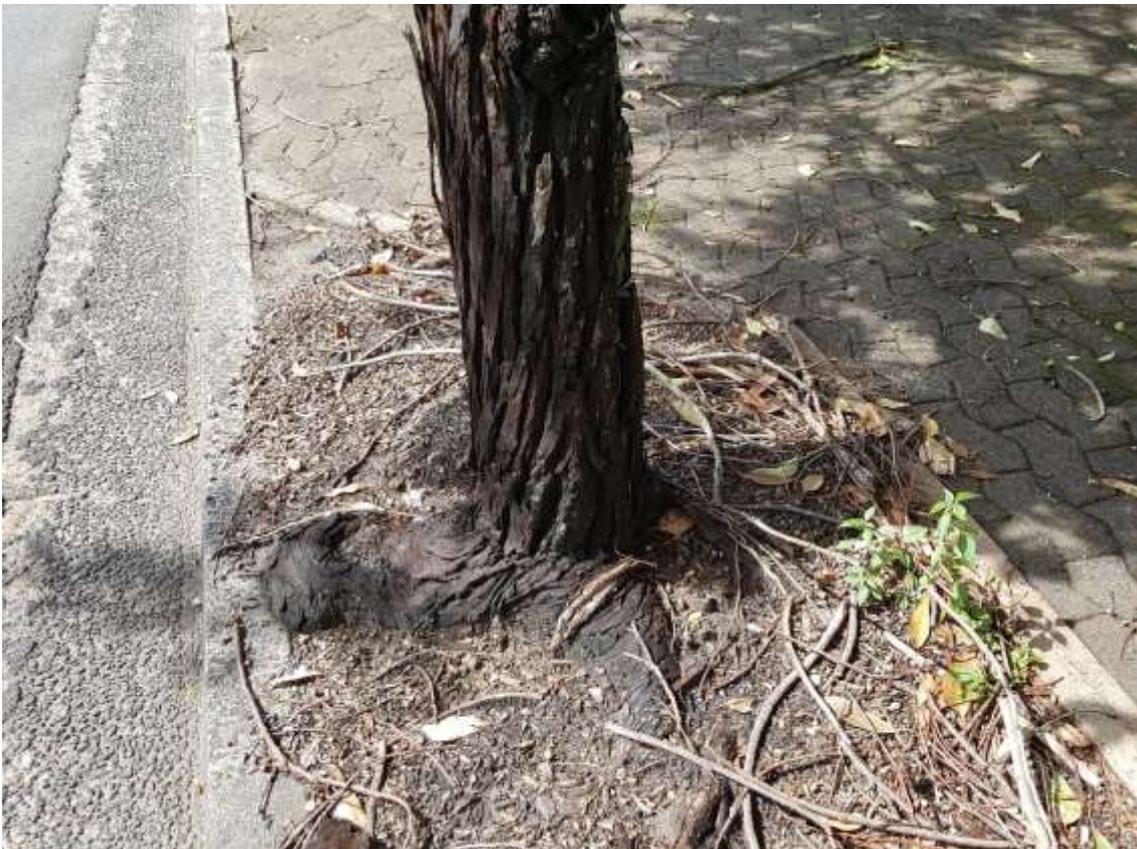
**Photograph 22 – Tree 8 slight root girdling**

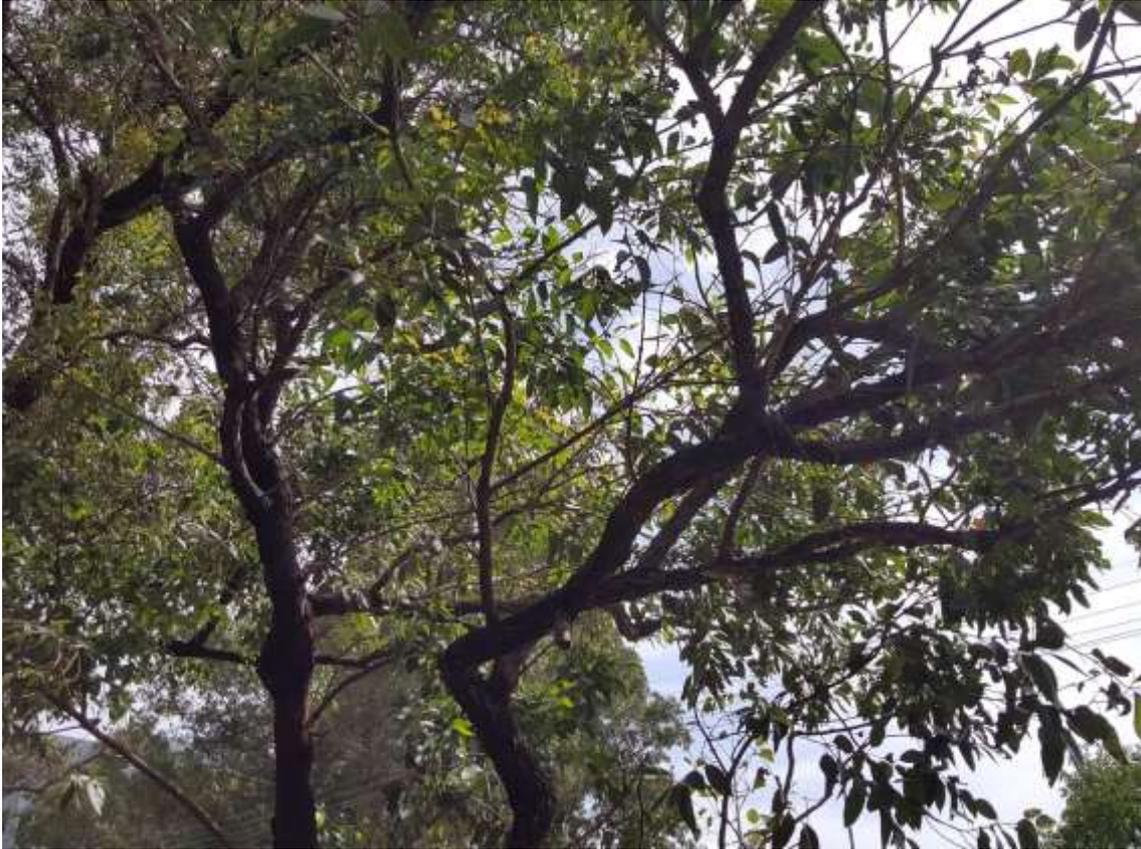
**Photograph 23 – Tree 8 canopy**
