**ARBORIST REPORT  
for  
GOSFORD KIBBLEPLEX DEVELOPMENT**

***LOT 6 in DP 598833  
and  
LOT 1 in DP 540292***

***Henry Parry Drive  
GOSFORD***

***PREPARED BY  
TATTERSALL LANDER  
PTY LTD  
DEVELOPMENT CONSULTANTS  
February 2020***

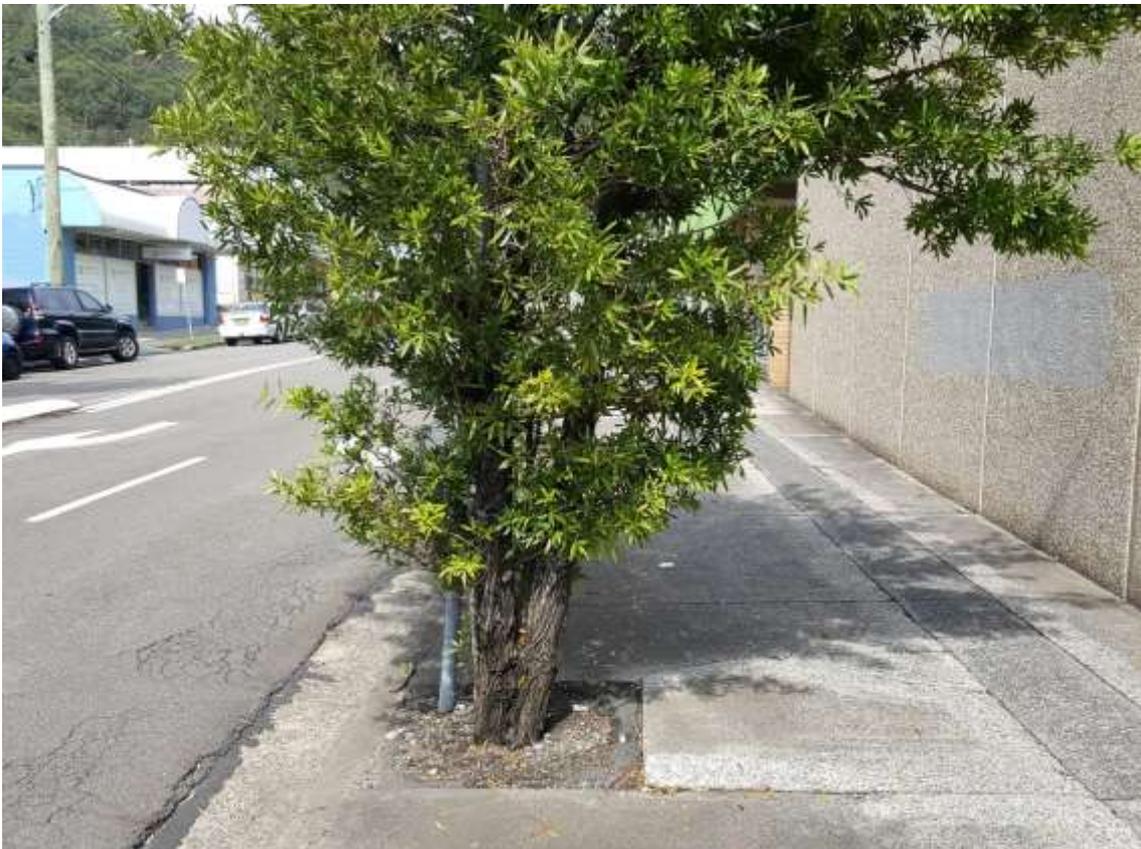
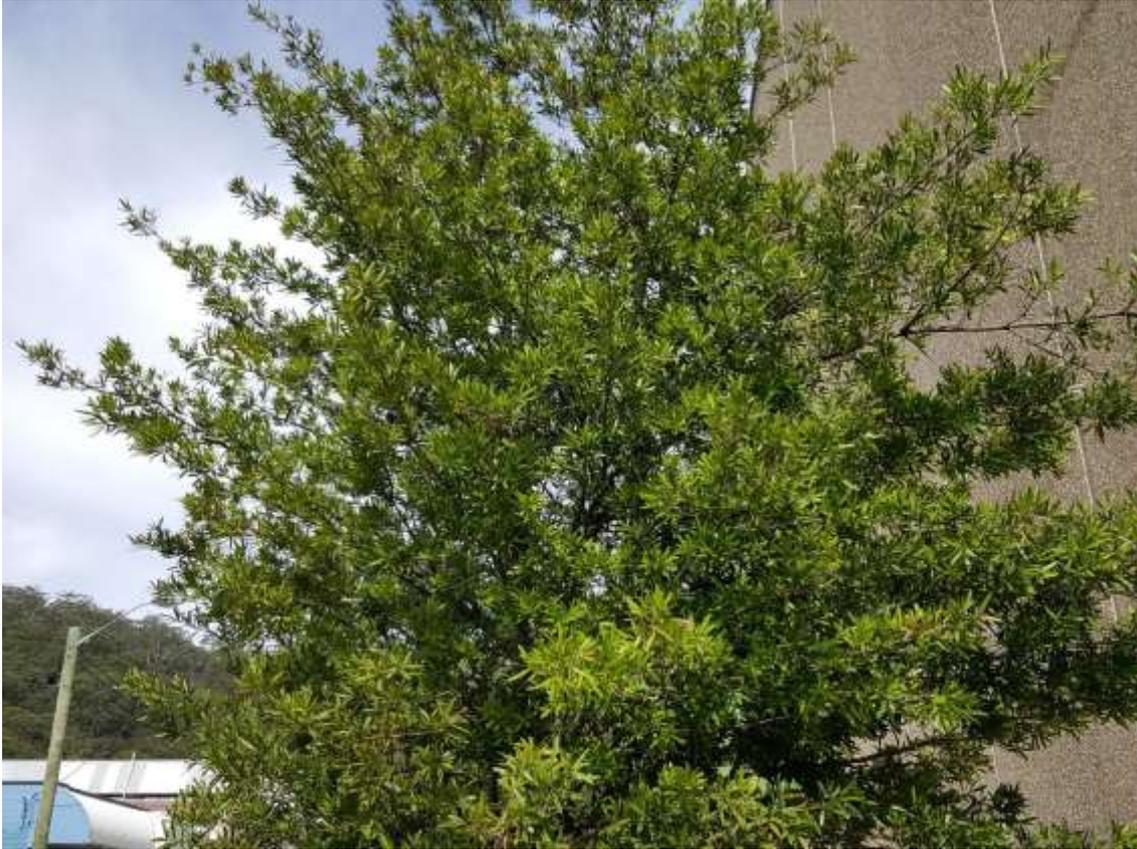
**Photograph 24 – Tree 9**

**Photograph 25 – Tree 9**

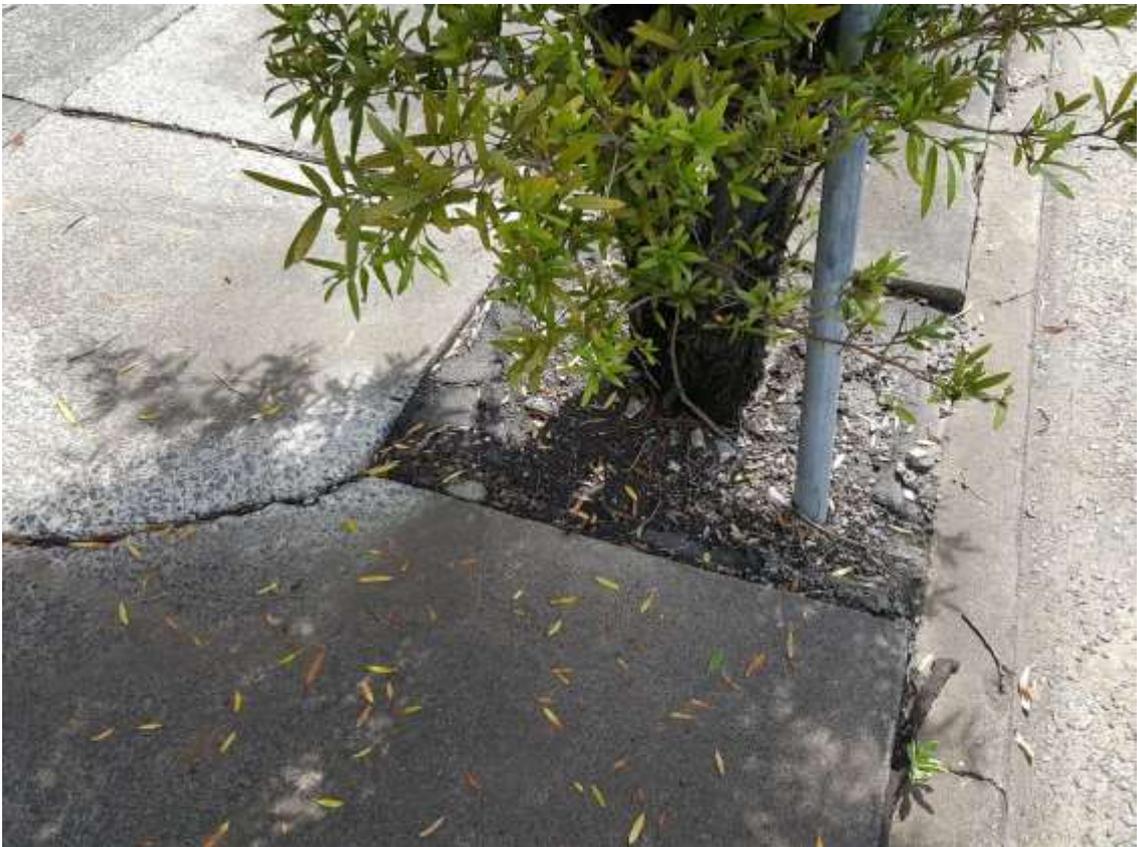
**Photograph 26 – Tree 9 and adjacent damage to pavement**
