**RE: ELECTROLYSIS RISK TESTING AT  
12 STURT STREET, TELOPEA NSW 2117**

**ELECTROLYSIS RISK TESTING**  
**12 STURT STREET, TELOPEA NSW 2117**  
**FRASERS PROPERTY AUSTRALIA**

DOCUMENT NUMBER: W20889A/J740  
REVISION: A  
DATE: 7 February 2022

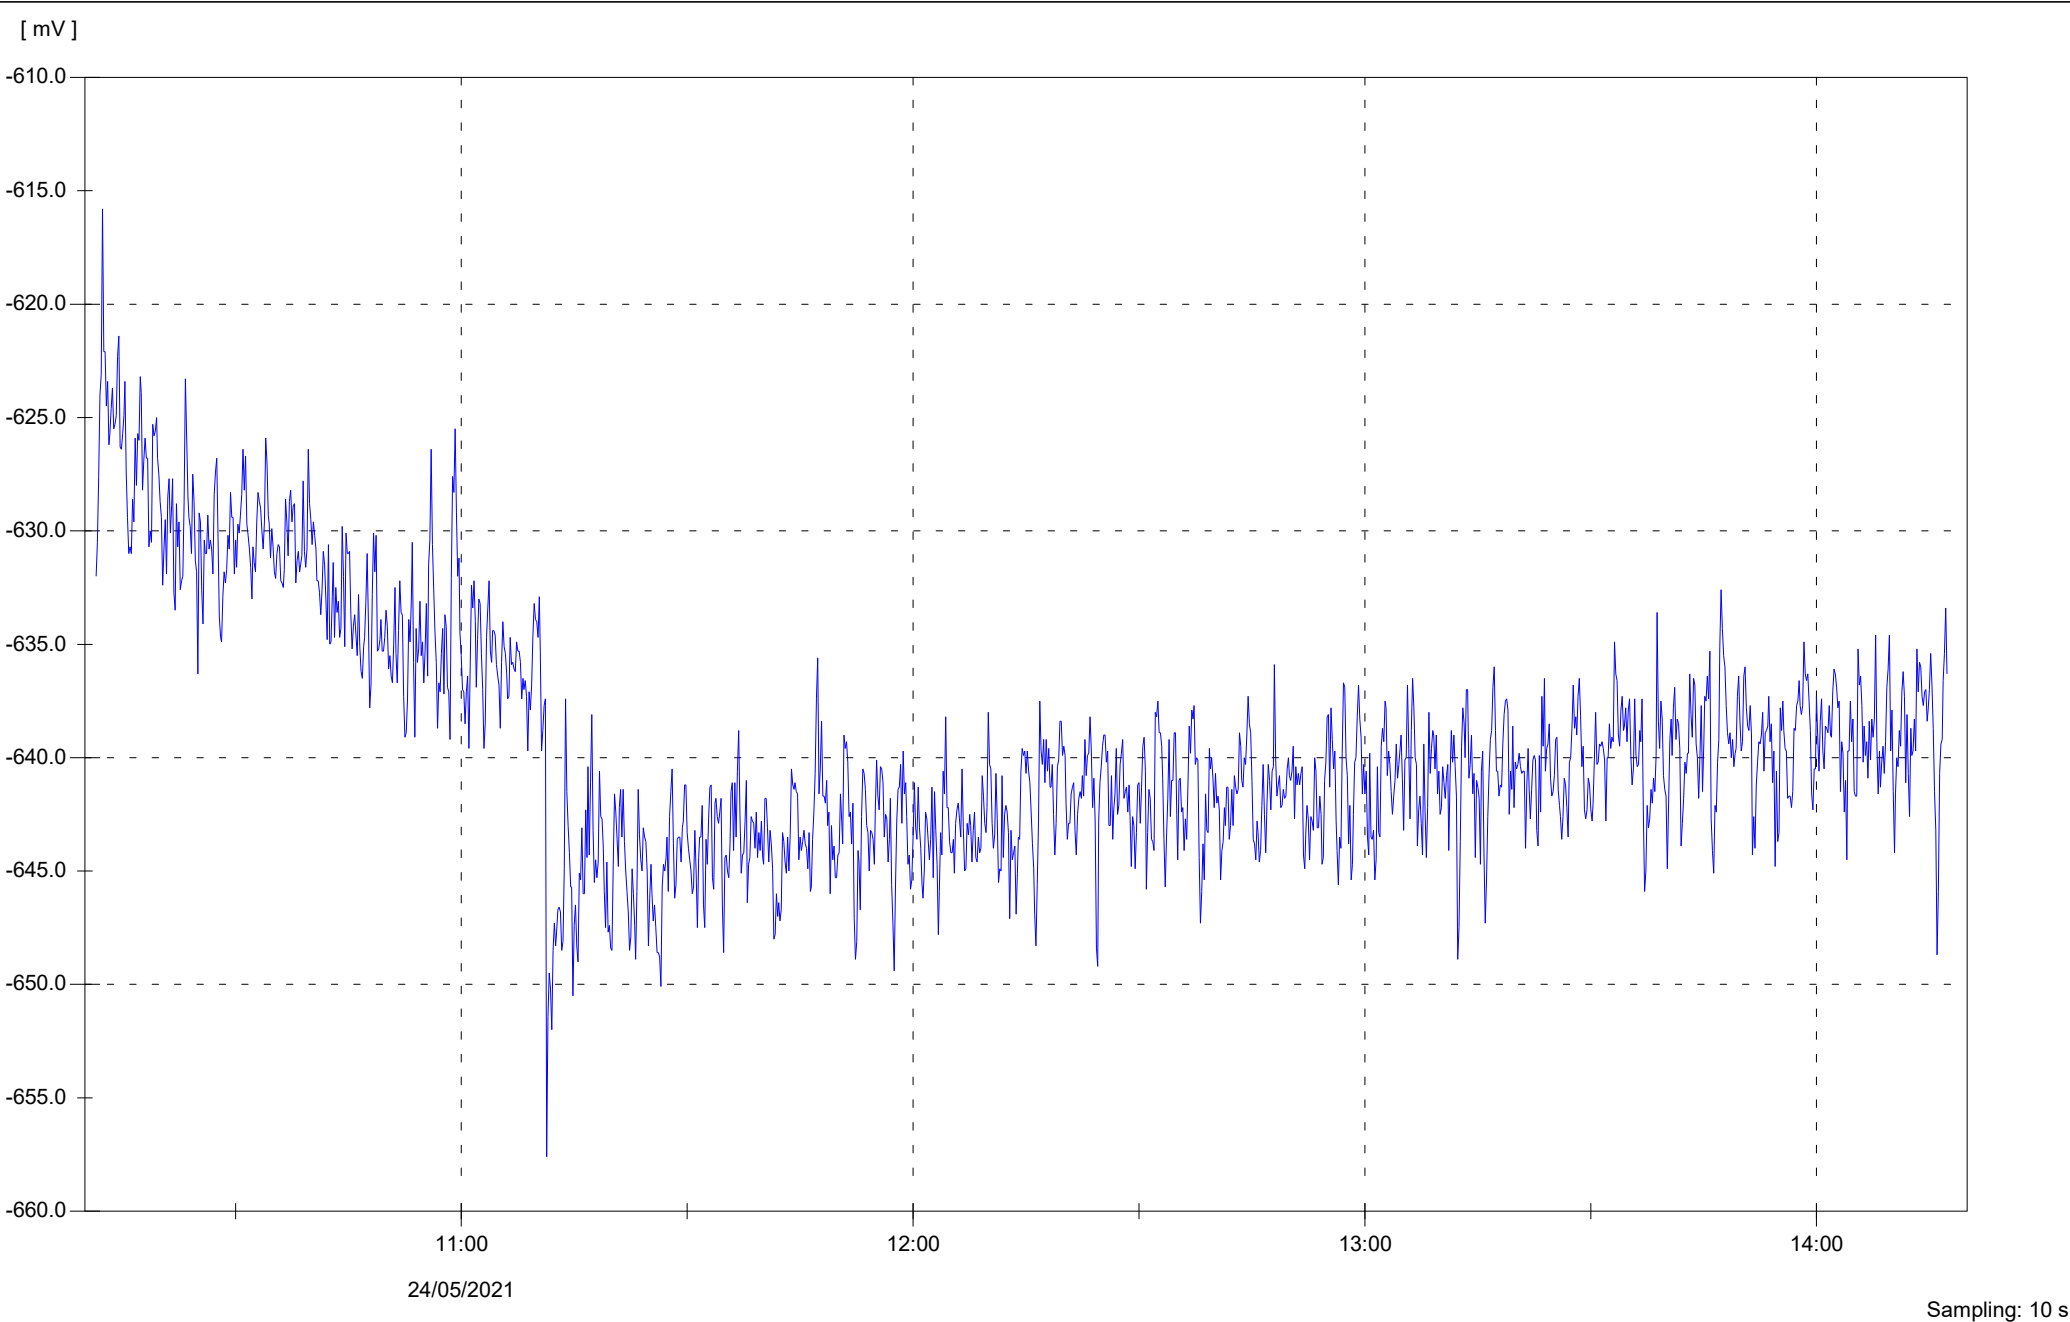
**Electrolysis Test**  
**12 Sturt Street, Telopea**  
**Logger Serial Number: 2734**  
**North to South**

1. The logger chart for the steel earth stakes across the north-south length of site shows minor traction current effects.
2. The logger chart for the steel earth stakes across the east-west width of site shows minor traction current effects.
3. The logger chart for the railway fence shows minor traction current effects.
4. The logger chart for the water meter shows minor traction currents effects.

Min	Max	Average	Std. dev.
DC 1	-0.658 V	-0.616 V	-0.639 V	0.005 V

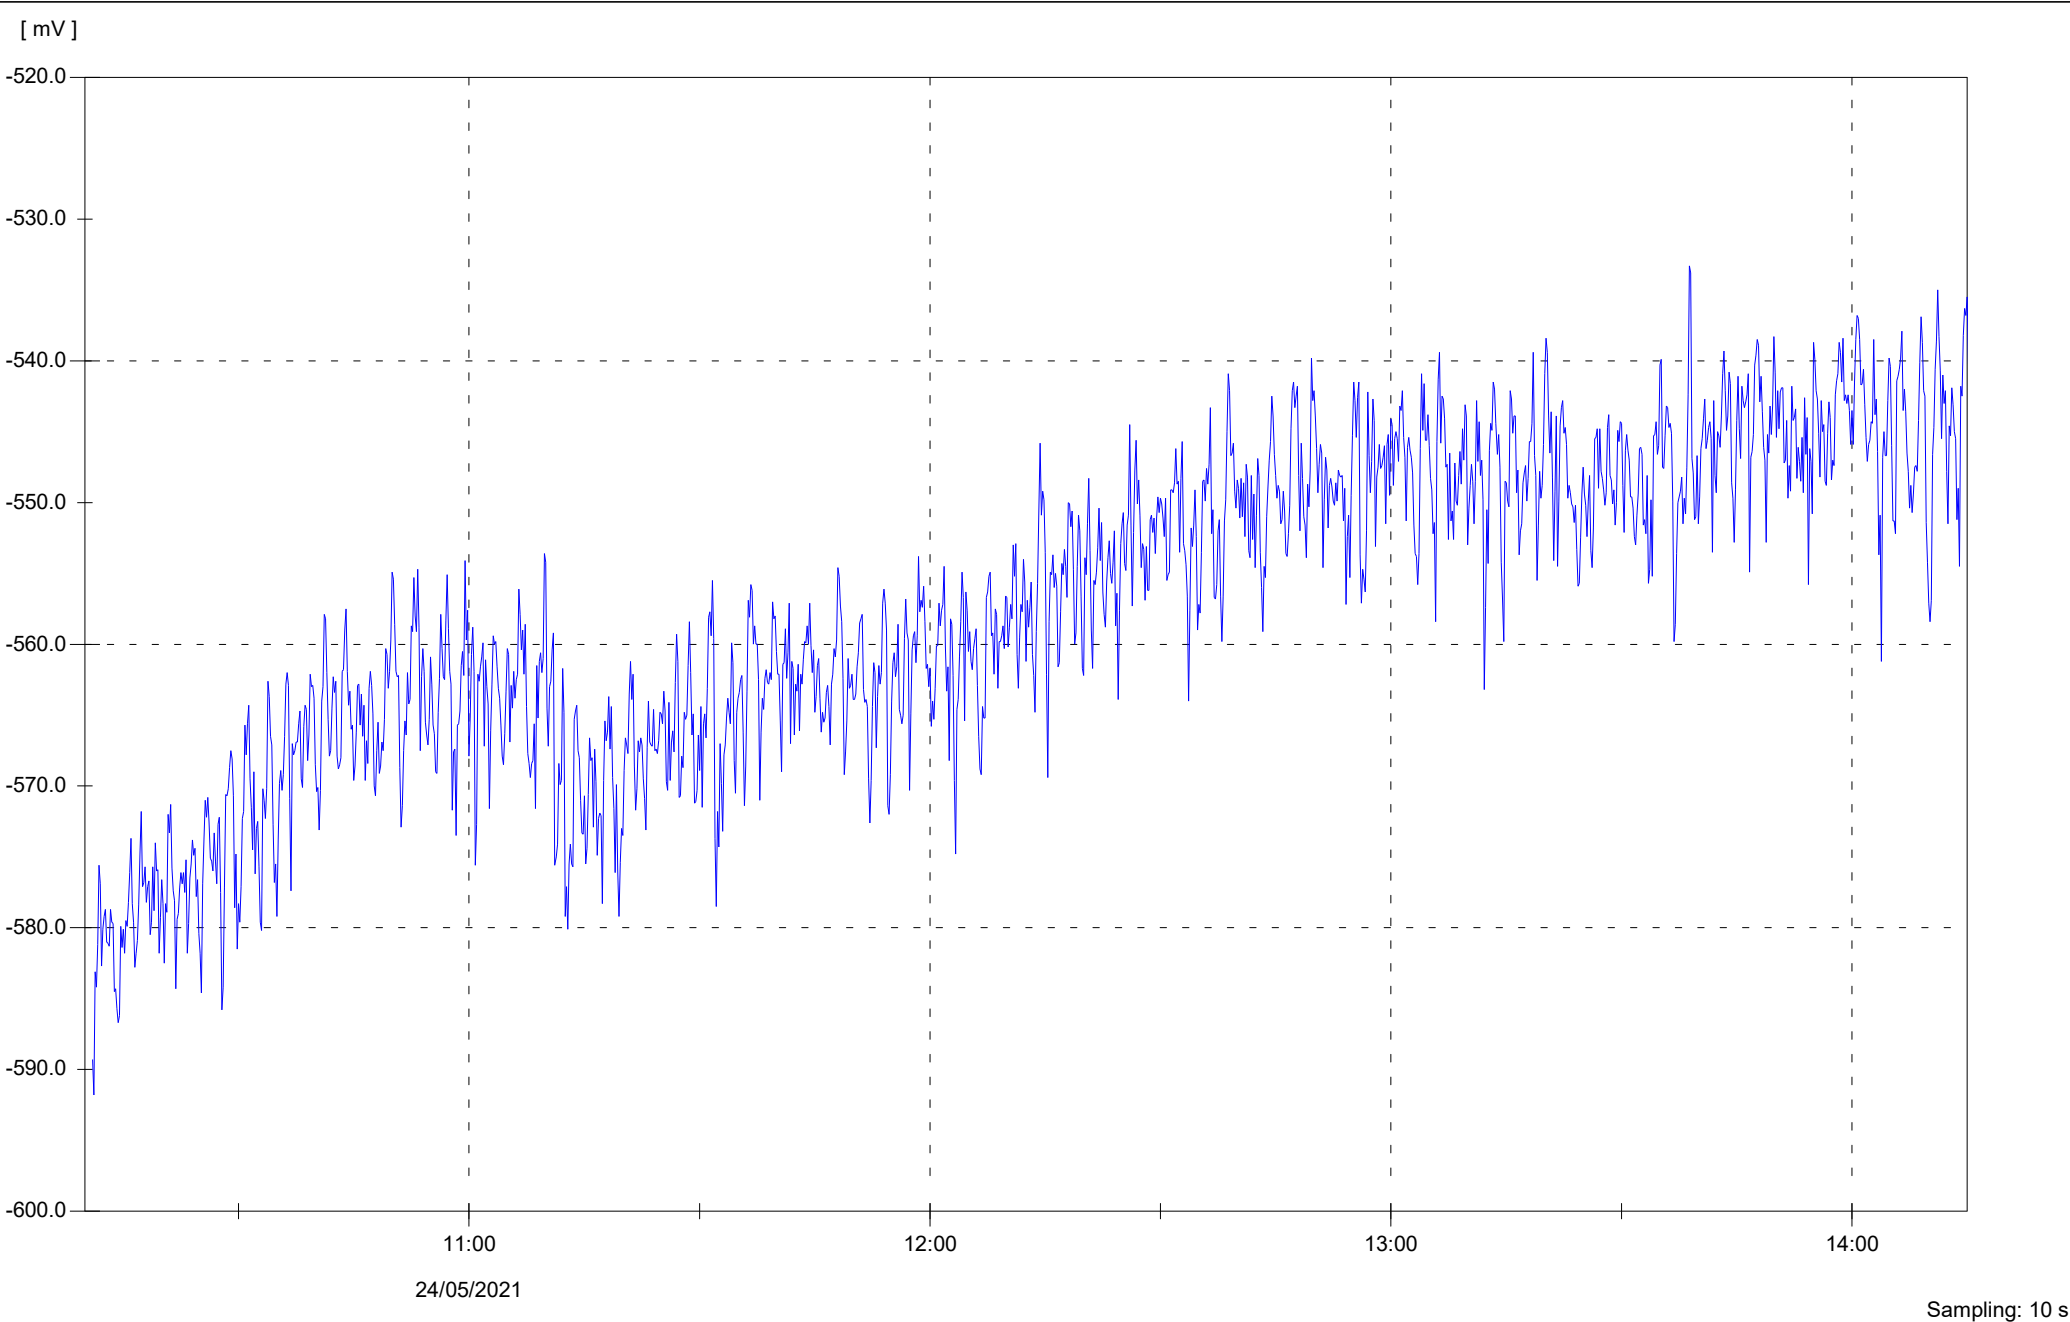
**Electrolysis Test**  
**12 Sturt Street, Telopea**  
**Logger Serial Number: 2731**  
**East to West**

Min	Max	Average	Std. dev.
DC 1	-0.592 V	-0.533 V	-0.557 V	0.011 V

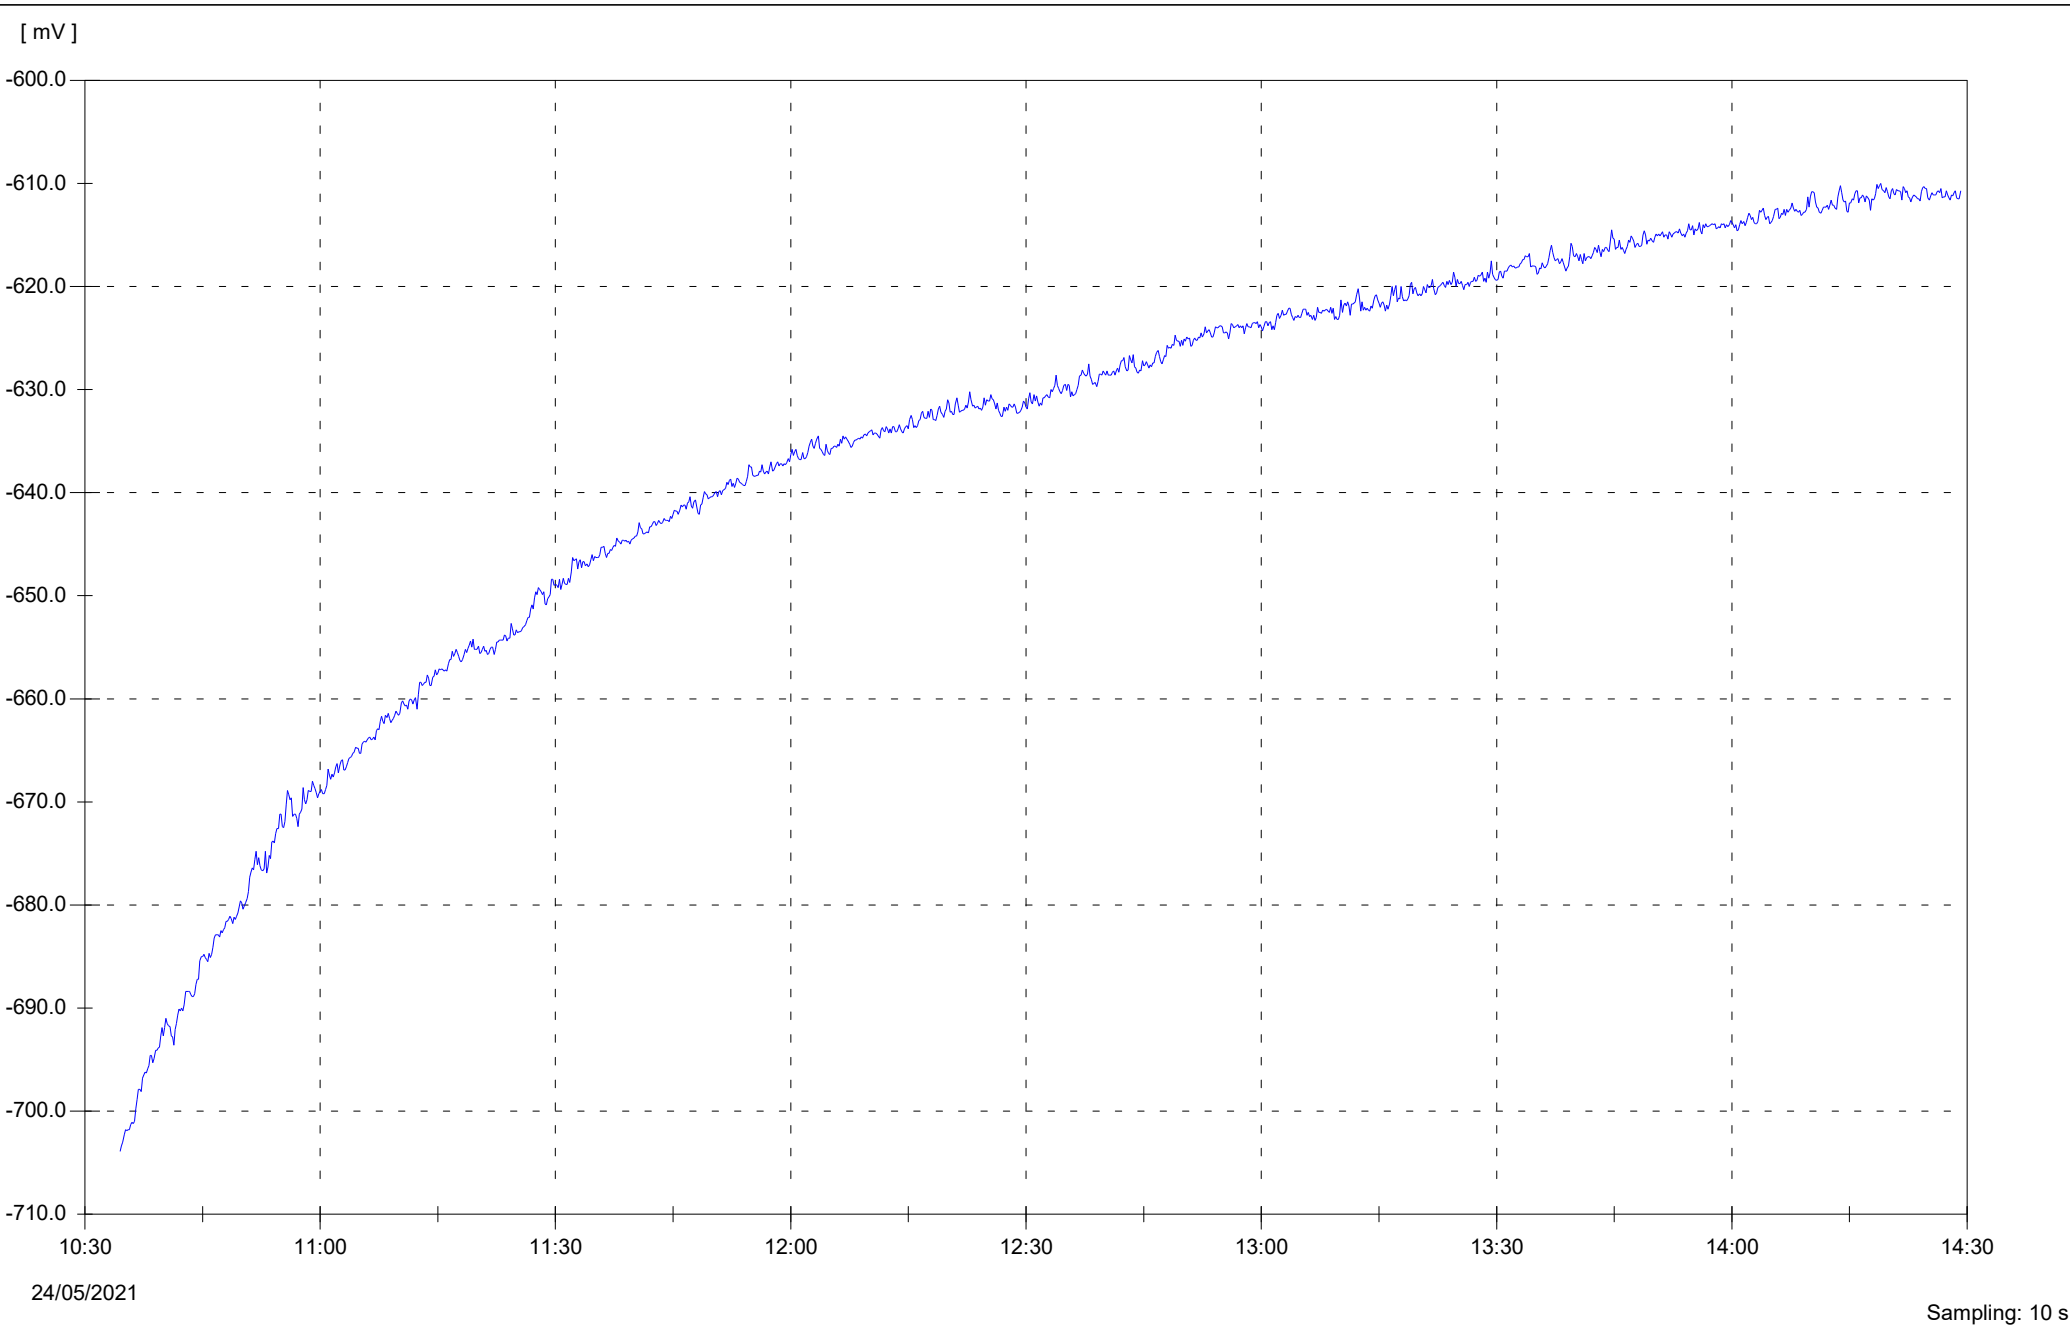
**Electrolysis Test**  
**12 Sturt Street, Telopea**  
**Logger Serial Number: 2732**  
**Railway Fence**

Min	Max	Average	Std. dev.
DC 1	-0.704 V	-0.610 V	-0.636 V	0.022 V

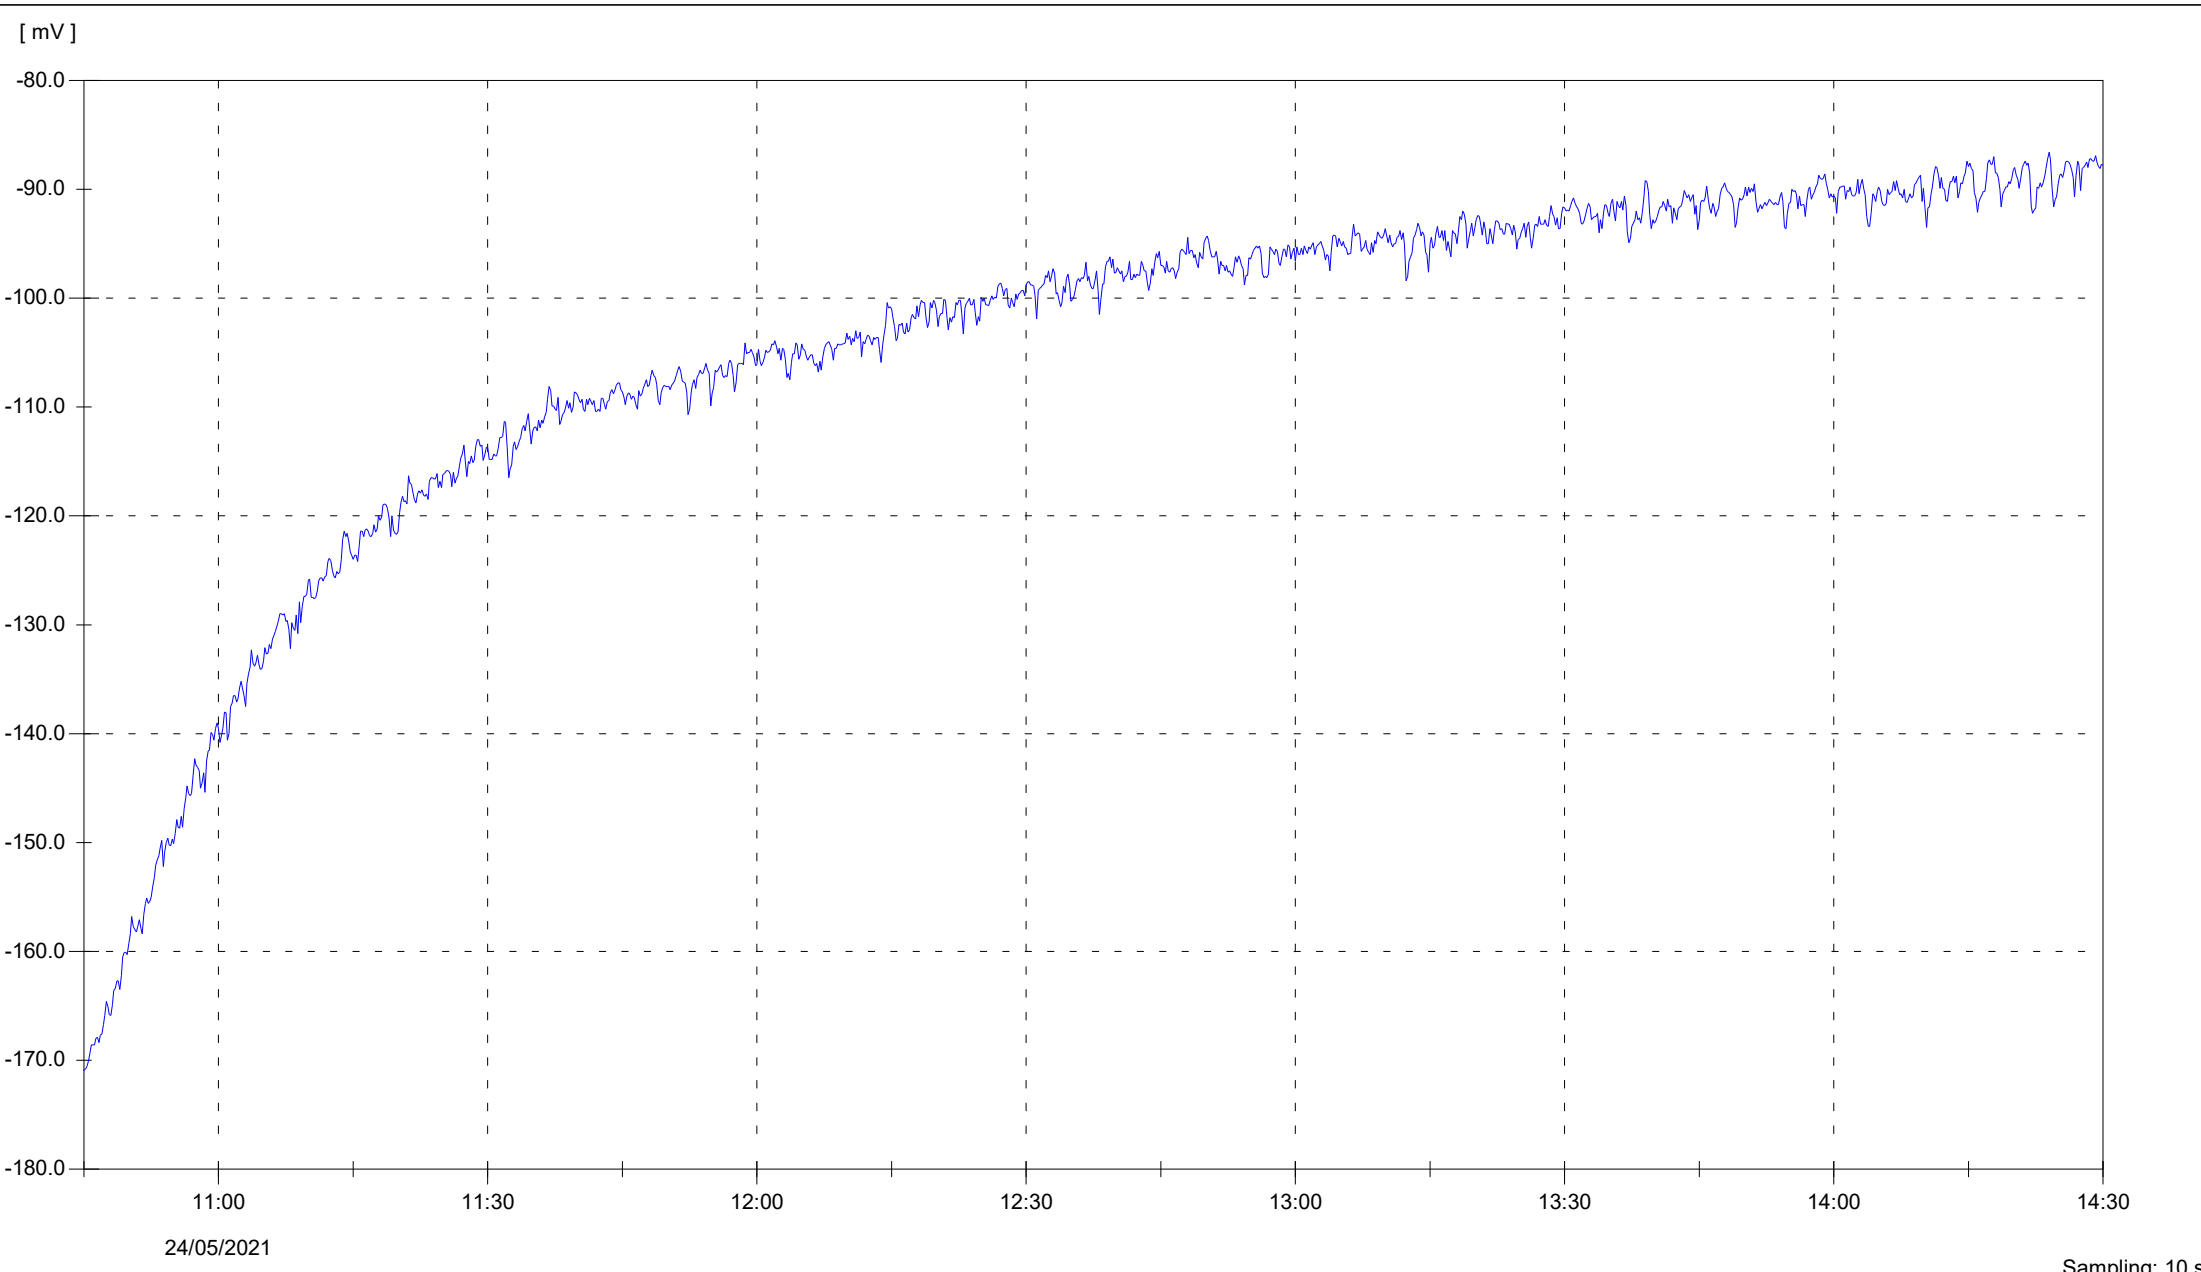
**Electrolysis Test**  
**12 Sturt Street, Telopea**  
**Logger Serial Number: 2747**  
**Water Service**

Min	Max	Average	Std. dev.
DC 1	-170.9 mV	-86.6 mV	-104.9 mV	17.7 mV
