Arborist Assessment Report

PROJECT: SSD-21854025 Wee Waa High School

Site Address: 105-107 Mitchel Wee Waa NSW

Date of Inspection: 16th February 2022

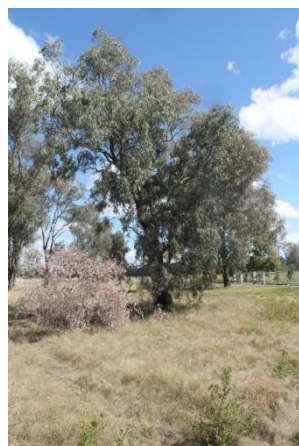
TREE 13

Coolibah								HIGH	
13	In Build Zone	Eucalyptus <i>microtheca</i> Coolibah	10	40/30	7	Mature good condition but poor form Lowest branch section failed	70	N/A	N/A	D2 Medium	REMOVE TREE & REPLANT
13A	In Build Zone	Eucalyptus <i>microtheca</i> Coolibah	8	20	3	Semi Mature Moderate condition	28	N/A	N/A	A2 High	REMOVE TREE & REPLANT
14	Not affected	Eucalyptus <i>microtheca</i> Coolibah	10	50/30/15	8	Mature good condition, structure good	80	3.0	7.0	A2 HIGH	RETAIN
14A-	Not affected	Eucalyptus <i>microtheca</i> Coolibah	10	30	5	Mature good condition, structure good	45	2.3	3.6	A2 HIGH	RETAIN
14B-G	X6 In Build Zone	Eucalyptus <i>microtheca</i> Coolibah	10	30	5	Mature good condition structure good		N/A	N/A		REMOVE TREE & REPLANT
15	Not affected	Eucalyptus <i>microtheca</i> Coolibah	12	35	5	Mature good condition, structure good	40	2.2	4.2	A2 HIGH	RETAIN
15A	Not affected	Eucalyptus <i>microtheca</i> Coolibah	10	40	6	Mature good condition, structure good	40	2.2	4.8	A2 HIGH	RETAIN

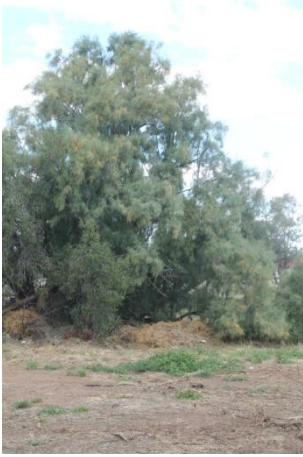
TREE 30C

Coolibah								HIGH	
39C	In Build Zone	Tamarix <i>aphylla</i> Athel Pine	8	multi	10	Mature moderate, structure fair identified as an Invasive weed species	70	N/A	N/A	D3 LOW	Identified invasive weed species REMOVE TREE
40	Not affected	Eucalyptus <i>microtheca</i> Coolibah	12	60	8	Mature good condition, structure good leans to southeast	80	3.0	7.2	D3 HIGH	Prune dead section RETAIN
41	In Build Zone	Geijera <i>parviflora</i> Wilga	8	multi	8	Mature moderate condition poor form borer attack	70	N/A	N/A	D3 MEDIUM	REMOVE TREE & REPLANT
42	In Build Zone	Eucalyptus <i>microtheca</i> Coolibah	10	30x3	8	Mature moderate condition poor form	80	N/A	N/A	A2 HIGH	REMOVE TREE & REPLANT
43	Not affected	Eucalyptus <i>microtheca</i> Coolibah	10	20x3	5	Mature moderate condition poor form	50	2.4	4.2	A2 N/A	RETAIN
44	Not affected	Eucalyptus <i>microtheca</i> Coolibah	10	40	6	Mature good condition, structure good	50	2.4	4.8	A2 N/A	RETAIN

- 7 The development approval must include a tree planting programme to replace the trees of the same species that are being removed being removed to maintain the biodiversity of the site. (*This excludes Tree 39C which is an invasive species*).

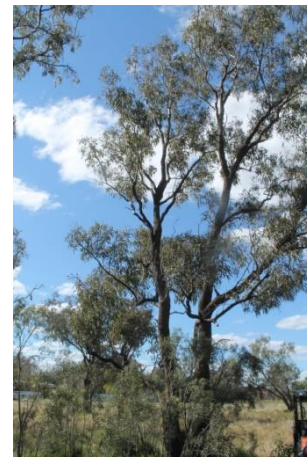
TREE 45

45	Not affected	Eucalyptus <i>microtheca</i> Coolibah	10	30/30	7	Mature moderate condition, inclusion @ base OK	60	2.7	4.2	D3 HIGH	RETAIN
46	Not affected	Eucalyptus <i>microtheca</i> Coolibah	10	70	8	DEAD several small hollows observed. HABITAT TREE	N/A	6.0	N/A	C4 HIGH	RETAIN, IF POSSIBLE, if removed condition habitat boxes installed in adjacent trees
47x4	Not affected	Eucalyptus <i>microtheca</i> Coolibah	10	30	6	Semi mature good condition, some damage at base and union	40	2.2	3.6	D3 HIGH	RETAIN
48	Not affected	Geijera <i>parviflora</i> Wilga	12	40/40	8	Mature moderate condition borer attack decay in trunk. Leans to south tree appears to be declining in health & vigour review in 6	60	2.6	6.8	D3 Medium	RETAIN review tree status in 6 months' May have implications on

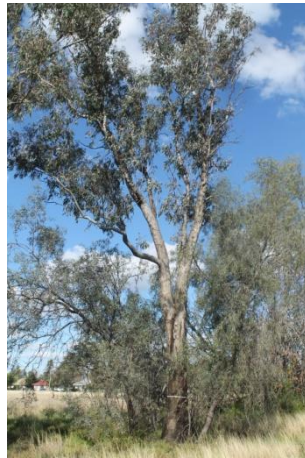
TREE 53

53	Not affected	Eucalyptus <i>microtheca</i> Coolibah	12	60	7	Mature poor condition, structure moderate developing epicormics, tree declining	60	2.7	7.2	D3 HIGH	RETAIN
53A Group 5	Not affected	Melia <i>azedarach</i> White Cedar	10	multi	6	Mature moderate condition structure OK seasonal leaf cover not present, review in 3 months for vigour	40	2.2	4.8	D2 MEDIUM	RETAIN
54	In Build	Eucalyptus <i>microtheca</i>	12	60	9	Mature good condition, structure	85	N/A	N/A	A2	REMOVE TREE & REPLANT
