**ANGEL PLACE
LEVEL 8, 123 PITT STREET
SYDNEY NSW 2000**

ADINA CENTRAL, 2 LEE STREET, HAYMARKET - SCHEDULE OF CONSERVATION WORKS (INTERIOR ONLY)

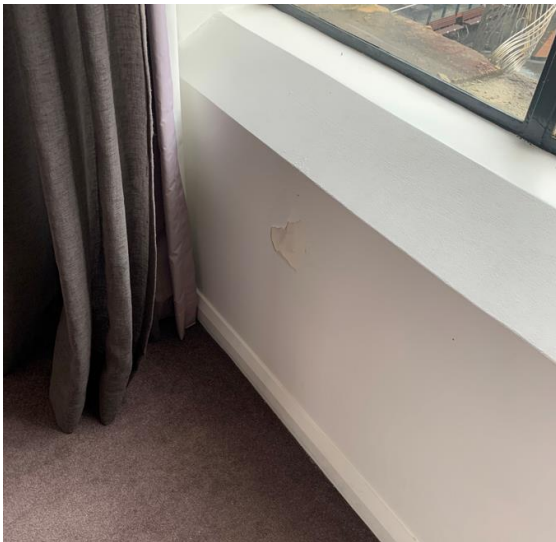
Figure 1 Minor paint peeling noted in Unit 10 (Level 1).

- Cracking and peeling paint and the minor presence of mould throughout are assumed to be predominantly addressed in conjunction with the removal of all existing internal fit out and subsequent redevelopment of the building internally. Following rectification of any structural issues and external conservation issues, the interior faces of all external walls are to be inspected and paint patched throughout in approved colours as required.

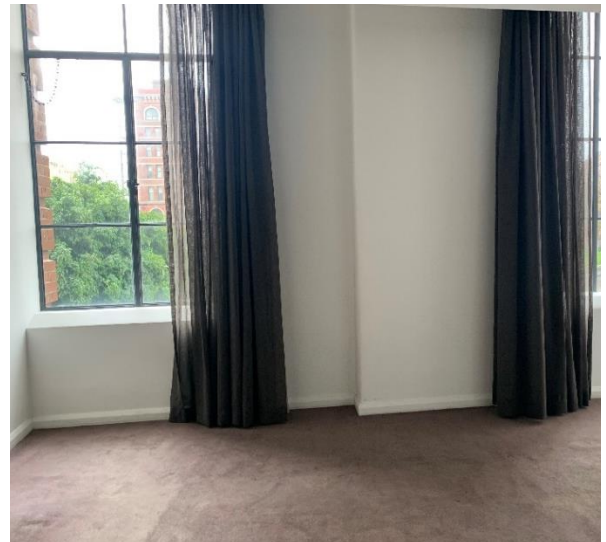
Figure 2 General condition of original structural fabric as noted in Unit 10 (Level 1).

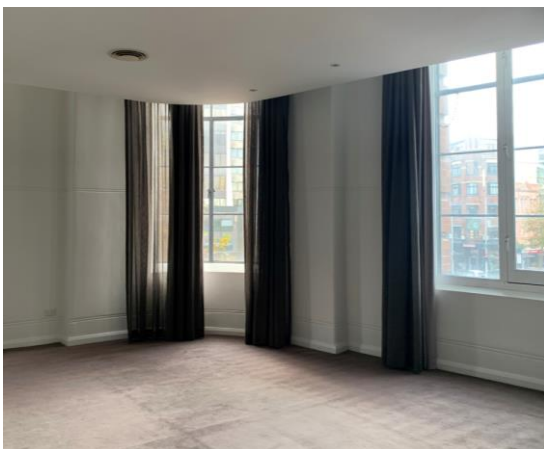
Figure 3 General condition of original structural fabric as noted in Unit 6 (Level 1).

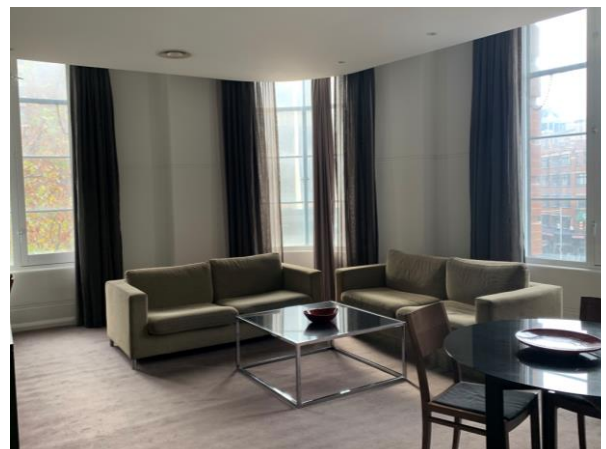
Figure 4 General condition of original structural fabric as noted in Unit 19 (Level 2).

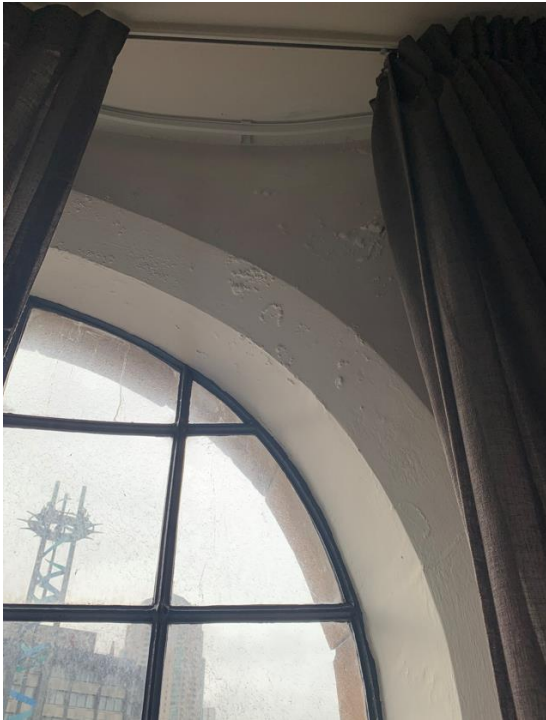
Figure 5 Detail view to minor paint bubbling to window interior within Unit 38 (Level 3).

- Bubbling paint indicates potential damp near ceiling height at Level 3 as pictured above. Paint to the area to be carefully removed from a minimum area of 2000mm around visible evidence of damp. Where further evidence of damp is in exposed areas remove paint from an additional surrounding 1000mm. HC to inspect with suitably qualified engineer to diagnose cause of damp, extent of damage to plaster and masonry, and appropriate further action. Following completion of all remediation/conservation works to area, allow to refinish in a method agreed with HC TMO.

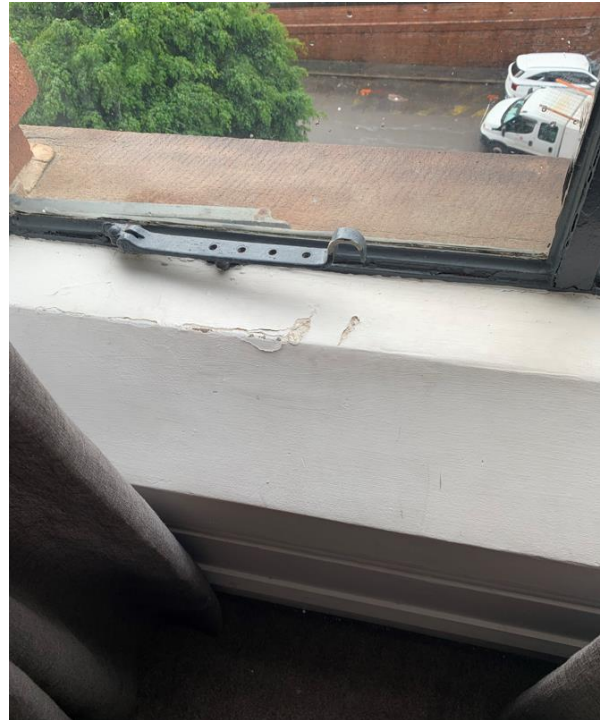
Figure 6 Detail view to minor paint flaking and peeling to window interior within Unit 42 (Level 3).

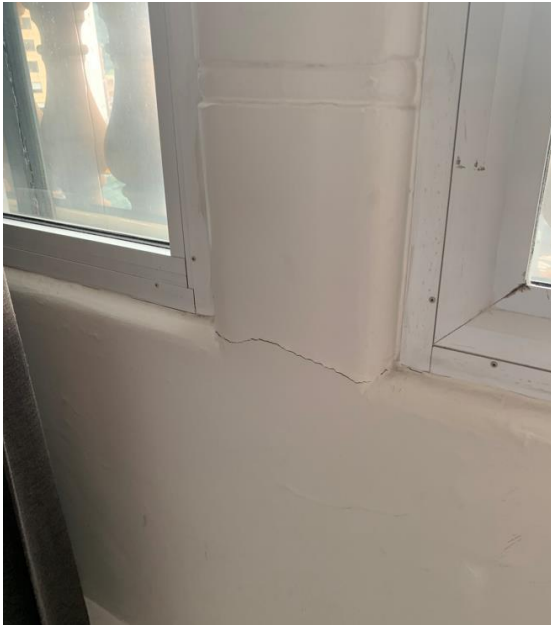
Figure 7 Detail view to minor paint cracking to original fabric wall in Unit 62 (Level 4).

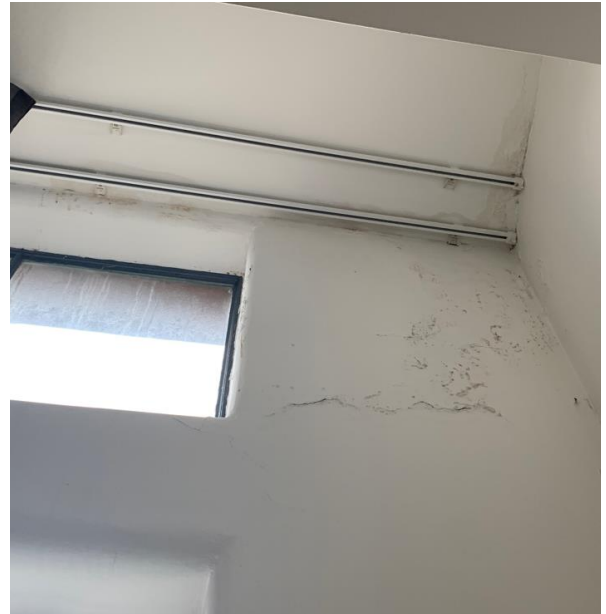
Figure 8 Detail view to minor water damage and mould within Unit 73 (Level 5).

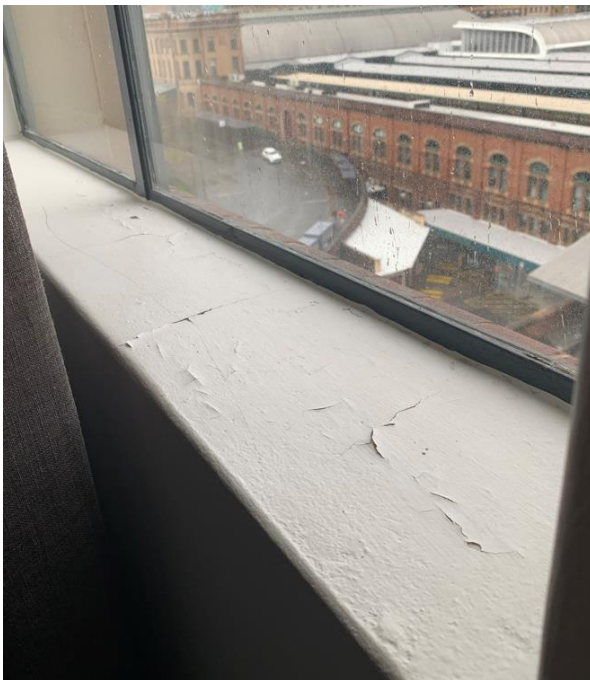
Figure 9 Detail view to minor paint flaking to window interior within Unit 77 (Level 5).

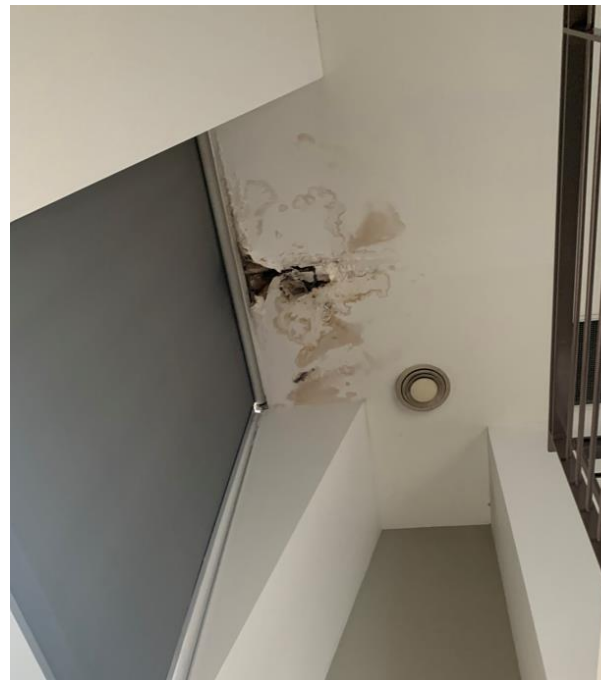
Figure 10 Detail view to water damage to later addition fabric within Unit 90 (Level 6).
