1527 – Former Department of Lands Building

22-33 Bridge Street, Sydney

Trial Salvage & Prototype Off Site Repair and Reinstatement Report

Report A – TRIAL SALVAGE

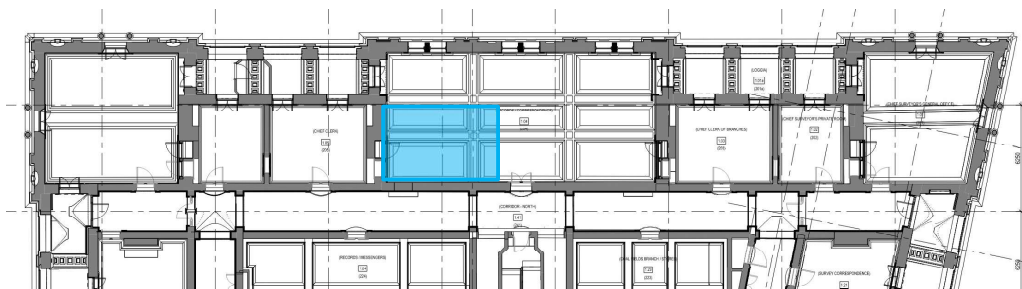
This report covers the salvaging process outlined in Item A above. A location for the prototyping works has been chosen in a separate room (Refer to Image 1.2 below) in which, due to the previous spontaneous collapse of similar cornices and decorative beams mouldings the fabric is deemed to already compromised and therefore provides a unique opportunity to confirm the methodology previously submitted. A larger and more comprehensive report is to be progressively compiled whilst working through the remaining three processes and shall be issued as soon as each of the subsequential processes are completed.

**IMAGE 1.2 – Proposed Location of Prototype ‘Lathe & Plaster’ Cornice Salvage**

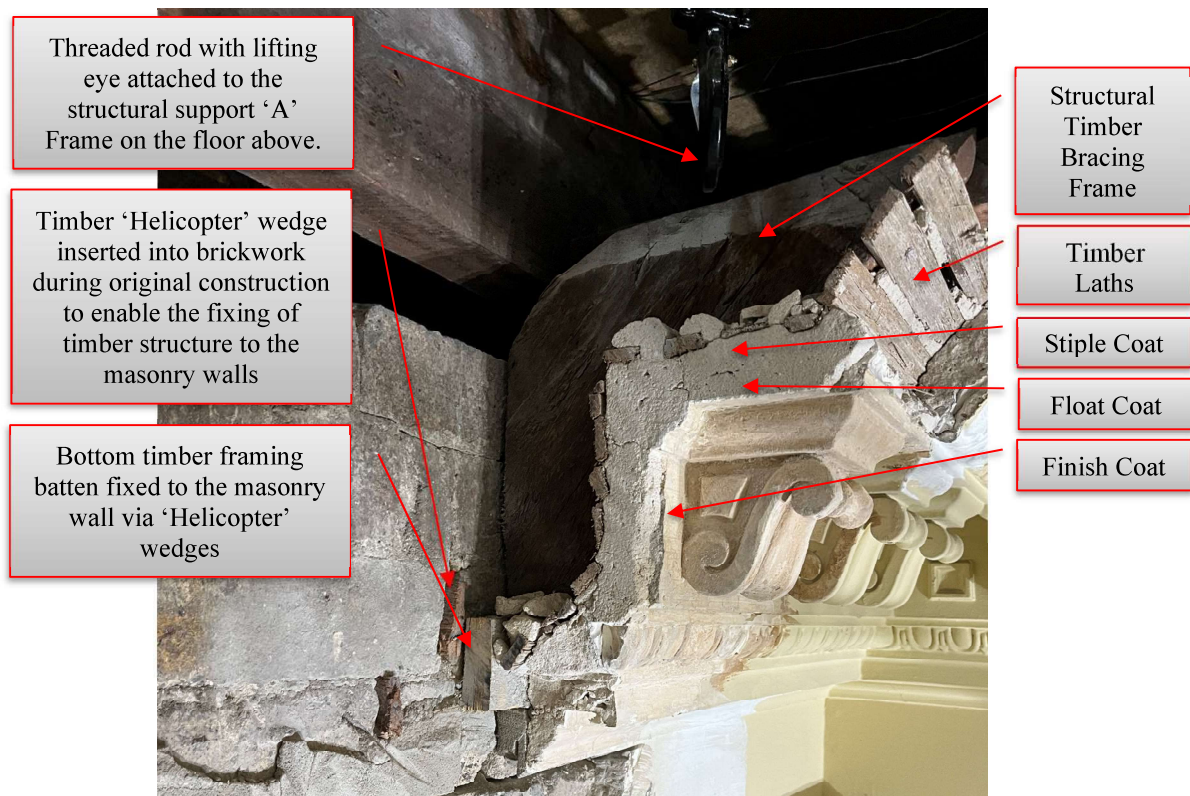
The integrity of the build up is not based on any cement (Strong Hydraulic Lime) which modern construction would expect to use to secure the materials into place. The ceilings are usually fragile, subject to structural failure as a consequence of the sheering off or fracturing of the plaster 'Keys' by builders, tradesman and homeowners attempting to access subfloor cavities for services OR movement and vibration due to building works or seismic events.

The cornice, in the case of the Lands Department Building and this prototype work, is constructed in the same manner (Refer to Image 1.4 below).

IMAGE 1.4 – Remnant compromised cornice in the prototype room

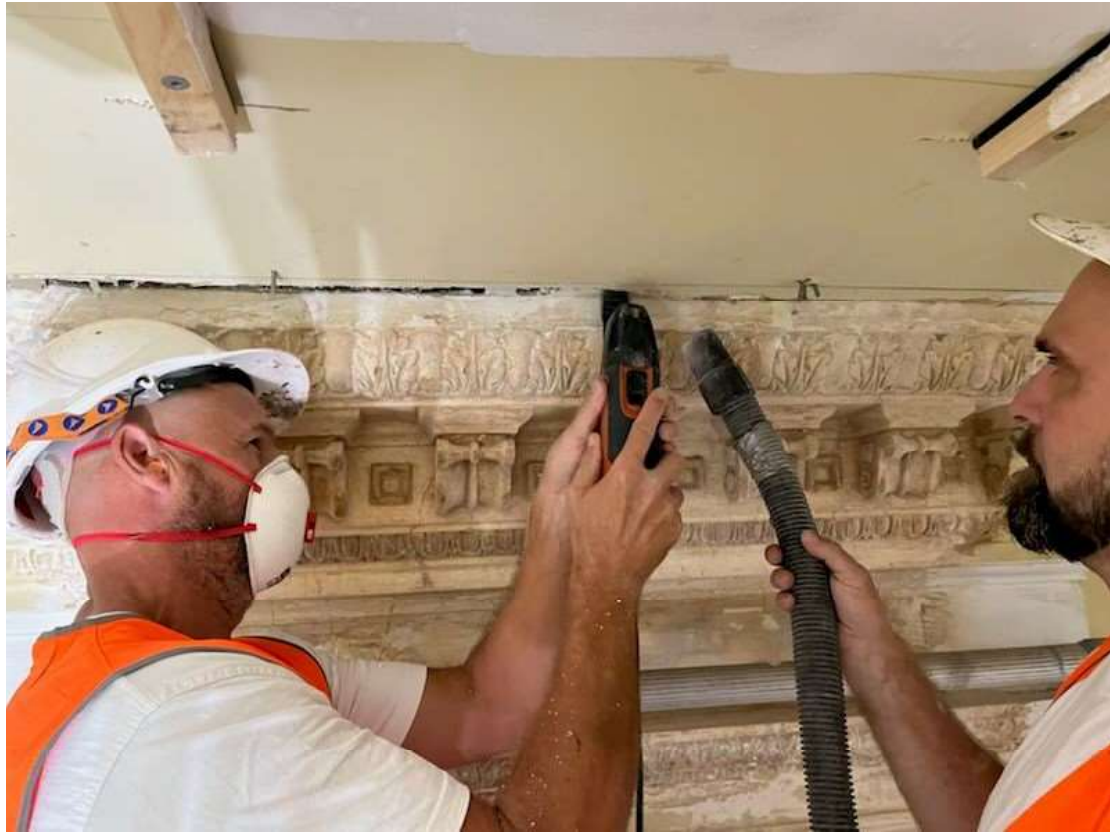
A strip of the lime ceiling plaster was gently cut and successfully removed from the ceiling exposing the timber lathes. The lifting system was adjusted and tensioned to ensure that as closely as can be determined, the full weight of the cornice was being taken up by the lifting system. The timber lathes were then cut using an oscillating tool fitted with a timber blade. This completed the disconnection of the cornice from the wall and ceiling.

IMAGE 1.4 – Oscillating cutter being used to cut through timber lathes

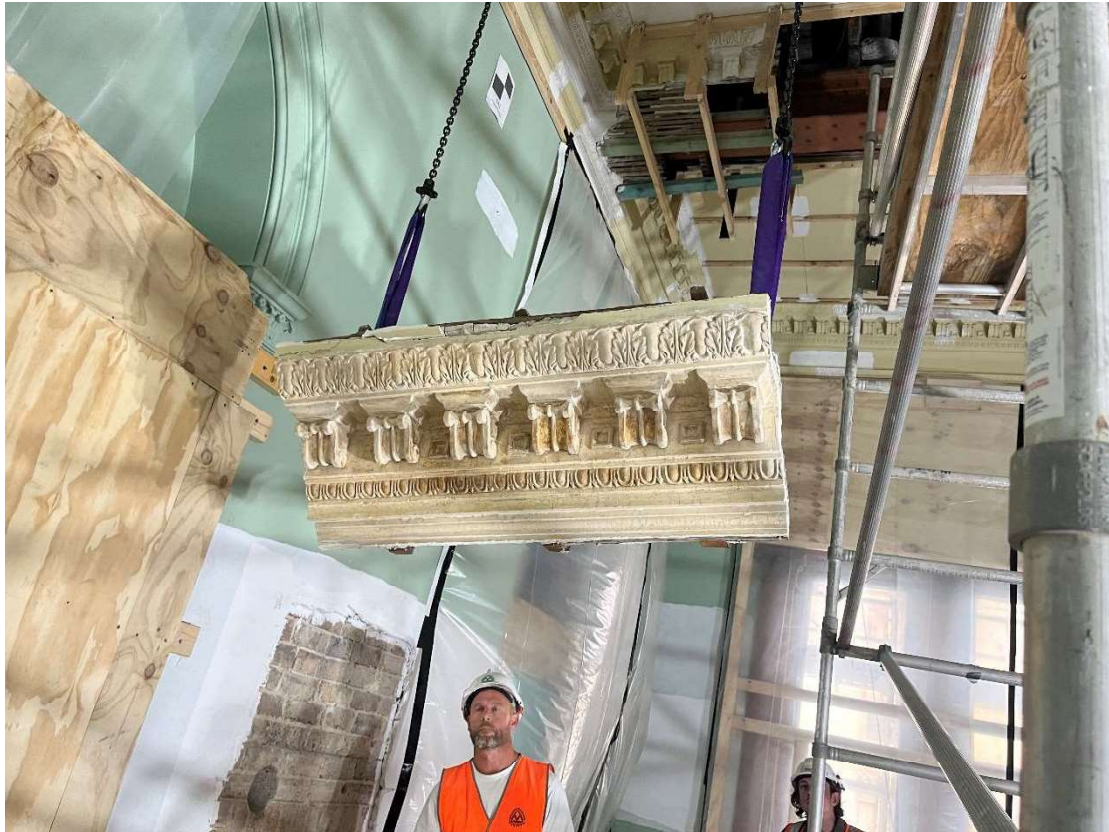
IMAGE 1.5 – Salvaged Cornice from Beams being lowered to the floor below

The coffered beam lathe and plaster was salvaged without any incident or breakage and is considered by TRC to be easier to remove than the cornices on the masonry walls, as the structural timber frame was not attached to the steel beam and only wedged in place. This makes the coffered beam cornice and moulded linings more fragile and subject to spontaneous detachment if disturbed by vibration, flexural movement or impact whilst presenting a more certain success for salvage if removed early before being disturbed.
