# Arboricultural Impact Assessment

Site Address: 10 Lomas Lane Nulkaba, NSW

Client: St Philips Christian College

Date: December 2024 (Amendment)

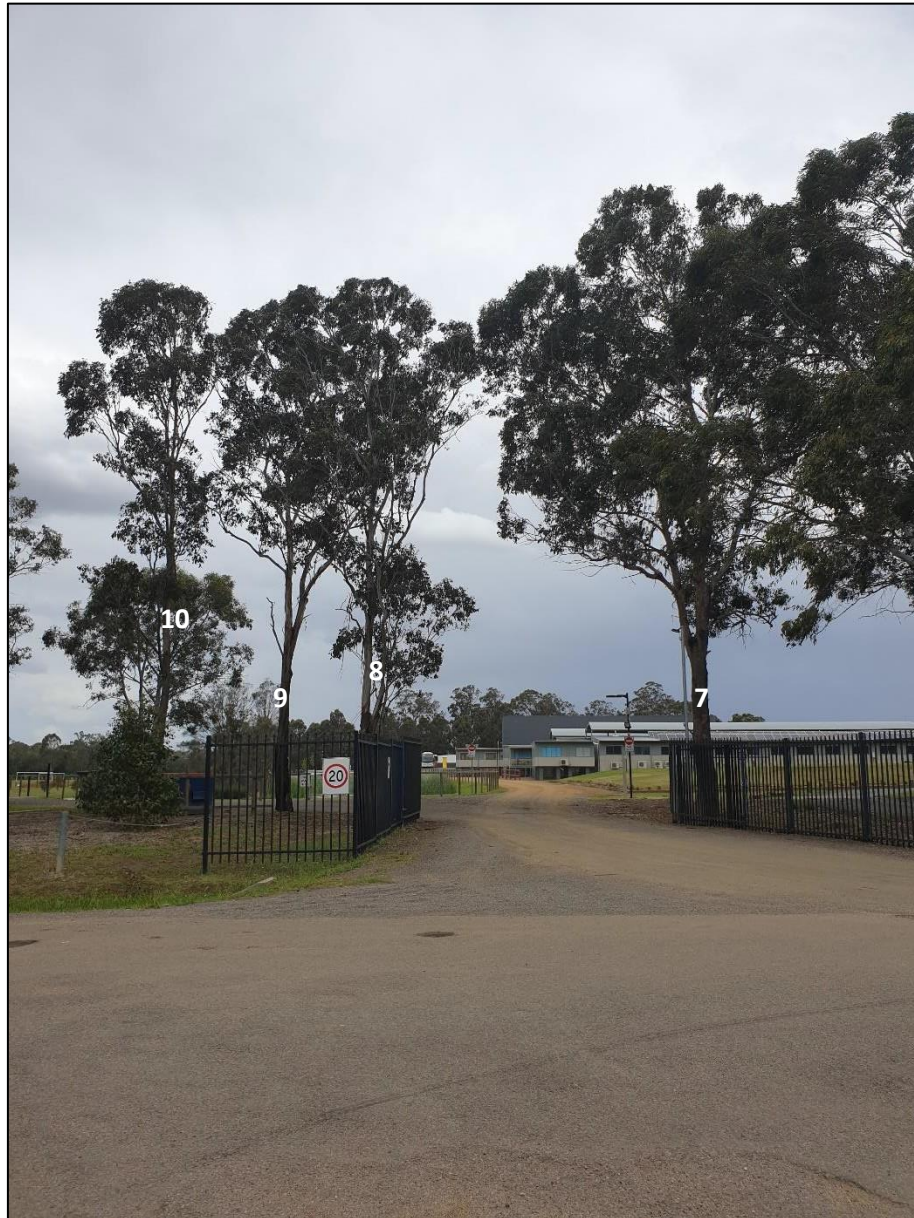
Figure 1 Trees 7 – 10 *Eucalyptus moluccana* adjacent to the site entry

| No | Common Name | Species | DBH (M) | TPZ (M) | SRZ (M) | HEIGHT (M) | SPREAD (M) | Vigour | Age Class | SULE | Comments |
|---|---|---|---|---|---|---|---|---|---|---|---|
| 7 | Grey Box | <i>Eucalyptus moluccana</i> | 0.56 | 6.72 | 2.81 | 20 | 11 | g | m | 2a | Minor deadwood noted, canopy bias to South |
| 8 | Grey Box | <i>Eucalyptus moluccana</i> | 0.38 | 4.56 | 2.43 | 18 | 10 | g | m | 2a | Minor deadwood noted, otherwise appears structurally sound |
| 9 | Grey Box | <i>Eucalyptus moluccana</i> | 0.5 | 6 | 2.74 | 18 | 9 | av | m | 3a | Sparse canopy, wound seam at base |
| 10 | Grey Box | <i>Eucalyptus moluccana</i> | 0.31 | 3.72 | 2.37 | 12 | 5 | av | sm | 2a | Minor deadwood noted suppressed by nearby trees |

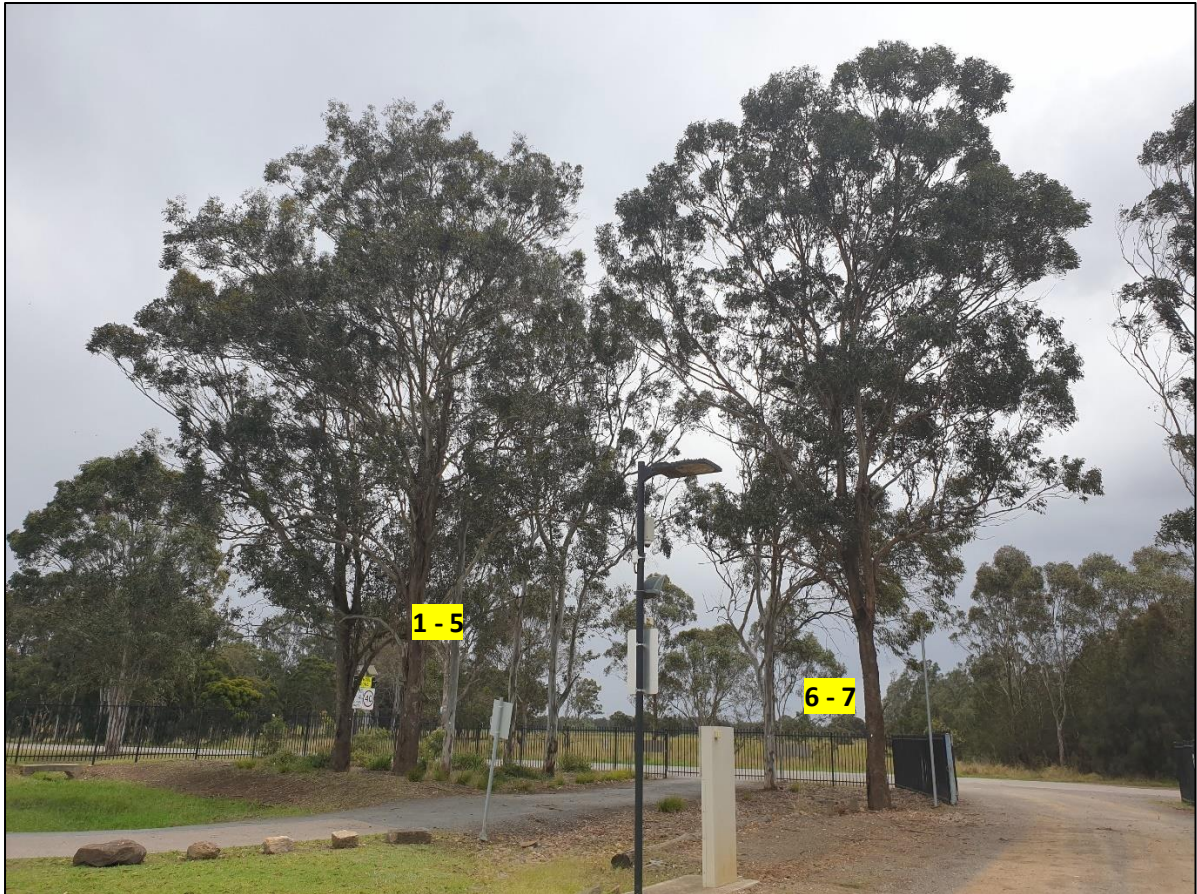
| No | Common Name | Species | DBH (M) | TPZ (M) | SRZ (M) | HEIGHT (M) | SPREAD (M) | Vigour | Age Class | SULE | Comments |
|---|---|---|---|---|---|---|---|---|---|---|---|
| 6 | Forest Red Gum | <i>Eucalyptus tereticornis</i> | 0.4 | 4.8 | 2.43 | 15 | 11 | g | m | 2a | Minor deadwood noted, canopy bias to North. |

| No. | Species | Health and Vigour | Condition | Suitability | Sustainability | Landscape rating | Retention Value | Encroachment level* | Proposal |
|---|---|---|---|---|---|---|---|---|---|
| 6 | <i>Eucalyptus tereticornis</i> | Good | Good | High | 15-40 years | 2 | High | 10% TPZ | Retention |
| 7 | <i>Eucalyptus moluccana</i> | Good | Good | High | 15-40 years | 2 | High | 50% TPZ<br>50% SRZ | Removal |

**Figure 3 Trees 6 – 7 will be subject to encroachment from construction of the proposed roadway**

That Trees 7-9, 11, 12 and 24-27 are approved for removal to facilitate the proposed development in its current form subject to the provision of compensatory replacement planting of endemic native trees within the boundary of the subject site.

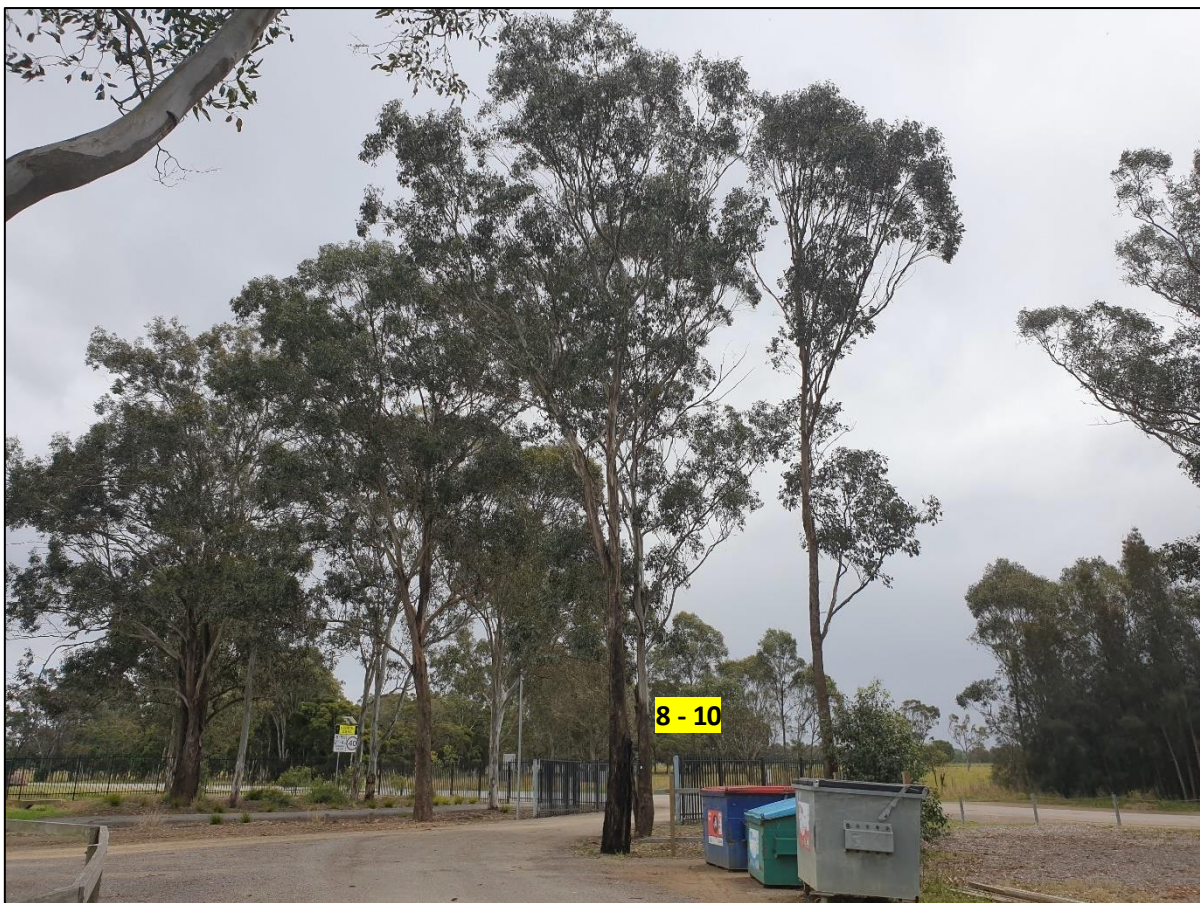
| No. | Species | Health and Vigour | Condition | Suitability | Sustainability | Landscape rating | Retention Value | Encroachment level* | Proposal |
|---|---|---|---|---|---|---|---|---|---|
| 8 | <i>Eucalyptus moluccana</i> | Good | Good | High | 15-40 years | 2 | High | 60% TPZ/SRZ | Removal |
| 9 | <i>Eucalyptus moluccana</i> | Average | Good | High | 5-15 years | 3 | Moderate | 100% TPZ/SRZ | Removal |
| 10 | <i>Eucalyptus moluccana</i> | Average | Good | High | 15-40 years | 2 | High | 10% TPZ | Retention |

**Figure 4 Trees 8- 10 will be subject to encroachment from construction of the proposed roadway**

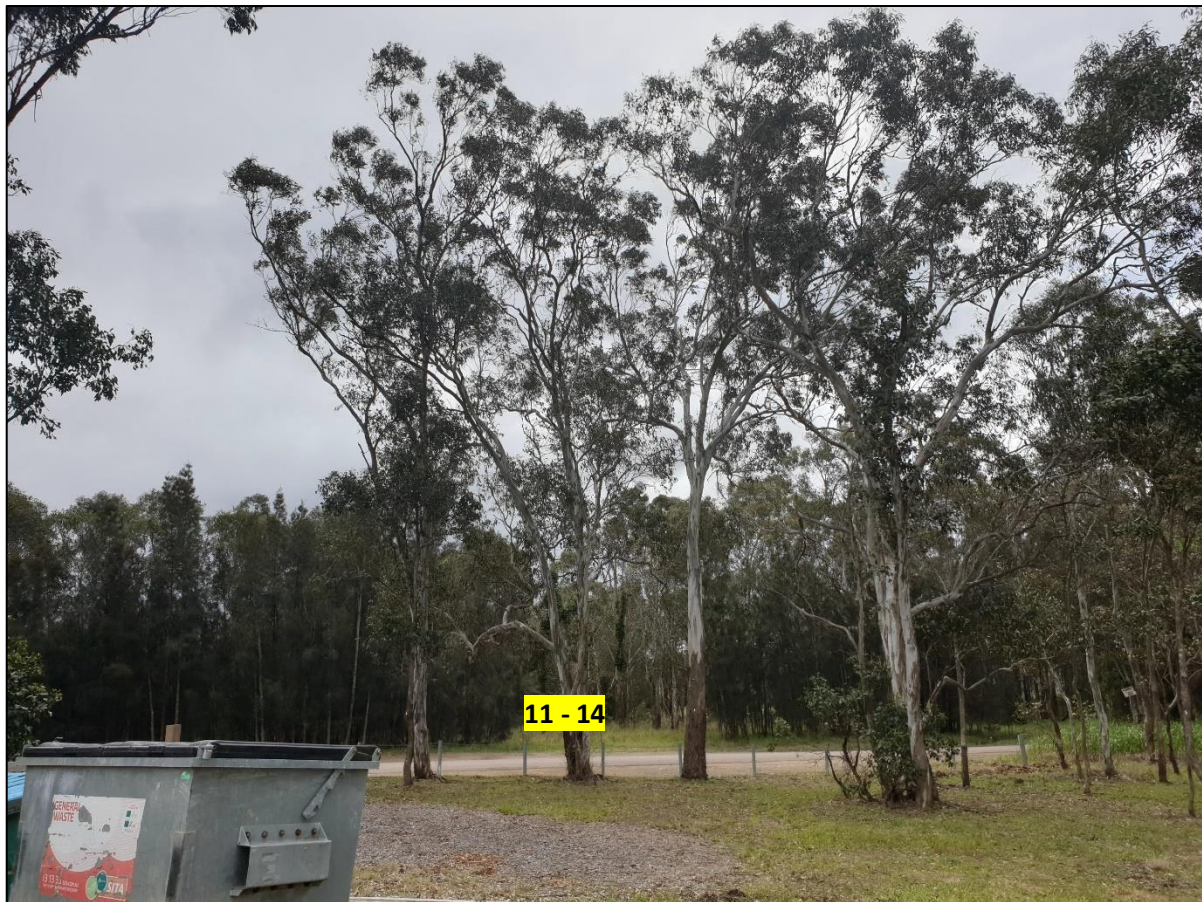
| No | Common Name | Species | DBH (M) | TPZ (M) | SRZ (M) | HEIGHT (M) | SPREAD (M) | Vigour | Age Class | SULE | Comments |
|---|---|---|---|---|---|---|---|---|---|---|---|
| 11 | Grey Box | <i>Eucalyptus moluccana</i> | 0.15 | 2 | 1.61 | 8 | 2 | g | j | 2a | Appears structurally sound |
| 12 | Forest Red Gum | <i>Eucalyptus tereticornis</i> | 0.38 | 4.56 | 2.37 | 16 | 9 | g | m | 2a | Minor deadwood noted, otherwise appears structurally sound |
| 13 | Forest Red Gum | <i>Eucalyptus tereticornis</i> | 0.68 | 8.16 | 2.67 | 16 | 11 | av | m | 3a | Minor deadwood noted, included fork union at 1.5 metres |
| 14 | Forest Red Gum | <i>Eucalyptus tereticornis</i> | 0.2 | 2.4 | 1.85 | 10 | 2 | av | sm | 2a | Minor deadwood noted suppressed by nearby trees |

| No. | Species | Health and Vigour | Condition | Suitability | Sustainability | Landscape rating | Retention Value | Encroachment level* | Proposal |
|---|---|---|---|---|---|---|---|---|---|
| 11 | <i>Eucalyptus moluccana</i> | Good | Good | High | 15-40 years | 2 | High | 100% TPZ/SRZ | Removal |
| 12 | <i>Eucalyptus tereticornis</i> | Good | Good | High | 15-40 years | 2 | High | 57% TPZ/SRZ | Removal |
| 13 | <i>Eucalyptus tereticornis</i> | Average | Good | High | 5-15 years | 3 | Moderate | 10% TPZ | Retention |
| 14 | <i>Eucalyptus tereticornis</i> | Average | Good | High | 15-40 years | 2 | High | 10% TPZ | Retention |

**Figure 5 Trees 11 - 14 will be subject to encroachment from construction of the proposed roadway**

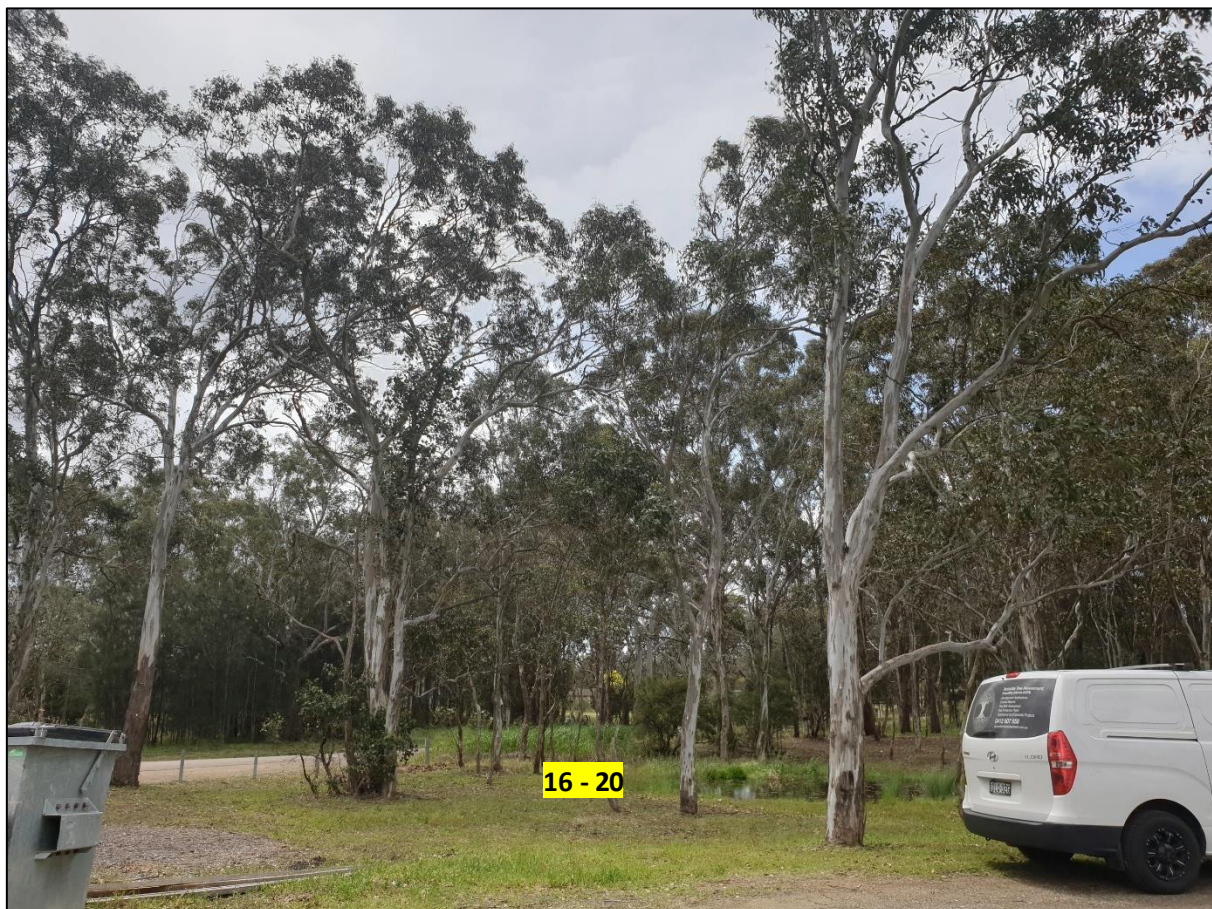
| No | Common Name | Species | DBH (M) | TPZ (M) | SRZ (M) | HEIGHT (M) | SPREAD (M) | Vigour | Age Class | SULE | Comments |
|---|---|---|---|---|---|---|---|---|---|---|---|
| 16 | Forest Red Gum | <i>Eucalyptus tereticornis</i> | .48, .12 | 5.88 | 2.63 | 16 | 12 | g | m | 2a | Minor deadwood noted, otherwise appears structurally sound |
| 17 | Forest Red Gum | <i>Eucalyptus tereticornis</i> | 0.25 | 3 | 2.00 | 9 | 1 | p | om | 4a | Damaged, entire canopy comprised of epicormic growth |
| 18 | Grey Box | <i>Eucalyptus moluccana</i> | 0.1 | 2 | 1.68 | 5 | 1 | g | j | 1a | Appears structurally sound |
| 19 | Forest Red Gum | <i>Eucalyptus tereticornis</i> | 0 | 3.12 | 2.13 | 14 | 9 | av | m | 2a | Sparse canopy, minor deadwood noted |
| 20 | Forest Red Gum | <i>Eucalyptus tereticornis</i> | 0.31 | 3.72 | 2.37 | 16 | 9 | g | m | 2a | Minor deadwood noted, canopy bias to South |

| No. | Species | Health and Vigour | Condition | Suitability | Sustainability | Landscape rating | Retention Value | Encroachment level* | Proposal |
|---|---|---|---|---|---|---|---|---|---|
| 17 | <i>Eucalyptus tereticornis</i> | Poor | Poor | High | < 5years | 4 | Very low | 10% TPZ | Retention |

**Figure 6 Trees 16 – 20 will be retained in conjunction with the proposed development**

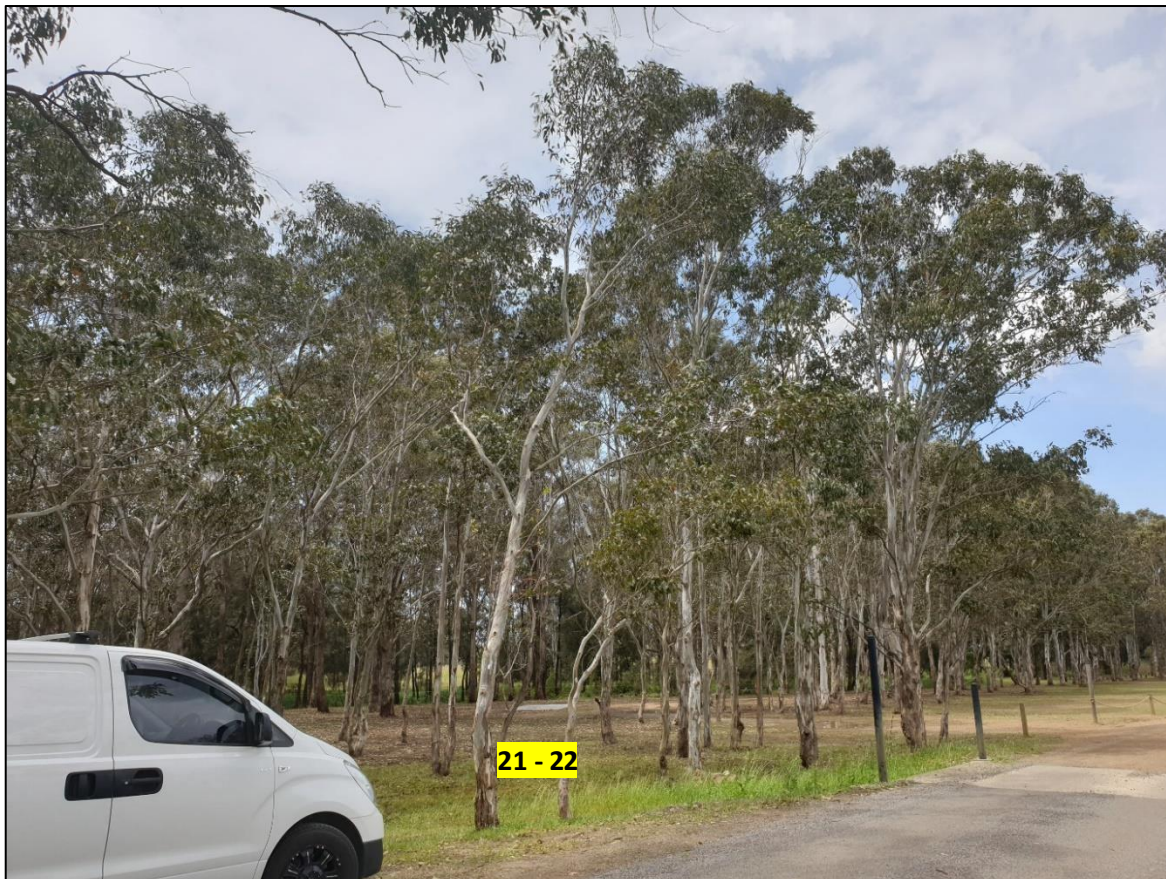
| No | Common Name | Species | DBH (M) | TPZ (M) | SRZ (M) | HEIGHT (M) | SPREAD (M) | Vigour | Age Class | SULE | Comments |
|---|---|---|---|---|---|---|---|---|---|---|---|
| 21 | Forest Red Gum | <i>Eucalyptus tereticornis</i> | 0.2 | 2.4 | 1.94 | 9 | 4 | g | sm | 2a | Minor deadwood noted, otherwise appears structurally sound |
| 22 | Forest Red Gum | <i>Eucalyptus tereticornis</i> | 0.1 | 2 | 1.50 | 3 | 1 | g | j | 1a | Appears structurally sound |

| No. | Species | Health and Vigour | Condition | Suitability | Sustainability | Landscape rating | Retention Value | Encroachment level* | Proposal |
|---|---|---|---|---|---|---|---|---|---|
| 21 | <i>Eucalyptus tereticornis</i> | Good | Good | High | 15-40 years | 2 | High | *26% TPZ<br>18% SRZ | Retention |
| 22 | <i>Eucalyptus tereticornis</i> | Good | Good | High | 40+ years | 2 | High | *19% TPZ<br>SRZ 10% | Retention |

**Figure 7 Trees 21-22 *Eucalyptus tereticornis* are proposed for retention**

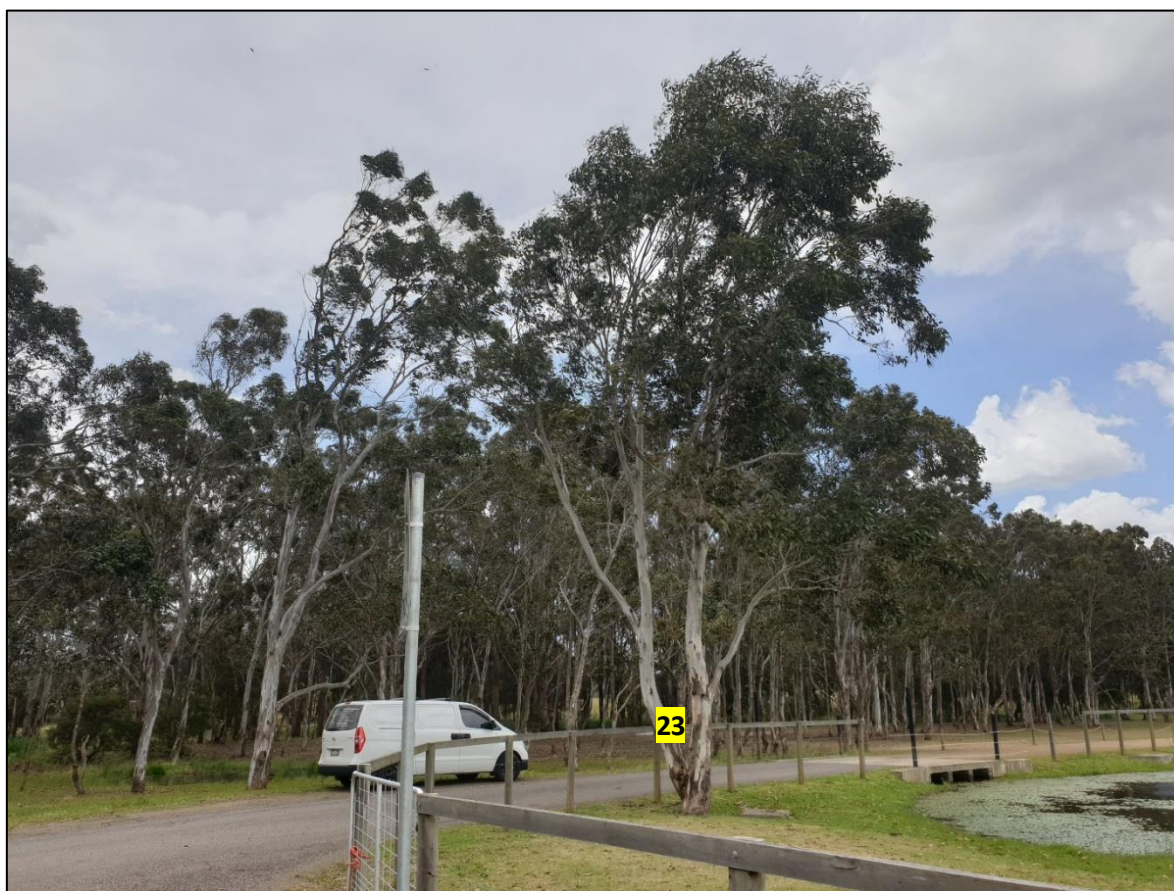
| No | Common Name | Species | DBH (M) | TPZ (M) | SRZ (M) | HEIGHT (M) | SPREAD (M) | Vigour | Age Class | SULE | Comments |
|---|---|---|---|---|---|---|---|---|---|---|---|
| 23 | Forest Red Gum | <i>Eucalyptus tereticornis</i> | .33, .37 | 6 | 2.59 | 12 | 9 | g | m | 1a | Co-dominant trunks from base, no included bark, appears structurally sound |

| No. | Species | Health and Vigour | Condition | Suitability | Sustainability | Landscape rating | Retention Value | Encroachment level* | Proposal |
|---|---|---|---|---|---|---|---|---|---|
| 23 | <i>Eucalyptus tereticornis</i> | Good | Good | High | 40+ years | 1 | High | *29% TPZ<br>6%SRZ | Retention |

**Figure 8 Tree 23 *Eucalyptus tereticornis* is proposed for retention**

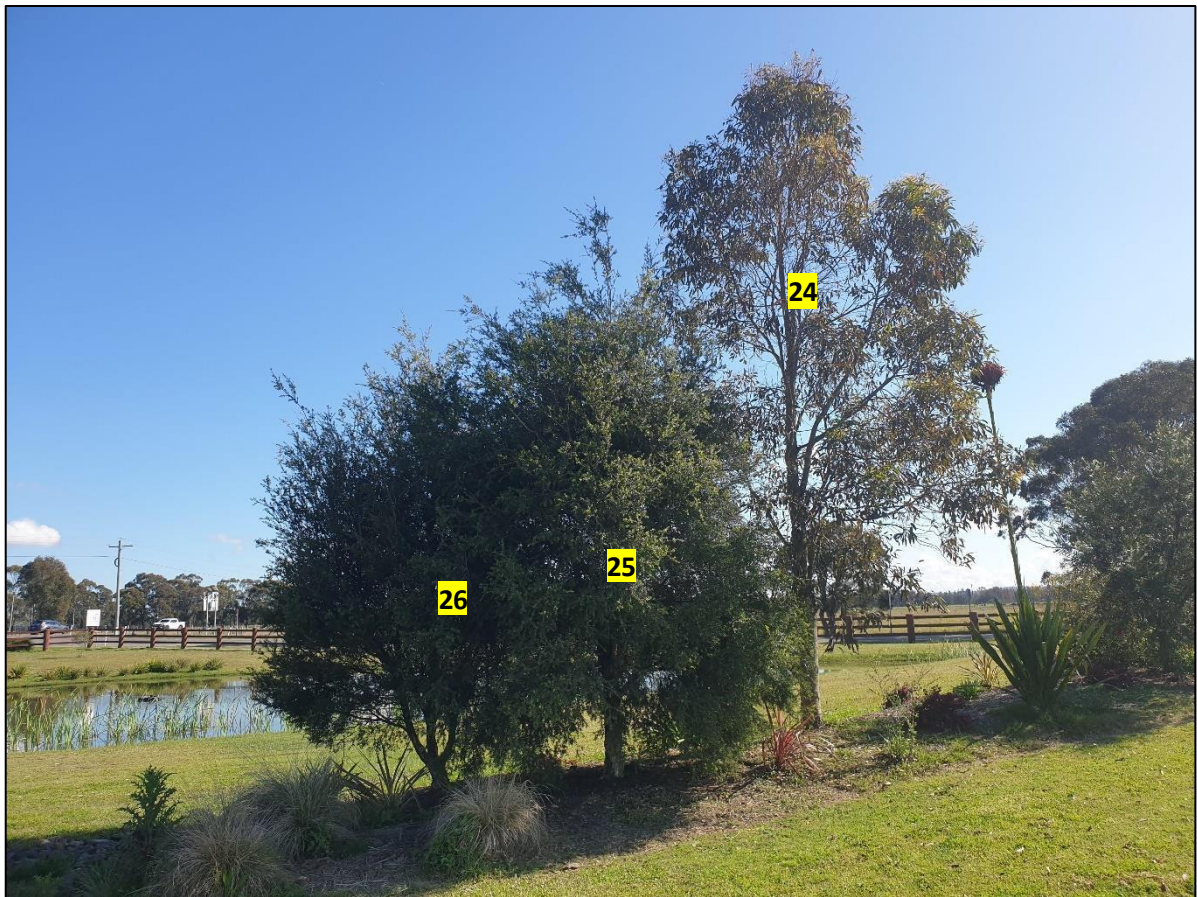
| No | Common Name | Species | DBH (M) | TPZ (M) | SRZ (M) | HEIGHT (M) | SPREAD (M) | Vigour | Age Class | SULE | Comments |
|---|---|---|---|---|---|---|---|---|---|---|---|
| 24 | Grey Gum | <i>Eucalyptus punctata</i> | 0.2 | 2.4 | 1.7 | 5.4 | 4 | g | sm | 1a | Appears structurally sound, co-dominant leaders |
| 25 | Prickly-leaved Paperbark | <i>Melaleuca stypheliodes</i> | 0.1 | 2 | 1.5 | 3.6 | 3 | g | sm | 5a | Appears structurally sound |
| 26 | Prickly-leaved Paperbark | <i>Melaleuca stypheliodes</i> | 0.1 | 2 | 1.5 | 3.2 | 2 | g | sm | 5a | Appears structurally sound |

| No. | Species | Health and Vigour | Condition | Suitability | Sustainability | Landscape rating | Retention Value | Encroachment level* | Proposal |
|---|---|---|---|---|---|---|---|---|---|
| 24 | <i>Eucalyptus punctata</i> | Good | Good | High | 40+ years | 4 | Moderate | 100% TPZ/SRZ | Removal |
| 25 | <i>Melaleuca stypheliodes</i> | Good | Good | High | 15-40 years | 4 | Moderate | 100% TPZ/SRZ | Removal |
| 26 | <i>Melaleuca stypheliodes</i> | Good | Good | High | 15-40 years | 4 | Moderate | 100% TPZ/SRZ | Removal |

**Figure 9 Trees 24 *Eucalyptus punctata*, 25-26 *Melaleuca styphelioides***

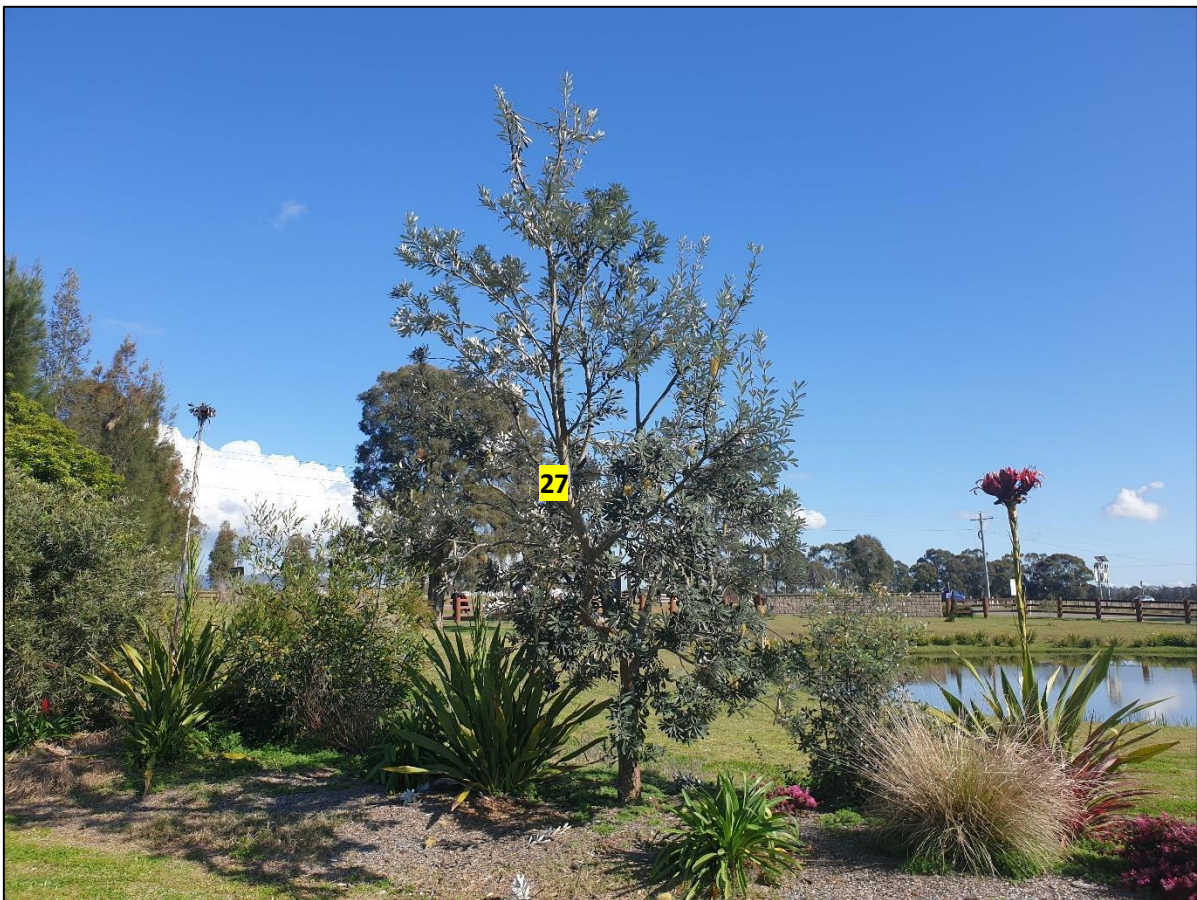
**Figure 10 Tree 27 *Banksia integrifolia***

| No | Common Name | Species | DBH (M) | TPZ (M) | SRZ (M) | HEIGHT (M) | SPREAD (M) | Vigour | Age Class | SULE | Comments |
|---|---|---|---|---|---|---|---|---|---|---|---|
| 27 | Coast Banksia | <i>Banksia integrifolia</i> | 0.12 | 2 | 1.5 | 3 | 3 | g | sm | 5a | Appears structurally sound, minor asymmetry |

| No. | Species | Health and Vigour | Condition | Suitability | Sustainability | Landscape rating | Retention Value | Encroachment level* | Proposal |
|---|---|---|---|---|---|---|---|---|---|
| 27 | <i>Banksia integrifolia</i> | Good | Good | High | 15-40 years | 4 | Moderate | 100% TPZ/SRZ | Removal |
