# Validation Report

105 & 113 Hollingsworth Road, Marsden Park NSW, Lot 10 & 11 DP1262052

Prepared for:  
BY Group Pty Ltd

7 February 2025

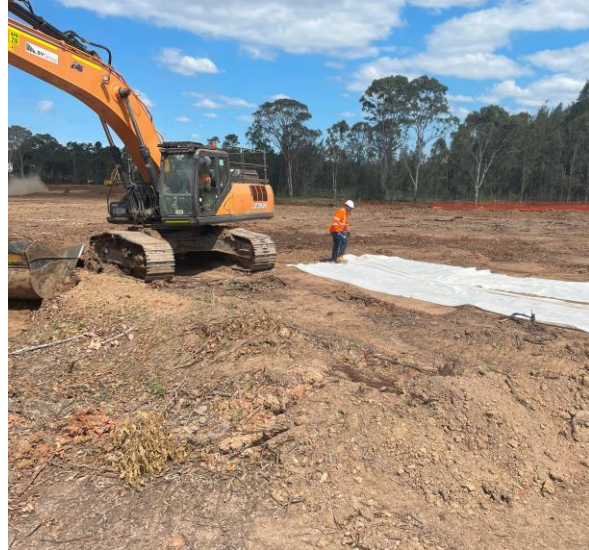
Photo 1: SP24 removal and placement on geofabric (21 November 2024)

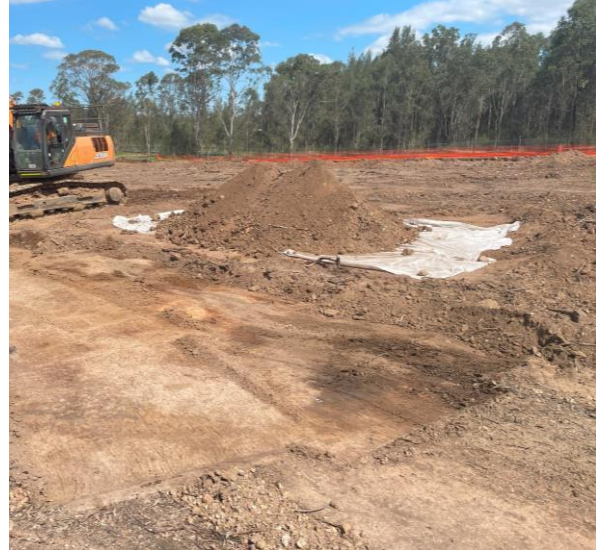
An inspection of the ground surfaces of the remedial excavation from which waste materials of SP24 were removed was completed by Stantec on 3 December 2024. Remaining surfaces comprised natural soil and no visible evidence of asbestos-impacted materials, or other contamination were noted.

Photo 2: SP24 ground surfaces comprising natural soil following remediation (21 November 2024)

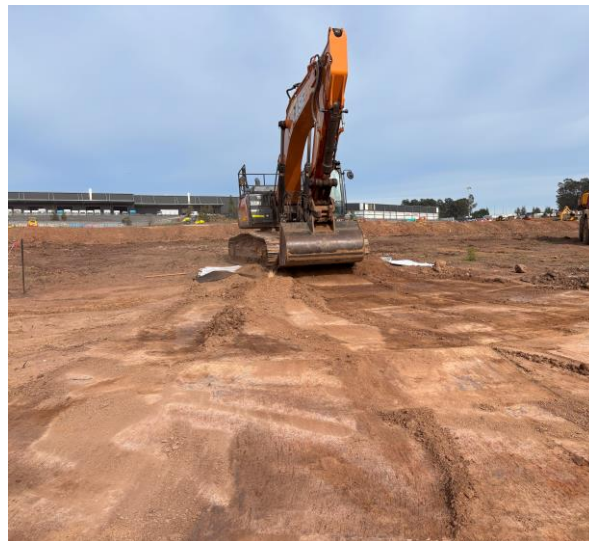
Photo 3: SP24 additional removal and placement on geofabric (3 December 2024)

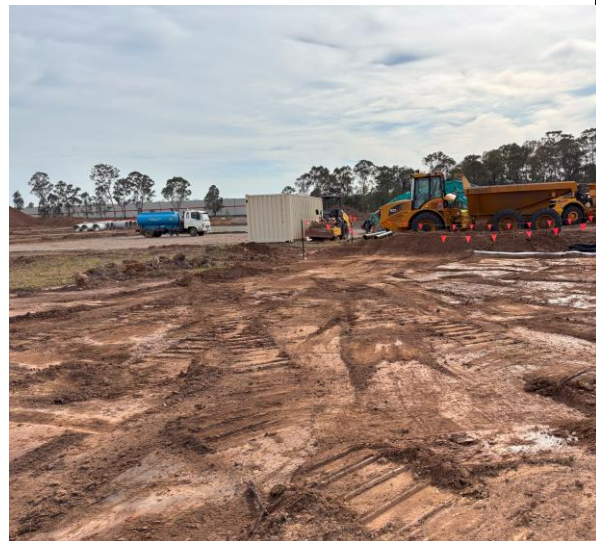
Photo 4: SP24 ground surfaces comprising natural soil following additional removal (3 December 2024)

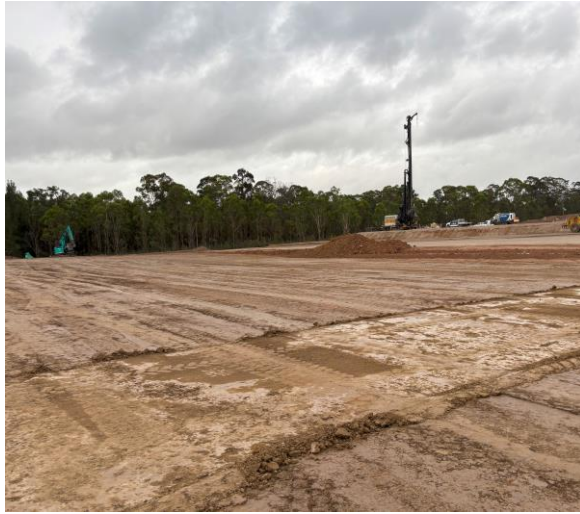
Following disposal of the remaining SP24 materials on 21 January 2025, a final inspection of the remedial excavations was undertaken by Stantec on 31 January 2025. The remaining ground surfaces within the SP24 remediation area and immediate surroundings comprised natural soil described as yellow/brown sandy silty clay or clayey silt. No visible evidence of asbestos-impacted materials, or other contamination were noted. Photos of the inspections Photos of the inspection are provided in **Appendix O**.

Photo 5: SP24 final inspection following complete removal (31 January 2025)

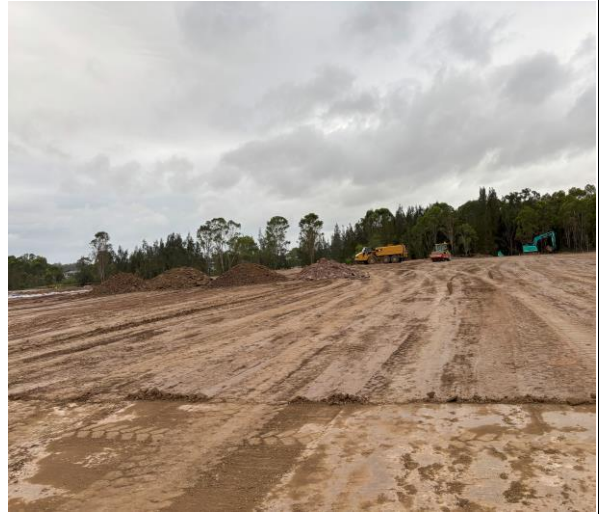
Photo 6: SP24 final inspection following complete removal (31 January 2025)

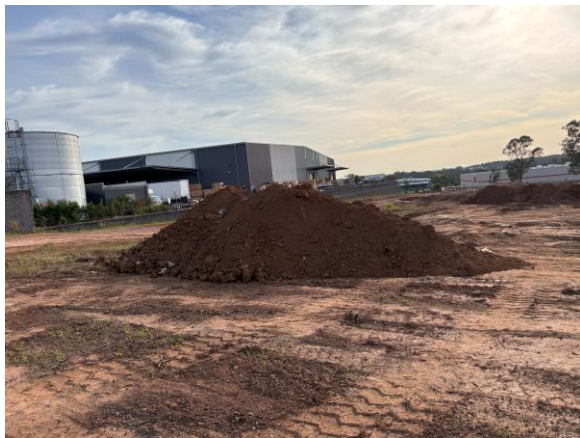
Photo 7: SP25 segregated soil including bulk waste material (3 December 2024)

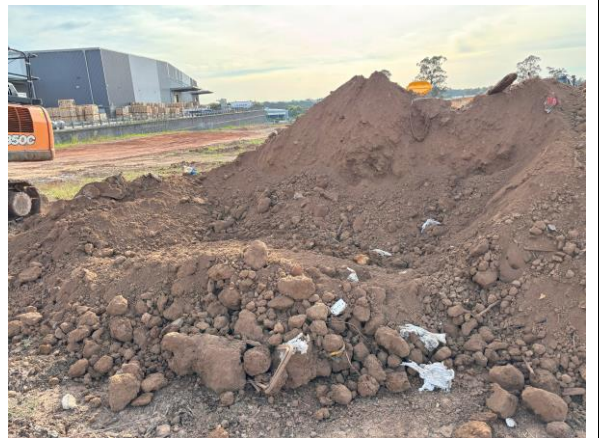
Photo 8: SP25 segregated soil including bulk waste material (3 December 2024)

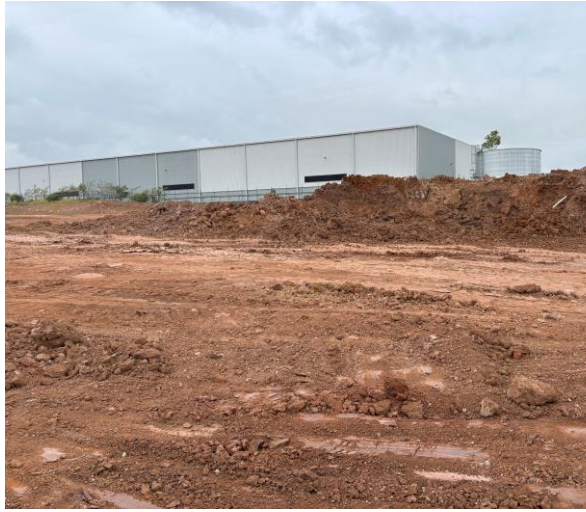
In accordance with the validation requirements outlined in **Section 6.6**, remedial excavations and the SP25 stockpile footprint were inspected by a contaminated land professional, environmental scientist and competent person from Stantec on 31 January 2025. The inspection confirmed that remaining soil comprised natural soil described as yellow/brown sandy silty clay or clayey silt. No visible evidence of asbestos-impacted materials, or other contamination were noted on residual ground surfaces. Photos of the inspection are provided in **Appendix O**.

Photo 9: SP25 ground surfaces comprising natural soil following remediation (31 January 2025)

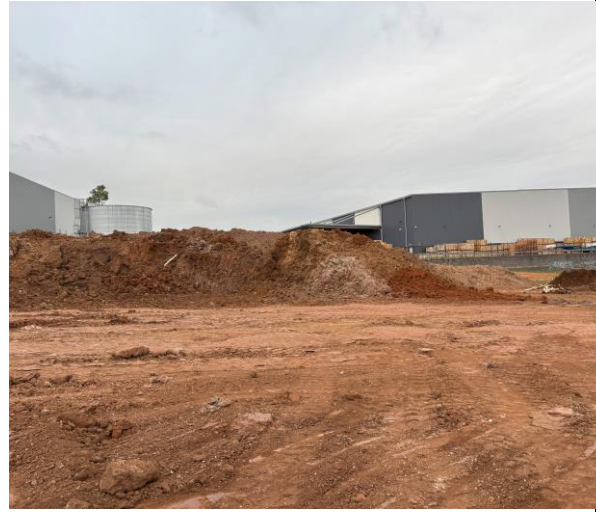
Photo 10: SP25 ground surfaces comprising natural soil following remediation (31 January 2025)
