**Report on Hazardous Building Materials  
(HAZMAT) Survey**

**270-272 Pacific Highway  
Crows Nest NSW**

**Project 214296.04**

**18 July 2025**

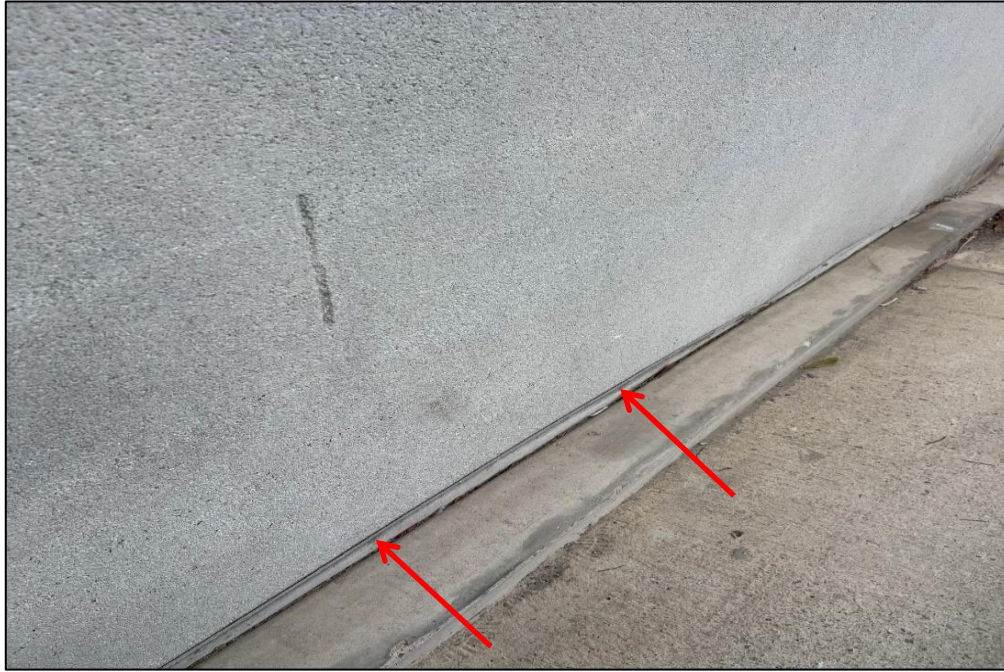
Photograph 3: North Tower, exterior, western end, base of wall, expansion gap, fibrous board, no asbestos detected by analysis.

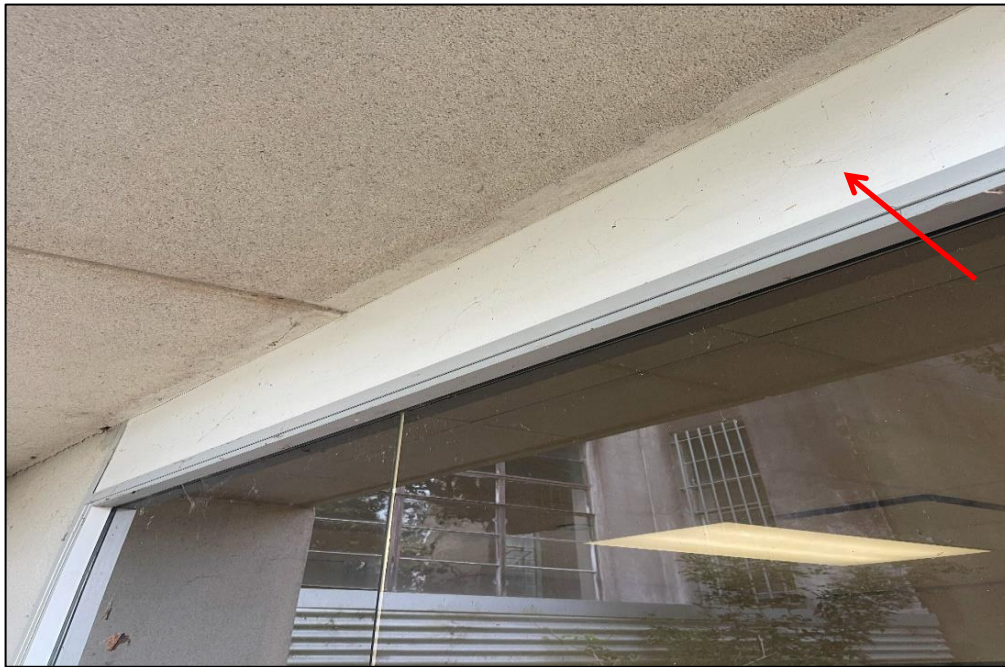
Photograph 4: North Tower, exterior, western end, infill panel, suspected non-asbestos.

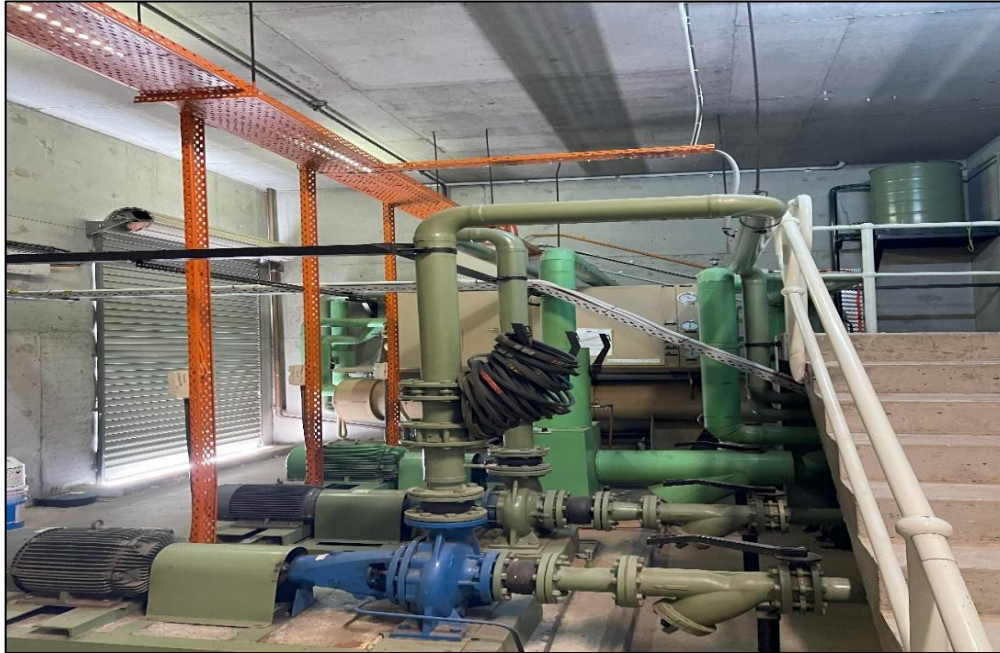
Photograph 5: North and South Tower, Level 5, Plant Room, sheathed pipes and plant, bulk insulation, SMF and foam identified visually.

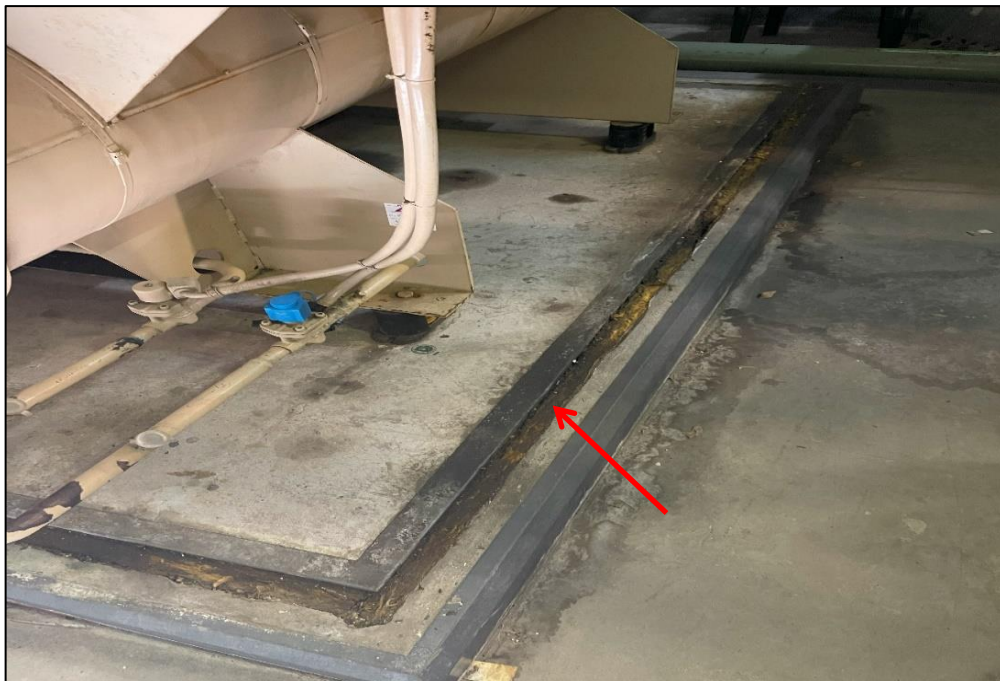
Photograph 6: North Tower, rooftop plant room, floor surface, sealant / mastic, no asbestos detected by analysis.

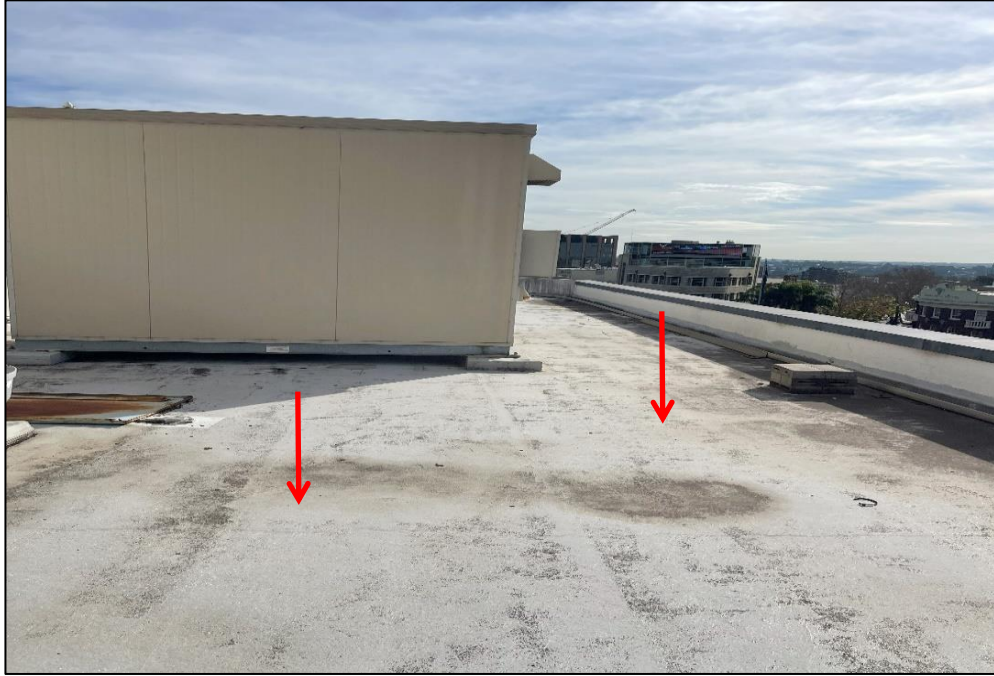
Photograph 7: North Tower, rooftop, exposed waterproof lining, fibrous membrane, no asbestos detected by analysis (SMF detected).

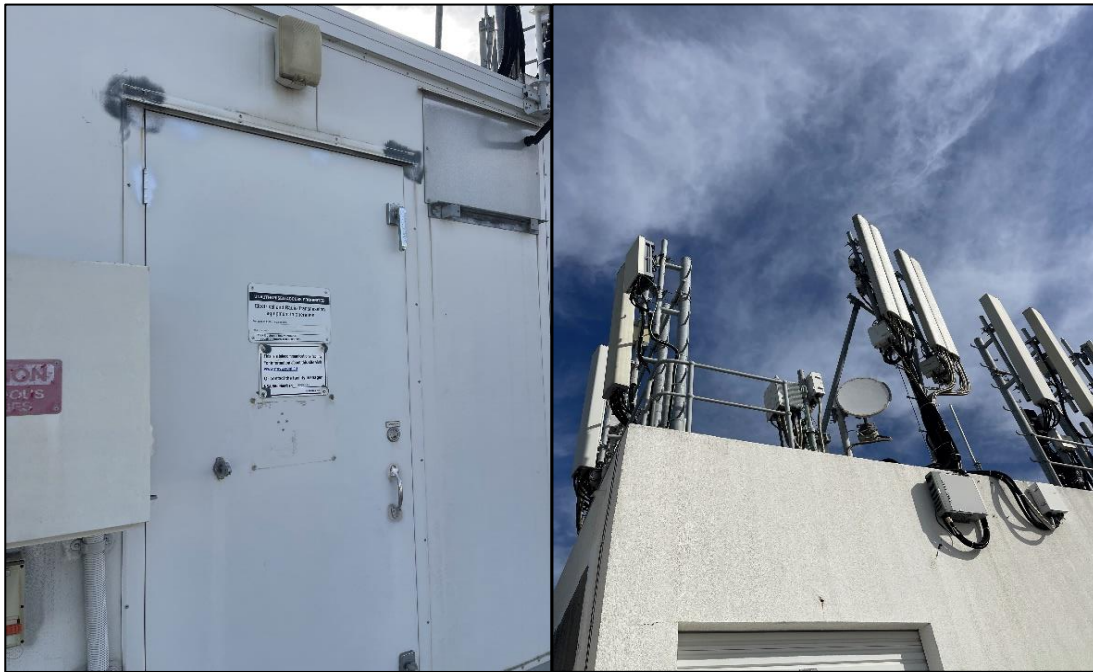
Photograph 8: North Tower, rooftop, plant/transmission rooms and other areas generally, materials in general, inaccessible.

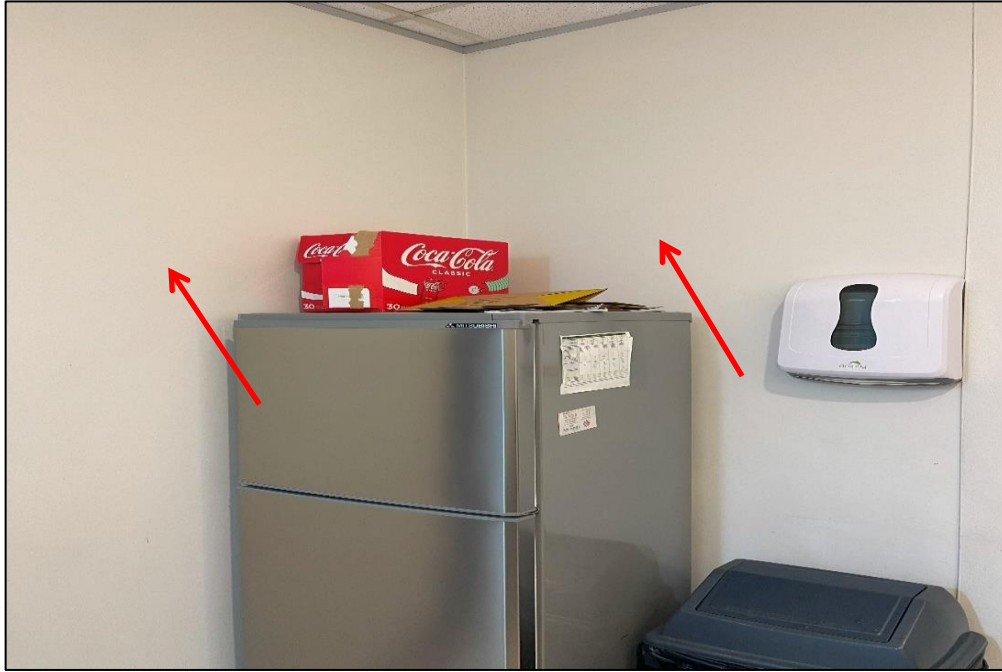
Photograph 9: North Tower, level 4, kitchen, wall lining, fibre cement, no asbestos detected by analysis (SMF detected).

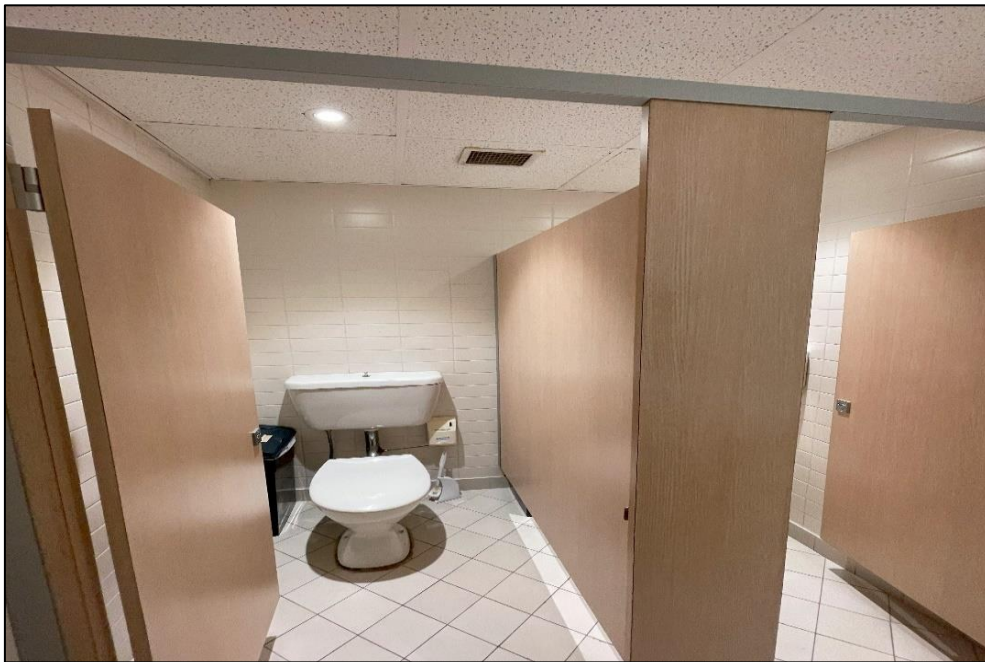
Photograph 10: North Tower, level 4, toilets, below ceramic tiled walls and floors, substrate, inaccessible.

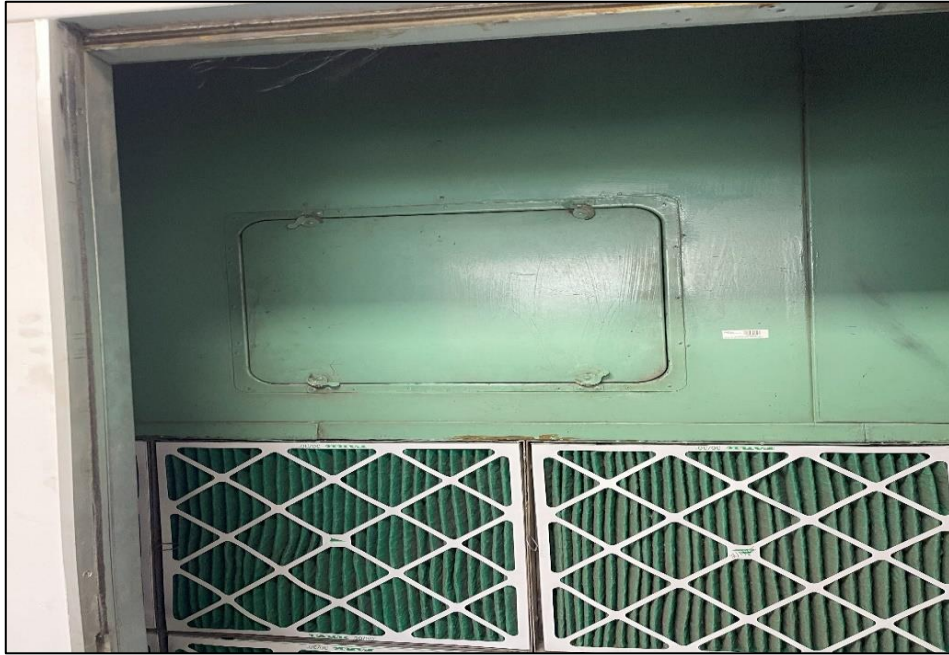
Photograph 11: North and South Tower, building generally, plant room, air handling duct work generally, SMF (suspected).

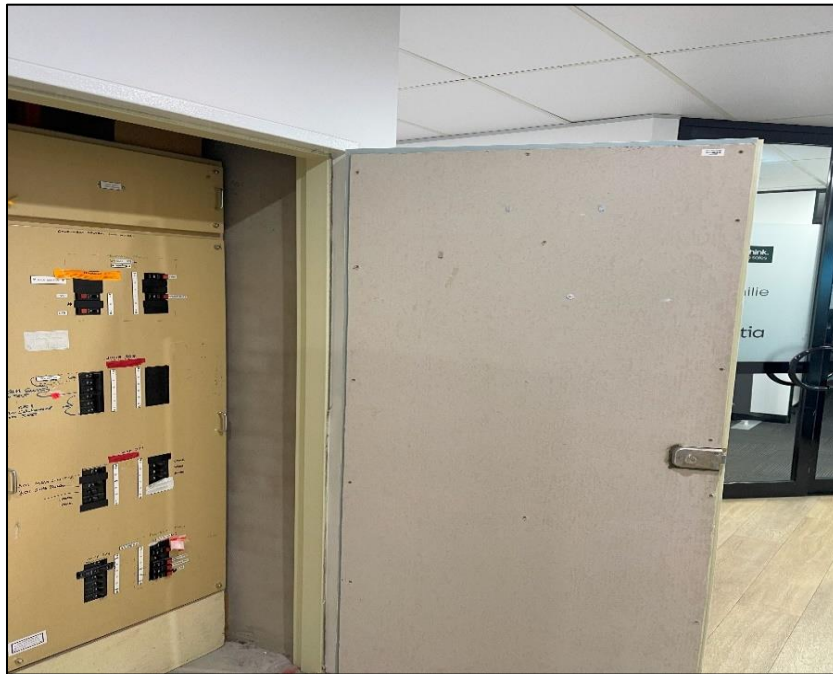
Photograph 12: North Tower, level 3, lobby, EDB cupboard door lining, fibre cement sheeting, no asbestos detected by analysis.

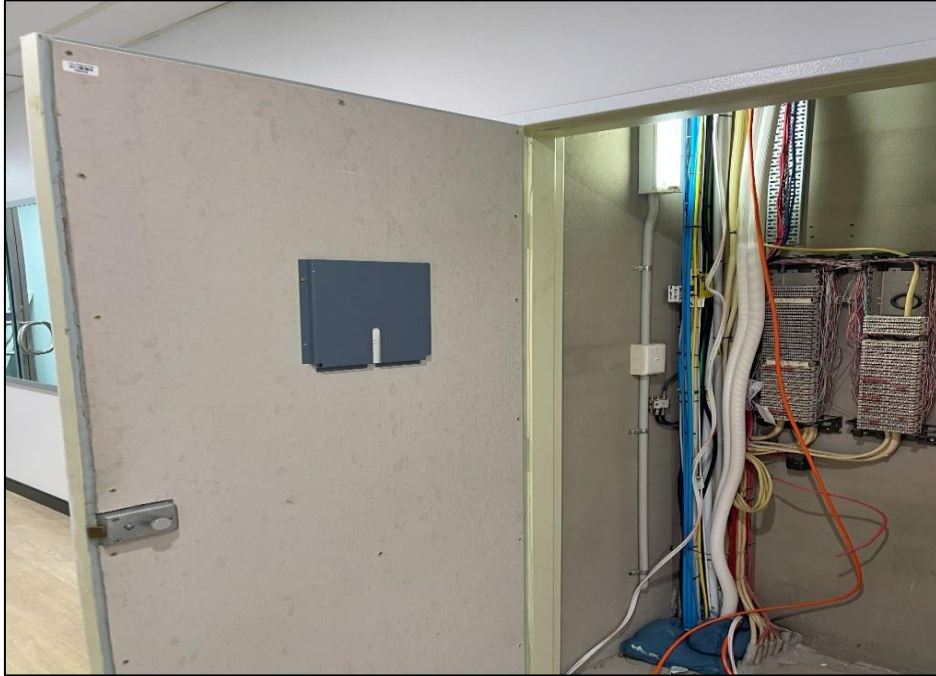
Photograph 13: North Tower, level 3, lobby, Comms cupboard door lining, fibre cement sheeting, no asbestos detected by analysis.

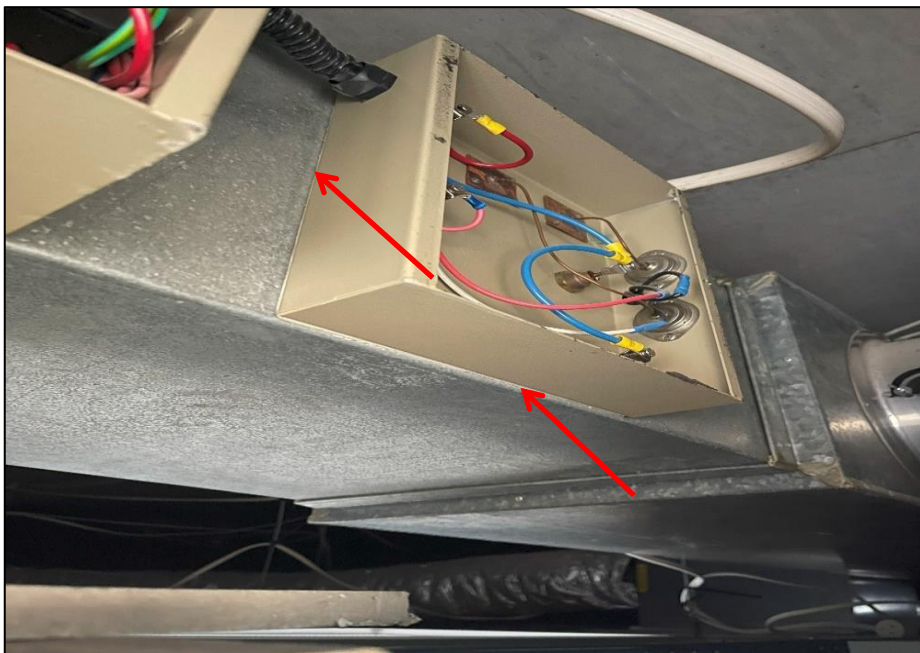
Photograph 14: North Tower, unit 304, ceiling cavity, duct work, sealant / mastic, no asbestos detected by analysis (SMF detected).

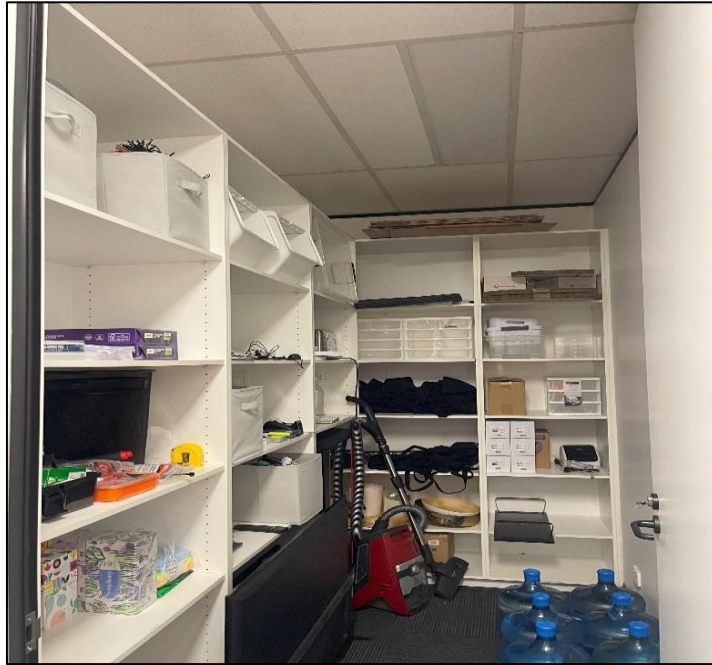
Photograph 15: North Tower, tenanted offices / retail shops, throughout, materials in general, limited access, suspected non-asbestos.

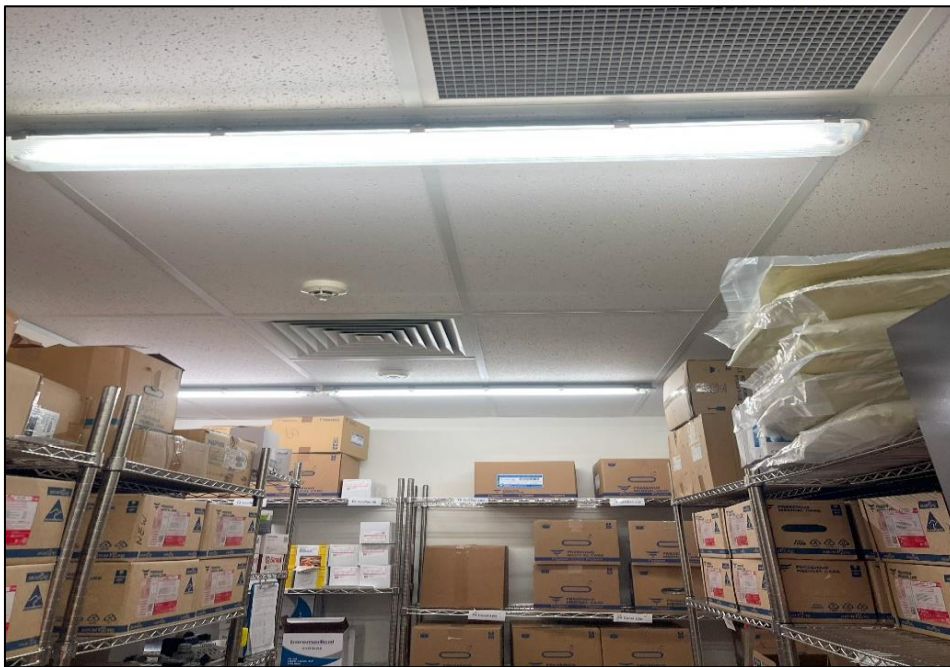
Photograph 16: North Tower, tenanted offices / retail shops, throughout, materials in general, limited access, suspected non-asbestos.

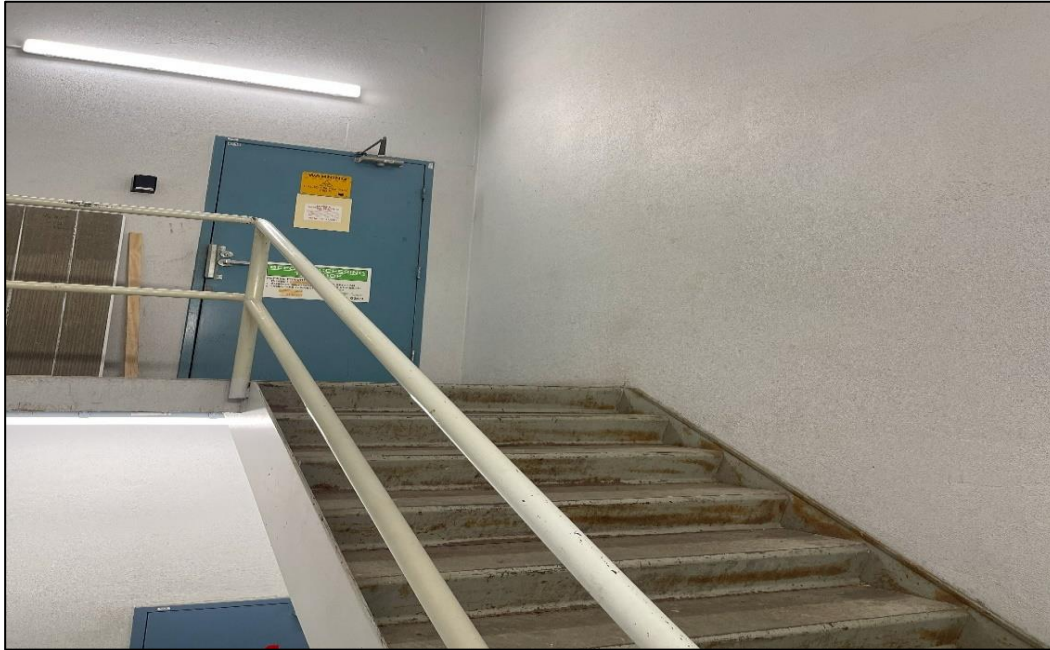
Photograph 17: North Tower, rooftop, fire stairs, white paint to hand rail, blue paint to door and grey paint to wall, negative spot tests.

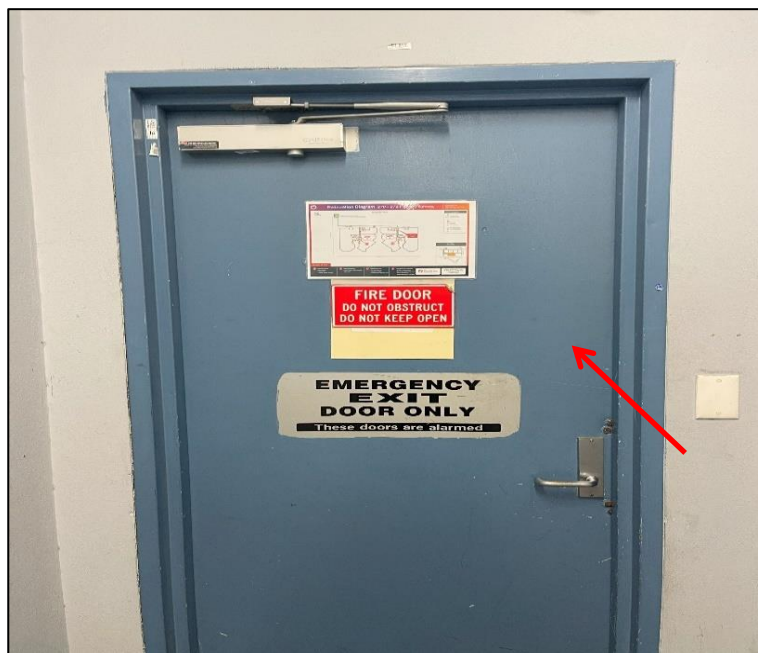
Photograph 18: North Tower, ground level, fire door, blue paint.

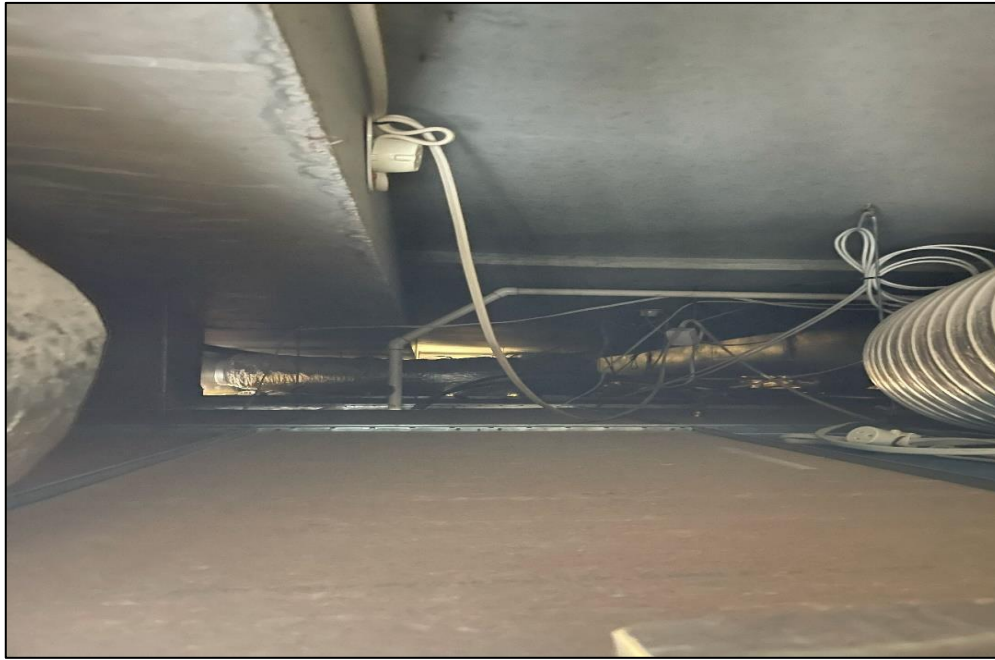
Photograph 19: North Tower, unit 301, ceiling cavity, settled dust / debris, elevated lead concentration detected.

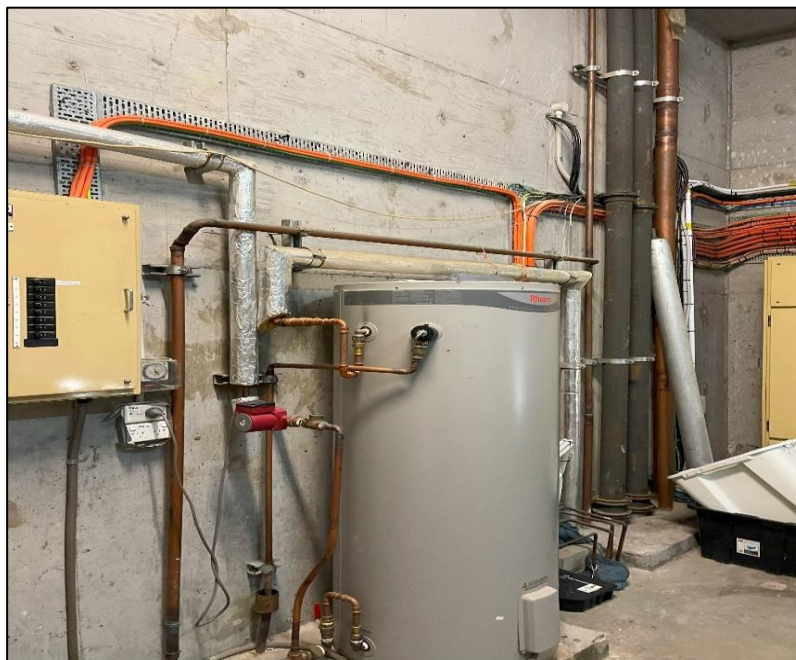
Photograph 20: North Tower, rooftop, plant room, water heater, insulation materials, SMF (suspected).

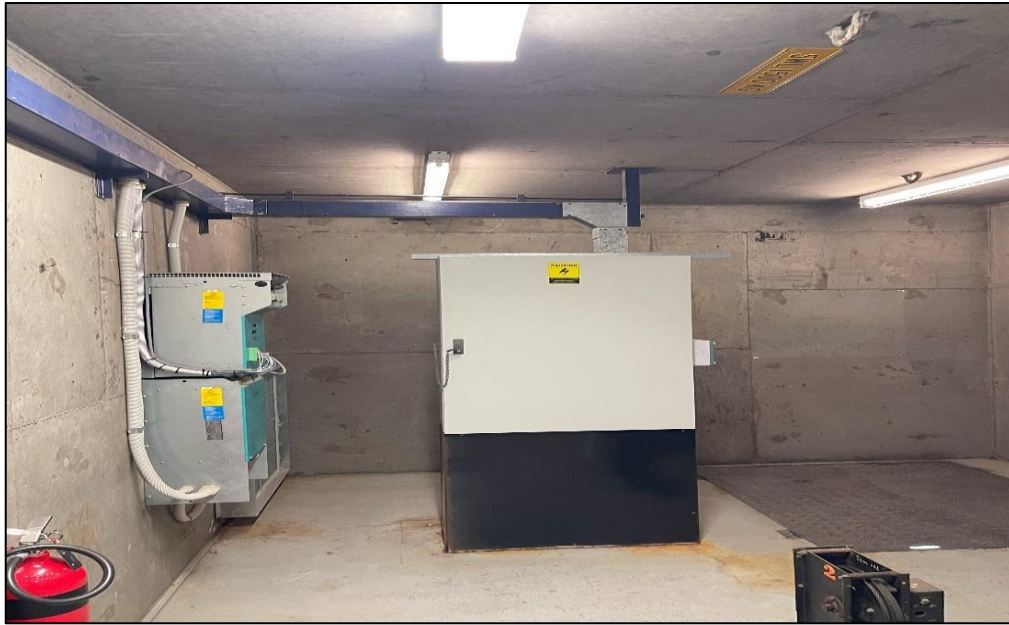
Photograph 21: North Tower, rooftop plant room, fluorescent light fittings, internal components, PCB (suspected).

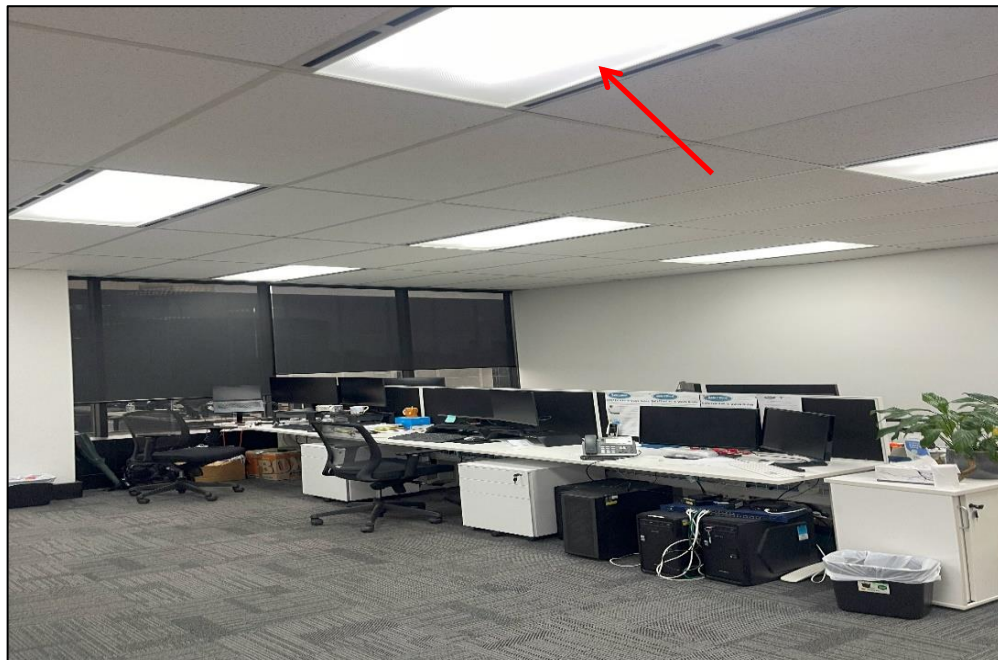
Photograph 22: North Tower, unit 401, fluorescent light fittings, internal components, PCB (suspected).

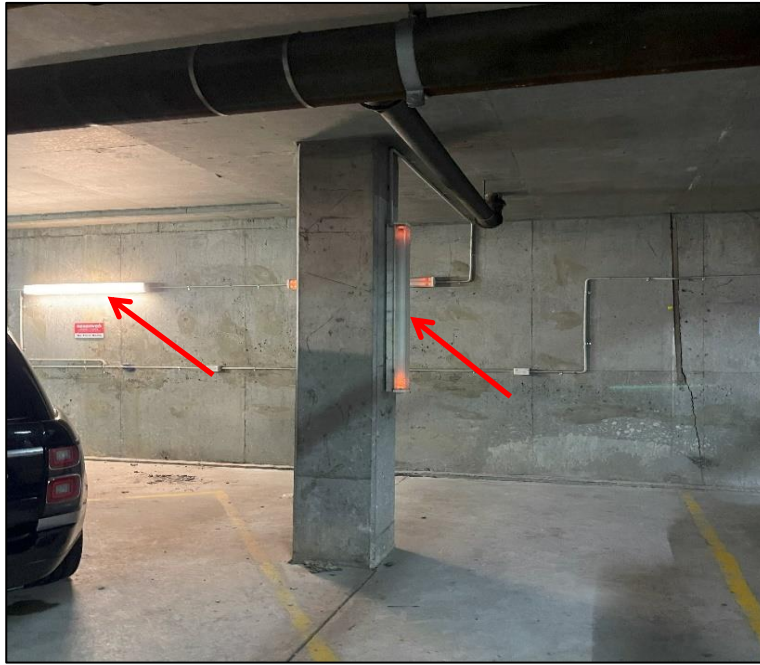
Photograph 23: Basement car park, fluorescent light fittings, internal components, PCB (suspected).

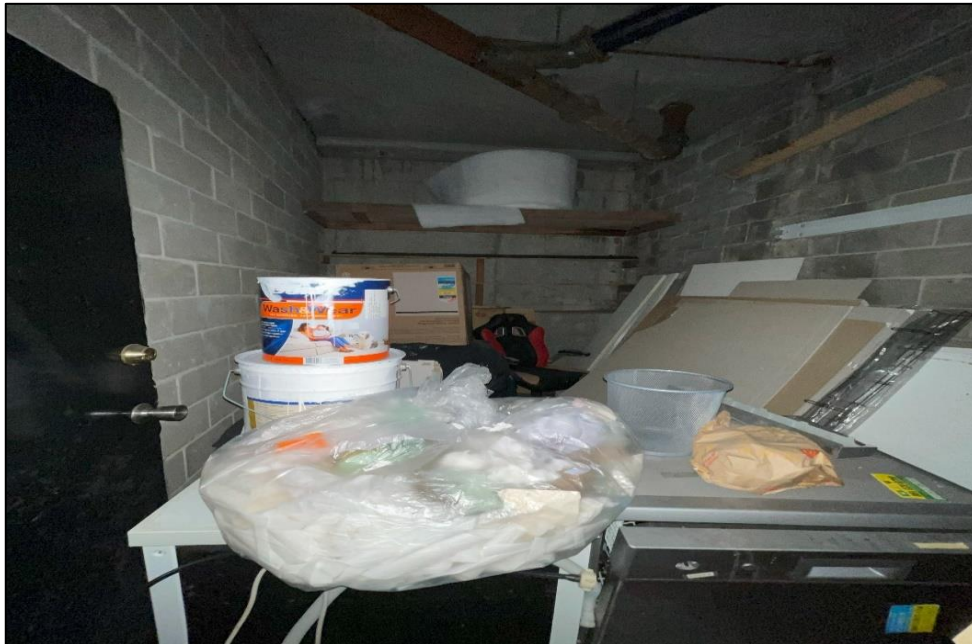
Photograph 24: 270-272 Pacific Highway, basement car park, storage rooms, materials in general, inaccessible.

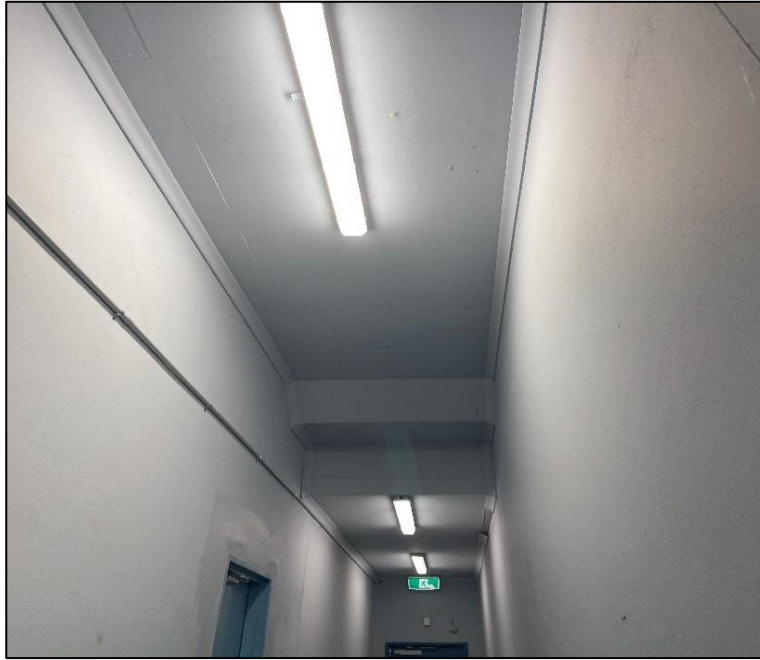
Photograph 25: North Tower, ground level, fire exit corridor, fluorescent light fittings, internal components, PCB (suspected).

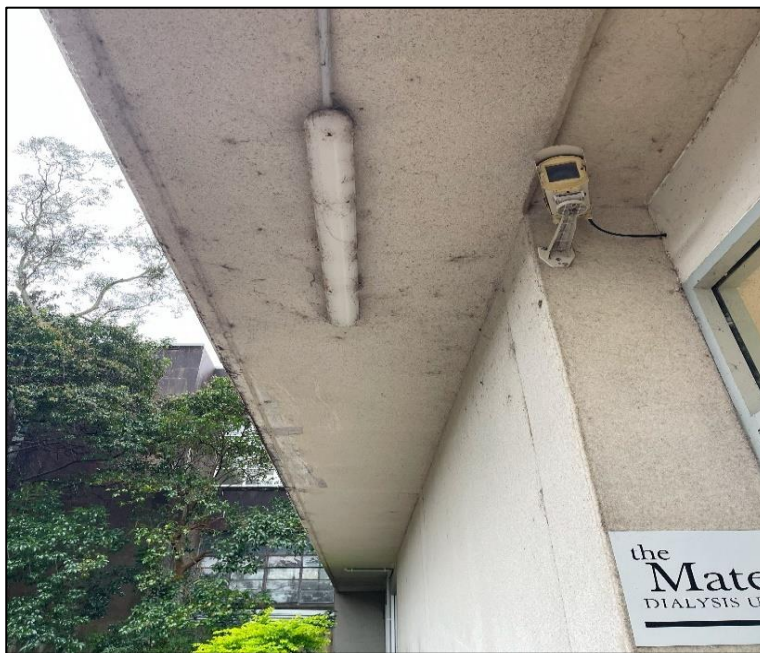
Photograph 26: North Tower, exterior, western façade, fluorescent light fittings, internal components, PCB (suspected).

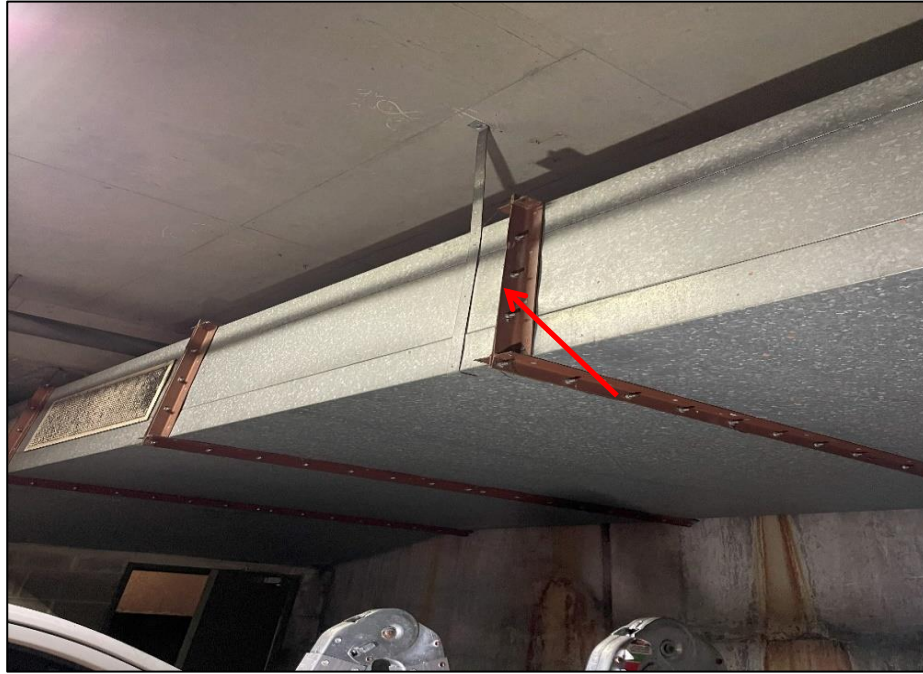
Photograph 27: Basement car park, southern end, air handling duct work, duct joint, mastic, no asbestos detected by analysis.

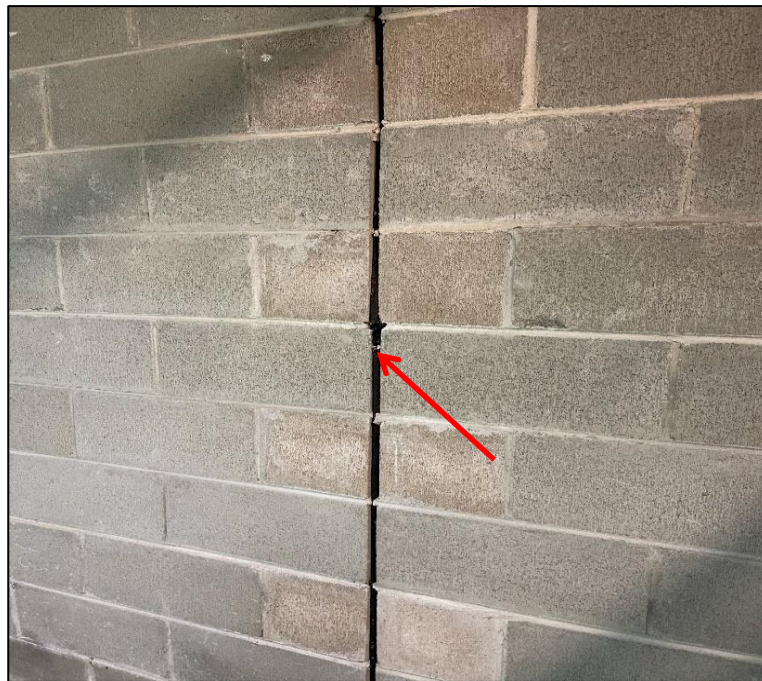
Photograph 28: Basement car park, southern end, wall, expansion gap, lining, no asbestos detected by analysis.

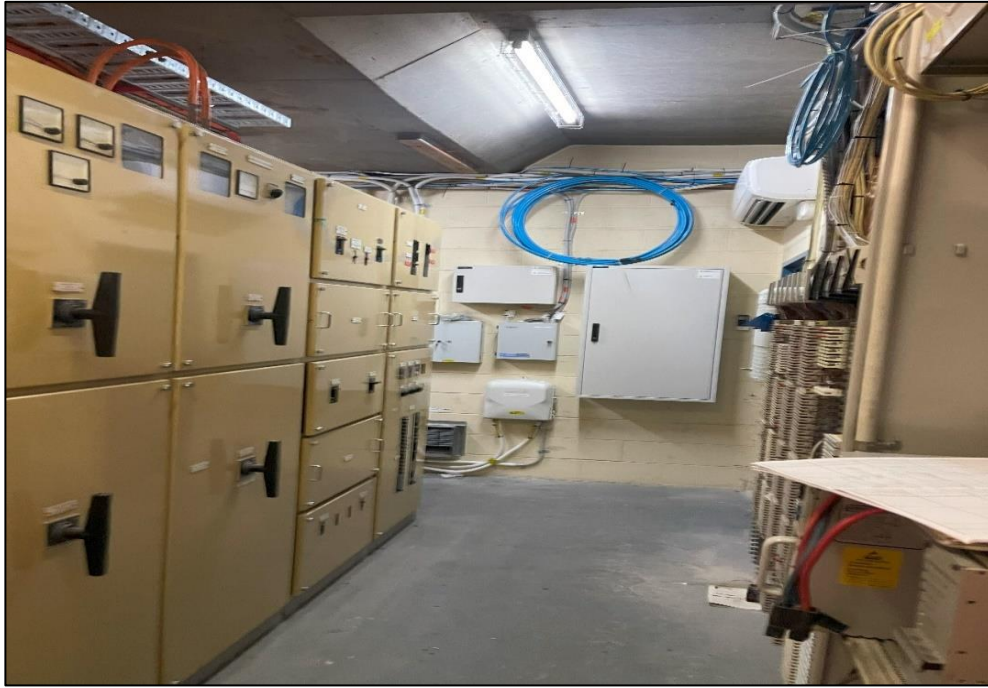
Photograph 29: Basement car park, services room, materials in general, limited access, suspected non-asbestos.

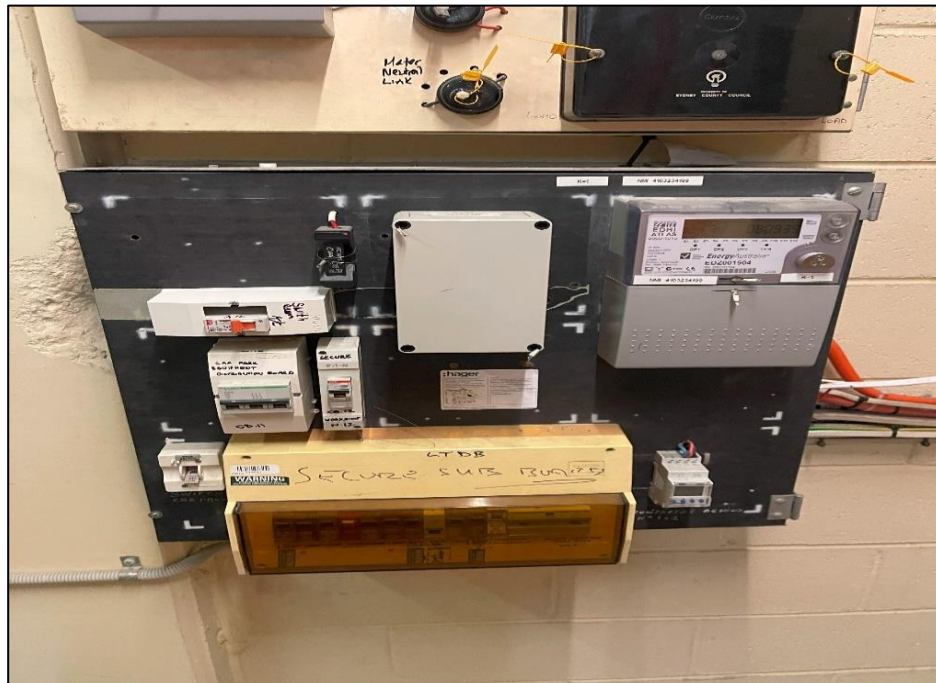
Photograph 30: Basement car park, services room, electric backing board, suspected non-asbestos.

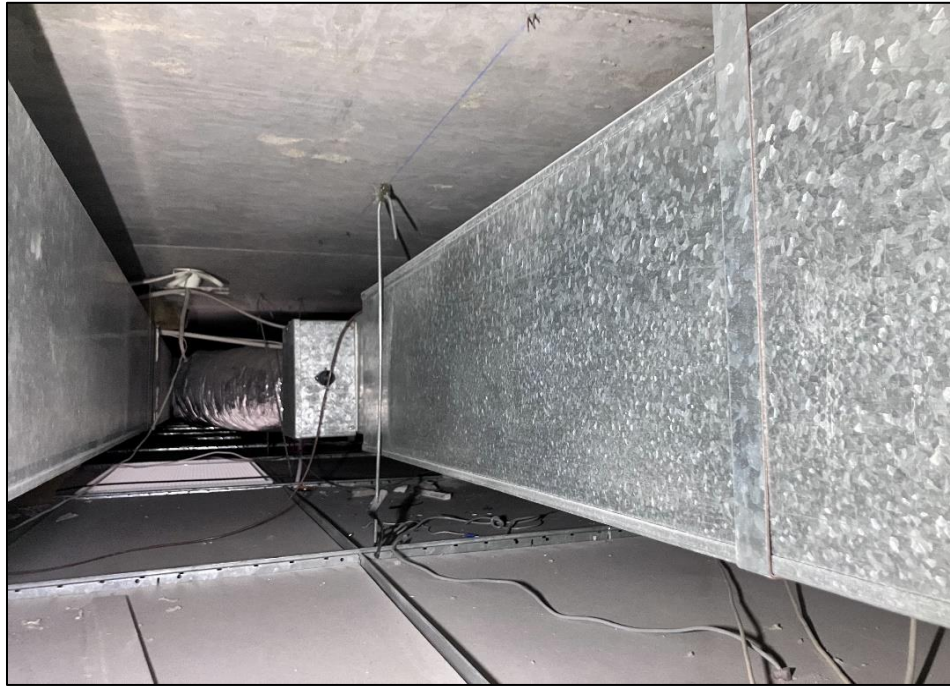
Photograph 31: South Tower, building in general, air conditioning duct work at re-heat elements, duct insulation, inaccessible.

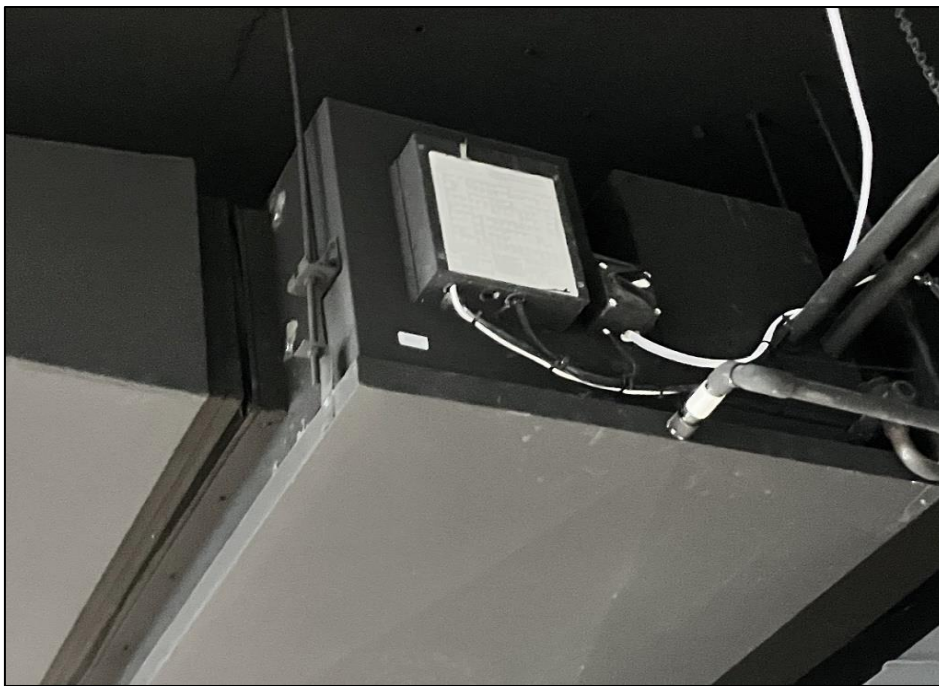
Photograph 32: South Tower, building in general, air conditioning duct work at re-heat elements, duct insulation, inaccessible.

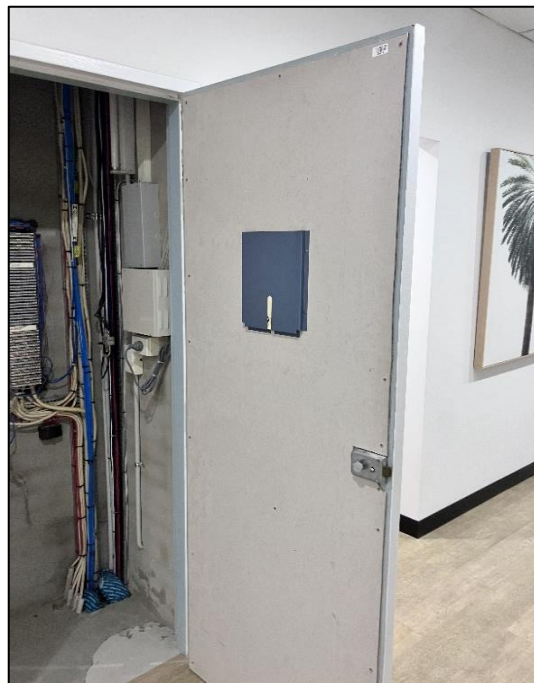
Photograph 34: South Tower, Level 3, lift foyer, Comms cupboard, fibre cement linings, no asbestos detected by analysis.

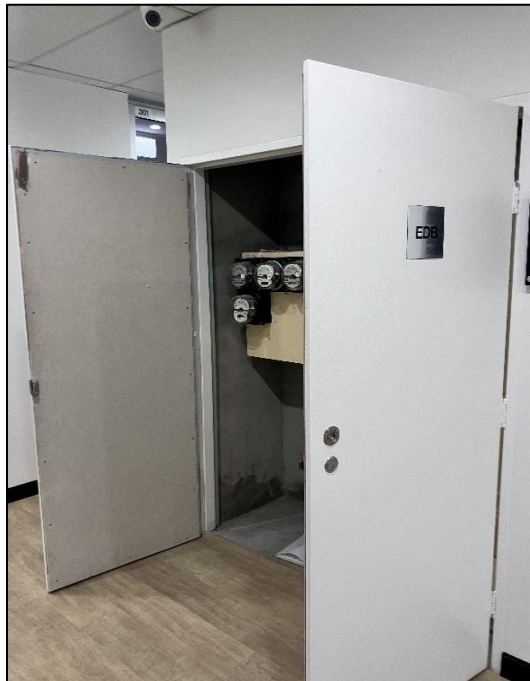
Photograph 36: South Tower, Level 3, lift foyer, EDB cupboard, doors, fibre cement linings, no asbestos detected by analysis.

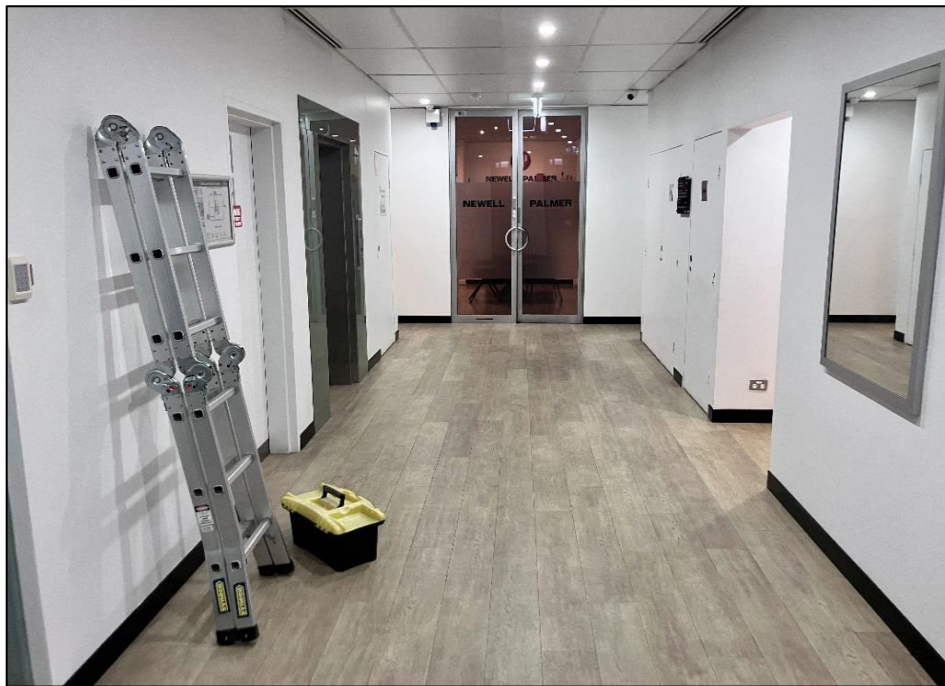
Photograph 38: South Tower, lift foyers generally, floor (below exposed floor coverings), substrate, inaccessible.

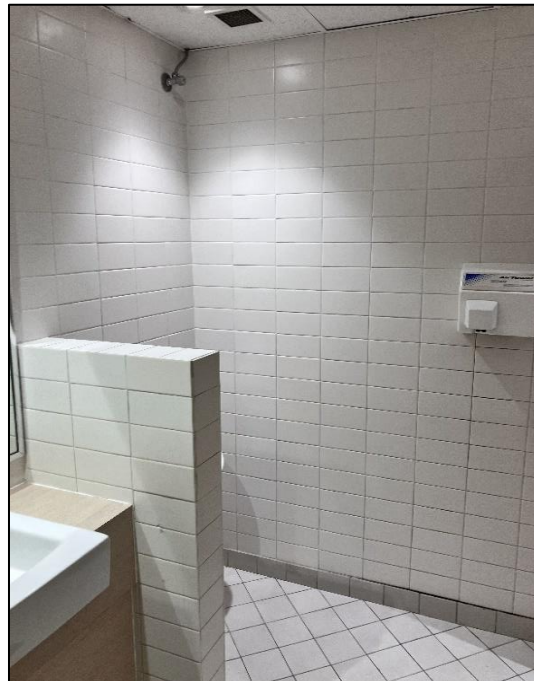
Photograph 40: South Tower, Levels in general, lift foyers, amenities generally, below ceramic floor and wall tiles, substrate, inaccessible.

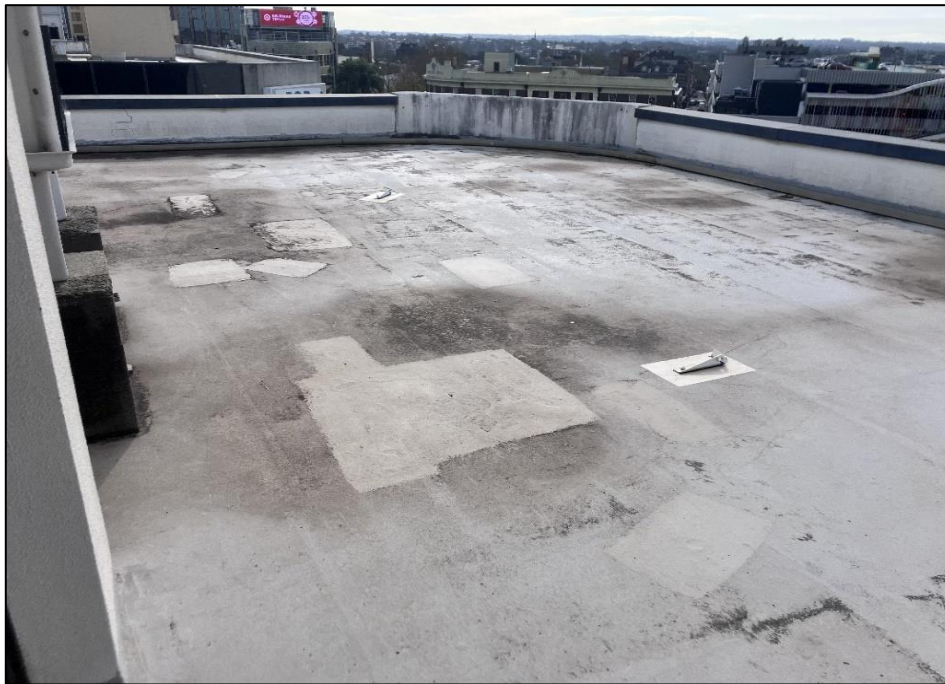
Photograph 42: South Tower, Level 5, open rooftop area, throughout, materials in general, limited access.

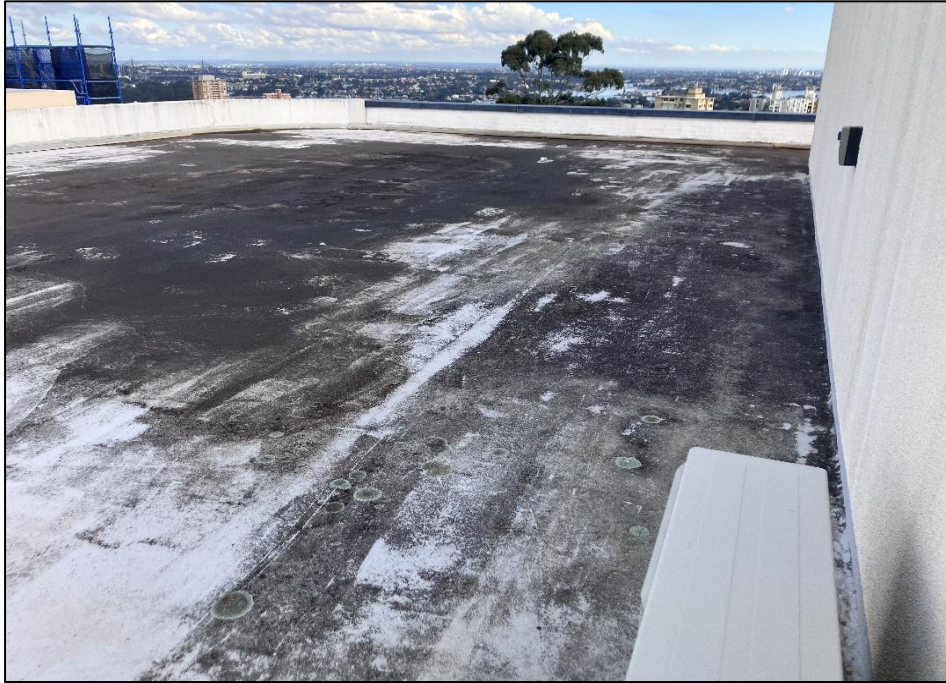
Photograph 43: South Tower, Level 5, open rooftop area, throughout, materials in general, limited access.

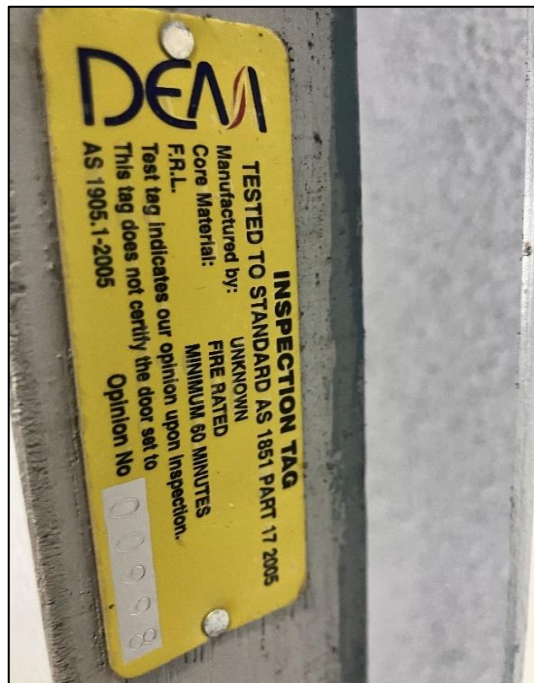
Photograph 44: South Tower, Level 5, Plant Room, "DEM" fire door (circa 2000's), insulation, suspected non-asbestos.
