**Report on Hazardous Building Materials  
(HAZMAT) Survey**

**270-272 Pacific Highway  
Crows Nest NSW**

**Project 214296.04**

**18 July 2025**

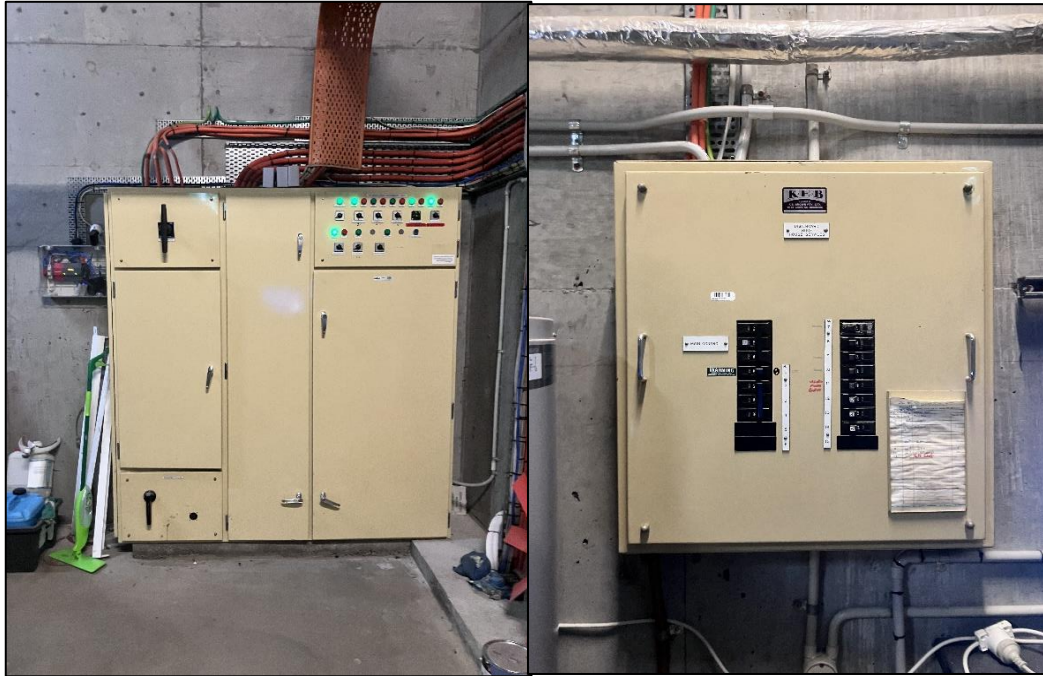
Photograph 45: South Tower, Level 5, Plant Room, various electrical cabinets, internal components (e.g. backing boards), inaccessible.

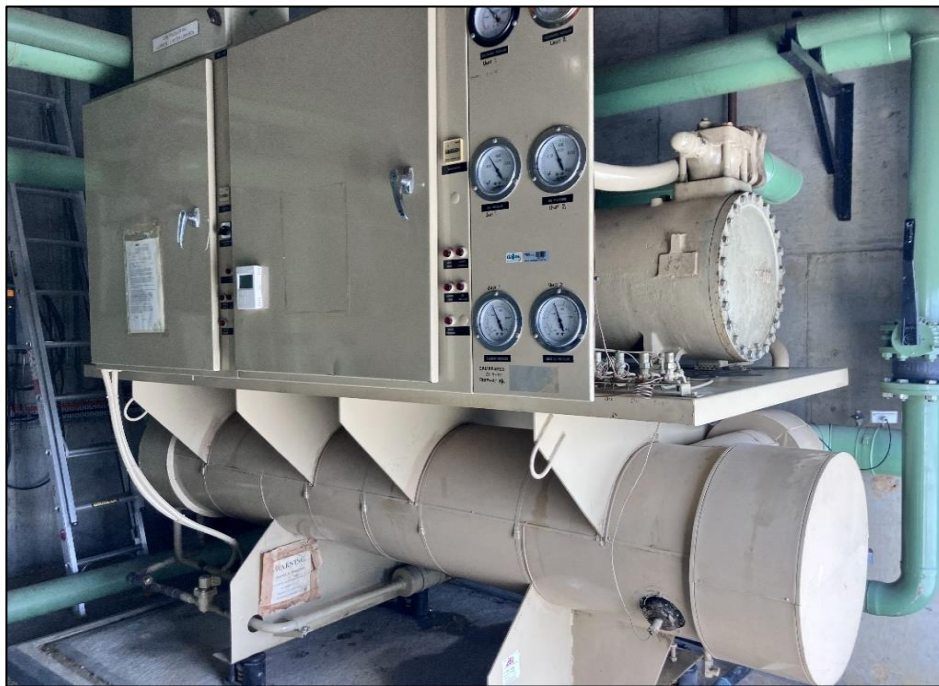
Photograph 46: South Tower, Level 5, Plant Room, boiler unit(s), bulk insulation, inaccessible.

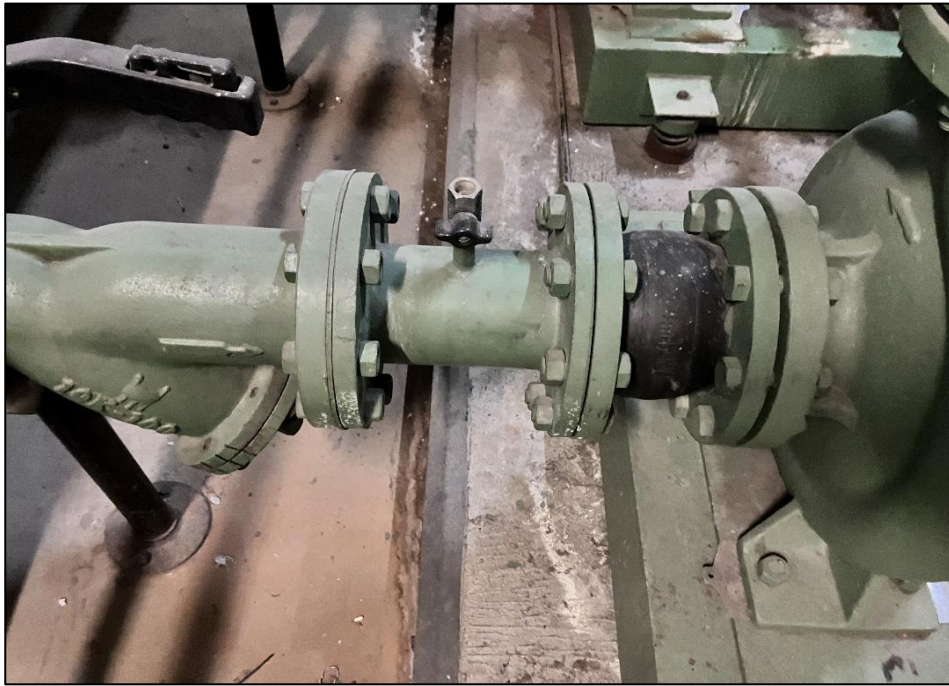
Photograph 47: South Tower, Level 5, Plant Room, pumping plant, pipework, gasket, no asbestos detected by analysis.

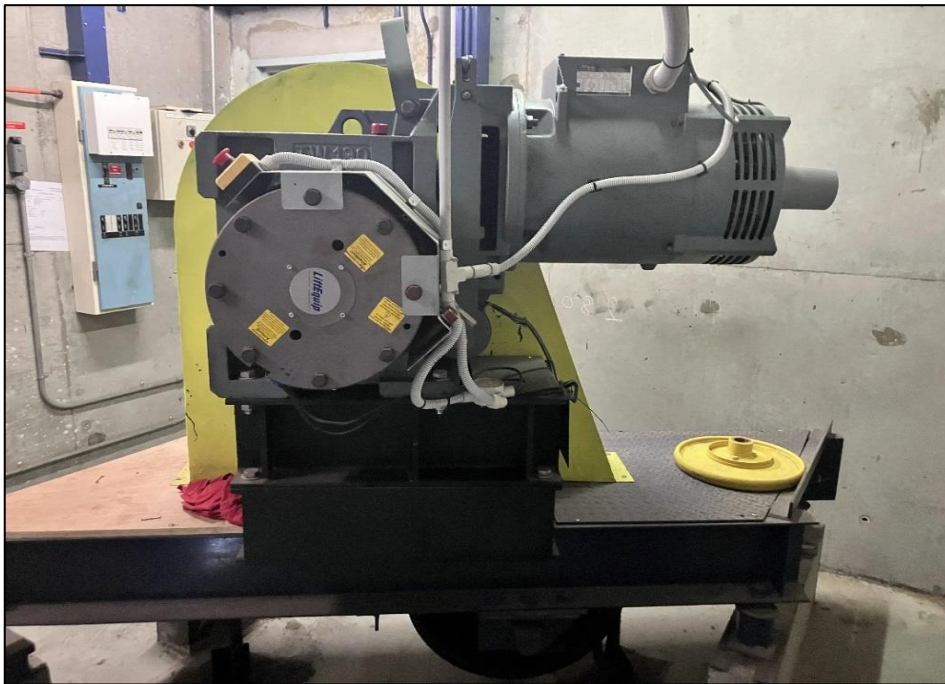
Photograph 48: South Tower, Level 5, Lift Motor Room, lift plant, internal components (e.g. friction pads), inaccessible.

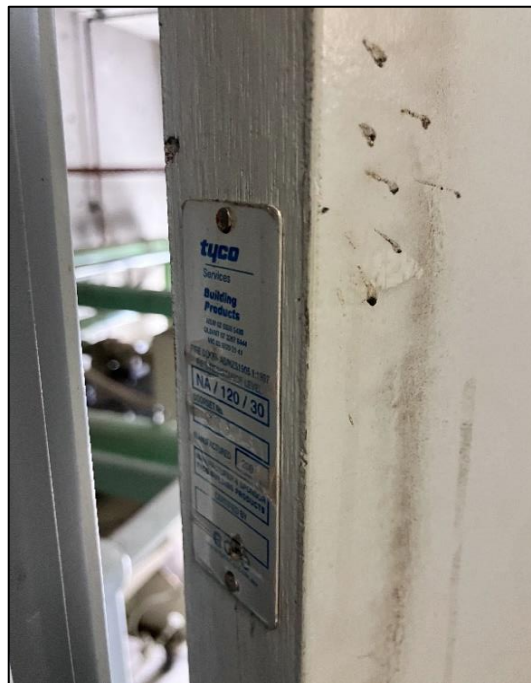
Photograph 50: South Tower, Level 5, Lift Motor Room, "Tyco" fire door (circa 2000's), insulation, suspected non-asbestos.

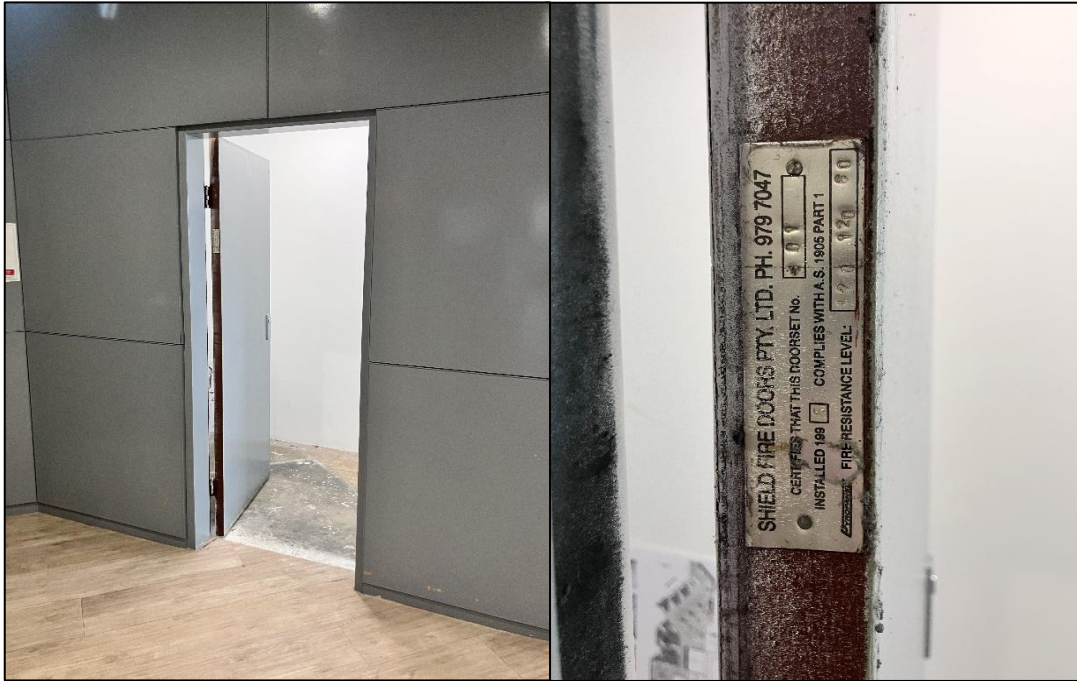
Photograph 51: South Tower, Ground Level, lift foyer, internal entrance to Unit 2, "Shield" fire door (c. 1995), insulation, suspected asbestos.

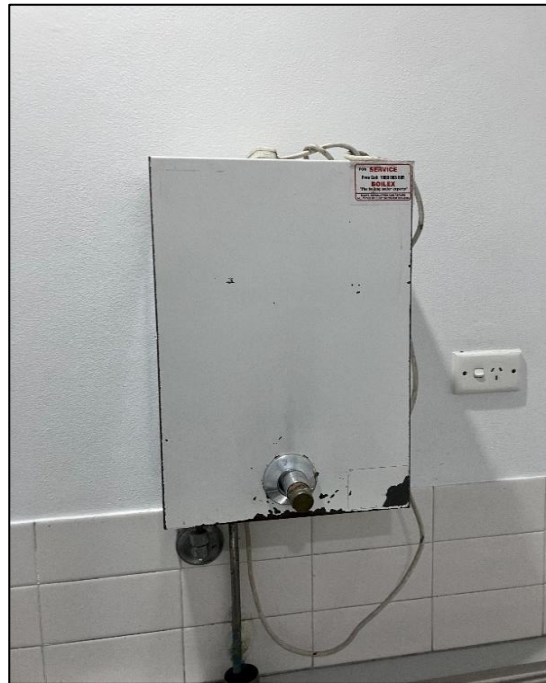
Photograph 52: South Tower, Ground Level, mailroom corridor, boiling water unit, insulation, inaccessible.

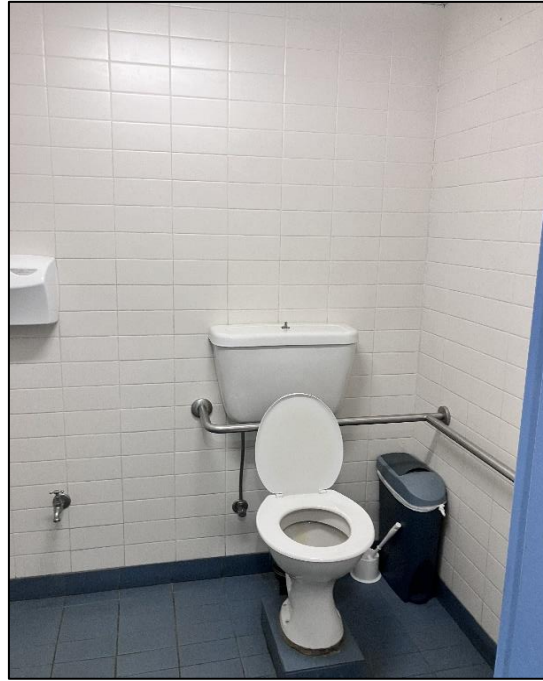
Photograph 53: South Tower, Ground Level, mailroom corridor, disabled toilet, below ceramic tiles, substrate, inaccessible.

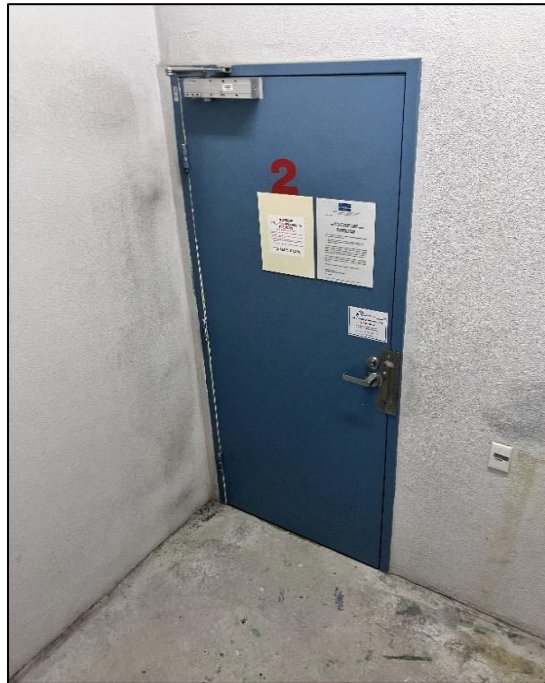
Photograph 54: South Tower, main stairwell, typical doorframe, blue paint.

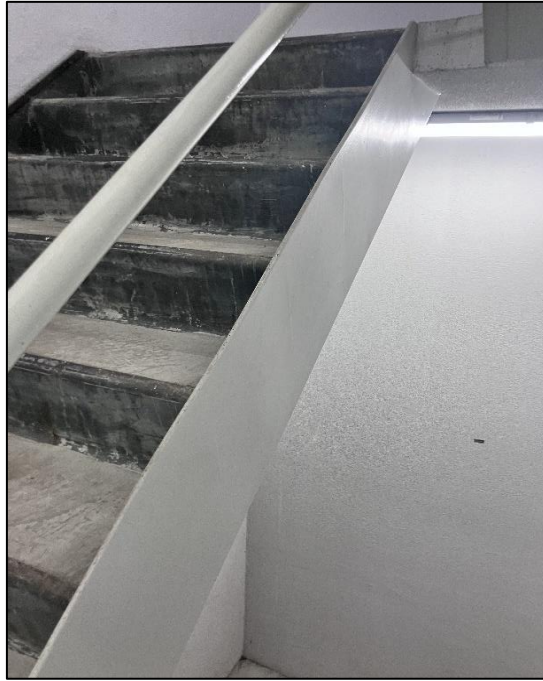
Photograph 55: South Tower, main stairwell, metal facing to stairs, white paint.

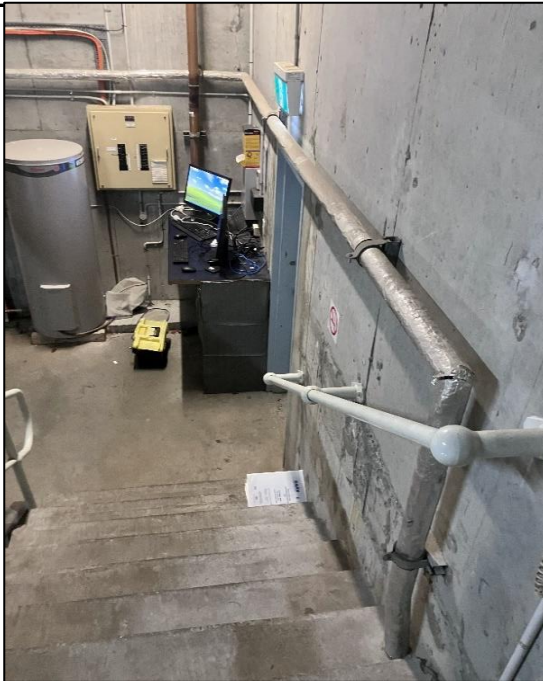
Photograph 56: South Tower, Level 5, Plant Room, accessible water pipe work, bulk insulation, SMF identified visually.

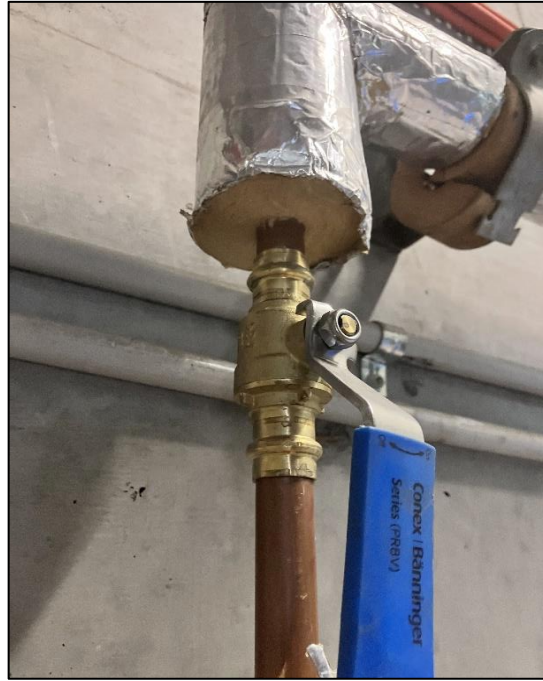
Photograph 57: South Tower, Level 5, Plant Room, accessible water pipe work, bulk insulation, SMF identified visually.

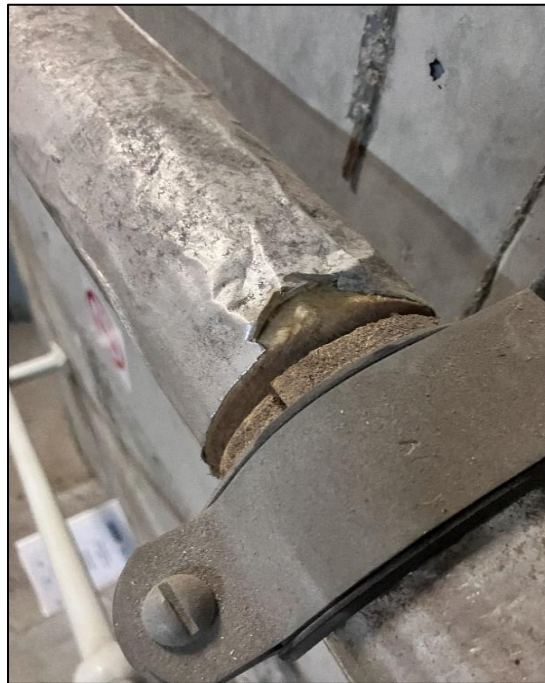
Photograph 58: South Tower, Level 5, Plant Room, accessible water pipe work, bulk insulation, SMF identified visually.

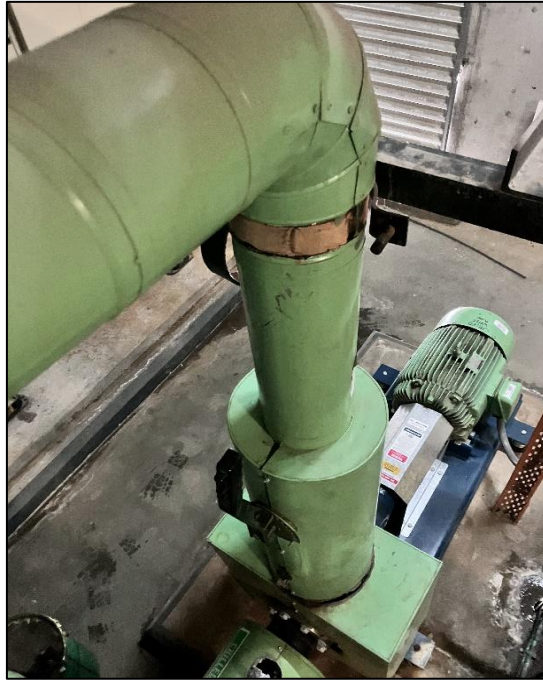
Photograph 59: South Tower, Level 5, Plant Room and open roof area, sheathed pipes and plant, bulk insulation, SMF and foam identified visually.

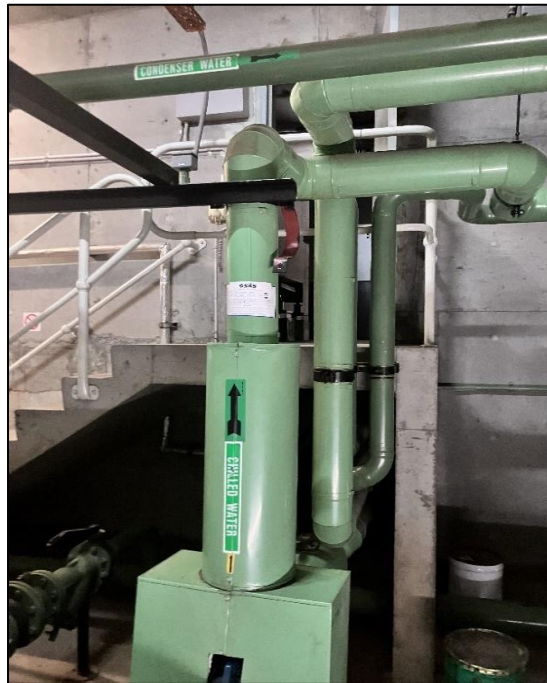
Photograph 60: South Tower, Level 5, Plant Room and open roof area, sheathed pipes and plant, bulk insulation, SMF and foam identified visually.

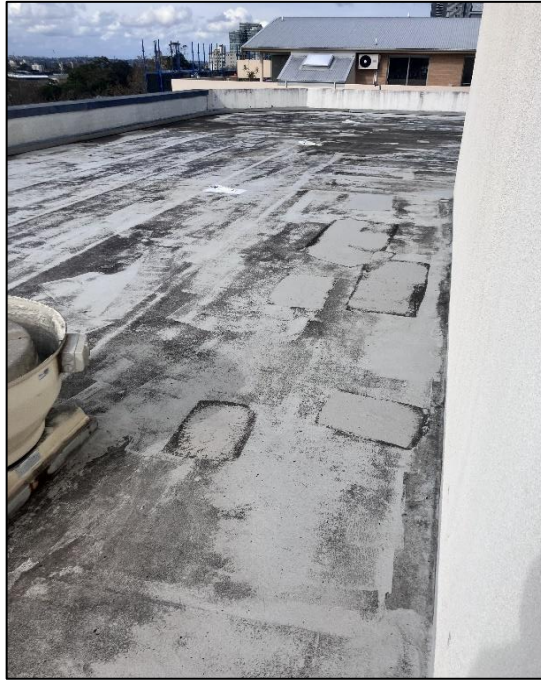
Photograph 61: South Tower, Level 5, open rooftop area, roof surface, exposed waterproofing membrane, SMF detected by analysis.

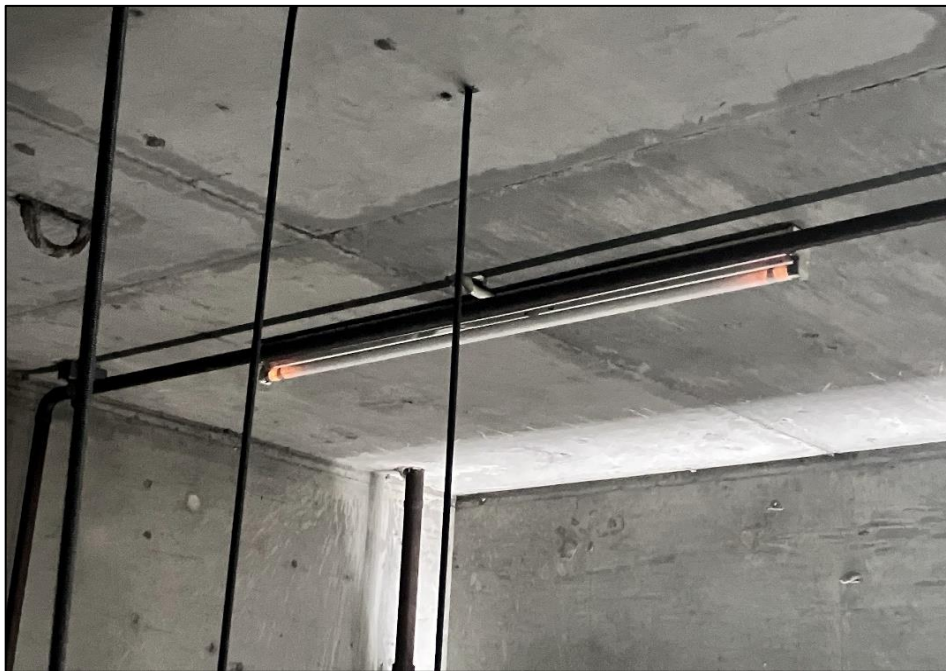
Photograph 62: South Tower, Level 5, Plant Room, fluorescent light fittings, internal components, PCB (suspected).

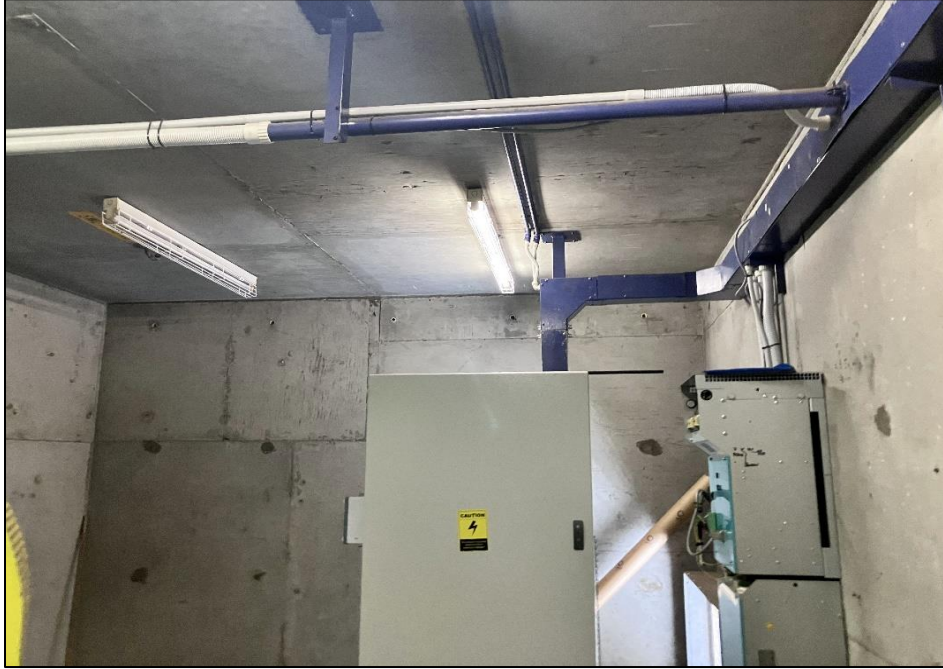
Photograph 63: South Tower, Level 5, Lift Motor Room, fluorescent light fittings, internal components, PCB (suspected).

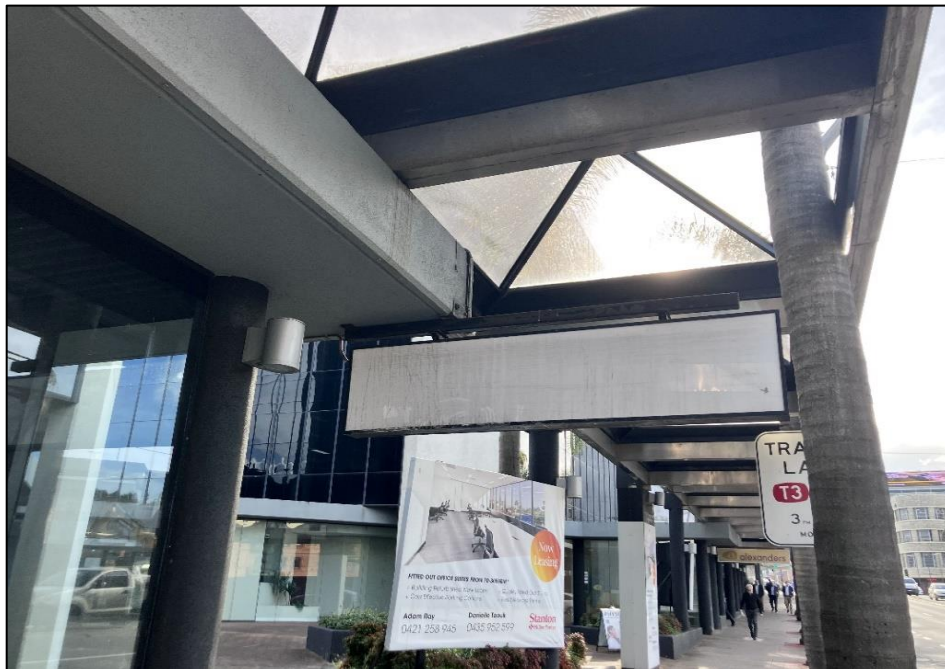
Photograph 64: South Tower, Ground Level, exterior façade, fluorescent light fittings, internal components, PCB (suspected).

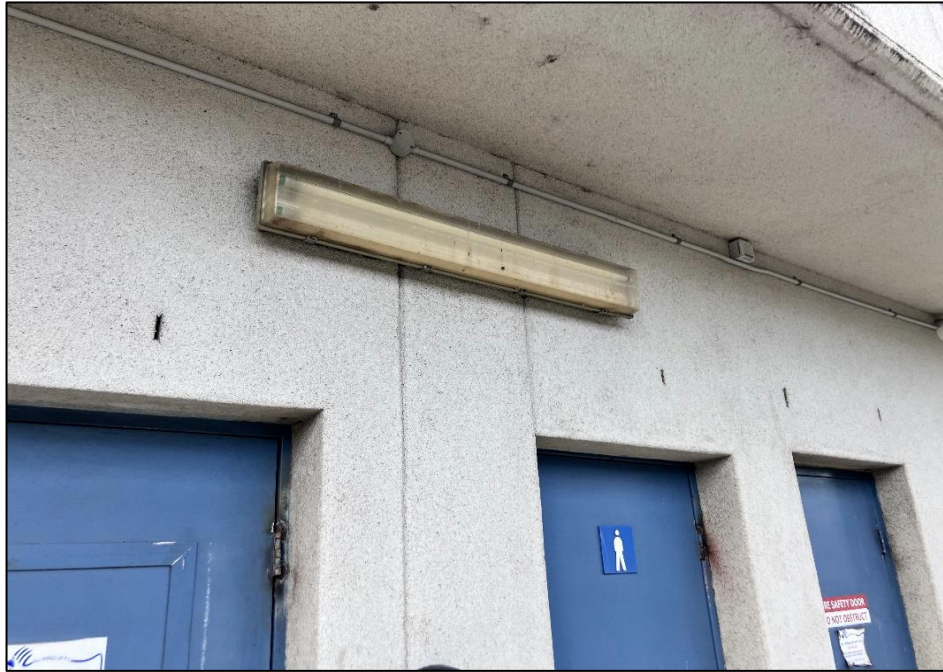
Photograph 65: South Tower, Ground Level, exterior façade, fluorescent light fittings, internal components, PCB (suspected).

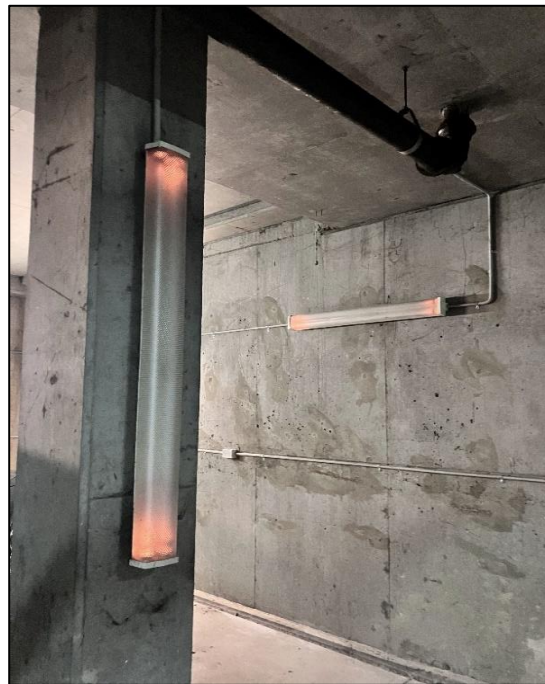
Photograph 66: South Tower, Basement, fluorescent light fittings, internal components, PCB (suspected).
