HUNTER INDOOR SPORTS CENTRE (HISC)

ARBORICULTURAL IMPACT ASSESSMENT

SEPTEMBER 2025

Arboricultural Impact Assessment

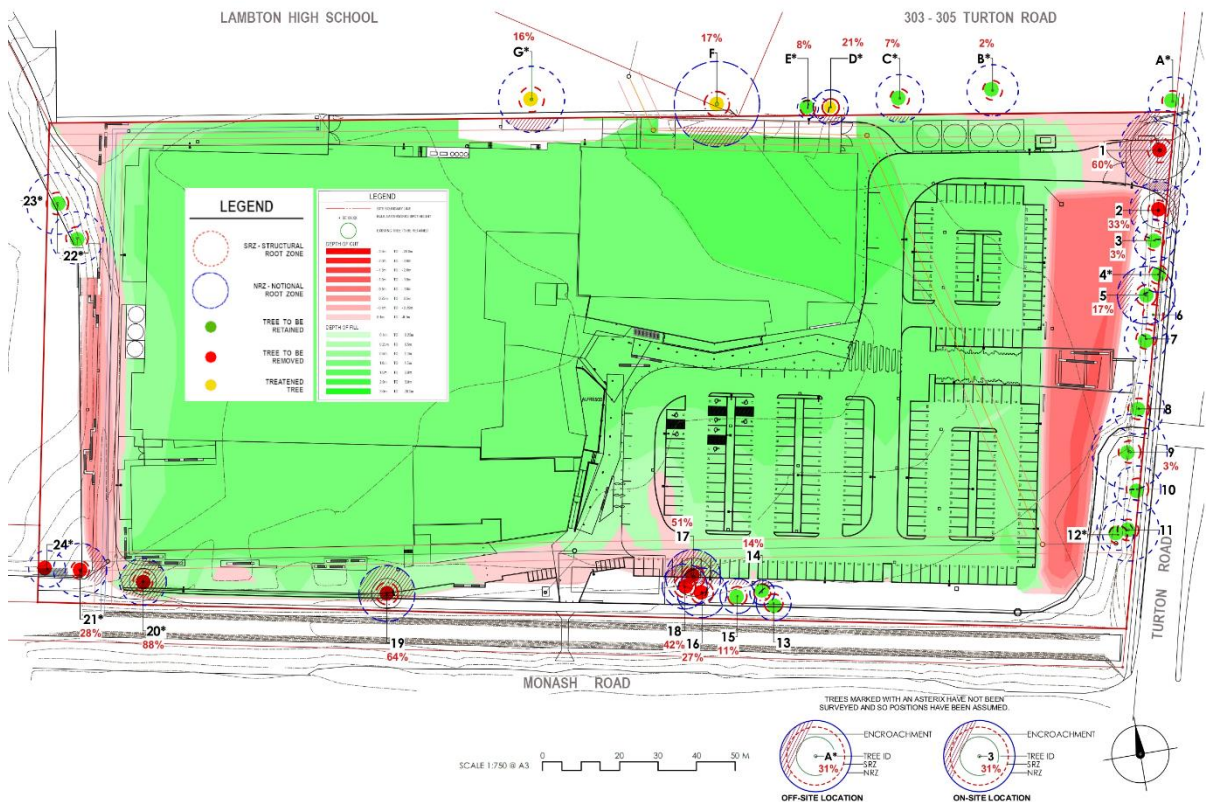
FIGURE 8: TREE IMPACT ASSESSMENT DIAGRAM.
[SOURCE: EJE ARCHITECTURE]

Figure 8 (and Appendix C2) shows that Trees 1, 2, 16-21 and 24 will need to be removed based on the proposed design. Changes to the design has protected all but two trees growing within the verge of Turton Road. Trees 1 and 2 will be required to be removed to allow access into the site. Trees 21 and 24 will be significantly impacted by the construction of a rain garden needed as part of the site's stormwater strategy

Trees 3 – 15, 22 and 23 will not be impacted by the the proposed 3 works as the NRZs of these trees will be subjected to minor encroachments only, if at all. The exception is Tree 17 that has an encroachment of 17% . This is regaded as moderate and acceptable for a tree of this species with average vigour. A pedestrian walkway runs between Trees 7 and 8. Based on the details available, there will be on a slight encroachment to thes two trees but monitoring during the detailed design phase and construction will be required.

Off-site Trees A, B, C, D, and E will also be retained as encroachments are within acceptable limits having regard to their locations, type of tree and condition. It should be noted that Tree D has an encroachment of 21% which is the upper tolerance for this species having average vigour. Soil levels around this tree are not being changed and so consideration has included the impact of the roadworks. Nevertheless routine monitoring will be required and so it has been designated as "Threatened" requiring monitoring by the Project Arborist during construction.

Trees F and G have been also assessed as being "Threatened". Although the enchroachments for these trees are with acceptable limits for a moderate NRZ encroachment according to AS 4970-2025, soil levels around these trees are not being changed and so consideration has included the impact of the roadworks including the provision of an elevated deck over the NRZ of Tree G. Tree G will also be impacted by the relocation of the sewer. It is considered that the type of encroachment and with proper management of the areas associated with the trees including implementing the the Preliminary Tree Protection Plan (Appendix D), it will be possible for these trees to be retained.

Tree 16 has also been noted as being "Removed". This tree is in severe decline and even if left undisturbed, it is likely to fail. By removing the existing containers and making changes nearby, it is likely that its decline will be hastened although not directly affected by the construction works. Changes to the design of the proposal, even if practical, would not prevent this tree from failing.

- that Trees 1, 2, 16-21 and 24, occurring on-site, be removed;
- that Trees 3-15, 22, 23, A-C and E be retained; and,
- that Trees D, F and G be retained by following the requirements of the Preliminary Tree Protection Manual (refer Appendix D) subject to careful detailing during the detailed design and documentation phases and further investigations occurring at the commencement of construction to ensure major roots are not damaged and/or further action taken.

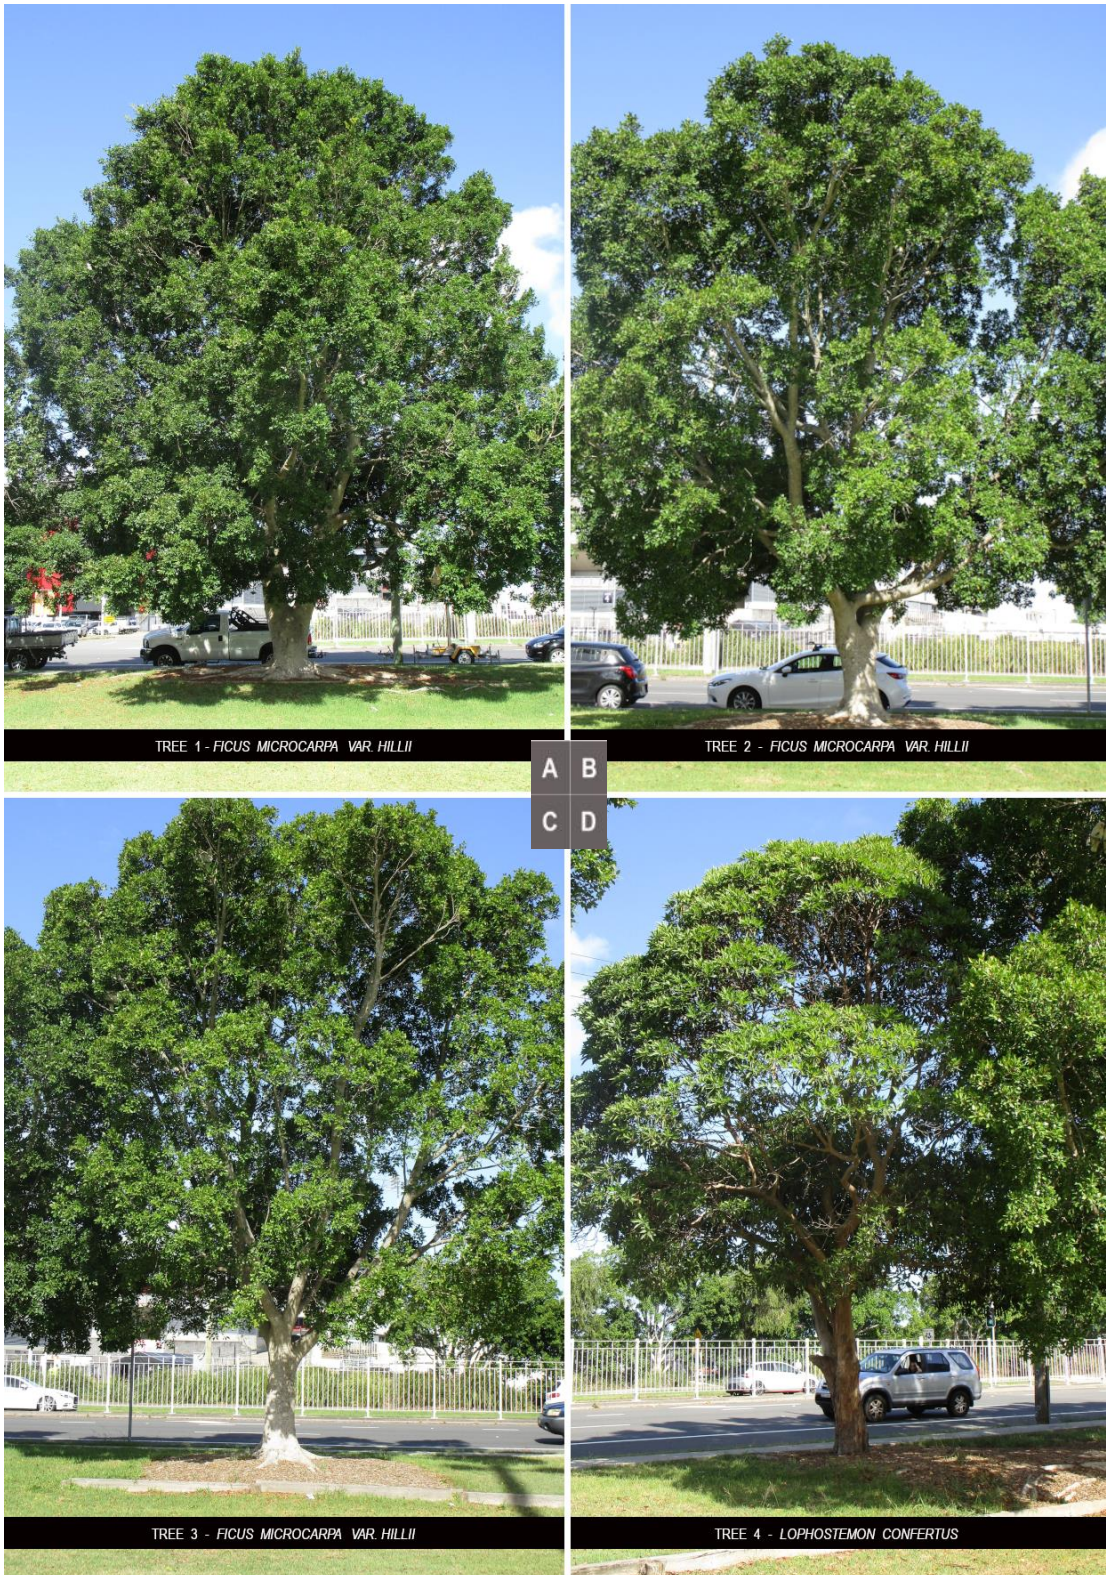
FIGURE A1: Trees 1-4 (INSPECTED 2024/02)

3	<i>Ficus microcarpa var. hillii</i>	Hills Weeping Fig	M	11	460	5.52	540	2.55	+40	AV	AV	A1	A1C	3. [CoN TREE ID 67123] LARGE SURFACE ROOTS MANY RUNNING PARALLEL TO ROAD DUE TO THE PRESENCE OF TIMBER EDGING TO THE WEST AND FOOTPATH TO THE EAST. TREE ROOTS NOW RUNNING BEYOND EDGING AND INTO NEARBY TURF. PRUNING TO ROADSIDE CANOPY RESULTING IN AN ASYMMETRIC CANOPY. SOOTY MOULD PRESENT TO THE FOLIAGE OF THE LOWER CANOPY. TO BE RETAINED
4	<i>Lophostemon confertus</i>	Brush Box	M	7.5	390 ¹	4.68	480	2.43	15-40	P	AV	A1	A1D	4. [CoN TREE ID 67122] [DBH: 300/250] TREE PLANTED CLOSER TO POWERLINES. PRUNING TO ROADSIDE CANOPY RESULTING IN AN ASYMMETRIC CANOPY. EPICORMIC GROWTH PRESENT AT PRUNING SITES. SNAPPED FIRST ORDER BRANCH WITH BRANCH TEAR (OLD). TO BE RETAINED
5	<i>Ficus microcarpa var. hillii</i>	Hills Weeping Fig	M	13	630	7.56	630	2.73	+40	AV	AV	A1	A2A	5. [CoN TREE ID 67121] TREE WITH SLIGHT LEAN TO THE WEST. TREE DISLODGING EDGING. LARGE SURFACE ROOTS MANY RUNNING PARALLEL TO ROAD DUE TO THE PRESENCE OF TIMBER EDGING TO THE WEST AND FOOTPATH TO THE EAST. TREE ROOTS NOW RUNNING BEYOND EDGING AND INTO NEARBY TURF. MODERATE ENCROACHMENT. TO BE RETAINED

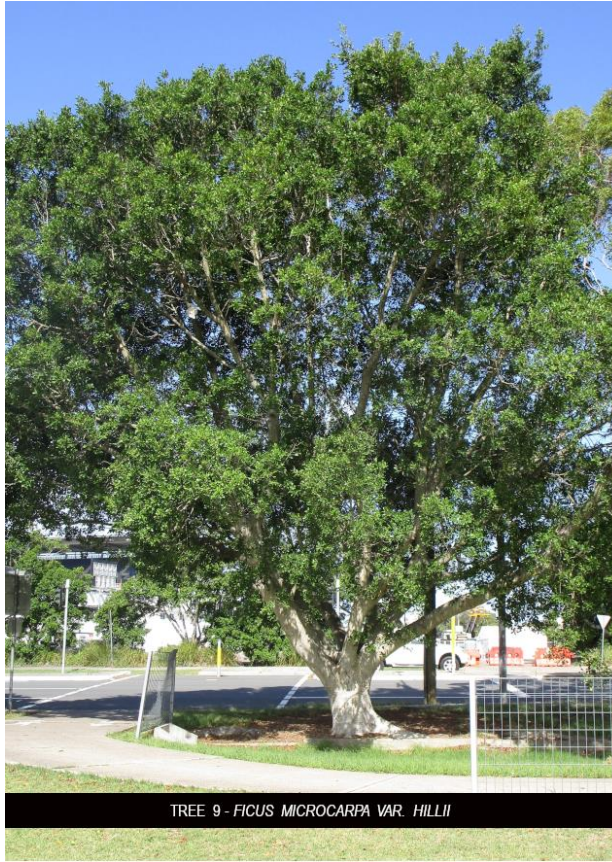
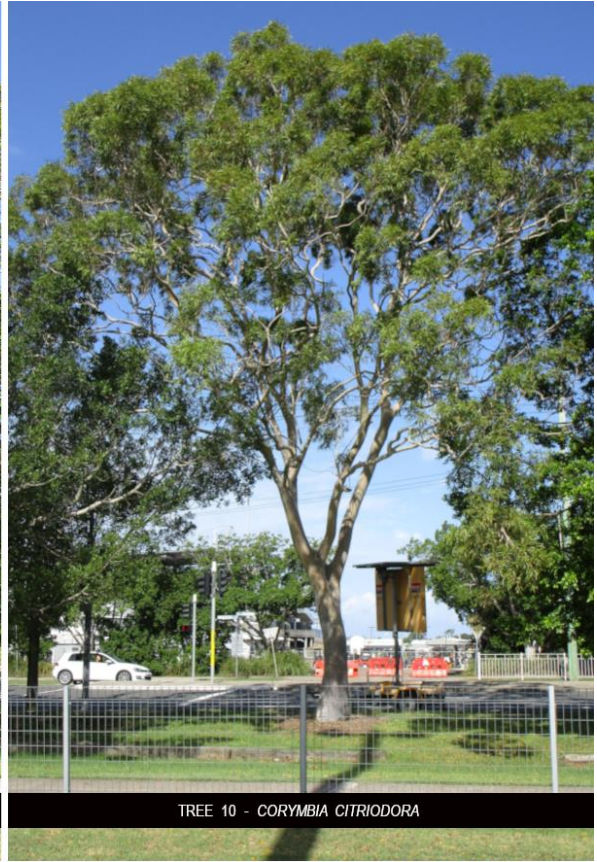
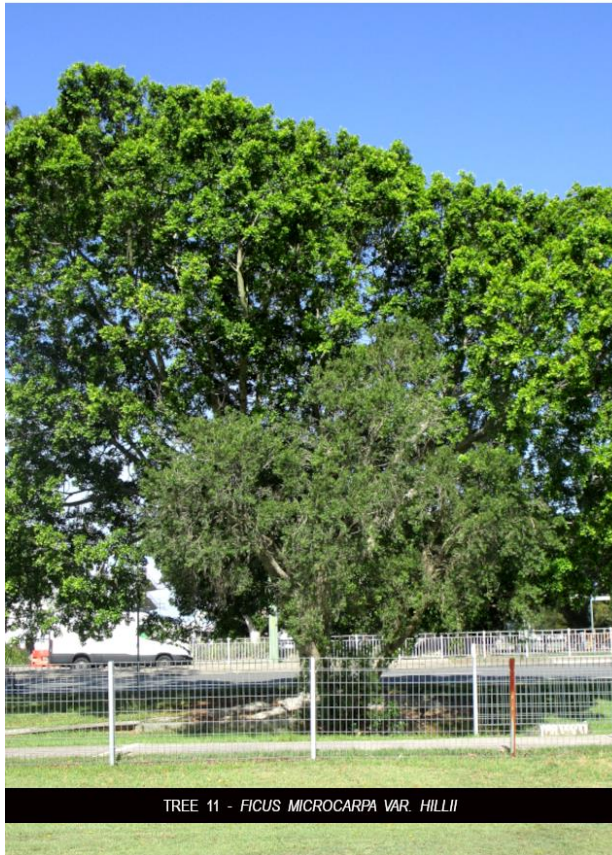
FIGURE A3: Trees 9-12 (INSPECTED 2024/02)

10	<i>Corymbia citriodora</i>	Lemon-scented Gum	M	17	510	6.12	720	2.88	+40	AV	AV	A1	A3B	10. [CoN TREE ID 67116] PAST PRUNING OF LOWER CANOPY WITH UPPER BRANCHES CLEAR OF WIRES. PRUNING TO ROADSIDE CANOPY RESULTING IN AN ASYMMETRIC CANOPY. TO BE RETAINED
11	<i>Ficus microcarpa var. hillii</i>	Hills Weeping Fig	M	14	680	8.16	650	2.76	+40	AV	AV	A1	A3C	11. [CoN TREE ID 67115] SEWER MANHOLE NOTED NEARBY INDICATING PRESENCE OF SEWER. MECHANICAL DAMAGE TO SURFACE ROOTS. PRUNING TO ROADSIDE CANOPY RESULTING IN AN ASYMMETRIC CANOPY. TO BE RETAINED
12	<i>Callistemon viminalis</i>	Weeping Bottlebrush	M	4	340	4.08	460	2.39	15-40	F	AV	A1	A3D	12. [CoN TREE ID 67114] [DBH: 160/300] TREE OCCURRING CLOSE TO TREE 11 RESULTING IN SUPPRESSED GROWTH AND ASYMMETRIC CANOPY. BASE OF TREE BEING ENCIRCLED BY ROOTS FROM TREE 11. PREVIOUS PRUNING OF LOWER BRANCHES. SUCKER GROWTH PRESENT. TO BE RETAINED
13	<i>Casuarina cunninghamiana</i>	River She-oak	M	11	380	4.56	480	2.43	+40	F	F	A1	A4A	13. [CoN TREE ID 67109] TREE LOCATED ON FENCELINE RESULTING IN DISTORTION OF FENCE. LOWER BRANCHES REMOVED ESPECIALLY THOSE THAT WOULD HAVE IMPACTED ON SHARE PATH USERS. CO-DOMINANT TRUNK OCCURRING @ 1.7M AGL SLIGHT LEAN IN THE TRUNK FROM THE MIDDLE AND UPPER CANOPY. TO BE RETAINED

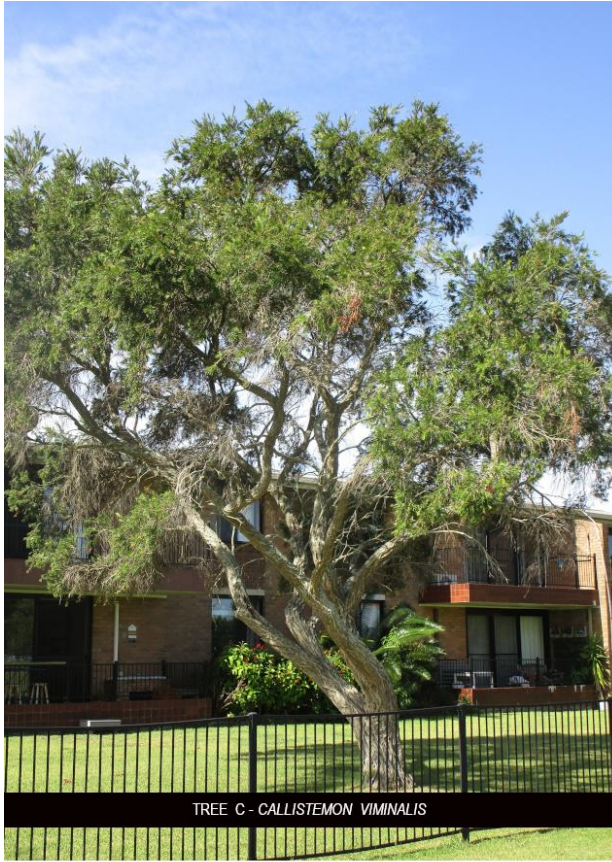
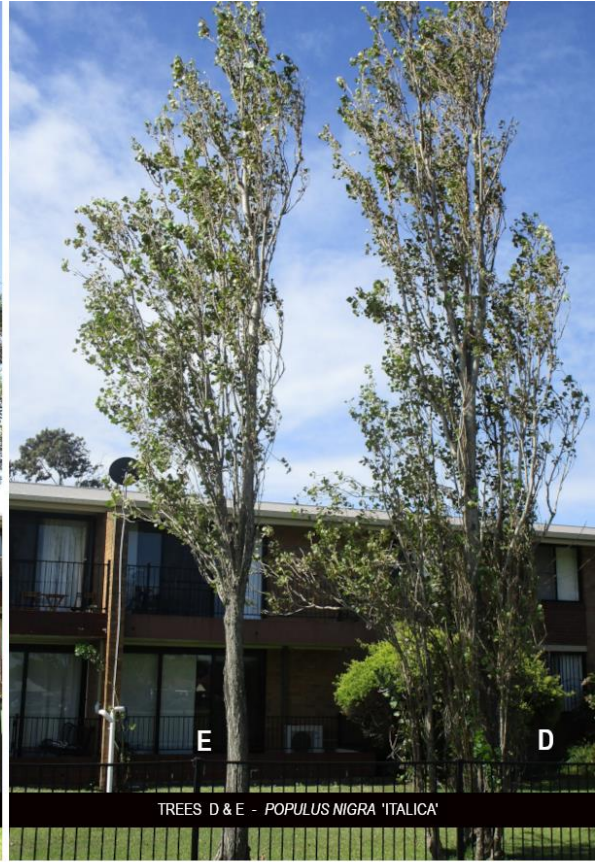
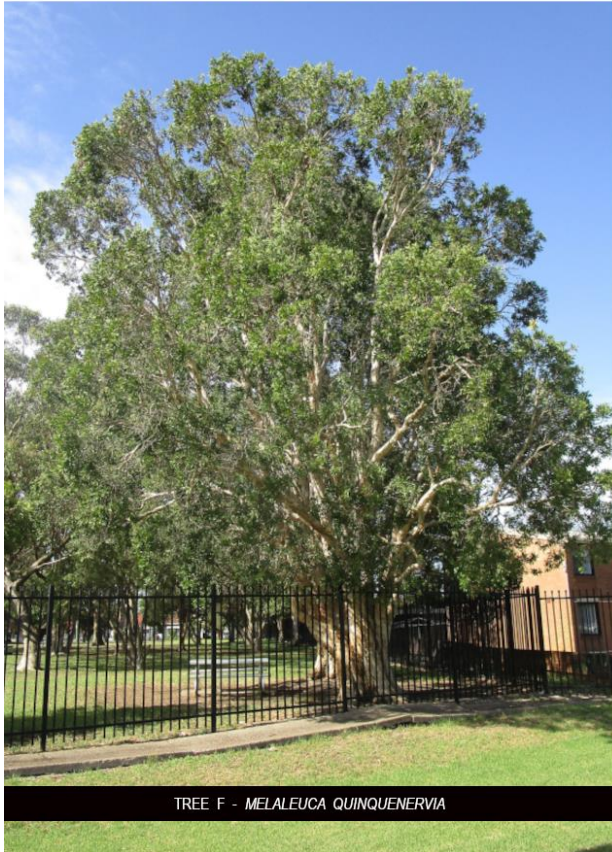
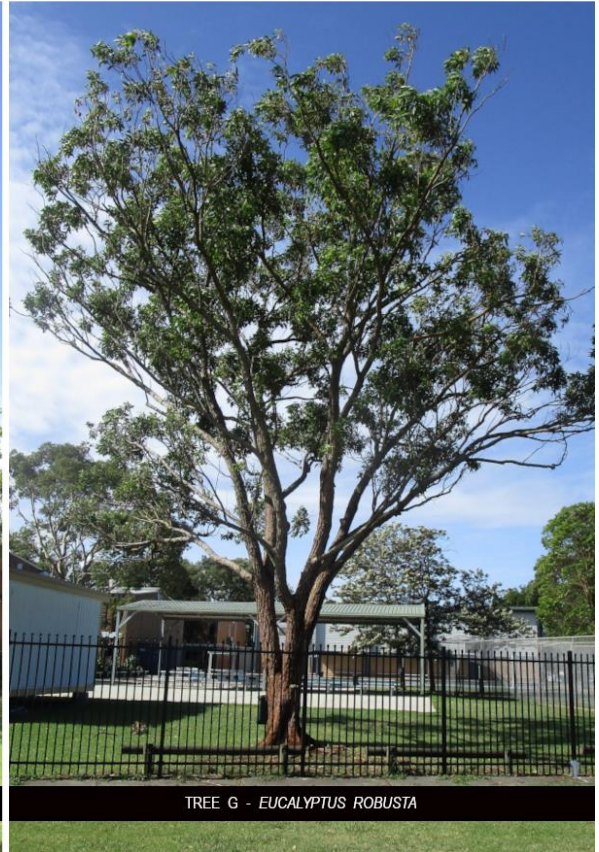
FIGURE A6: Trees C-F (INSPECTED 2024/02)

E*	<i>Populus nigra Italica'</i>	Lombardy Poplar	M	9	230	2.76	300	2.00	+40	F	AV	A1	A6B	E. SLIGHT MECHANICAL DAMAGE AT THE BASE OF THE TREE. IT APPEARS THAT THE TREE MAY HAVE BEEN LOPPED AT 3M AGL SOME TIME AGO AS SECONDARY GROWTH NOW WELL ESTABLISHED. TO BE RETAINED
F	<i>Melaleuca quinquenervia</i>	Swamp Paperbark	M	12	930	11.16	970	3.27	+40	AV	AV	A1	A7C	F. MULTI-TRUNKED TREE WITH 6 MAJOR LEADERS FORMING AT 800MM AGL. PAST PRUNING HAS BEEN DONE POORLY, RESULTING IN THE EXISTENCE OF BRANCH STUBS - SOME WITH WOOD ROT. GROUND AROUND THE BASE OF THE TREE HEAVILY COMPACTED BY STUDENTS GATHERING UNDER THE TREE. NEARBY DISH DRAIN AFFECTED BY TREE ROOTS. THREATENED TREE. IMPLEMENTATION OF TREE PROTECTION MANUAL REQUIRED.
G*	<i>Eucalyptus robusta</i>	Swamp Mahogany	M	14	720	8.64	800	3.01	+40	AV	AV	A1	A7D	G. CO-DOMINANT TRUNK @ 1.3M AGL. SPREADING CANOPY. MINOR DEADWOOD AND EPICORMIC GROWTH THROUGHOUT. SURROUNDING GROUND MILDLY COMPACTED. MEDIUM CROWN DENSITY. THREATENED TREE. IMPLEMENTATION OF TREE PROTECTION MANUAL REQUIRED.

- It is further suggested with the approval of the high school, to the base of Tree F: remove picnic seating; hand cultivate the NRZ area to a depth of 100mm-150mm to break-up the surface crust; undertake an application of a plant growth regulator that assists the initiation of compensatory root growth (e.g. Seasol®); apply 25mm (approx.) of a root zone conditioner (e.g. soured lucerne, worm castings and well-composted mulch followed by 50mm (approx.) thick application of an organic mulch (e.g. Mixed Leaf and Wood Chip Mulch) for the purpose of retaining moisture and to provide a protective layer to prevent further compaction.

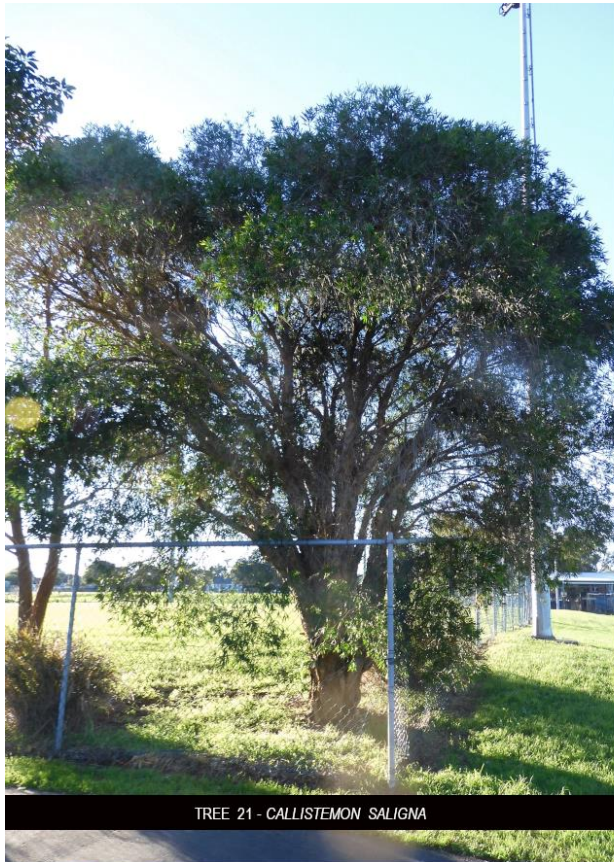
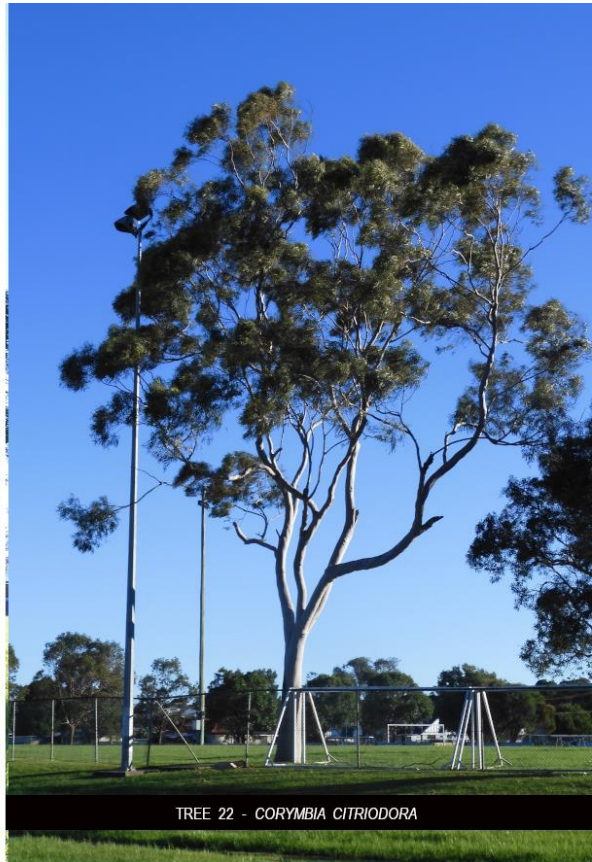
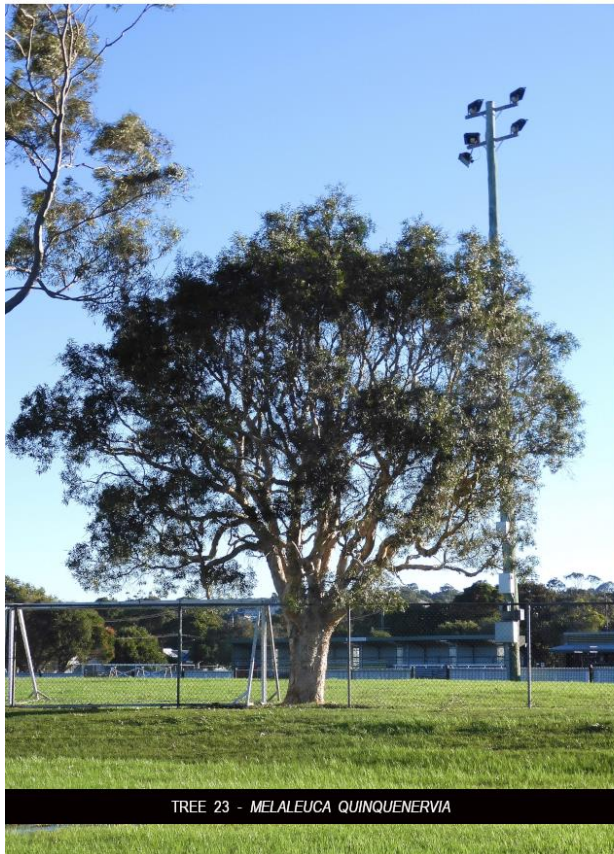
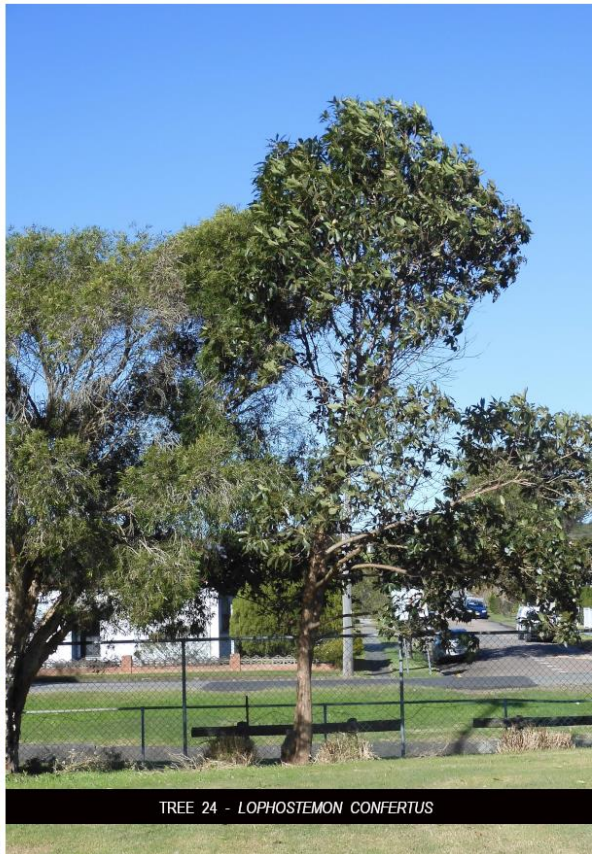
FIGURE A8: Tree 21 - 24 (INSPECTED 2025/05/24)

21	<i>Callistemon salignus</i>	Willow Bottlebrush	M	8	580	6.96	460	2.39	+40	F	AV	A1	A8A	21. [CoN TREE ID 67087] [DBH: 230/280/330/220/130] MULTI CO-DOMINANT TRUNK. LOCATED ON SIDE-SLOPE TO ADJOINING OVAL. EVIDENCE OF PRIOR PRUNING. THIS TREE WILL NEED TO BE REMOVED.
22	<i>Corymbia citriodora</i>	Lemon-scented Gum	M	17	570	6.84	730	2.90	+40	AV	AV	A1	A8B	22. [CoN TREE ID 67058] OPEN CANOPY. CO-DOMINANT TRUNK @ 3.5M AGL. SOME OLD STORM DAMAGE WITH REMNANT BRANCH STUBS REMAINING WITH INCLUDED BARK. TO BE RETAINED
23	<i>Melaleuca quinquenervia</i>	Swamp Paperbark	M	10	670	8.04	720	2.88	+40	AV	AV	A1	A8C	23. [CoN TREE ID 67057] GOOD SPECIMEN WITH SPREADING CANOPY THAT HAS GROWN WITHOUT COMPETITION ALLOWING FOR CURRENT FORM. TO BE RETAINED
24	<i>Lophostemon confertus</i>	Brush Box	SM	7	230*	2.76	390	2.23	15-40	F	AV	A1	A8D	24. [CoN TREE ID 67086] [DBH: 170/1600] CO-DOMINANT TRUNK ARISING FROM NEAR GROUND LEVEL WITH INCLUDED BARK. SUPPRESSED CANOPY FROM TREE 21. THIS TREE WILL NEED TO BE REMOVED.
