## ANNEXURE 7 — REPORTED DAMAGE AS A RESULT OF EXCAVATION

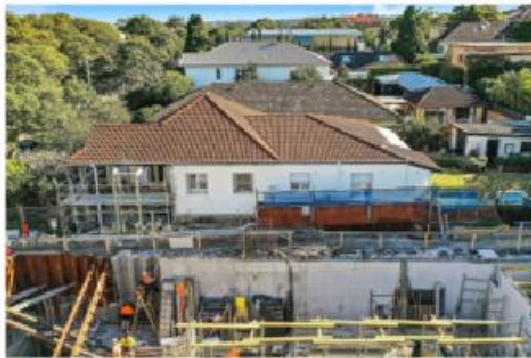
**Wilberforce Avenue** — House partially collapsed and had to be demolished after catastrophic structural failure due to single storey basement excavation next door.

The front rooms of a house next to a development site on Wilberforce Avenue in Rose Bay caved after the excavation of a single storey. Ray White

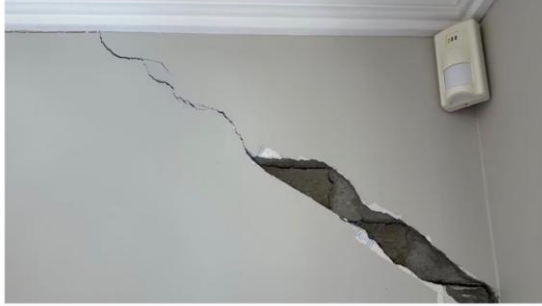
Cracks which developed in a home 200 metres away from a construction site in Rose Bay, which the resident claims are linked to excavation. Picture: Rose Bay Residents Action Group
