Fax Transmission

To	Ben Fryer	From	Matt Rowbotham
Fax No		Date	12/12/07
Company	Doug Gow and Associates	Reference	Preliminary Geotechnical Assessment Workshop Letter
cc		Page	1 of
Subject	Preliminary Geotechnical Assessment - The Lakes Estate Stages 1.2 to 9.2

client:	DOUG GOW AND ASSOCIATES PTY LTD
project:	THE LAKES ESTATE STAGES 1.2 to 9.2
title:	SITE PLAN SHOWING APPROX. TEST PIT LOCATIONS
project no:	GEOTCOFH02233AA
figure no:	FIGURE

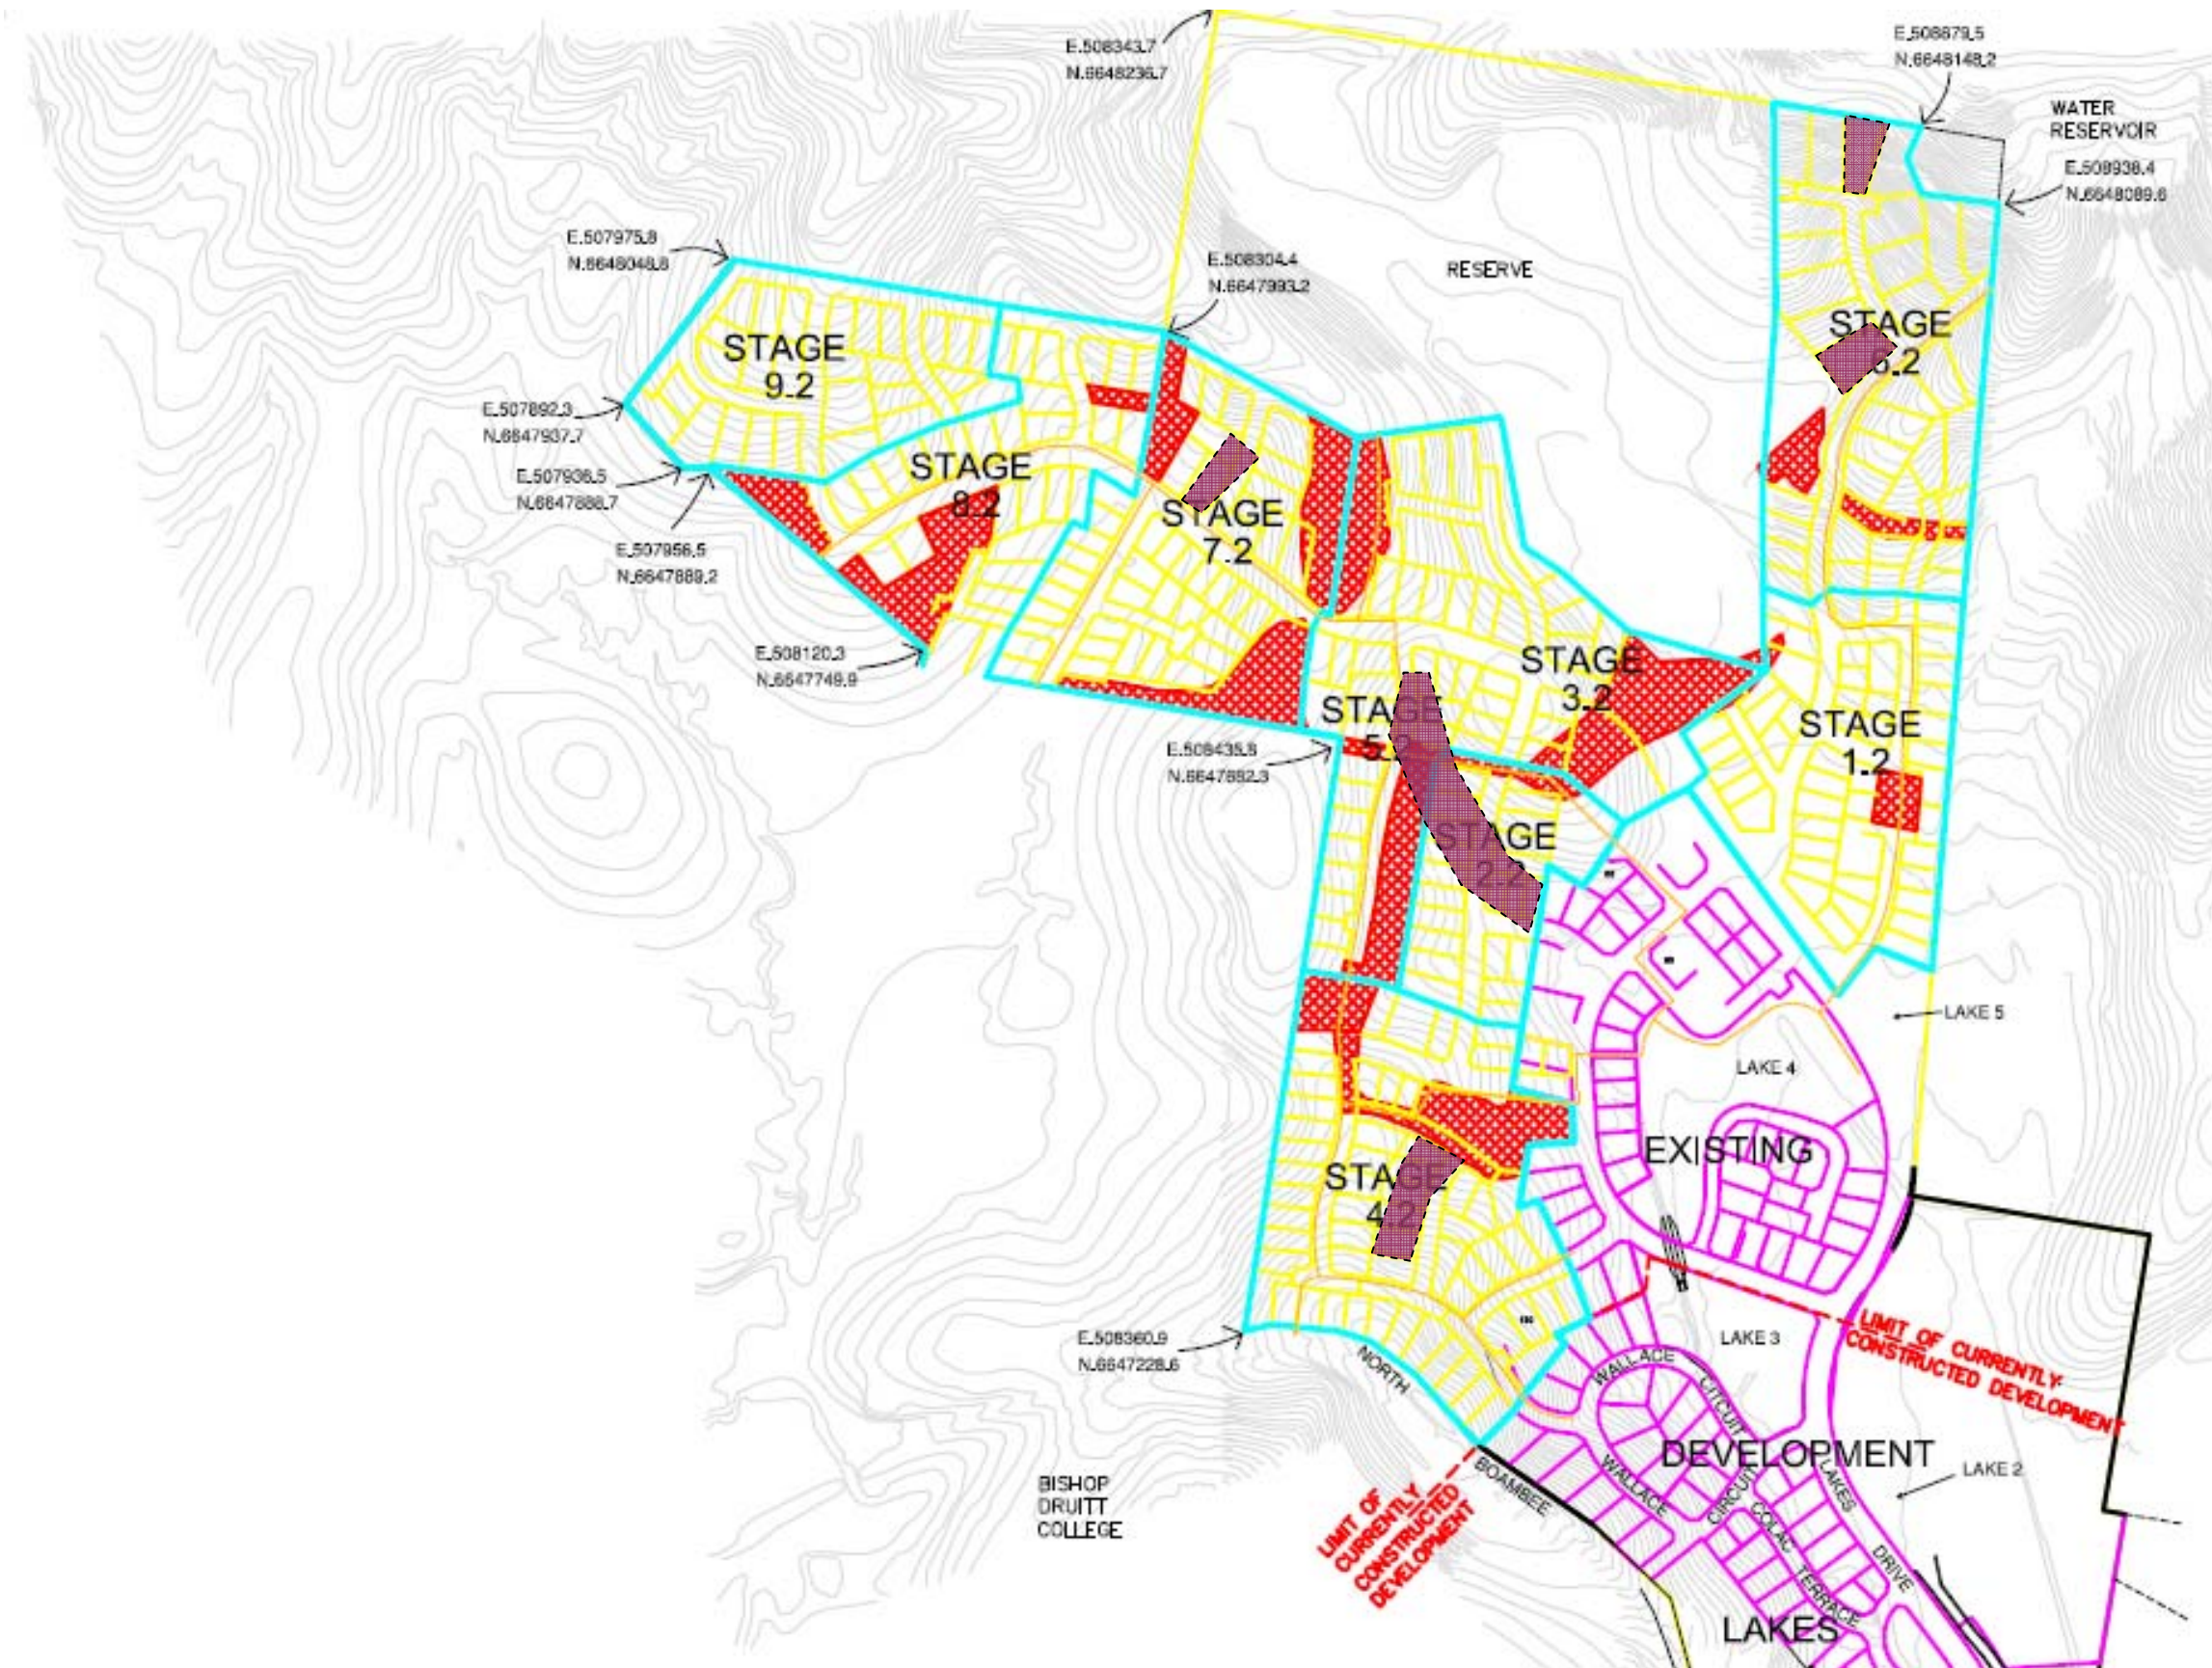
client:	DOUG GOW AND ASSOCIATES PTY LTD
project:	THE LAKES ESTATE STAGES 1.2 TO 9.2
title:	HOUSING NOT RECOMMENDED IN WATERCOURSES
project no:	GEOTCOFH02233AA
figure no:	FIGURE

Some housing plots are shown within axes of watercourses where compressible subsoils are expected and extreme runoff (surface water) frequently occurs. A plan of such affected areas is attached.

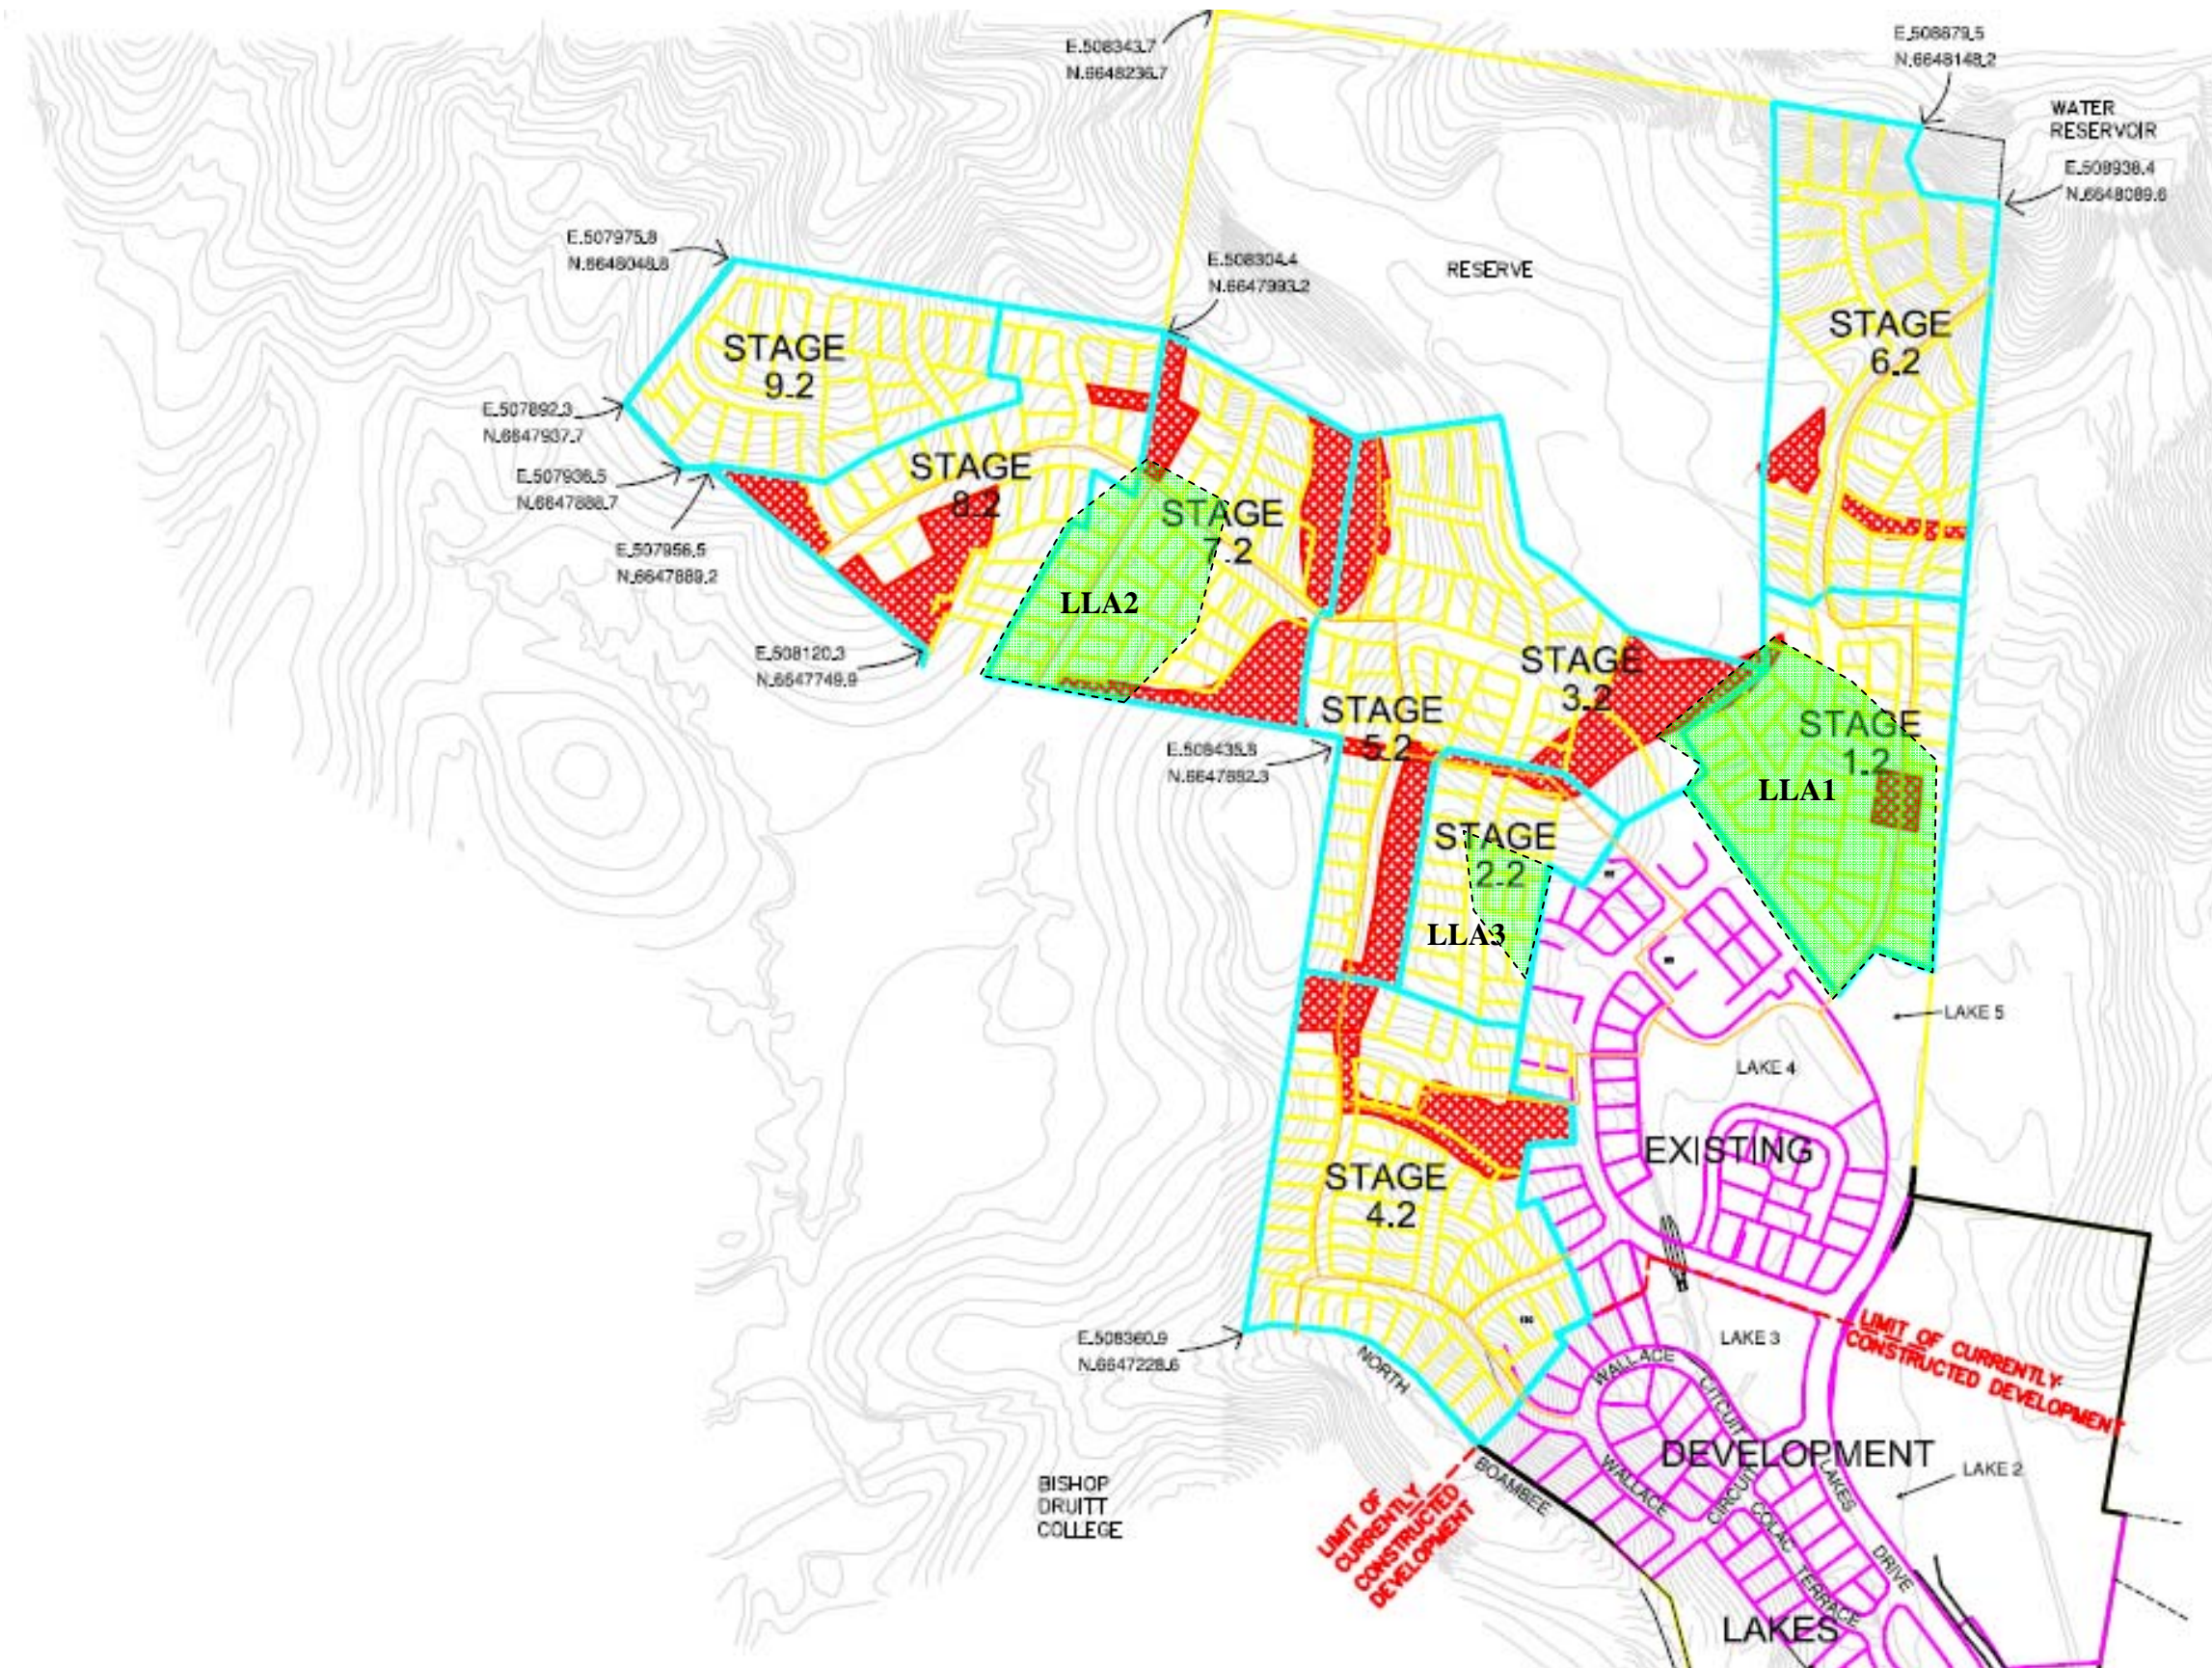
coffey geotechnics SPECIALISTS MANAGING THE EARTH	client:	DOUG GOW AND ASSOCIATES PTY LTD		
					approved	IT		project:	THE LAKES ESTATE STAGES 1.2 to 9.2		
					date	12/12/07		title:	LOW LYING AREAS		
					scale	NTS		project no:	GEOTCOFH02233AA	figure no:	FIGURE
					original size

Three low lying areas were identified during the investigation which may present difficulties during construction, Low Lying Area 1 (LLA1), LLA2 and LLA3 indicated on the plans provided.

LLA1 is located adjacent and nearby to the land currently under earthworks construction at The Lakes Estate. LLA1 is located in Stage 1.2.

Investigation undertaken in this area was principally aimed at acid sulphate soil assessment. Test pits indicated shallow groundwater, soft to firm clay soil and significant lenses of silt. Based on our experience with the adjacent earthworks and being typical of silt, the subsurface conditions and shallow water level together are likely to present difficulties. Compaction of wet fine grained soils and problems with traffickability have been encountered. To allow construction to proceed in this area, improved drainage will be needed. Importation and compaction of granular fill (e.g. quarried rock fill) will likely be required to allow a relatively rigid working platform to be placed that will enable placement of fill to achieve filling to a required standard for the support of structures (e.g. 'level 1' in accordance with AS3798-2007).

LLA2 is located between Stage 7.2 and Stage 8.2 in the axis of the valley. From the test pit investigation subsurface conditions are known to comprise moist to wet and firm to stiff 'hillwash' clay extending to some 1m depth overlying stiff to very stiff clay. Within the upper 1m groundwater seepage was observed.

LLA3 is located in Stage 2.2. Based on our earthworks experience in the adjacent stage it is likely that similar conditions will present to that of LLA1.

Further to the above it is likely that significant portions of the silt and soft to firm clay will require over excavation and removal prior to placement and compaction of the quarried fill. Care must be taken to avoid excavation below the water table in silt.

Based on the plans provided, an access road and residential lots are to be located in this area. Similar to LLA1 improved drainage and the replacement of superficial clay with appropriately moisture conditioned clay fill or granular fill (rock fill) is likely to be needed.

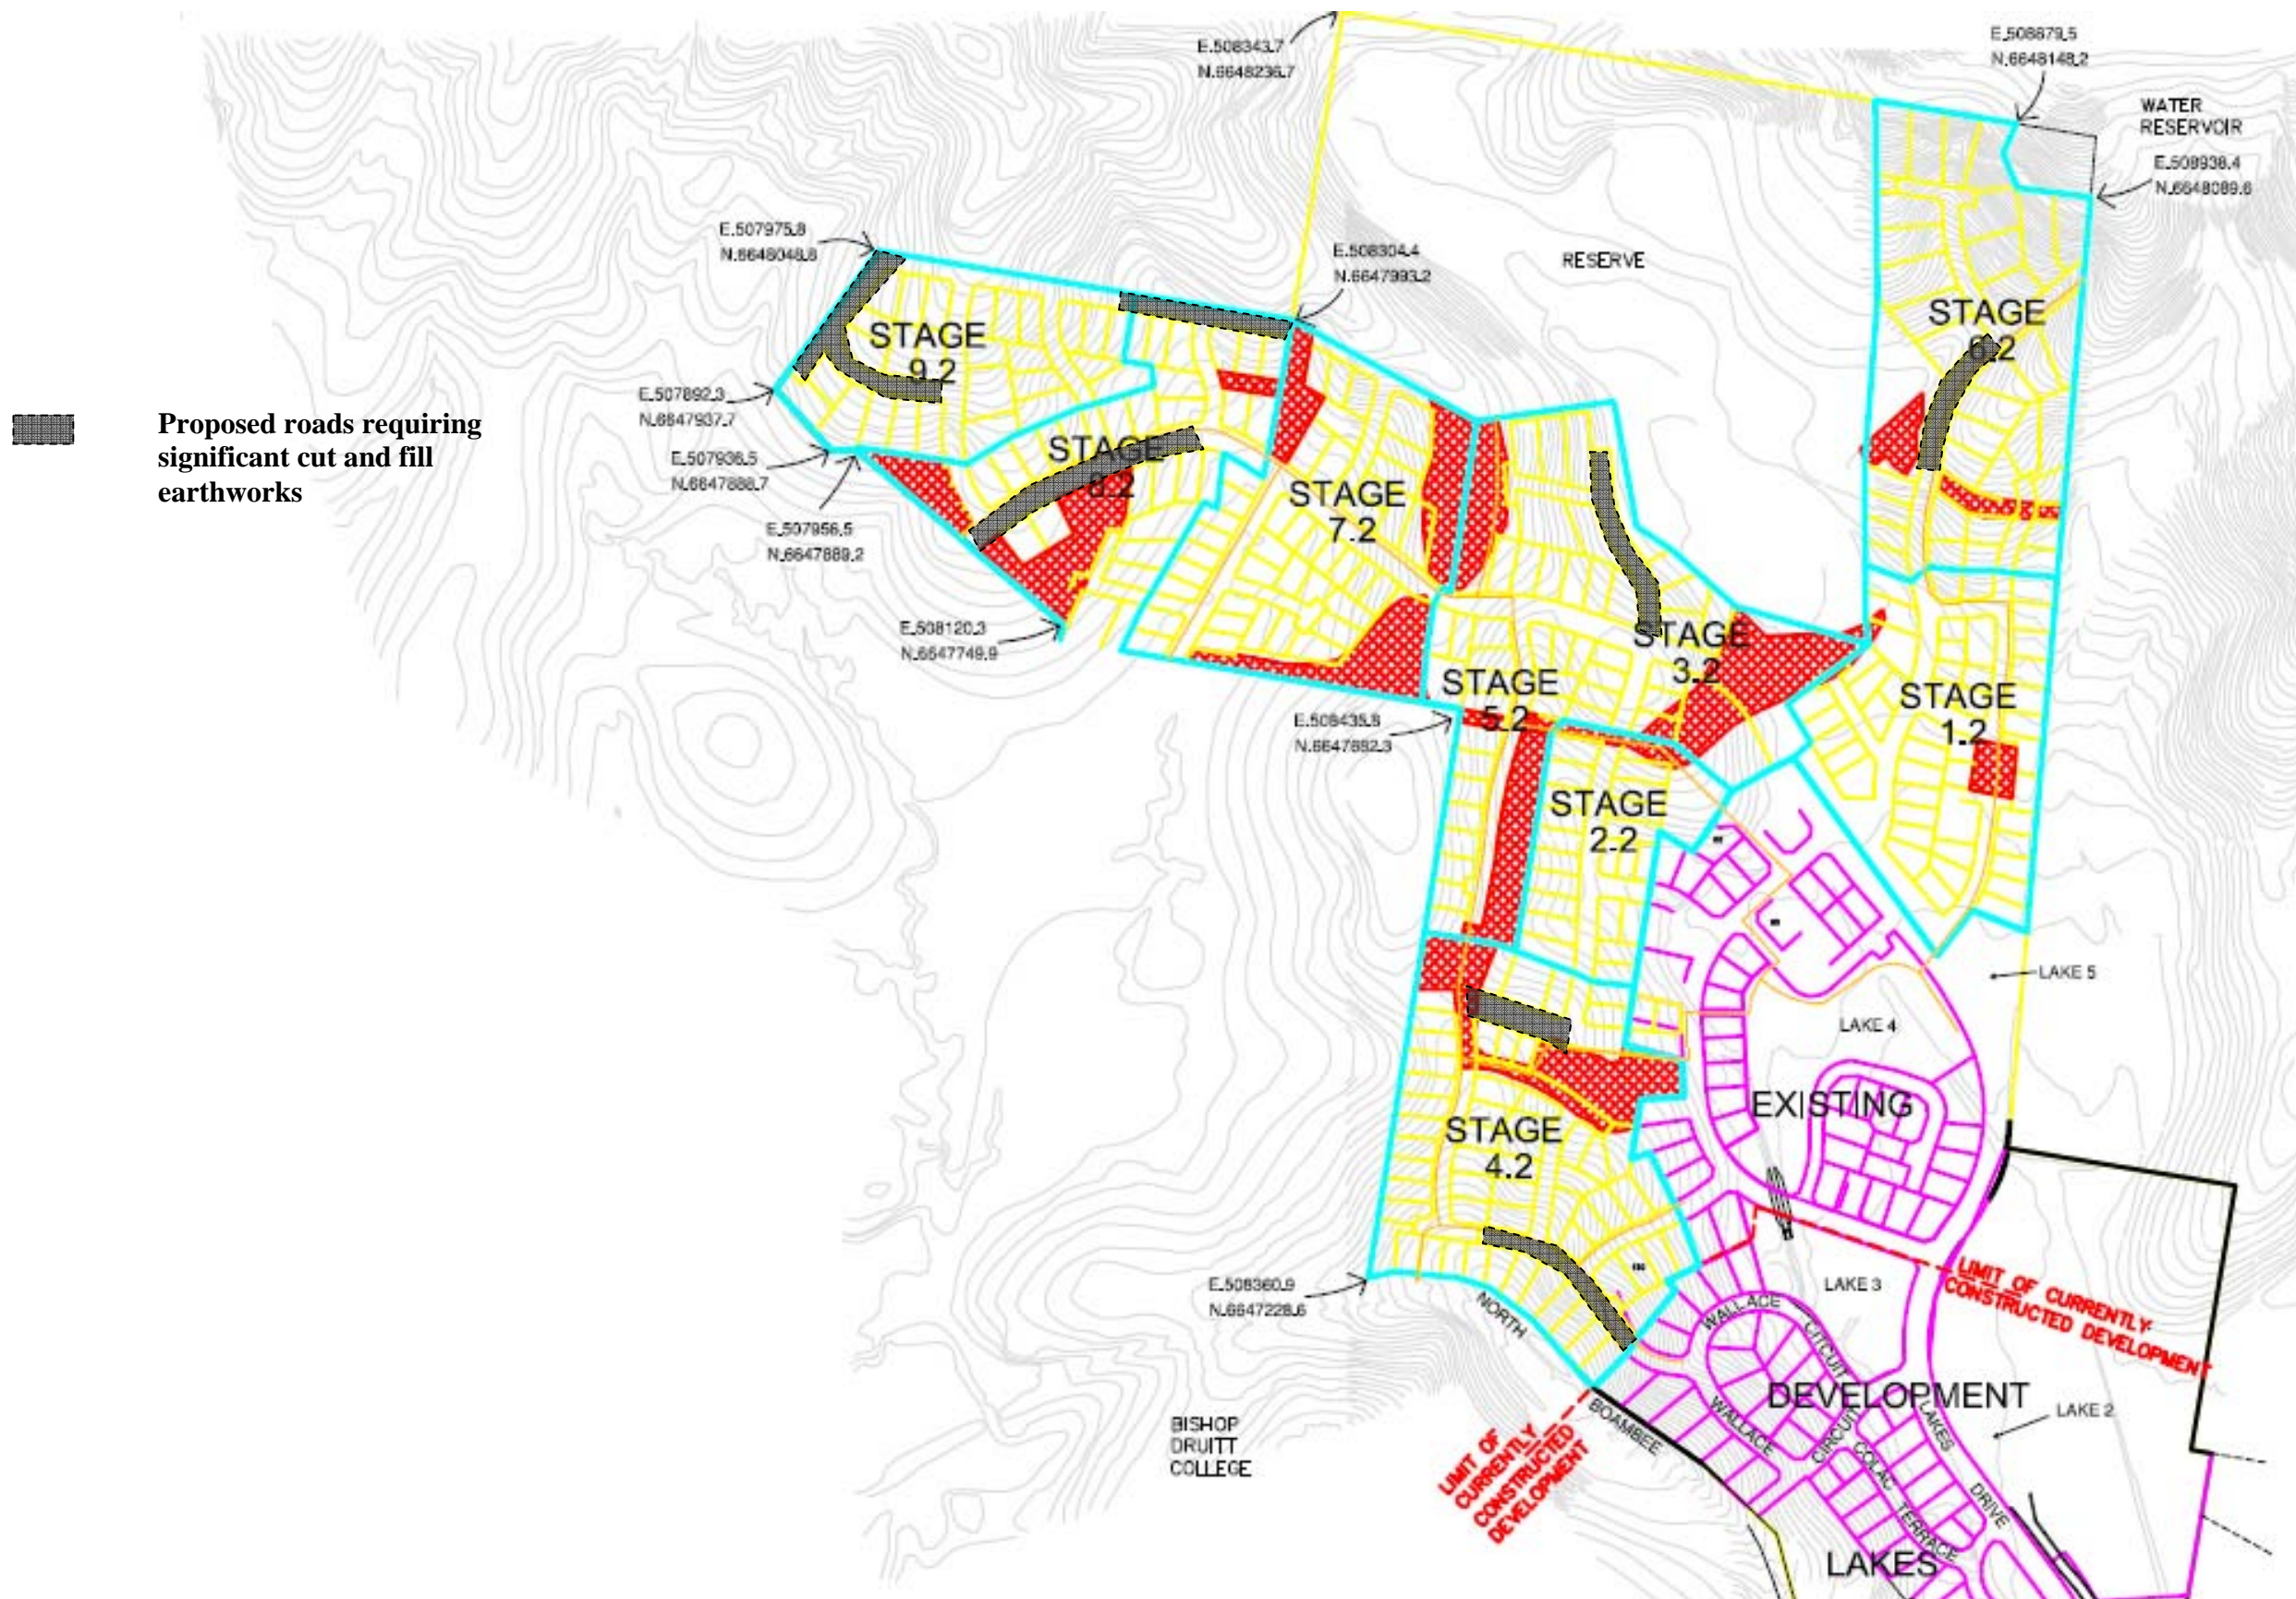
client:	DOUG GOW AND ASSOCIATES PTY LTD
project:	THE LAKES ESTATE STAGES 1.2 to 9.2
title:	ROADS LIKELY TO REQUIRE CUT AND FILL EARTHWORKS
project no:	GEOTCOFH02233AA
figure no:	FIGURE

The design plans provided to date indicate that some of the access roads are planned along the sides of watercourses or steep slopes. Roads located in these areas will require cut and fill earthworks to effectively bench/key the roads into the sides of the hillslopes.

A plan is attached indicating critical locations.

Depending on the slope angles and the space provided for the roads their final design may need to incorporate retaining walls on the high side or low sides of the roads. For permanent batter slopes cut and fill batters should typically be constructed no steeper than 1V:2H (26°). The provision of free drainage from slopes will be essential for their maintenance.

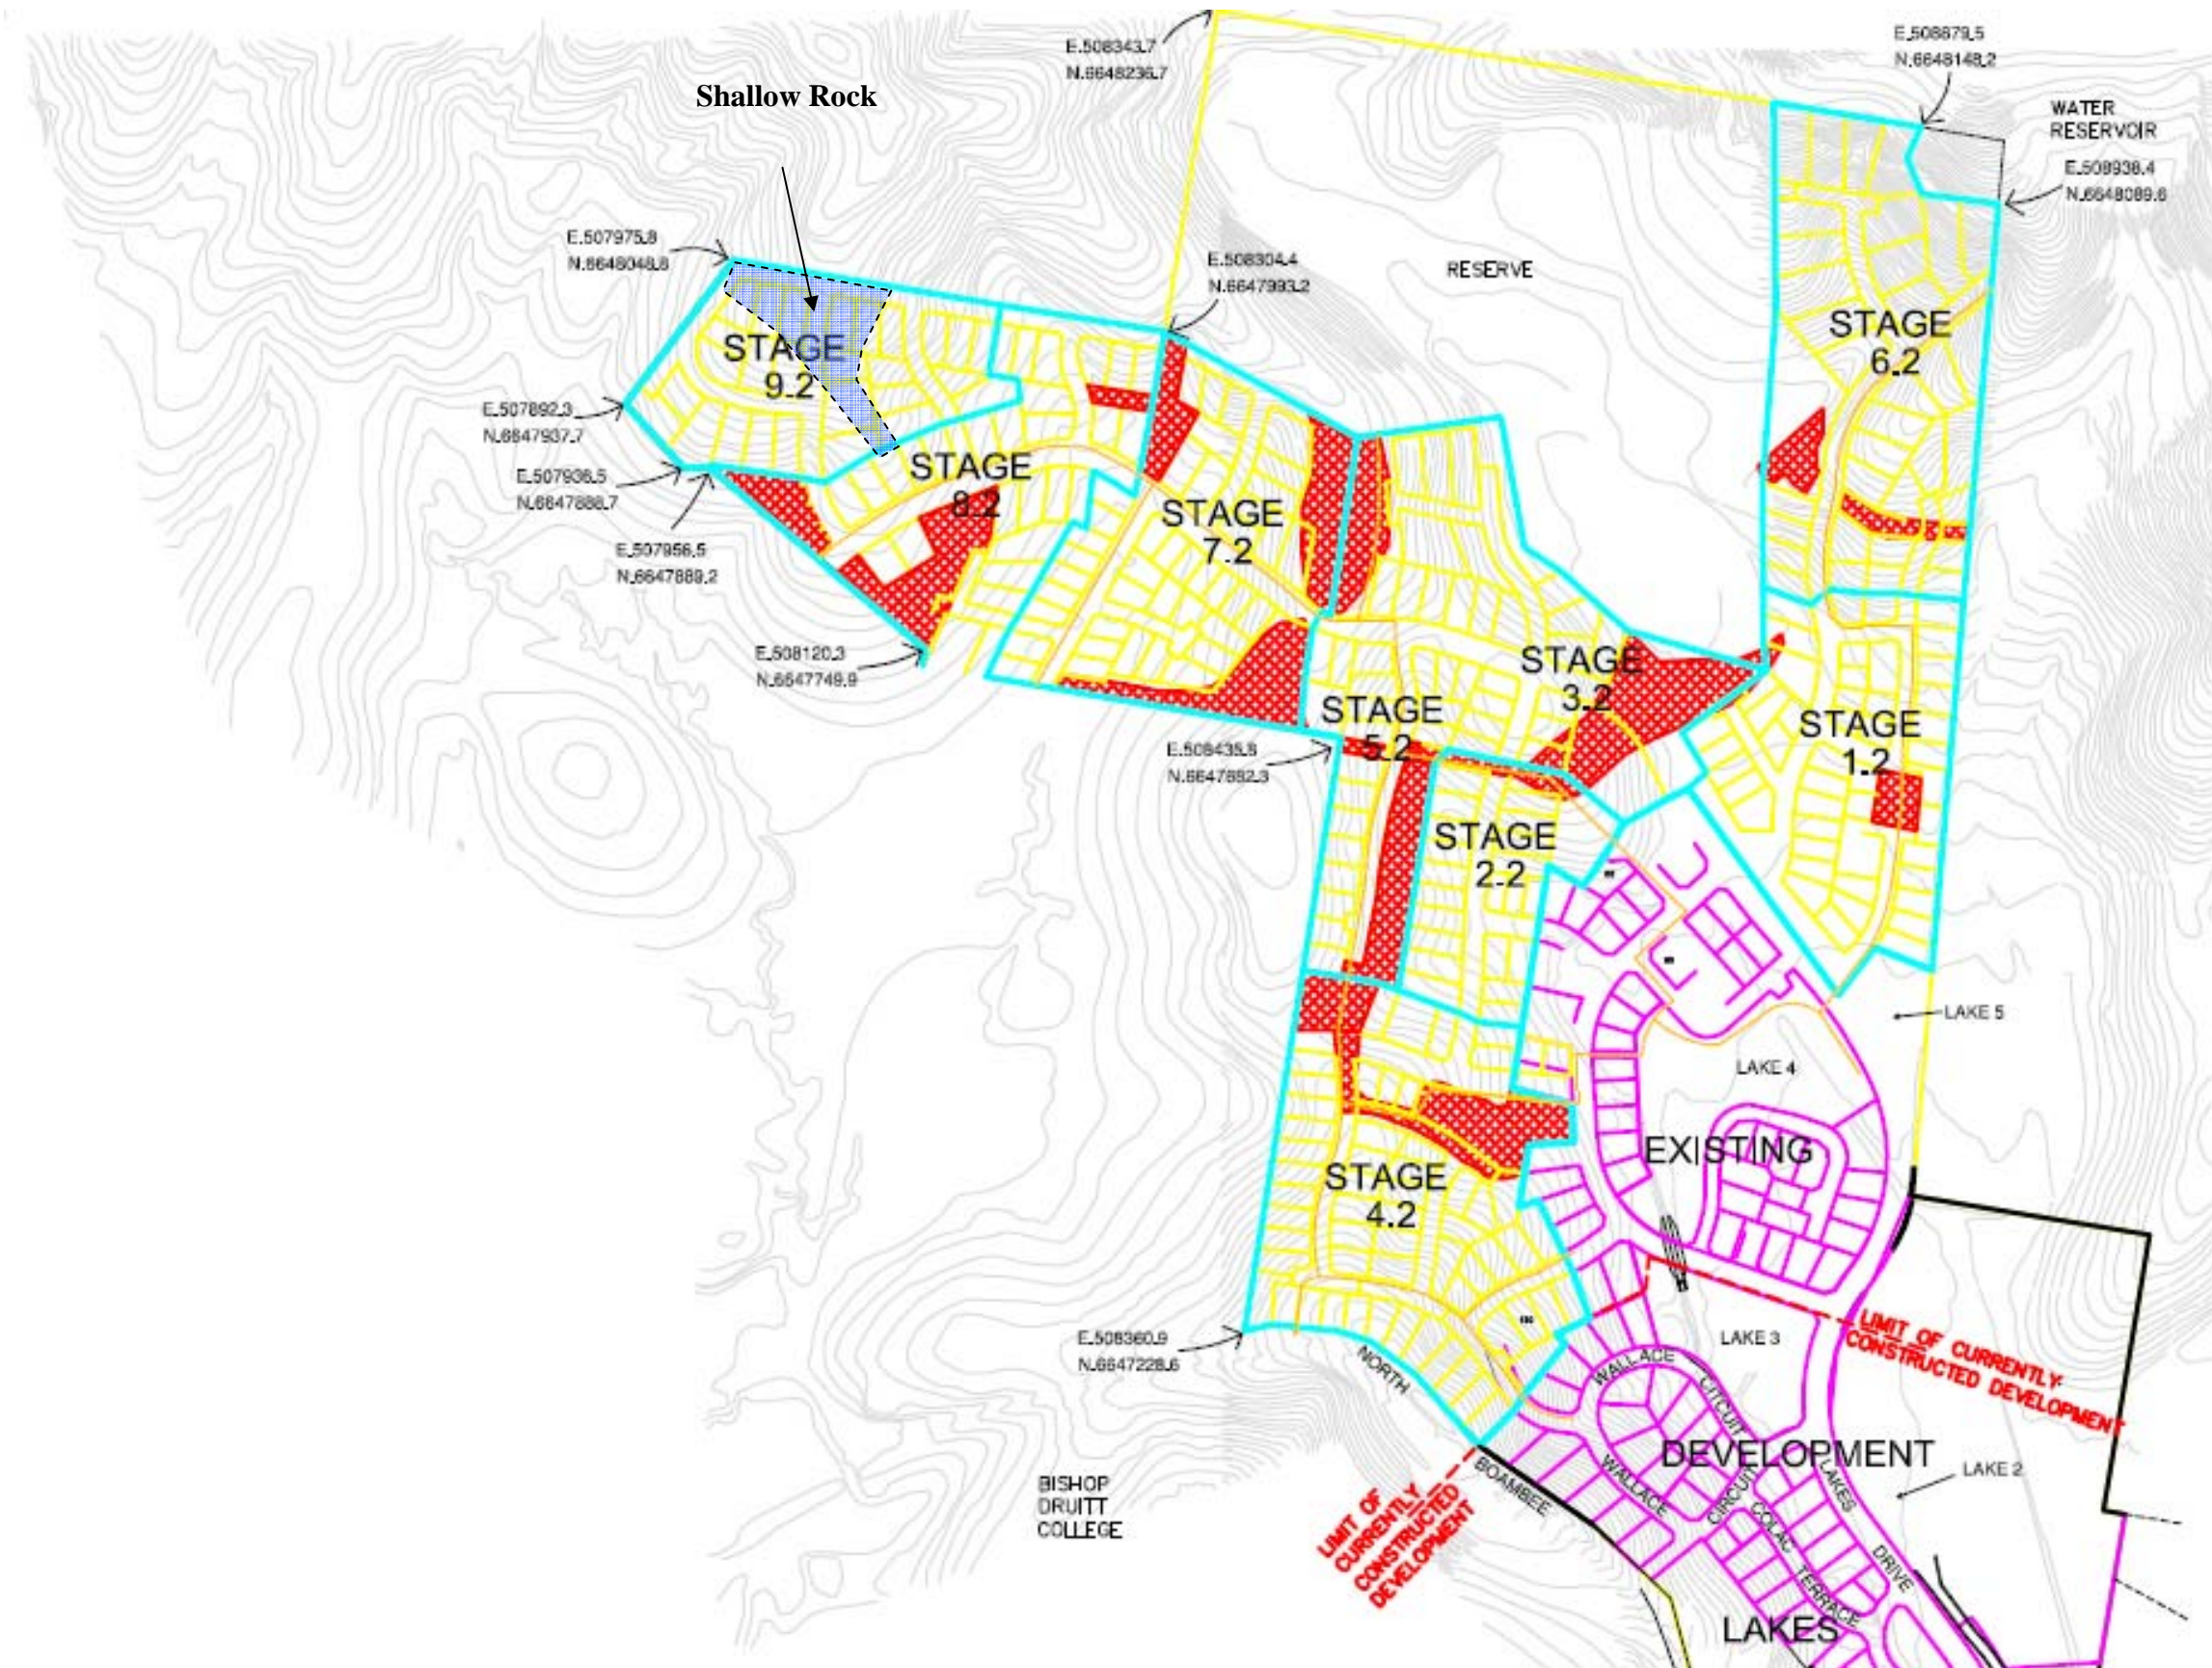
client:	DOUG GOW AND ASSOCIATES PTY LTD
project:	THE LAKES ESTATE STAGES 1.2 to 9.2
title:	SITE PLAN OF AREAS WITH SHALLOW BEDROCK
project no:	GEOTCOFH02233AA
figure no:	FIGURE

The top of the ridge in the far south-western end of the site has a shallow cover of soil overlying high strength meta-siltstone. In some areas the bedrock is exposed at the surface. This will provide adequate bearing capacity for the proposed houses. Further investigation to include core drilling into the bedrock will help with assessment of its capacity to withhold uplift on piles or anchors that are extended into the bedrock. There might be increased construction costs associated with difficult excavation into strong rock for footings or services. A plan is attached showing the location of shallow or exposed bedrock.

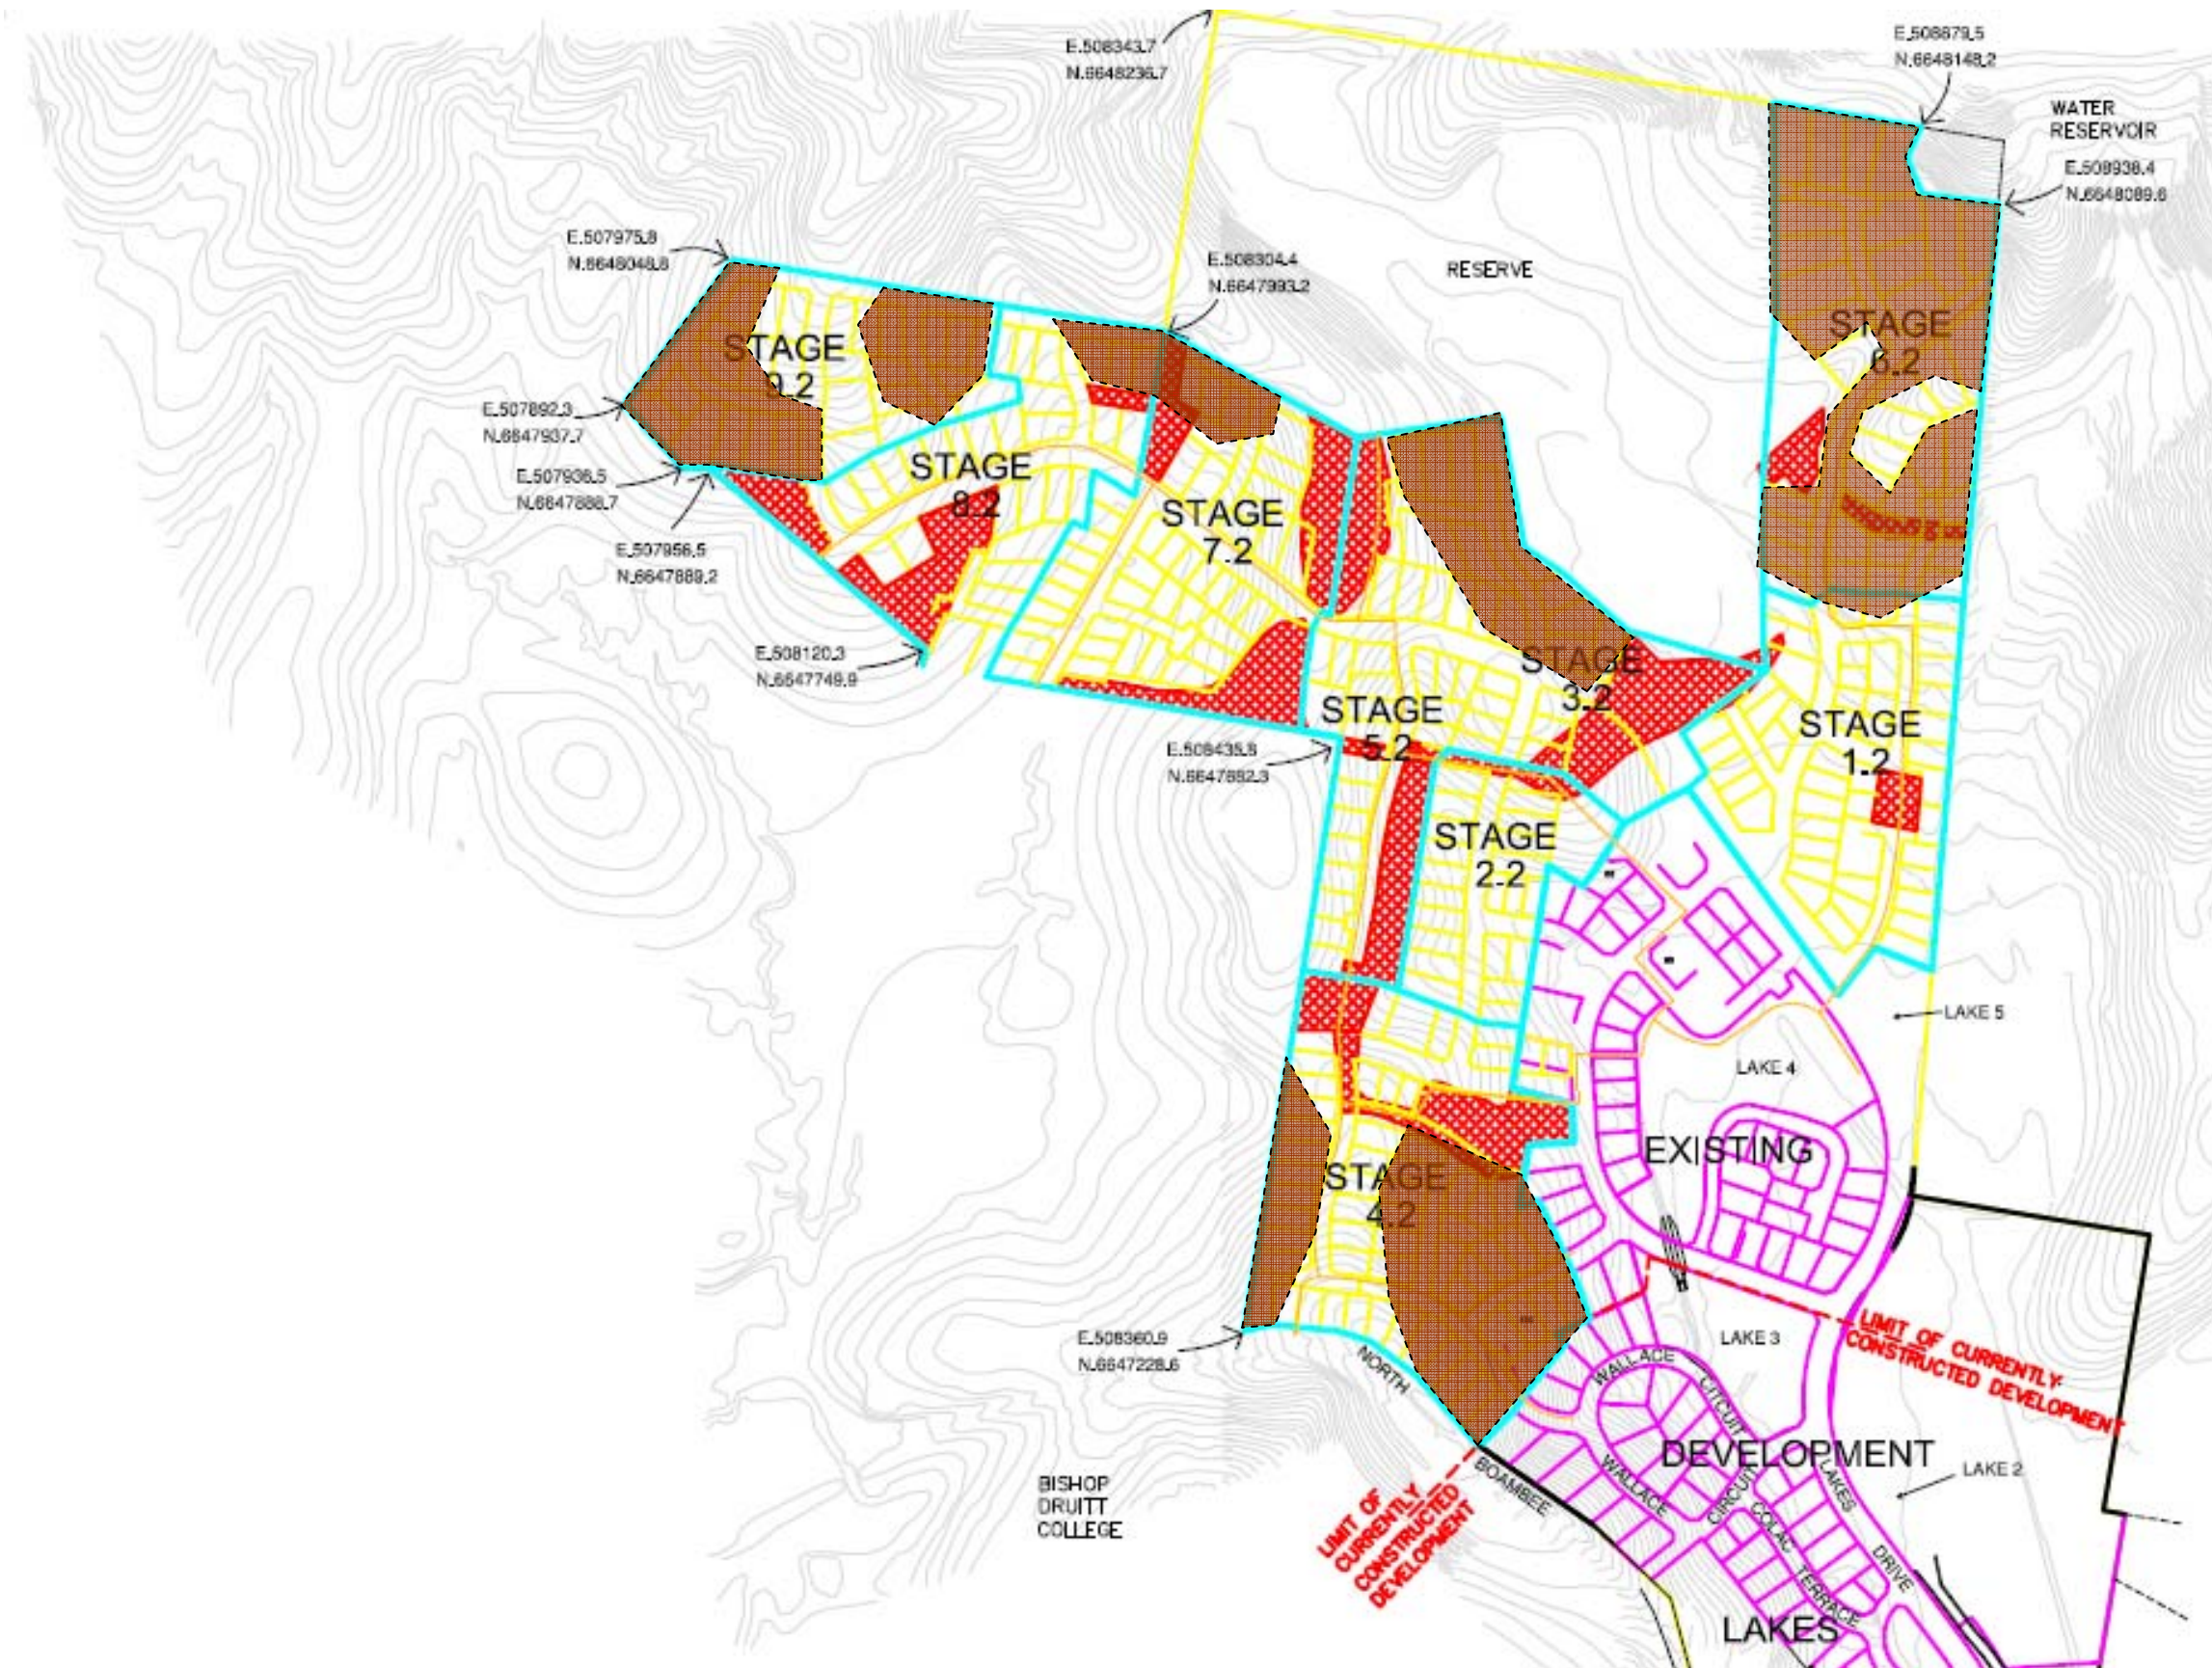
client:	DOUG GOW AND ASSOCIATES PTY LTD
project:	THE LAKES ESTATE STAGES 1.2 to 9.2
title:	STEEP SLOPES POSSIBLE REQUIRING PILES
project no:	GEOTCOFH02233AA
figure no:	FIGURE

Despite the above it is assessed that steep slopes across the site (in particular areas with slopes greater than 10°) will be subject to near surface soil creep movement.

On sloping ground soil movement (including shallow creep) can have a severe impact on shallow footings and slabs potentially requiring deep foundations to be constructed. It is anticipated that buildings constructed on hillslopes will need to be piled to the underlying bedrock. Where colluvium is identified the piles should be extended to penetrate rock that might be encountered at some 2m to 4m depth. Bedrock typically comprises heavily fractured and low strength weakly metamorphosed and partly siliceous siltstone that provides carrying capacity for, largely end bearing, piles and also skin friction capacity that could be a consideration against uplift loads.
