As part of this traffic assessment, a road safety deficiency assessment was conducted in accordance with the RTA's *Guide to Traffic Generating Developments (2002)*. This assessment includes the roads used by the majority of construction and operational traffic associated with the Mangoola Coal Mine plan modifications and proposed ETL relocation.

### 2.7.1 Road safety deficiencies

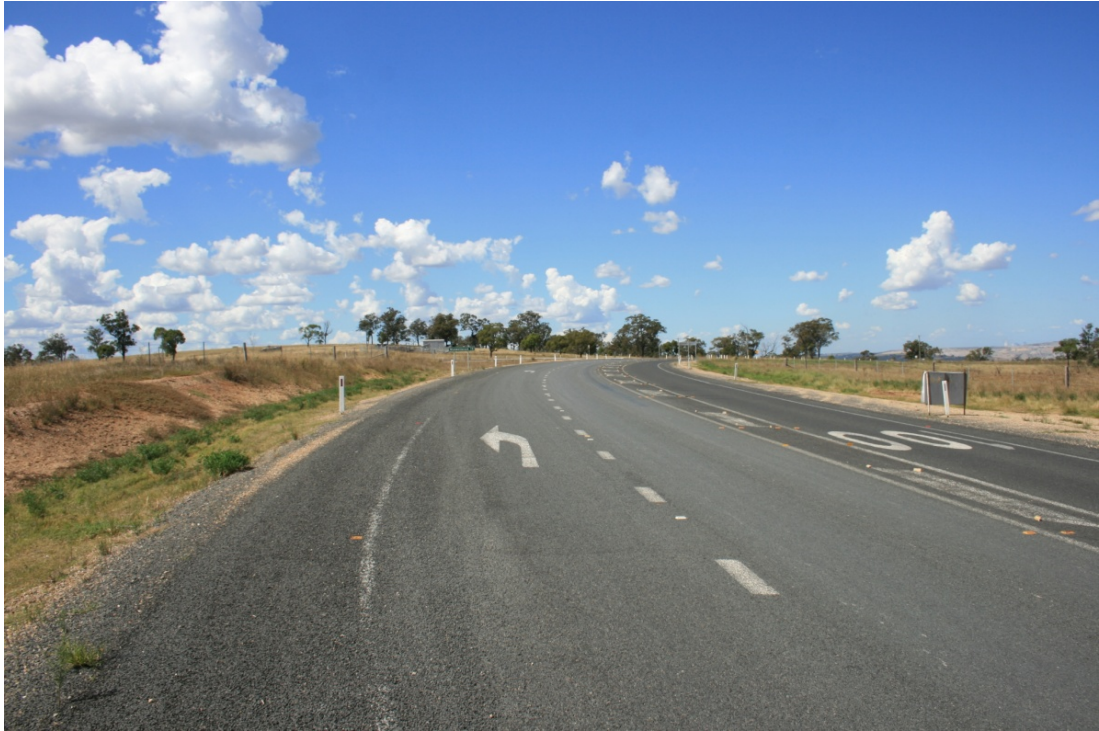
- On approach to the intersection with Bengalla Link Road, the edge line is covered with chipseal aggregate and as such is not clearly visible (refer to Figure 2.22) while some of the road markings at the intersection is faded with no sufficient contrast between the road markings and the pavement (refer to Figure 2.23). Both these deficiencies may results in poor road delineation at night and in adverse weather conditions, affecting safety of the road users<sup>2</sup>.

**Figure 2.22** Edge line covered with chipseal aggregate - Wybong Road, looking eastbound toward its intersection with Bengalla Link Road

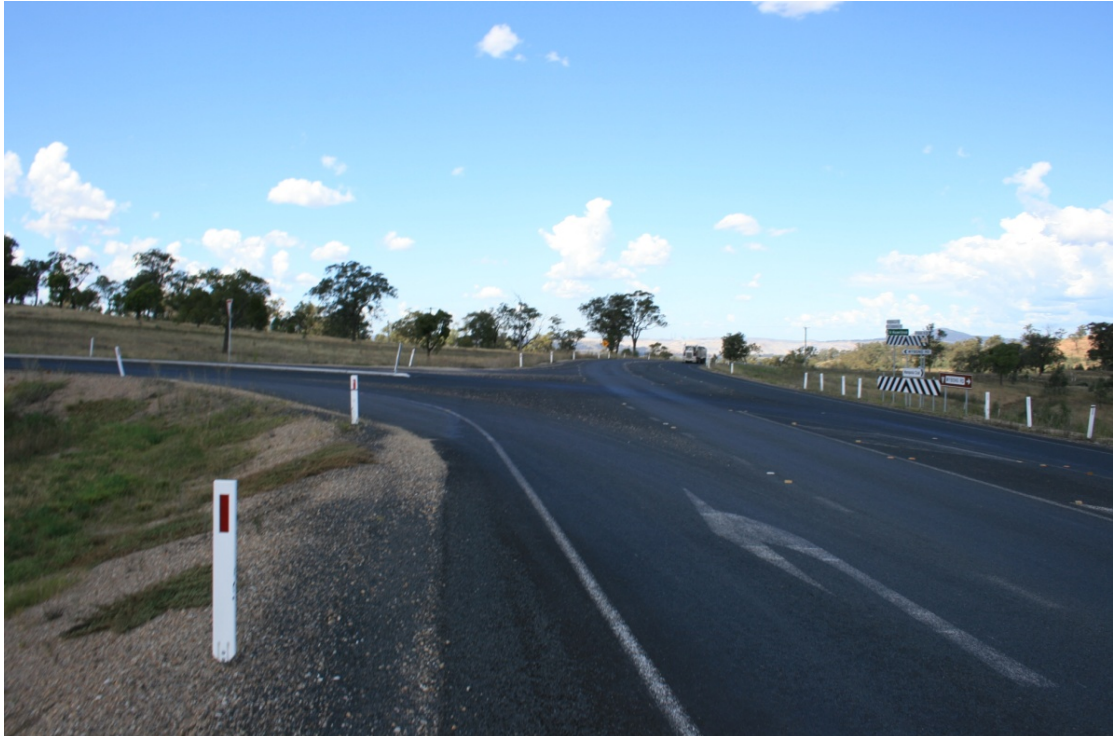
**Figure 2.23** No sufficient contrast between the road markings and the pavement - Wybong Road/Bengalla Link Road intersection

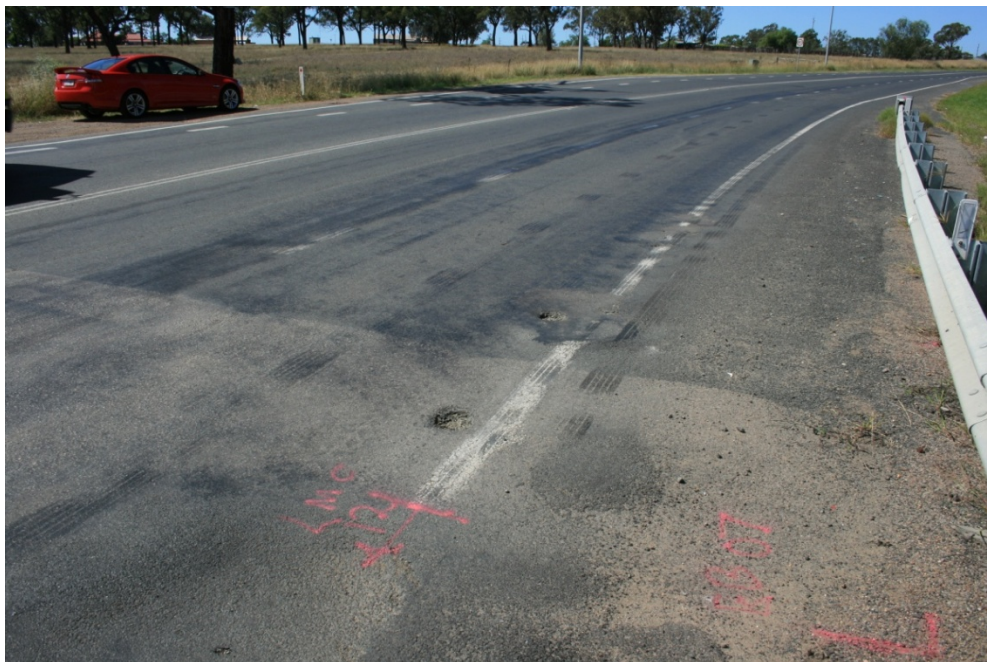
- There are quite narrow sealed shoulders provided on both sides of the road. Considering the annual average daily traffic of over 1,000 vehicles per day, the shoulder width is less than minimum required 2.0 m, as prescribed by the *RTA's Road Design Guide*.
- There are some potholes, uneven road surface and other pavement deficiencies on approach to and at the intersection with Denman Road (refer to Figures 2.24 to 2.26). Potholes and uneven road surface can cause safety problems for road users as well as moisture infiltration resulting in even further road deterioration.

**Figure 2.24 Potholes, uneven road surface and other pavement deficiencies - Thomas Mitchell Drive, looking eastbound from its intersection with Denman Road**

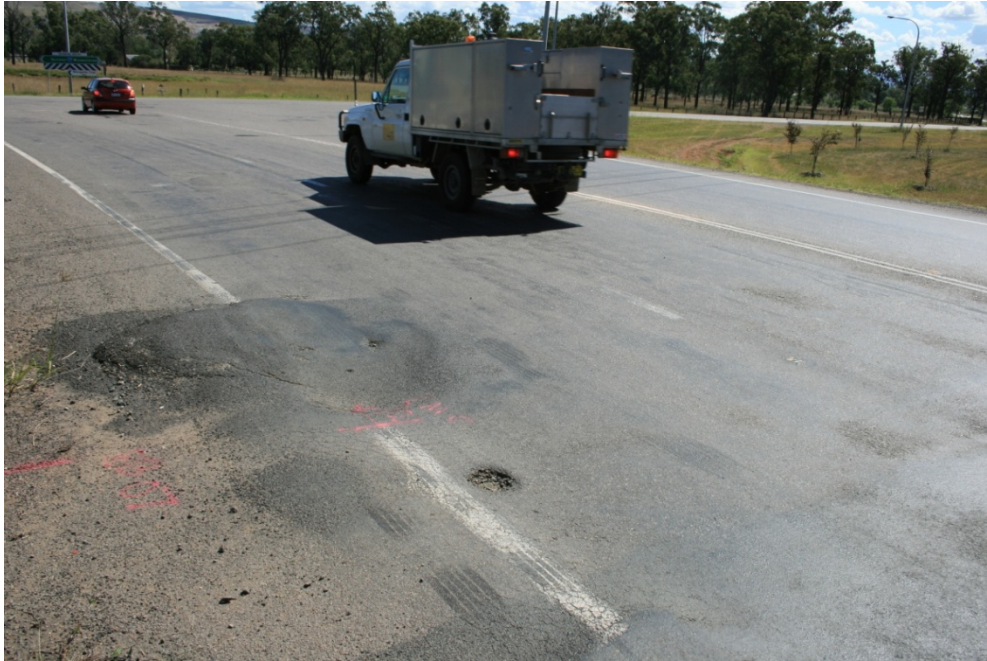
**Figure 2.25** Potholes, uneven road surface and other pavement deficiencies - Thomas Mitchell Drive, looking toward its intersection with Denman Road

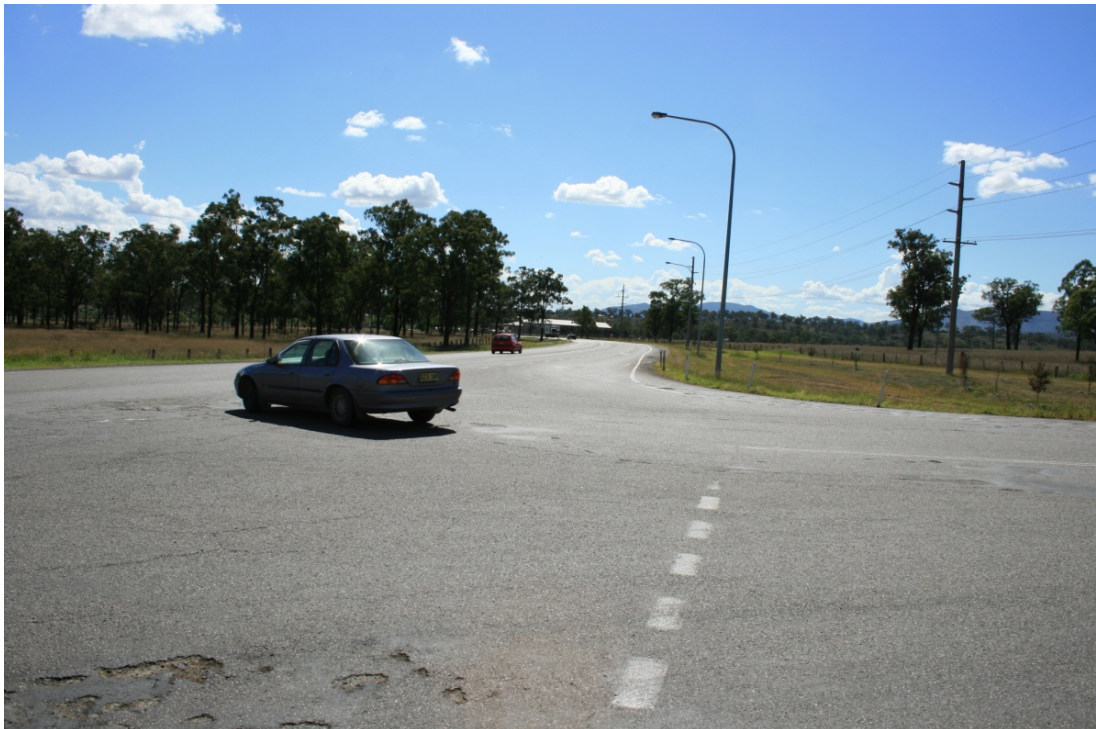
**Figure 2.26** Potholes -Thomas Mitchell Drive/Denman Road intersection

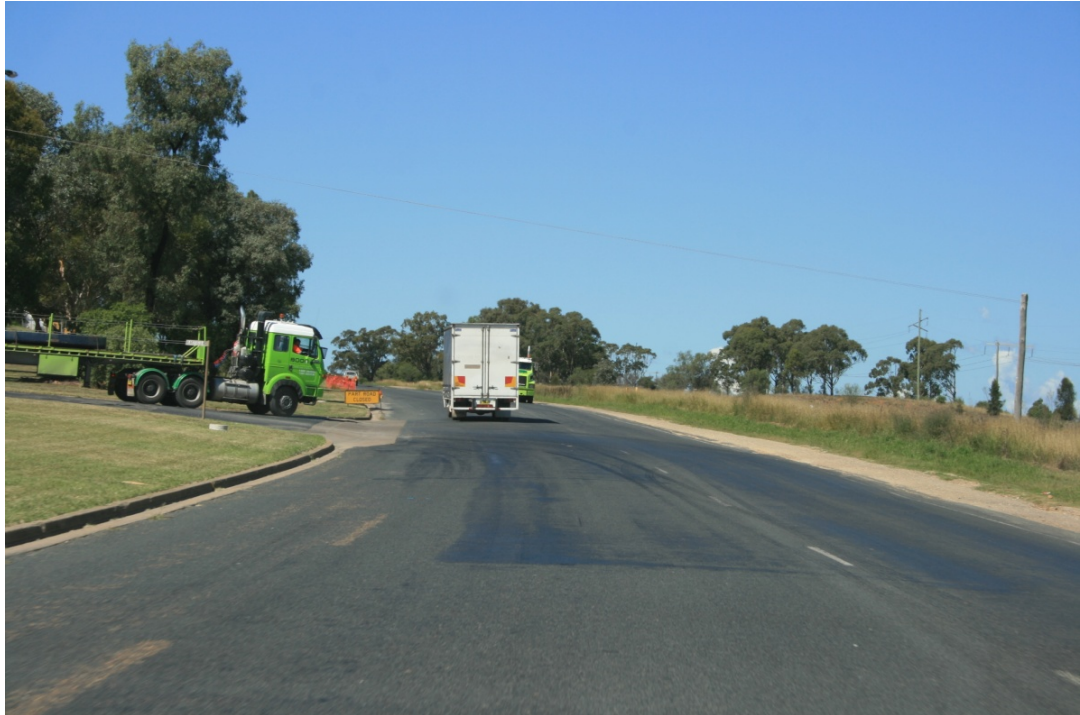
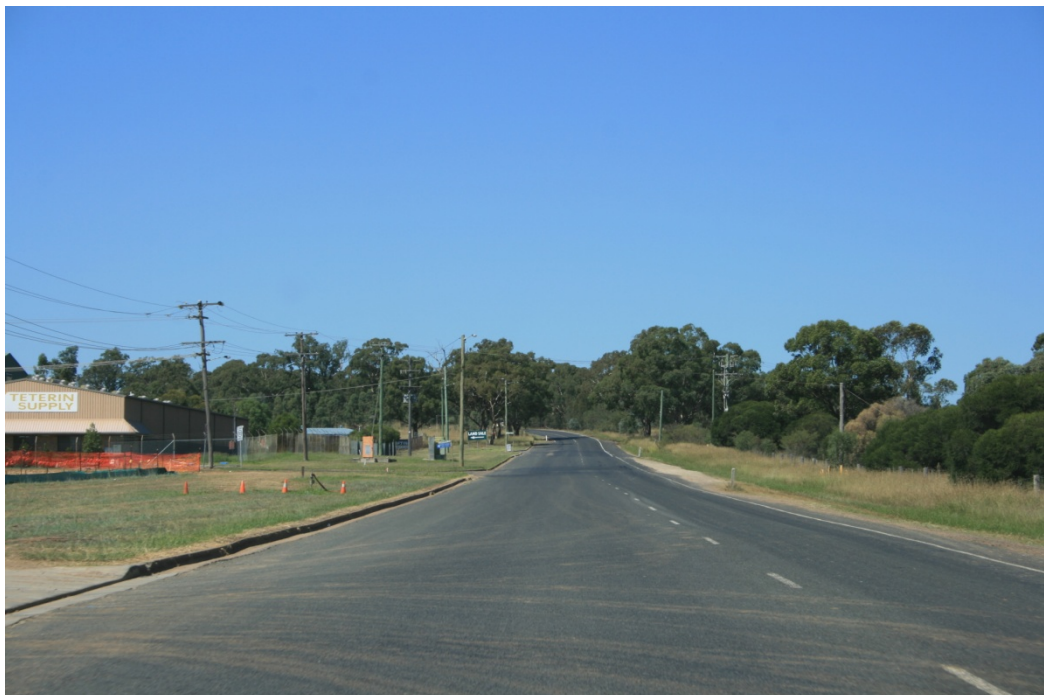
- There is no edge line painted along the section of the road thorough the Muswellbrook Industrial Estate, resulting in poor road delineation especially at night and in adverse weather conditions (refer to Figures 2.27 and 2.28).

**Figure 2.27 No edge line painted - Thomas Mitchell Drive, looking eastbound**

**Figure 2.28 No edge line painted - Thomas Mitchell Drive, looking eastbound**

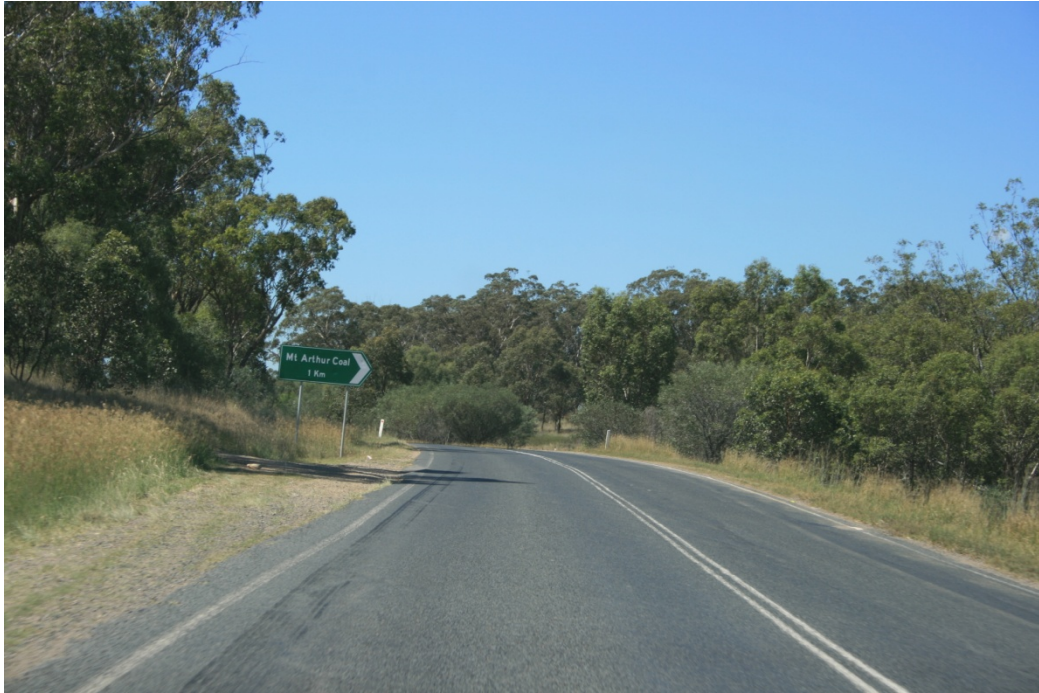
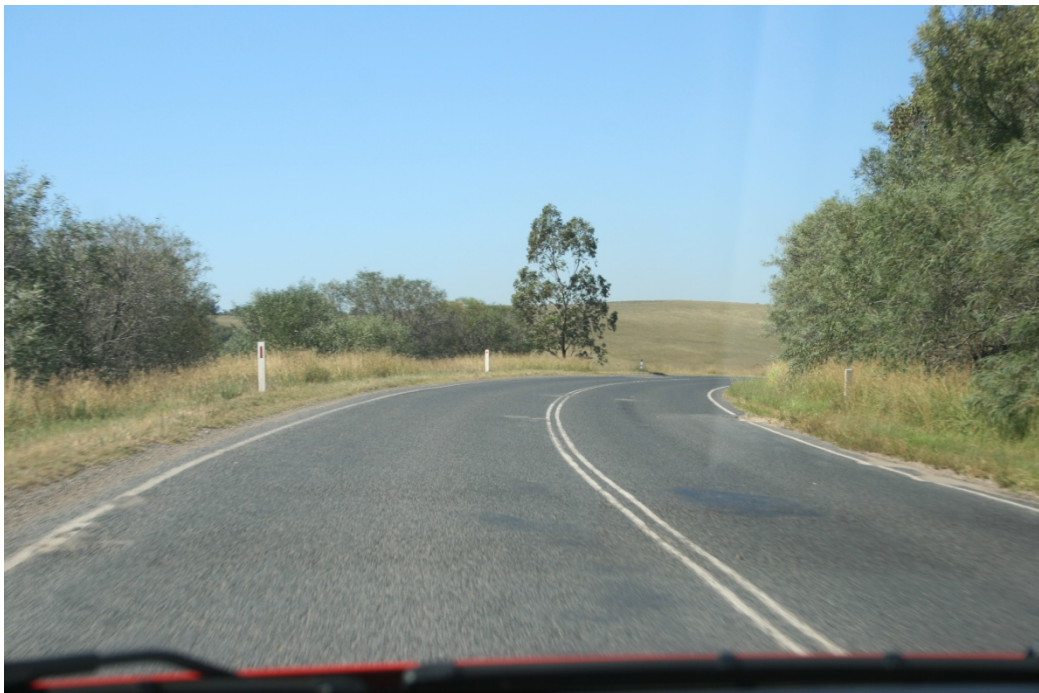
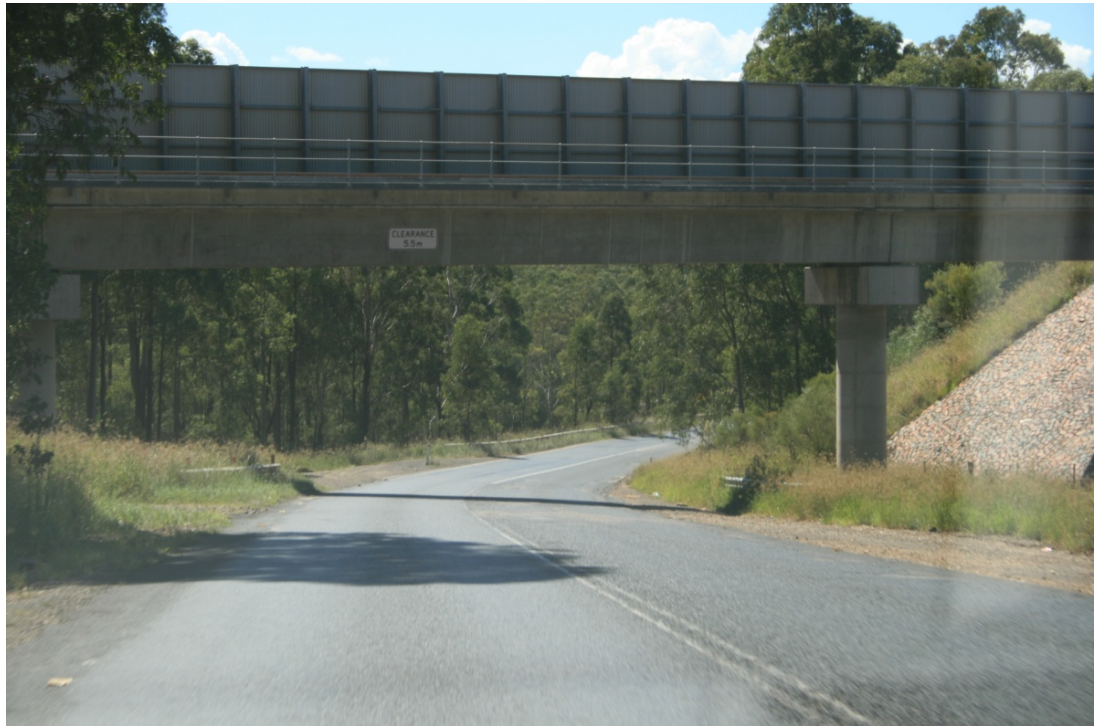
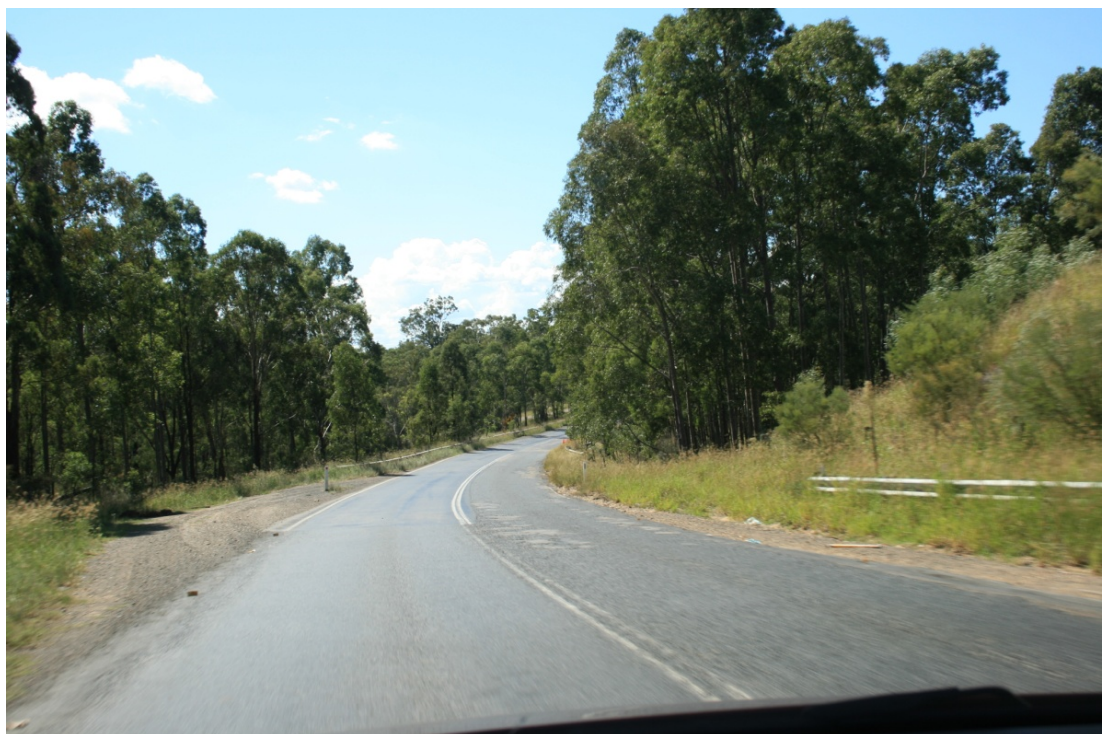
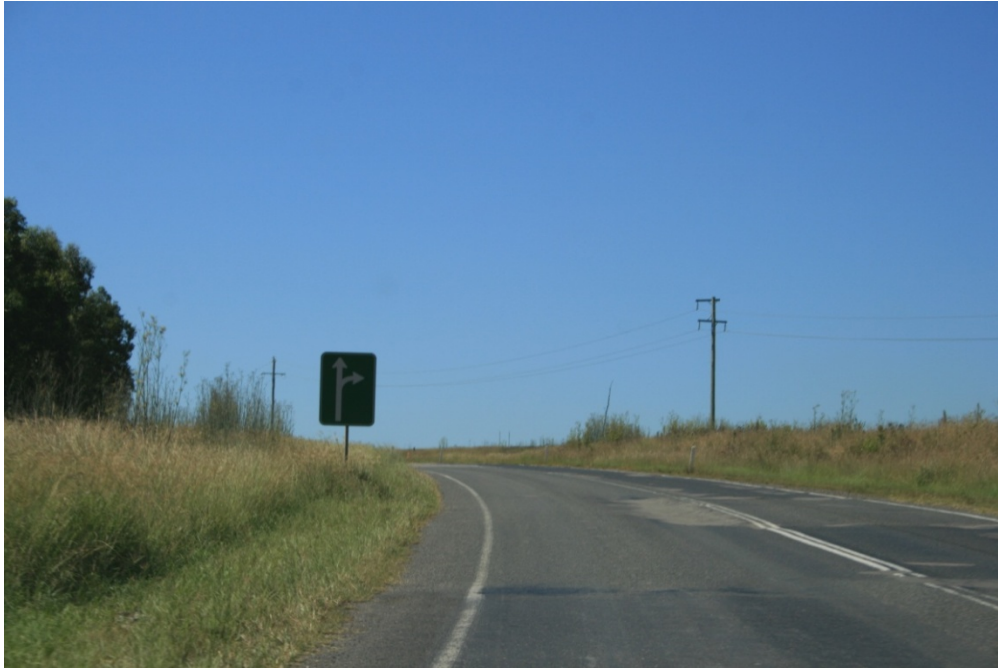
- There are a number of substandard curves along the road where sufficient delineation is not provided (e.g. lack of CAMs or/and guide posts) (refer to Figures 2.29 to 2.33). This increases the risk of loss of control crashes to occur, especially at night and in adverse weather conditions.

**Figure 2.29 Substandard curve with no sufficient delineation provided - Thomas Mitchell Drive, looking eastbound**

**Figure 2.30 Substandard curve with no sufficient delineation provided - Thomas Mitchell Drive, looking eastbound**

**Figure 2.31 Substandard curve with no sufficient delineation provided - Thomas Mitchell Drive, looking eastbound**

**Figure 2.32 Substandard curve with no sufficient delineation provided - Thomas Mitchell Drive, looking eastbound**

**Figure 2.33** Substandard curve with no sufficient delineation provided - Thomas Mitchell Drive, looking eastbound

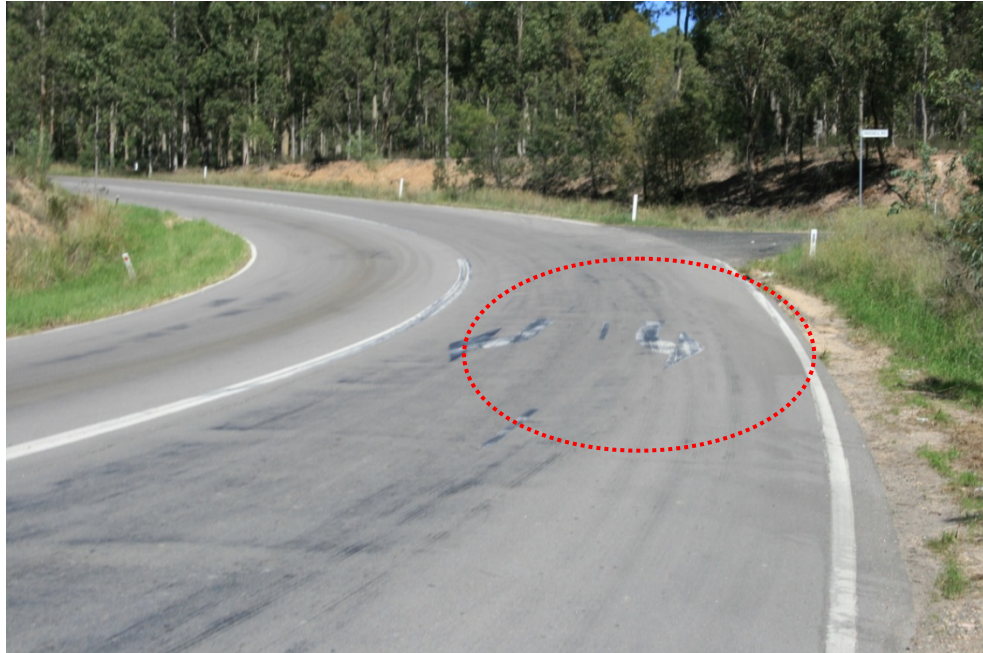
- Pavement arrows are covered by tyre marks and therefore not clearly visible on approach to the intersection with the New England Highway (refer to Figure 2.34). It may result in driver's poor lane discipline and even some confusion on approach to the intersection, especially at night and in adverse weather conditions, affecting the safety of road users.

**Figure 2.34 Pavement arrows covered by tyre marks - Thomas Mitchell Drive, looking westbound, on approach to its intersection with the New England Highway**
