Holcim Dunloe Sands Quarry

Dunloe Sands Quarry Access/ Pottsville Road Intersection

Response to Road Safety Audit

March 2018

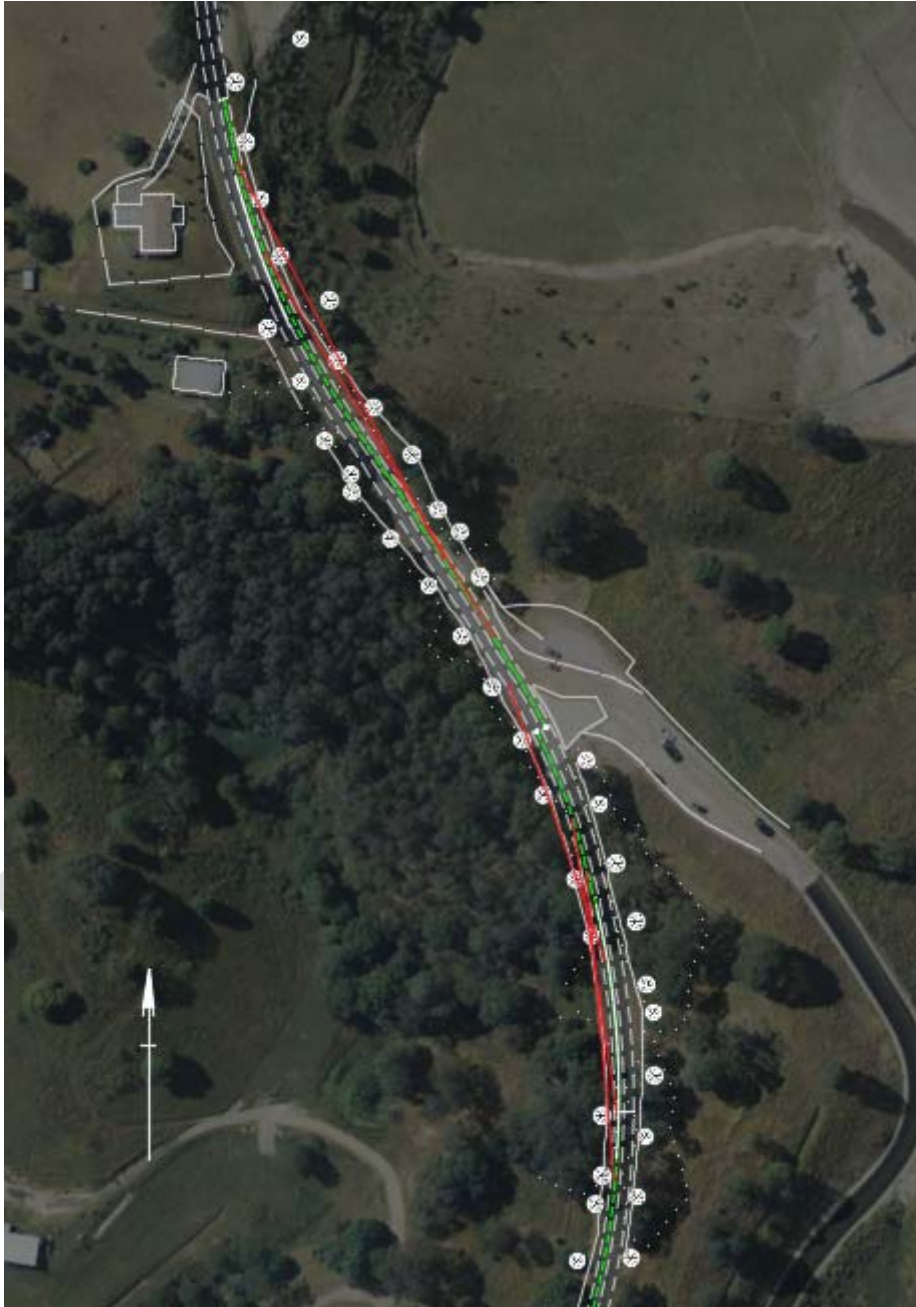
Figure 2: Preliminary SSD check showing absolute minimum design parameters (red lines)

As shown above in Section 2.2 the SSD values impact on existing trees, it is recommended to adopt and satisfy the absolute minimum design parameters by removing few minor trees ($\leq 100\text{mm}$ diameter) on the inside of the curve of Pottsville Road (eastern side).

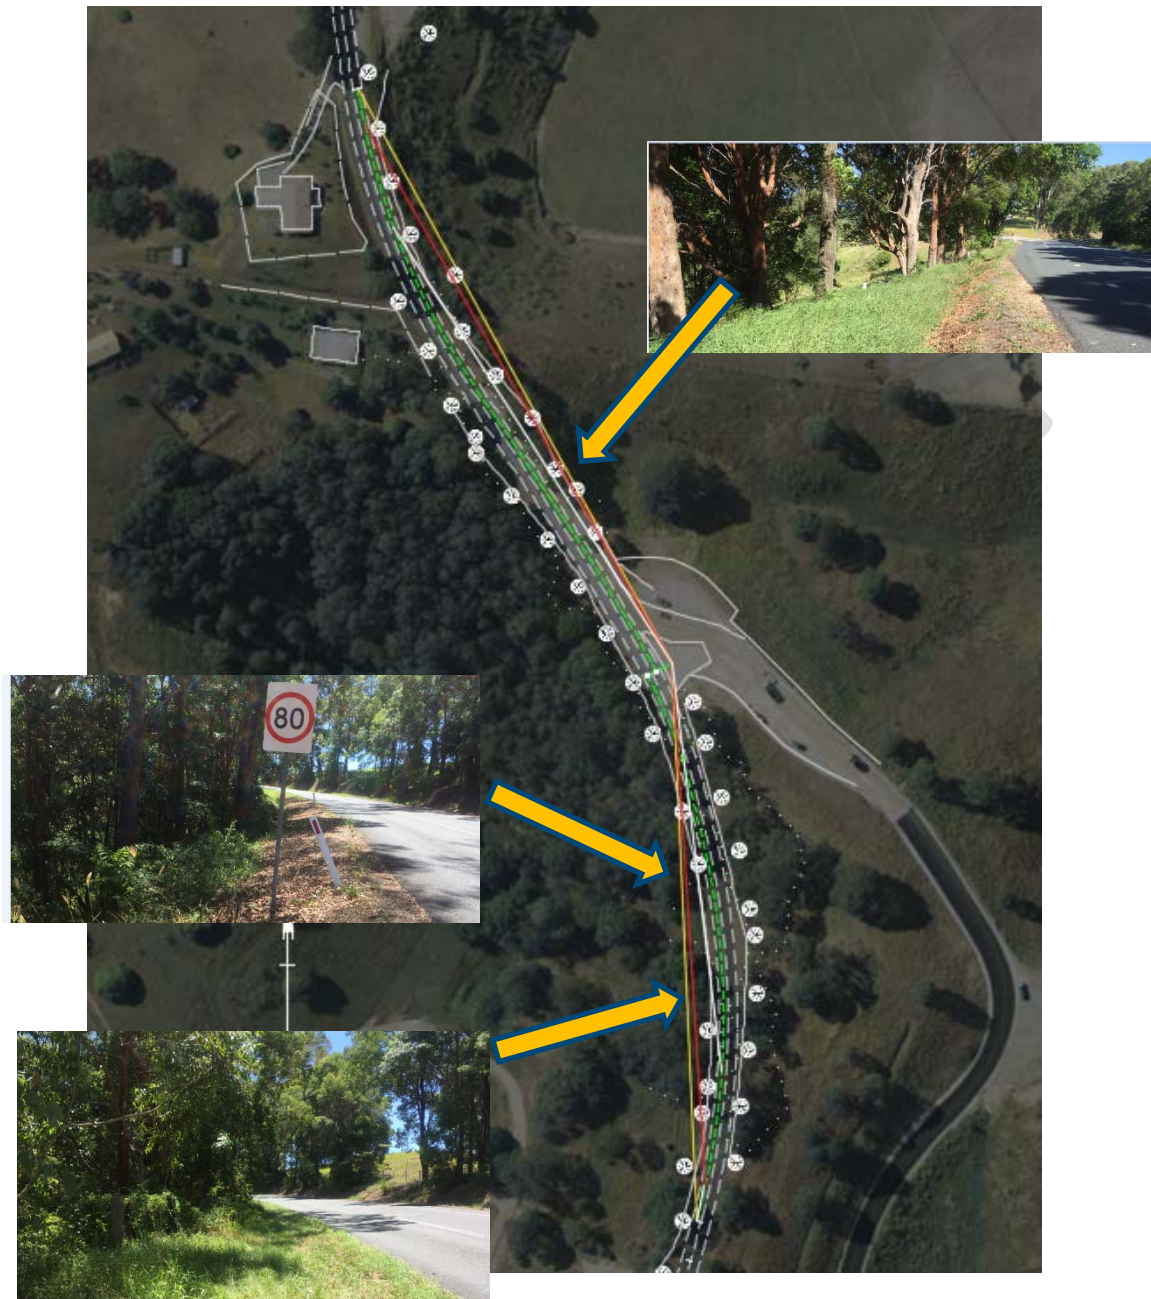
Figure 3: Preliminary SISD check showing absolute (red lines) and preferred (yellow lines) minimum design parameters

Based on the absolute and desirable SISD values in Section 2.3, the initial solution to achieve an unobstructed sight line is to remove the obstruction (i.e. clear existing trees) within the influence of the required SISD. However, clearing of trees in the area is not considered a preferred option at this stage due to a number of environmental implications (i.e. koala habitat area, cutting of trees would cause erosion on existing steep batters). Thereby, this report aims to propose the following options to address the SISD issues raised in the RSA report **without cutting the existing trees**.

Option 1: Proposed speed reduction on Pottsville Road (road section 250m on each side of Dunloe Quarry access)

Based on the SISD values and their impact on existing trees (refer Section 2.3), it is proposed to adopt and satisfy the desirable SISD minimum design parameters with a design speed of 70 km/hr (posted speed 60 km/hr) and avoid the removal of major trees on both uphill and downhill SSDs. This proposal will not warrant the need for minor tree clearing in the SSD assessment (refer Section 2.4.1).

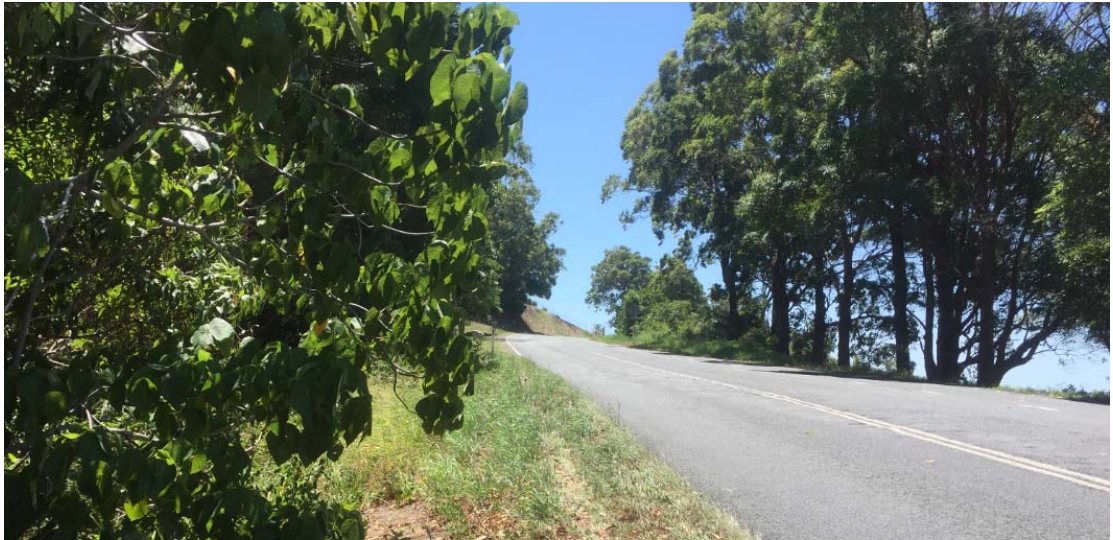
Figure 4: Example of existing trees within the clear zone

Existing hazards such as existing trees with significant trunk diameter (i.e. 300mm to 600mm) and steep embankment slope (as steep as 1:1 with existing trees) are located within the clearzone (refer Figure 4 and Figure 5). Some of these hazards have 2m offset from the edge of road.

The RSA report has recommended the installation of safety barriers to protect the vehicles from the identified hazards (refer Section 3.3).

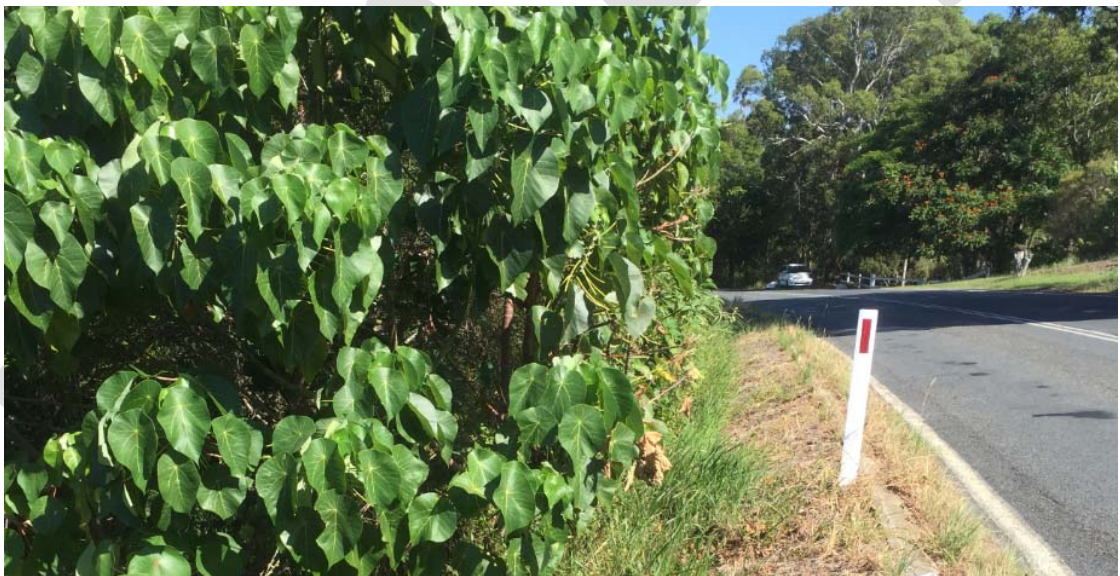
Figure 5: Example of existing 0.5m shoulder (with concrete kerb) next to a steep batter

The western side of Pottsville Road, at the southern side of the Quarry Access road, has no sealed shoulder. The eastern side of Pottsville Road has sealed shoulder but a significant length of the shoulder at the northern side of the Quarry Access road is only 0.5m wide with concrete kerb immediately next to a steep batter.

Where a shoulder is not available, a 1m wide shoulder will be proposed before the barrier location.

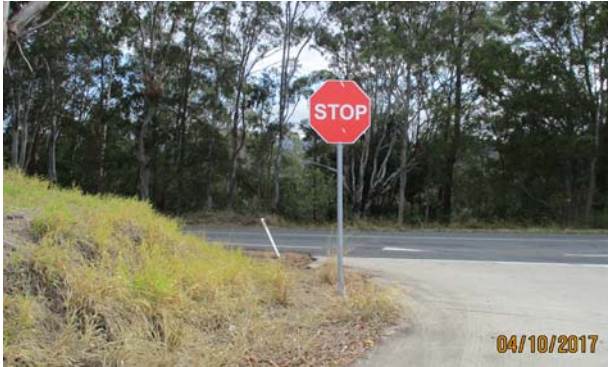
Item	Priority	Issue	Illustration	Suggested Treatment(s)
1.3	C	<p>Stop sign does not comply with the standard requirements of a stop sign as stipulated in AS1742. The stop sign is also not retroreflective and therefore is not clearly visible at night.</p>

<p>Replace existing sign with Stop Sign (R1-1) compliant with AS1742. The new sign should be installed in accordance with the orientation and height requirements of AS1742.2</p>

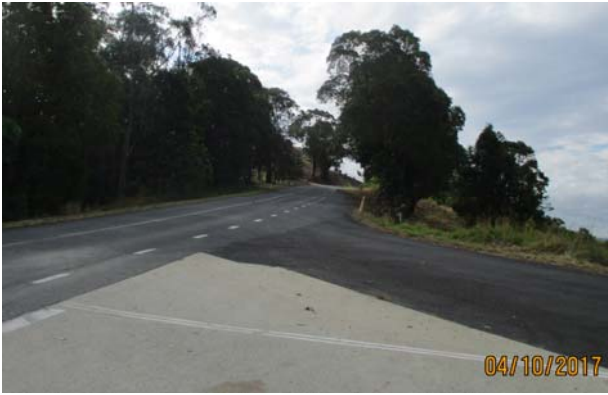
1.4	A	<p>The Safe Intersection Sight Distance (SISD) to the north was measured to be approximately 205m. The available sight distance to the north does not comply with the Safe Intersection Sight Distance (SISD) of 236m stipulated in Austroads Guide to Road Design Part 4A.</p> <p>Sight distance to the north is obscured by vegetation on the inside of the curve on Pottsville Road (eastern side).</p> <p>The SISD requirement was based on a 2.0 second reaction time and design speed of 90km/h (posted speed 80km/h) which warrants an SISD of 214m. On site the average grade of Pottsville Road was measured to be approximately 7% through the intersection (downgrade for vehicles approaching from the north). On this basis an additional 22m SISD is required for grade correction (interpolated based on correction factors for 6% and 8%).</p> <p>The total SISD requirement is therefore 236m.</p>

<p>Vegetation removal / vegetation trimming along Pottsville Road to the north of the subject intersection, along the eastern extent of the road to maximise the available sight distances.</p> <p>Provision of signage on the major road (Pottsville Road) on approach to the intersection to provide additional warning to drivers. Signage may include Side Road Intersection on a Curve (W2-9(R)) and xx m sign (W8-5). Example signage is shown below.</p>

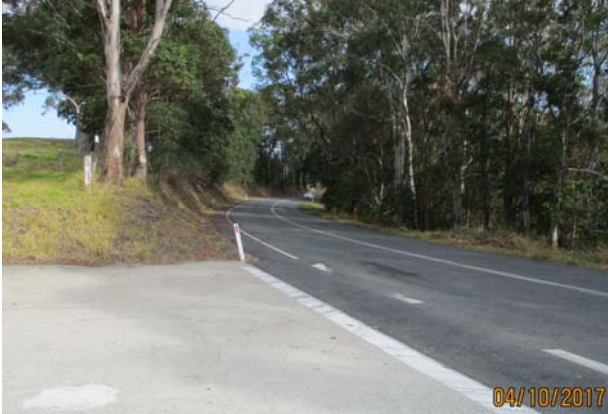
Item	Priority	Issue	Illustration	Suggested Treatment(s)
1.5	A	<p>The Safe Intersection Sight Distance (SISD) to the south was measured to be approximately 135m. The available sight distance to the south does not comply with SISD requirement of 203m.</p> <p>The Stopping Sight Distance (SSD) to the south was measured to be approximately 115m. The available sight distance to the north does not comply with SISD requirement of 138m.</p> <p>Sight distance is obscured by vegetation on the inside of the curve on Pottsville Road (western side).</p> <p>The SISD requirement was based on a 2.0 second reaction time and design speed of 90km/h (posted speed 80km/h) which warrants an SISD of 214m. On site the average grade of Pottsville Road was measured to be approximately 7% through the intersection (upgrade for vehicles approaching from the south). On this basis a reduction of 11m SISD is permitted for grade correction (interpolated based on correction factors for 6% and 8%). The total SISD requirement is therefore 203m.</p> <p>The SSD requirement was based on the requirement for trucks with a reaction time of 2.0 seconds and design speed of 90km/h which warrants an SSD of 160m. A reduction of 22m was applied for grade correction.</p>

<p>Vegetation removal / vegetation trimming along Pottsville Road to the south of the subject intersection, along the western extent of the road to maximise sight distances.</p> <p>Consider relocating the existing stop bar (to the east of its current location) to improve sight distance.</p> <p>Minor relocation of the stop bar (to the east) may result in some sight distance improvements.</p> <p>Provision of signage on the major road (Pottsville Road) on approach to the intersection to provide additional warning to drivers. Signage may include Side Road Intersection on a Curve (W2-9(L)) and xx m sign (W8-5). Example signage is shown below.</p> <div style="text-align: center;">

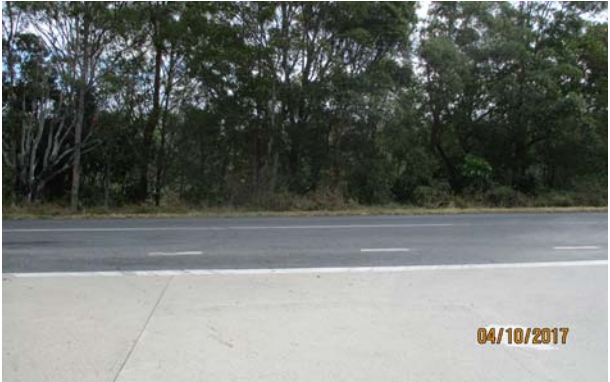
Item	Priority	Issue	Illustration	Suggested Treatment(s)
1.6	C	Westbound approach to intersection includes differing pavement surfaces (both bitumen and concrete) and is confusing for motorists navigating the intersection and trying to identify the intersection configuration (especially for vehicles approaching from the south and turning right into the access road). The concrete sections also make line marking difficult for motorists to see	  <p>04/10/2017</p>	Provide a consistent pavement finish for the approach to the intersection (i.e. all bitumen seal or all concrete)
1.7	C	Absence of Unidirectional hazard marker (D4-2-3)

<p>04/10/2017</p>	Install Unidirectional hazard marker (D4-2-3) on Pottsville Road the opposite westbound approach to the intersection

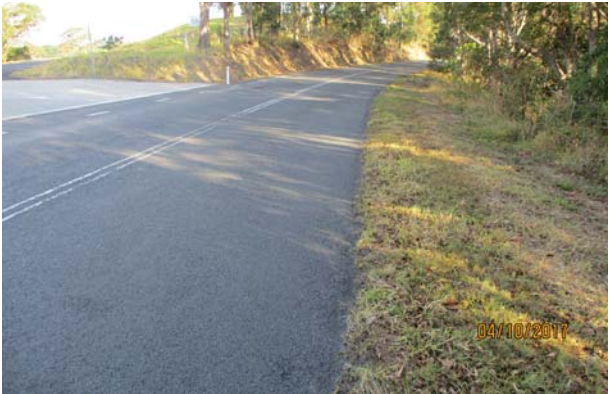
1.9	A	Absence of sealed shoulder on inside of curve (western side of Pottsville Road).

Provide a minimum 1m sealed shoulder in accordance with Austroads requirements for rural roads with an AADT between 1000-3000 veh/day
1.10	A	The unsealed shoulder on the western side of the intersection is slightly raised above traffic lane and may result in surface water drainage issues / water pooling

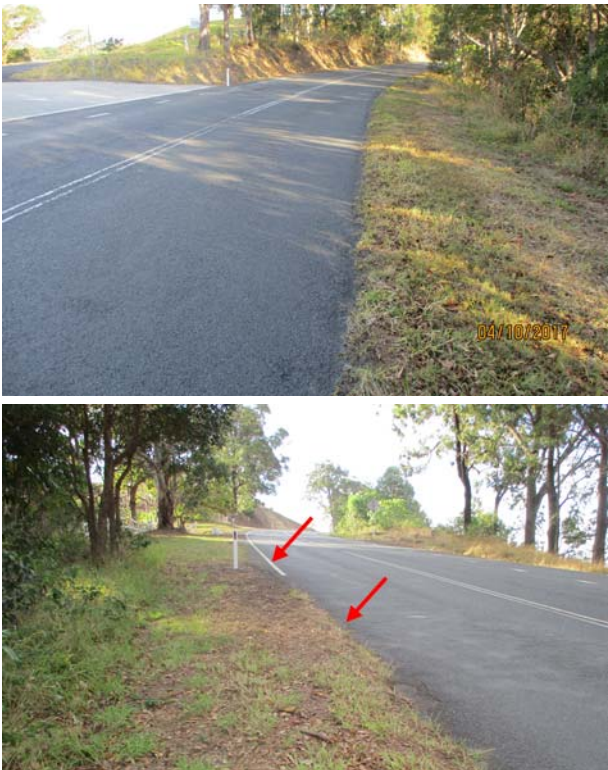
1.11	C	<p>No edgeline provided on western side of Pottsville Road and is inconsistent with adjacent sections of where edgelines have been provided on both sides</p>

<p>Provide edgeline. Consideration to be given to Item 1.9 (i.e. shoulder widening) prior to edgeline provision</p>

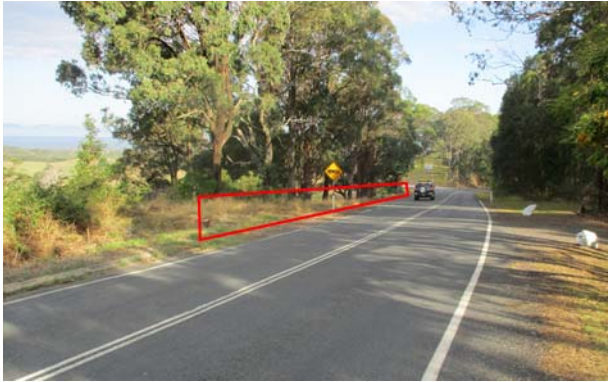
Item	Priority	Issue	Illustration	Suggested Treatment(s)
1.18	A	Unprotected hazards in clearzone (embankment, trees) on eastern side of Pottsville Road

Install guardrail along this section of road to protect hazards
1.19	A	Unprotected hazards in clearzone (embankment, trees) on eastern side of Pottsville Road

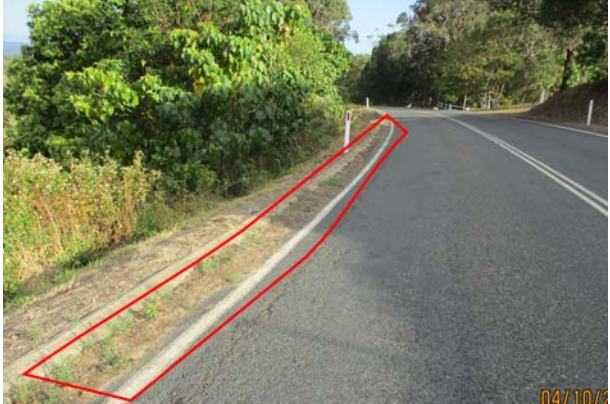
1.20	A	Possible surface water drainage issues / water pooling on eastern side on Pottsville Road due to kerb design and crossfall

Drainage to be investigated further. Treatment will depend on findings however may include upgrades to kerb / provision of culverts (or other design feature to remove excess water from road edge)

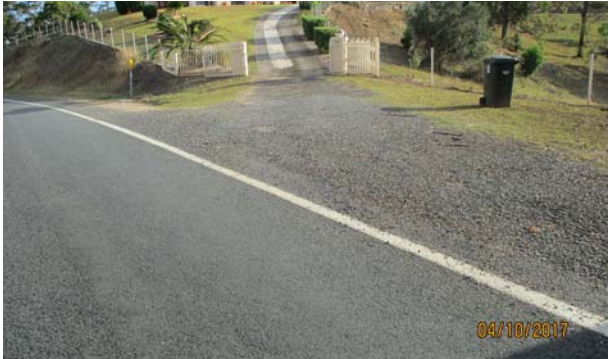
Item	Priority	Issue	Illustration	Suggested Treatment(s)
1.21	A	Loose gravel on road from adjacent driveway

Remove any loose gravel
1.22	A	Unprotected hazards in clearzone (embankment, trees) on western side of Pottsville Road

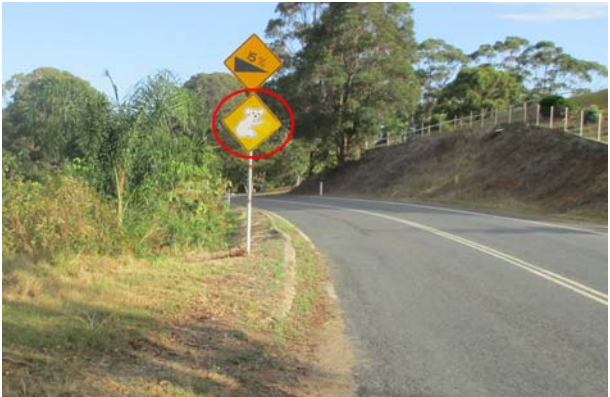
Protect hazards with guardrail (extend existing guardrail)
1.23	D	Non-compliant Koala warning sign

Replace with Koala (Symbolic) (W5-47)
