Preliminary site assessment of existing steel gantry

**Sydney Harbour Common User Services Park,
White Bay NSW**

Ref: AUS02-16013_Report1revA

12th August 2015

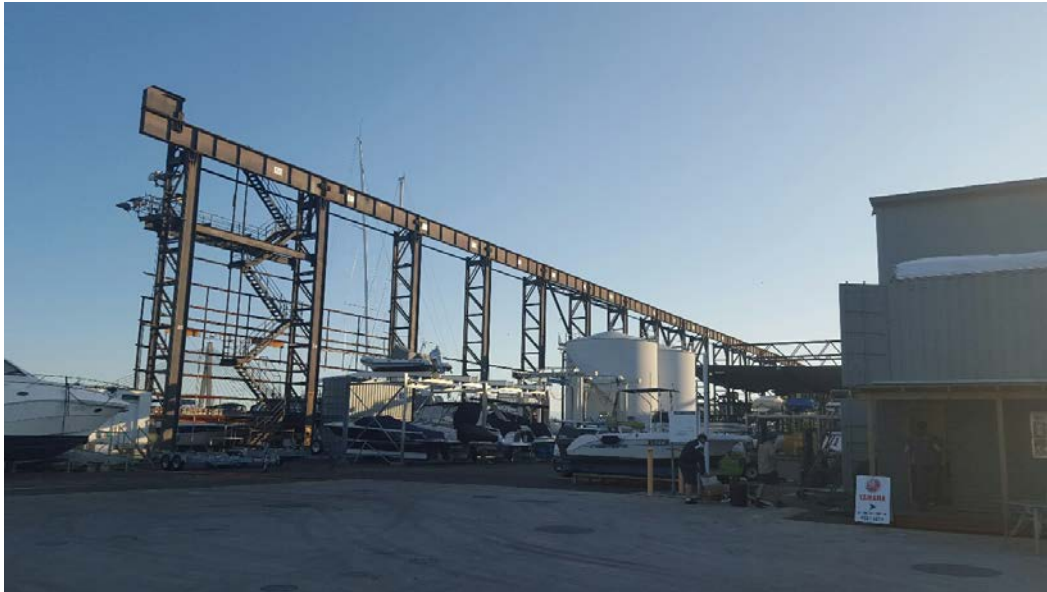
PHOTO 1: Existing Steel Gantry location for proposed Cantilevered Roof – Southern Gantry

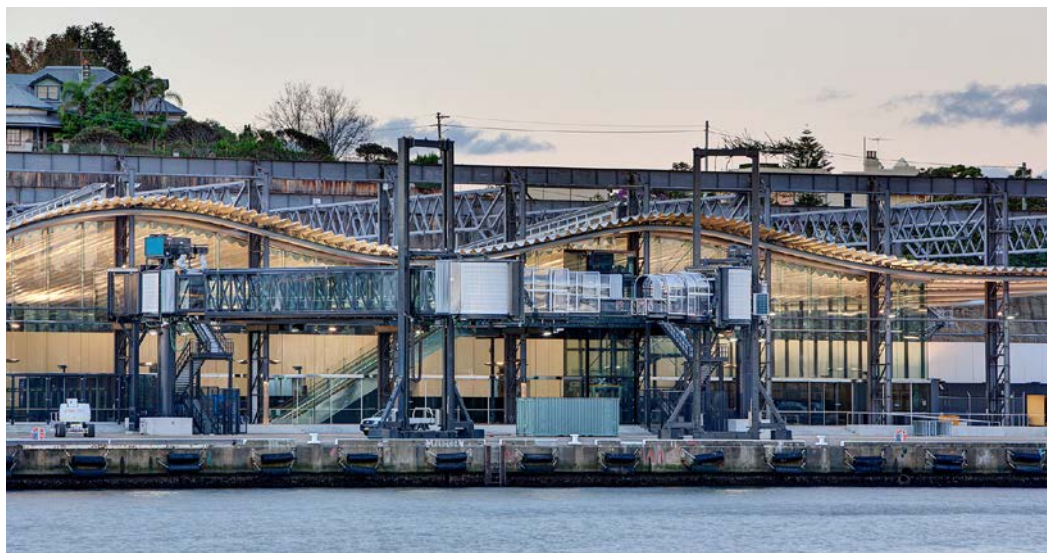
IMAGE 2: Existing steel gantry used integrally at White Bay Cruise Terminal - image by others

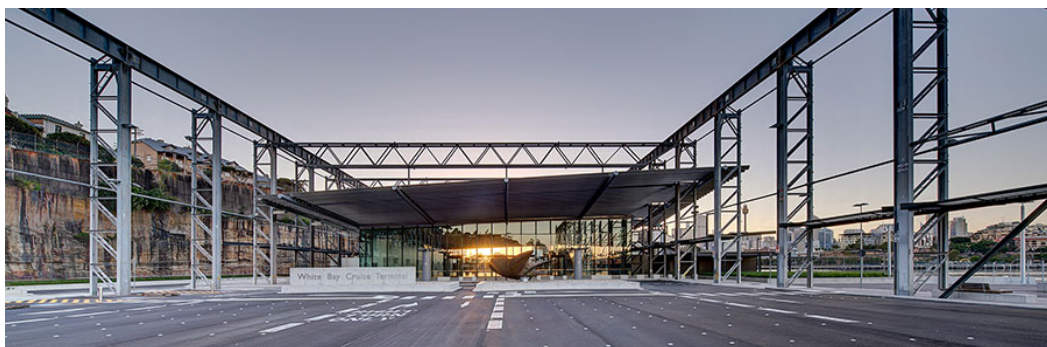
IMAGE 3: Existing steel gantry used integrally at White Bay Cruise Terminal - image by others

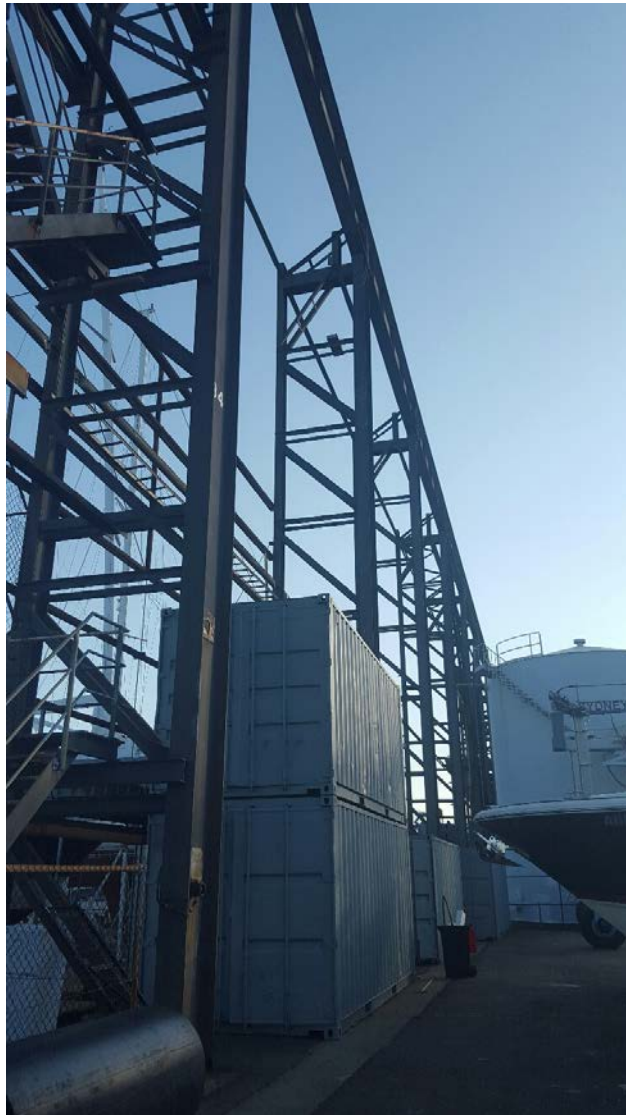
PHOTO 4: Existing Steel Gantry in location of proposed Cantilevered Roof
(Southern Gantry)

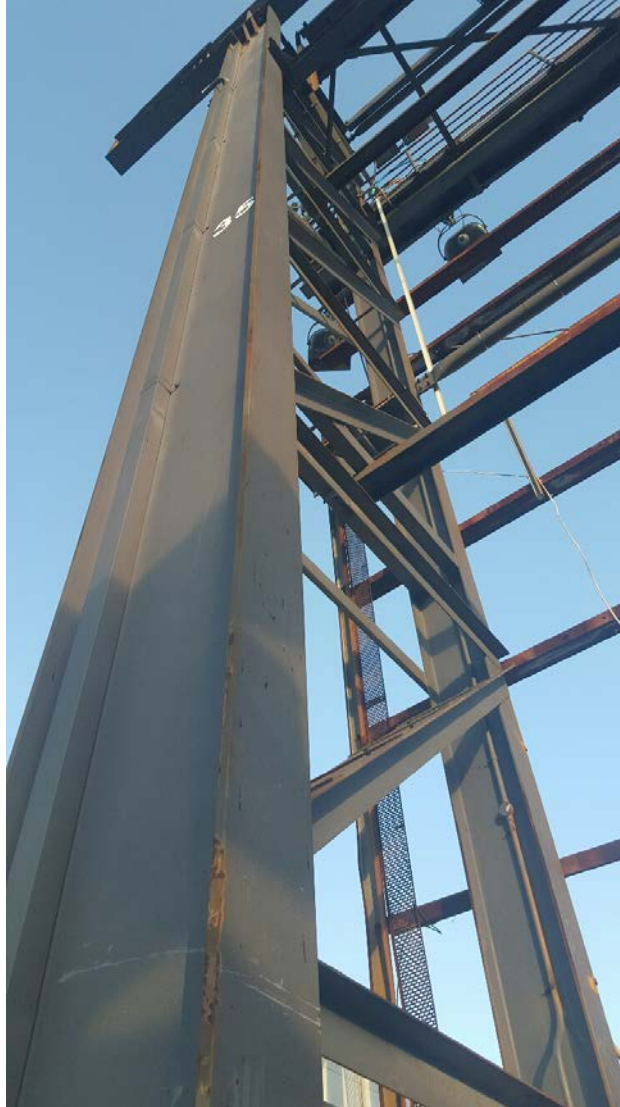
PHOTO 5: Existing Steel Gantry columns in location of proposed Cantilevered Roof

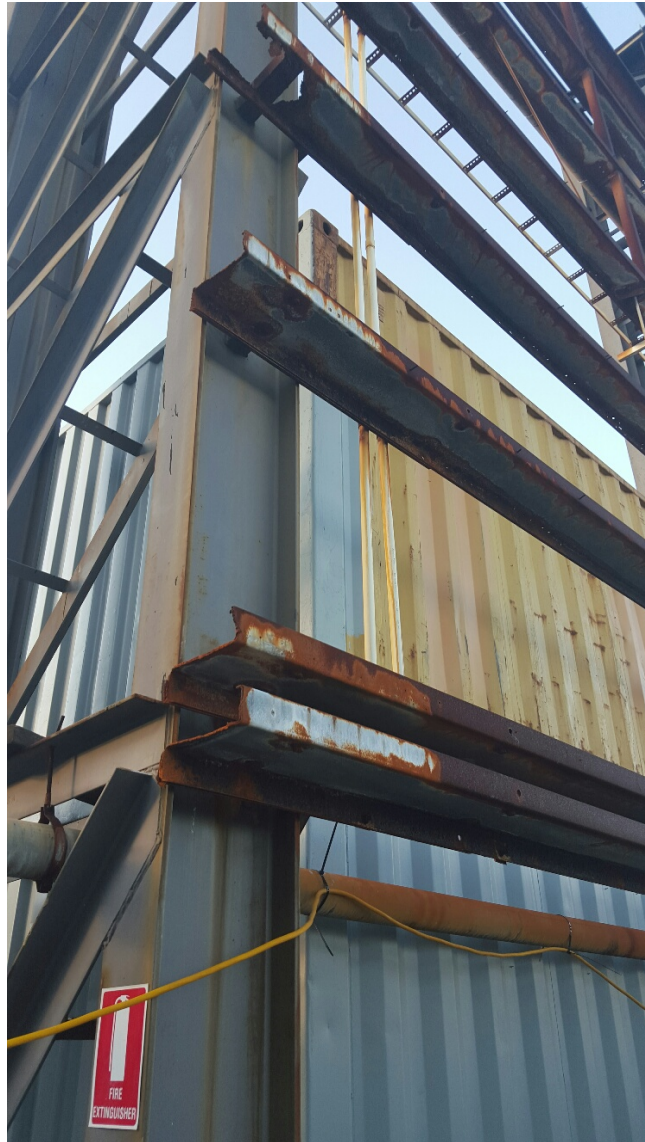
However there are minor maintenance requirements and repairs that would be recommended for example - the steel stairs, some existing girts, some bracing members and other components (refer photographs below in Appendix A), and however, the detail is outside the scope of this report.

PHOTO 6: Existing Steel Gantry girts in location of proposed Cantilevered Roof

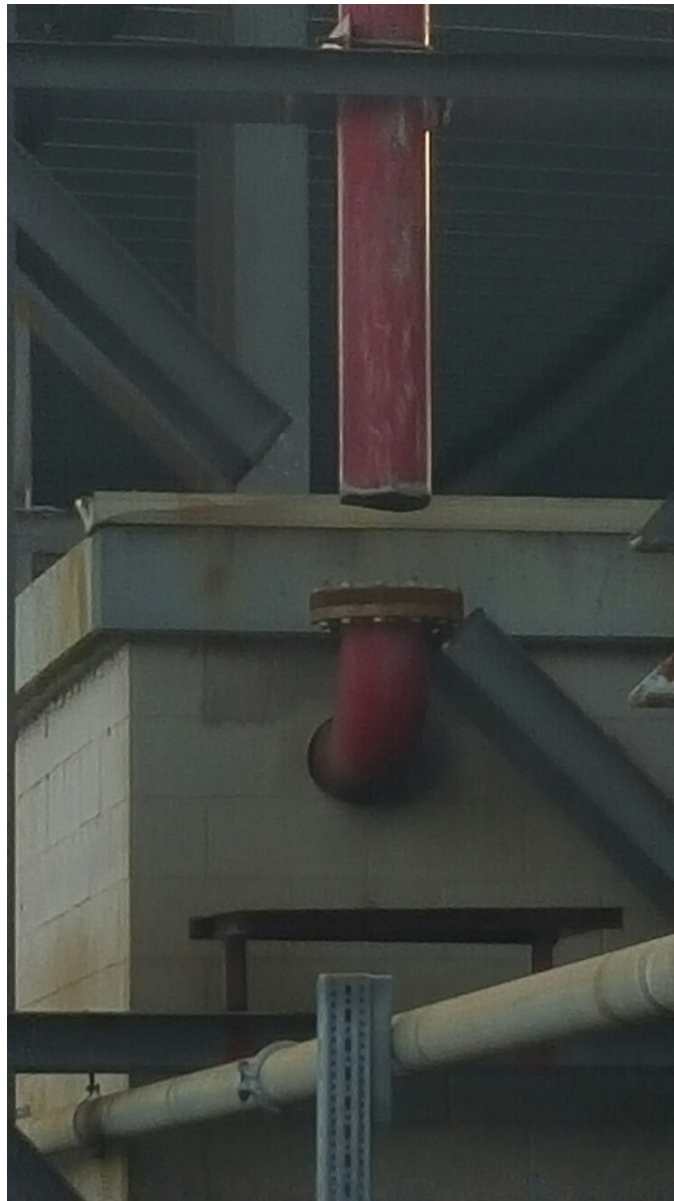
PHOTO 7: Existing Steel Gantry bracing cut in location of proposed Cantilevered Roof
