our ref: BB2798

25th February 2008

Re: **Proposed Subdivision of Lot 2 DP250984 Grandfathers Gully Lilli Pili**
Slope Stability

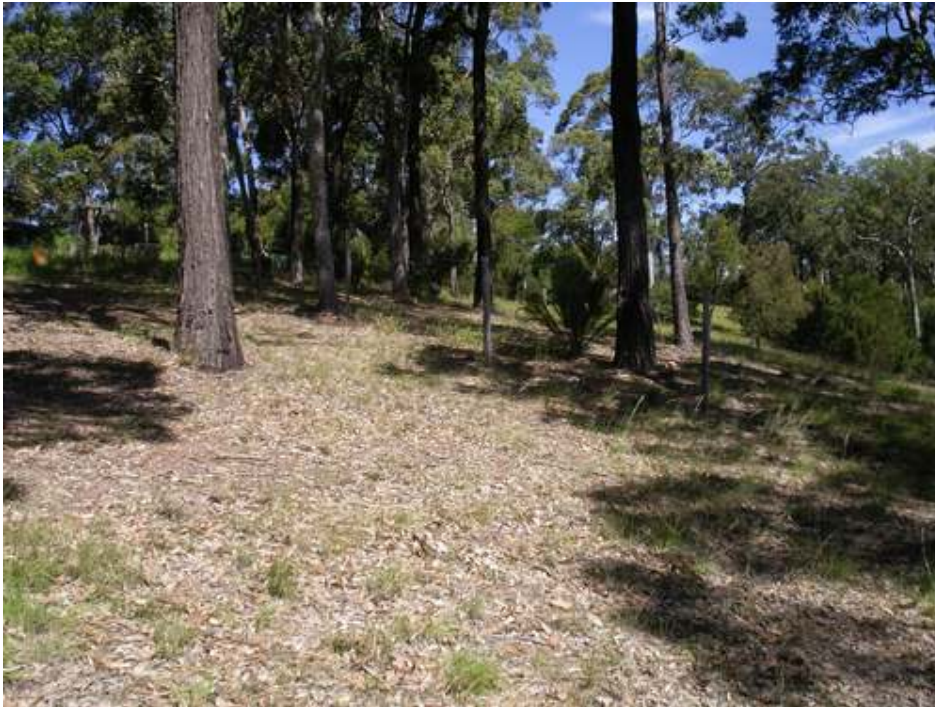
Sites 12 and 13 are located on the western side of the ridge and are similar to sites 7 and 8 with regard to topography and geology and also have a very low risk of slope instability.

Looking SE from site 13 - typical of the landform of the higher ridge sites.

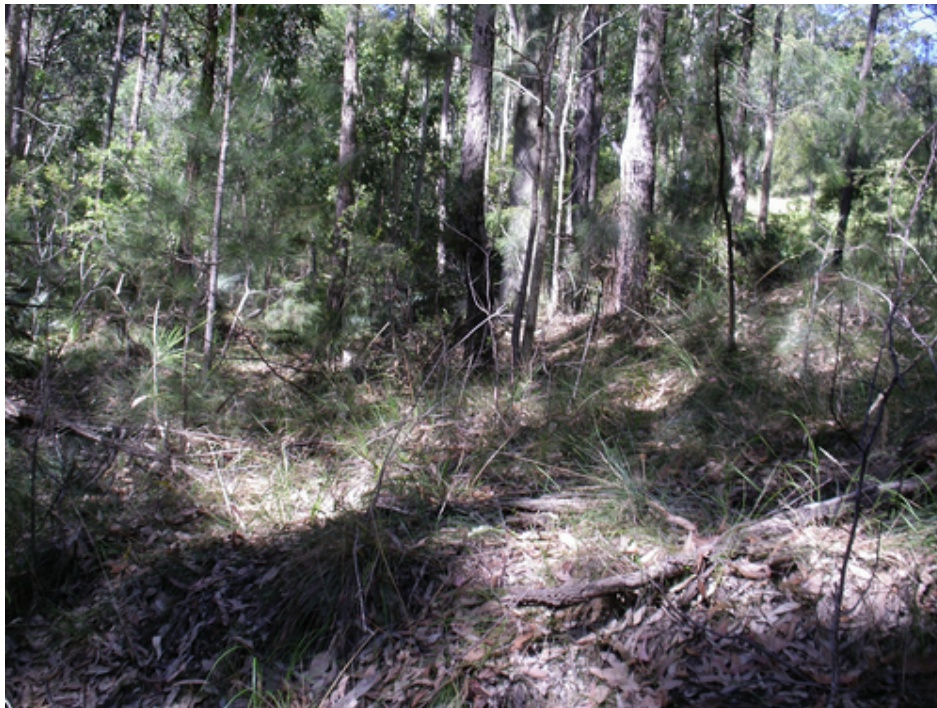
Site 1 is further North, down the ridge, in the thick bush area. It slopes at 18% – 25% with steeper 25% – 32% at the NE edge of the site. There is a thicker topsoil layer at Site 1 with leaf litter and organic matter. There were extensive local ground undulations, with humps and depressions up to 1m as shown in the photo below. These are most likely the natural ground conditions. The topsoil at this site was friable pale grey sandy loam to about 0.3m. The subsurface was pale orange clay with a high content of laminated shale chips. Most of the vegetation at this site will be cleared as part of the APZ. Measures for stabilizing sloping ground and revegetating after clearing have been dealt with in reports by others.

Looking East across Site 1 from the existing access track.

We have assessed Site 1 to have a very low risk of slope instability, mainly due to the soil profile.
