New Gas-Fired Co-Generation Plant, Shoalhaven Starches (MOD23)

Stability Assessment – Bomaderry Creek
Bank

Manildra Group

2 July 2021

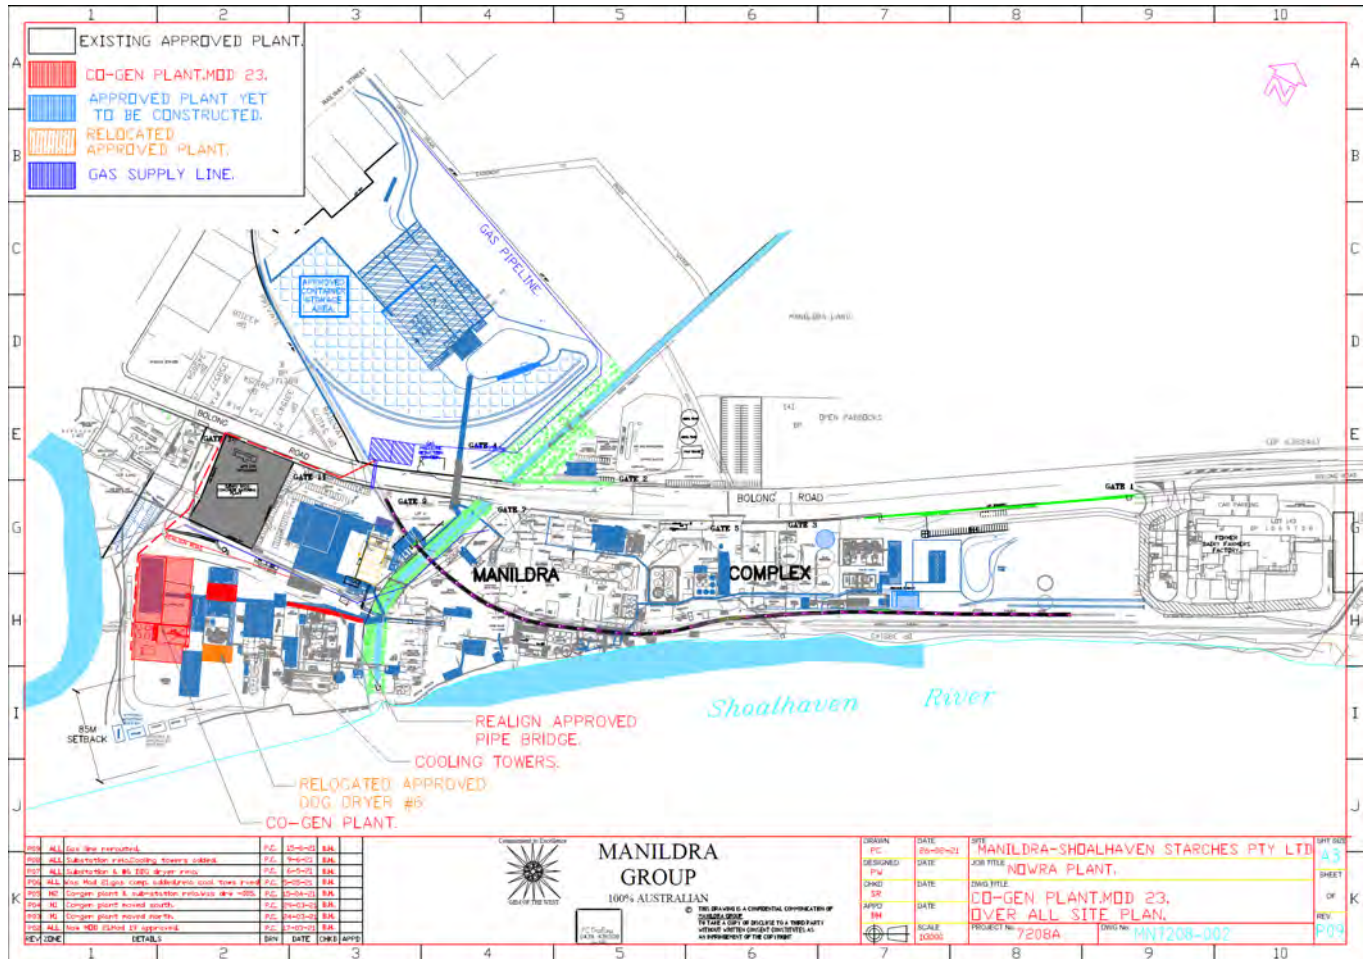
Figure 2.1 Shoalhaven Starches Overall Site Plan, Co-Gen Plant Mod 23 Proposal (Manildra Group Ref: Project 7208A, DWG No. MN7208-002 rev. P09)

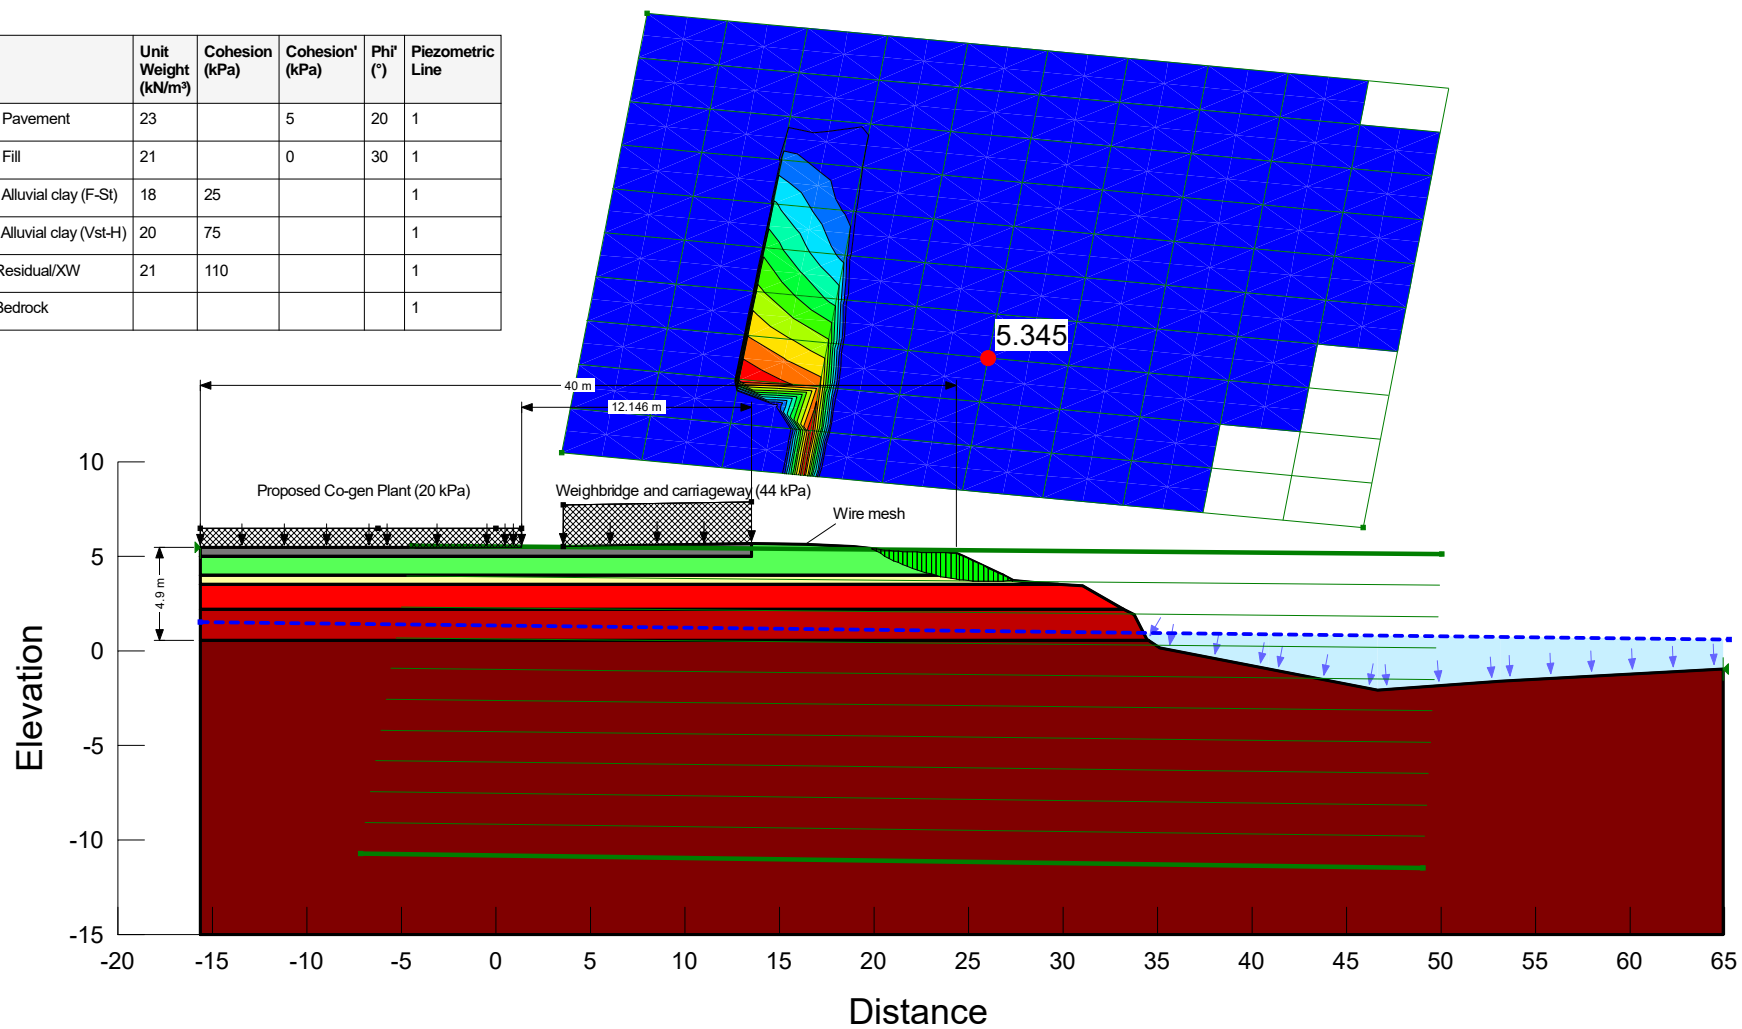
Scenario No.	Groundwater condition	Section A-A' FoS	Section B-B' FoS
1	Normal condition	5.34	3.72
2	Raised water level (flood)	5.34	3.78
3	Rapid drawdown	5.34	3.72

The analyses show that the failure scenarios are driven by slope instability approximately between the wire mesh fence and the top of the creek bank as shown in Section A-A'. The failure scenarios at Section B-B' extend to the weighbridge and edge of carriageway. A minimum FoS of 3.72 was achieved for all slope stability scenarios, indicating currently stable conditions and a very low risk of slope instability under current and recent flood conditions.

Section A-A' - Normal condition
12548413 MOD 21 Slope Stability Analysis.gsz
09/04/2021
1:400

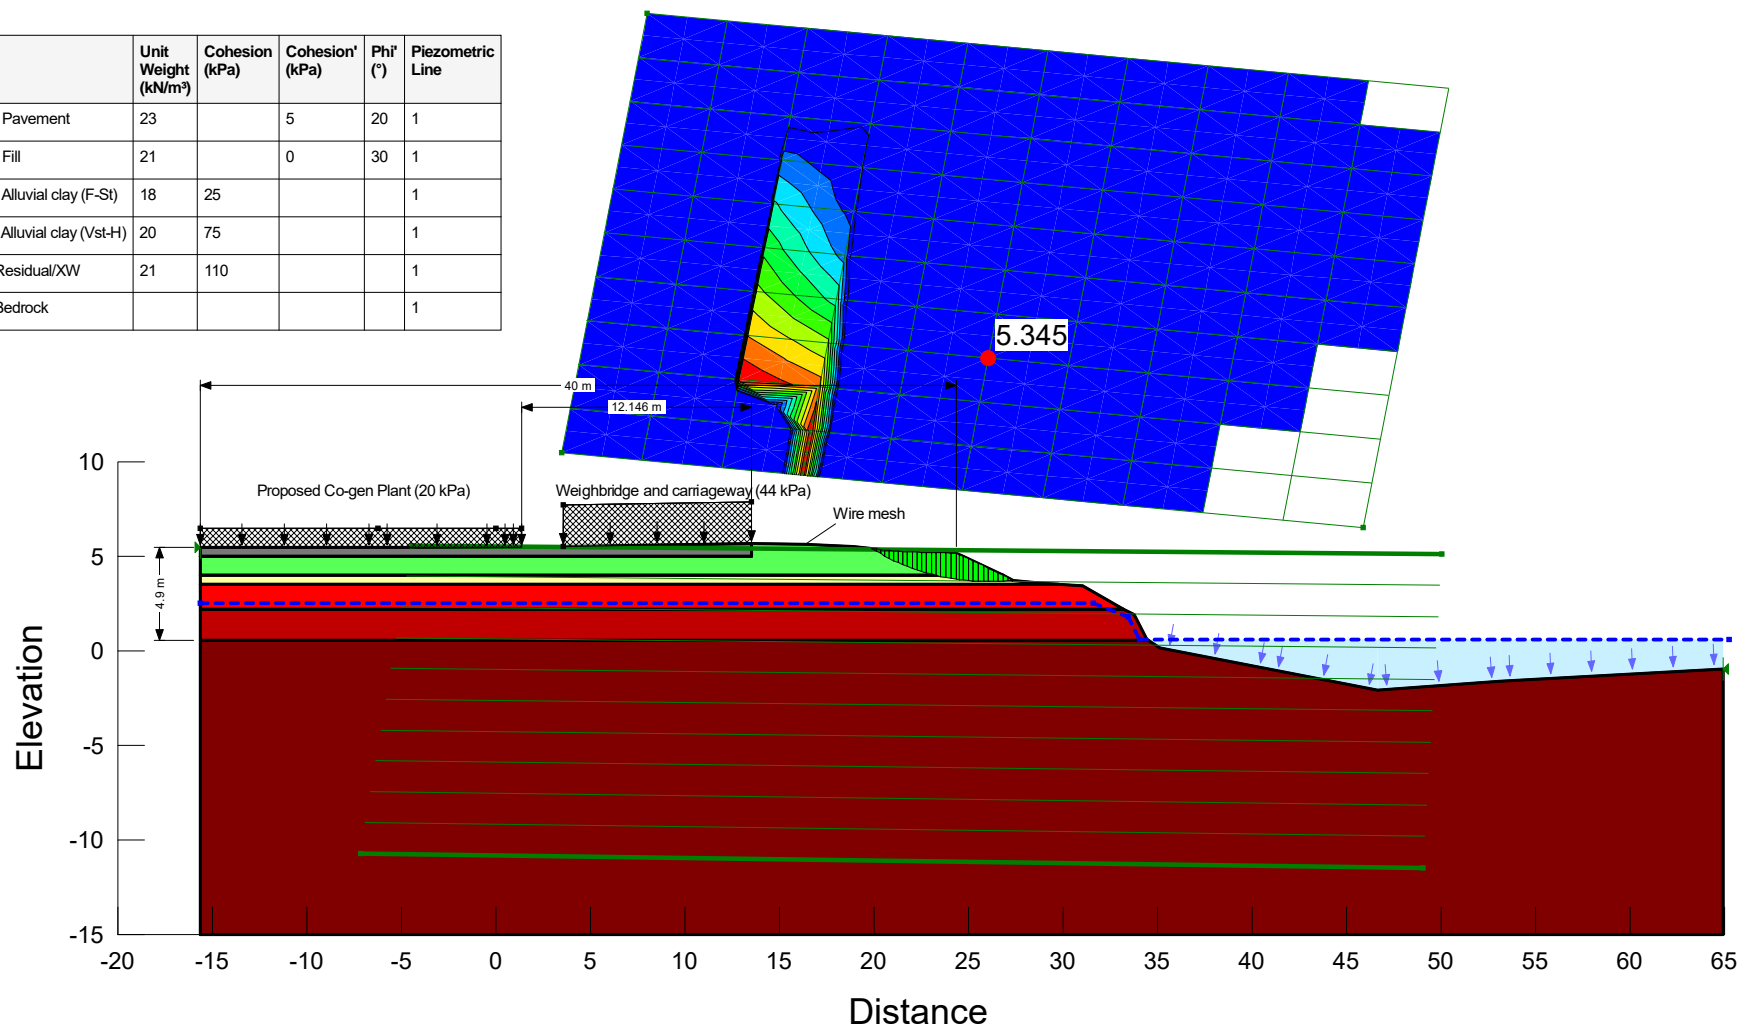
Section A-A' - Rapid drawdown
12548413 MOD 21 Slope Stability Analysis.gsz
09/04/2021
1:400

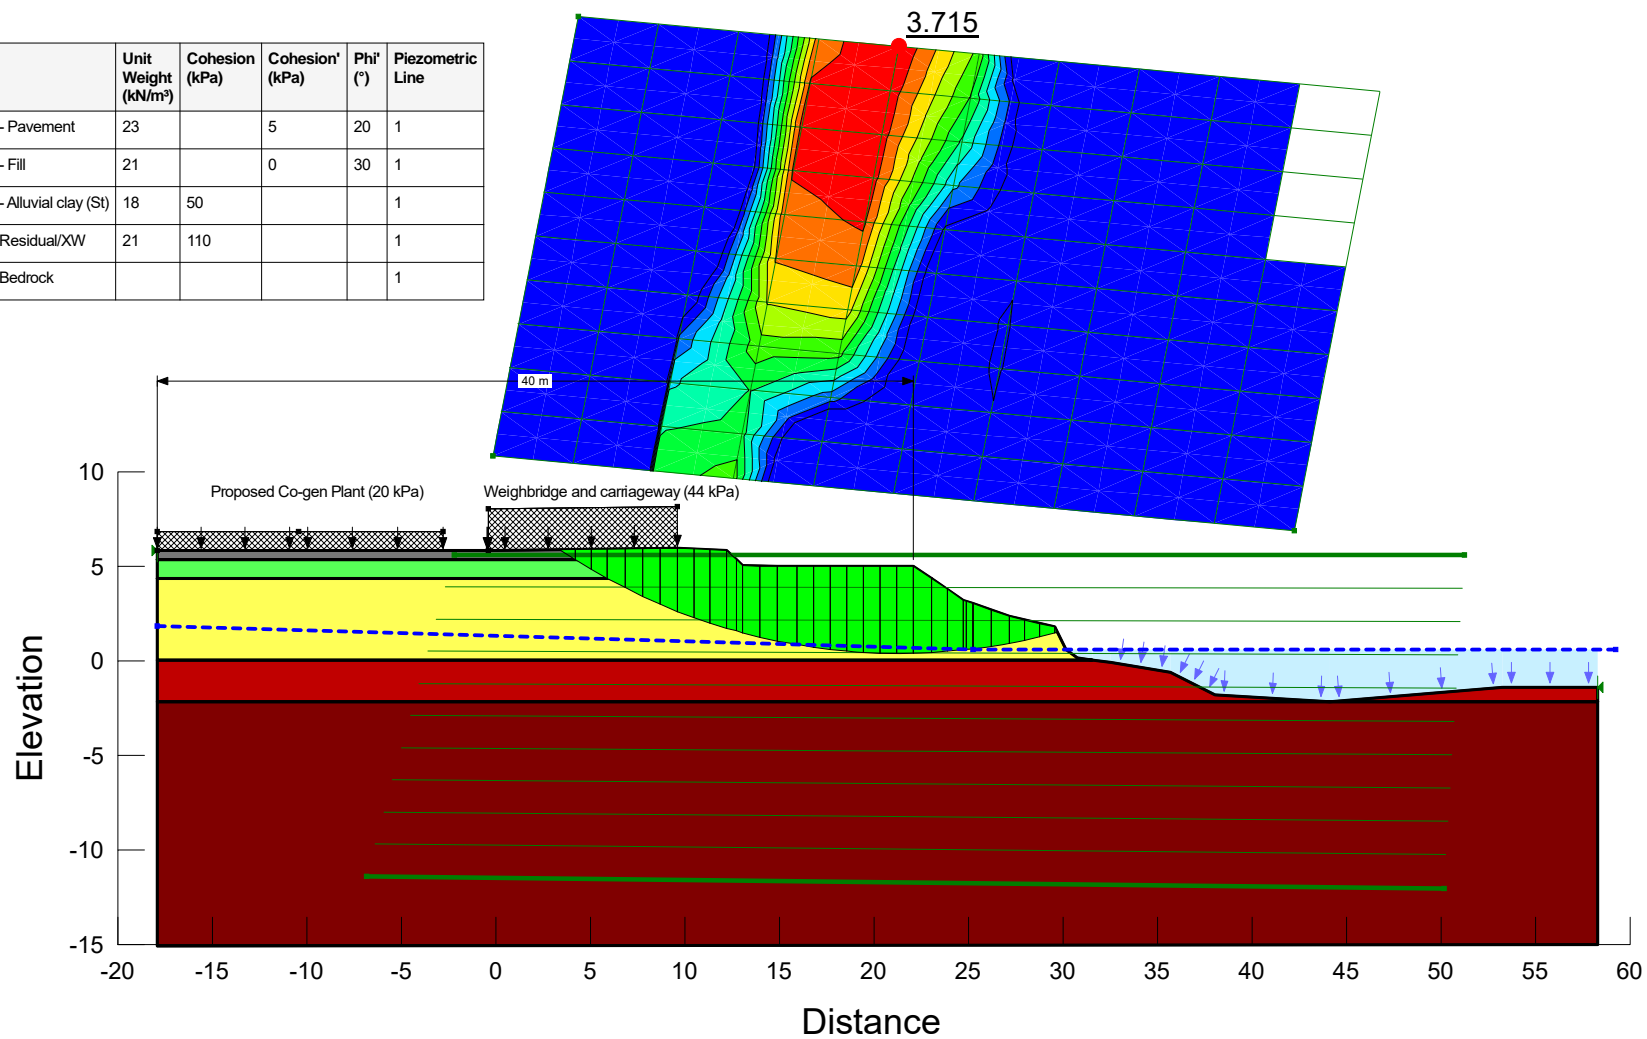
Section B-B' - Normal condition
12548413 MOD 21 Slope Stability Analysis.gsz
09/04/2021
1:400

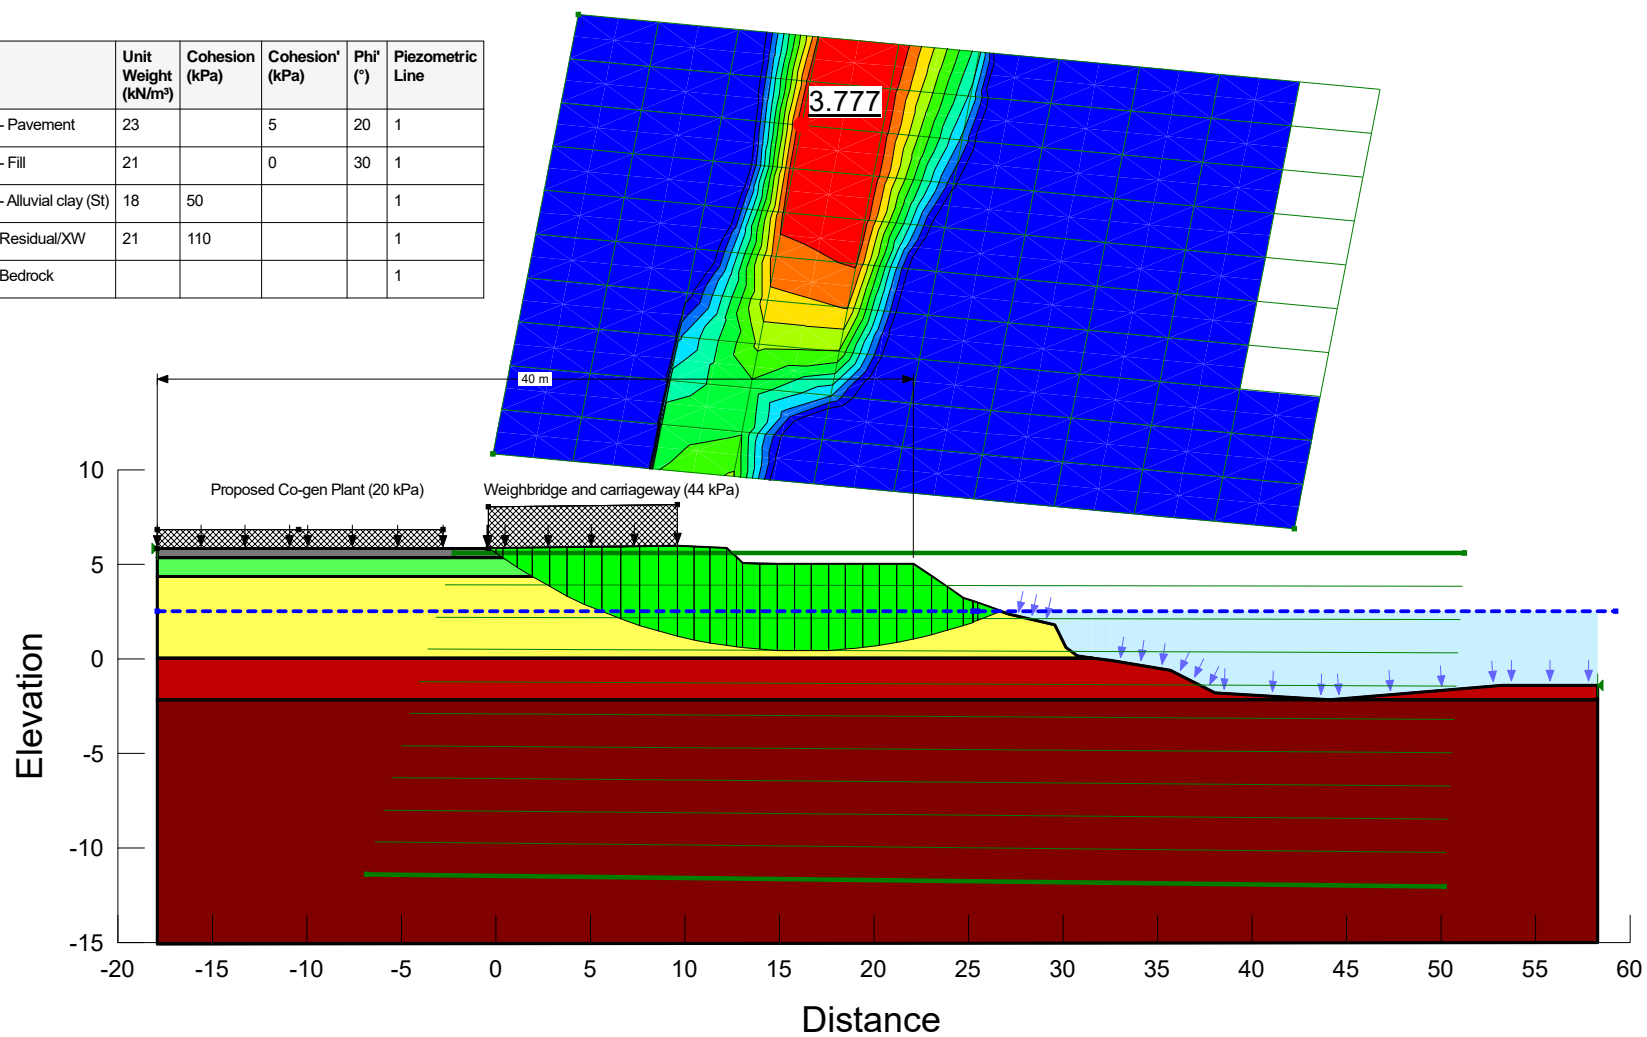
Section B-B' - Flood condition
12548413 MOD 21 Slope Stability Analysis.gsz
09/04/2021
1:400

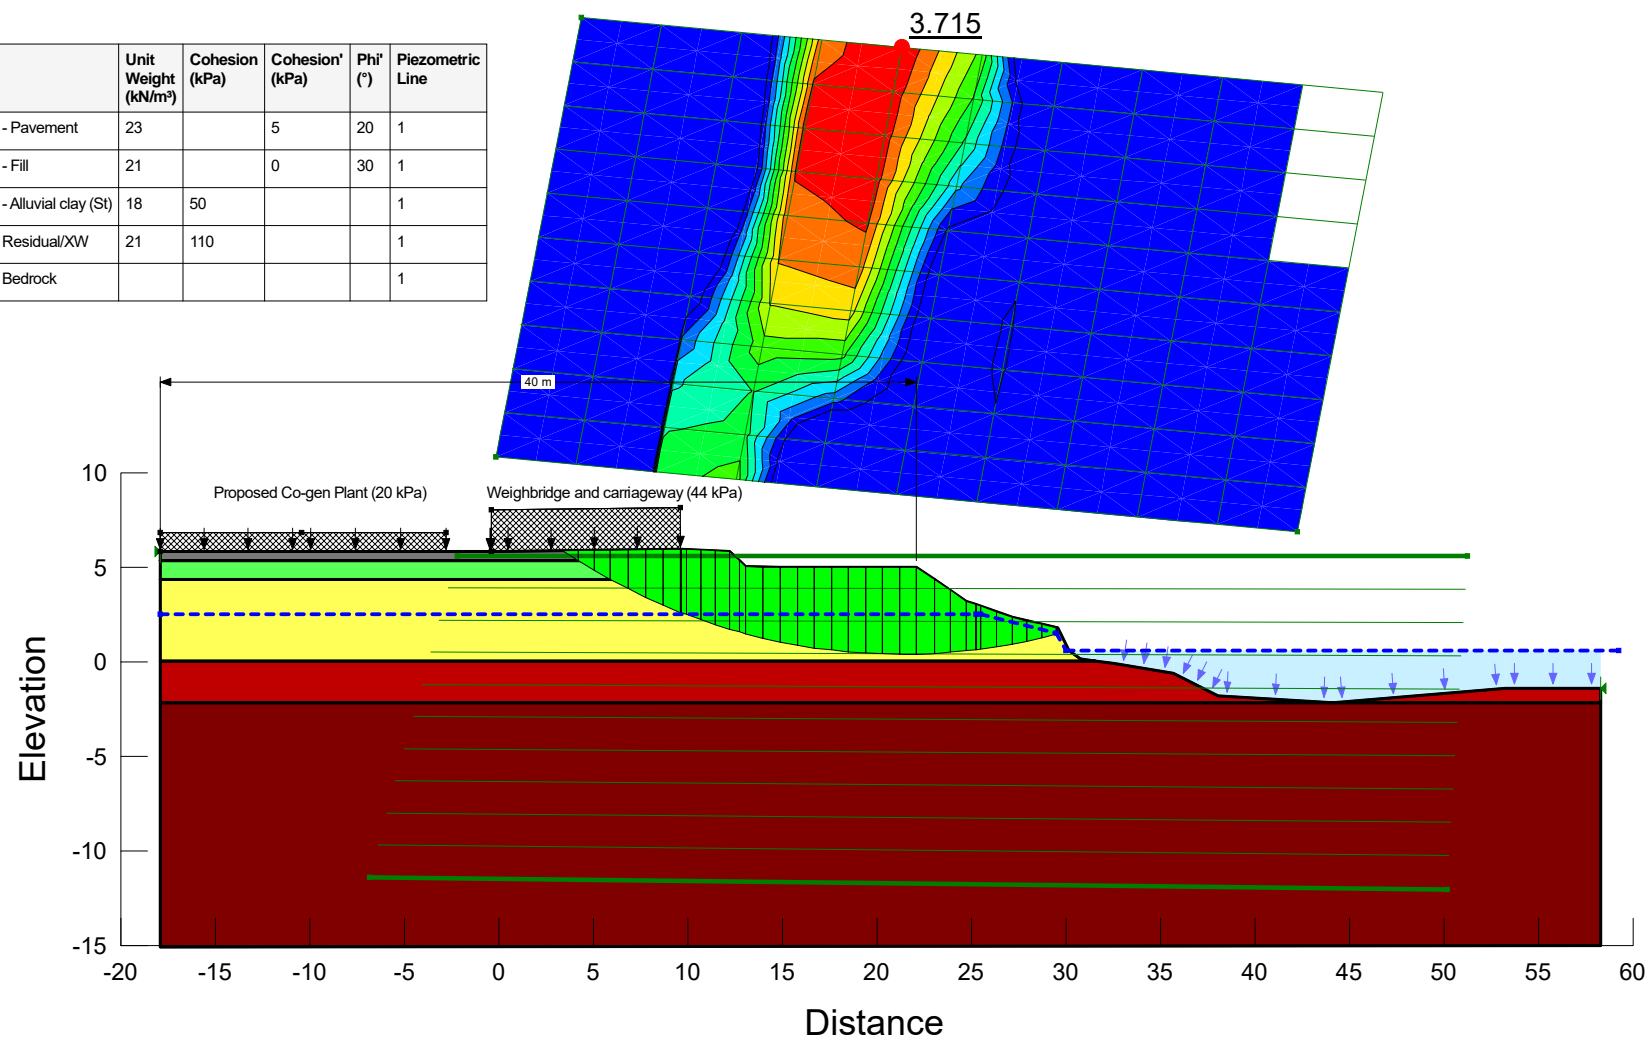
Section B-B' - Rapid drawdown
12548413 MOD 21 Slope Stability Analysis.gsz
09/04/2021
1:400

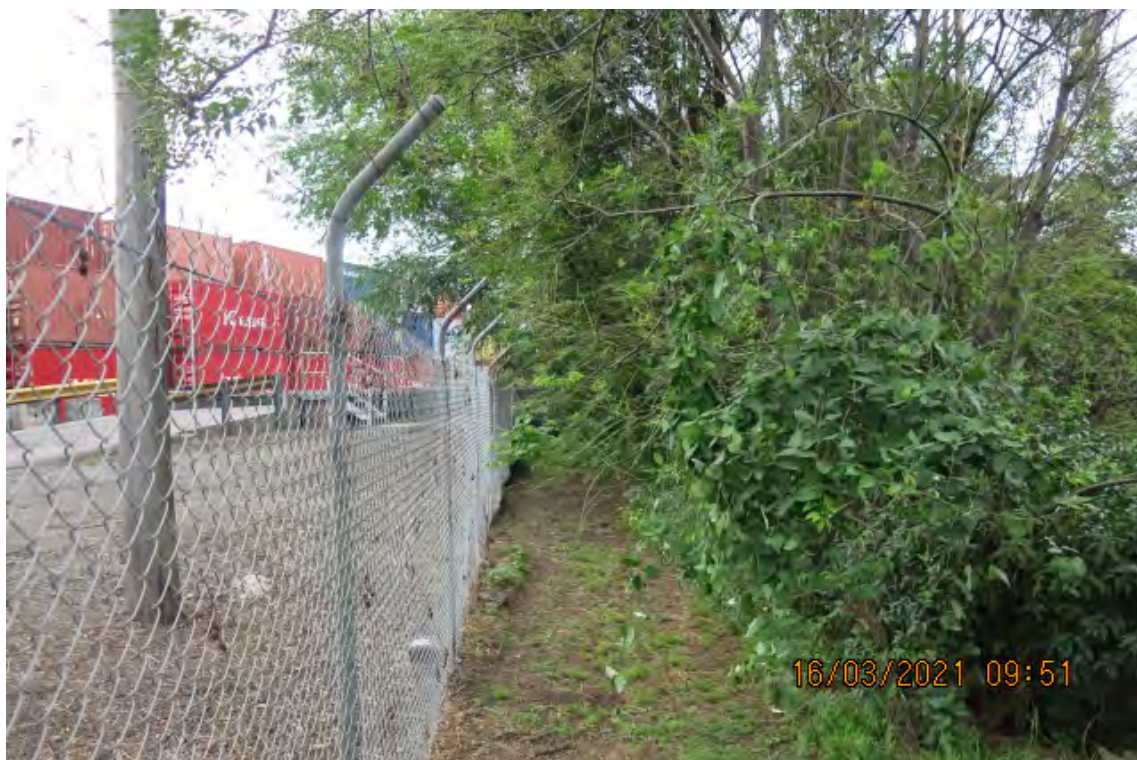
Photograph 1: View looking southwest along site boundary about 20m from western side of Co-generation plant. Note thick vegetation in riparian corridor above Bomaderry Creek

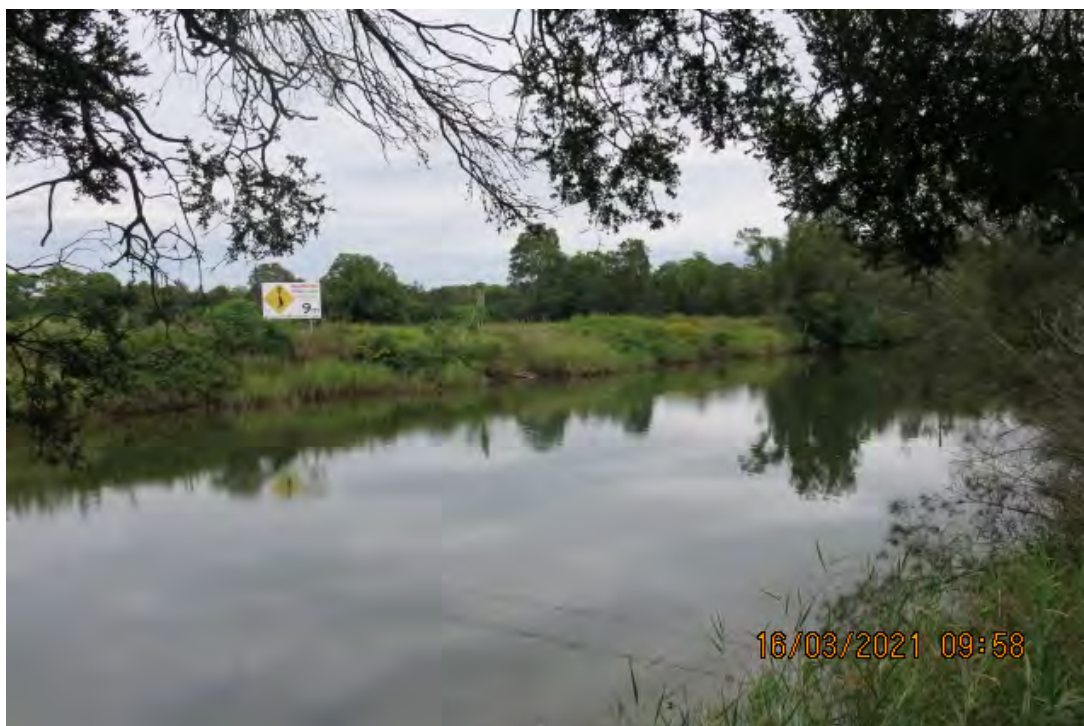
Photograph 2: View looking northwest across Bomaderry Creek from riparian corridor west of the Co-generation plant.

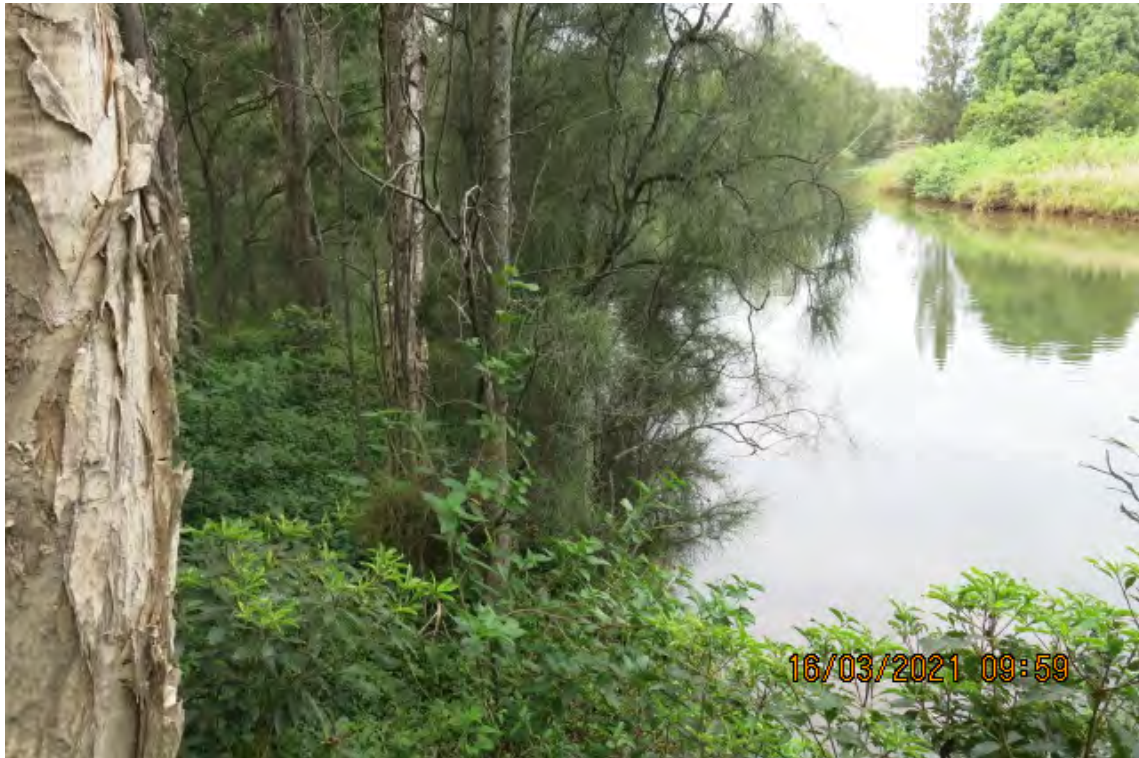
Photograph 3: Significant tree growth close to shoreline of Bomaderry Creek providing bank support.

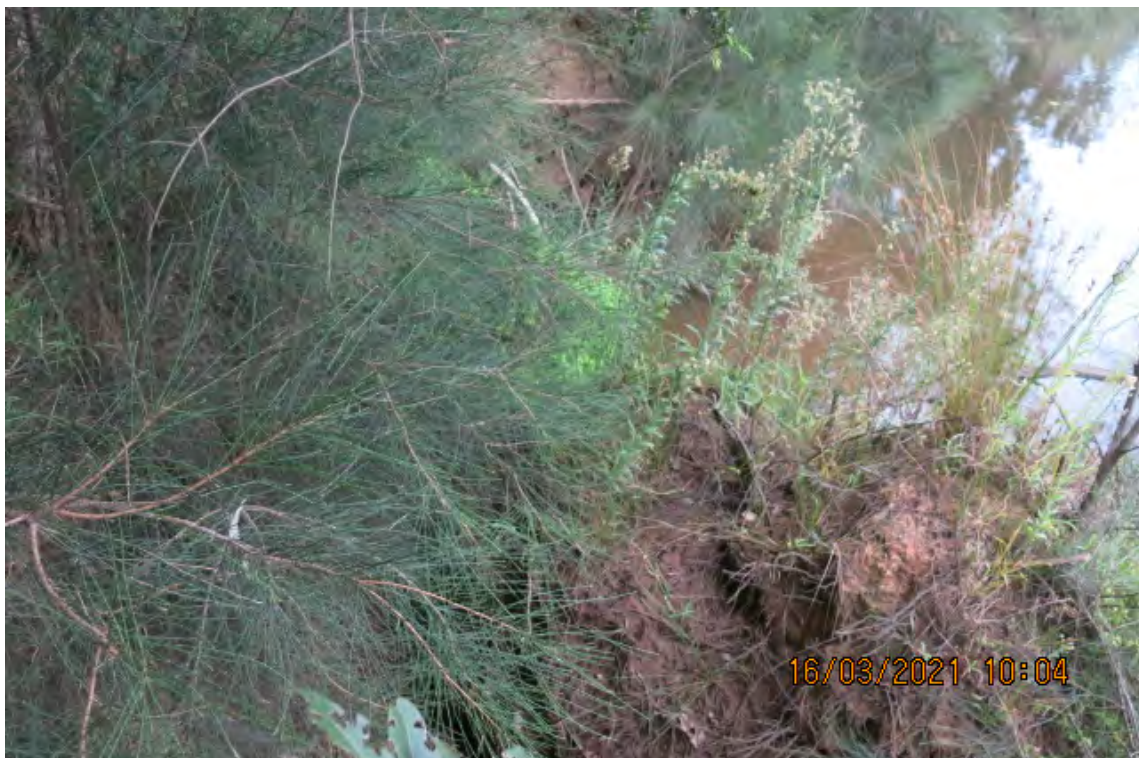
Photograph 4: Recent erosion and slumping along shoreline of Bomaderry Creek during minor flood event and raised river and creek levels in March 2021.

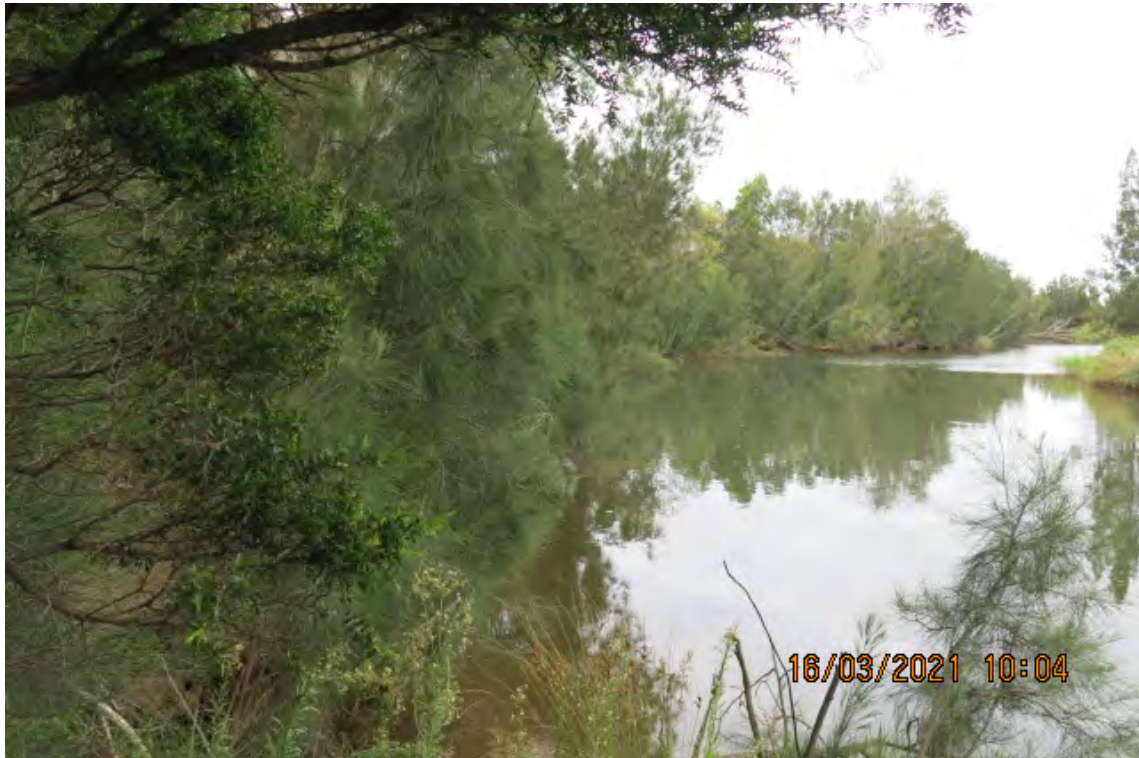
Photograph 5: View looking southwest over Bomaderry Creek showing substantial tree growth and undergrowth along banks.

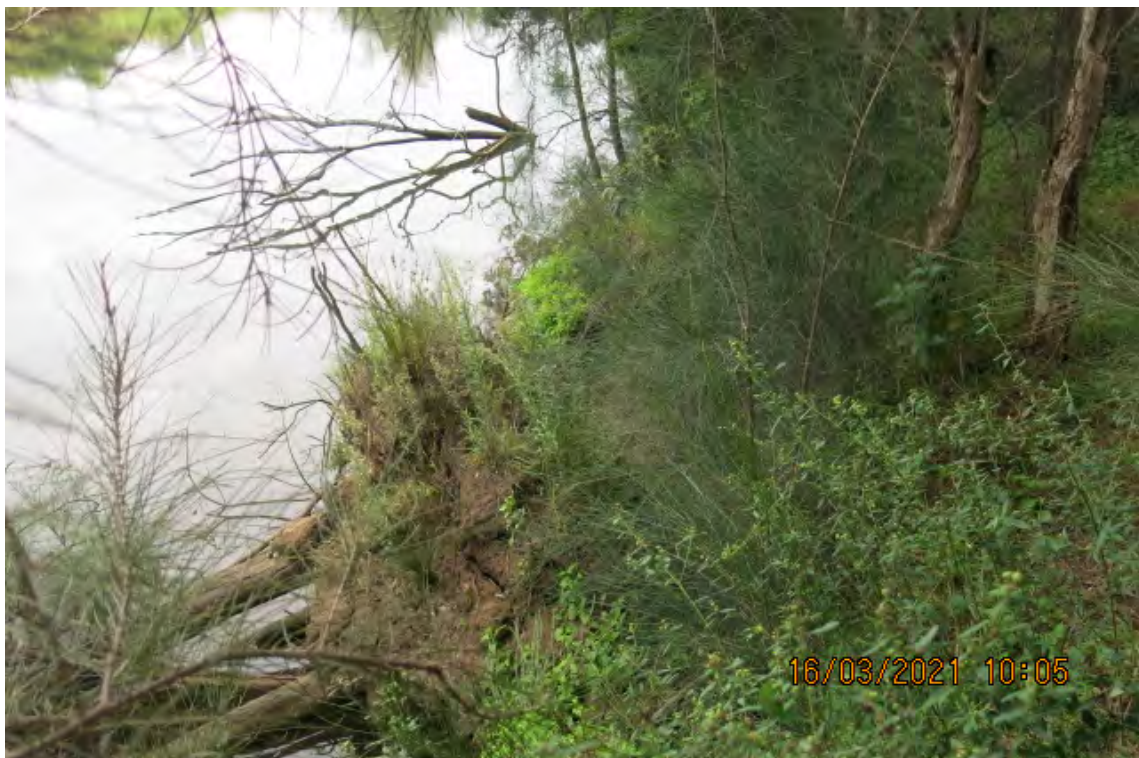
Photograph 6: Lower part of eastern bank of Bomaderry Creek where local slumping and collapse of trees into the creek has occurred.

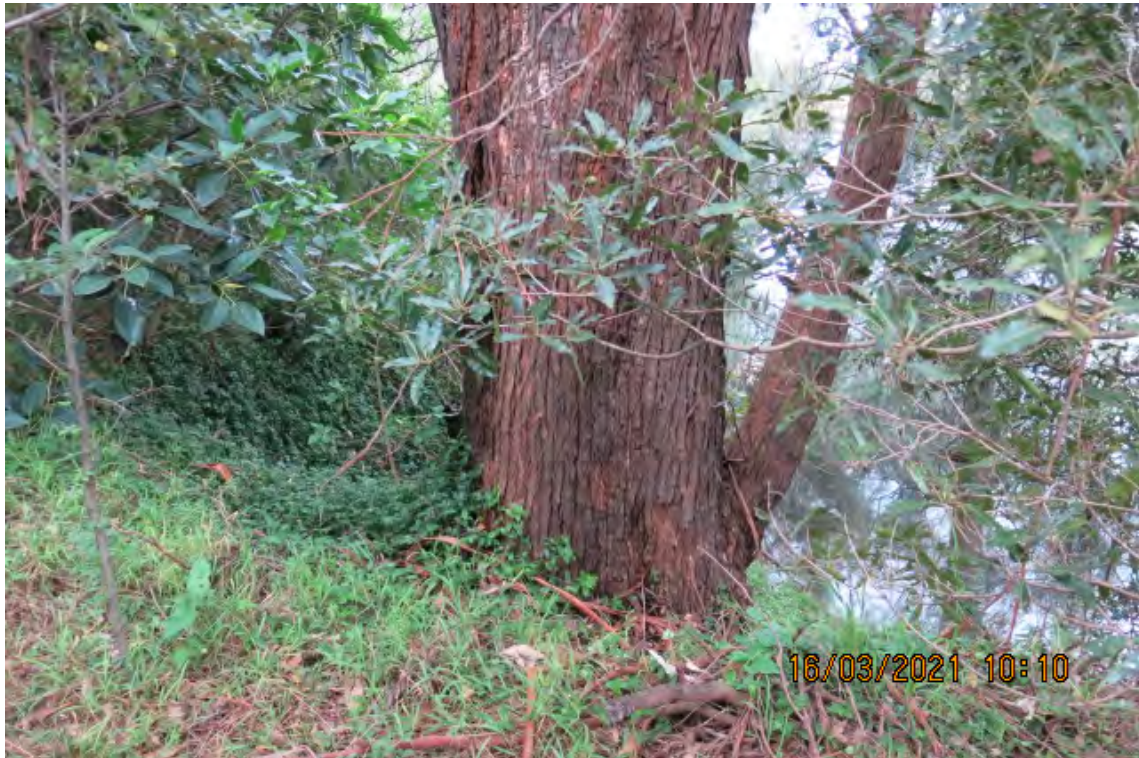
Photograph 7: Large tree at top of eastern bank of Bomaderry Creek. Tree is at least 40 years old indicating no large-scale failure of the bank has occurred during this time.

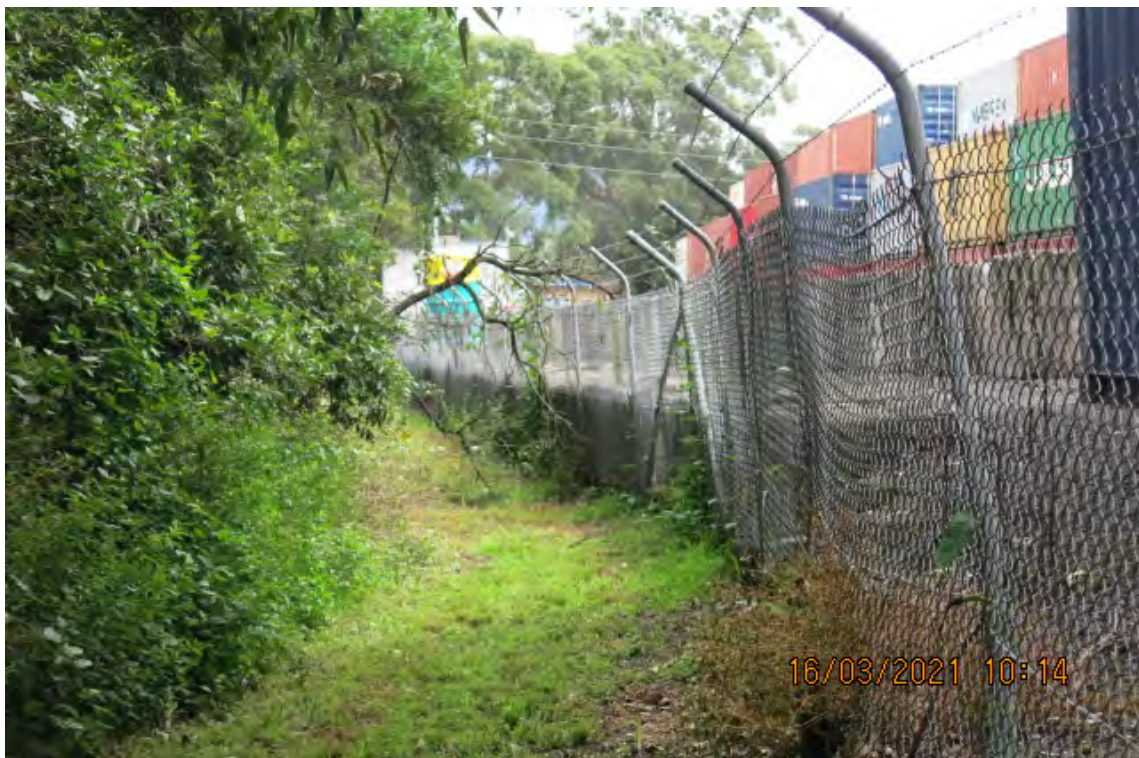
Photograph 8: Looking north along the boundary fence, showing upper riparian corridor and concrete block wall with container storage in the background.

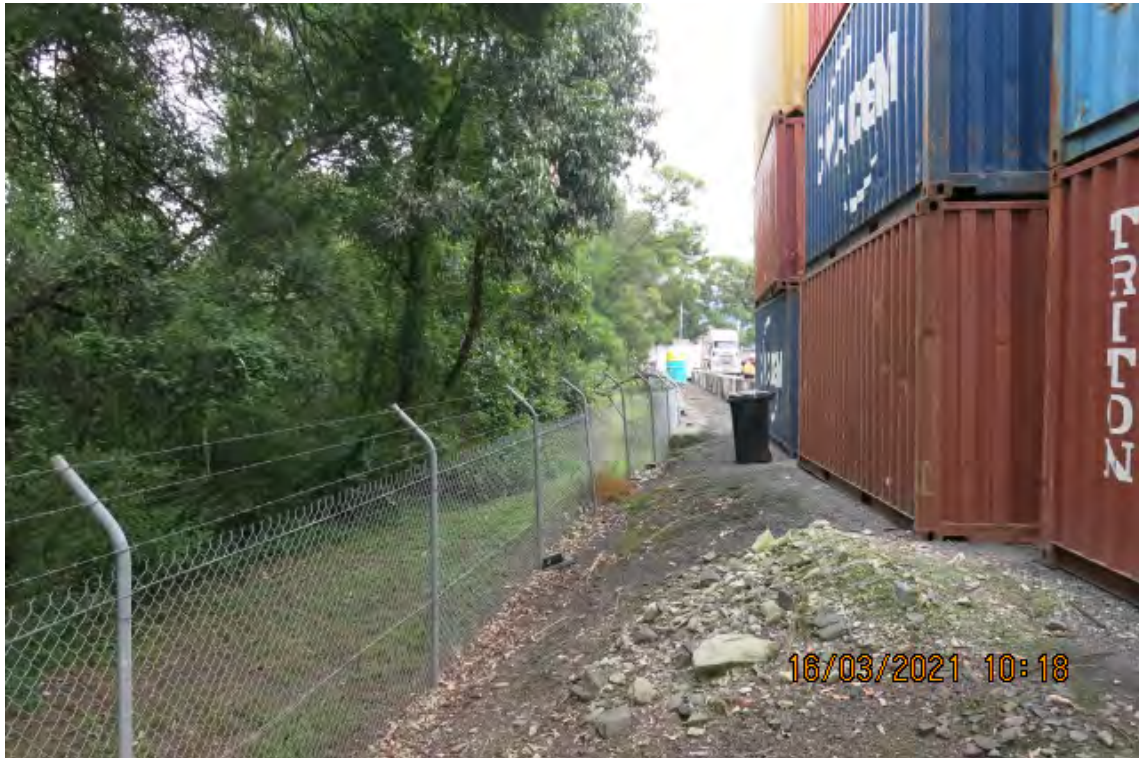
Photograph 9: Looking north along boundary with container storage close to top of fill batter. These containers are located to southwest of the proposed co-generation plant.

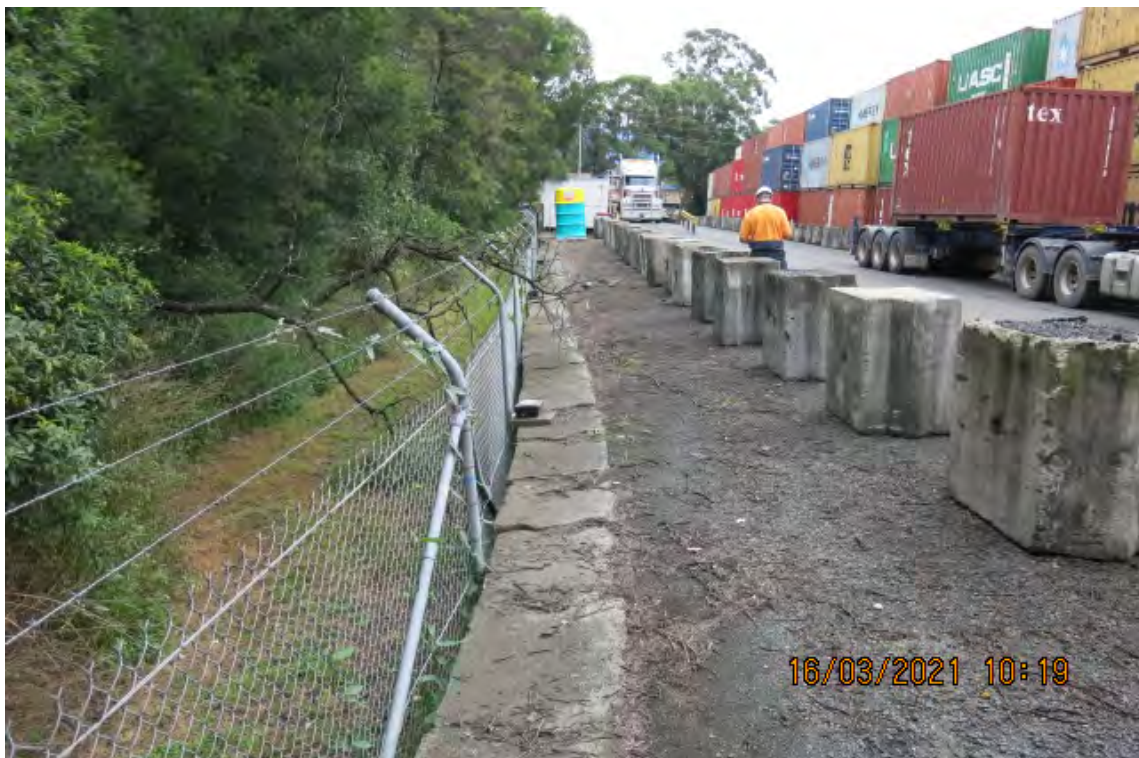
The site is located to the east of the existing weighbridge which will remain in its current position close to the western boundary fence. A stacked concrete mass block has been constructed within the property parallel to the fence and weighbridge alignment. A section of the concrete block wall adjacent to stacked containers is tilted and the adjacent containers are also tilted. The tilting of the concrete block wall and containers is likely due to settlement of fill and poor drainage behind the wall.

Photograph 10: Looking north along western boundary with co-gen plant site to right of photo. Note tilting of concrete block wall supporting fill and paved area.

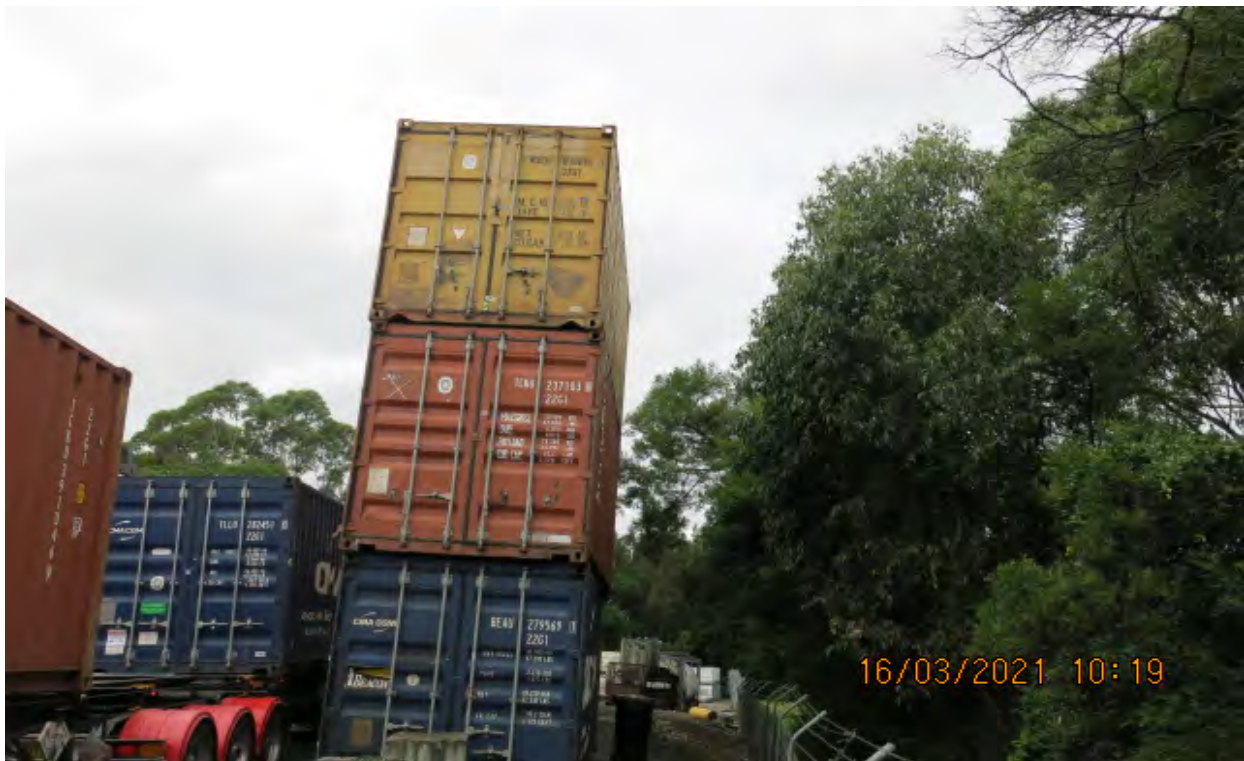
Photograph 11: Looking south towards containers shown in Photo 11, noting that containers are tilted likely due to settlement of fill.

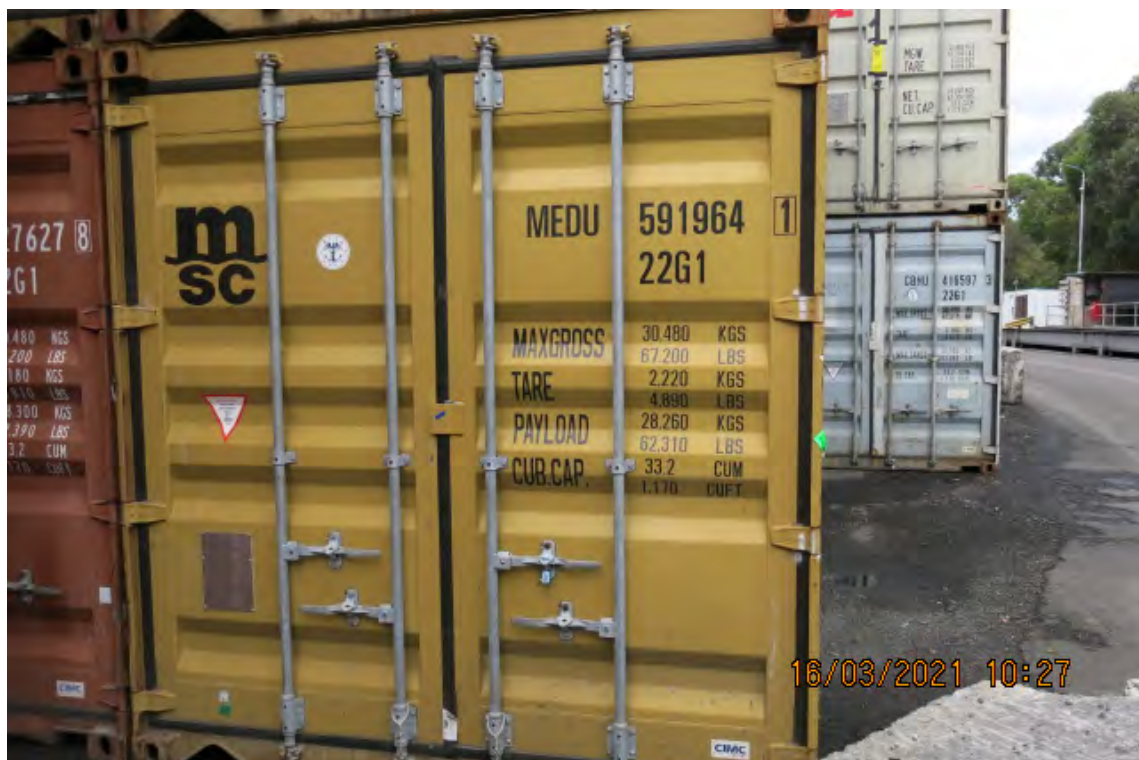
Photograph 12: Typical shipping container in storage yard at site of co-generation plant. Containers typically weigh about 2t when empty and 30t when loaded.

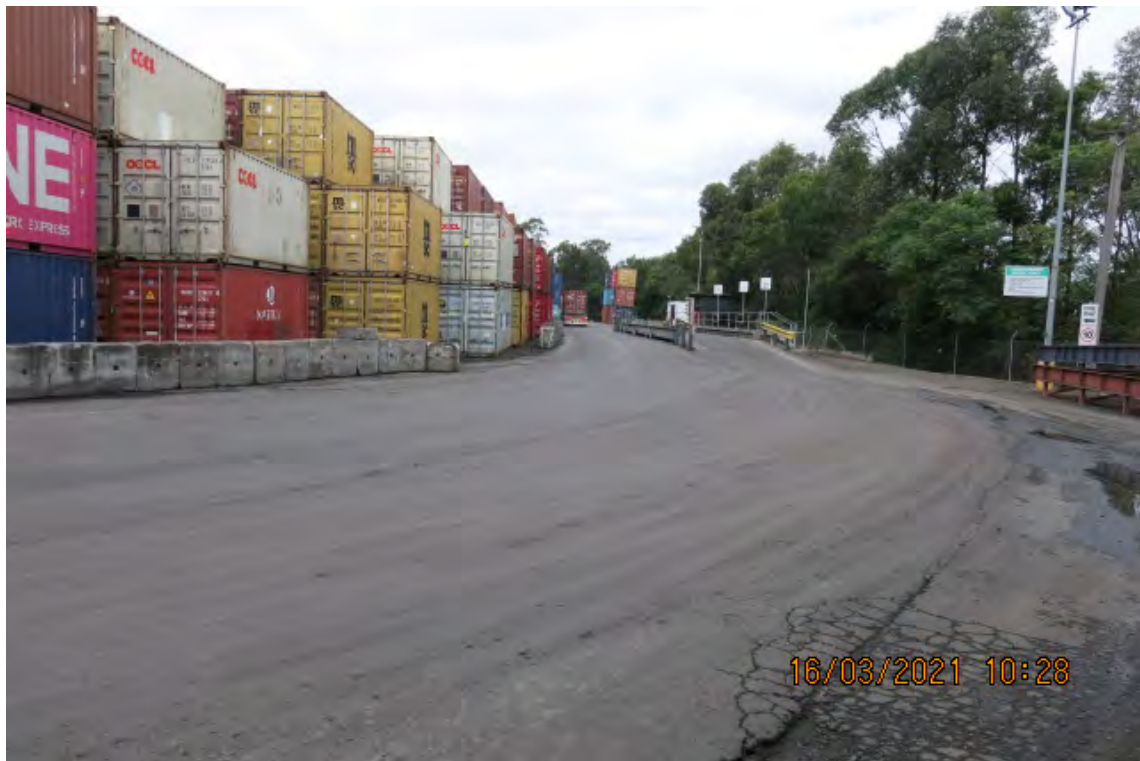
The container storage area is paved with an asphalt wearing course and appears to be performing satisfactorily under heavy vehicle loads. Some localised damage to the pavement was observed at the edges of the asphalt. At the time of our site observations, multiple heavy vehicles were entering and leaving the site and passing over the weighbridge.

Photograph 13: Looking south over paved access and storage area. Co-generation plant is to be located in area currently occupied by shipping containers. Note local pavement damage along edge of accessway to storage area.

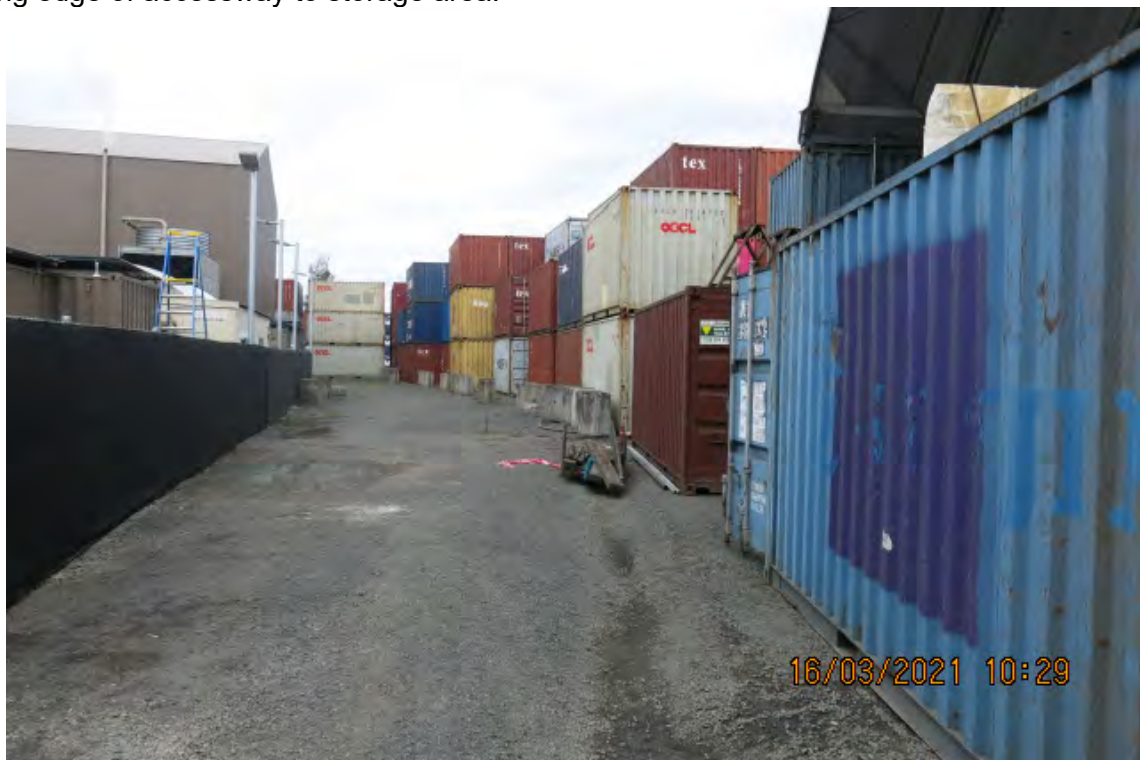
Photograph 14: Looking south along eastern side of proposed co-generation plant, with container storage currently occurring over hardstand pavement.
