# HUNTER VALLEY OPERATIONS

## **2020 Annual Environmental Review**

This Annual Environmental Review (Annual Review) reports on the environmental performance of Hunter Valley Operations (HVO) during the 2020 calendar year and satisfies the requirements of HVO's Development Consents and Mining Leases. The structure of the 2020 Annual Review intends to align with the NSW Government Post-approval requirements for State significant mining developments – Annual Review GUIDELINE (October 2015).

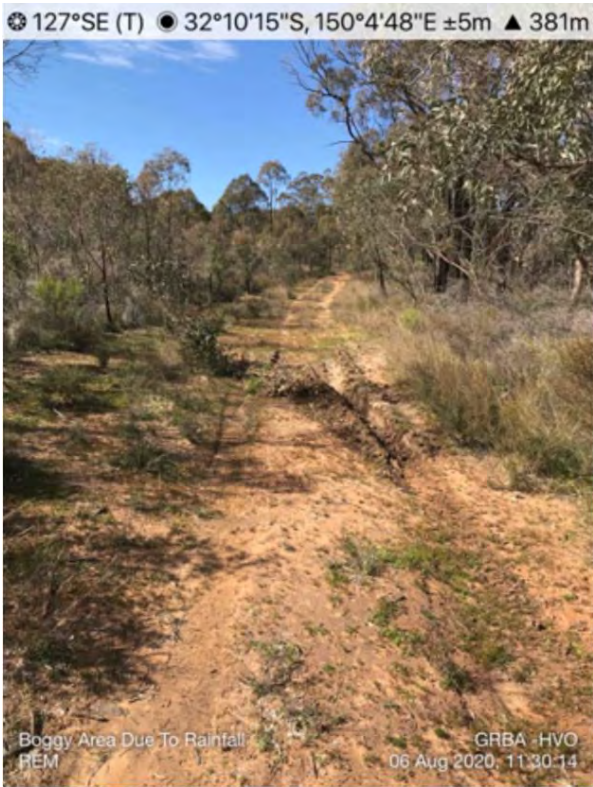
Figure 109 - Boggy area identified on a track within the HVO portion of the Goulburn River BA.

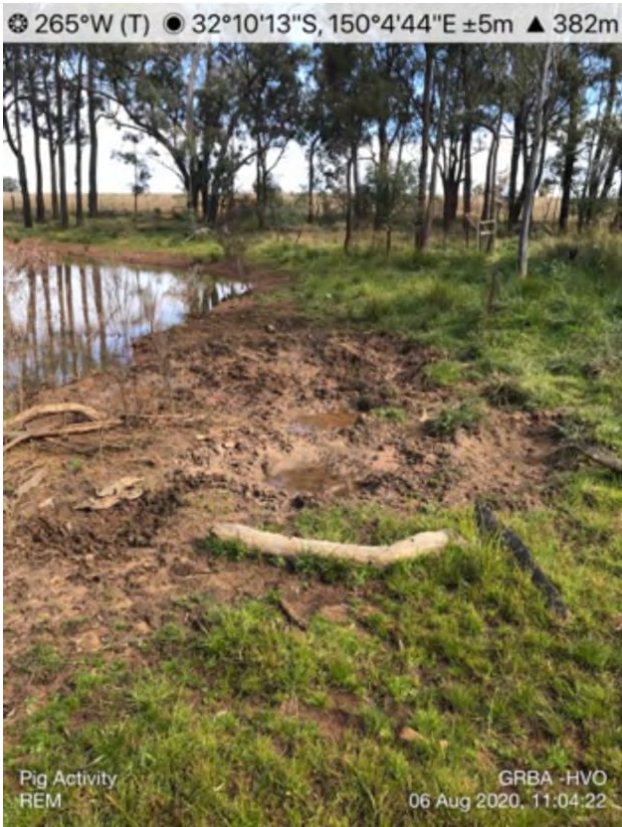
Pig activity was sighted throughout the offset, including wallows near the dam (**Figure 110**), mud rub marks on trees and recent tracks. As mentioned previously, pig management will continue in 2021 and target the locations where pig activity has been found to occur.

Figure 110 - Pig activity observed within the HVO portion of the Goulburn River BA.

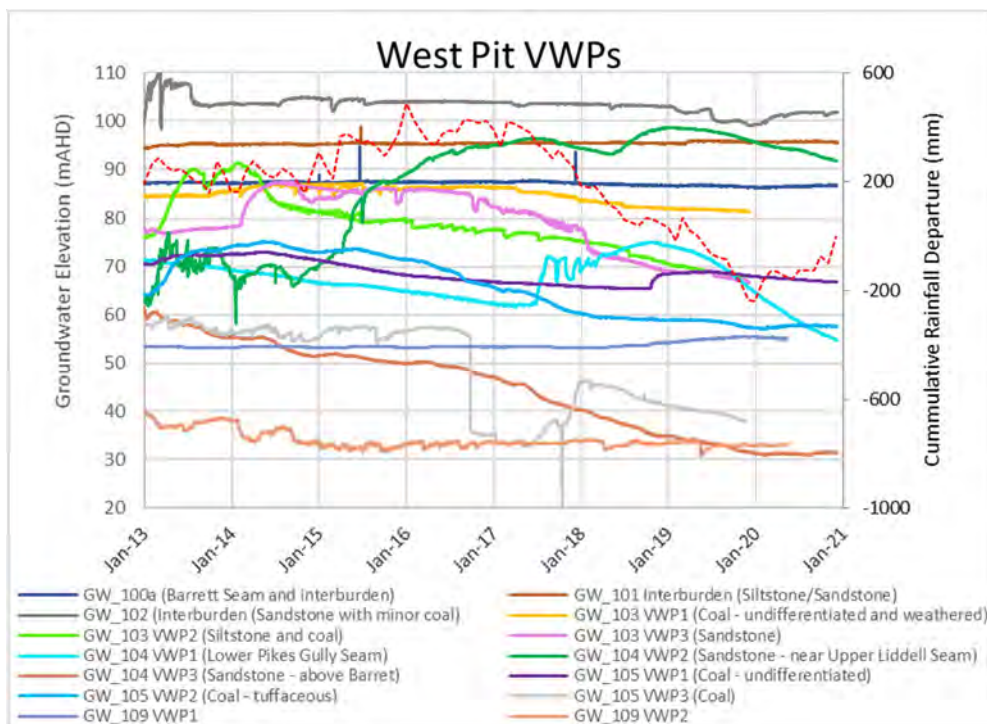
Figure 5-14 Hydrograph of Permian Coal Measures Bores – West Pit VWPs

VWP GW-103, VWP GW-104, VWP GW-105 and GW-110 are located south of West Pit. All VWP sensors in GW-103 appear to have failed on the 20<sup>th</sup> of January 2020. Groundwater levels at GW-104 VWP1 (Lower Pikes Gully Seam) and VWP2 (interburden material) continued to decline due to depressurisation from coal mining at West Pit, while groundwater levels at VWP3 (in sandstone above the Barrett Seam) were stable. Groundwater levels at GW-105 VWP1 and VWP2 were stable over 2020. GW-105 VWP3 appears to have failed on the 17<sup>th</sup> of February 2020. VWP GW-110 sensors were unstable and is being removed from the monitoring network.

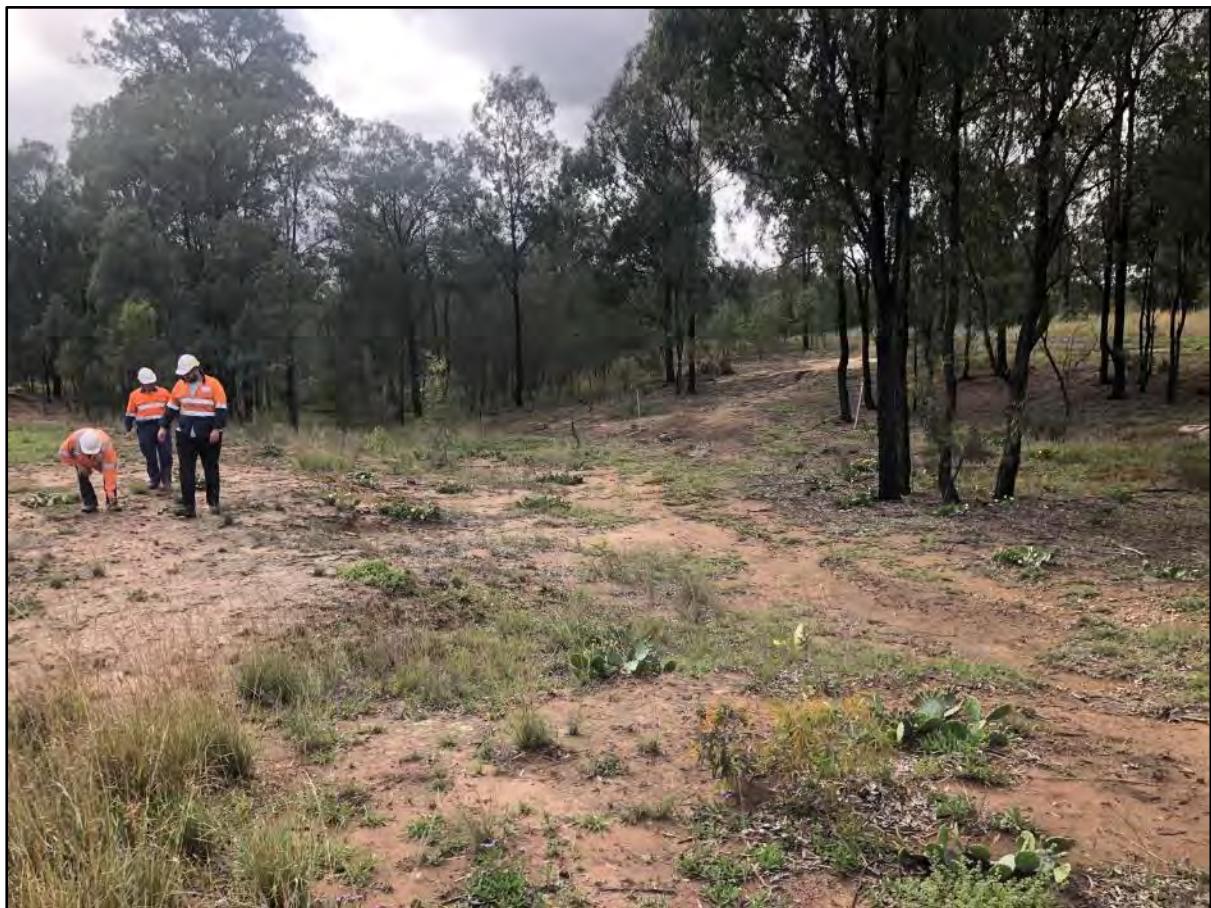
***Area where artefacts were noted on opposite side of creek to currently barricaded 'LID6' site.***

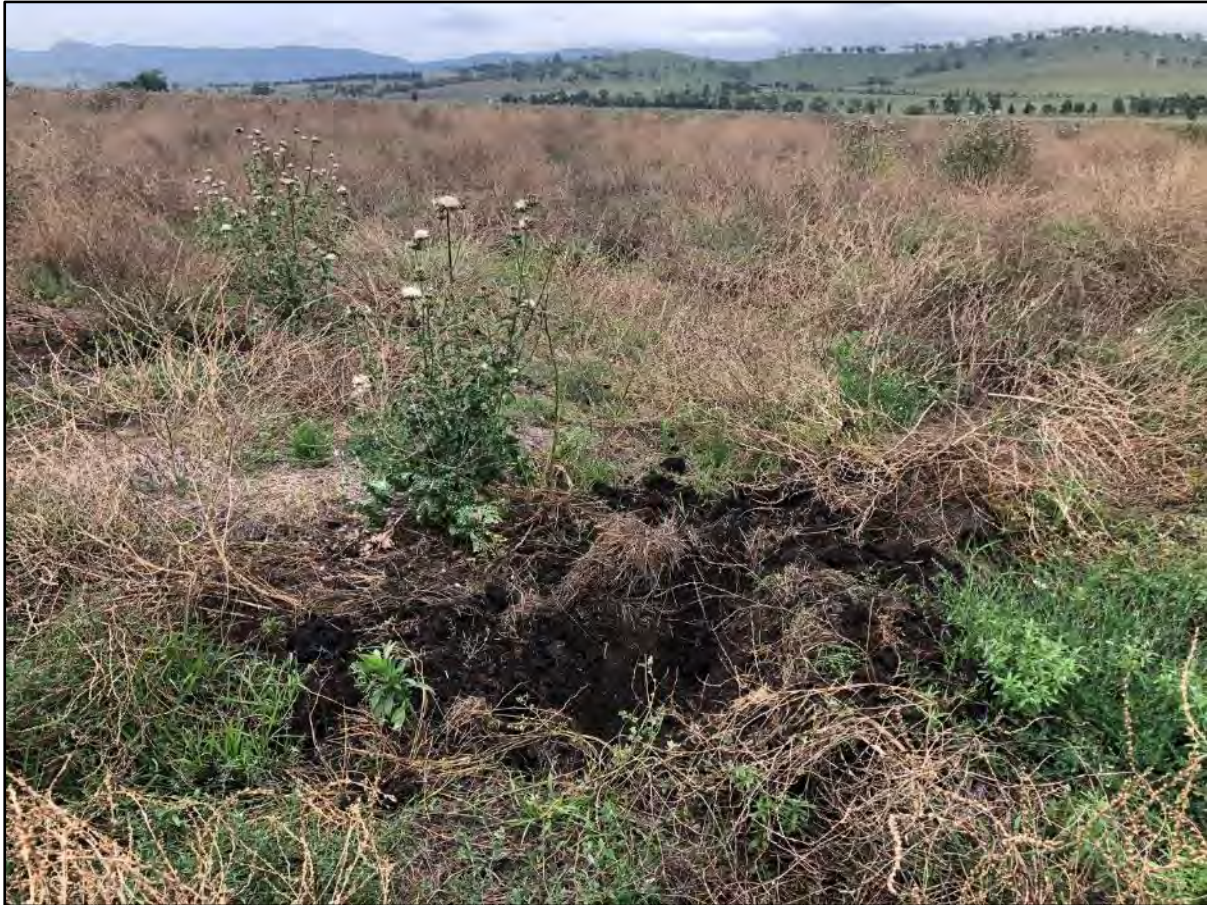
*Evidence of pig digging and weed growth within fenced area but outside of CM-CD1 disturbance exclusion buffer zone.*

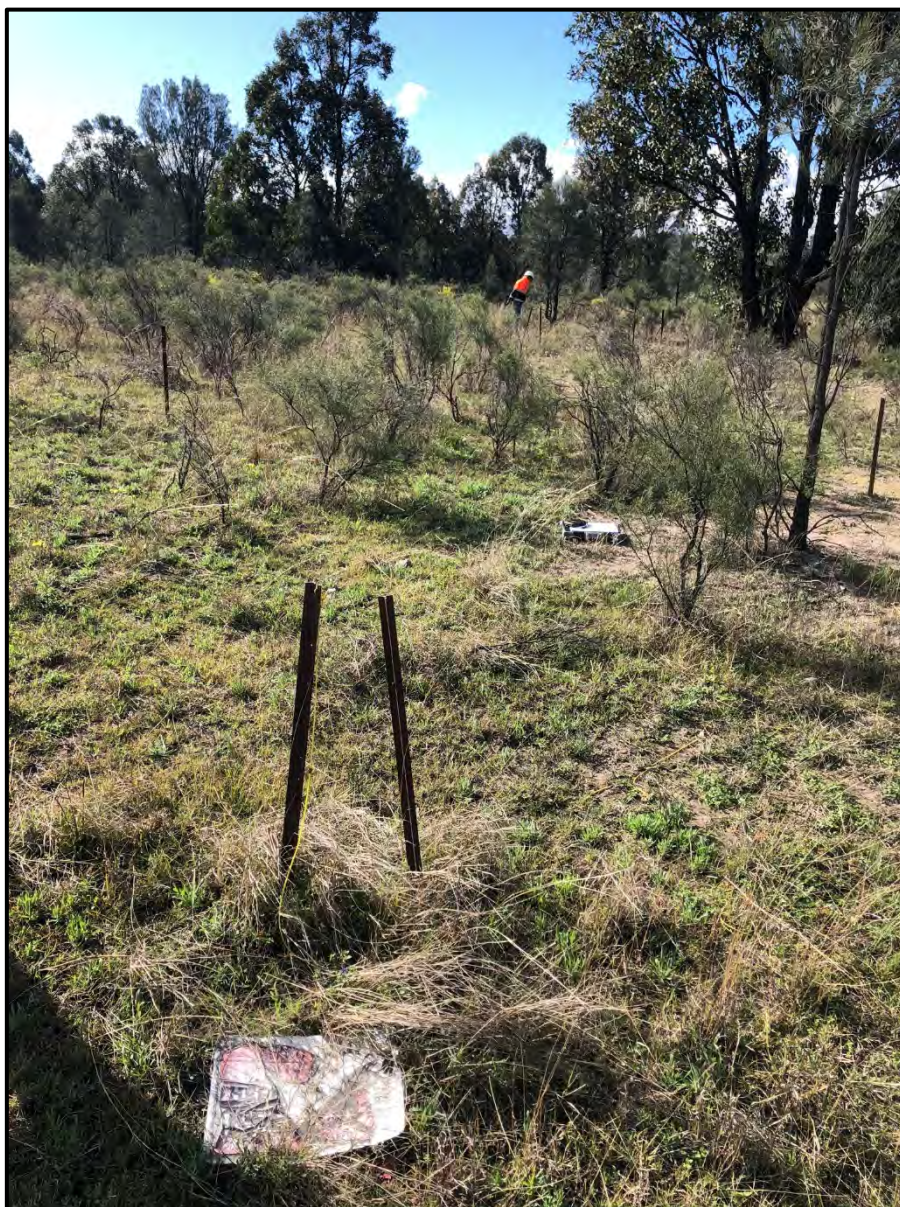
***An example of dilapidated barricading at ACH sites HVO-105 and 106***

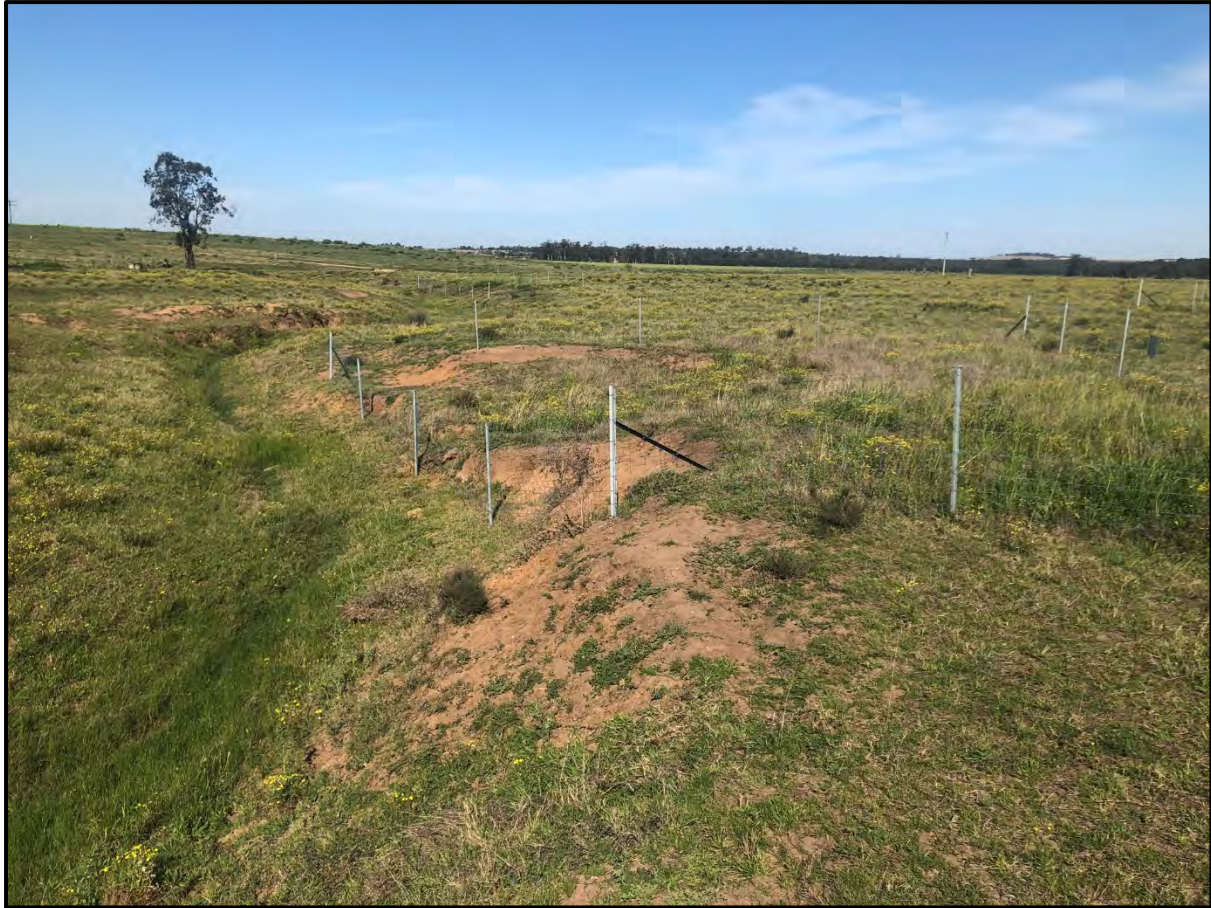
***Example of ACH site where sediment fencing would be useful to the preservation of the site***

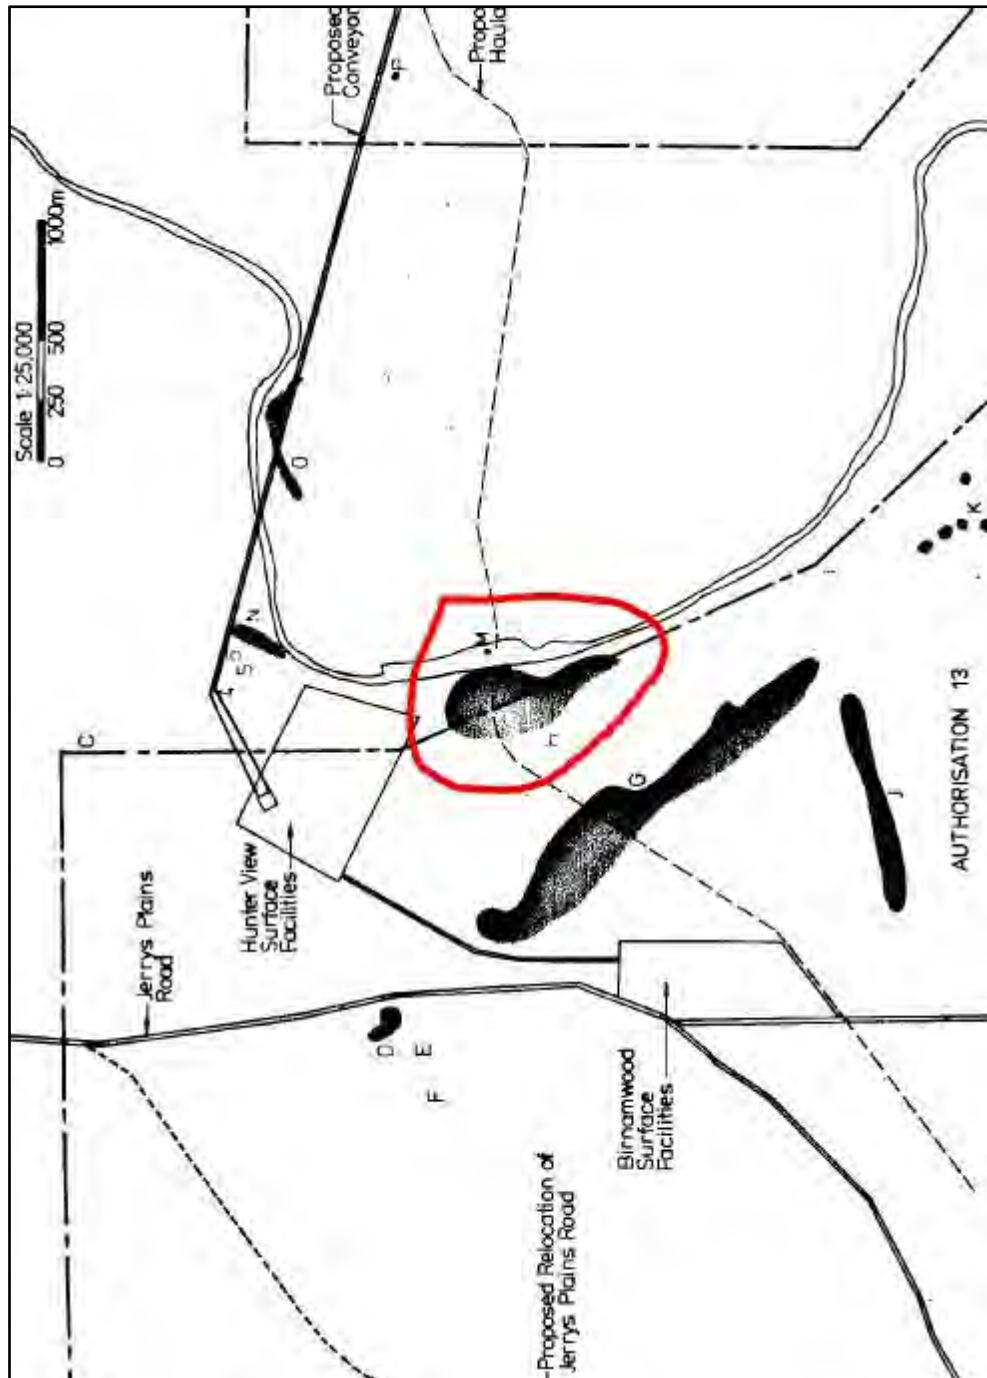
**Original 1981 archaeological survey map showing the location of ACH site 37-5-0047 "H" (circled in red) with the now current haul road (dashed line) intersecting it.**
