Hunter Valley Operations Aboriginal Heritage Management Plans October 2021 Compliance Audit Inspections

Report prepared for
Hunter Valley Operations

November 2021

ARROW
HERITAGE SOLUTIONS

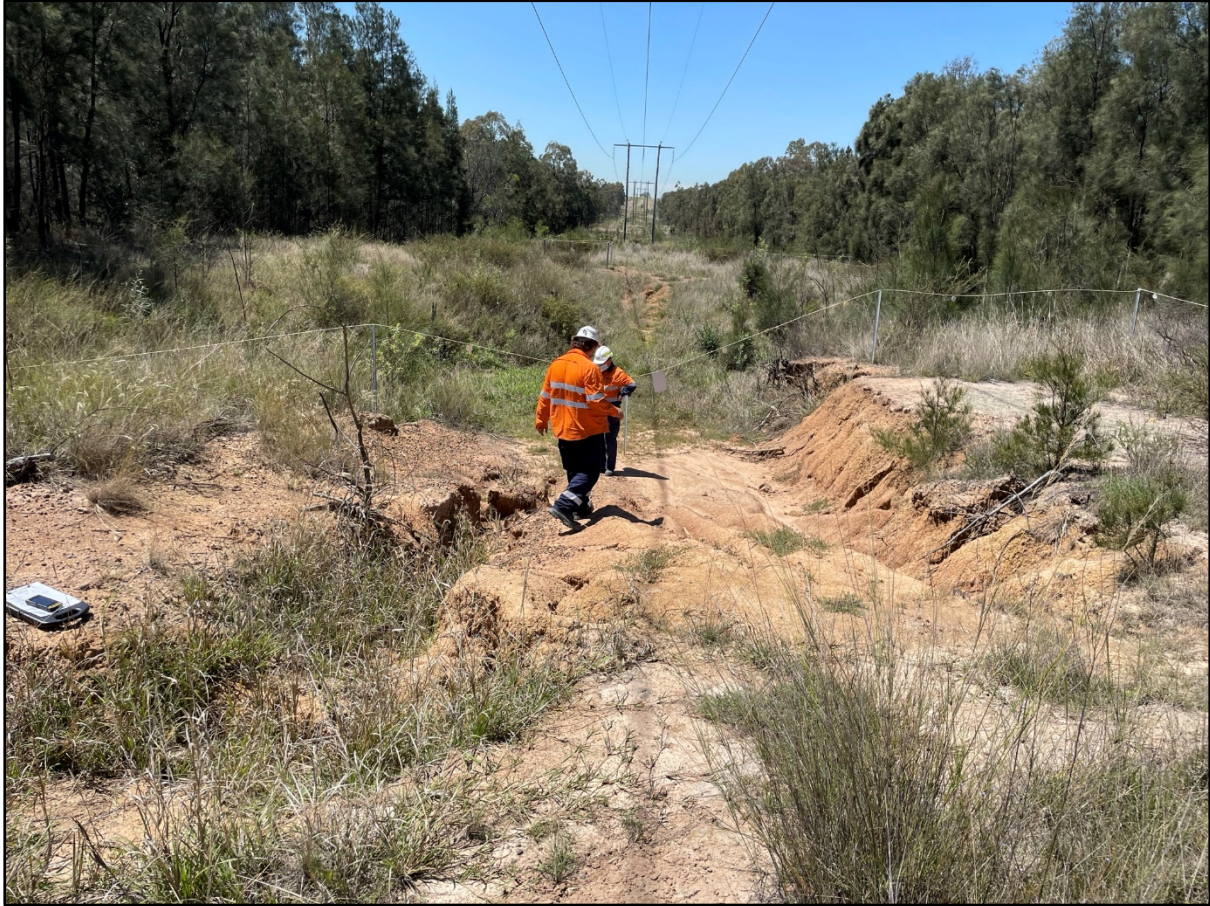
Both of these sites are located adjacent to an eroding gully. During the current inspection, it was noted that artefactual material was located within the erosion zone and in danger of being impacted. Although some previous erosion control measures had been implemented, these have not been entirely successful. It is recommended that structures incorporating coir sediment control logs be installed to help halt erosion and capture sediments prior to their removal by fluvial action.

Example of erosion at site 37-2-0806

3. **To prevent further damage from erosion, install control measures, such as coir logs, at sites 37-2-0806 & 37-2-0807.**
4. **Reassess site 37-6-0166 when vegetation levels are much lower to ascertain actual location of site & amend fencing accordingly.**

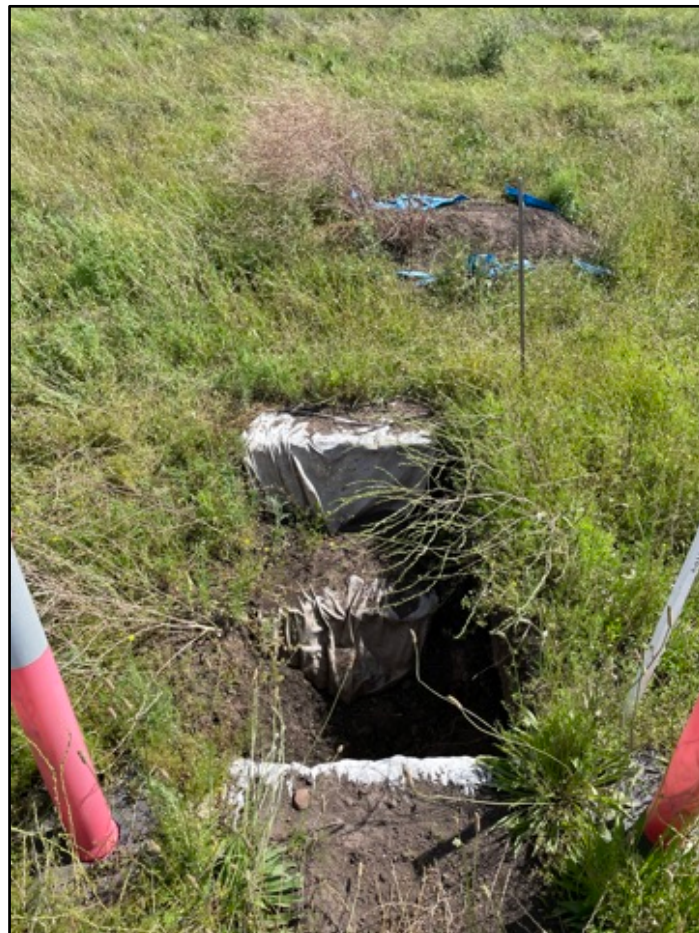
During the October 2021 inspection of CM-CD1 no unauthorised ground disturbance was noted within the disturbance exclusion buffer area (as depicted in Map 4 and the co-ordinates in Point 2 below). It should be noted, however, that the archaeological excavation pits that had been recently conducted as part of studies for the HVO North Continuation project remain open and should be filled in as soon as possible.

Open excavation pit within CM-CD1.

- **The open archaeological pits should be backfilled as soon as possible, ensuring geofabric is in place to delineate the extent of the excavated layers**

5. **Salvage sites 37-6-3316, 37-6-3317 & 37-6-3325 under the auspices of the HVO South AHMP.**
6. **The open archaeological pits located at CM-CD1 should be backfilled as soon as possible, ensuring geofabric is in place to delineate the extent of the excavated layers.**

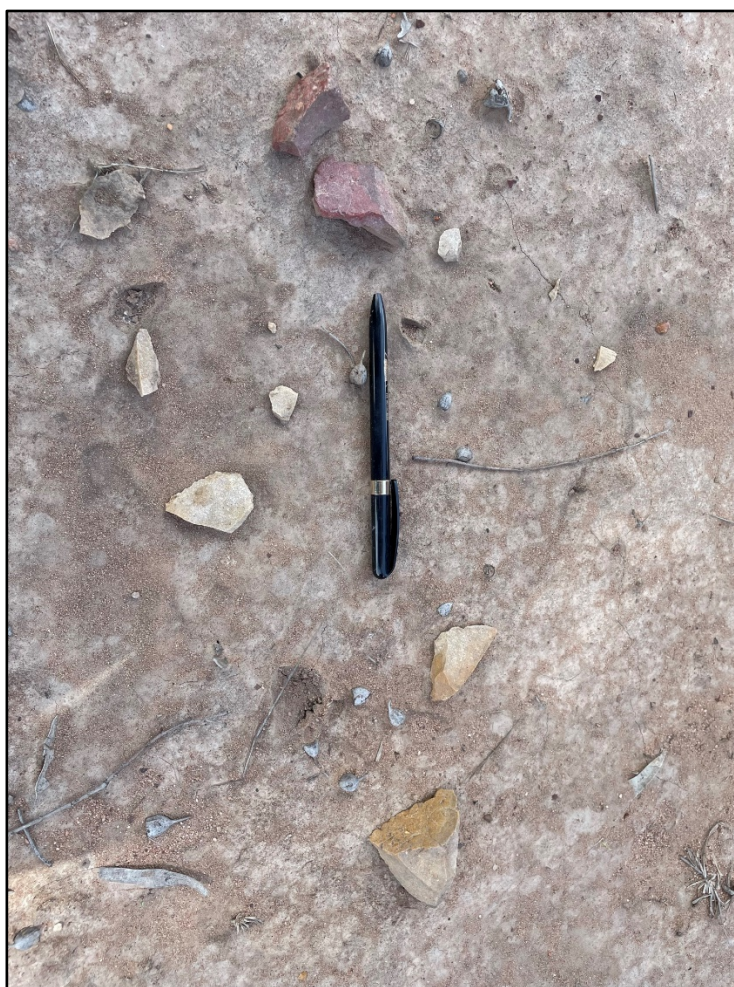
This site consists of c.10 flakes of silcrete located adjacent to an existing track under a tree. The site extends c.10x10m. Several artefact sites are located in the vicinity.

Examples of artefacts found at HVO-2140

9. The CM-CD1 area should continue to be targeted during HVO's vermin control program in order to reduce feral pig disturbance as much as possible.
10. Register the new ACH site HVO-2140 on the AHIMS database.

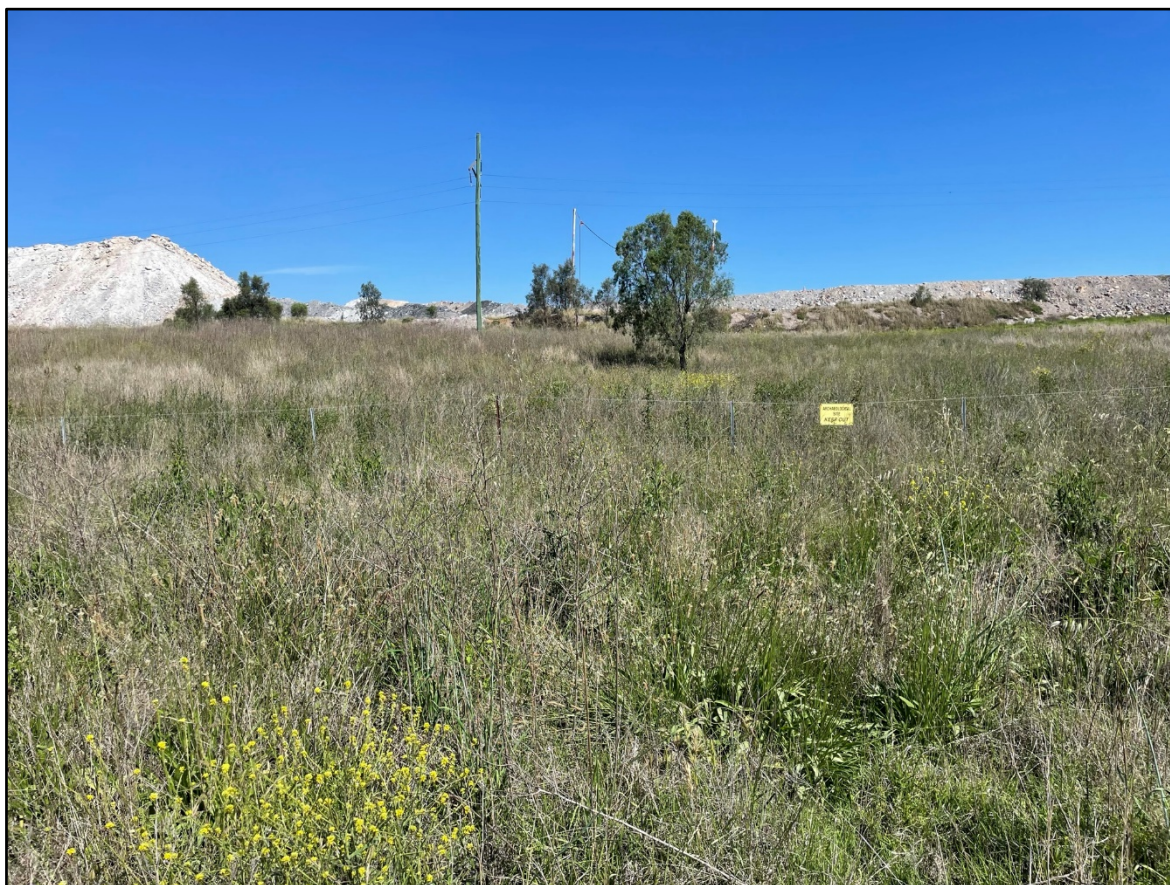
This site has been fenced but the area is currently infested by a thick covering of weeds and grasses. The site is an old recording and it is unclear whether the current fencing is arbitrary or accurately reflects the site's extent. It is recommended that the site is revisited with the report and site cards when vegetation levels are much lower so that better attempts can be made to relocate its contents.

View of vegetation cover across 37-6-0166
