# **PRELIMINARY PHASE 1 SITE INVESTIGATION**

140 Upper Orara Road  
Karangi NSW

31 January 2007

Stefan Everingham  
Environmental Engineer  
Coffs Infrastructure Alliance

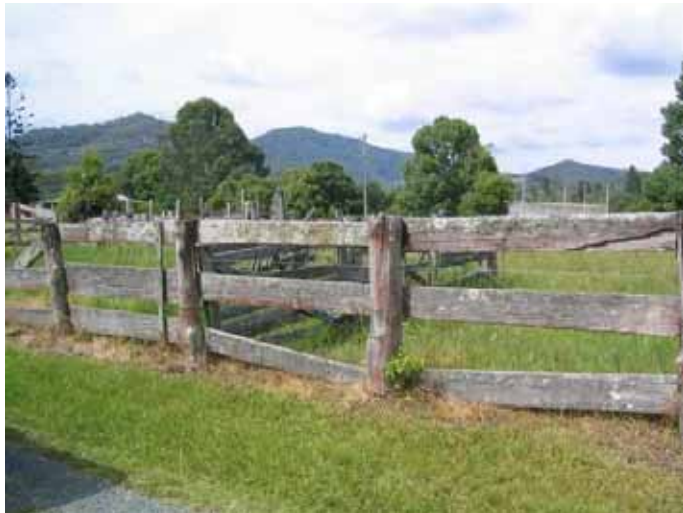
| Area | Comment |
|---|---|
| Stockyard | Consists of a system of old timber fences within the paddock at the southern section of the site fronting Upper Orara Road. |

**Photograph 1:** Cattle Stockyard – looking north east.

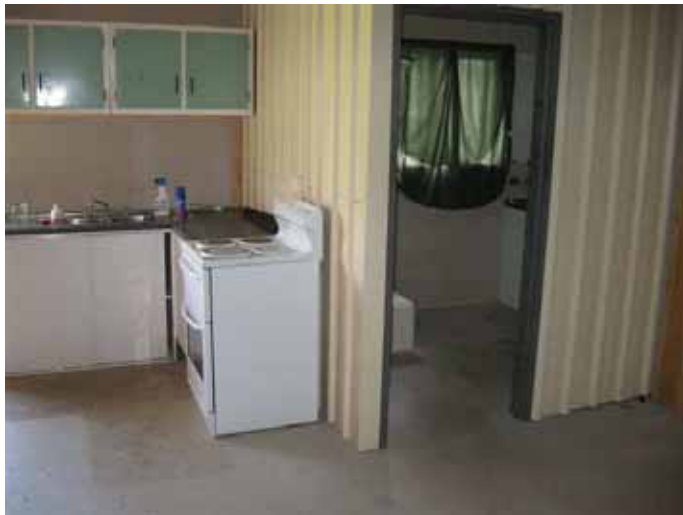
**Photograph 2:** Interior of large shed – looking north towards kitchen and bathroom.

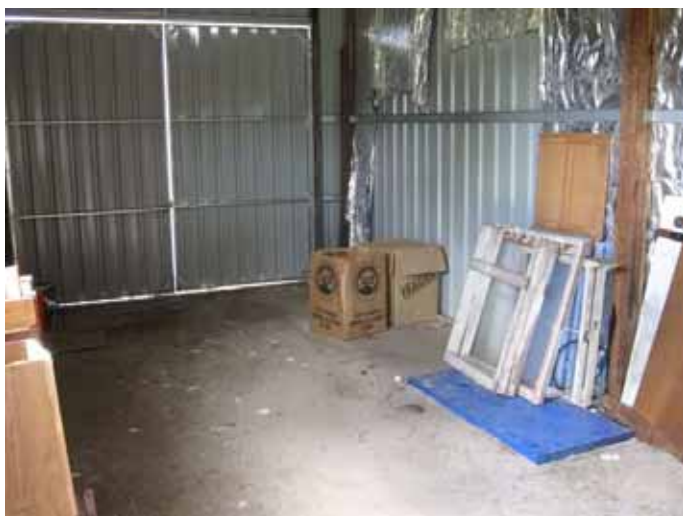
**Photograph 3:** Interior of garage / shed adjacent to large shed – looking south.

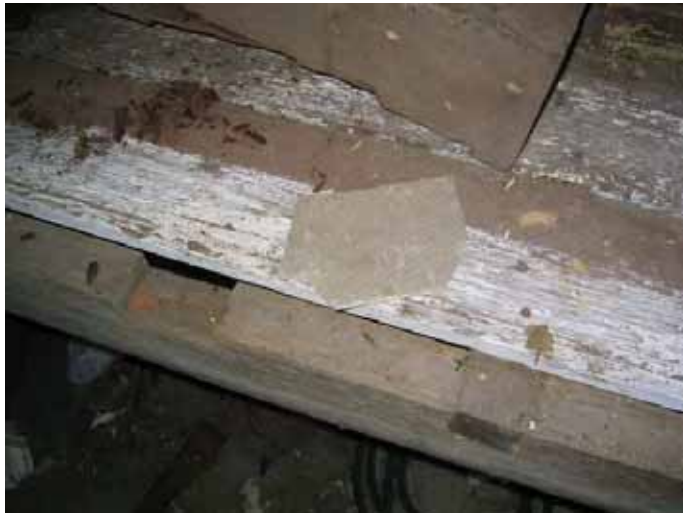
**Photograph 4:** Small piece of cement fibre sheeting potentially containing asbestos within garage / shed adjacent to large shed.

It is recommended that removal works involving material potentially containing asbestos be carried out in accordance with the Occupational Health and Safety Regulations (2001) and the Code of Practice for the Safe Removal of Asbestos (NOHSC, 2002(2005)). To validate the removal process, surface soil samples should be collected from around the locations of the former sheds and houses for asbestos analysis and additionally hydrocarbon analysis (where appropriate).

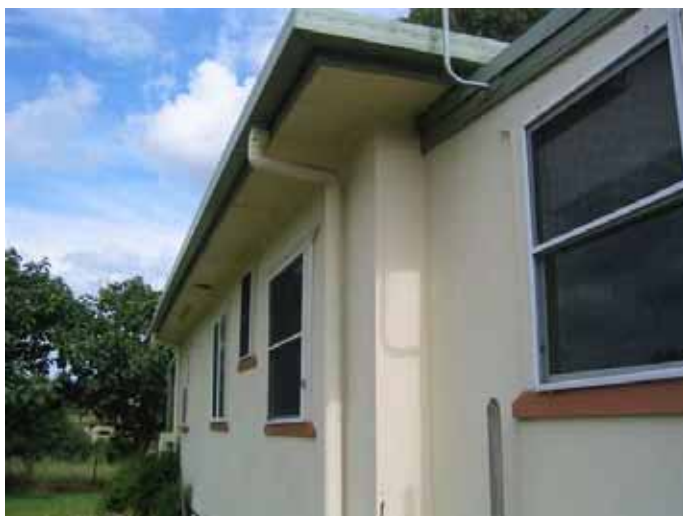
| Area | Comment |
|---|---|
| Main residence | <p>The main residence is clad in cement fibre material (potentially containing asbestos) with a colourbond / corrugated iron roof. The residence contained two bedrooms, bathroom, laundry, kitchen and living areas. The wet areas (kitchen, bathroom and laundry) appeared to have contained cement fibre walls with the remainder of the residence appearing to have a masonite type wall.</p> <p>There are three small sheds to the rear of the main house, with the two smaller sheds previously being used to house chickens and store wood. The larger shed was used to store garden equipment and chemicals (5L oil, 20 L roundup, 25 L floor cleaner and paint visible during the inspection) and potentially vehicle storage and maintenance (an old motor bike being present and some oil staining being visible during the inspection).</p> |

**Photograph 6:** Northern exterior of house with cement fibre cladding on exterior walls and eaves.

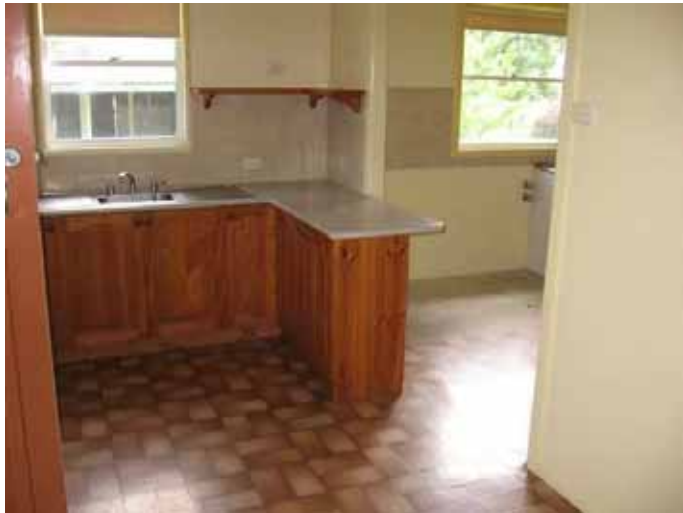
**Photograph 7:** Interior of house, 'wet area' walls consisting of cement fibre sheeting.

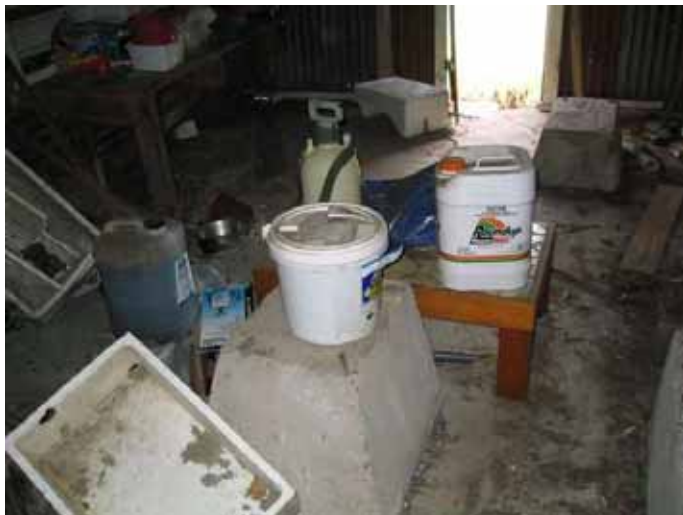
**Photograph 8:** Interior shed at the rear (north) of the house. Note presence of household type and quantity chemicals.

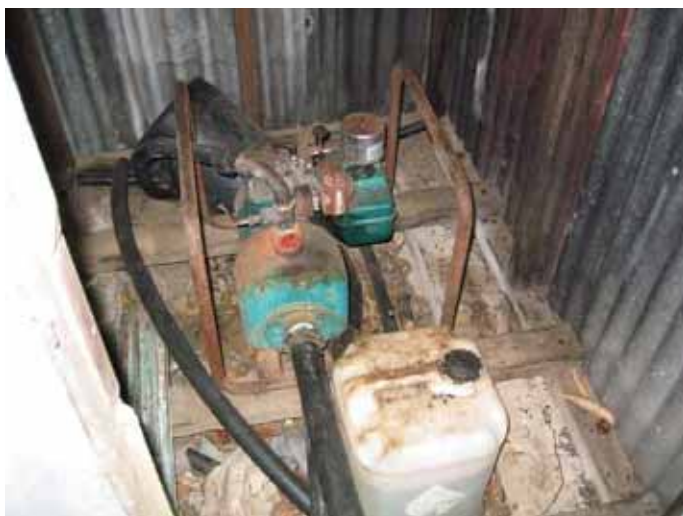
| Area | Comment |
|---|---|
| Pump station | A small pump station containing a small petrol powered pump was located at the northern edge of the site adjacent to the Orara River. The pump inlet was positioned in the river with the outlet directed via buried pipes to the south (in the general direction of the house) |

**Photograph 9:** Interior of small pump station adjacent to Orara River.

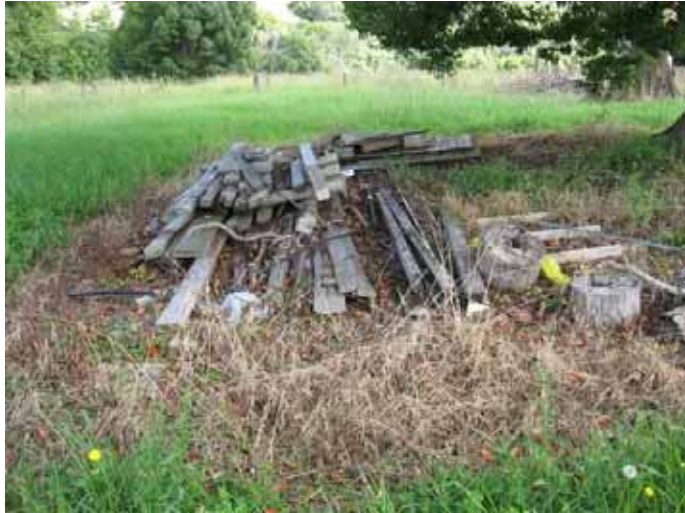
**Photograph 10:** Pile of scrap wood to the north of the large shed.

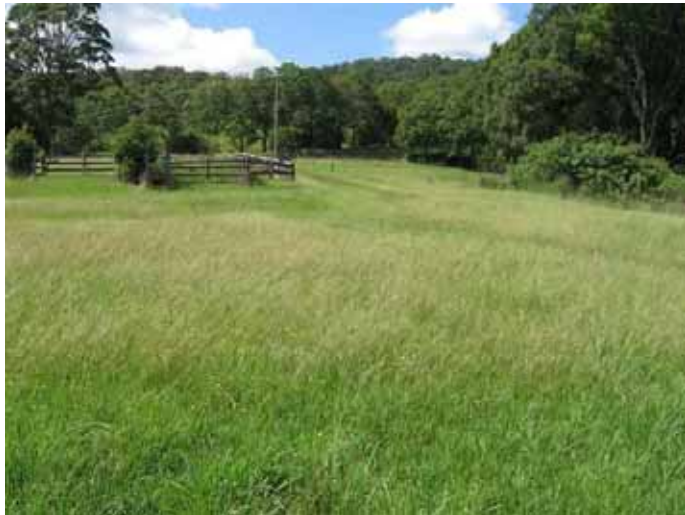
**Photograph 11:** Site looking south from large shed with cattle stockyard in background.

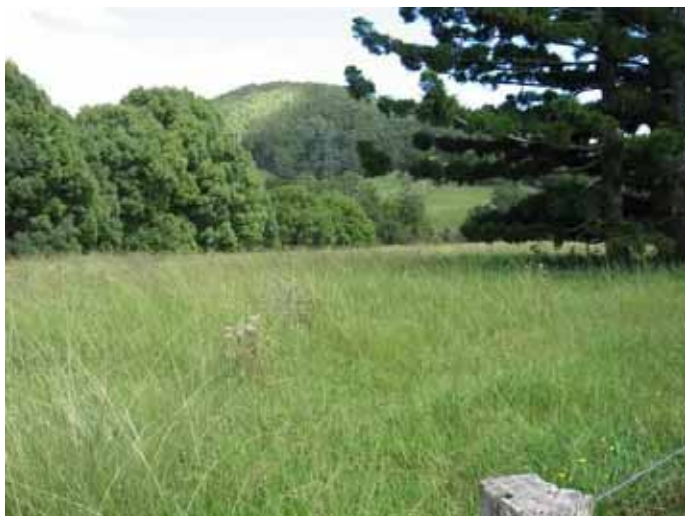
**Photograph 12:** Site paddock looking north from the large shed.
