# **Newcrest Mining Limited**

## **CVO AEMR - Surface and Groundwater Assessment Report**

September 2020

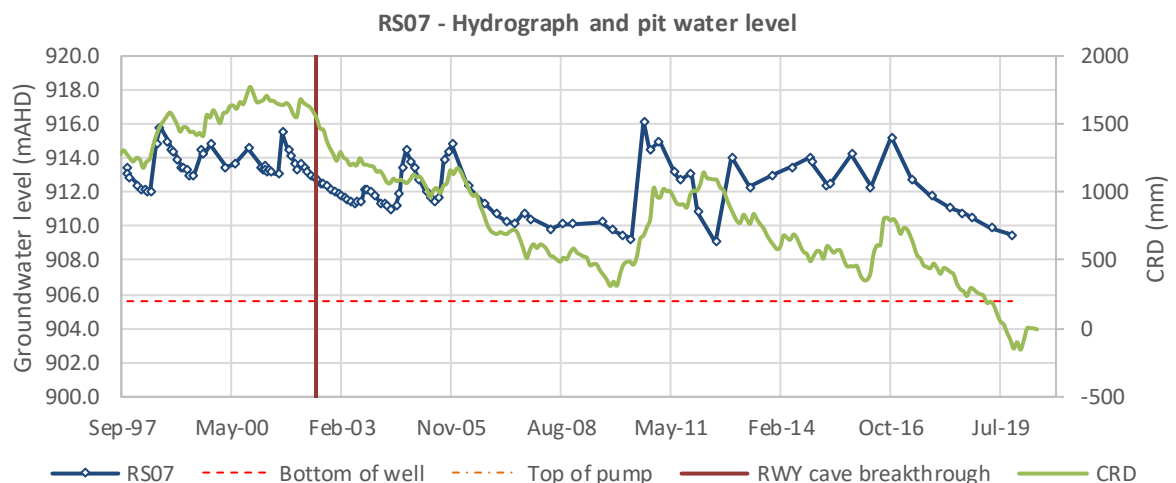
**Figure 3-4 RS07 groundwater level hydrograph**

Historically there are large variations in the groundwater levels in shallow bores RS07 and RS08. The groundwater levels at RS07 and RS08 showed declining trends during the previous reporting period which was consistent with the CRD. This decreasing trend continued for the portion of the reporting period up to November 2019 where groundwater levels at RS07 and RS08 decreased by 0.43 m and 0.33 m respectively, which is consistent with CRD. For the remainder of the reporting period groundwater levels at RS07 and RS08 increased slightly by 0.04 m and 0.12 m respectively, which is consistent with CRD. Groundwater levels at RS07 are shown in Figure 3-4.

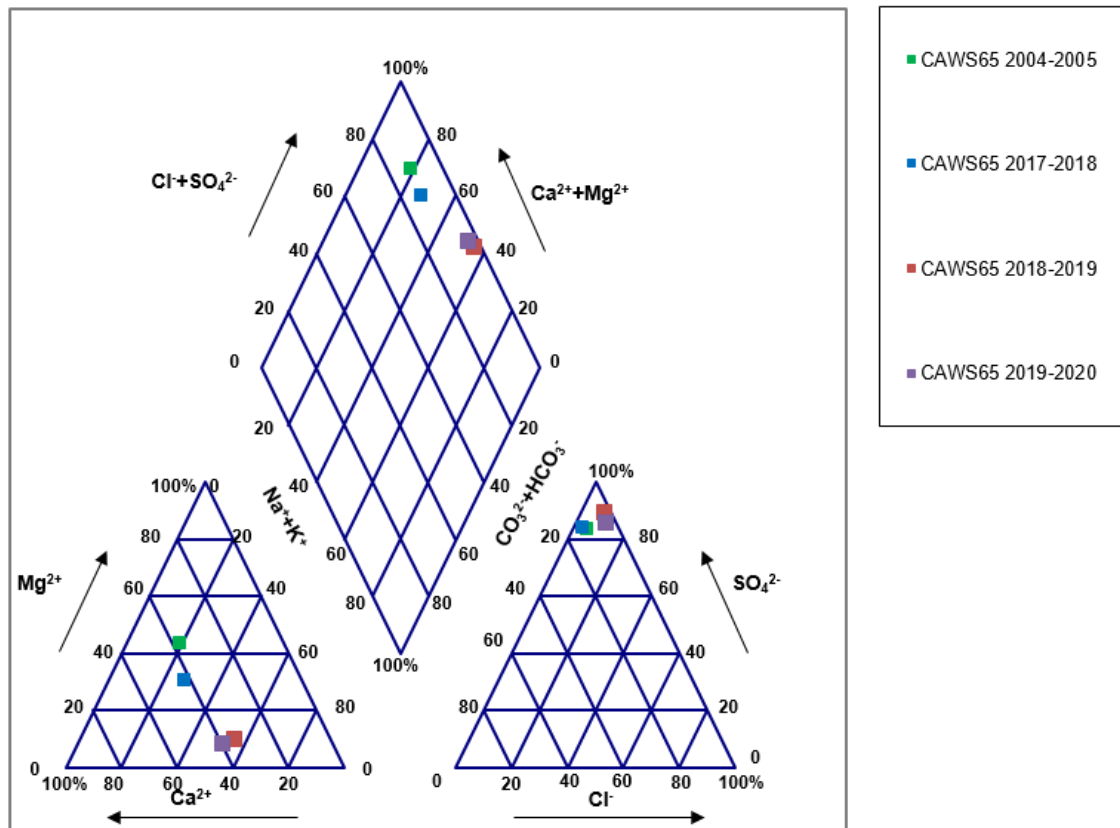
**Figure 3-6 Piper chart showing differences in major ion compositions following tailings deposition**

Based on major ion concentrations, the water in the pit was calcium sulfate dominant prior to the deposition of tailings and this has changed to sodium sulfate dominant since deposition commenced, refer to Figure 3-6. Sulfate concentrations have historically shown an increasing trend, but shows a decreasing trend in 2020 results.

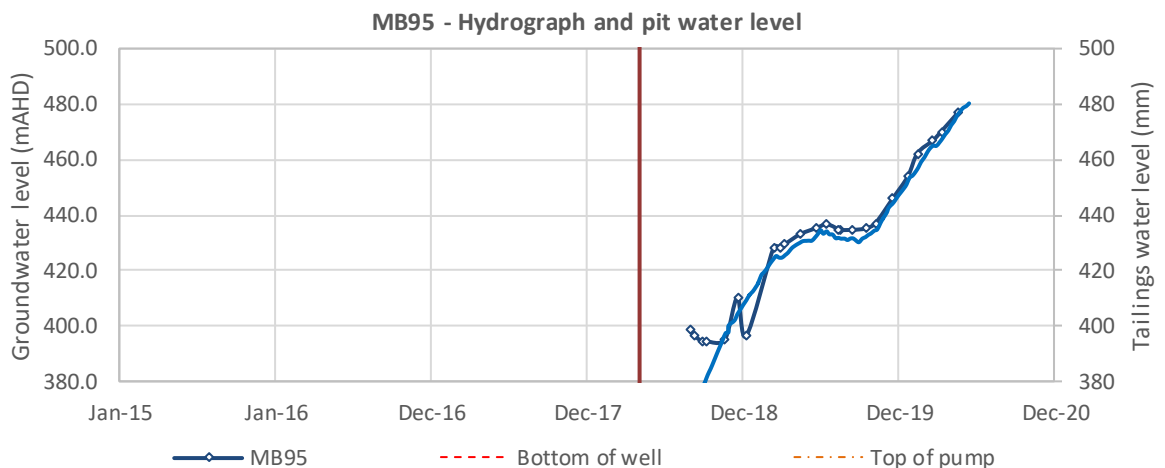
**Figure 3-10 MB95 groundwater level hydrograph**

MB95 is the only bore with groundwater levels at a similar elevation to the decant pond level. The increasing trend observed at MB95 is similar to the increasing trend in the decant pond water level, refer Figure 3-10. MB95 and the pit decant appear to be hydraulically connected. During the monitoring period the groundwater level at MB95 has generally remained two to three metres higher than the decant pond level which suggests groundwater flow towards the pit rather than seepage from the pit. The January 2019 groundwater level measurement at MB95 was considered erroneous.

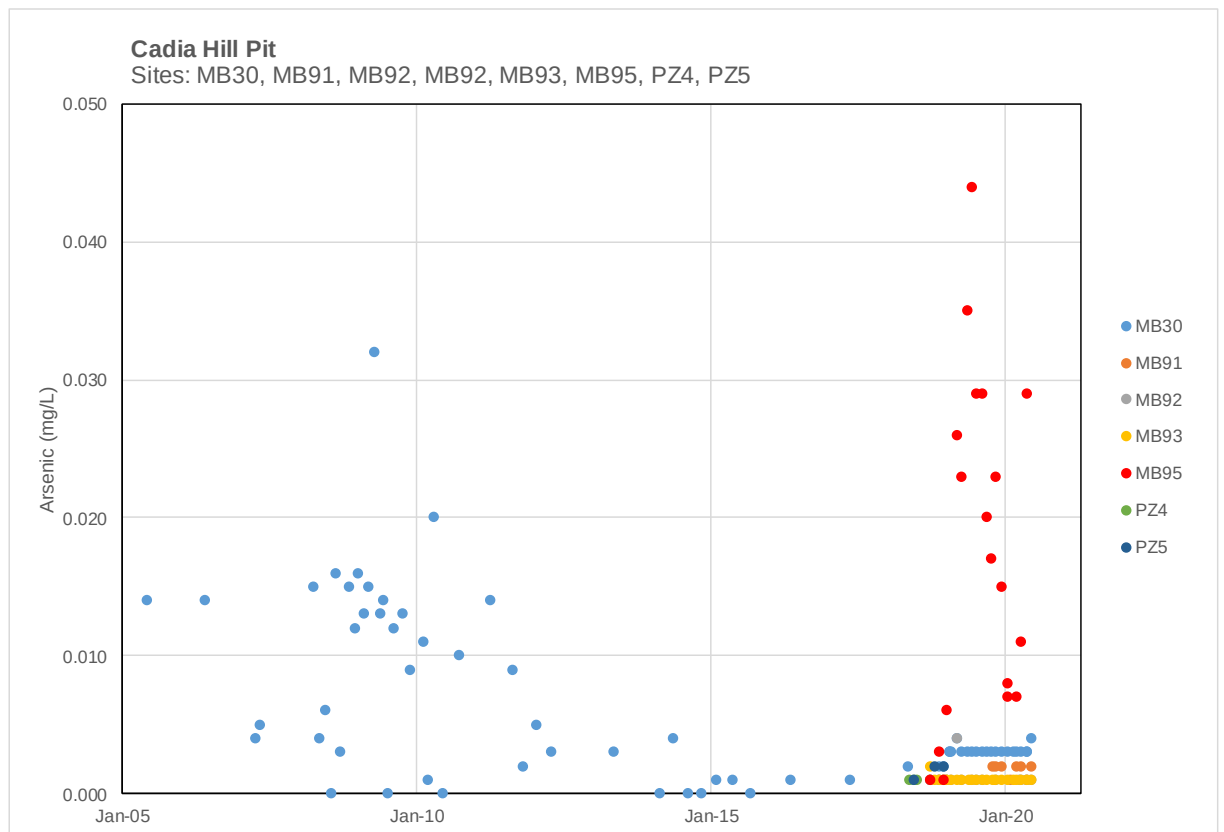
**Figure 3-11 Arsenic concentrations in the Cadia Hill Pit area**

The trigger value for arsenic was exceeded at MB95 during the current reporting period. An increasing trend in arsenic concentrations was observed during the previous reporting period, refer Figure 3-11. During the current reporting period, arsenic concentrations at MB95 were generally lower, varying between 0.029 mg/L and 0.007 mg/L. There was an increasing trend in manganese at MB95 during the reporting period. There were minor detections of molybdenum (>0.009 mg/L) in May and June 2020. During the previous reporting period there were increasing concentrations of chromium and nickel observed, however during the current reporting period concentrations were lower. During the current monitoring period there was a declining trend in magnesium.

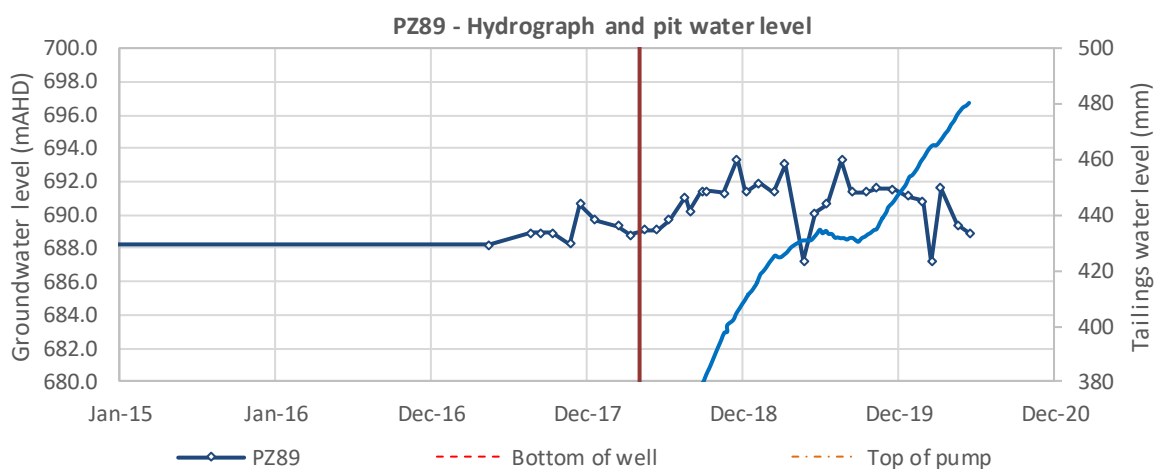
**Figure 3-12 PZ89 groundwater level hydrograph**

Groundwater levels at PZ90 were relatively stable throughout the monitoring period, with levels varying by only about 1 m. Groundwater levels at PZ89A have been stable since monitoring commenced. A large drop in groundwater level was observed at PZ89A between October 2019 and February 2020, however subsequent monitoring indicates this was a measurement error with groundwater levels returning to historical levels.

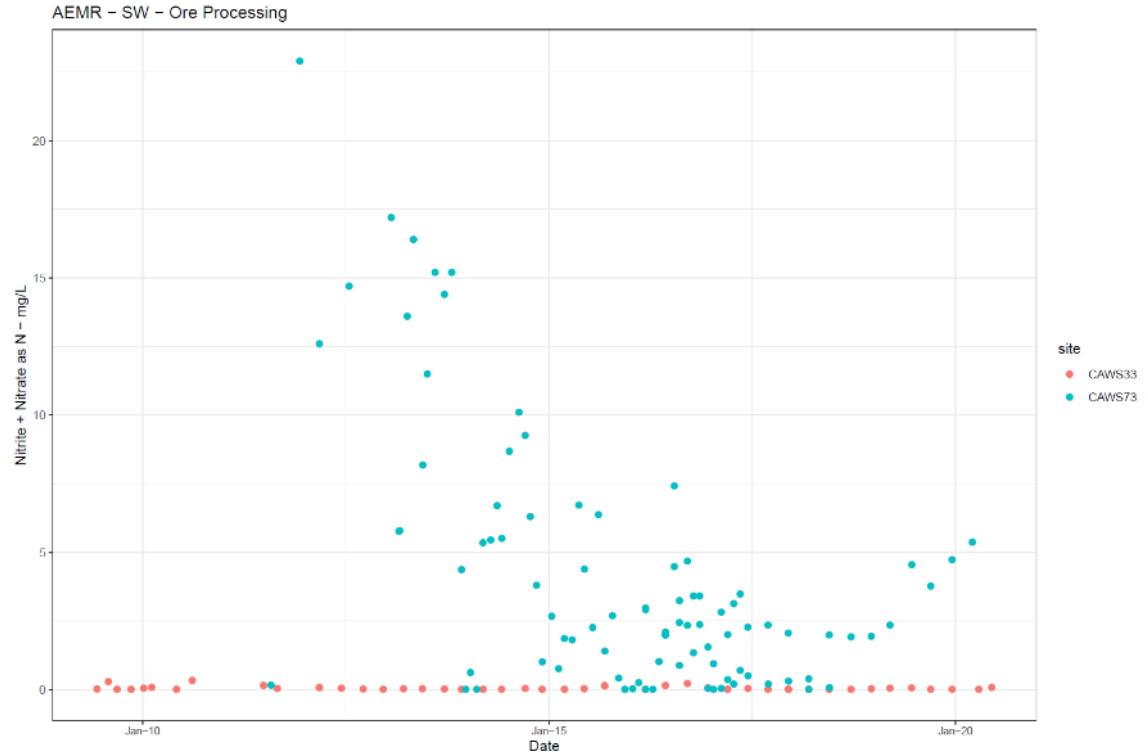
**Figure 3-16 Nitrogen oxides concentrations in the Ore Processing Area**

No similar trend was observed in total phosphorous concentrations at CAWS73. No trend in nutrient concentrations at CAWS33 has been observed across the period of monitoring.

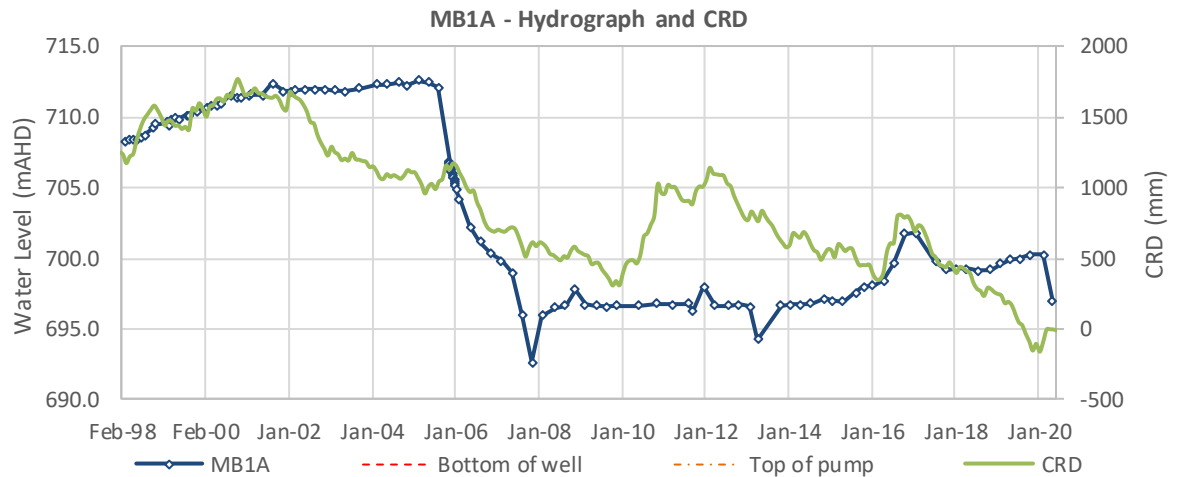
**Figure 3-18 MB1A groundwater level hydrograph**

The groundwater level at MB1A has historically not shown any relationship with CRD. This trend at MB1A has continued during the monitoring period, with groundwater levels at MB1A increasing over the monitoring period up to March 2020 despite generally decreasing CRD. Groundwater levels at MB1A were 3.3 m lower in June 2020. Additional monitoring conducted in August 2020 indicated this groundwater level observed at MB1A from June 2020 is an anomaly.

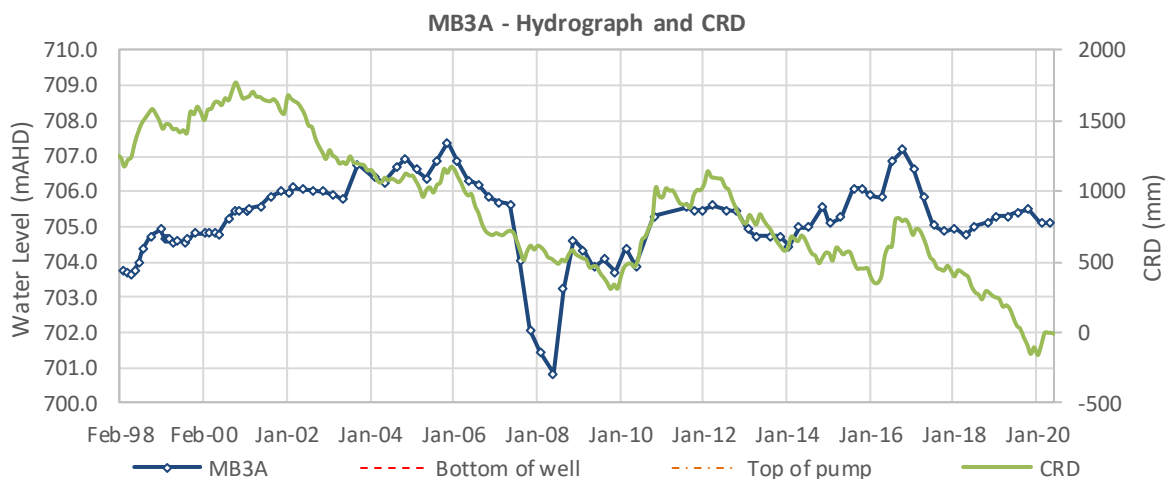
**Figure 3-20 MB3A groundwater level hydrograph**

The groundwater levels at MB3A and MB3B generally reflect the trends in the CRD for the majority of the monitoring period. For the previous reporting period the groundwater level increased at MB3A and remained stable at MB3B despite decreasing CRD. During the current reporting period groundwater levels at MB3A and MB3B were gradually increasing up to November 2019 despite decreasing CRD over this period. Groundwater levels at MB3A and MB3B fell slightly (by approximately 0.4 m) in March 2020 despite relatively steady CRD. Groundwater levels at MB3A are shown in Figure 3-20.

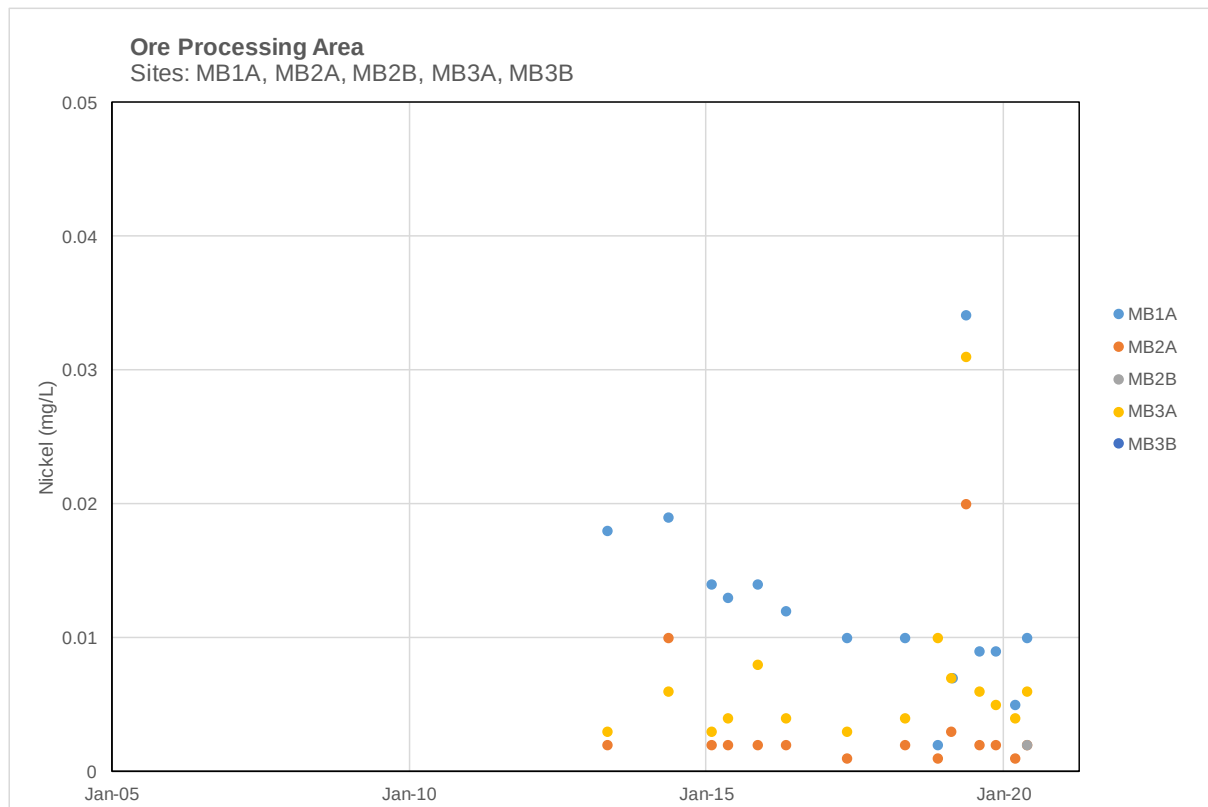
**Figure 3-21 Nickel concentrations in the ore processing area**

During the previous reporting period, concentrations of TDS, nickel, calcium and sulfate were observed to be increasing at MB3A. During the current reporting period, concentrations of these parameters were stable or decreasing.

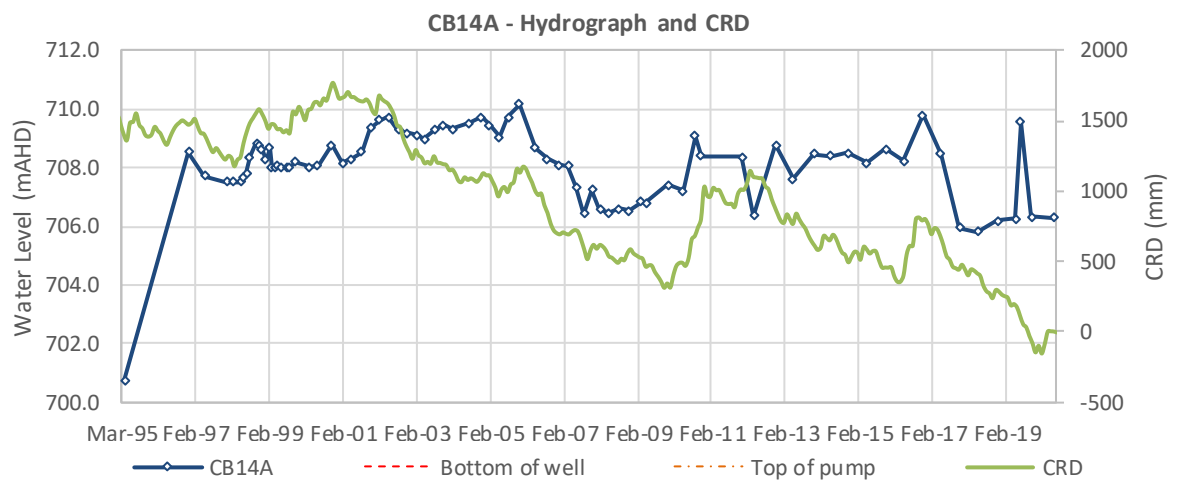
**Figure 3-22 CB14A groundwater level hydrograph**

During the previous reporting period groundwater levels increased by 0.5 m at CB14A and were steady at CB14B despite decreasing CRD. During the current monitoring period, groundwater levels at CB14A and CB14B were steady despite decreasing and increasing trends in the CRD. Groundwater levels at CB14A are shown in Figure 3-22. The observed groundwater level in July 2019 is considered to be an error.

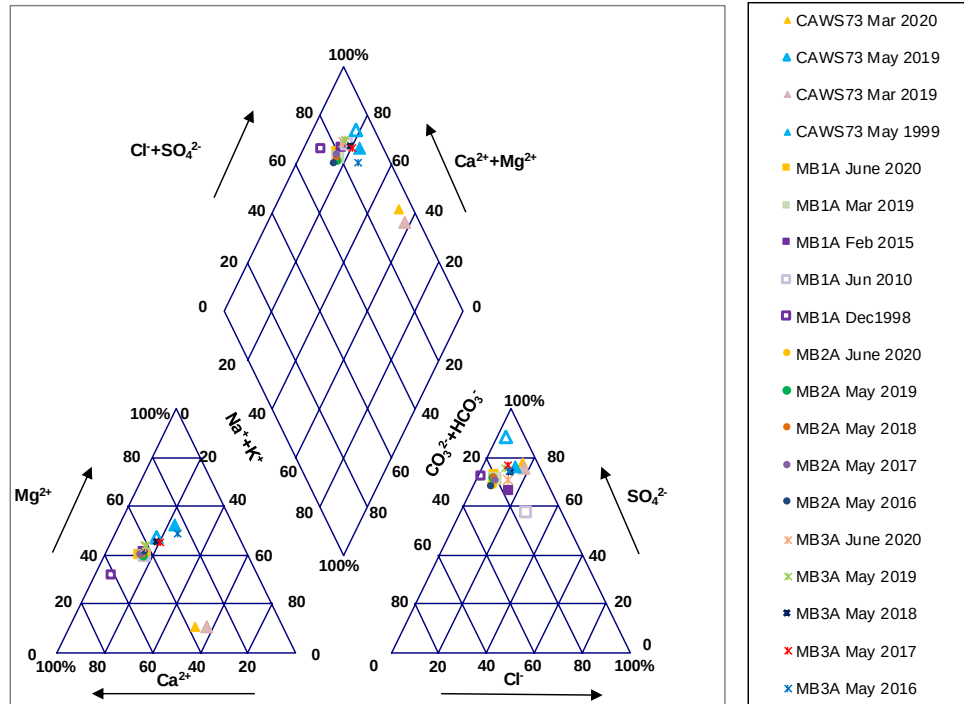
**Figure 3-23 Piper diagram for MB1A, MB2A, MB3A and CAWS73**

The piper diagram in Figure 3-23 compares the major ion chemistry for CAWS73 and bores MB1A, MB2A and MB3A. The stormwater in the SROP and shallow groundwater are similar water types and have generally not changed over time so it is not possible to determine whether there is an increasing influence of pond water on groundwater. It is noted that the major ion concentrations are generally higher in groundwater.

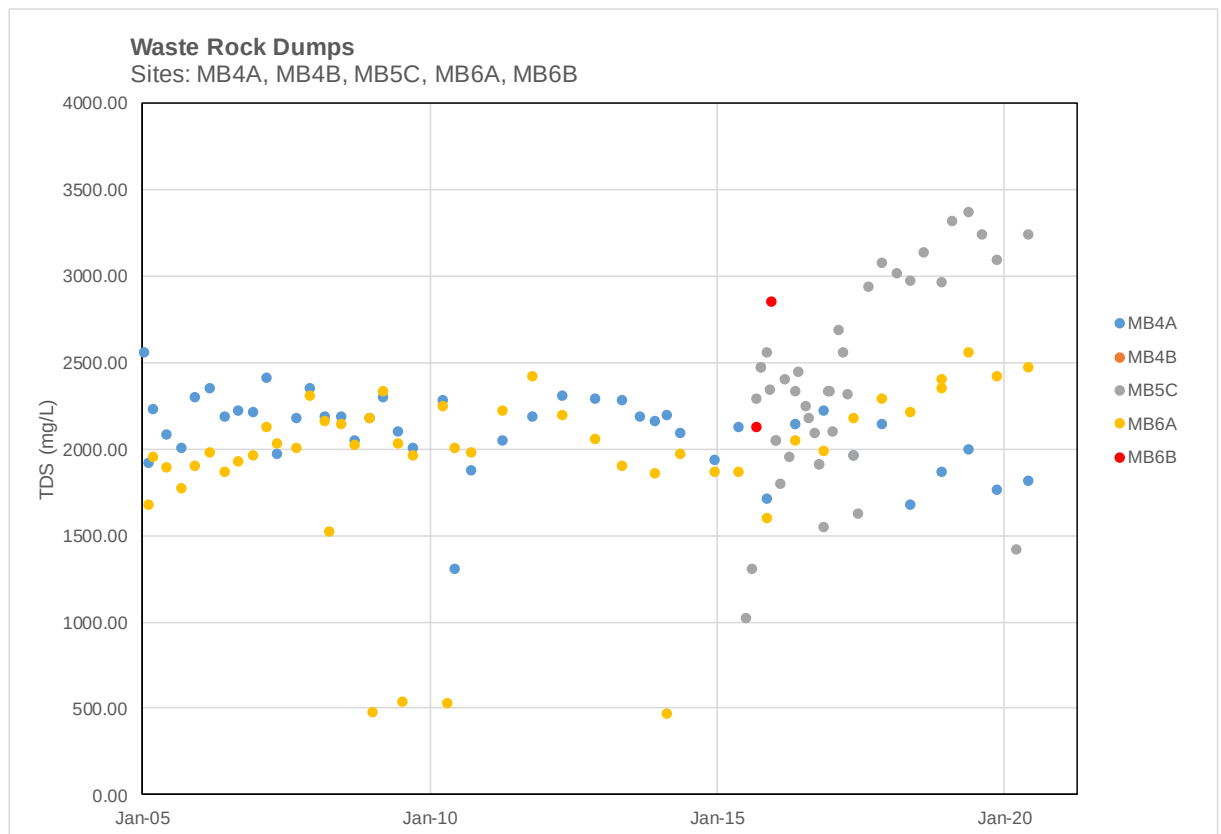
**Figure 3-32 TDS concentrations for monitoring bores within the waste rock dump area (northern bores)**

At the northern bores (MB4A, MB5C and MB6A), during the reporting period TDS and EC was generally constant or slightly decreasing. TDS concentrations at northern bores are plotted in Figure 3-32. Concentrations of calcium, magnesium, sodium and sulfate at these bores were generally constant during the monitoring period. At MB5C, which is monitored quarterly, variability in EC, TDS and major cations and anions due to rainfall was evident. At MB5C, concentrations of these parameters were lower in March 2020 following a period of above average rainfall.

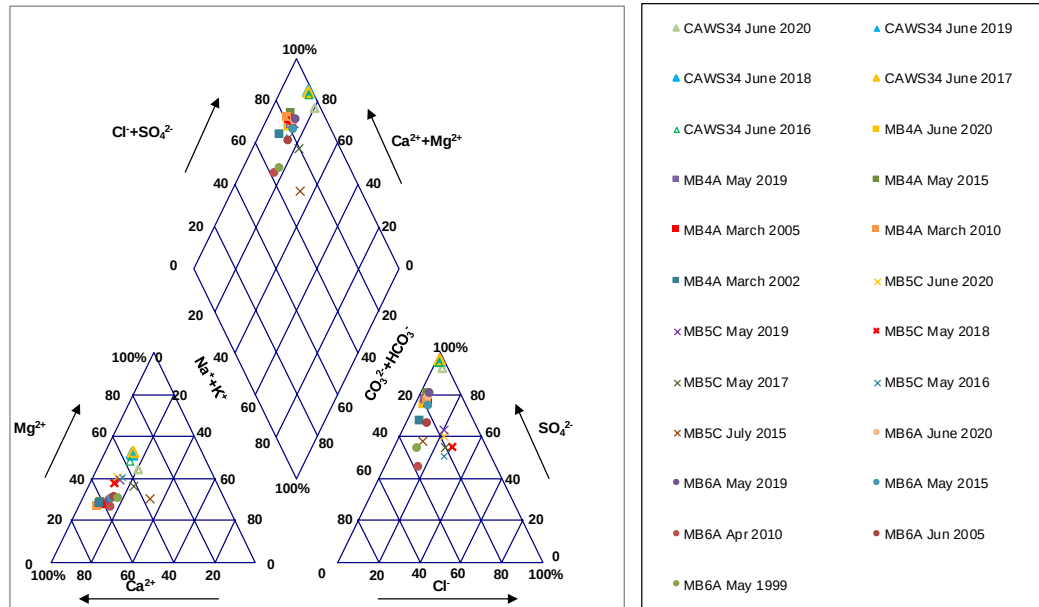
**Figure 3-33 Piper diagram for MB6A, MB4A, MB5C and CAWS34**

The Piper diagrams in Figure 3-33 and Figure 3-34 compare major ion chemistry of local groundwater to that of the northern leachate pond and southern leachate pond respectively. Waste rock dump leachate is calcium/magnesium sulfate dominant. Groundwater is generally calcium sulfate dominant. Prior to the current monitoring period, there appears to be some increase in sulfate dominance over time at MB5C, MB6A, MB8A and MB10A which indicates there may be some localised influence of SWRD leachate on groundwater. However, with the exception of manganese at MB6A, there are no trends in metals or nitrate that indicates influence of SWRD leachate at these bores.

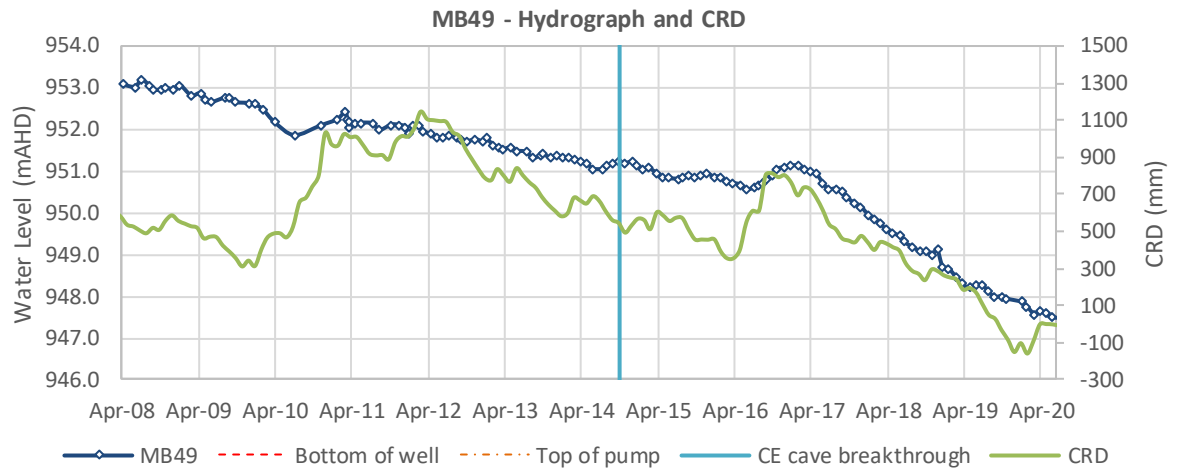
**Figure 3-37 MB49 groundwater level hydrograph**

The groundwater level at MB49 has displayed a historical decreasing trend, generally attributable to the overall declining CRD. During the reporting period this decreasing trend generally continued. Groundwater levels at MB49 were relatively stable between March 2020 and June 2020, likely due to a period of increasing CRD (refer Figure 3-37). pH below the guideline value was observed at MB49 which could be attributable to the ongoing drawdown in groundwater level.

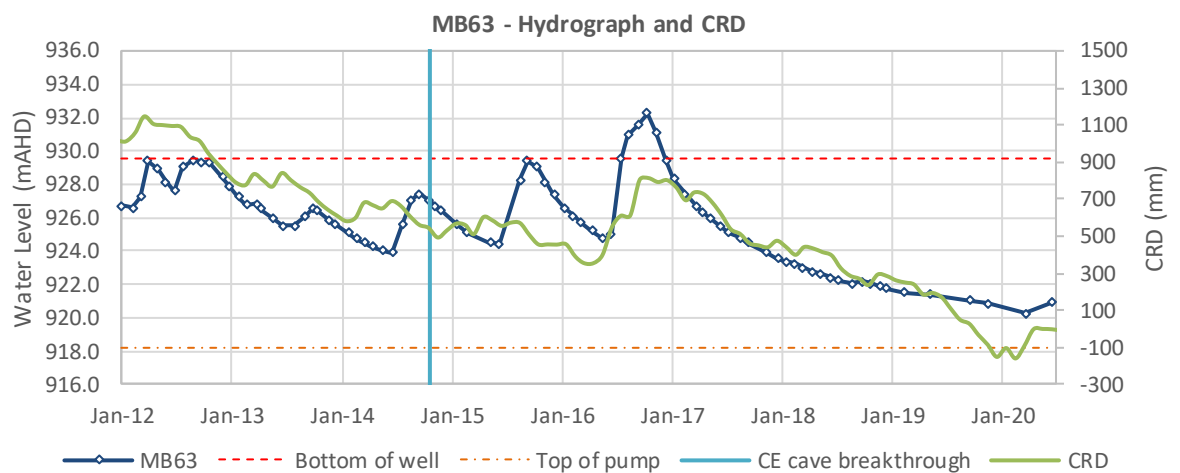
**Figure 3-40 MB63 groundwater level hydrograph**

The groundwater level hydrograph for MB63 was assessed using the HARTT method. The HARTT analysis indicated a statistically insignificant time trend. The historical declining groundwater level trend between 2017 and 2019 is therefore consistent with the CRD, and the lack of any significant rainfall recharge events over this period. Regression statistics are shown in Appendix D.

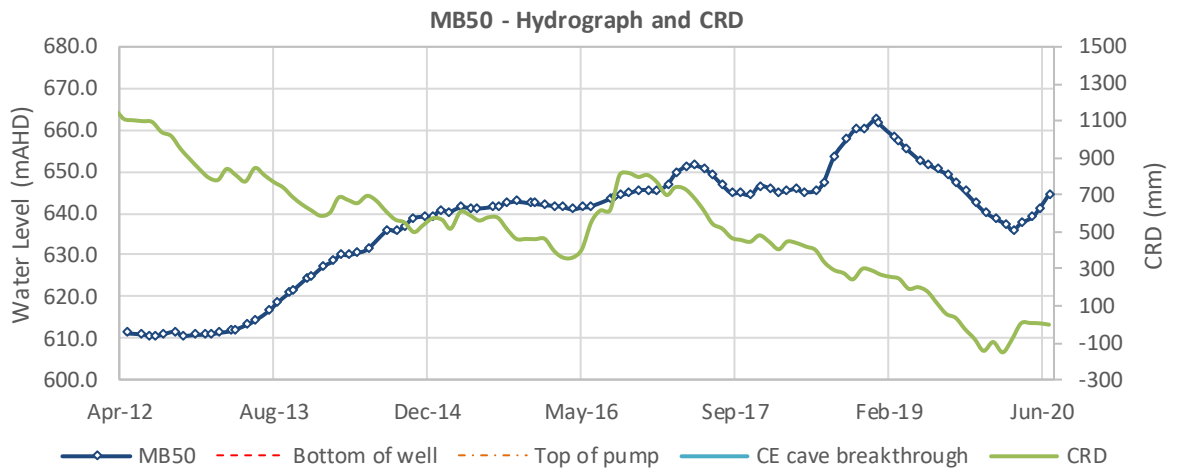
**Figure 3-41 MB50 groundwater level hydrograph**

Monitoring bores MB50, MB51 and MB52 are located to the south of Cadia East and potentially within the influence of mining, based on 2016 groundwater modelling. The monitoring bores are also located near the SWRD. MB50 has generally shown an increasing trend since monitoring commenced (refer Figure 3-41). The 2017-2018 AEMR attributed increasing groundwater levels to the SWRD. Since December 2018 groundwater levels at MB50 have been generally decreasing in accordance with decreasing CRD. However groundwater levels at MB50 did respond between April and June 2020 following a period of increasing CRD.

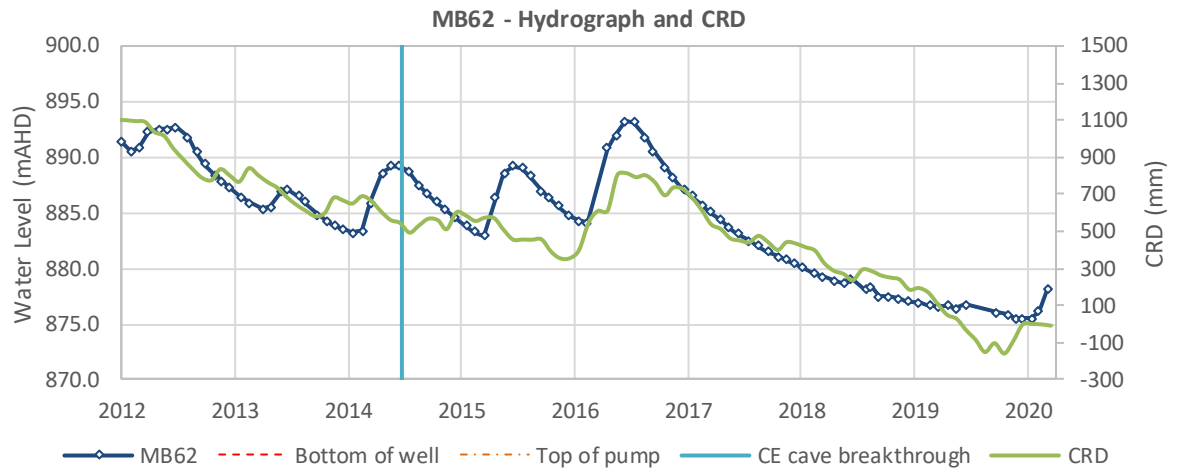
**Figure 3-43 MB62 groundwater level hydrograph**

pH below the guideline value was observed at MB62 during the reporting period. The low pH value may be due to historically low groundwater levels at MB62 due to a long period of below average rainfall between 2017 and December 2019.

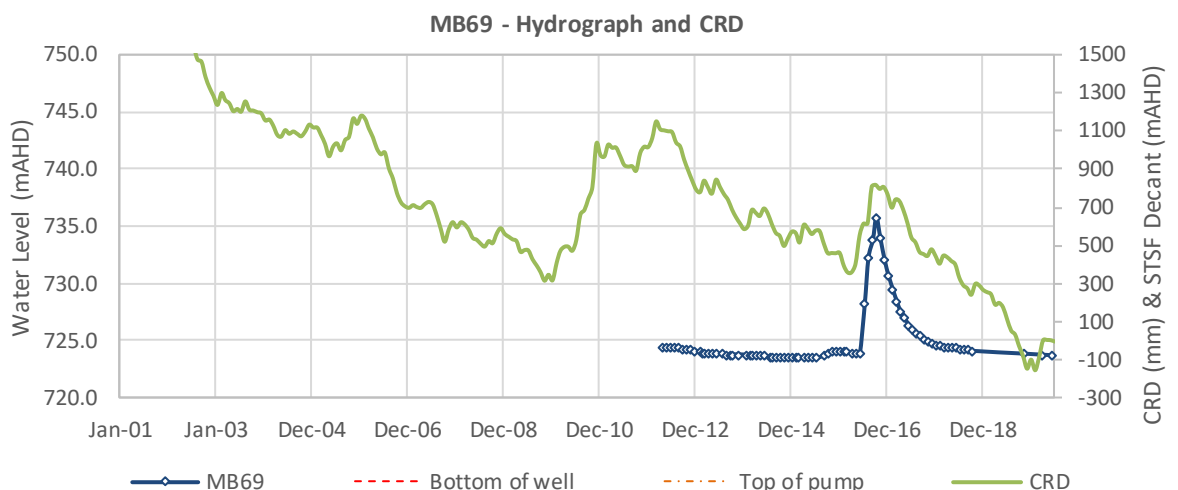
**Figure 3-52 MB69 groundwater level hydrograph**

Historically groundwater levels at MB69 show a declining trend. The groundwater levels increased rapidly between May 2016 and November 2016 following a period of above average rainfall during the same period (refer Figure 3-52). Since October 2016 the groundwater level has declined which is generally consistent with CRD. During the reporting period, groundwater levels at MB69 were steady.

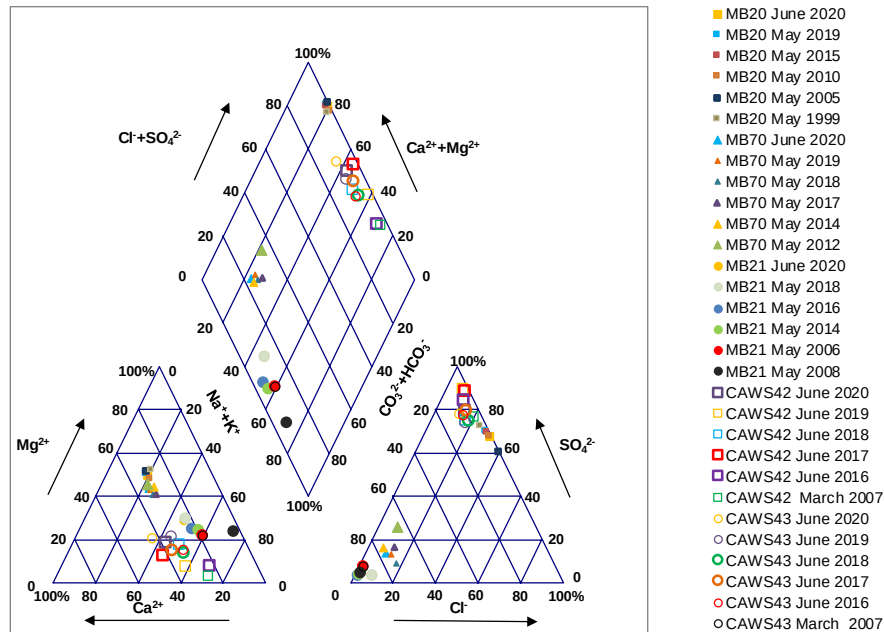
**Figure 3-54 Piper diagram for MB20, MB21, MB70, CAWS42 and CAWS43**

Based on the Piper diagram in Figure 3-54, groundwater in this zone is generally calcium/magnesium bicarbonate dominant, although MB20 is a more sulfate dominant groundwater. Most groundwater sites are dissimilar to decant water in terms of major ion composition with the exception of MB20, although it is noted that the elevated sulfate at MB20 has been observed prior to the operation of TSFs and is therefore likely to be representative of background groundwater.

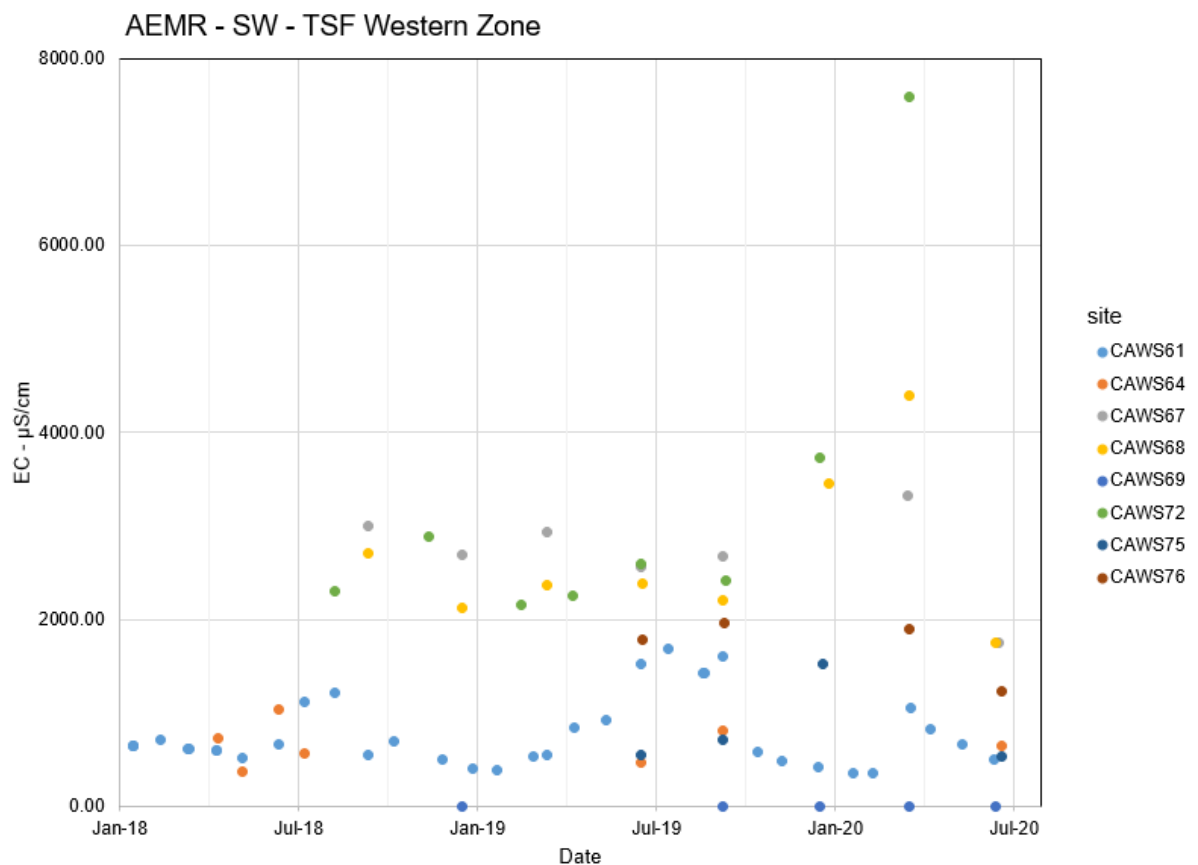
**Figure 3-55 EC at TSF western zone sites**

EC at sediment dam site CAWS72 has shown an increasing trend since June 2016, as shown in Figure 3-55. This likely reflects the prevailing dry conditions during this period, causing higher salinity levels from lack of flow into the sediment dam and increased evaporation.
