## **Preliminary Contaminated Land Assessment 'Super Lot 5'**

Proposed subdivision at  
Lot 54 DP 1222919, Hutley Drive, Lennox Head

For: Clarence Property Corporation Ltd  
Report No: 16174\_sepp55\_super\_lot\_5.docx  
Date: 31<sup>st</sup> January 2018

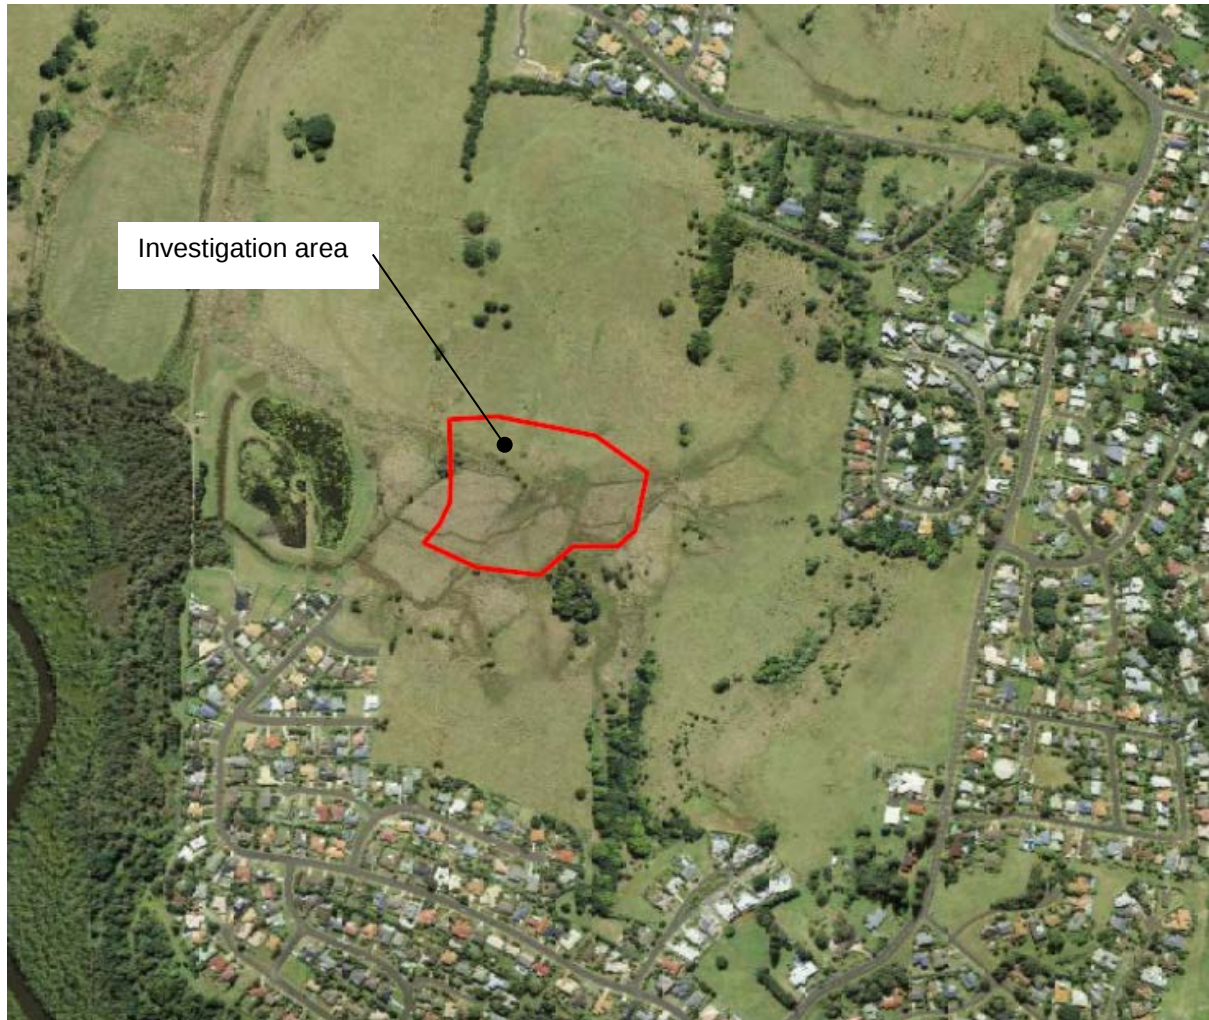
the site (*pers comm* Newton Denny Chapelle). It can be seen from NSW LPI Six viewer that the land contained drainage lines that have been levelled and filled prior to the assessment being undertaken.

Figure 7: Aerial photo showing drainage lines prior to filling (SIX Viewer 2018)

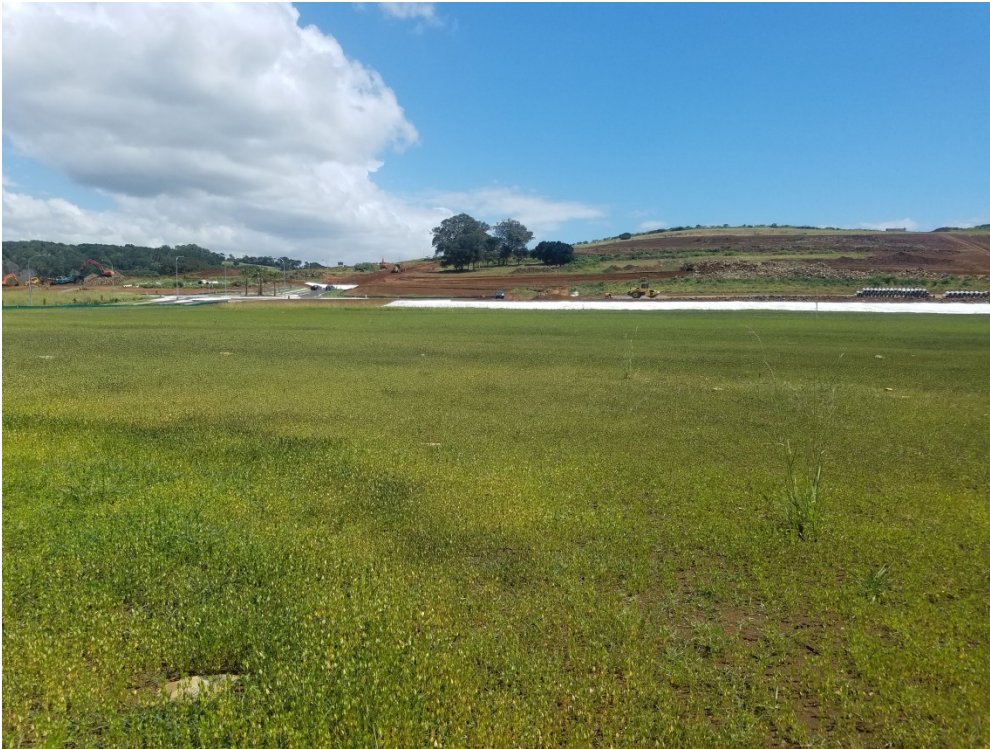
**Photograph 1: Investigation area with construction work to the north west (December, 2017)**

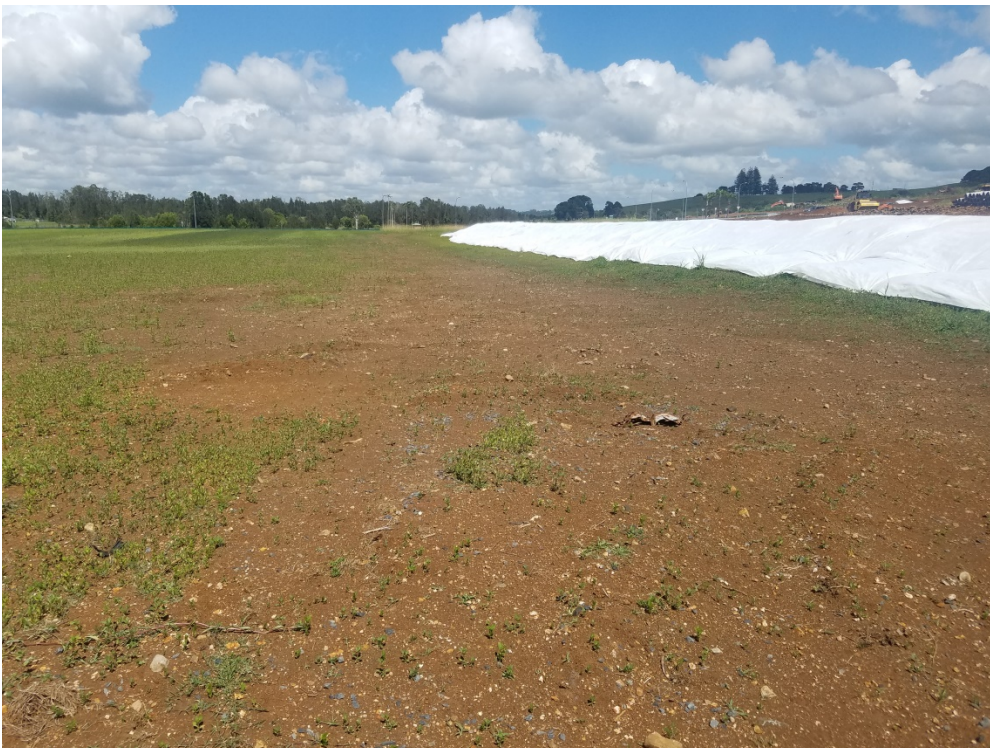
**Photograph 2: Investigation area looking to west (December 2017)**

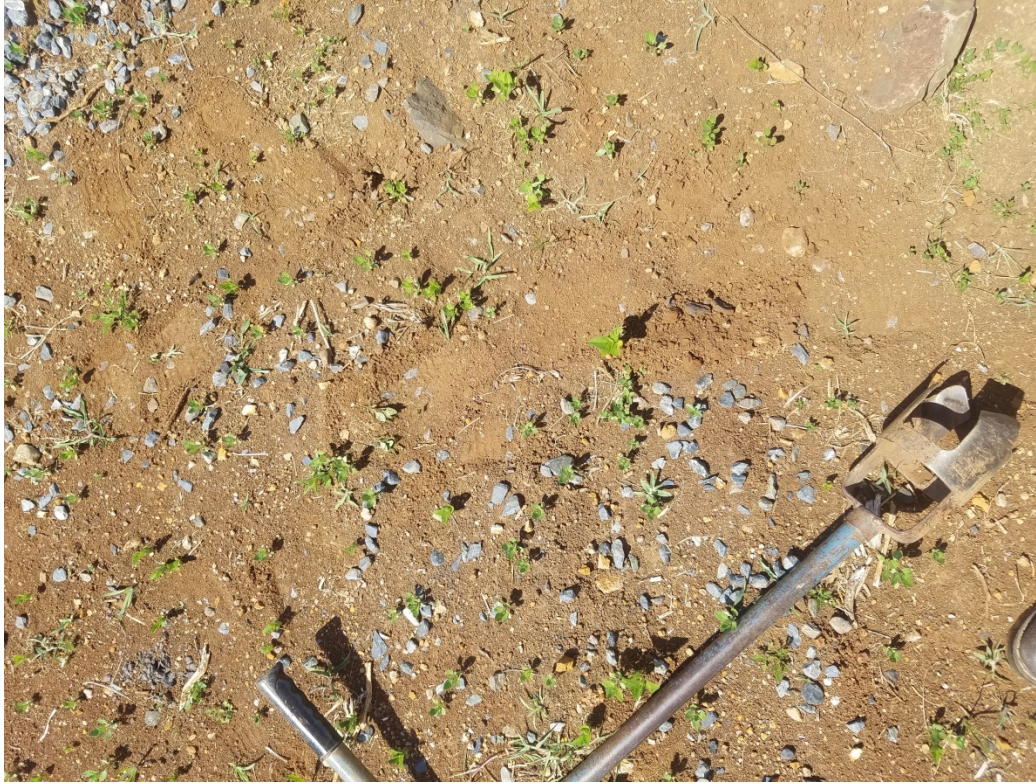
**Photograph 3: Rock fragments at surface of Investigation area (December 2017)**
