HAZARDOUS MATERIALS SURVEY REPORT

REPORT 10-6184

HAZARDOUS MATERIALS SURVEY REPORT Justinian House 30 Rocklands Road, Wollstonecraft, NSW 2065

22 OCTOBER 2007

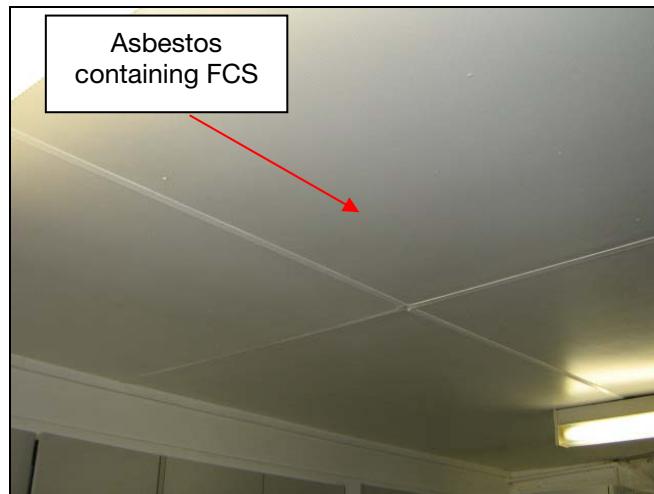
**Photograph 1: Ceiling, Kitchen Loading Dock, Building 4, Level 2, Interior**

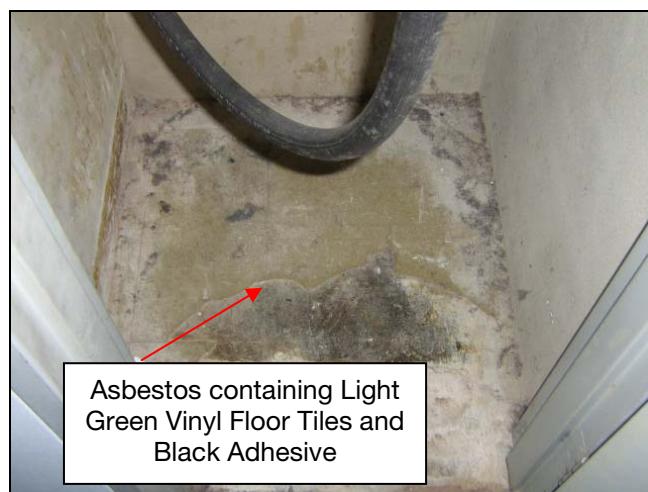
**Photograph 2: Fire Hose Reel Cupboard between DDOC Office and DOC Office, Building 4, Level 2, Interior**

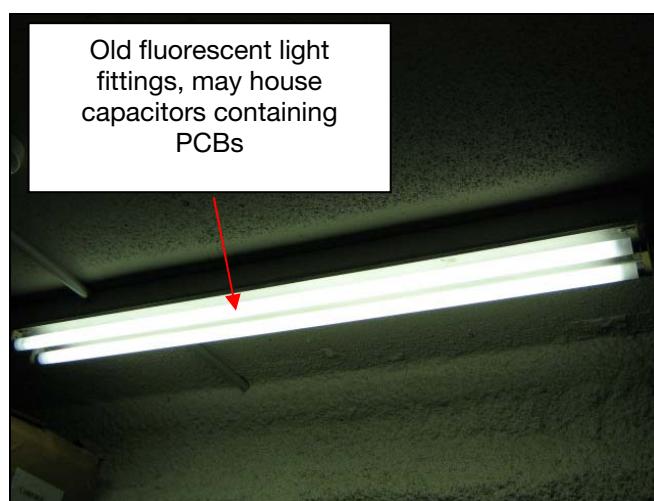
**Photograph 3: Locker Room, Building 2, Level 1, Interior**

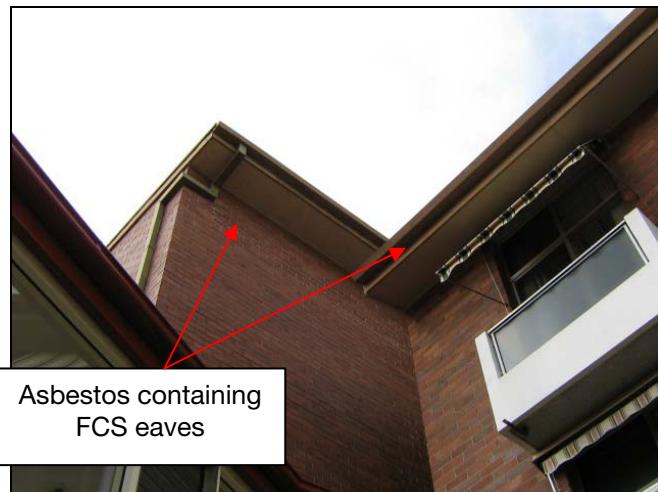
**Photograph 4: Northern wall, Building 5, Levels 5 and 6**

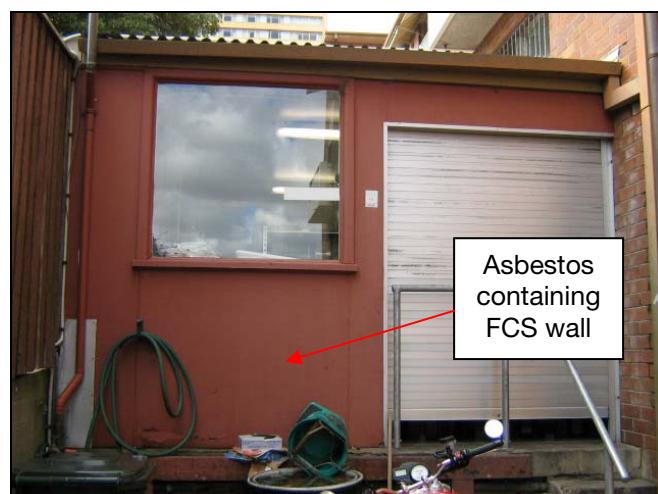
**Photograph 5: Kitchen Loading Dock, Building 4, Level 2, Exterior**

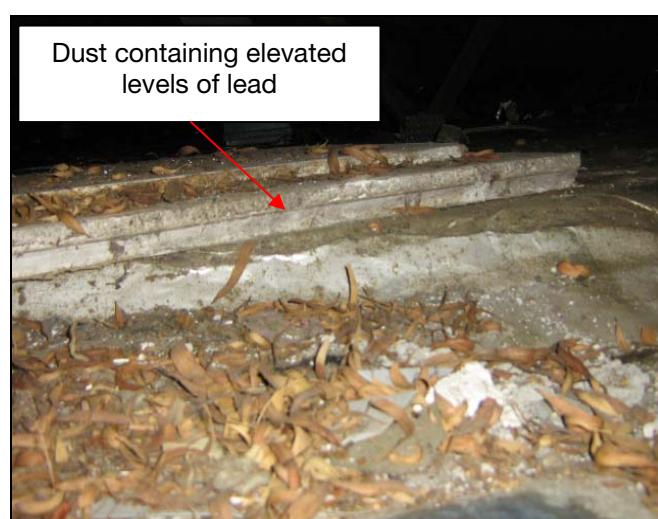
In consideration of the age of the building, past experience and the sample analysis results, all dust within ceiling cavities throughout the buildings is considered to contain potentially hazardous levels of lead.

**Photograph 6: Ceiling Void, Southwest of Stairwell 6, Building 1, Level 5, Interior**

- Access is restricted to ceiling spaces where elevated levels of lead in dust are likely to occur and a management plan is implemented to control the risk of human exposure to lead in ceiling dust. Ceiling manholes should be labelled to indicate the presence of lead in the ceiling dust.
- Any persons accessing ceiling cavities containing elevated levels of dust are to wear appropriate Personal Protective Equipment (PPE) such as disposable/washable coveralls and respiratory protection.

- Workers to wear appropriate PPE.
- Ceiling dust to be sprayed with a dilute polyvinyl acetate (PVA) emulsion to restrict the ability of the dust to become airborne.
- Vacuuming the ceiling free of dust before the application of a dilute PVA spray.
