**ARBORICULTURAL ASSESSMENT  
and  
DEVELOPMENT IMPACT REPORT**

**SITE ADDRESS**  
JUSTINIAN HOUSE  
30 ROCKLANDS ROAD  
CROWS NEST NSW

**OCTOBER 2007**

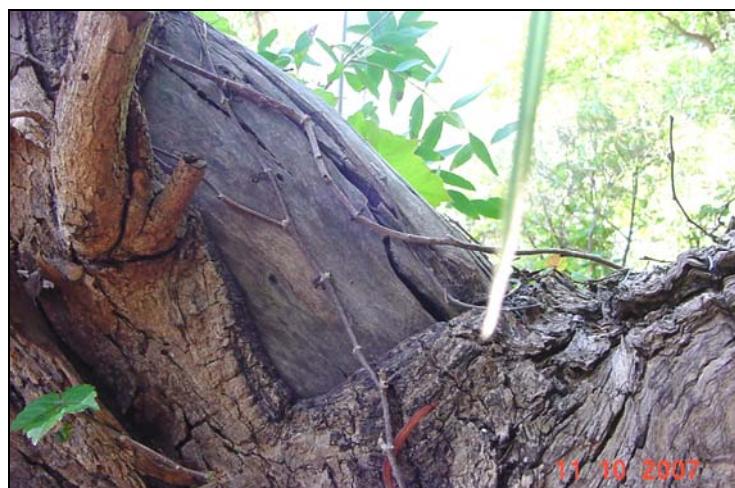
**Plate 1**

3.2.3 An examination of the tree has revealed the northern co-dominant stem growing over the footpath has a defect and associated problems that considerably lower the trees *Safe Useful Life Expectancy* (SULE). A wound to the upper side of the stem has prevented the formation of *tension wood*, which is the manner in which broad-leaved trees prevent leaning or subsidence of stems and large branches (Mattheck & Breloar 1994).

In an effort to stabilise the heavy stem the tree has formed *compression wood*, on the underside of the stem. The underside of the stem has wide bark 'plates' or section which are lighter in colour than the surrounding bark. This indicates the wood is loaded in compression, and the stem is slowly sinking.

An old wound on the upper side of the stem has decayed and formed a cavity, reducing the strength of the stem at this point. The tree is also unable to form tension wood to 'pull' the stem up.

3.2.5 The affected stem has a higher risk than normal of failure, due to its weakened structure (i.e. decayed wood in the upper side), and the inability of the tree to support the weight of the stem.

As this stem is growing over a public footpath and road, it presents a degree of risk to the public which must be addressed.

3.2.7 Under the Safe Useful Life Expectancy method of pre-development tree classification, such a tree would receive a classification of 4C (removal).

5.1.1 Remove Tree 14.

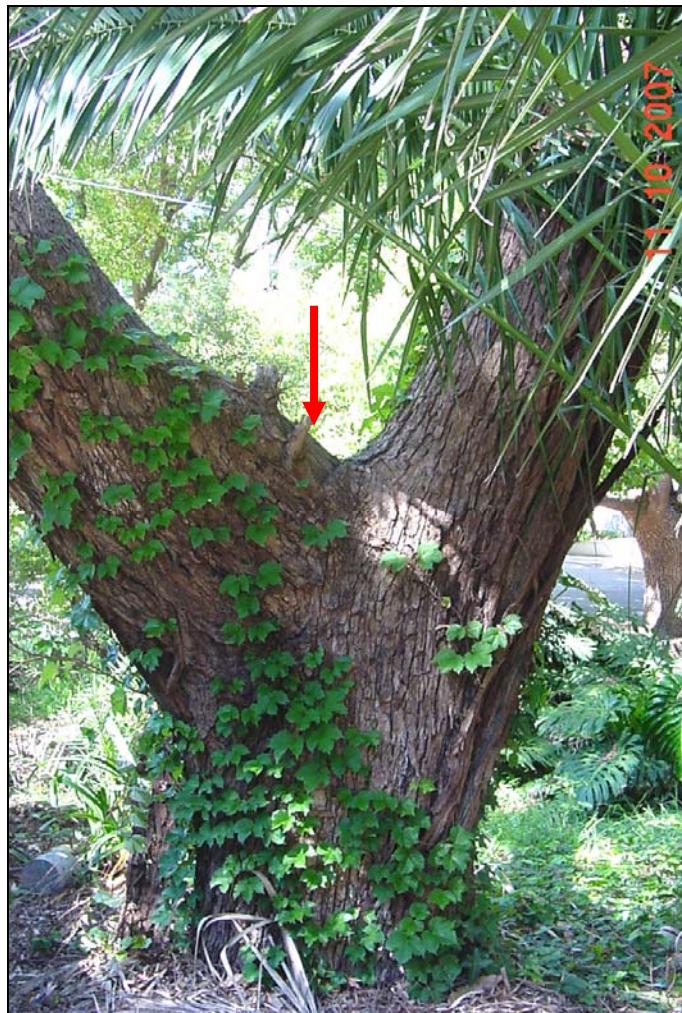
**Plate 2**

The photograph shows the co-dominant stems of the tree. The arrows points to an old wound on the upper side of the stem, near the union of both stems. The wound has decayed and formed a cavity, preventing the formation of tension wood on the upper side of the stem. Note the increase in stem diameter in the region of the upper and lower points of attachment to the stem on the right.

### 3.2.4 "By definition, co-dominant stems are a structural defect. The severity of this defect is increased by included bark, large crowns and strong wind."<sup>1</sup>
