## **Appendix A**

Site Photographs

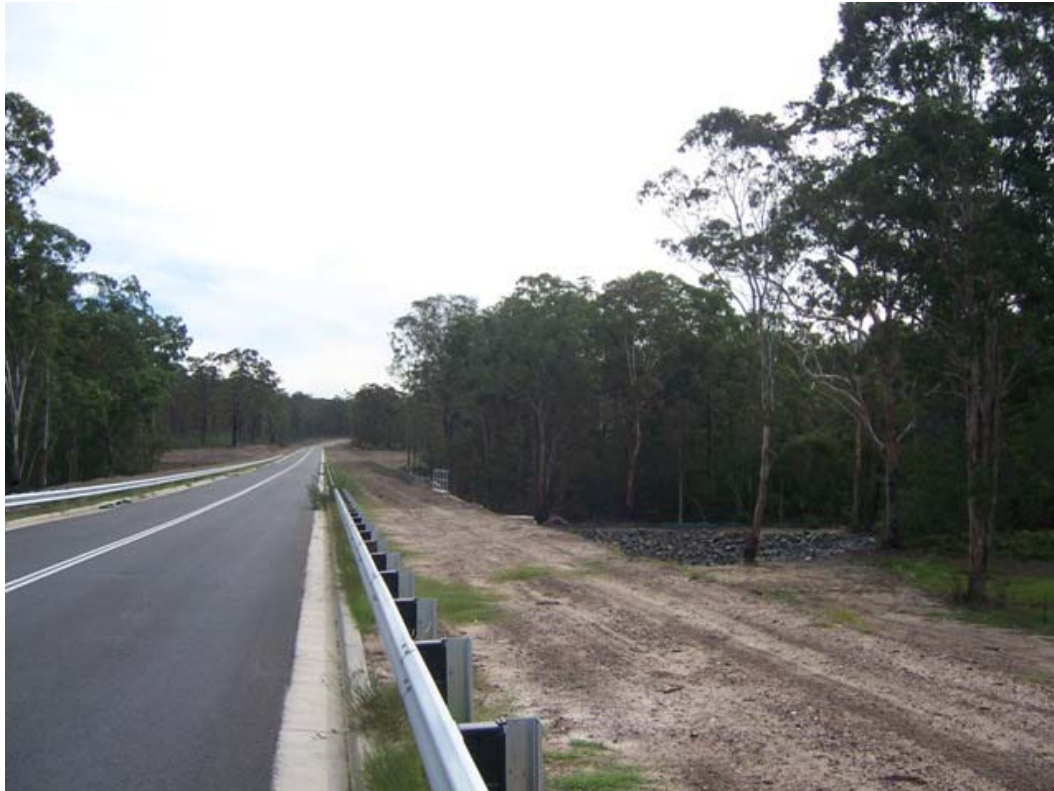
**Photograph 3:** Facing the North, showing the western and south western site boundary in the background, the nature corridor is present in the right of the photograph.

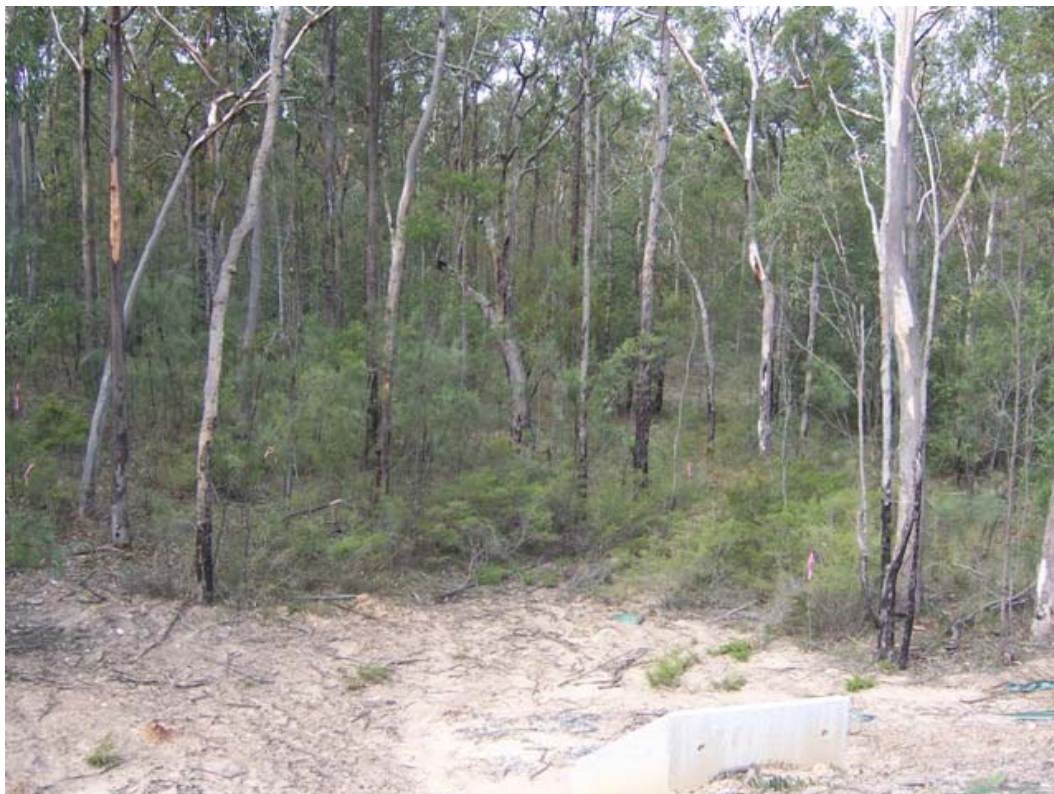
**Photograph 4:** Facing the East, showing scrubby native bushland, the culvert and the shallow gully are present in the eastern portion of the site.

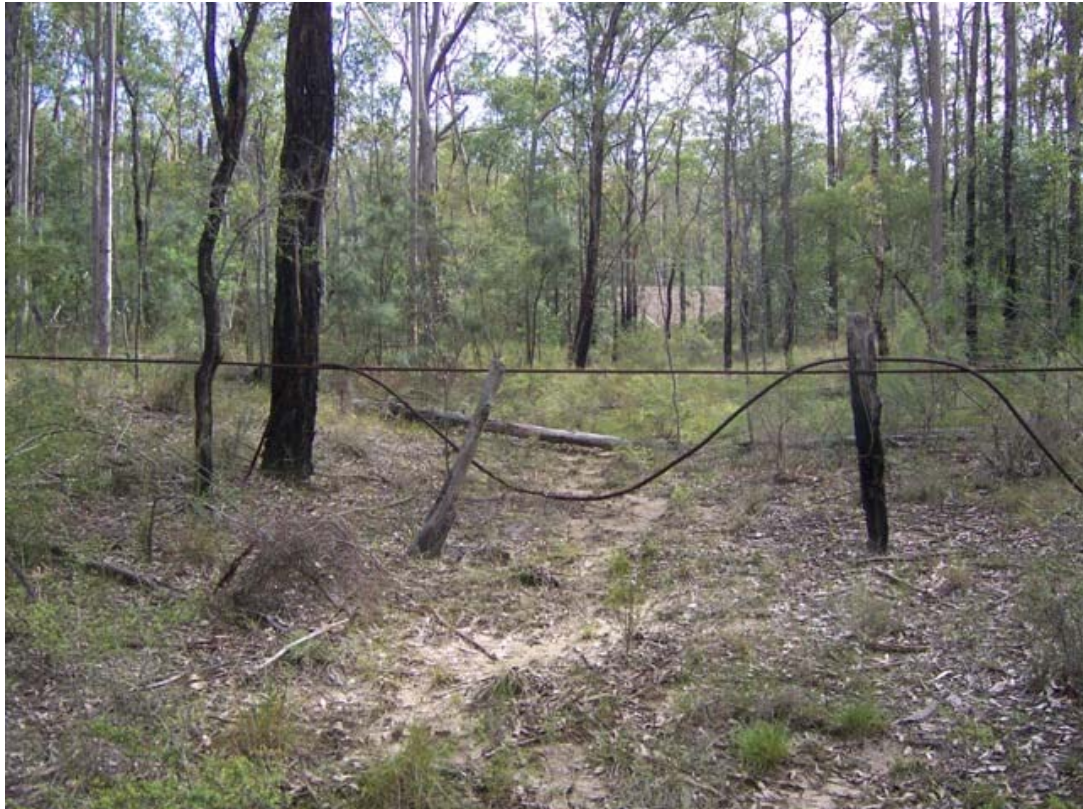
**Photograph 5:** Facing the west, taken from the middle of the shallow gully facing towards the road. Steel cable has been previously used for fencing materials, assumed a result of flooding of lighter fencing materials in the past.

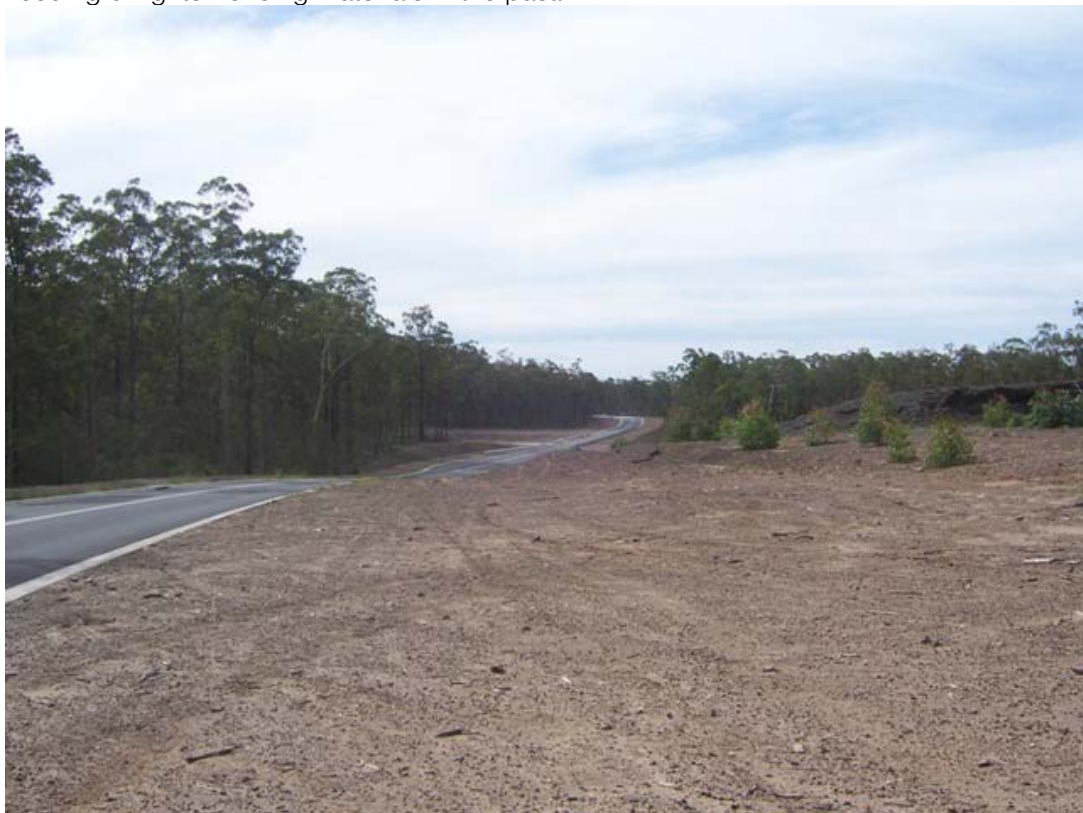
**Photograph 6:** Facing the North, showing fill materials used on the northern portion of the site, to the left of the picture scrubby native vegetation is present, while to the north minor revegetation the area has occurred.

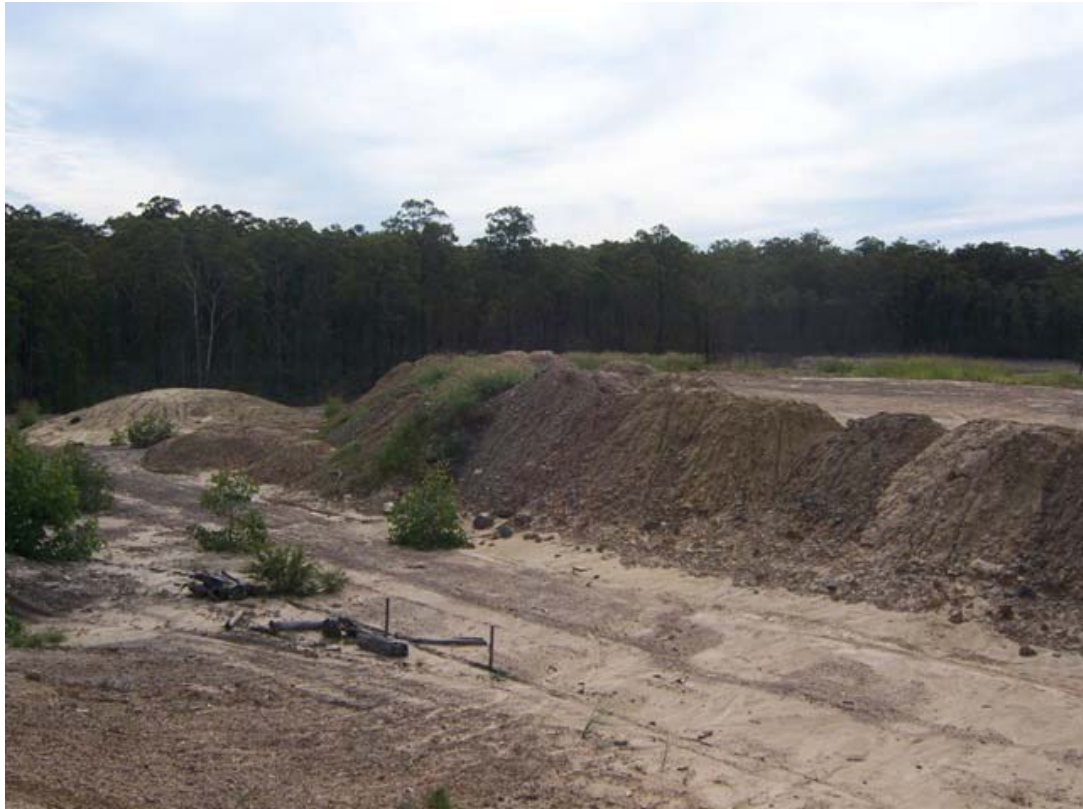
**Photographs 7:** Facing the North West along the northern site boundary shows fill materials assumed from the main road construction, currently stored on the north western portion of the site.

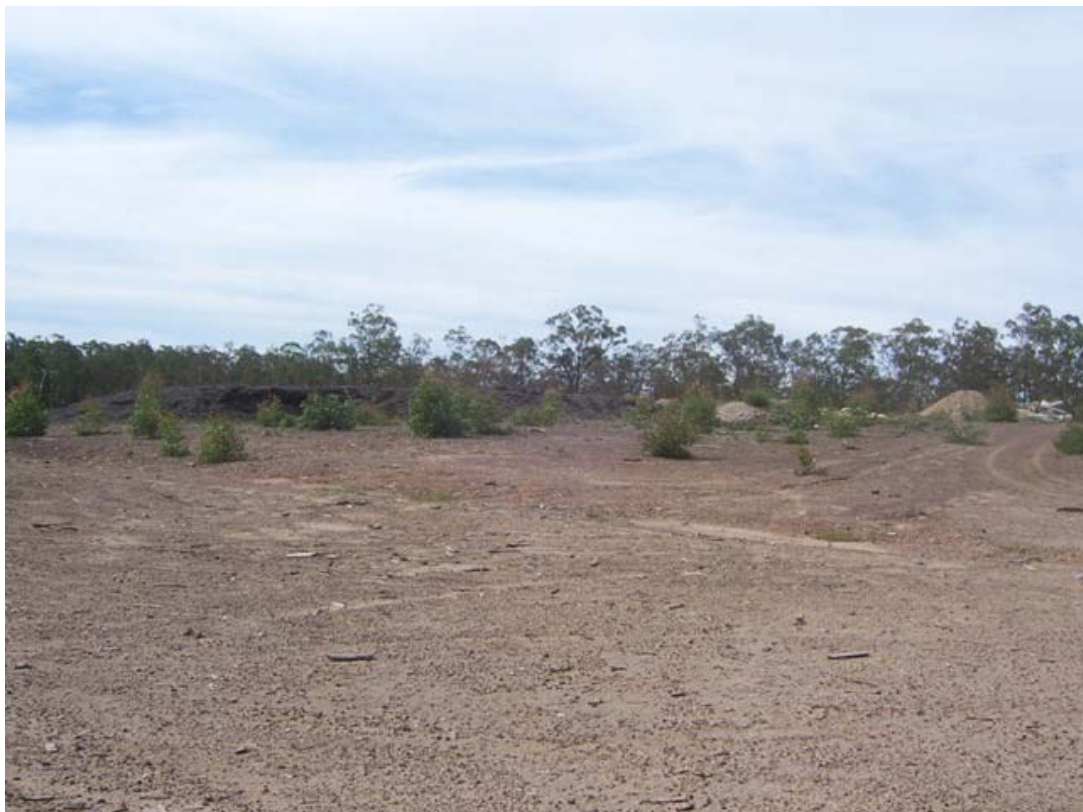
**Photograph 8:** Facing the north east from the front of the site, showing filled areas and some minor regrowth of juvenile eucalypts.

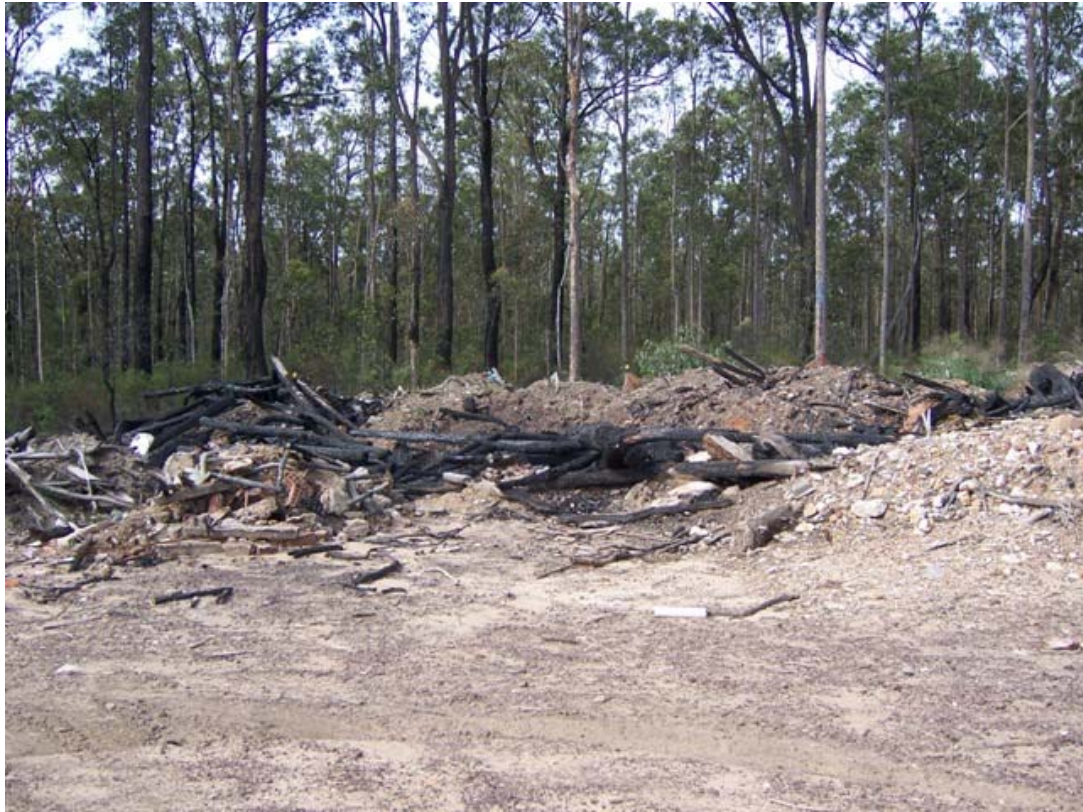
**Photograph 9:** Facing the east, some burnt timber and steel products are present around the filled areas in the north of the site.

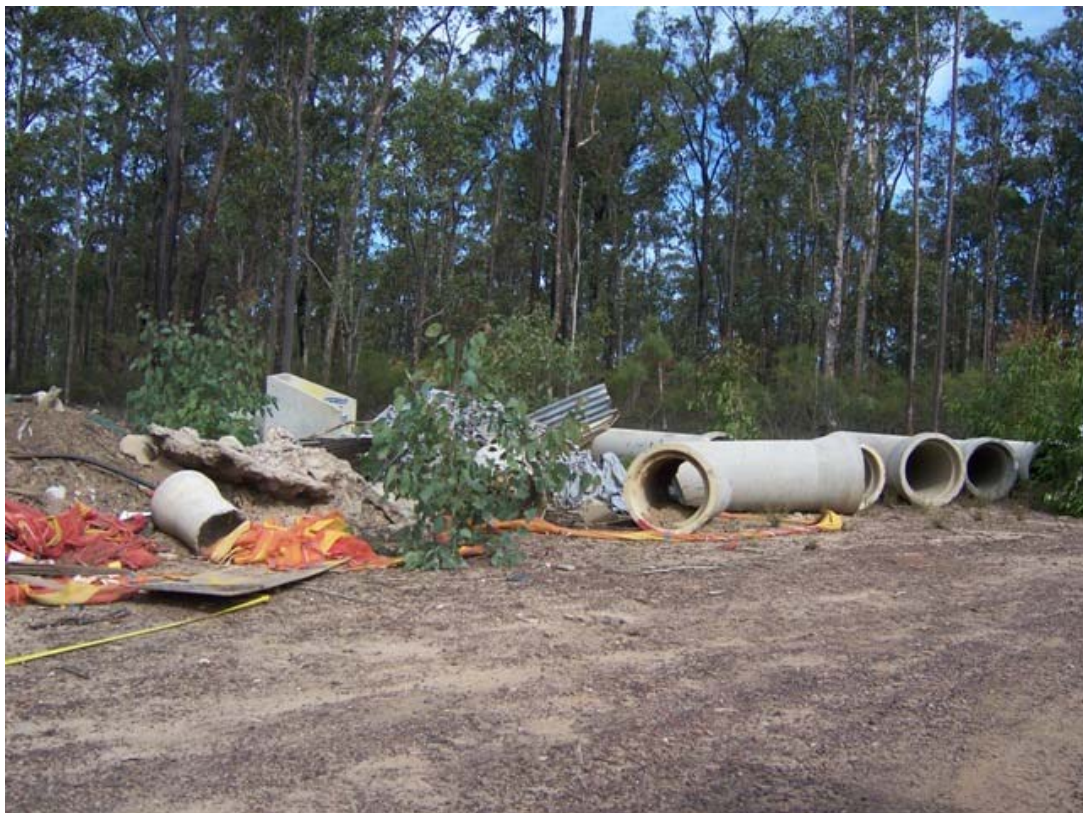
**Photograph 10:** construction materials and associated wastes present in the north western portion of the site.

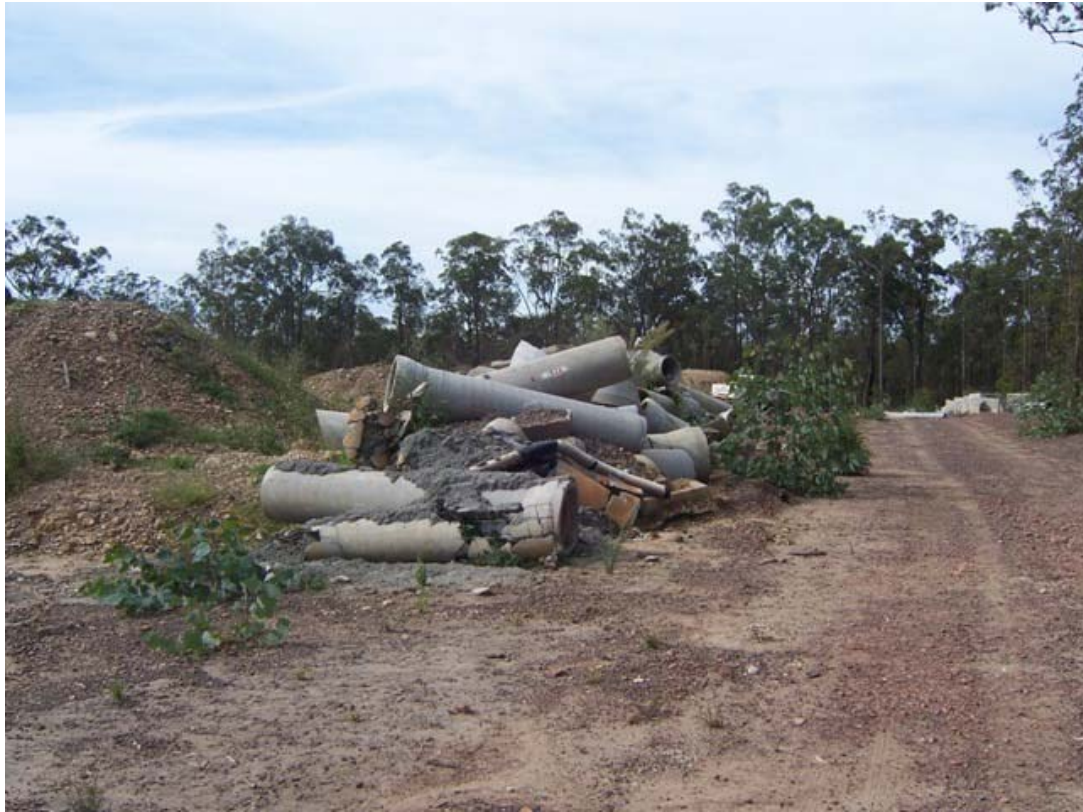
**Photograph 10:** Road Construction materials placed on the north western portion of the site.

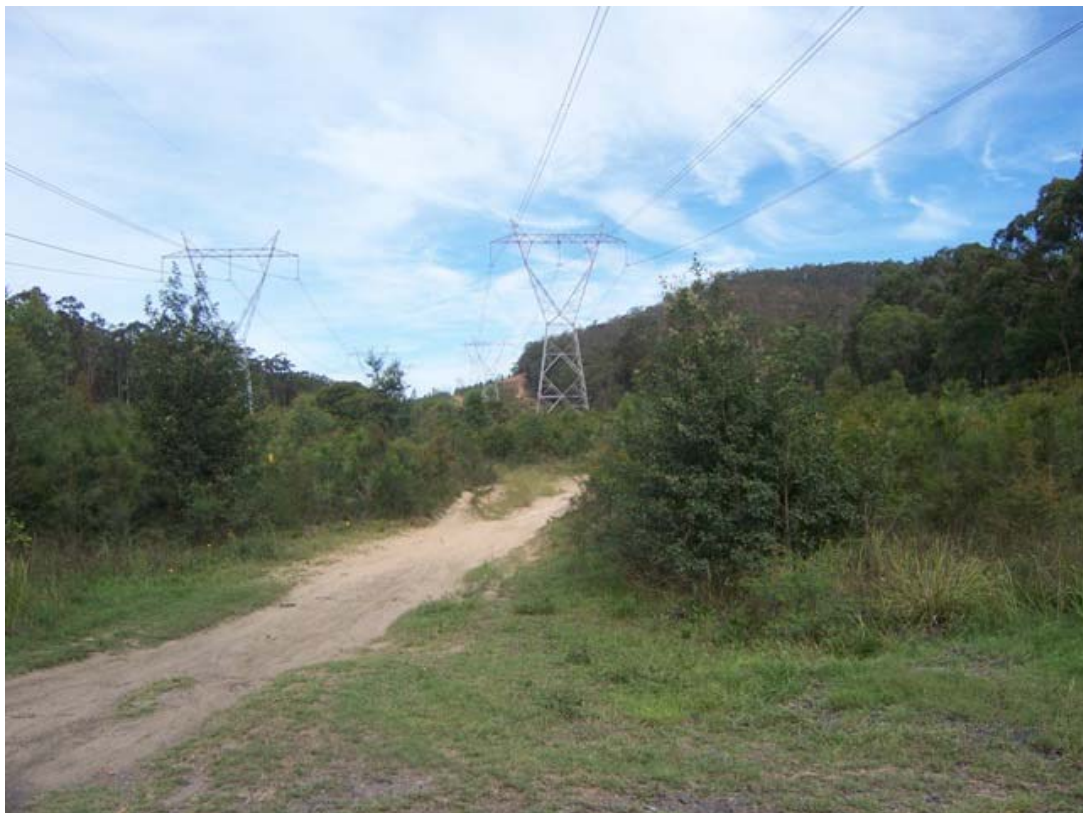
**Photograph 11:** Energy Transmission present running northwest-southeast approximately 200m to the southeast of the site.
