# D.F.Dickson & Associates Pty Limited

The Project Manager  
Murlan Consulting Pty Ltd  
Jones Bay Wharf  
Sydney  
2 October 2009  
Attn: Mr. Ben MacGibbon

## **RE: 35 WATER ST – WAHROONGA, FURTHER SUPPLEMENTARY HYDROGEOLOGY AND INFILTRATION REPORT.**

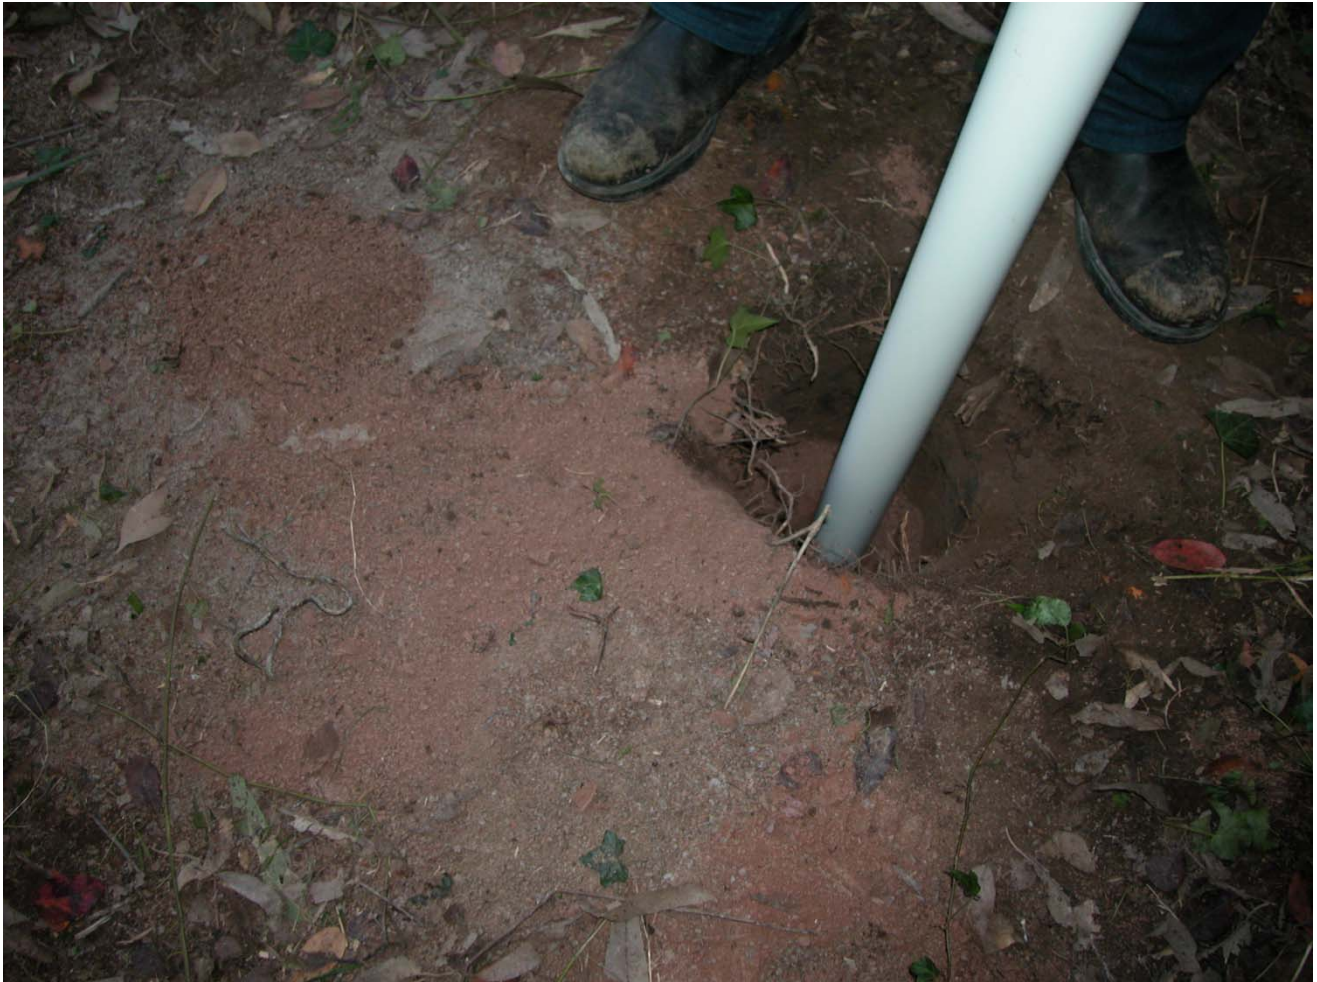
During the installation of the bore holes for the piezometers it was found that very hard clay was encountered from a depth of 20mm and refusal of the 100mm continuous flight auger with tungsten carbide drill bit occurred on weathered shale at a depth of 2.6 to 2.8m. The drilling was conducted using a 5hp two man auger drill and the cuttings examined and logged as they were cleared from the augers. The clays were dry from the surface and no free water or excess moisture was encountered, the weathered shale was also dry. Pocket penetrometer readings were not obtained from the cuttings due to the fine dry and often powdery nature of the cuttings. Penetrometer readings were taken within the bored 250mm concreting hole at a depth of 350mm from the surface ranging from 350kPa – 450kPa.

The above plate shows BH4 cuttings and installation of the piesometers tube. Note the dry clay cuttings (redish colour and grey dry shale cuttings).

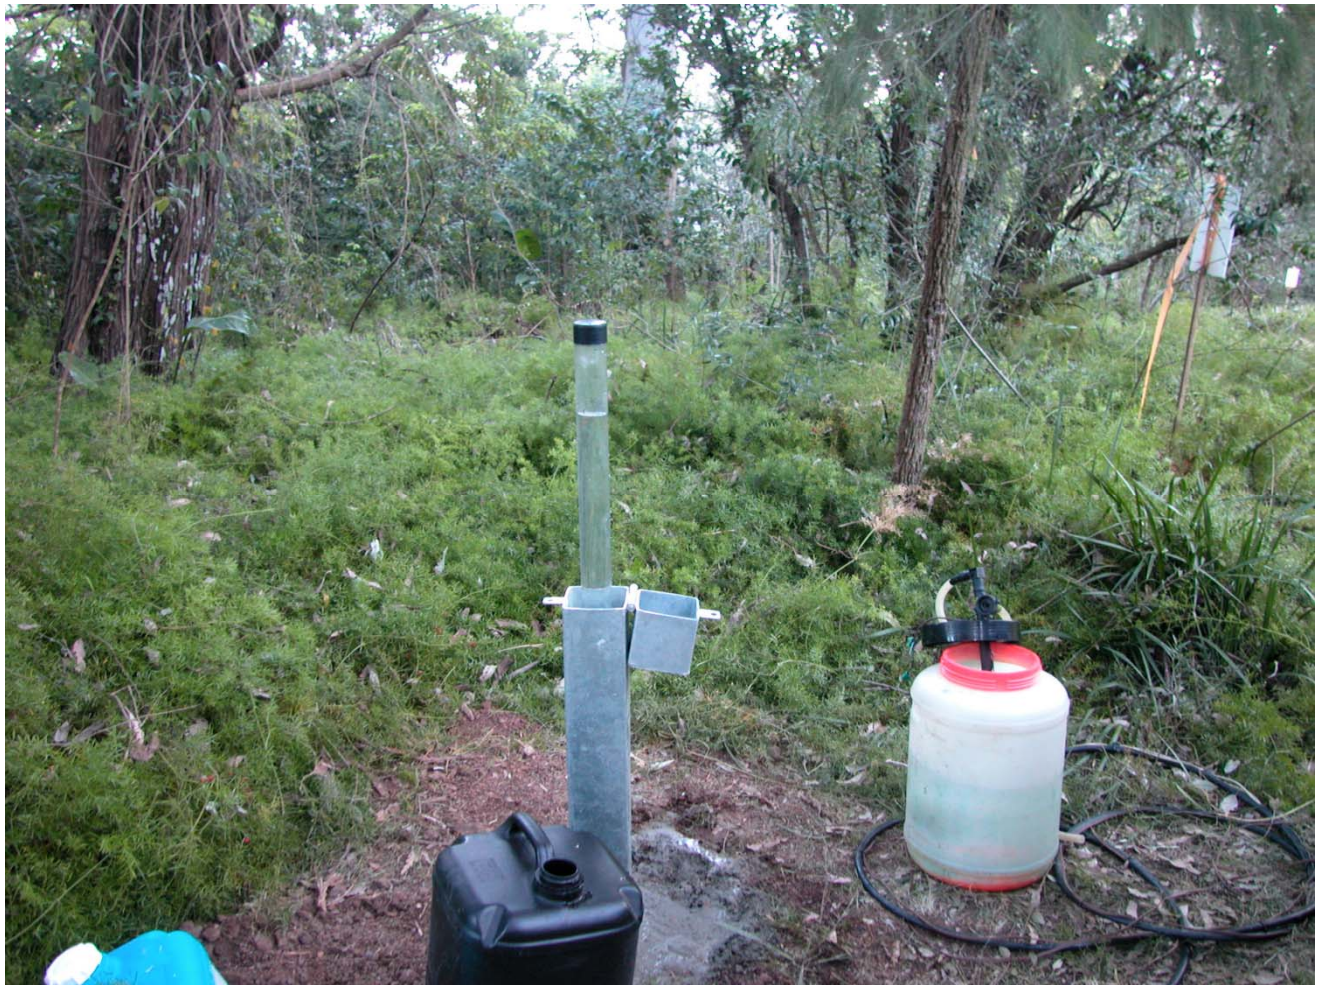
The above plate shows the permeameter in place during one test on BH5 the drums and electric pump are used for water storage and filling of the permeameter.

At BH 5 some difficulty with losses along the bore casing to the surface were experienced as the bentonite did not swell sufficiently to seal the bore in the first instance, additionally several tree roots were intersected during the installation of the bore and there appeared to be some structures within the upper soil around the roots which also contributed. The soil structures are tension cracks due to dessication, residual structure from the clay shale bedding planes and soil biology (worm tracks, spider and ant holes and the like). Even with these issues, the permeability was only marginally lower at  $k_m = 2.35 \times 10^{-8} \text{m/sec}$ .

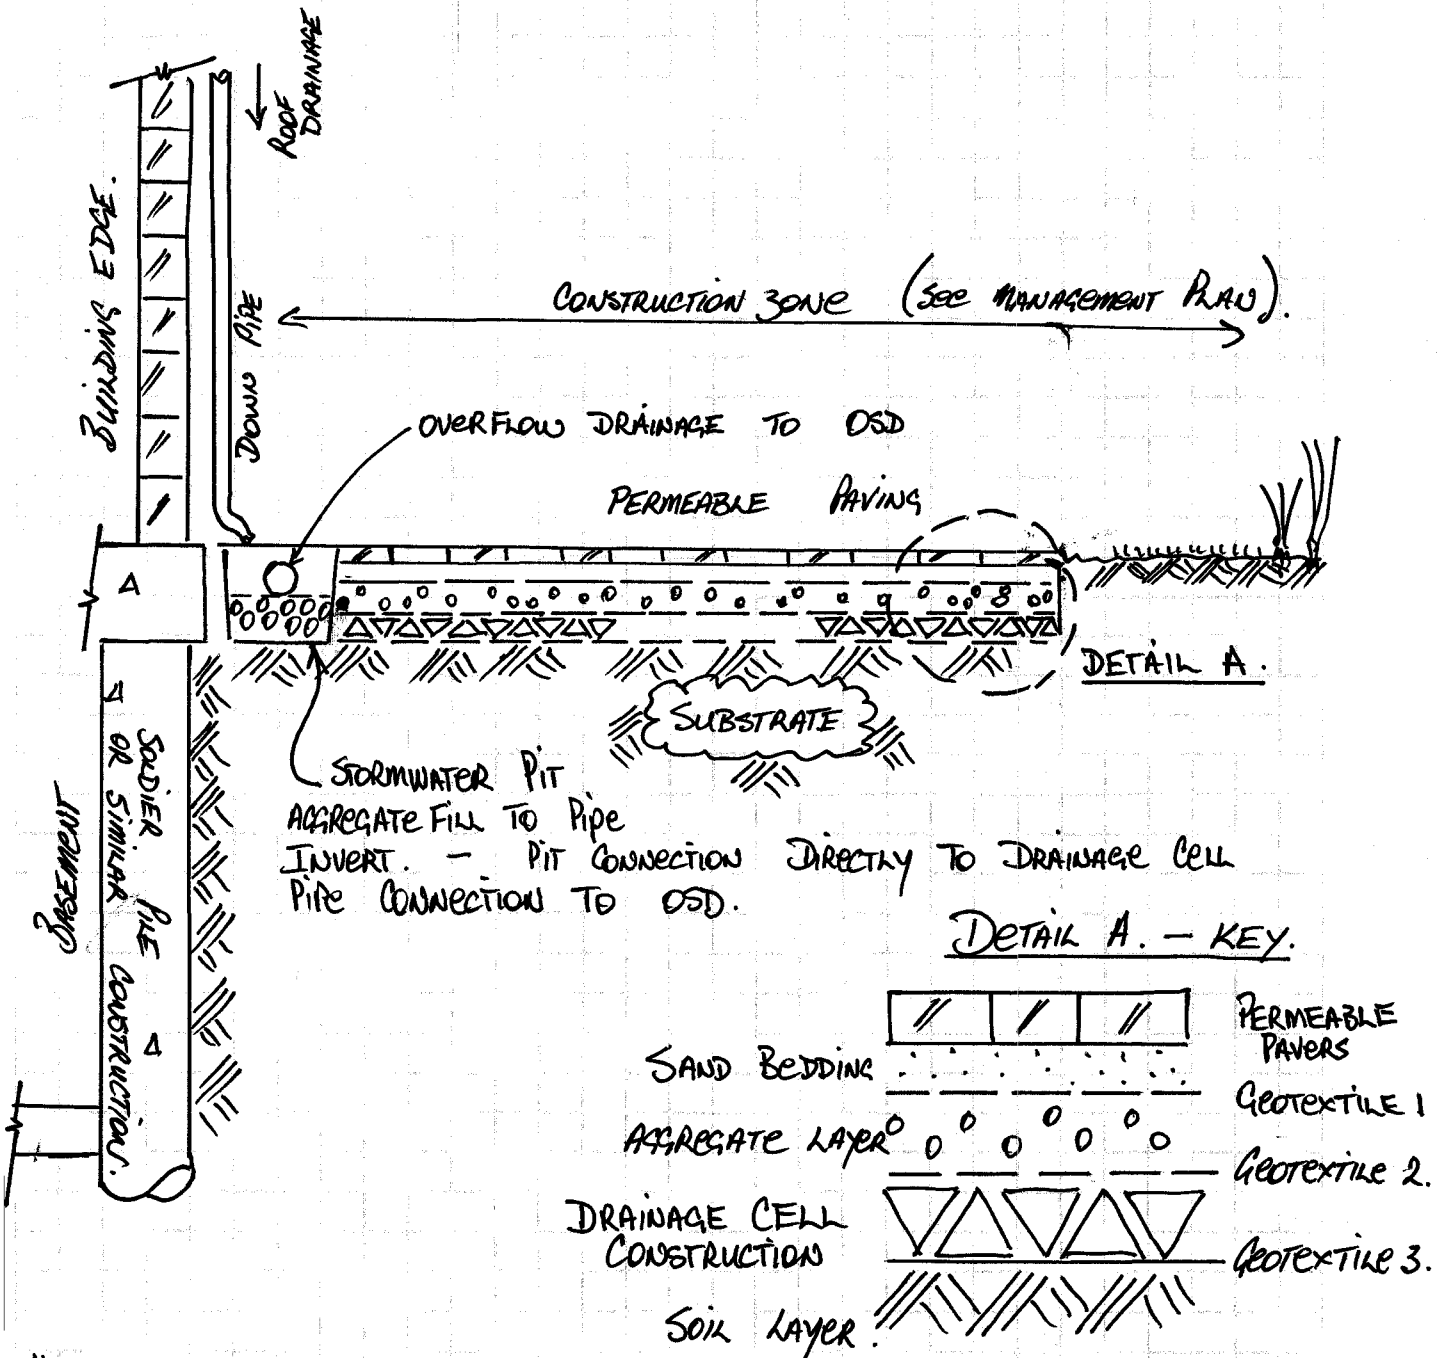
DRAINAGE CELL VOLUME = 1:5 YEAR ARI VOLUME x PRE EXISTING DEVELOPMENT NATURAL AREA LOSS x INFILTRATION RATE x STORM EVENT TIME (30min → 120min).

RAINFALL & INFILTRATION RATE WILL CONTROL THE VOLUME & THEREFORE THE LENGTH & WIDTH REQUIRED FOR THE CELLS WITHIN THE CONSTRUCTION ZONES.

The existing infiltration areas to be taken up by the proposed development can be replaced with a passive infiltration system utilising rainwater collected from the roof and directed to the areas most in need. The system is passive and self regulating due to the nature of the clay soils. A sketch and flow sheet of the proposed system is attached and, it is possible to measure the effectiveness of the system using the a soil moisture monitoring system such as the type described previously in our report of 16 February 2009.

- Based on the measured infiltration rates from BH4 and BH5 for the soil horizon, a moisture infiltration rate of 0.0021 Litres/m<sup>2</sup>/sec is to be expected and based on a 50m length of permeable paved infiltration zone 2m in width and 200mm deep, a total of 15,200 litres can be stored and 13,934 litres will be infiltrated in 24 hours.

- This infiltration system is proposed to be located along the southern sides of the development underneath the existing and new trafficable areas. This provides the infiltration necessary without sterilising any additional area available for landscape use.
