# impact of development on trees - proposed private hospital, 1-8 niel avenue, greenwich

prepared by  
Melanie Howden - Ass. Dip. Hort. (HaC), SoA Arb. (TAFE) , MAIH. MNAAA, MIACA

9 October 2008

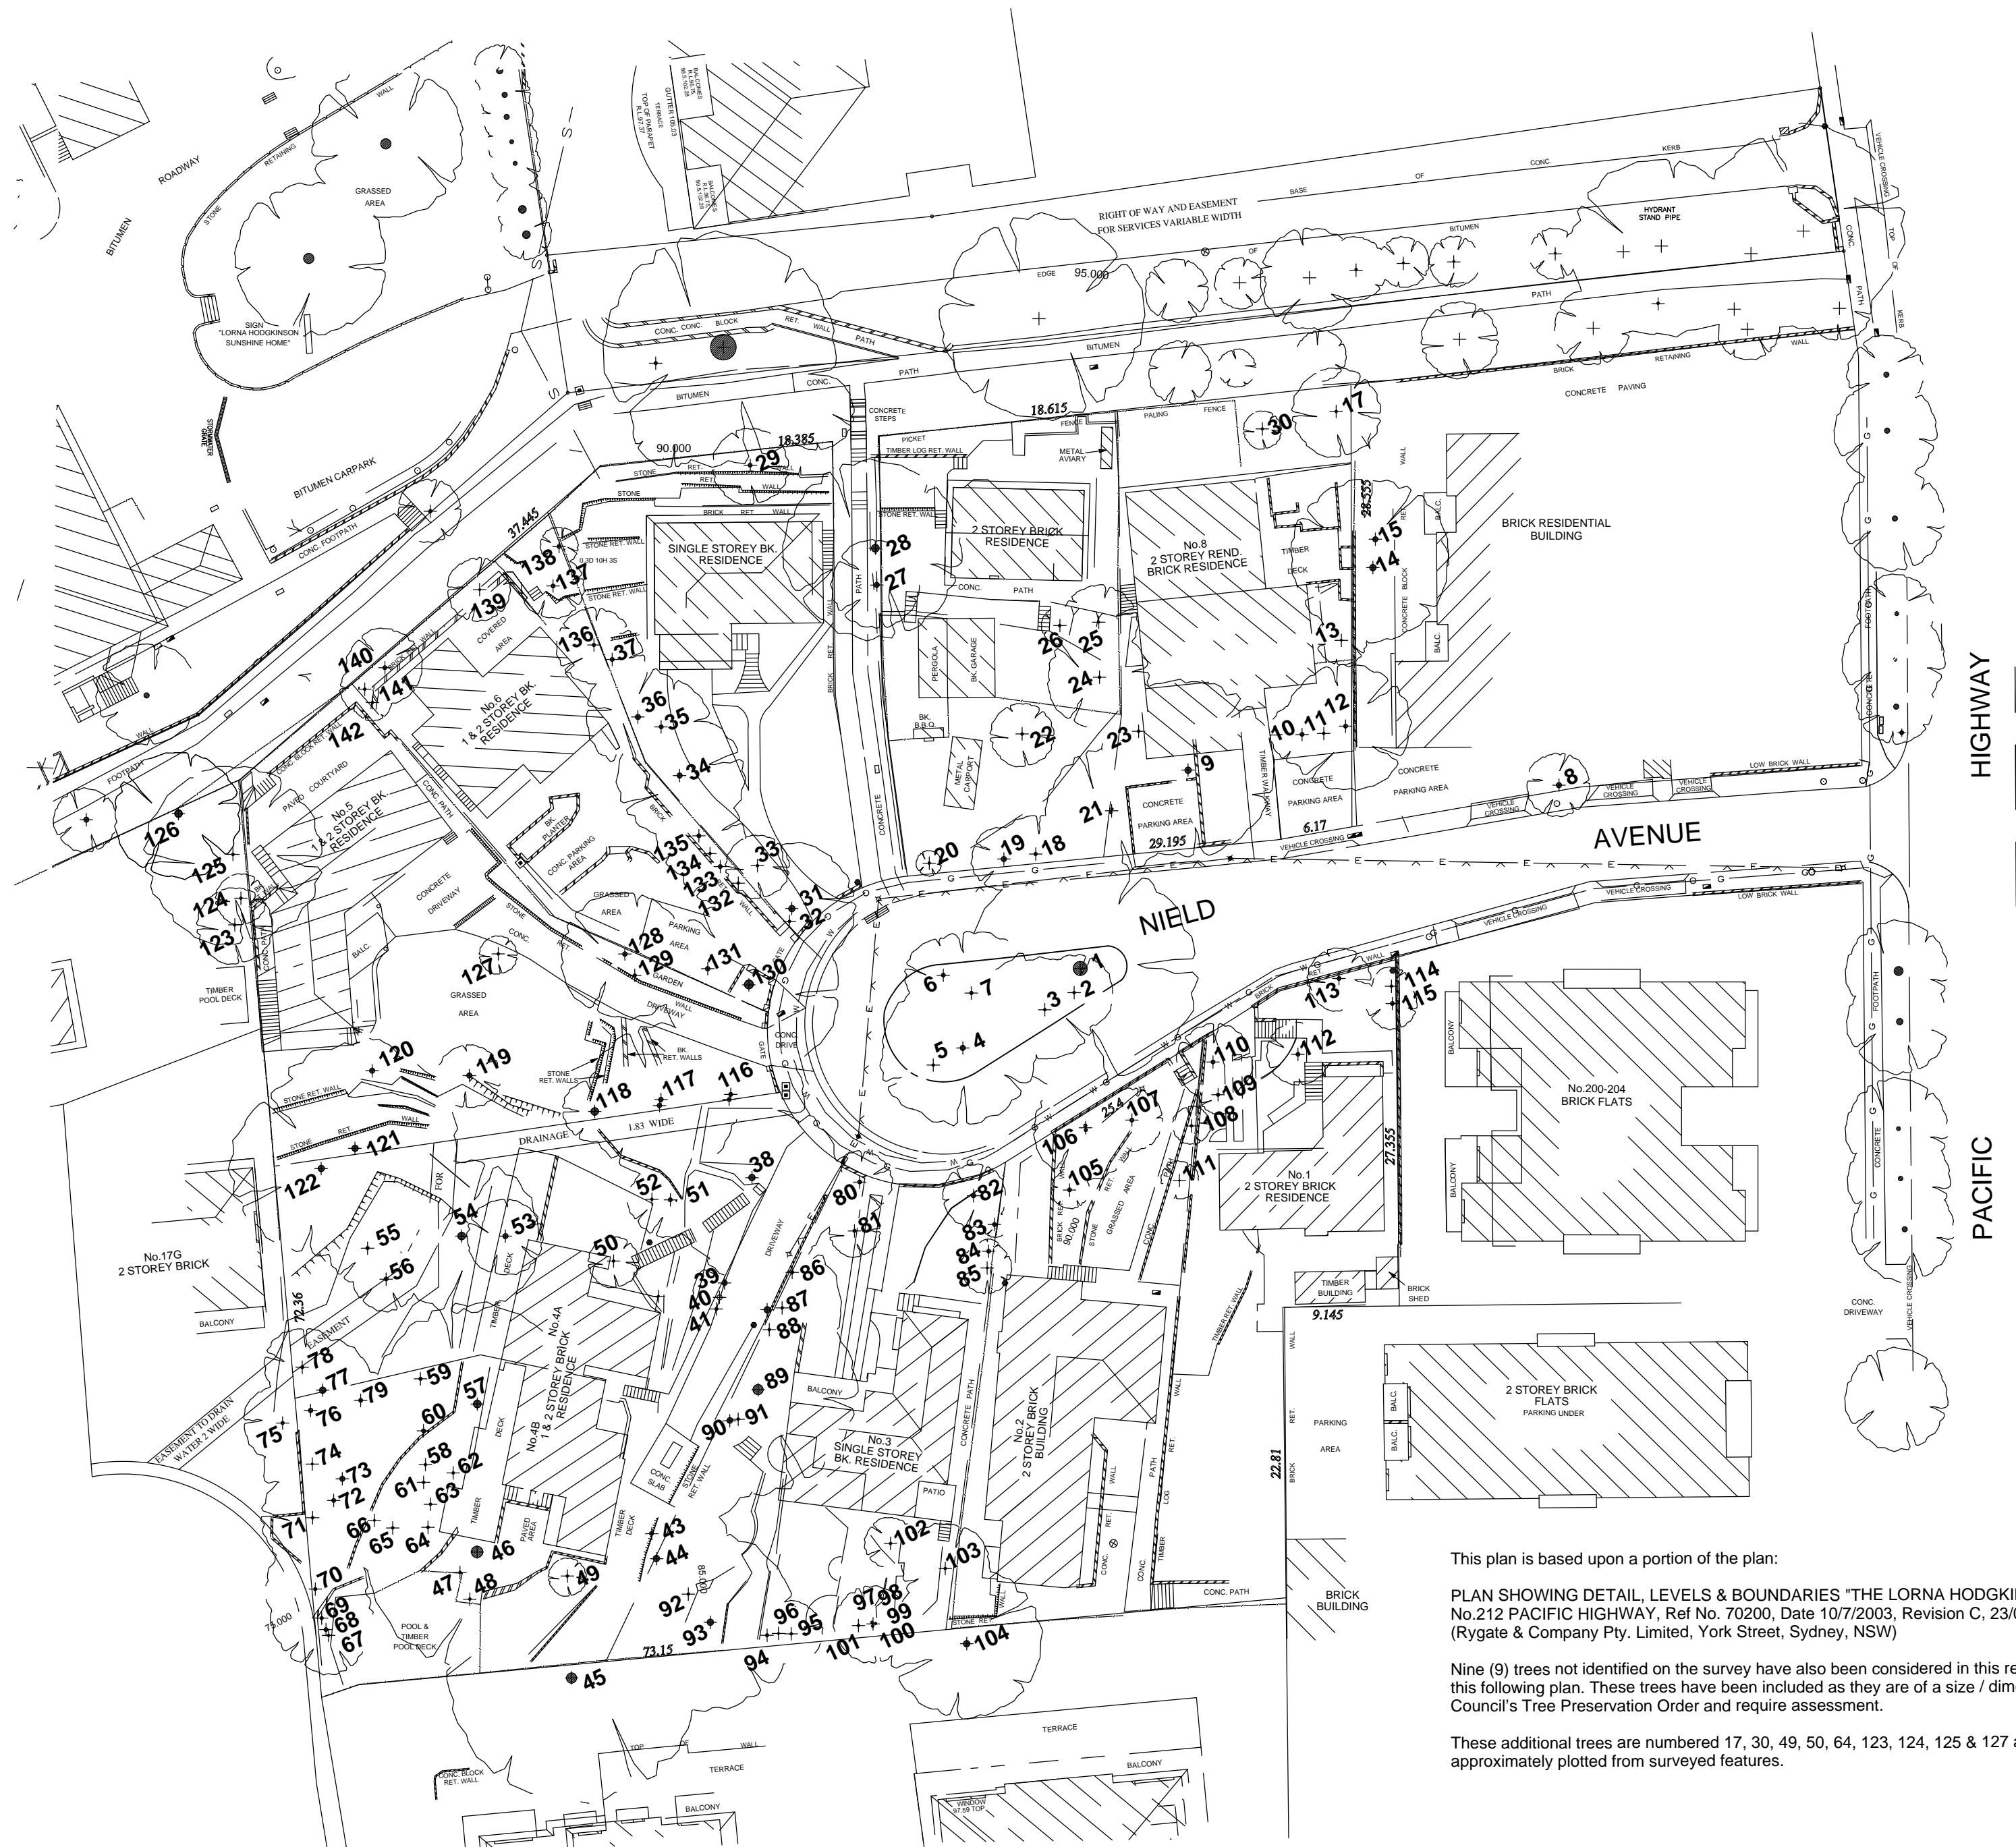
drawing title  
**existing site - tree locations &  
reference numbers**

Nine (9) trees not identified on the survey have also been considered in this report and have been added to this following plan. These trees have been included as they are of a size / dimension that is covered by the Council's Tree Preservation Order and require assessment.

These additional trees are numbered 17, 30, 49, 50, 64, 123, 124, 125 & 127 and their locations have been approximately plotted from surveyed features.

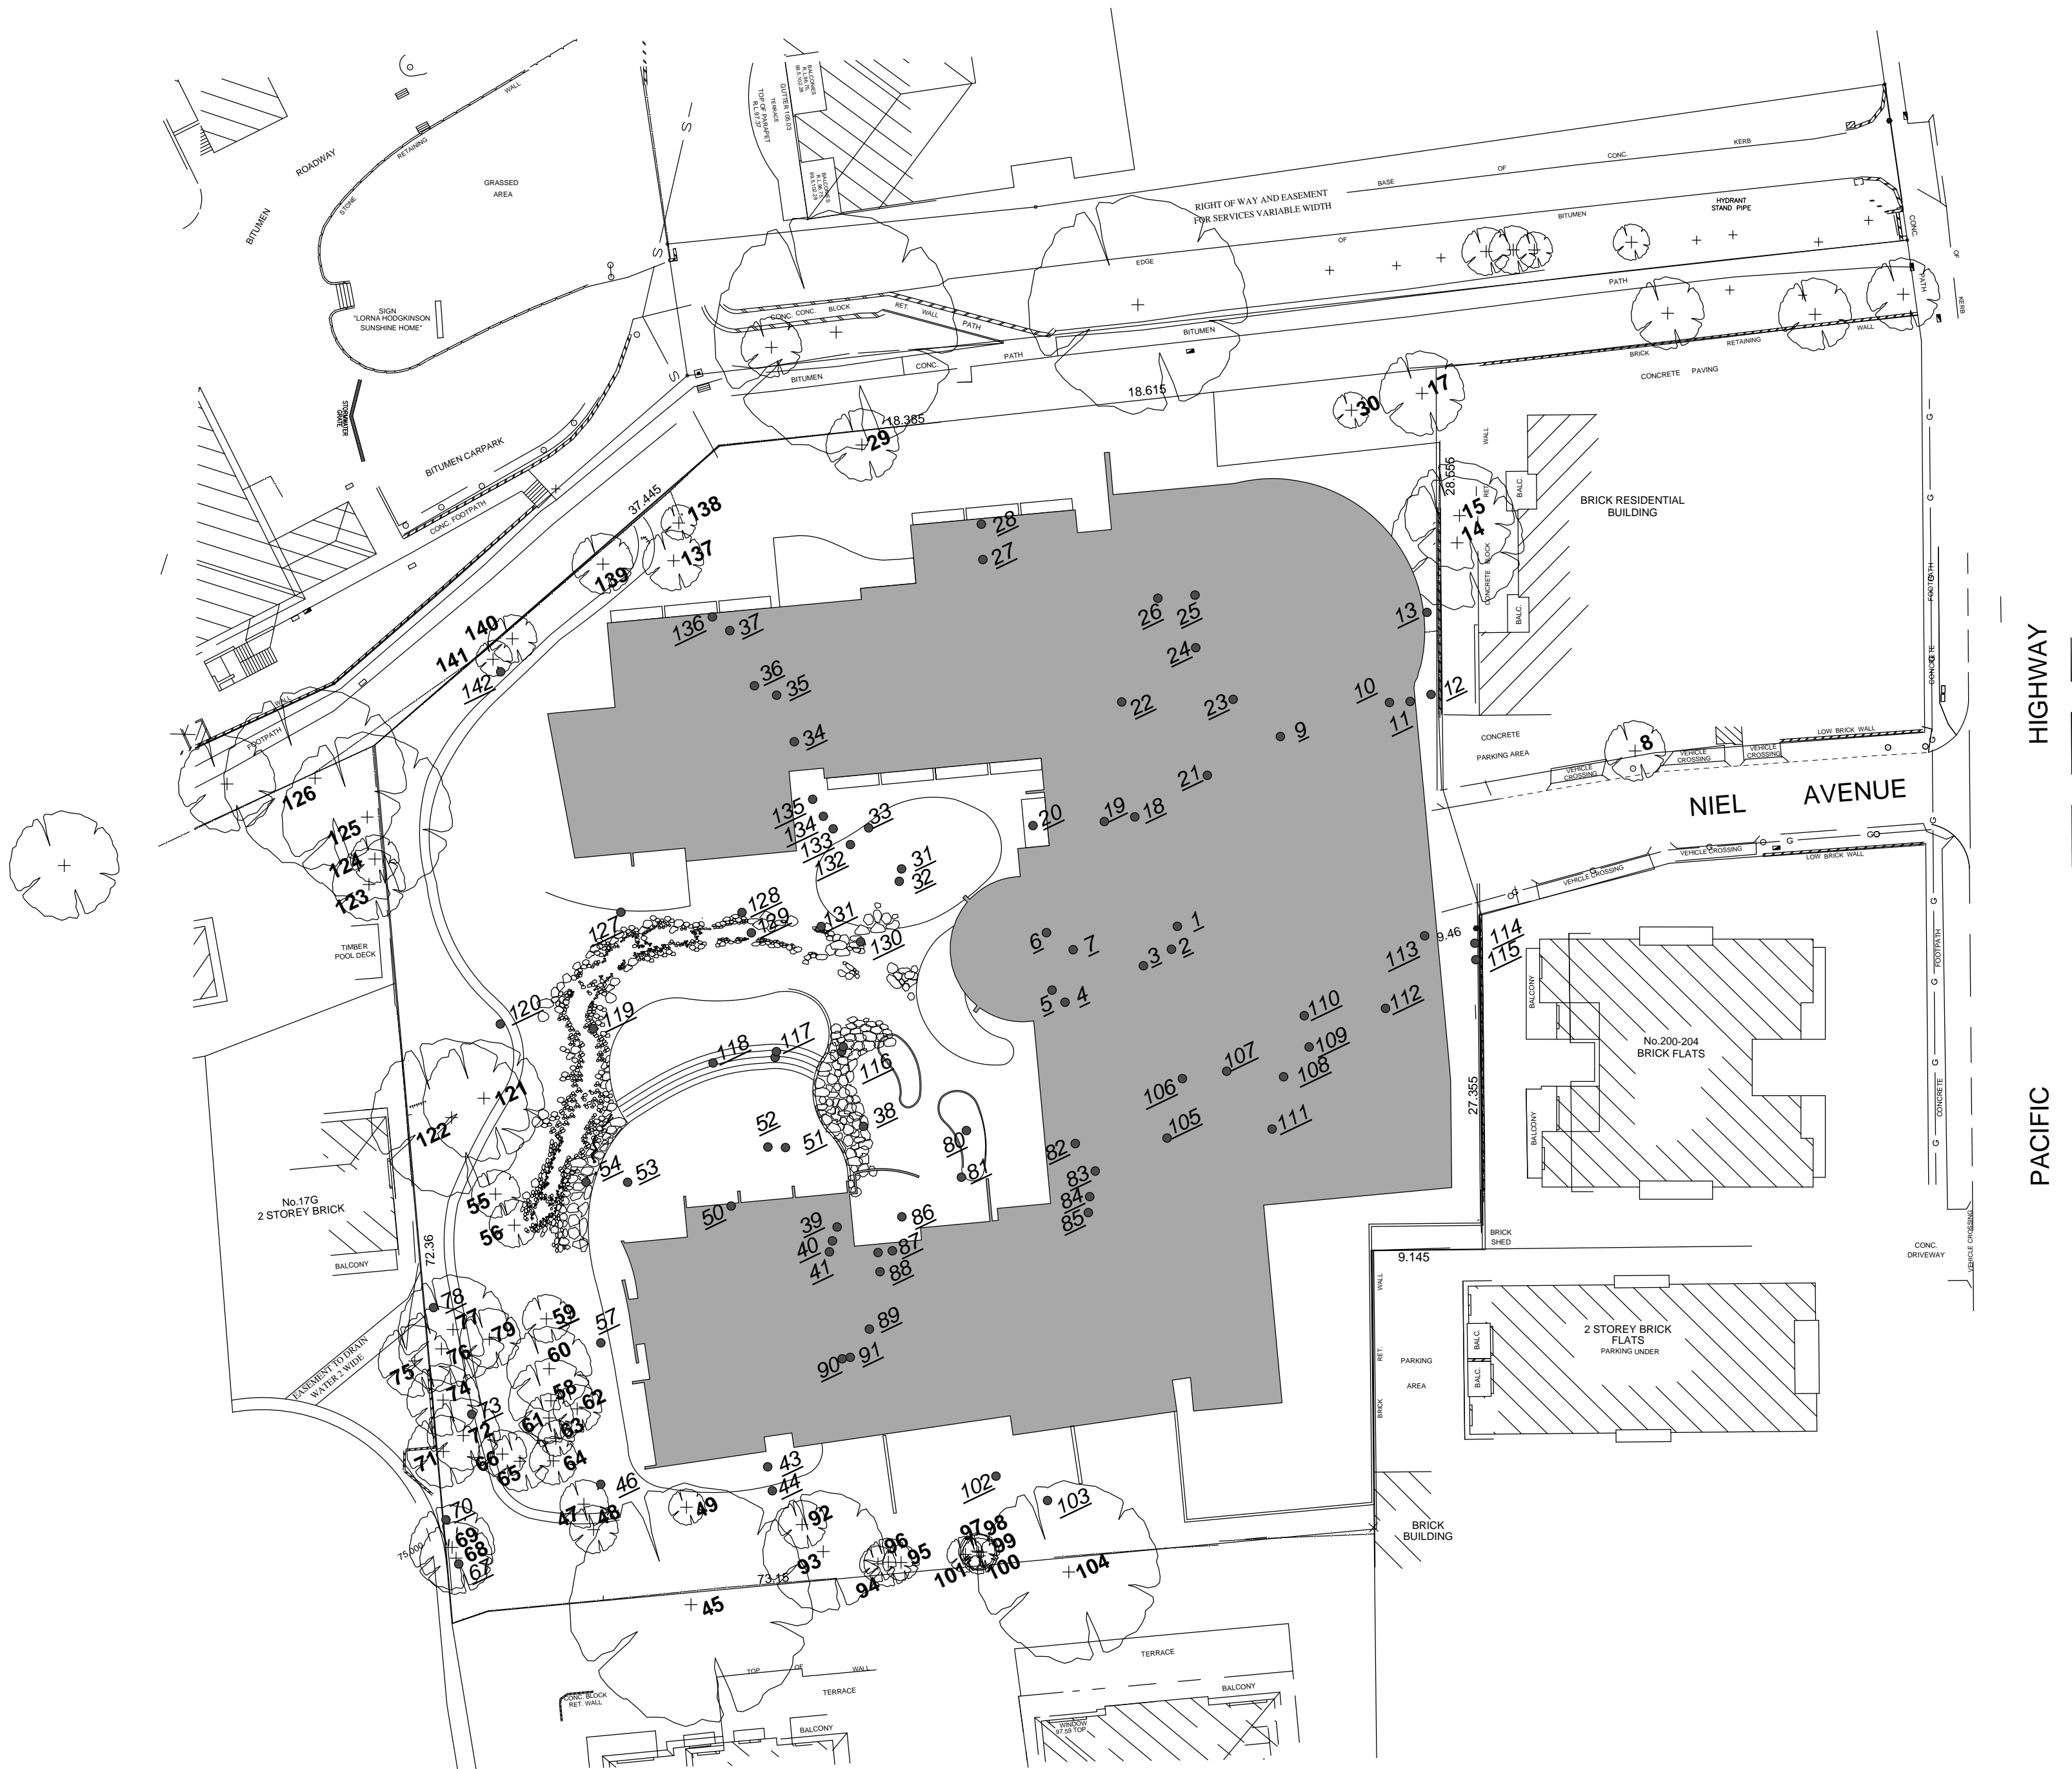
- trees to be retained
- trees to be removed
