BETTYS CREEK STREAM HEALTH AND STABILITY REPORT

June 2020

Prepared for: Integra Underground

SLR Ref: 630.12766
Version No: -v1.0
July 2020

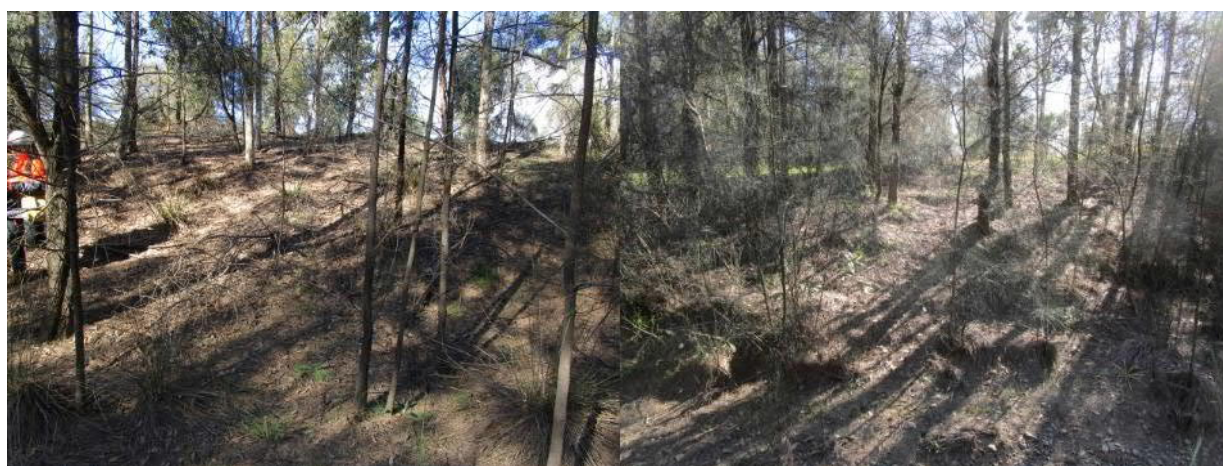
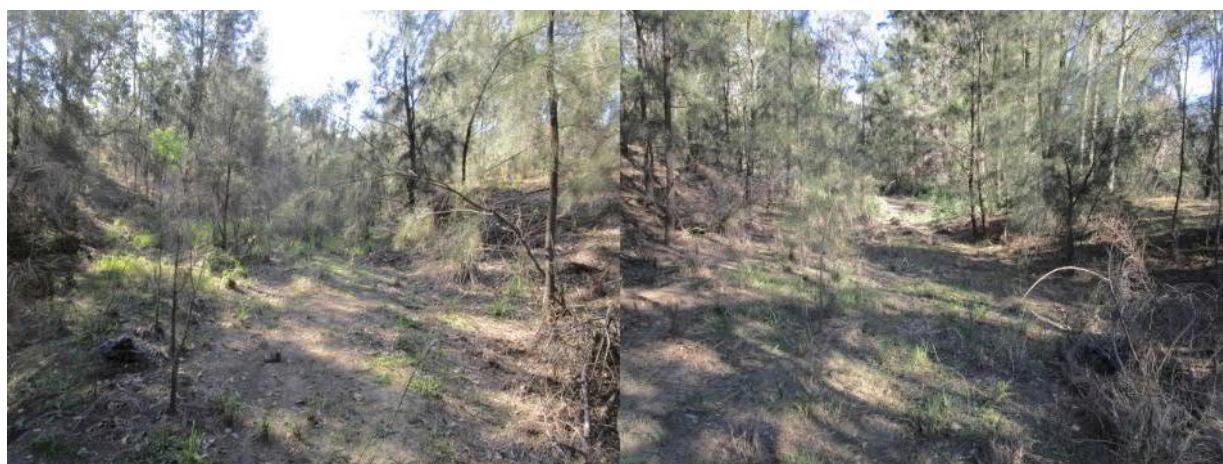
As per monitoring undertaken in October 2019, monitoring point MBD1 appears to be stable with good vegetation coverage. This monitoring point does not appear to have changed since the last assessment. Some erosion was again observed immediately upstream and downstream of this point (refer to Erosion Points E1 and E2).

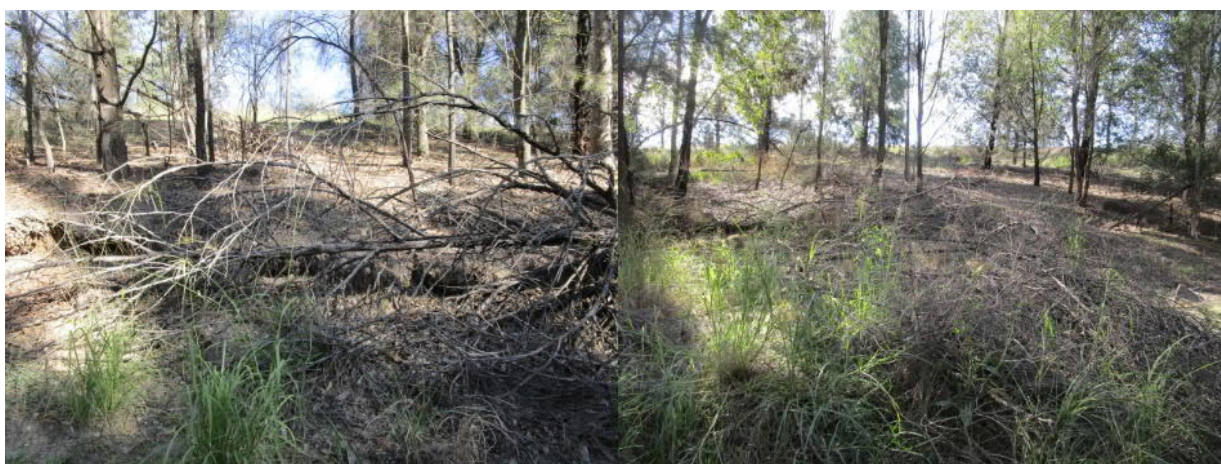
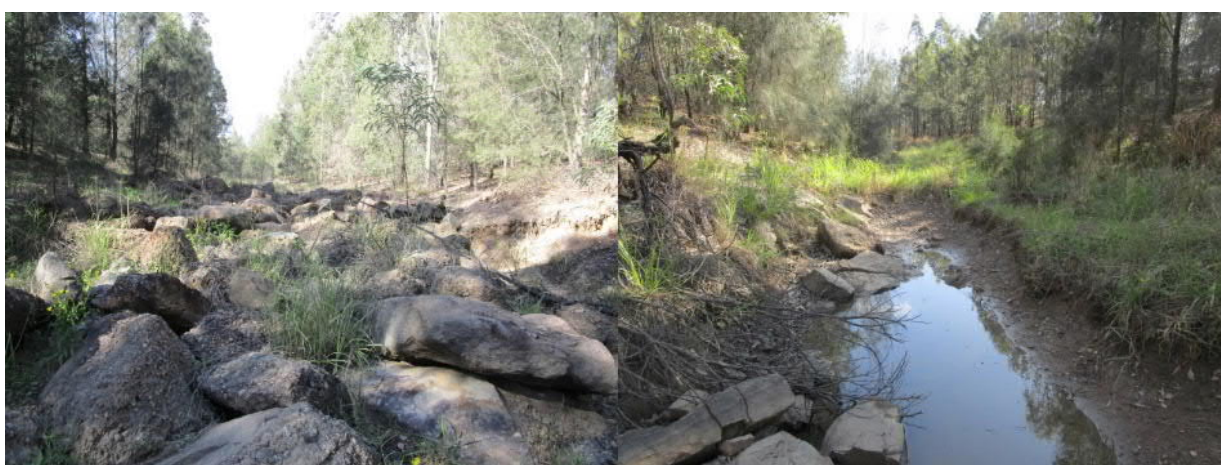
As per monitoring undertaken in October 2019, monitoring point MBD2 appears to be have good vegetation cover, however some exposed soil does exist on the left bank with some minor undercutting of the bank present. The diversion is lined with rip rap immediately upstream from this monitoring point. Unlike the last assessment, ponded water was observed within the channel.

The 'Potentially Stabilising' CSIRO channel stability classification is supported by site observations that suggest the existing erosion is stabilising. The change in the classification from the last round of monitoring is likely the result of small subjective differences brought about by a change of assessor for this round of monitoring rather than the result of a significant changes to the creek stability at this location.

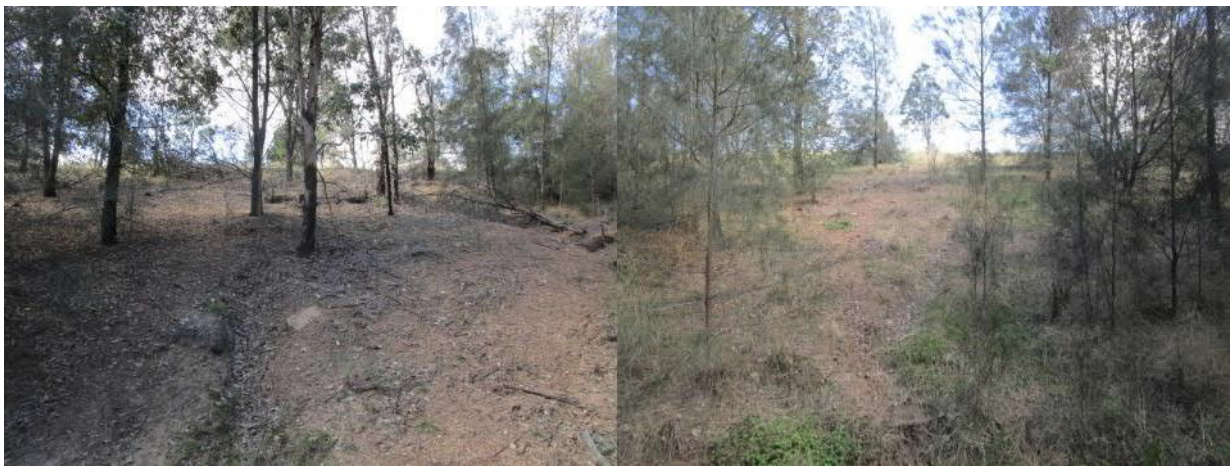
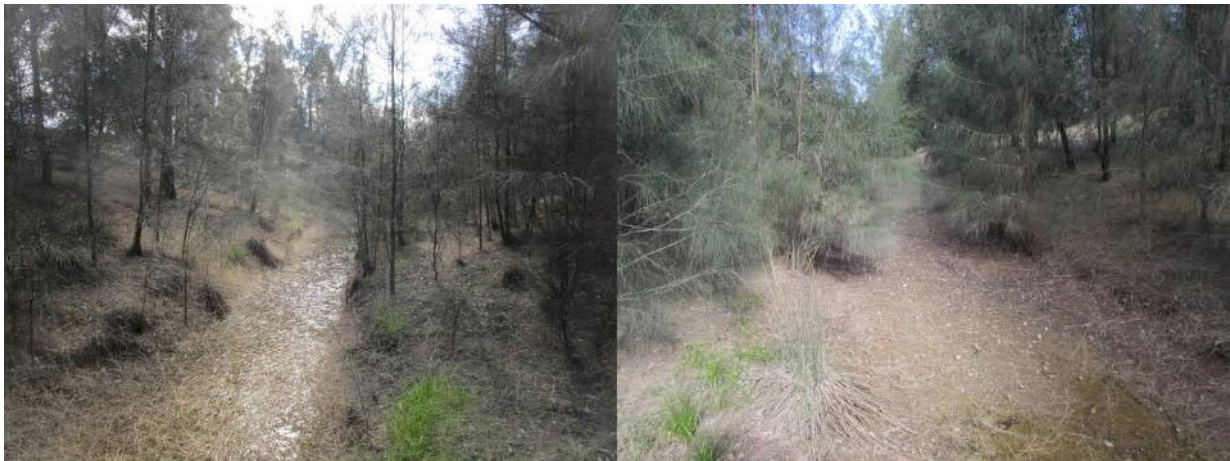
The 'Potentially Stabilising' CSIRO channel stability classification is supported by site observations that suggest the existing erosion is stabilising. The change in the classification from the last round of monitoring is likely the result of small subjective differences brought about by a change of assessor for this round of monitoring rather than the result of a significant changes to the creek stability at this location.

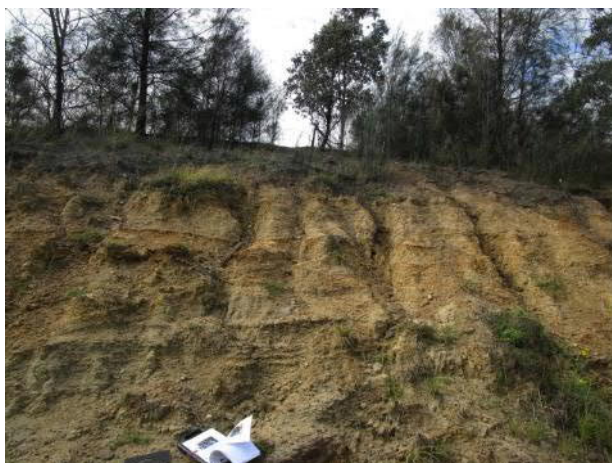
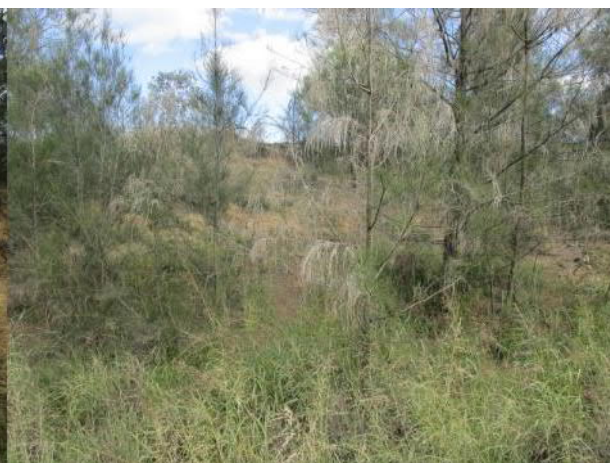
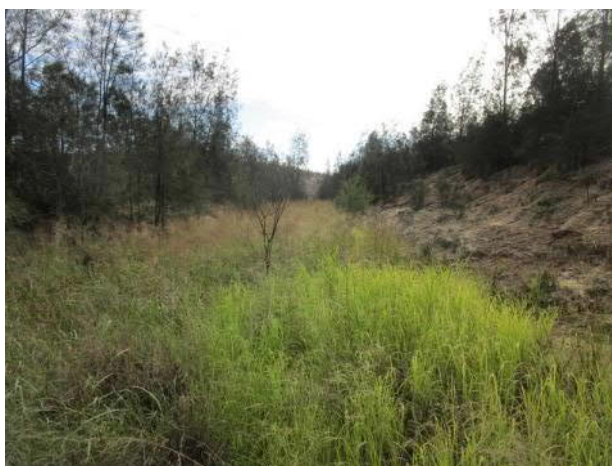
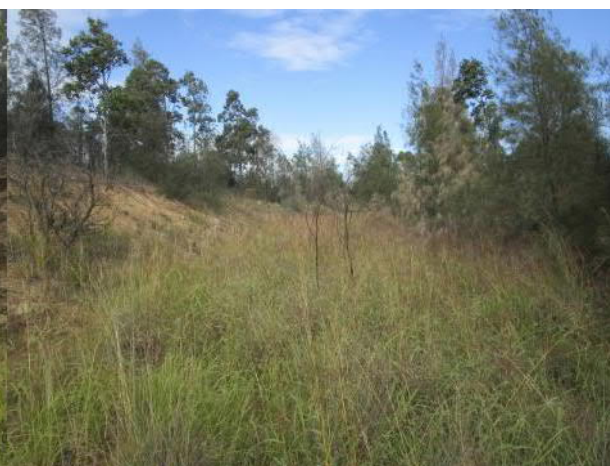
As per monitoring undertaken in October 2019, the left bank of the diversion and upstream of MBD4 has significant rill/gully erosion due to the exposed dispersive soils on this bank (refer to Erosion Point E8). Although the left bank appears to be actively eroding no significant changes were observed compared to the last assessment. The right bank and bed appear to be generally stable with some vegetation establishment.

The 'Potentially Stabilising' CSIRO channel stability classification is supported by site observations that suggest the existing erosion is not getting worse and may be stabilising.

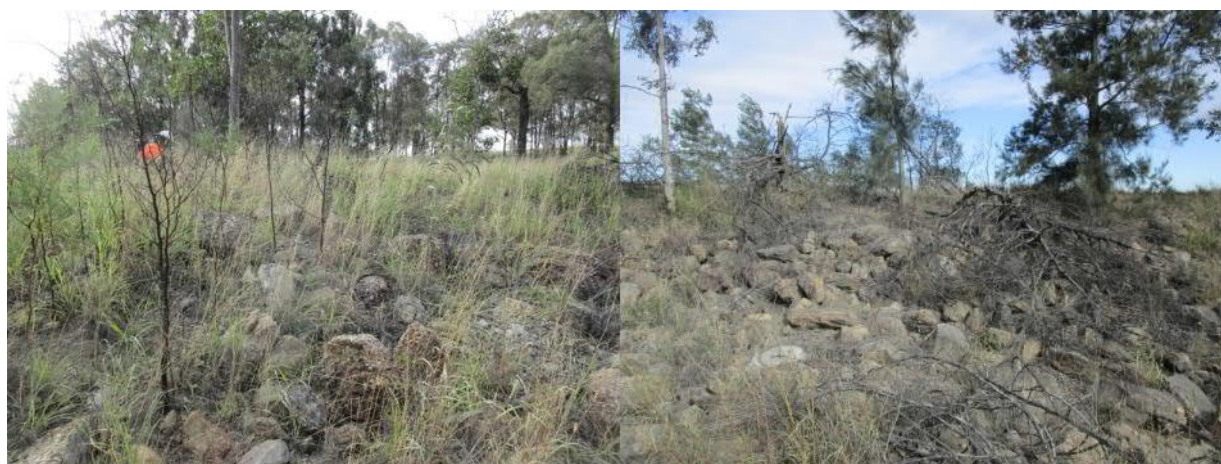
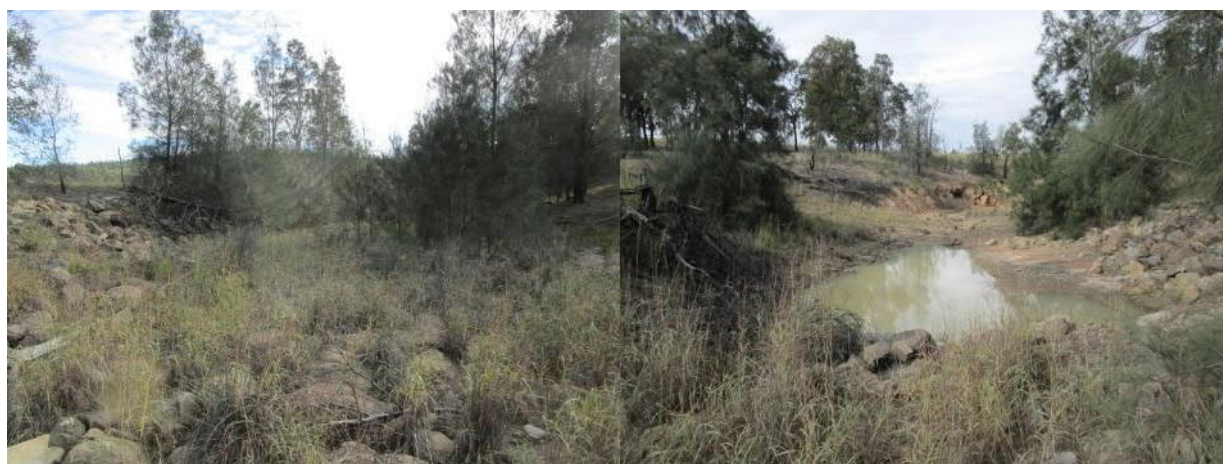
As per monitoring undertaken in October 2019, monitoring point MBD5 appears to be stable however the left bank downstream of MBD5 has significant rill/gully erosion due to the exposed dispersive soils on this bank (refer to Erosion Point E9). Generally, the monitoring point appears to be similar to what was observed during the last assessment with increased amounts of water ponding just downstream of MBD5 during this round of monitoring.

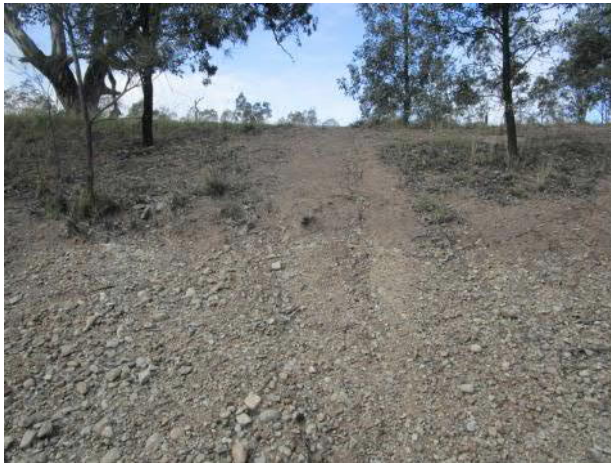
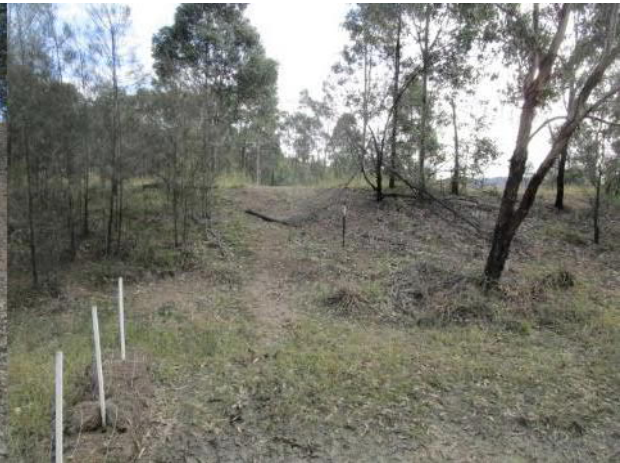
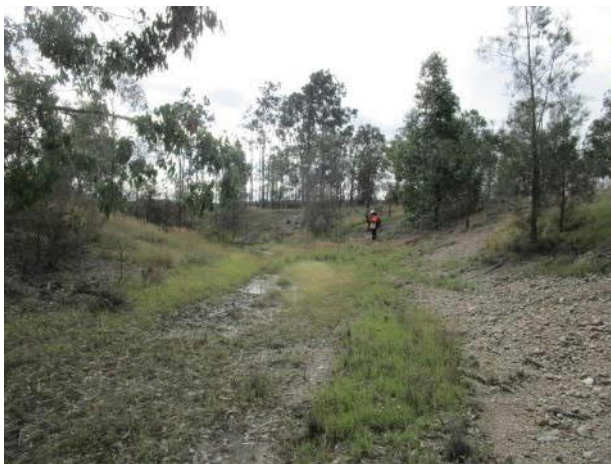
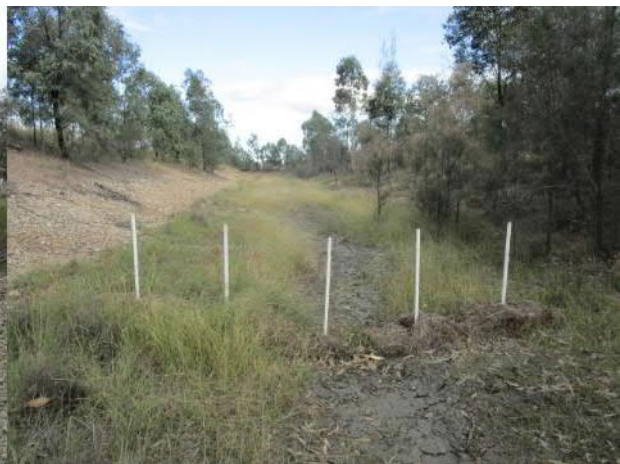
As per monitoring undertaken in October 2019, monitoring point MBD6 appears to be generally stable. Whilst there is limited vegetation establishment on the left bank no scouring of this bank has occurred. This monitoring point is located immediately to the south of the Mt Owen open cut pit and therefore receives very little upslope runoff. A hay bale check dam has been installed within the diversion at this monitoring point which was observed to be deteriorating. A gas pad has now been installed upstream of the monitoring point, with sediment fence around the pad to control sediment laden runoff. During this monitoring round mud was observed at the base of the diversion. An inlet to the diversion located approximately 20m upstream of the monitoring point is significantly eroded (refer to Erosion Point E10). The right bank appears to be stable with good vegetation establishment.

The 'Potentially Stabilising' CSIRO channel stability classification is supported by site observations that the exposed left bank is still not eroding over time.

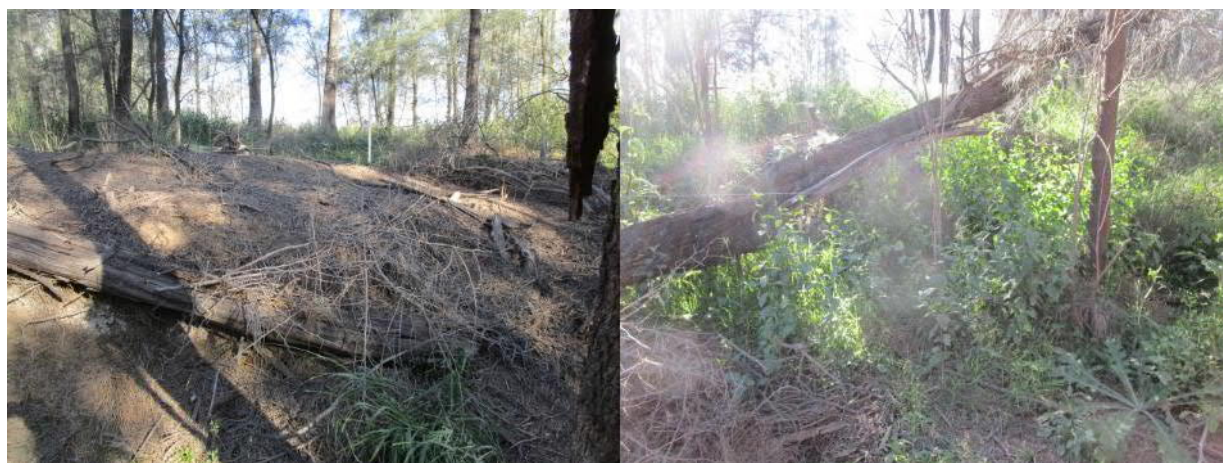
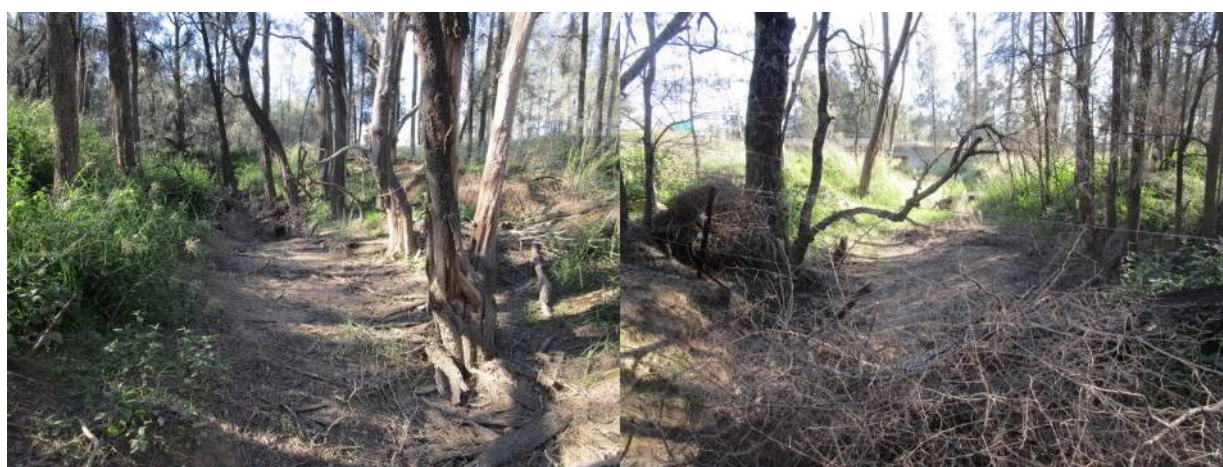
Monitoring point BC1 is located immediately upstream from the rail line crossing where gas and water pipeline works have previously been undertaken. A hay bale coffer dam has been installed upslope of these works and is starting to deteriorate. As per monitoring undertaken in October 2019, the site is stable with good tree coverage immediately adjacent to the creek.

The 'Stable' CSIRO channel stability classification is supported by site observations that indicate that creek is stable at this location.

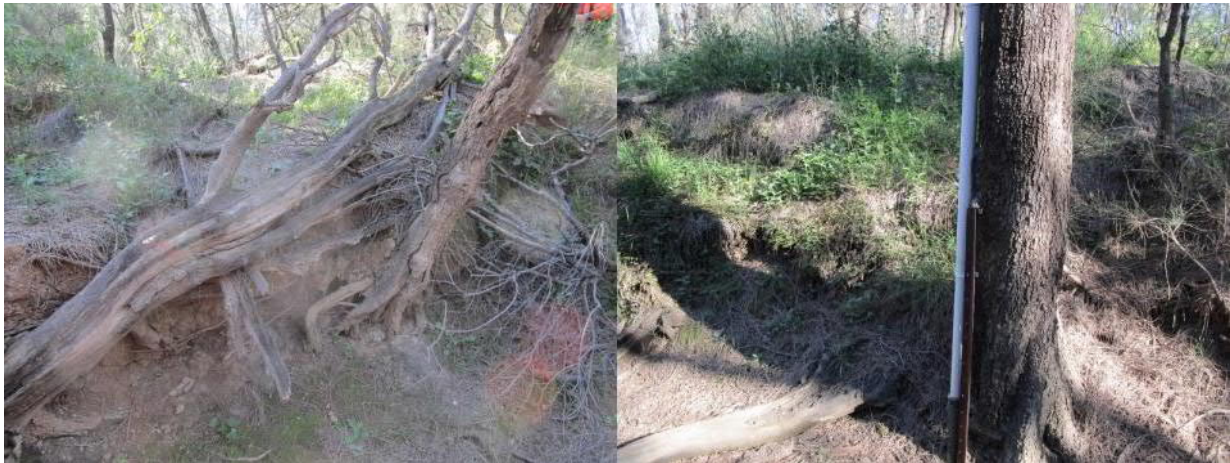
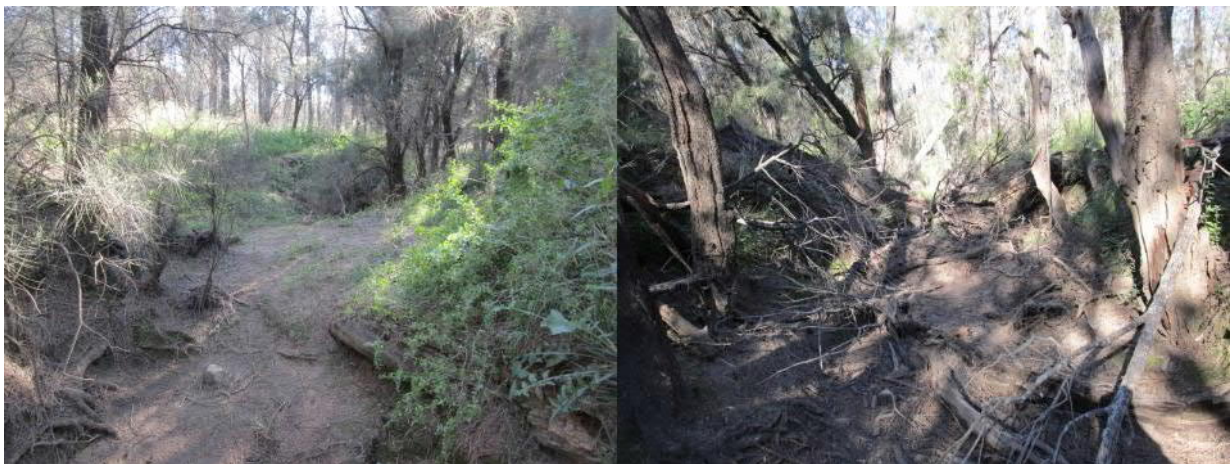
Monitoring point BC3 is located at the water level meter labelled as BC3. This monitoring point is situated downstream of a side arm inlet on the left bank. As per monitoring undertaken in October 2019, monitoring point BC3 is stable with good tree coverage immediately adjacent to the creek. The monitoring point is generally covered with leaf litter with some fallen trees / logs in the area. Some minor undercutting is present at and downstream of the monitoring point on the right bank, however, the right bank does not appear to be actively eroding. Some minor undercutting was also observed on the left bank during this monitoring round. No water was observed to be ponding in this section of the creek during the site inspection.

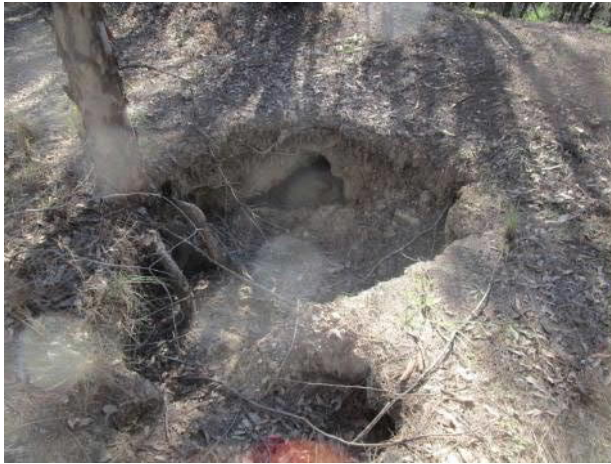
As per earlier monitoring undertaken in October 2019, erosion observed at E1 included tunnel erosion on the left bank downstream from monitoring point MBD2. This tunnel erosion begins in the upslope contour bank and appears to have gotten significantly worse since previous inspections. The contour bank contains a significant scour hole (4m x 2m x 1.5m) and a tree with exposed roots within this scour hole. It is possible that this tunnel was created by a wombat and has subsequently eroded. There is a high potential for ongoing erosion of this area.

Plate 37 Tunnel Erosion on Left Bank (entry)

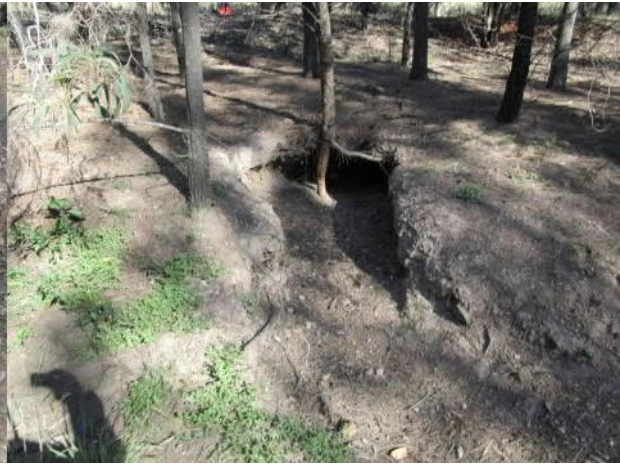
Plate 38 Tunnel Erosion on Left Bank (exit)

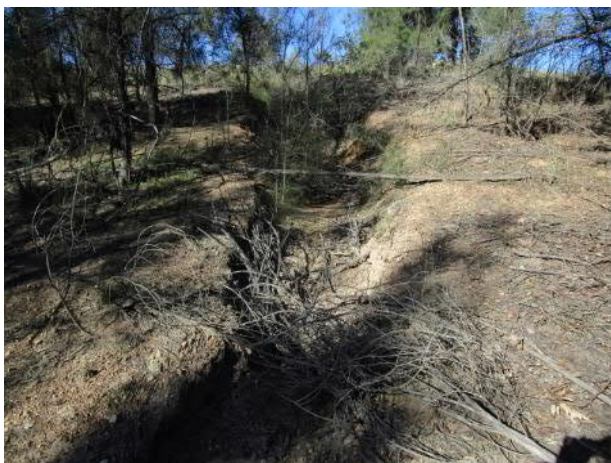
Plate 39 Gully Erosion on Left Bank (1)

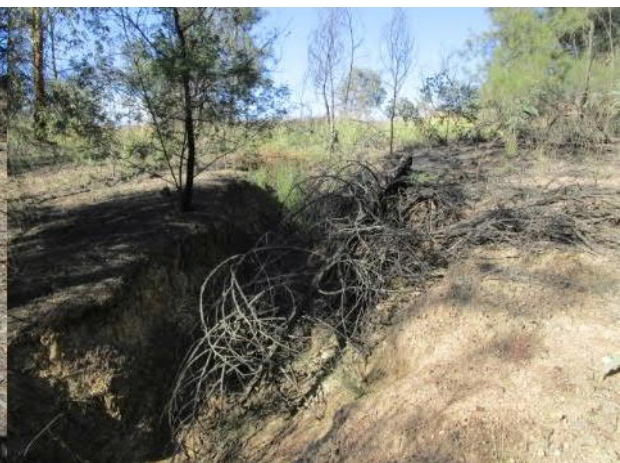
Plate 40 Gully Erosion on Left Bank (2)

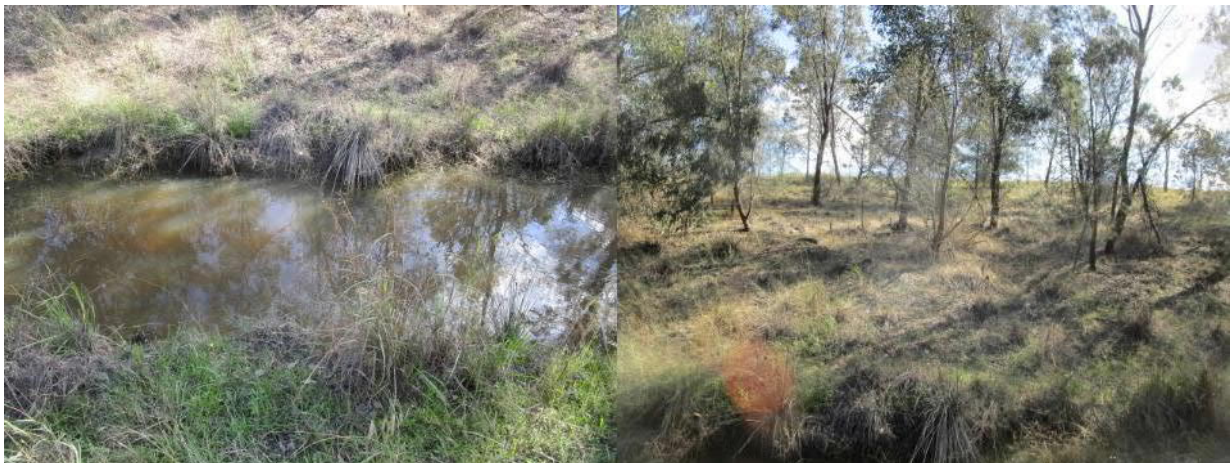
As per earlier monitoring undertaken in October 2019, a section on the right bank has eroded with vertical, slightly undercut banks. A scour hole previously observed at the toe of the left bank could not be found during this round of monitoring, possibly due to the additional volume of water ponded in the creek. This erosion doesn't appear to have progressed significantly since the last inspection but additional ponded water in the creek bed has made any comparison difficult.

The lateral crack observed near the top of the left bank in the last assessment still exists and is still approximately 10m long, 20cm wide and 20cm deep. This crack could be a result of settlement of the fill material at the interface of the natural ground and fill material following construction of the channel. Similar cracks were observed on the left bank in several sections of the Bettys Creek diversion, and all were identified prior to the recent longwall mining activities.

Plate 41 Water Ponding in Creek Bed

Plate 42 Vegetation on Right Bank

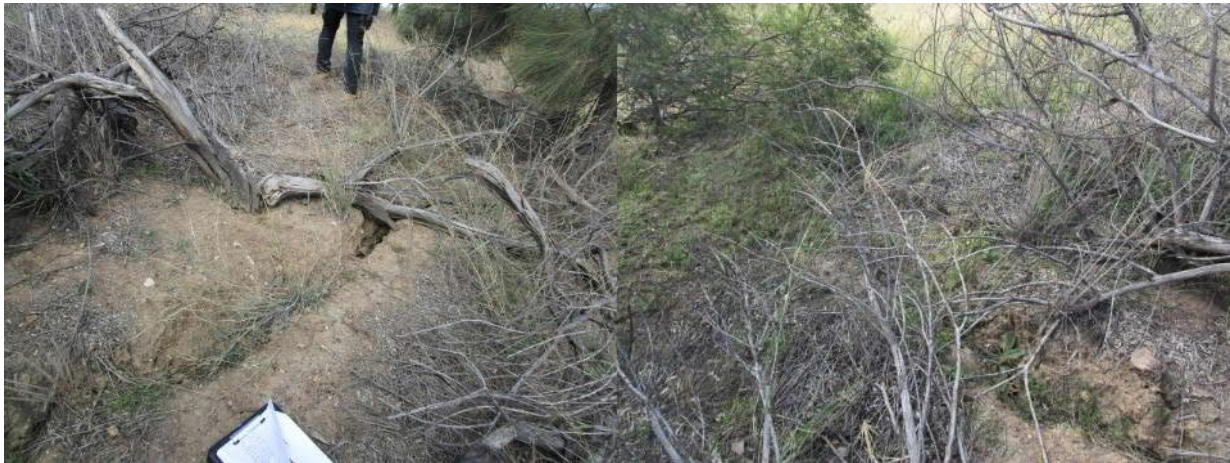
As per earlier monitoring undertaken in October 2019, a lateral crack was observed near the top of the left bank at E4. Similarly to other locations, this crack was approximately 20cm wide, 20cm deep and extended over a length greater than 50m. The crack becomes quite substantial above the top of the left bank. This crack is also located along the interface between natural ground and fill material of the ERP. The initial cracking is not likely to be related to subsidence from underground longwall mining but may have been increased by the mining of Longwalls 13, 14 and 15. Similar cracks were observed on the left bank in several sections of the Bettys Creek diversion and all were identified prior to the recent longwall mining activities.

Plate 43 Lateral Crack on Left Bank (1)

Plate 44 Lateral Crack on Left Bank (2)

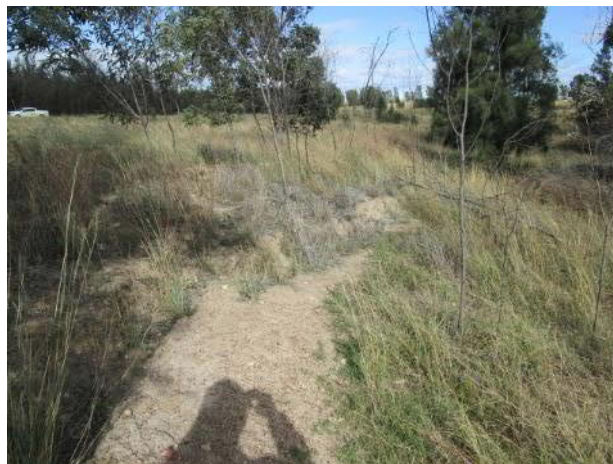
Plate 45 Vegetation on Left Bank

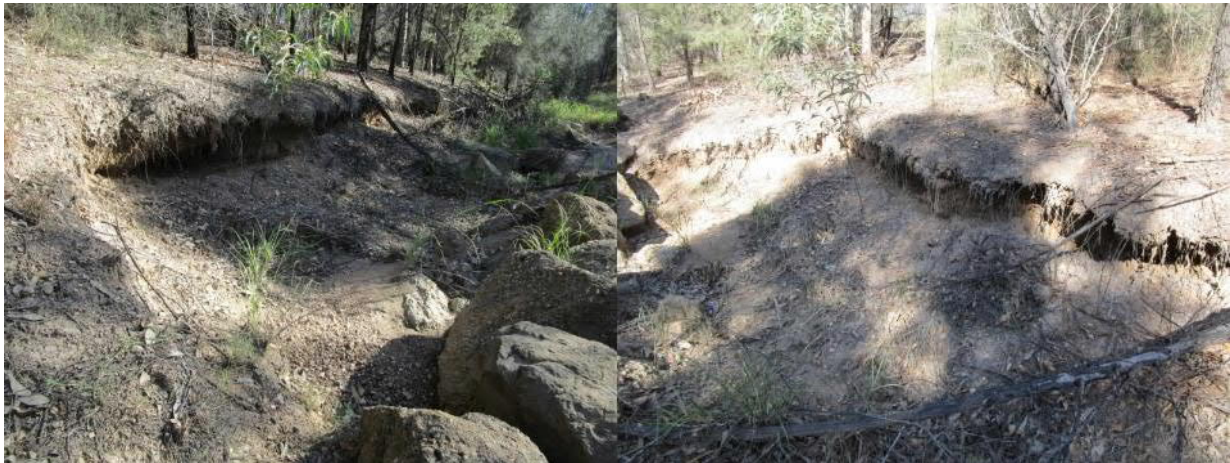
Plate 46 Scouring of Left Bank (1)

Plate 47 Scouring of Left Bank (2)

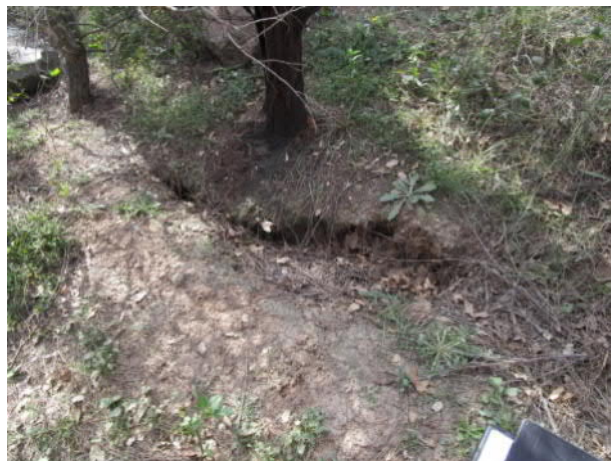
As per earlier monitoring undertaken in October 2019, a lateral crack was observed near the top of the left bank adjacent to a hickory wattle tree. Similarly to other locations, this crack was approximately 10m long, 20cm wide and 20-30cm deep. This crack is located along the interface between natural ground and fill material of the ERP. The initial cracking is not likely to be related to subsidence from underground longwall mining but may have been increased by the mining of Longwalls 13 and 14. Similar cracks were observed on the left bank in several sections of the Bettys Creek diversion and all were identified prior to the recent longwall mining activities.

Plate 48 Lateral Crack on Left Bank

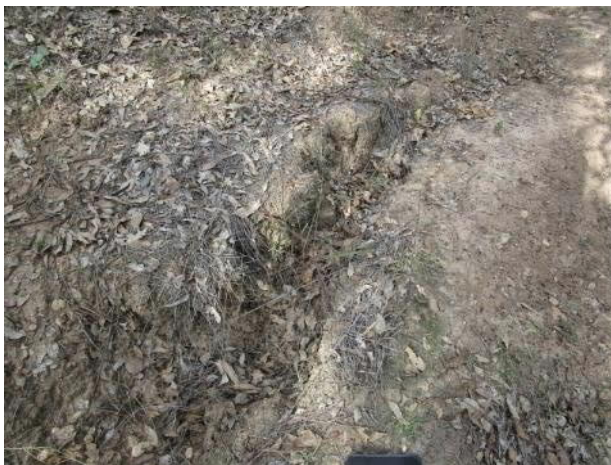
As per earlier monitoring undertaken in October 2019, a lateral crack (approximately 10m long, 20cm wide and 20cm deep) was observed near the top of the left bank at E7. This crack is located along the interface between natural ground and fill material of the ERP. Similar cracks were observed on the left bank in several sections of the Bettys Creek diversion and all were identified prior to the recent longwall mining activities.

Plate 49 Lateral Crack on Left Bank (1)

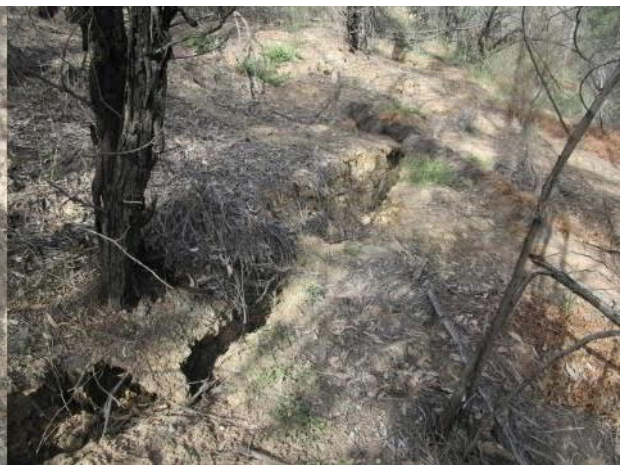
Plate 50 Lateral Crack on Left Bank (2)

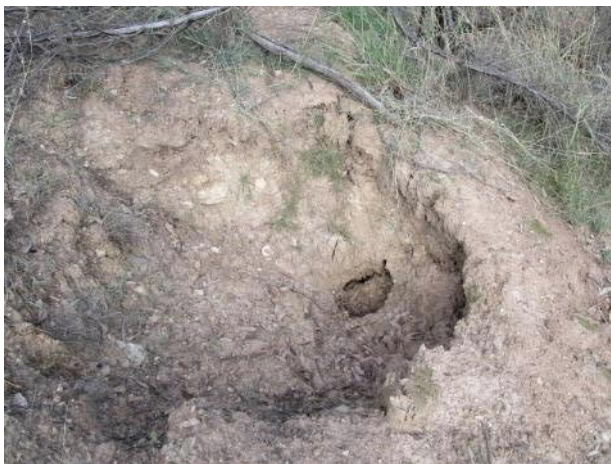
The crack appears to be similar to what was observed in the last assessment however, significant tunnel erosion was observed in the crack at several locations which was not present in October 2019. These tunnel erosion entrances are approximately 0.5m x 0.5m but the extent of the tunnel erosion could not be determined.

Plate 51 Tunnel Erosion on Left Bank (1)

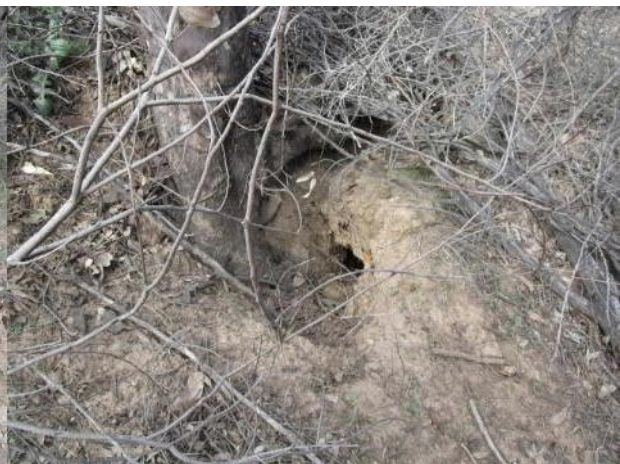
Plate 52 Tunnel Erosion on Left Bank (2)

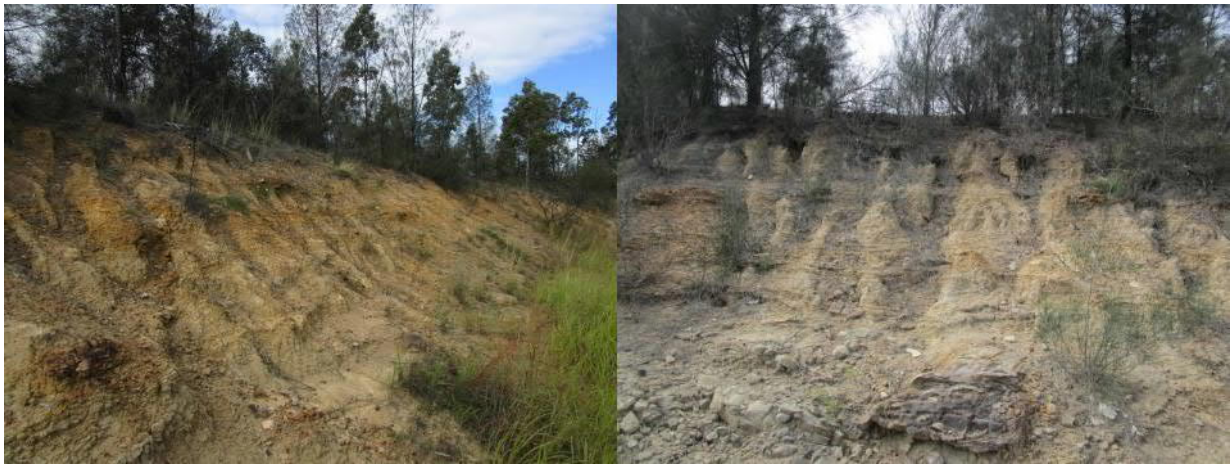
As per earlier monitoring undertaken in October 2019, the left bank of the diversion has exposed dispersive material present along several hundred metres between monitoring points MBD4 and MBD5. Rill erosion has occurred along the bank within this reach of the diversion and appears to be actively eroding due to the lateral inflows, steepness of the bank, and dispersive nature of the soils. Although this bank is actively eroding, no notable change in condition was observed since the last assessment.

Plate 53 Rill Erosion on Left Bank (1)

Plate 54 Rill Erosion on Left Bank (2)

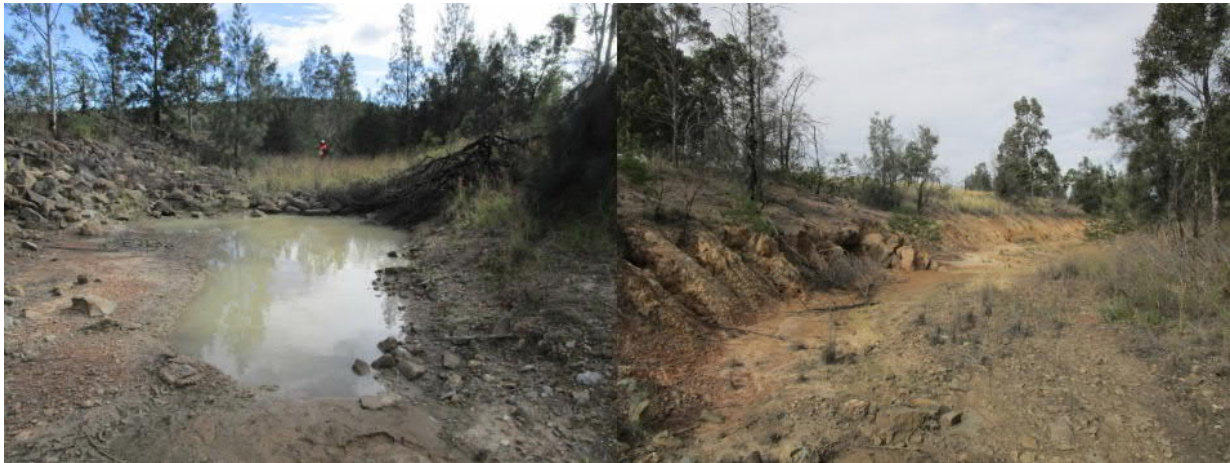
As per earlier monitoring undertaken in October 2019 and similar to E8, the diversion has exposed dispersive material present along the left bank. Rill erosion has occurred along the bank within this reach of the diversion and appears to be slightly worse since the last round of monitoring and actively eroding due to the lateral inflows. The mass wasting of the left-hand bank observed during the last assessment does not appear to have gotten worse.

Plate 55 Ponded Water in Diversion

Plate 56 Rill Erosion on Left Bank

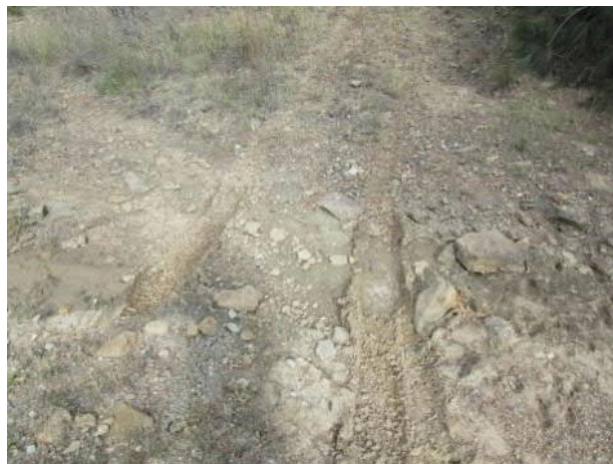
Muddy vehicle tracks were observed in the diversion at this location which appeared to have occurred relatively recently.

Plate 57 Evidence of Vehicle Movement Through Mud on Left Bank

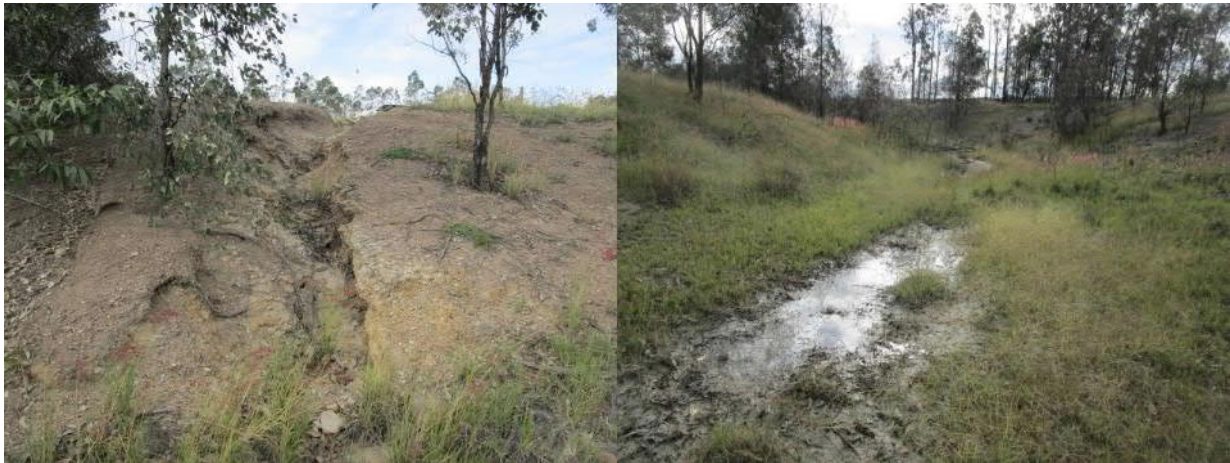
Plate 58 Erosion Left Bank

Plate 59 Water Poned in Diversion Downstream

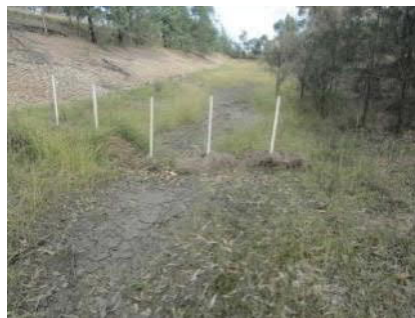
Plate 60 Hay Bale Downstream

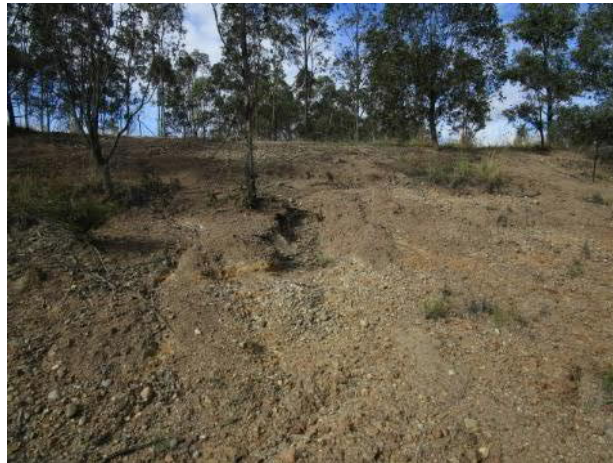
Plate 61 Erosion on Left Bank

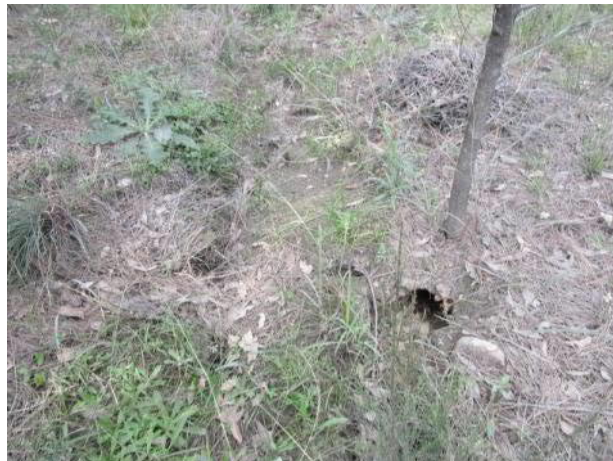
Plate 62 Cracking in Creek Bed (2)

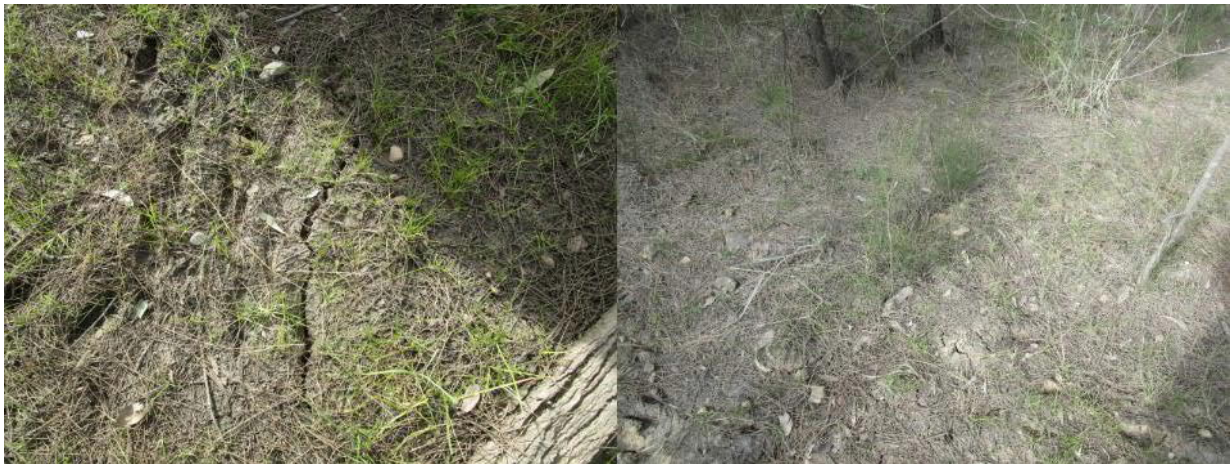
Plate 63 Cracking in Creek Bed (1)

Plate 64 Cracking in Creek Bed (2)

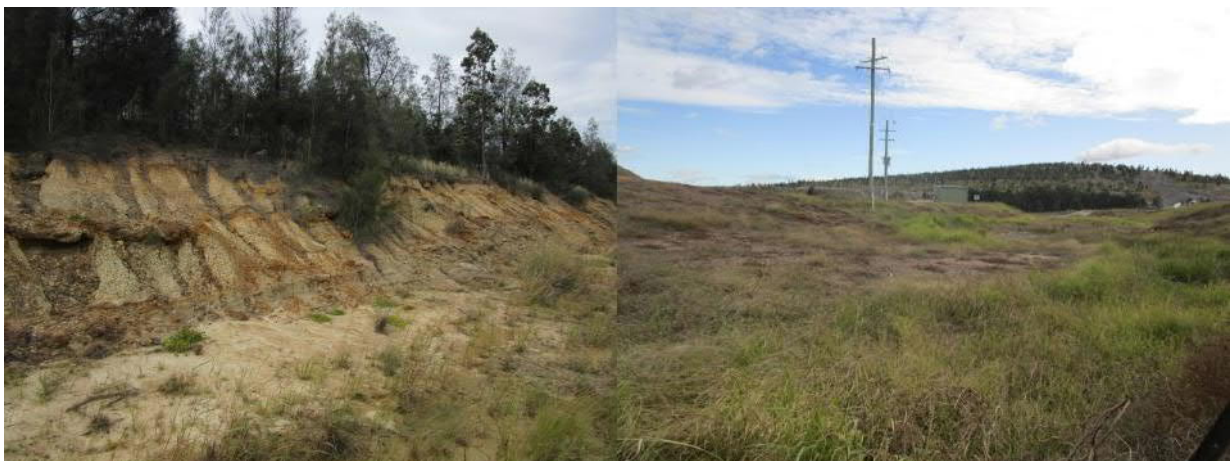
Plate 65 Rill Erosion on Left Bank

Plate 66 Vegetation on Right Bank

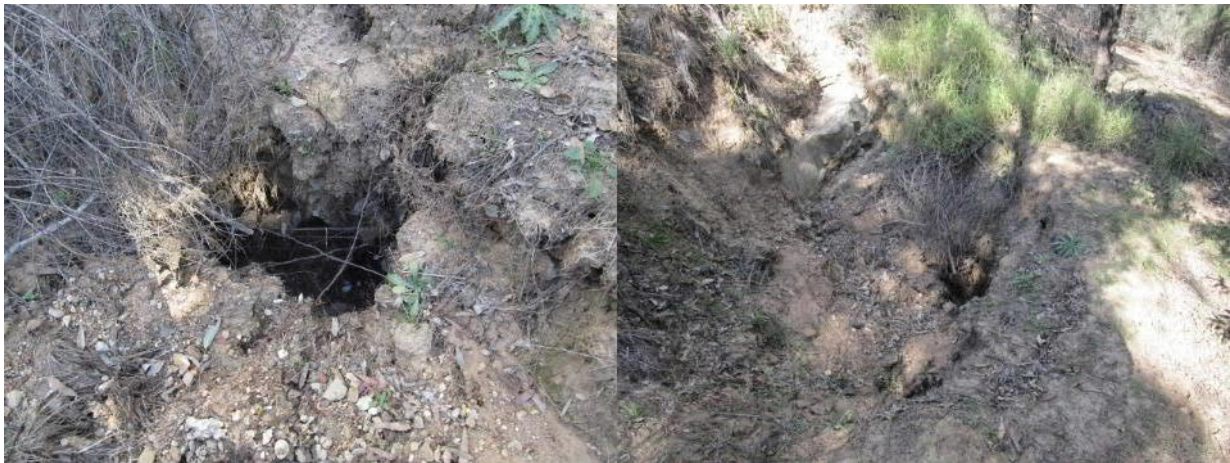
Plate 67 Tunnel Erosion on Left Bank (1)

Plate 68 Tunnel Erosion on Left Bank (2)

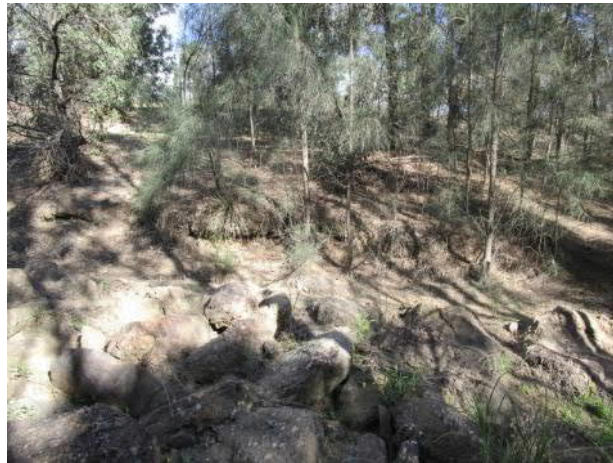
Plate 69 Undercutting of Left Bank

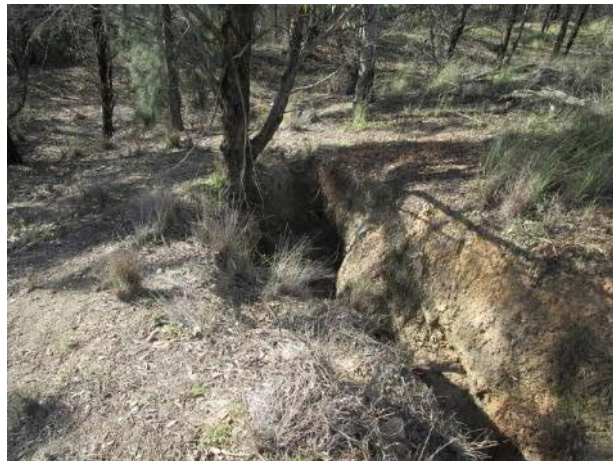
Plate 70 Erosion on Left Bank

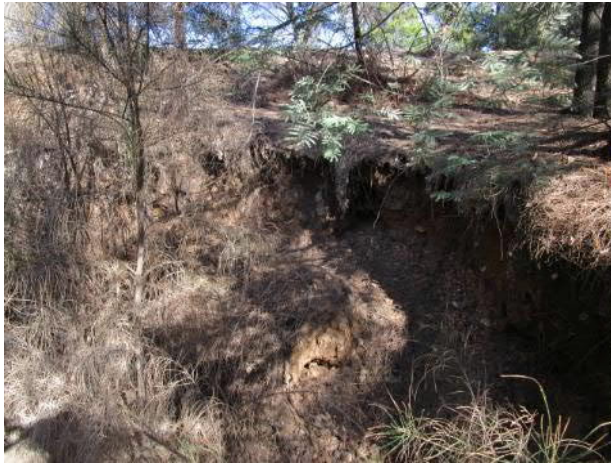
Plate 71 Undercutting of Bank (1)

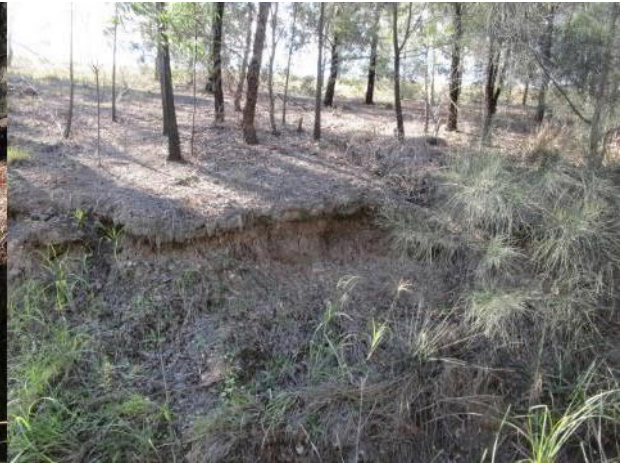
Plate 72 Undercutting of Bank (2)

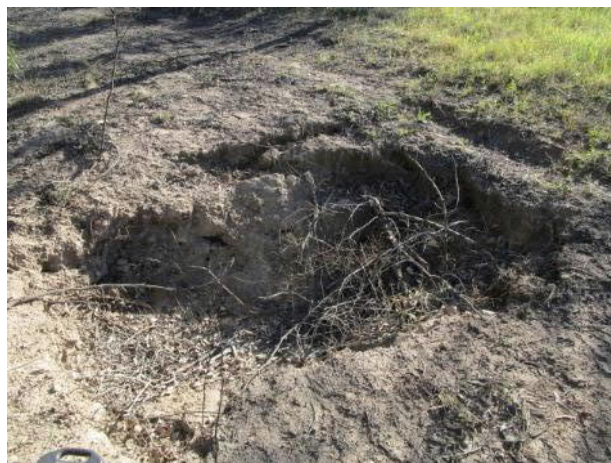
Plate 73 Scour Hole on the Right Bank

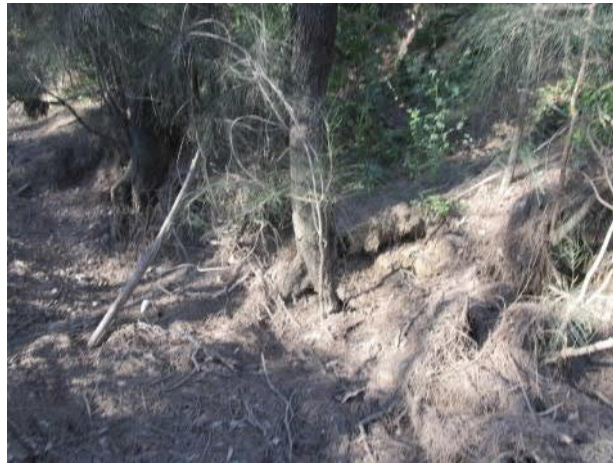
Plate 74 Undercutting of Left Bank
