BETTYS CREEK STREAM HEALTH AND STABILITY REPORT

June 2020

Prepared for: Integra Underground

SLR Ref: 630.12766
Version No: -v1.0
July 2020

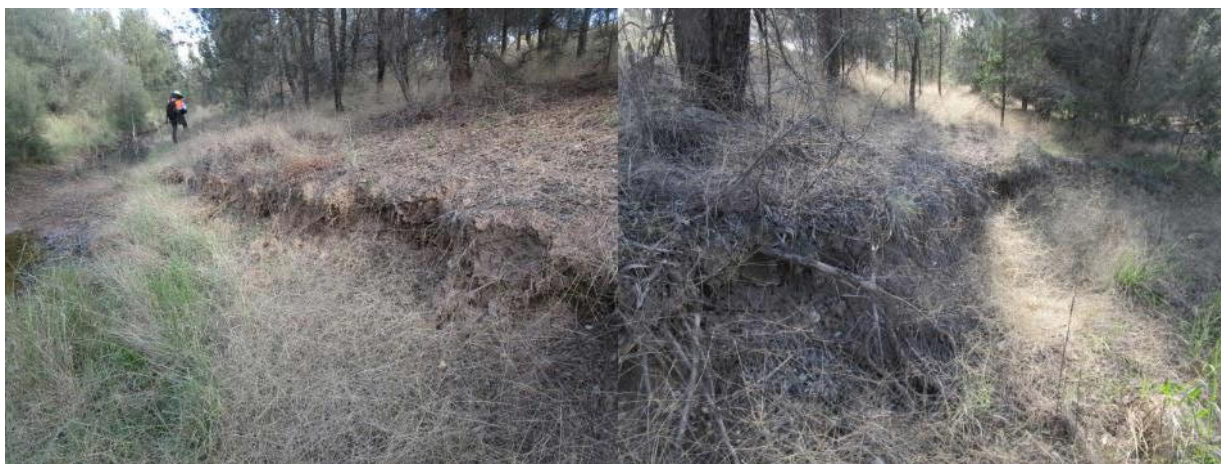
Plate 75 Undercutting of Right Bank (1)

Plate 76 Undercutting of Right Bank (2)

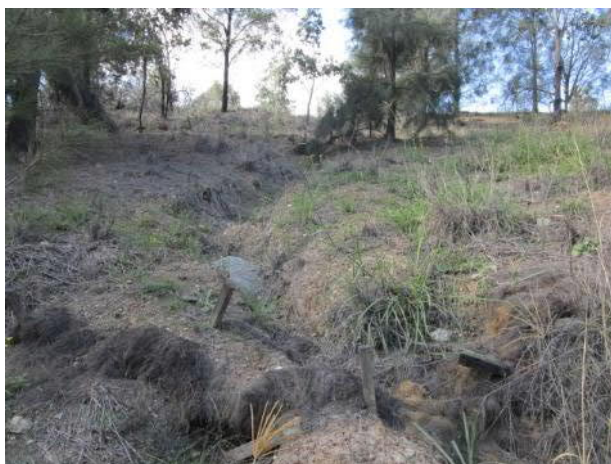
Plate 77 Gully Inlet Erosion on Left Bank
