Our ref: 125.89220

29 September 2022

**Appin Area 7 and Area 9, Extraction Plan  
Appin Longwalls 709-711 and Longwall 905  
GHD response to Approval Conditions**

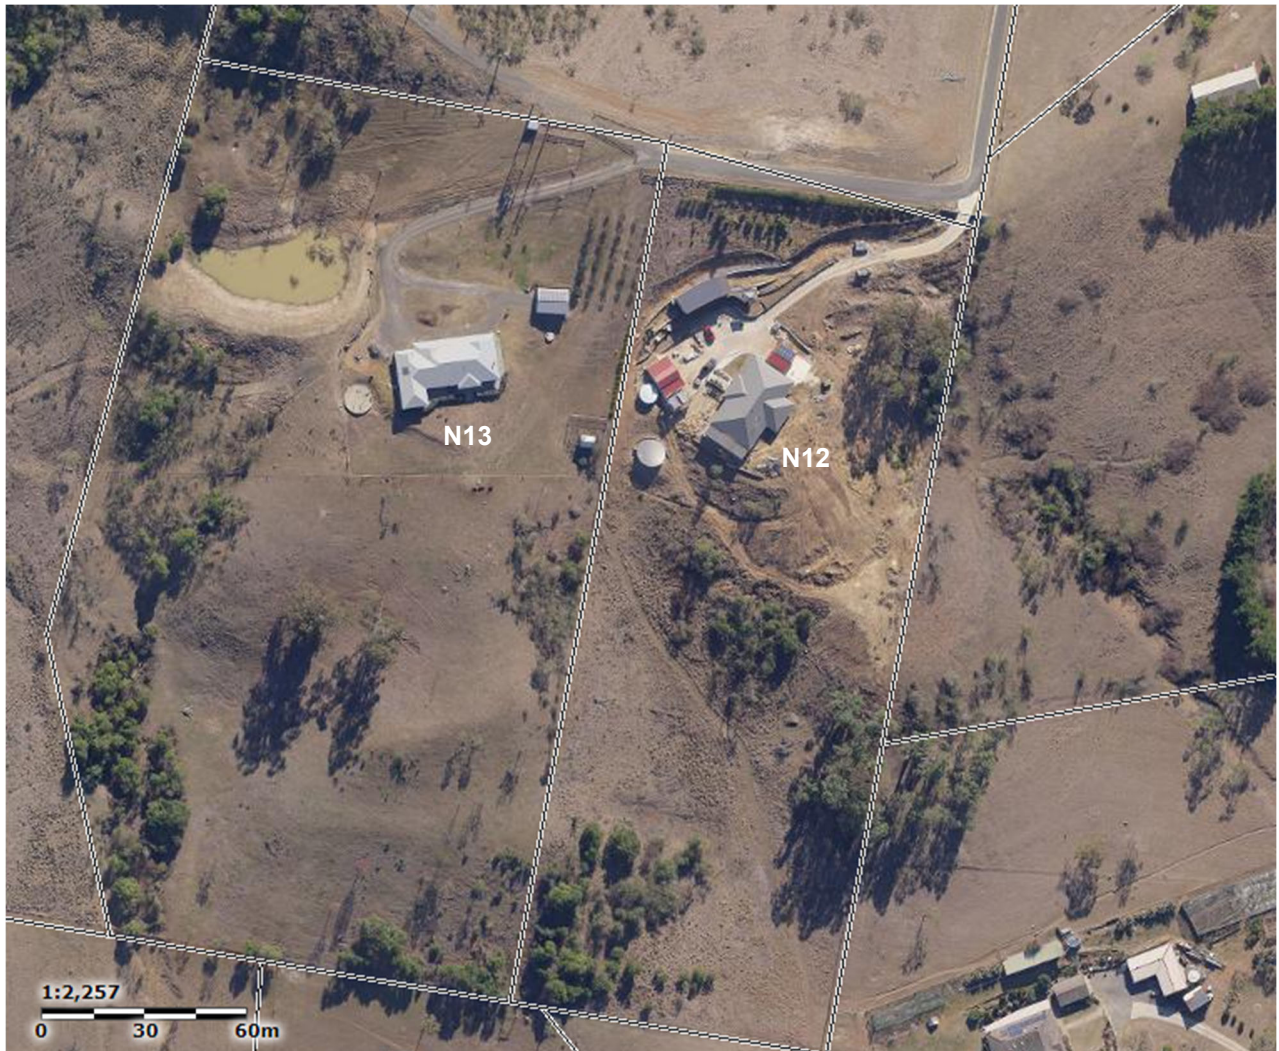
**Figure 01:** Property setting for Structure References N13 and N12 (ref: SIX Maps)

Structure Identification	Indicative Cumulative Hazard Rating	Context of Rating
N13 and N12 [refer Figure 01]	High	Structures are situated upon steep slopes below crest of ridgeline, are immediately adjacent to or over the footprint of LW905, the landform has been significantly modified to develop the building platforms. Nature and form of structure foundation system to be determined. Nature and quality of earthworks to be determined.
N16 and N15 [refer Figure 02]	Low	Structures are situated upon the crests of relatively level rounded ridgelines with expectation of shallow depth to shale bedrock. Dwellings are situated about half a panel-width outside the footprint of LW905 and over footprint of previously mined LW904.
N18 [refer Figure 03]	Low	Structure situated upon lower slopes well away from the Razorback Escarpment cliff-lines and outside extent of previous debris flows associated with natural slope forming processes endemic to the study area. Dwelling is situated approximately one panel-width outside the footprint of LW905 at the starting end, and situated over previously mined LW904.

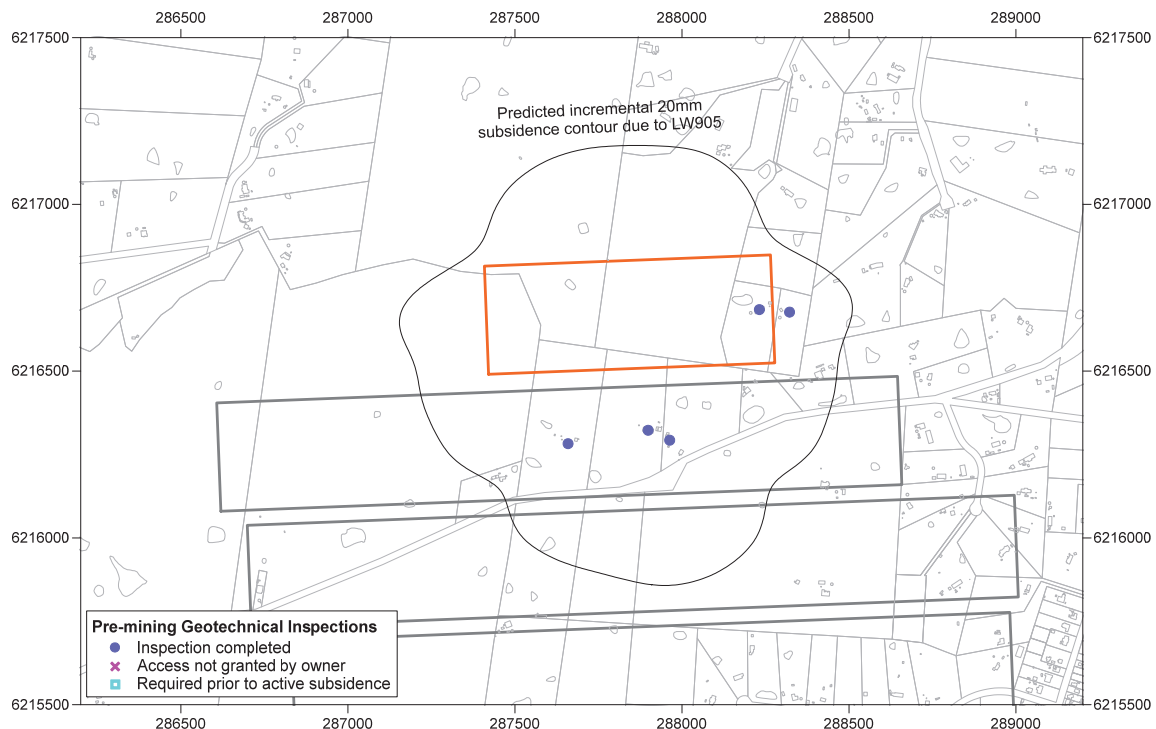
**Fig. 6.1 Pre-mining geotechnical inspections**

The pre-mining geotechnical inspections have been completed for five properties located within the Study Area (refer to Table 5.2). None have been declined or are pending. Geotechnical inspections are not required for the remaining properties within the Study Area because they are either not located on or near steep slopes or they are predicted to experience less than 150 mm total vertical subsidence after the mining of LW905.

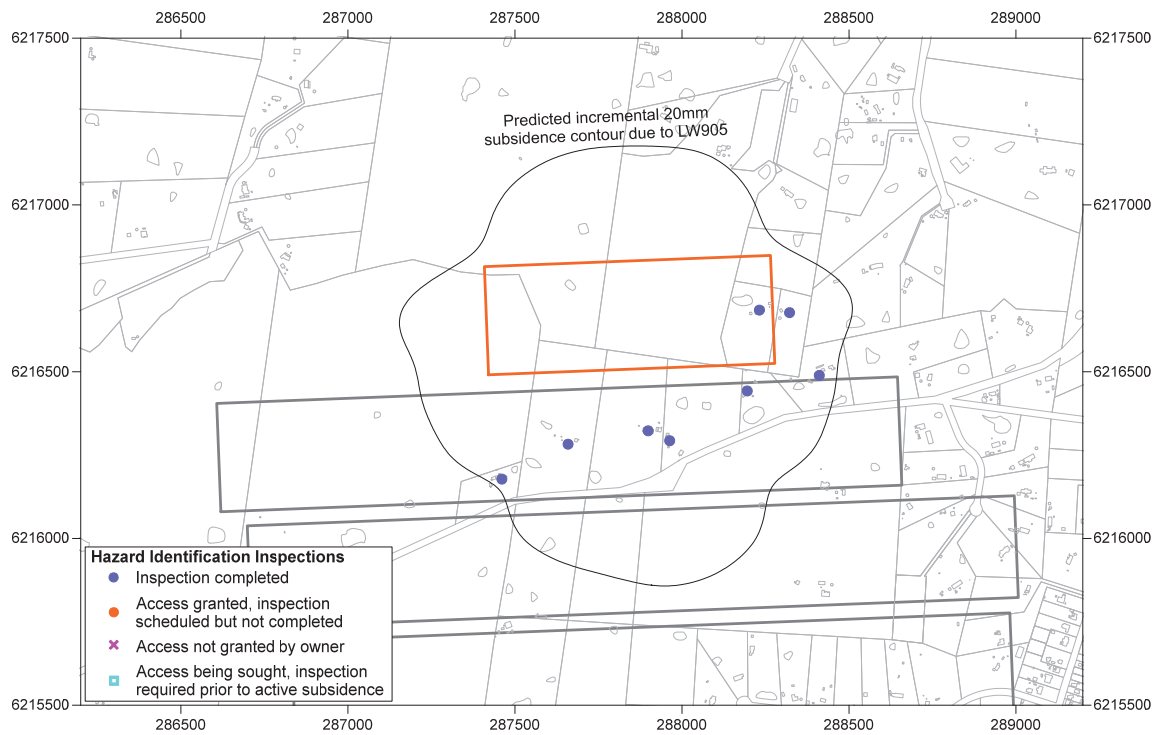
**Fig. 6.2 Pre-mining hazard identification inspections**

The hazard identification inspections have been completed for eight properties within the Study Area. None have been declined or are pending. Hazard identification inspections are not required for the remaining properties within the Study Area since they are predicted to experience less than 20 mm incremental vertical subsidence due to LW905.
