ULAN  
COAL

# Condition Assessment Report for Alternate Offset Area

## Assessment of Surface Features

**Number:** ULNCX-1862890609-3

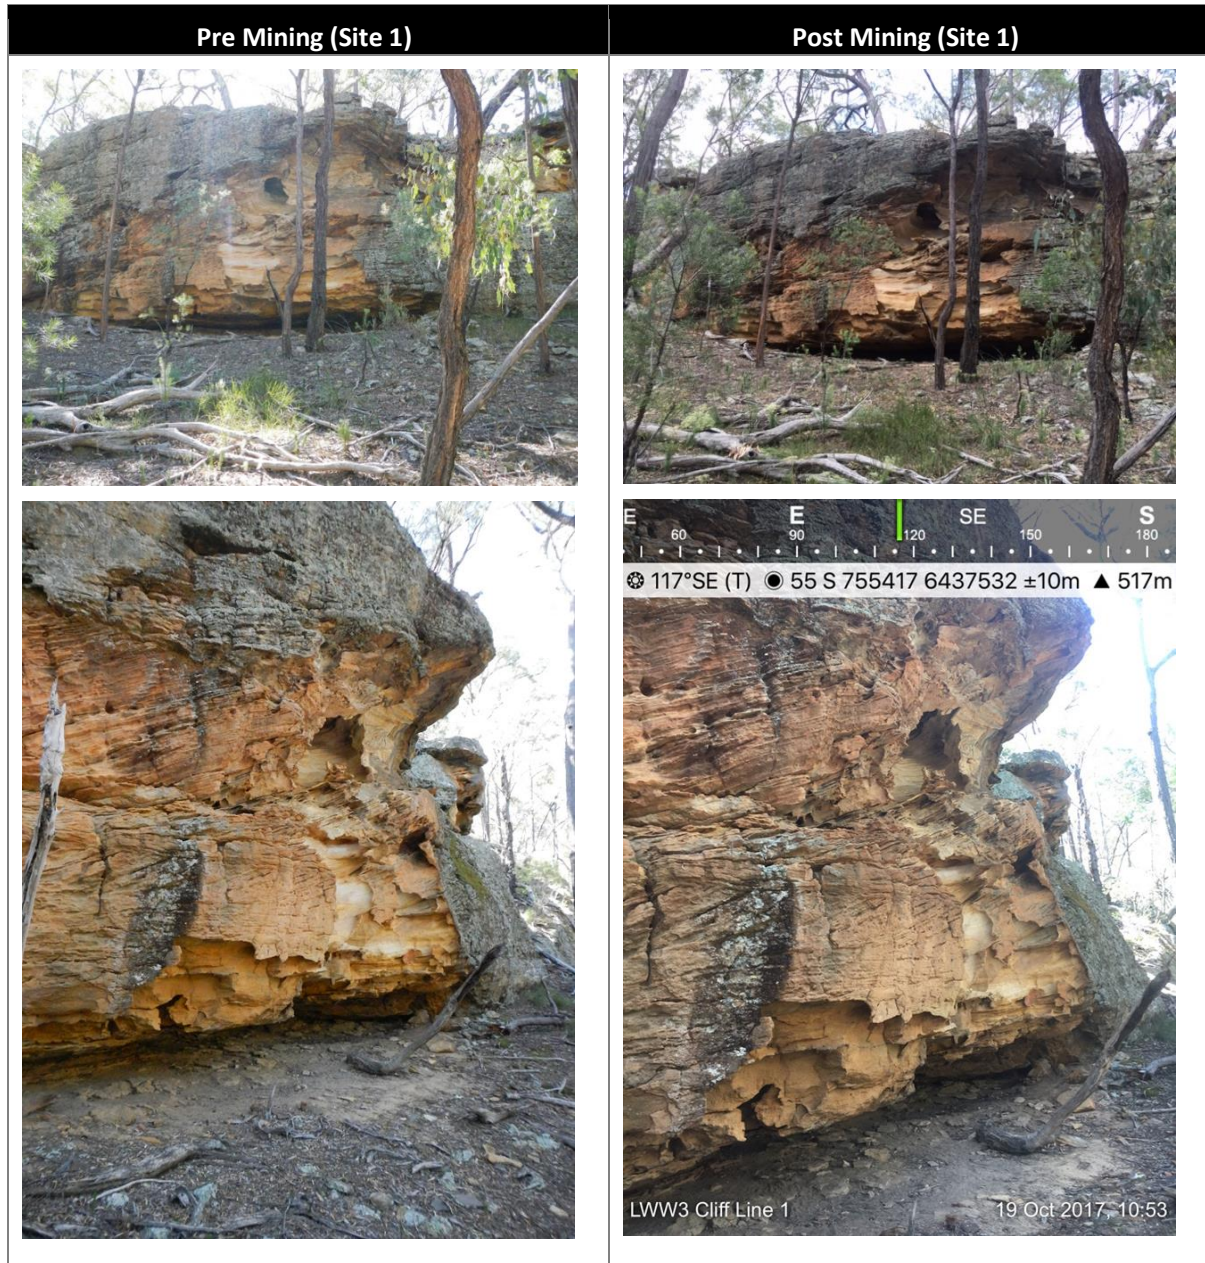
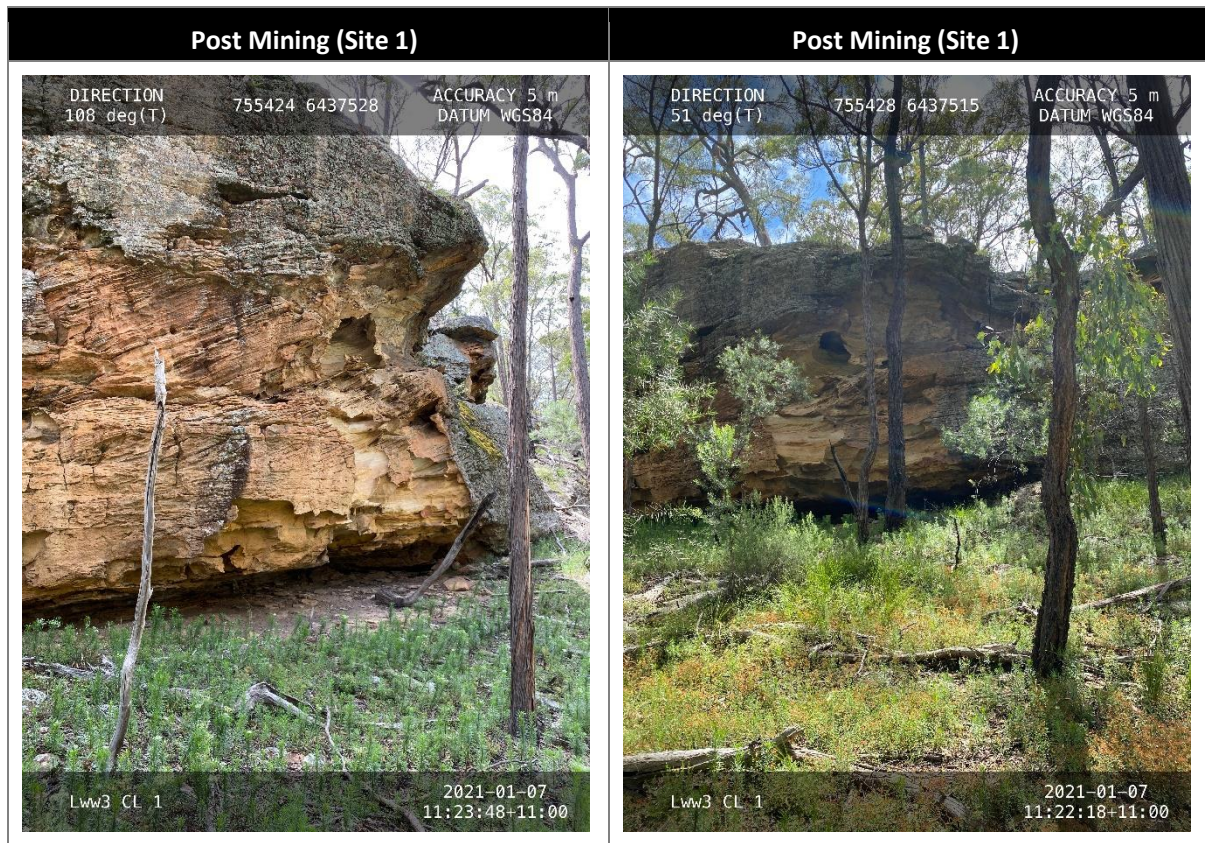
### 4.1 Cliff Lines (LWW3 – Site 1)

**Notes:** No perceptible change (as a result of subsidence) from pre-mining condition noted at the time of the post mining inspections.

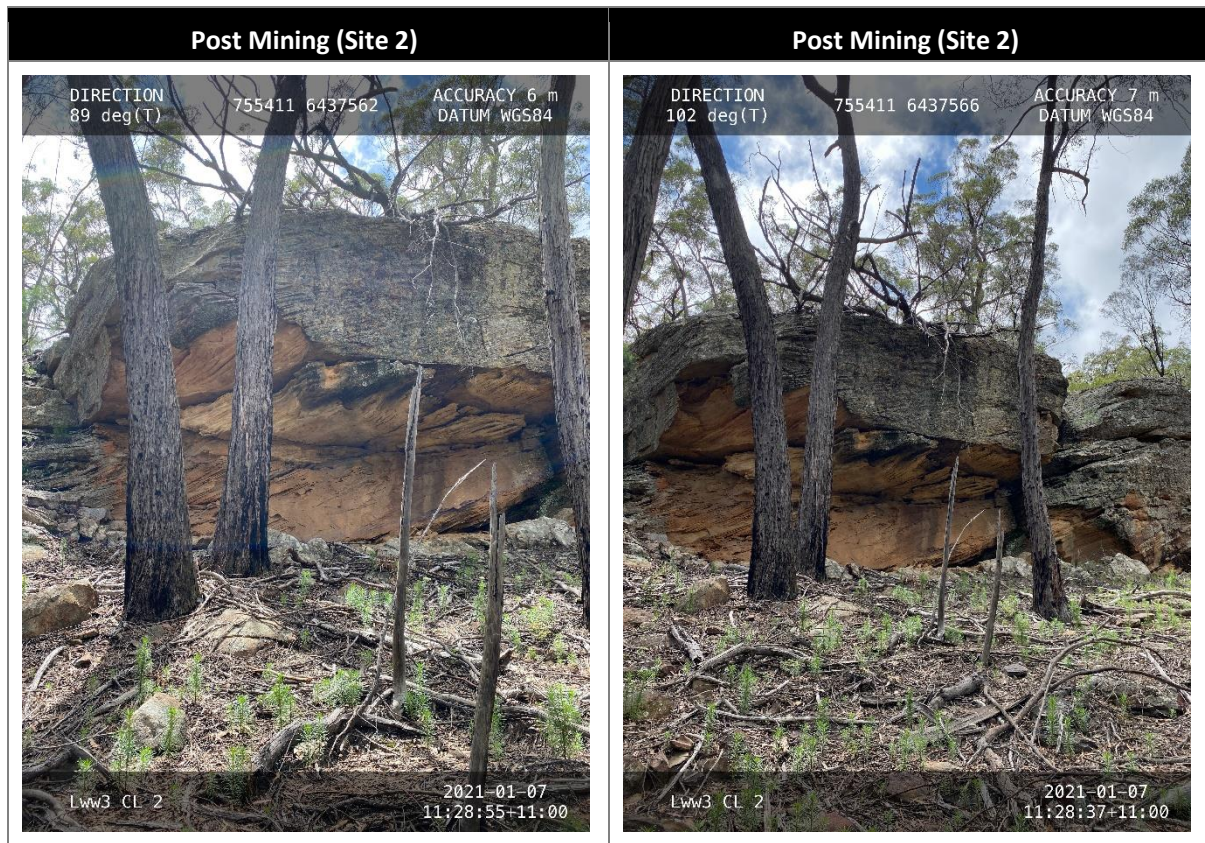
## 4.2 Cliff Lines (LWW3 – Site 2)

Pre Mining (Site 2)	Post Mining (Site 2)
<p>Photos Not Available</p>	  <p>LWW3 Cliff Line 24</p> <p>19 Oct 2017, 10:47</p>

**Notes:** No perceptible change (as a result of subsidence) from pre-mining condition noted at the time of the post mining inspections.

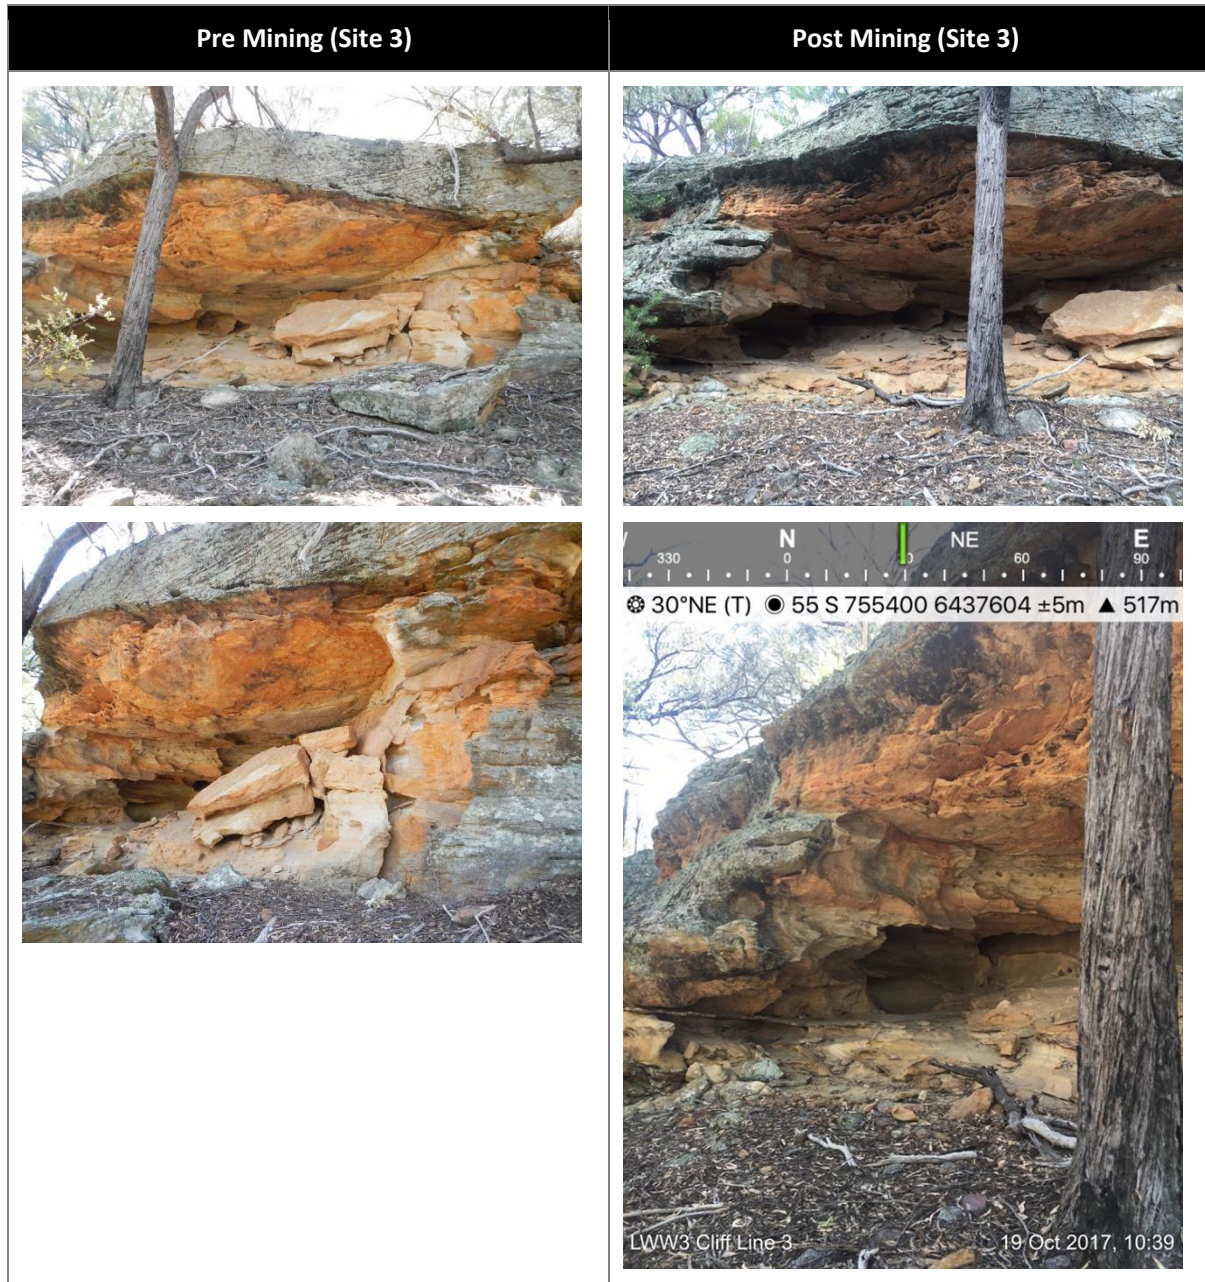
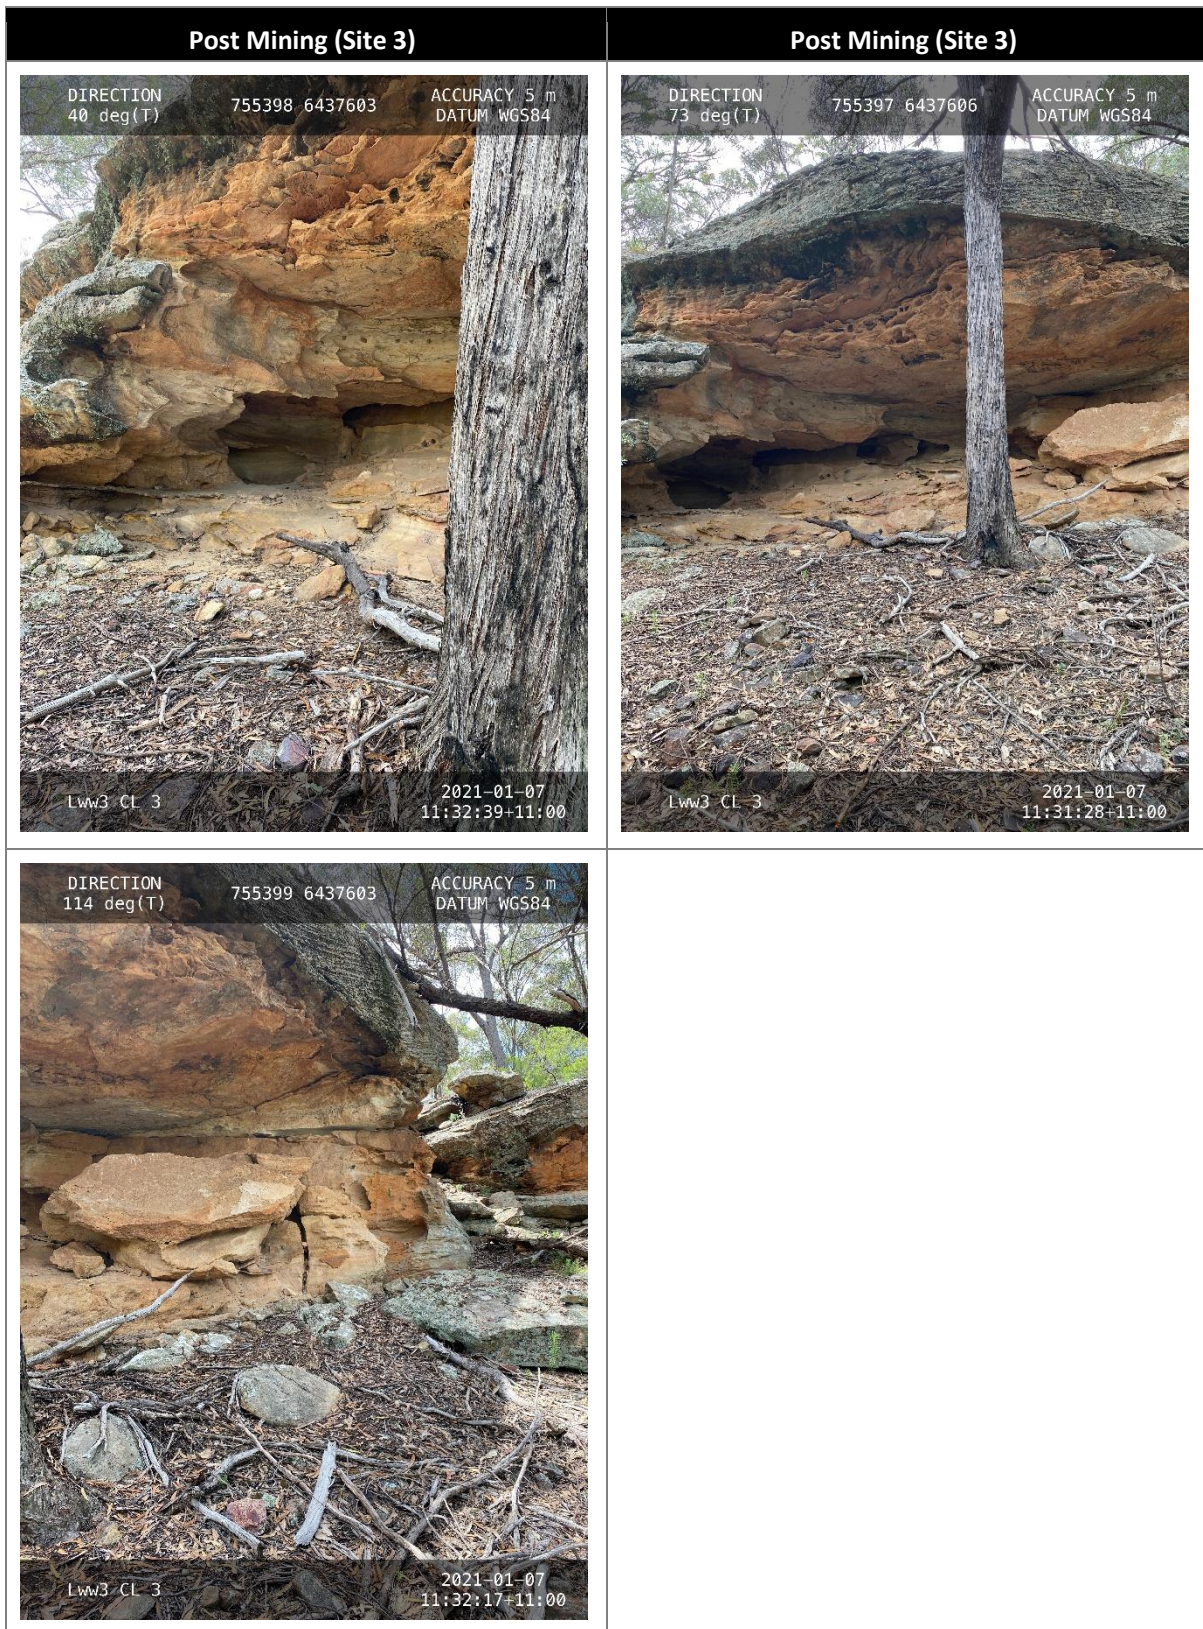
### 4.3 Cliff Lines (LWW3 – Site 3)

**Notes:** No perceptible change (as a result of subsidence) from pre-mining condition noted at the time of the post mining inspections.

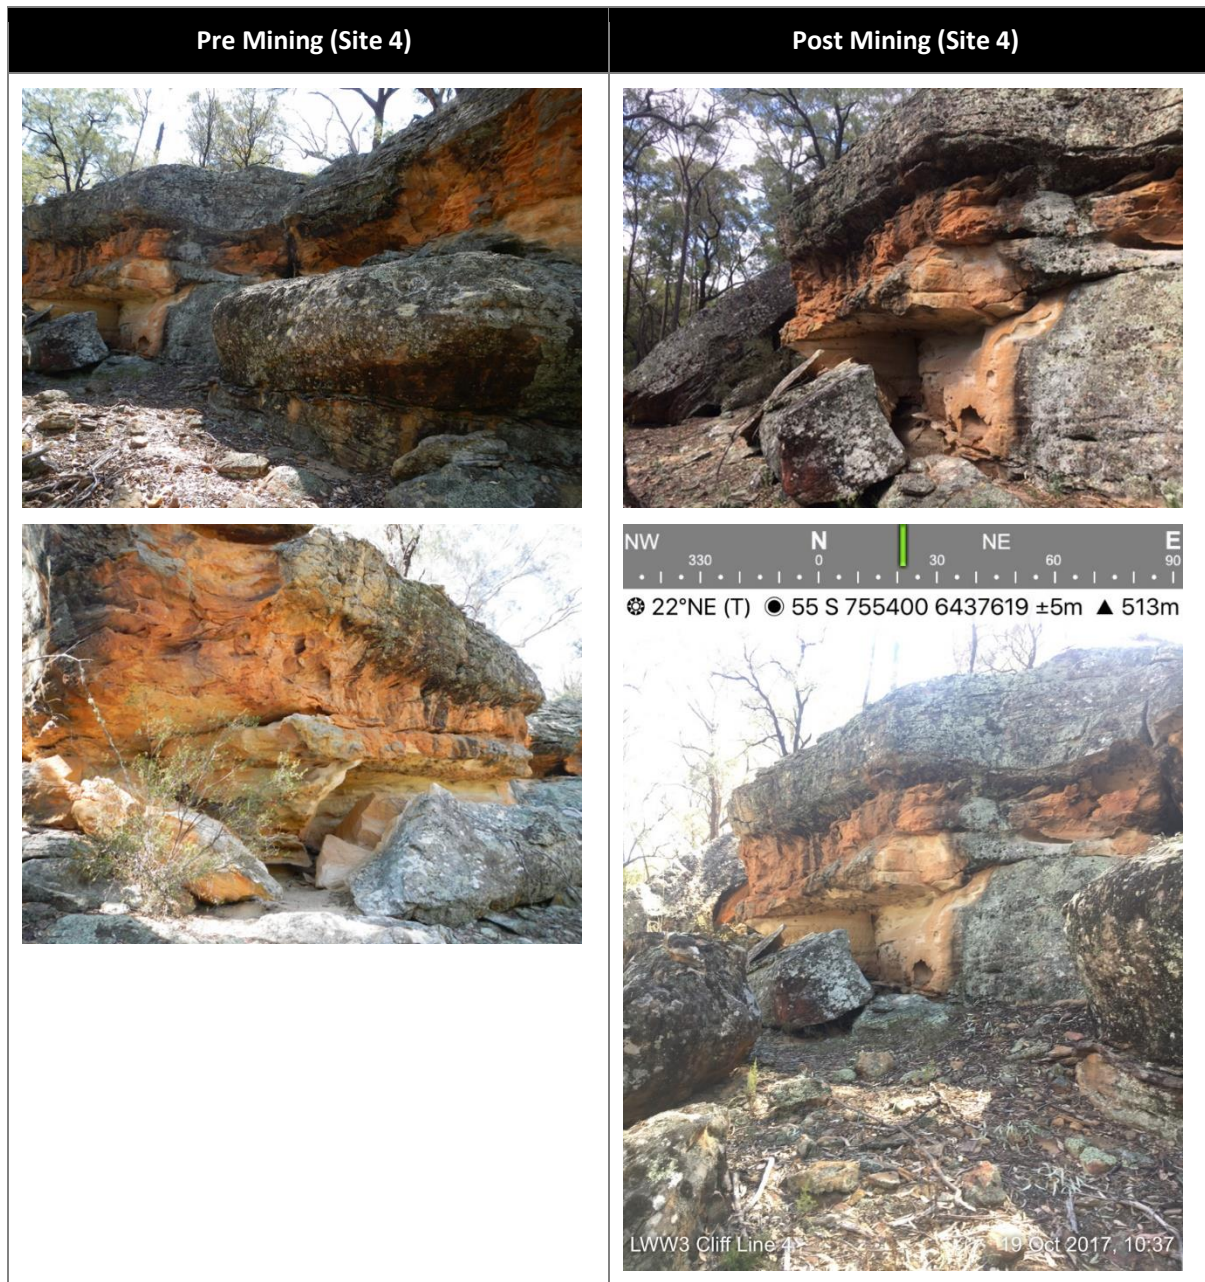
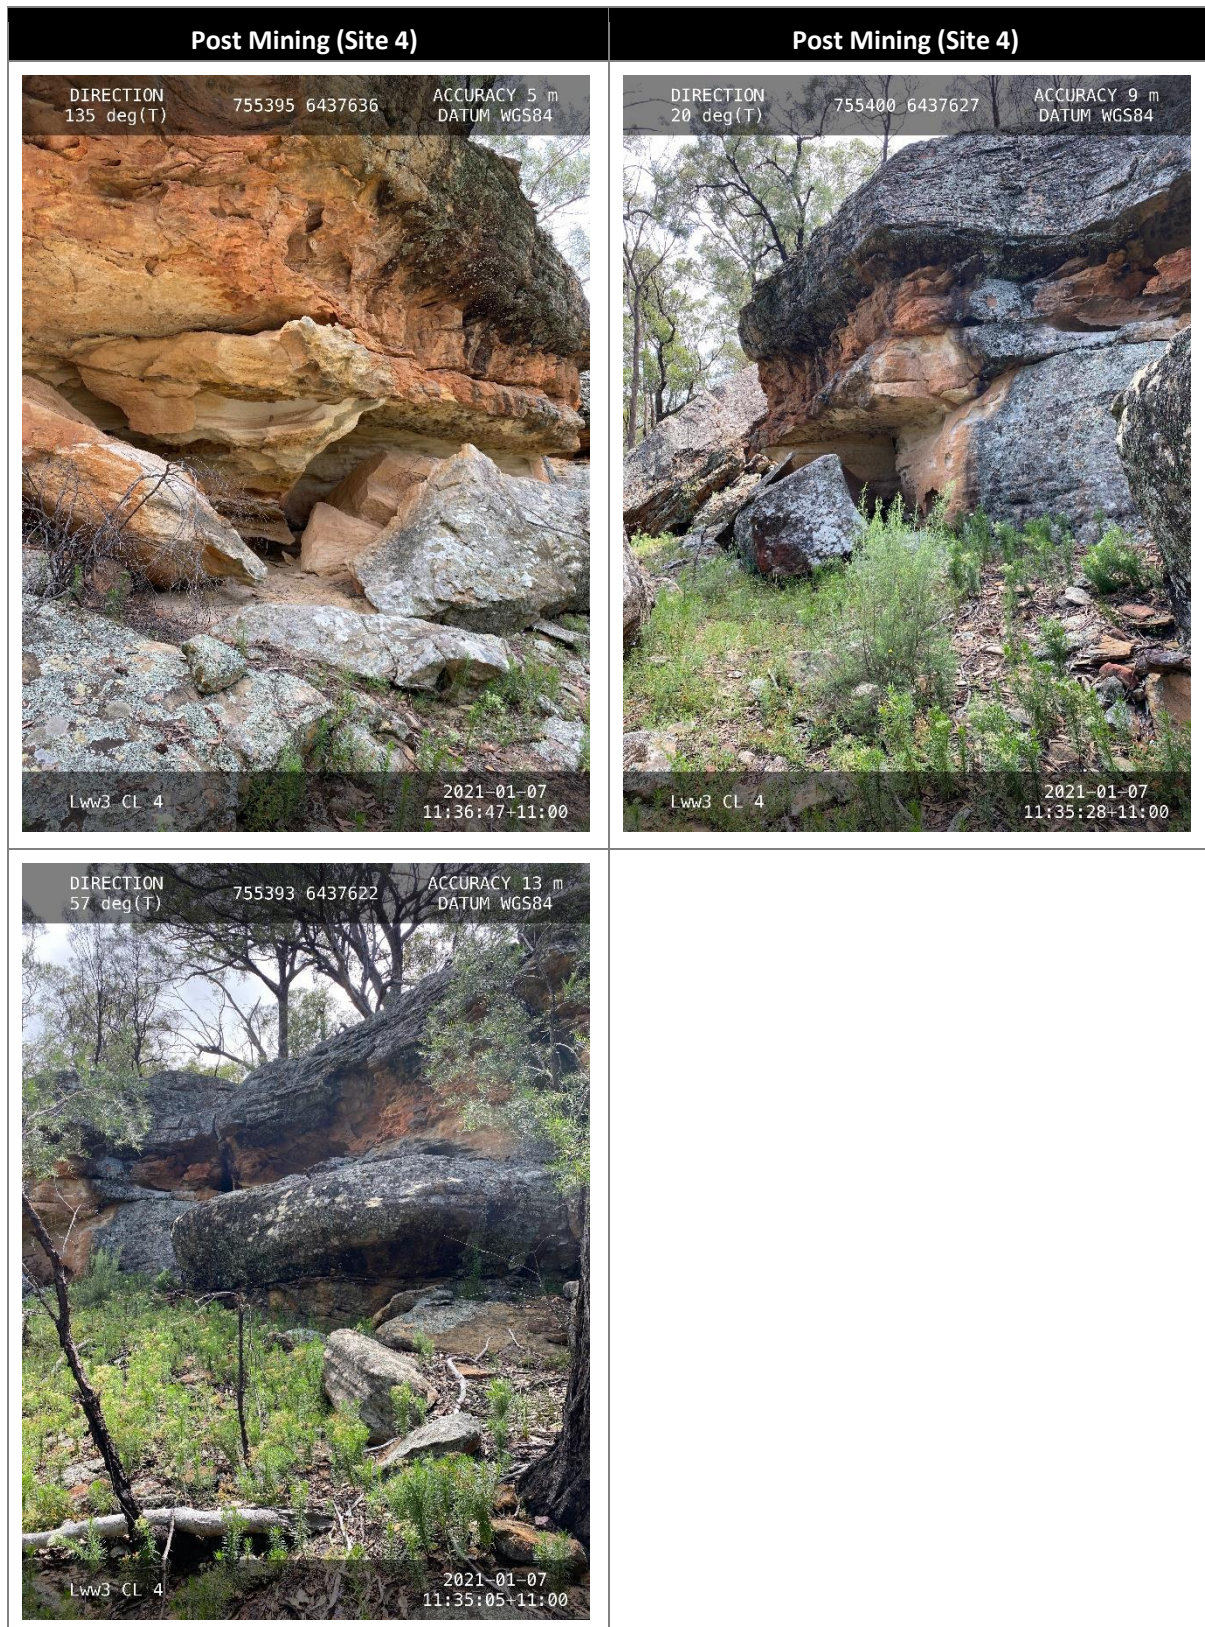
## 4.4 Cliff Lines (LWW3 – Site 4)

**Notes:** No perceptible change (as a result of subsidence) from pre-mining condition noted at the time of the post mining inspections.

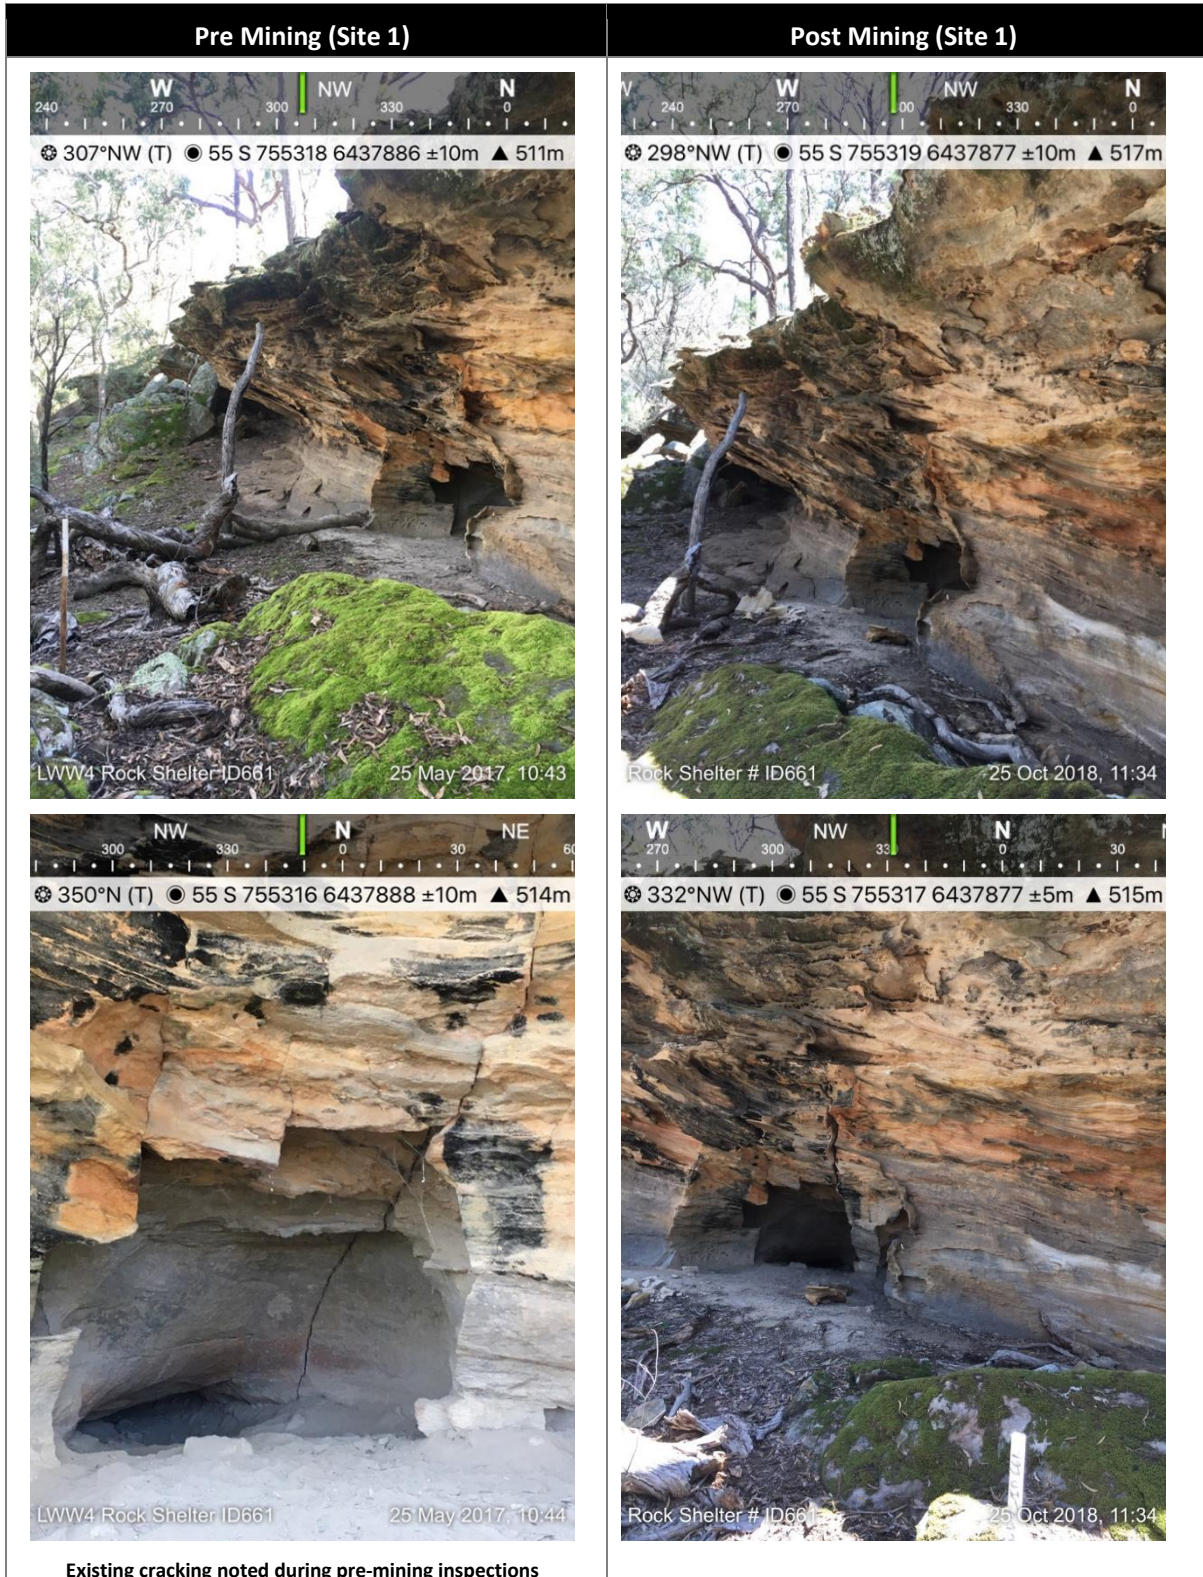
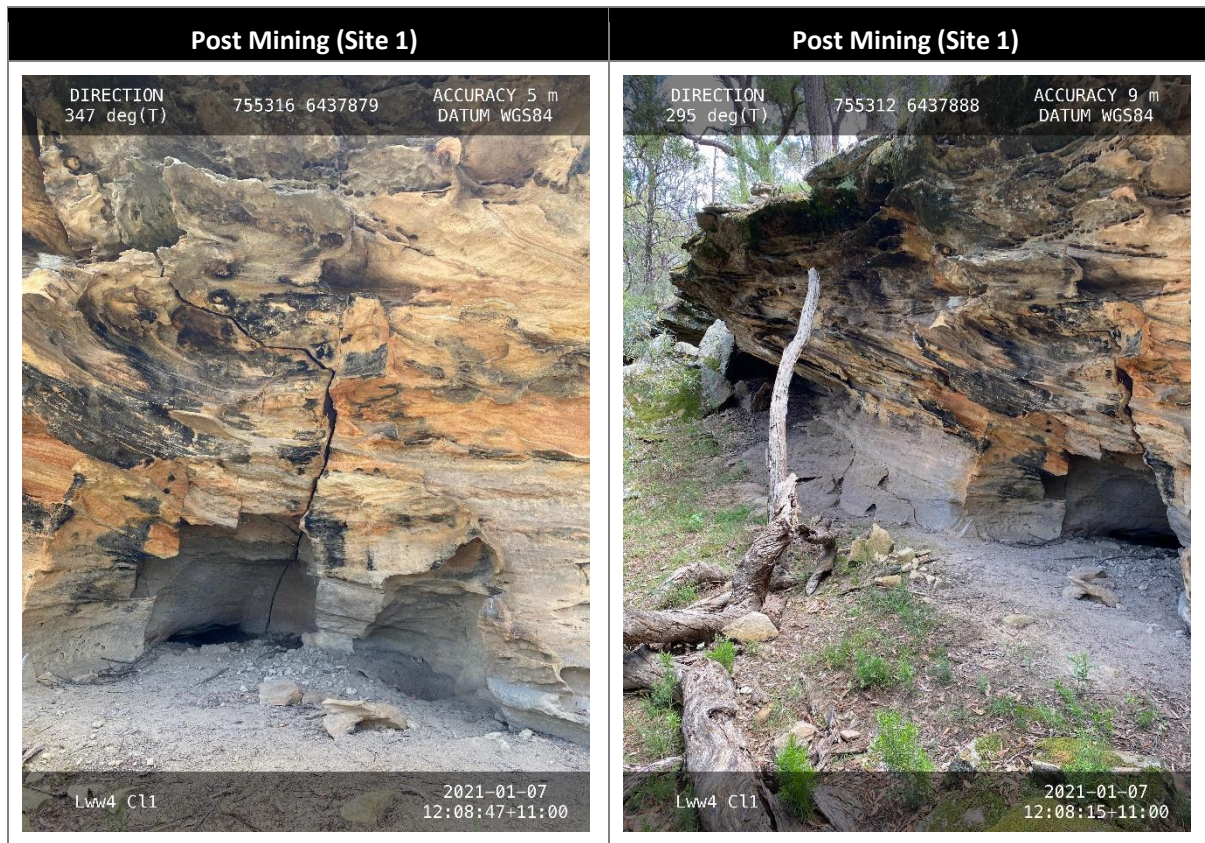
### 5.1 Cliff Lines (LWW4 – Site 1)

**Notes:** Isolated minor rock fall and existing crack widened (as a result of subsidence) was first recorded in October 2018. No further impacts as previously recorded were perceptible during the most recent post mining inspection in January 2021.

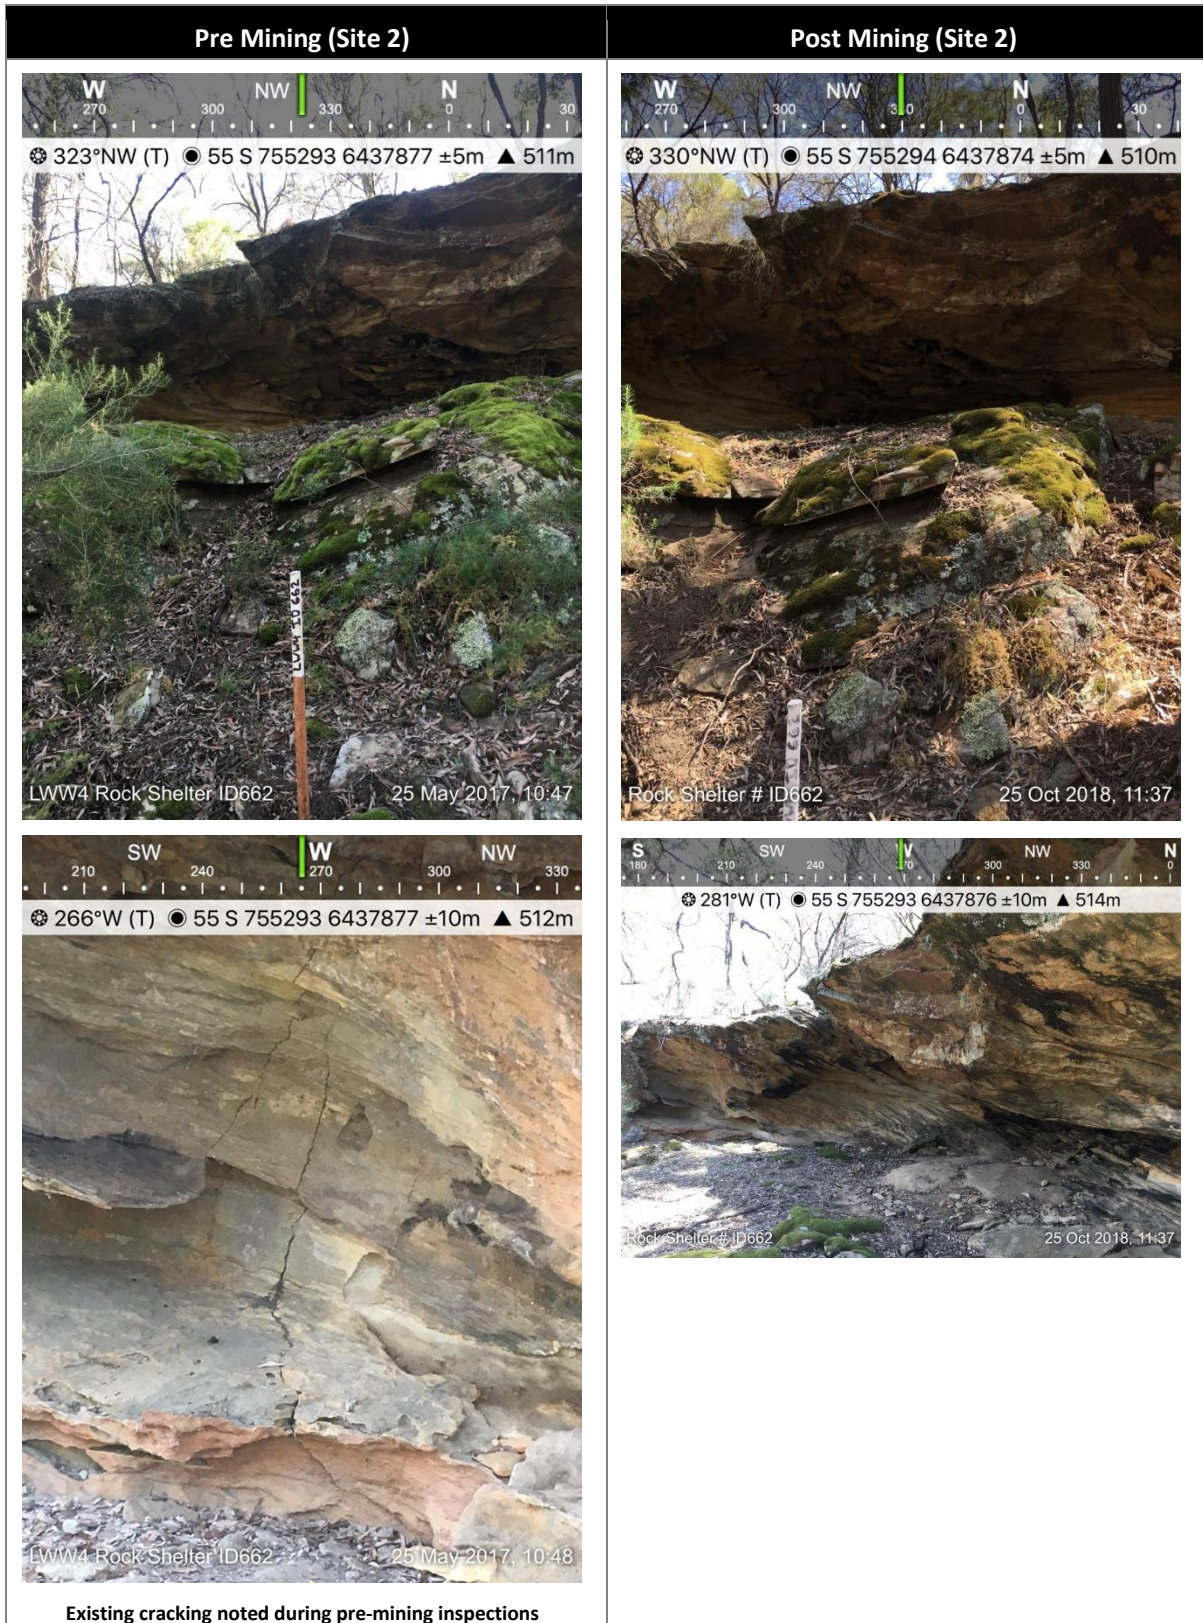
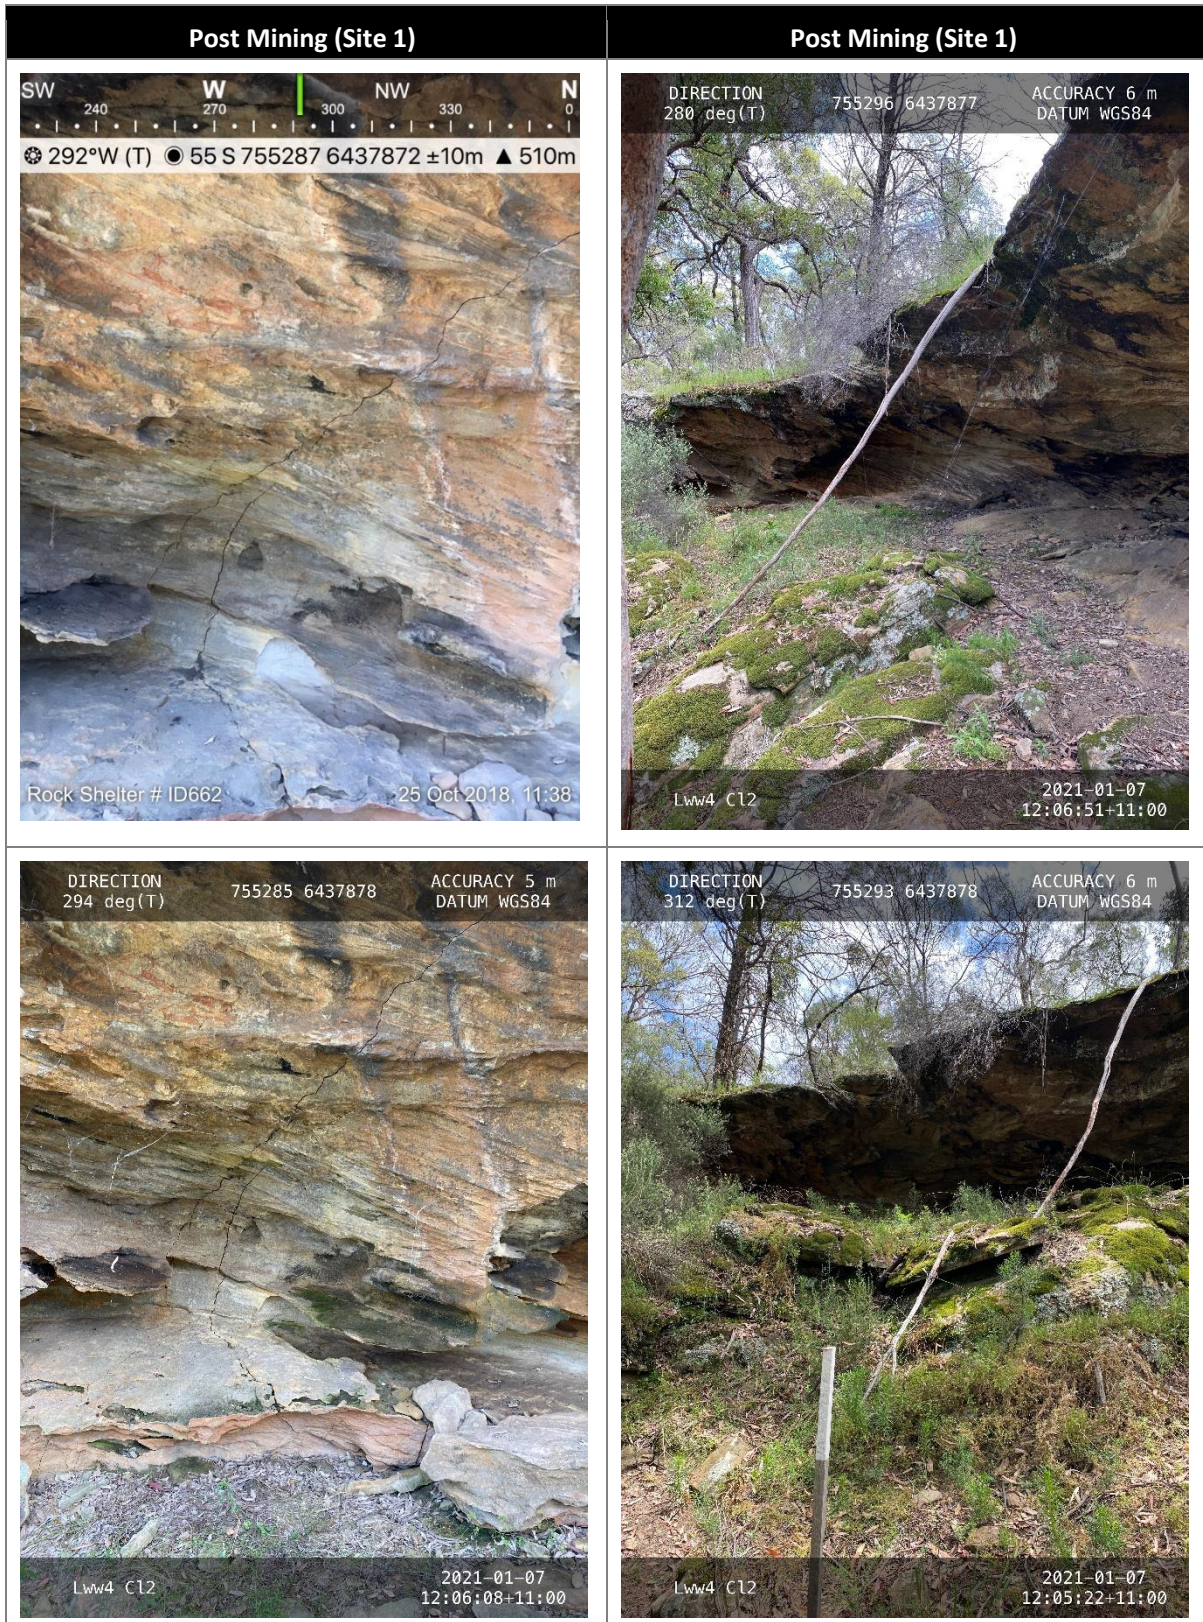
## 5.2 Cliff Lines (LWW4 – Site 2)

**Notes:** Isolated minor rock fall (as a result of subsidence) was first recorded in October 2018. No further impacts as previously recorded were perceptible during the most recent post mining inspection in January 2021. No perceptible change to the existing cracking first noted during the pre-mining inspection back in May 2017.

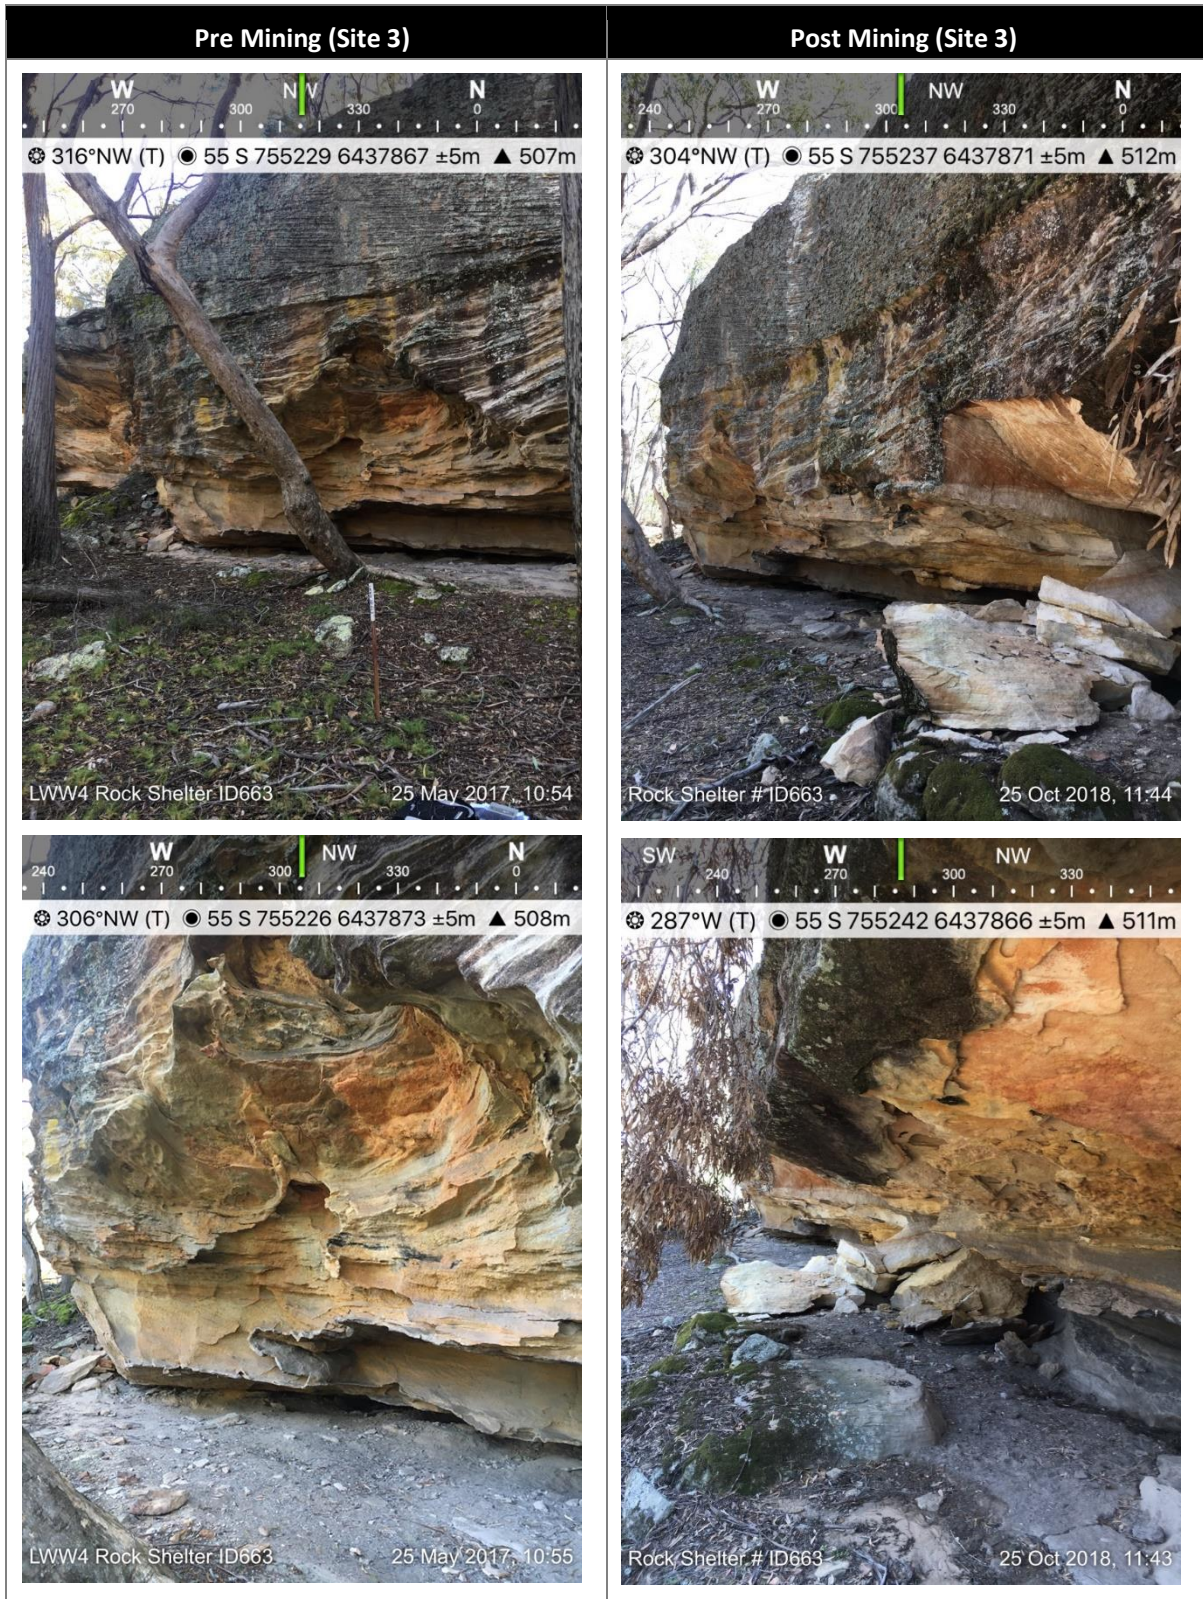
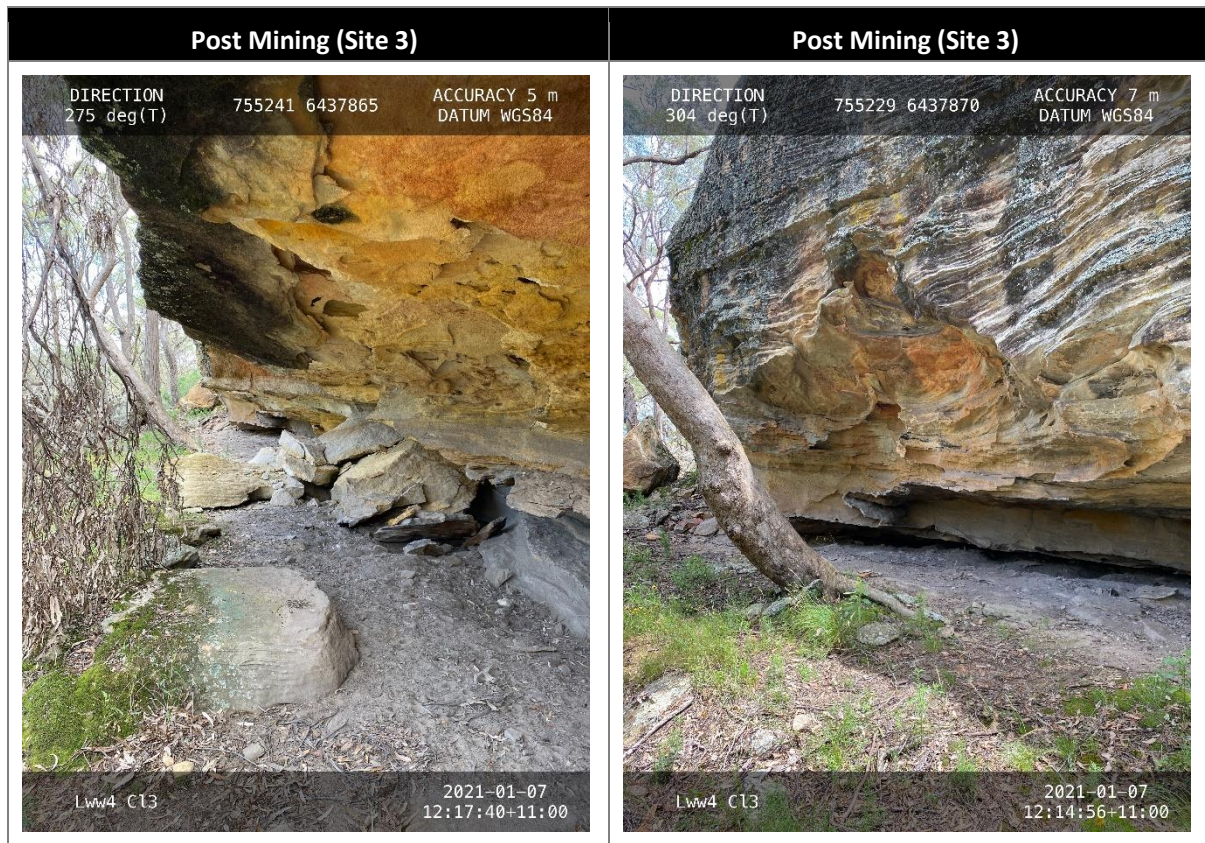
### 5.3 Cliff Lines (LWW4 – Site 3)

**Notes:** Rock falls measuring approximately 7-8m in total length and cracking across the face of the cliff feature (as a result of subsidence) was first recorded in October 2018. No further impacts were recorded during the most recent post mining inspection in January 2021.
