ULAN  
COAL

# Condition Assessment Report for Alternate Offset Area

## Assessment of Surface Features

**Number:** ULNCX-1862890609-3

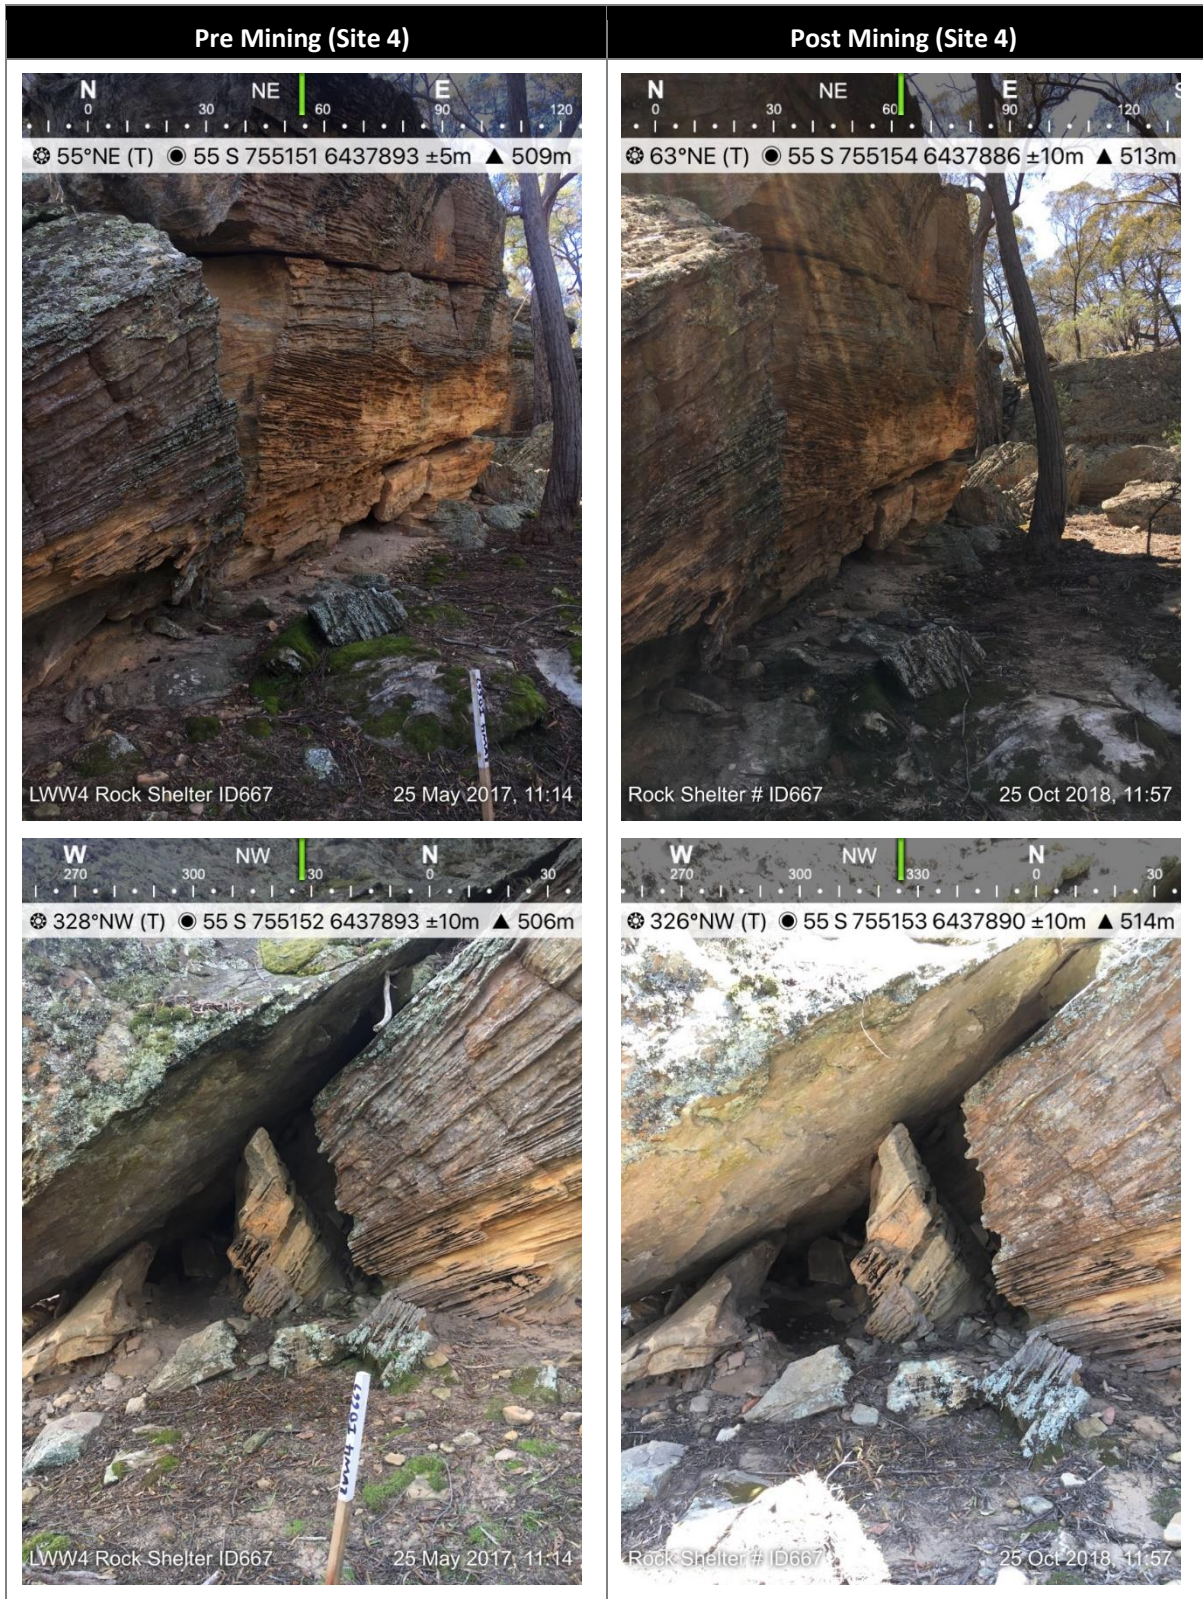
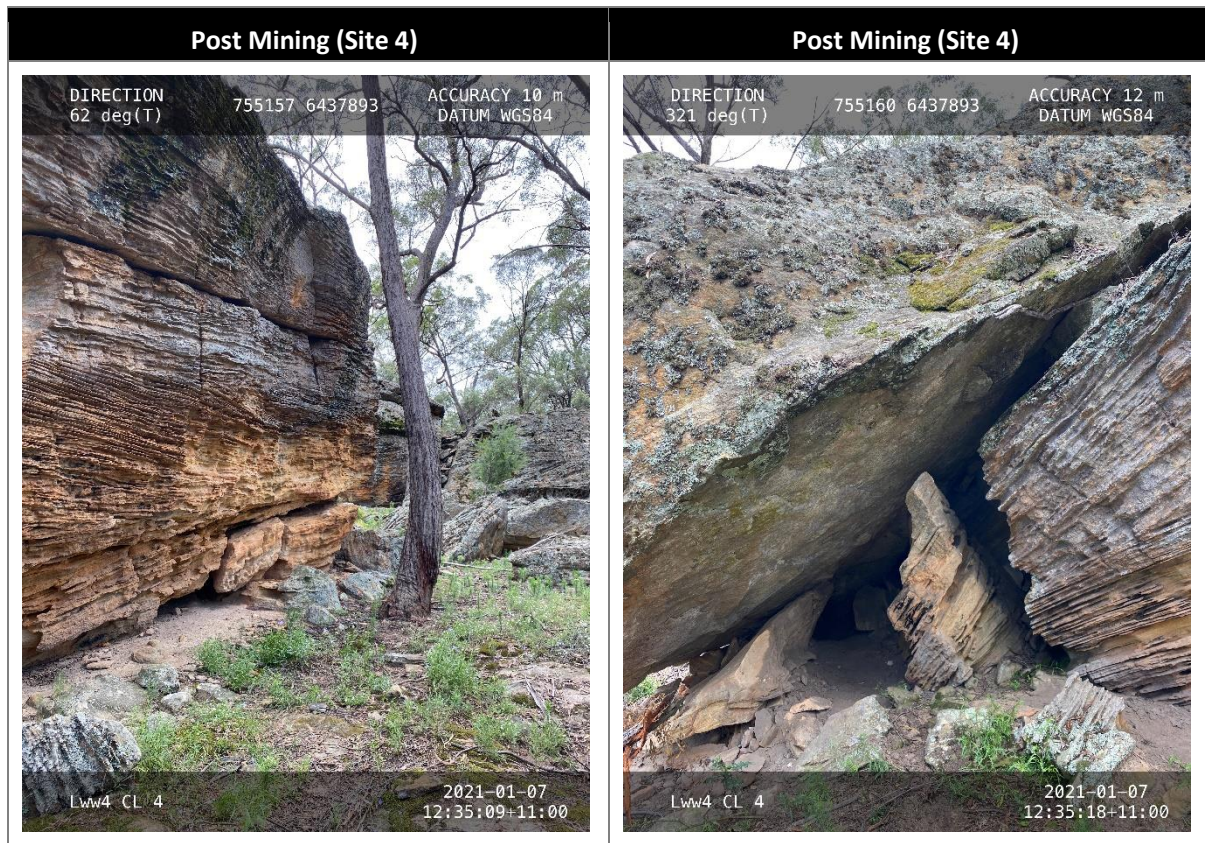
## 5.4 Cliff Lines (LWW4 – Site 4)

**Notes:** No perceptible change (as a result of subsidence) from pre-mining condition noted at the time of the post mining inspections.

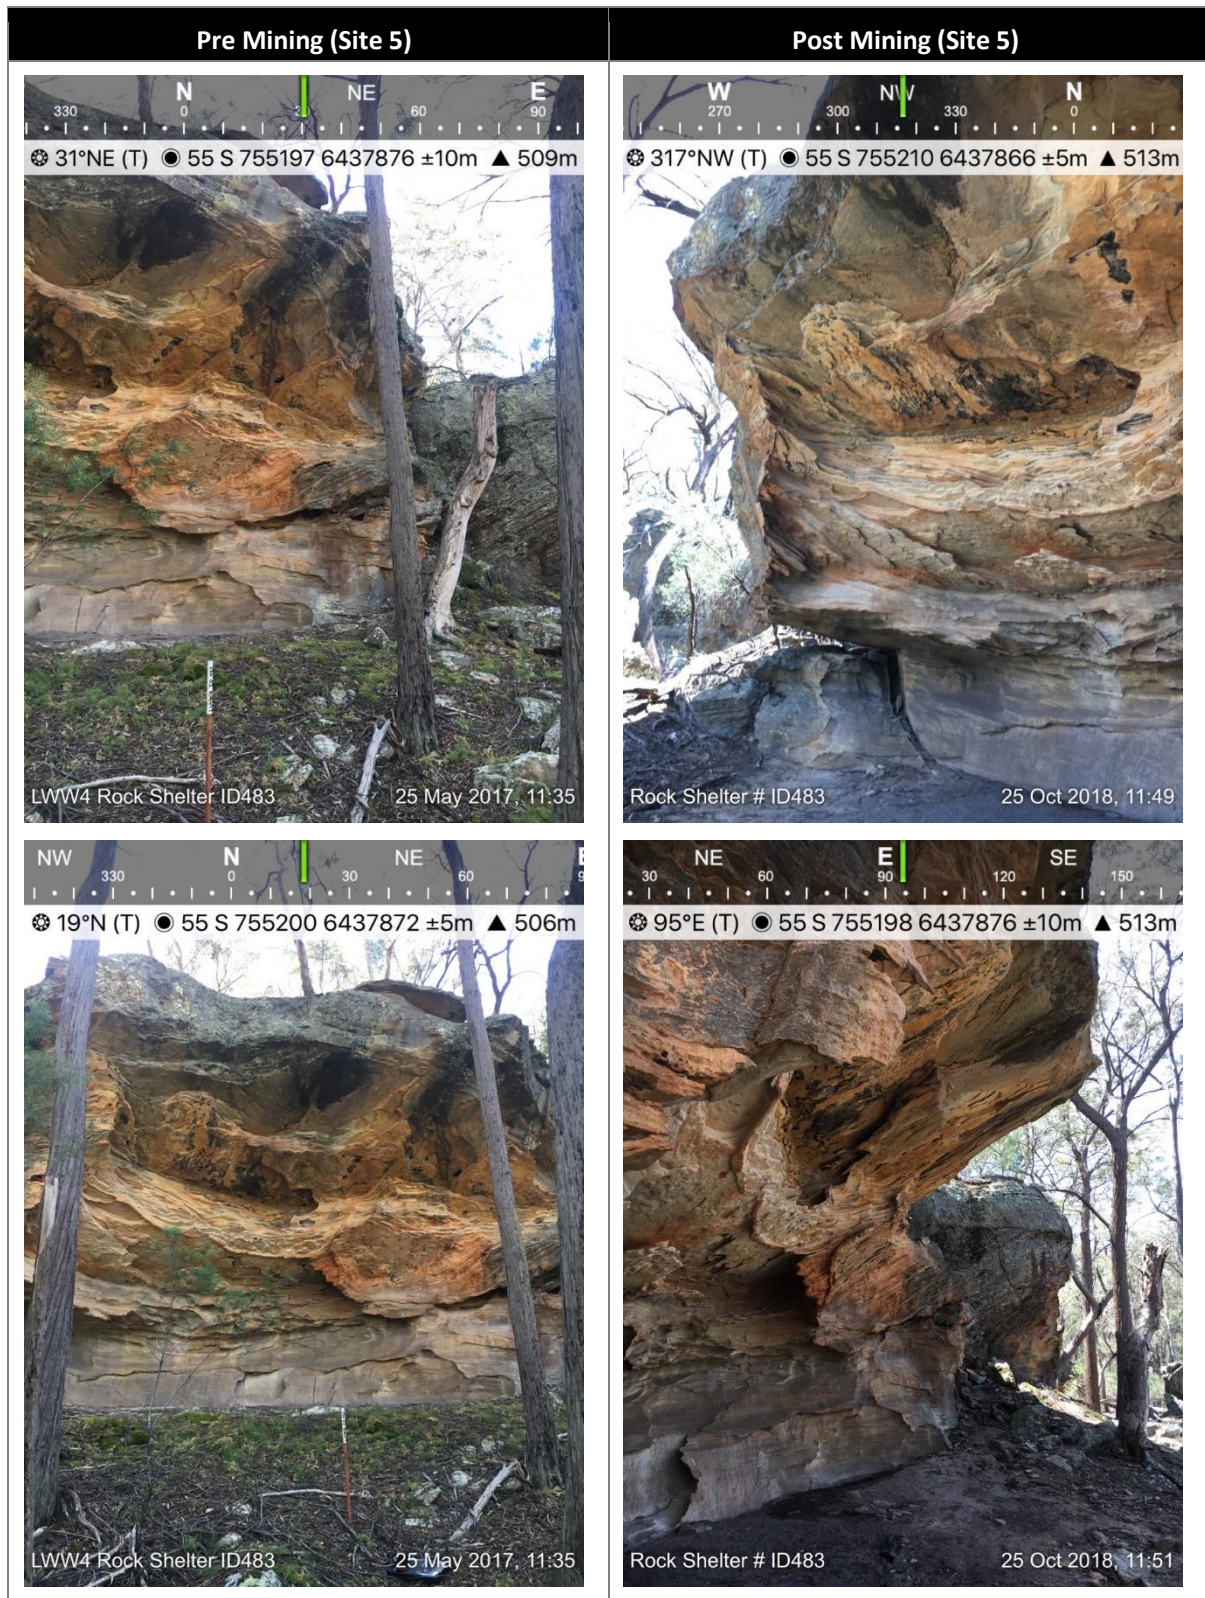
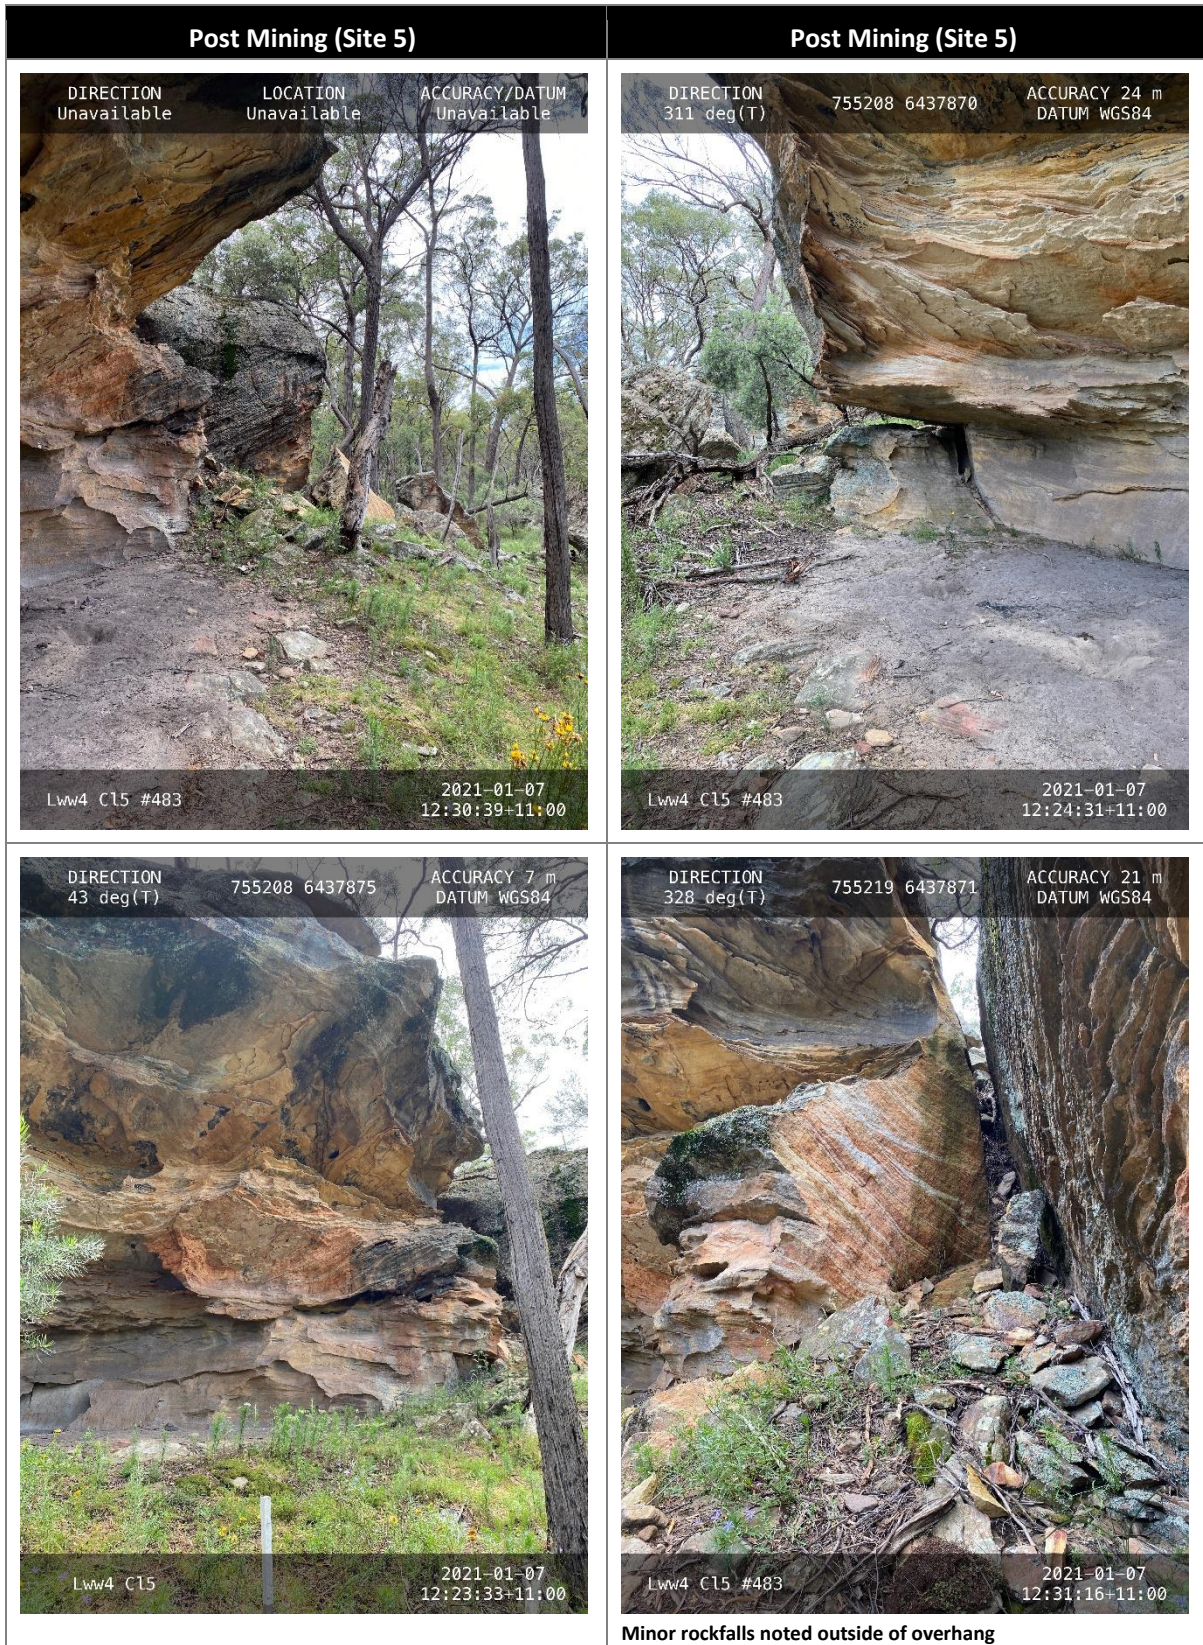
## 5.5 Cliff Lines (LWW4 – Site 5)

**Notes:** Minor isolated rock falls (as a result of subsidence) outside of overhang noted from pre-mining condition was first recorded in October 2018. The appearance of additional small rock material, likely to have fallen since 2018 was noted during the most recent post mining inspection in January 2021.

Ongoing impacts from subsidence was particularly minor and only identified at Site 5 above LWW4 with the appearance of several additional small rock falls within almost 2.5 years post mining of this longwall.

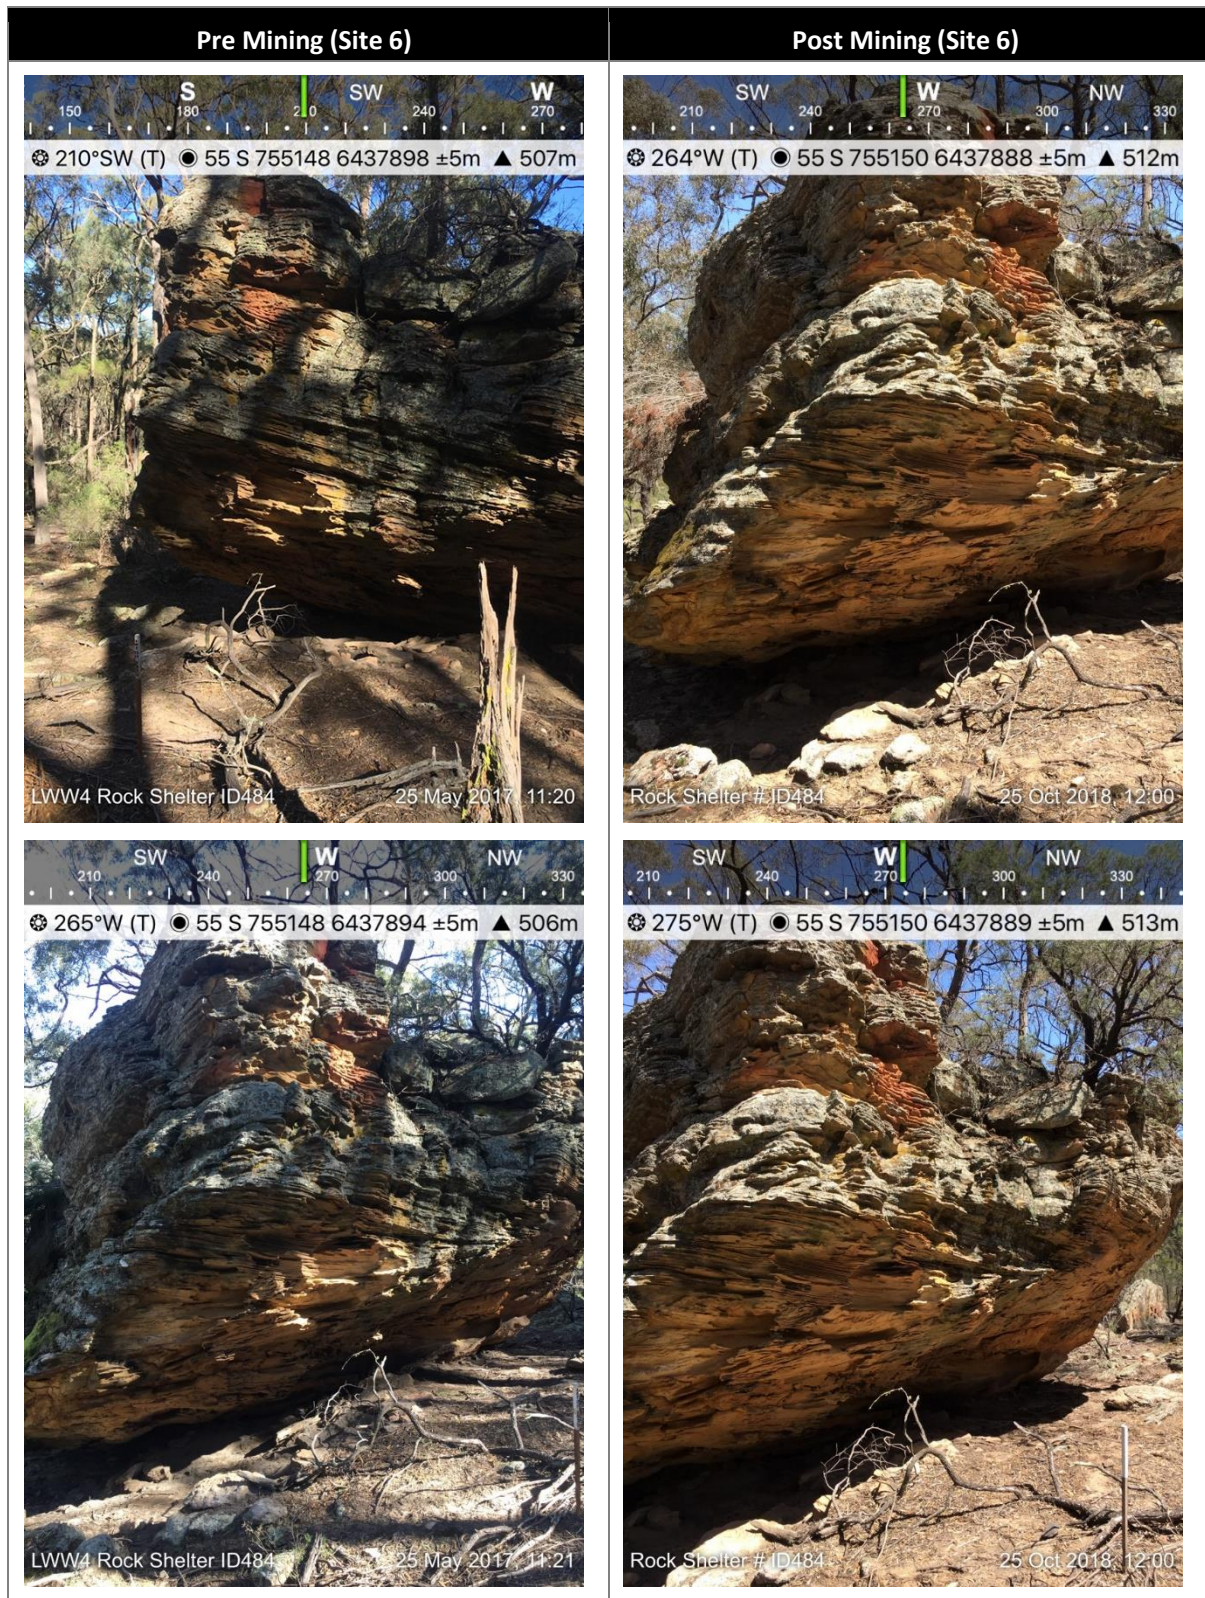
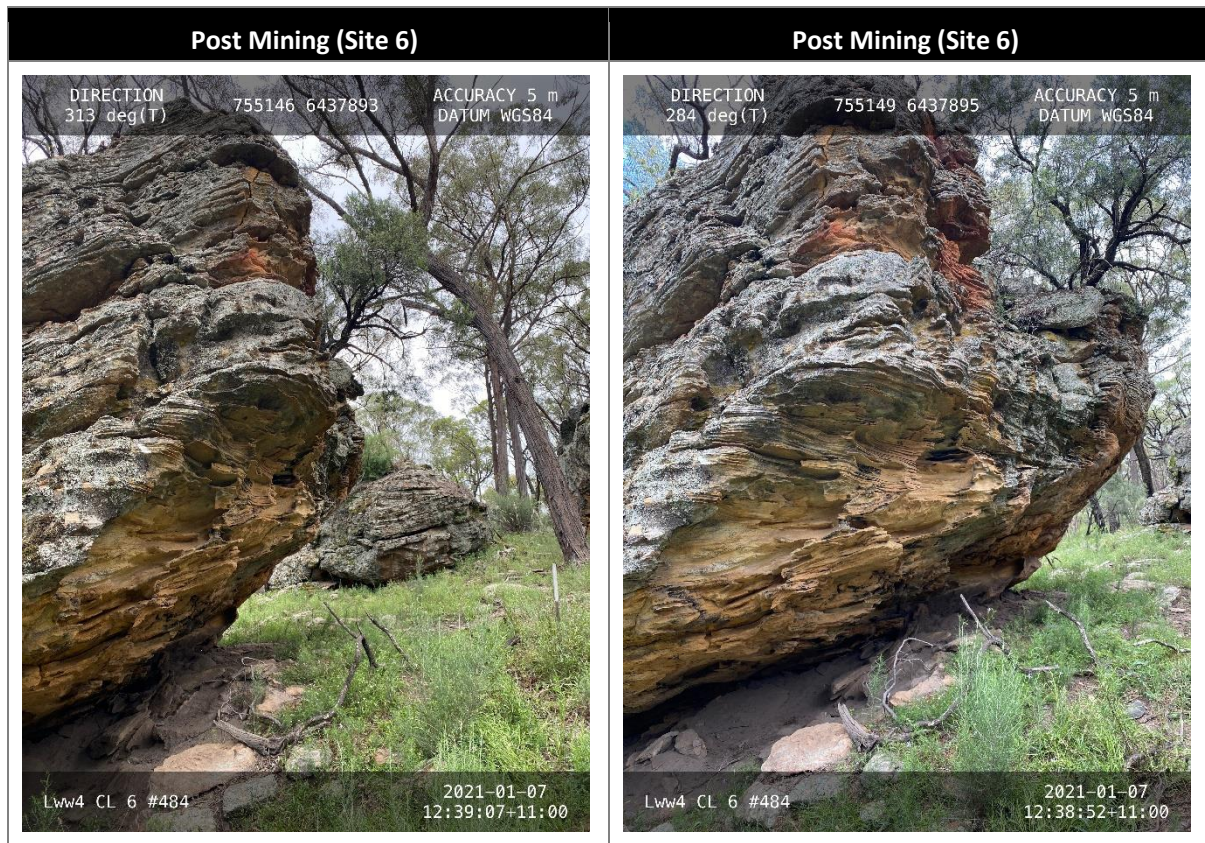
## 5.6 Cliff Lines (LWW4 – Site 6)

**Notes:** No perceptible change (as a result of subsidence) from pre-mining condition noted at the time of the post mining inspections.

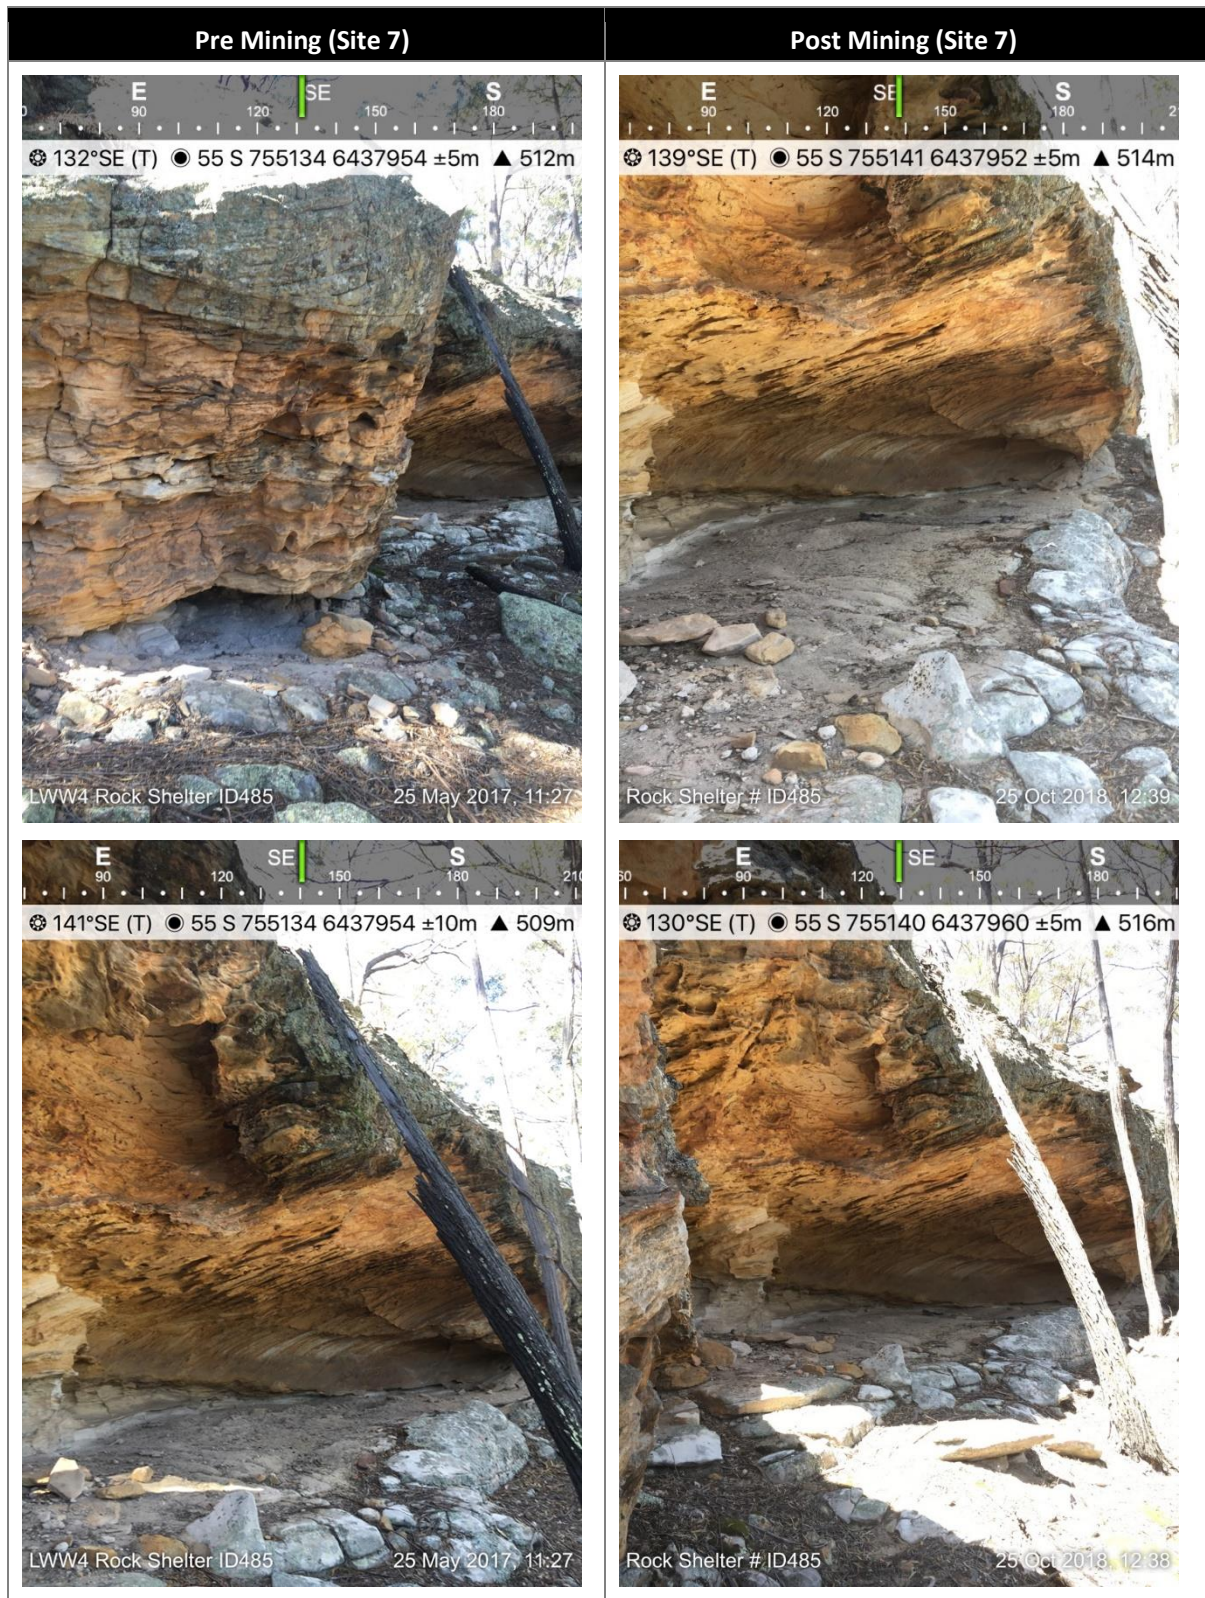
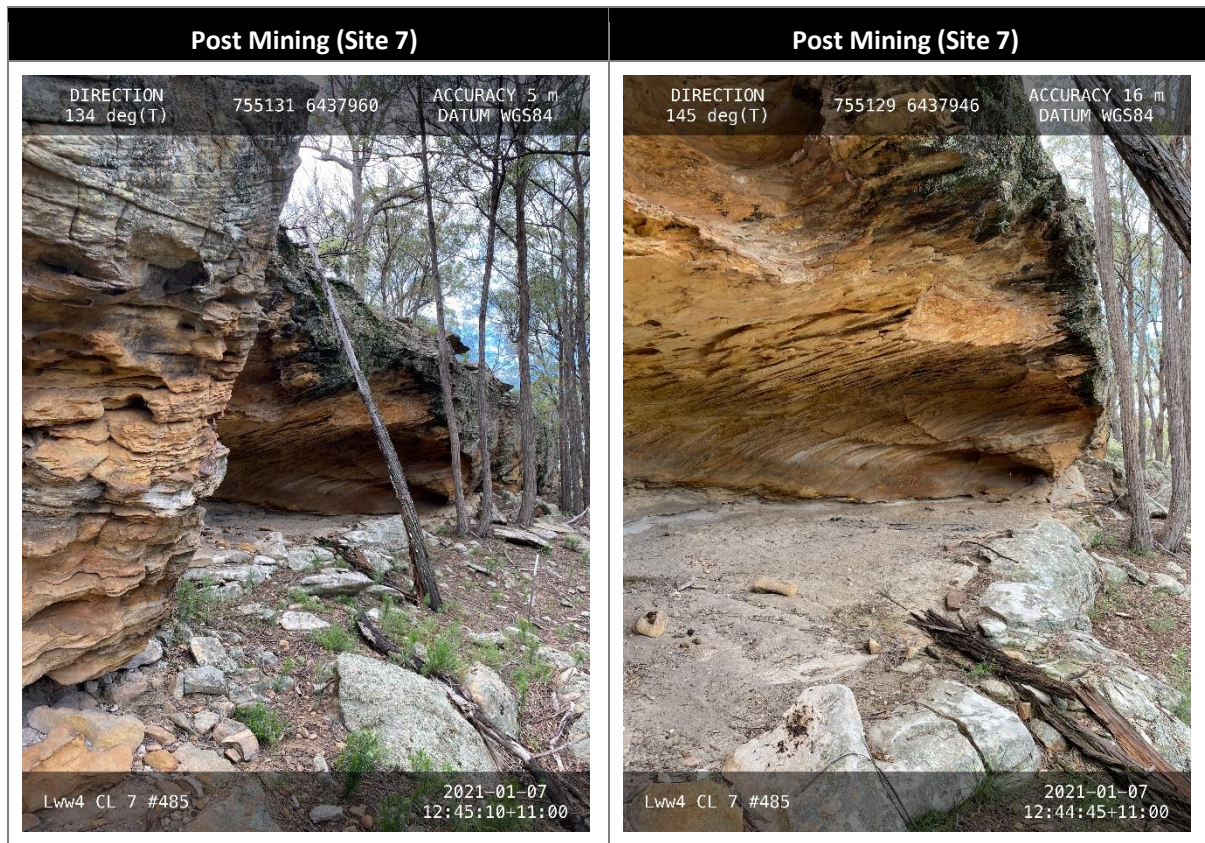
## 5.7 Cliff Lines (LWW4 – Site 7)

**Notes:** No perceptible change (as a result of subsidence) from pre-mining condition noted at the time of the post mining inspections.

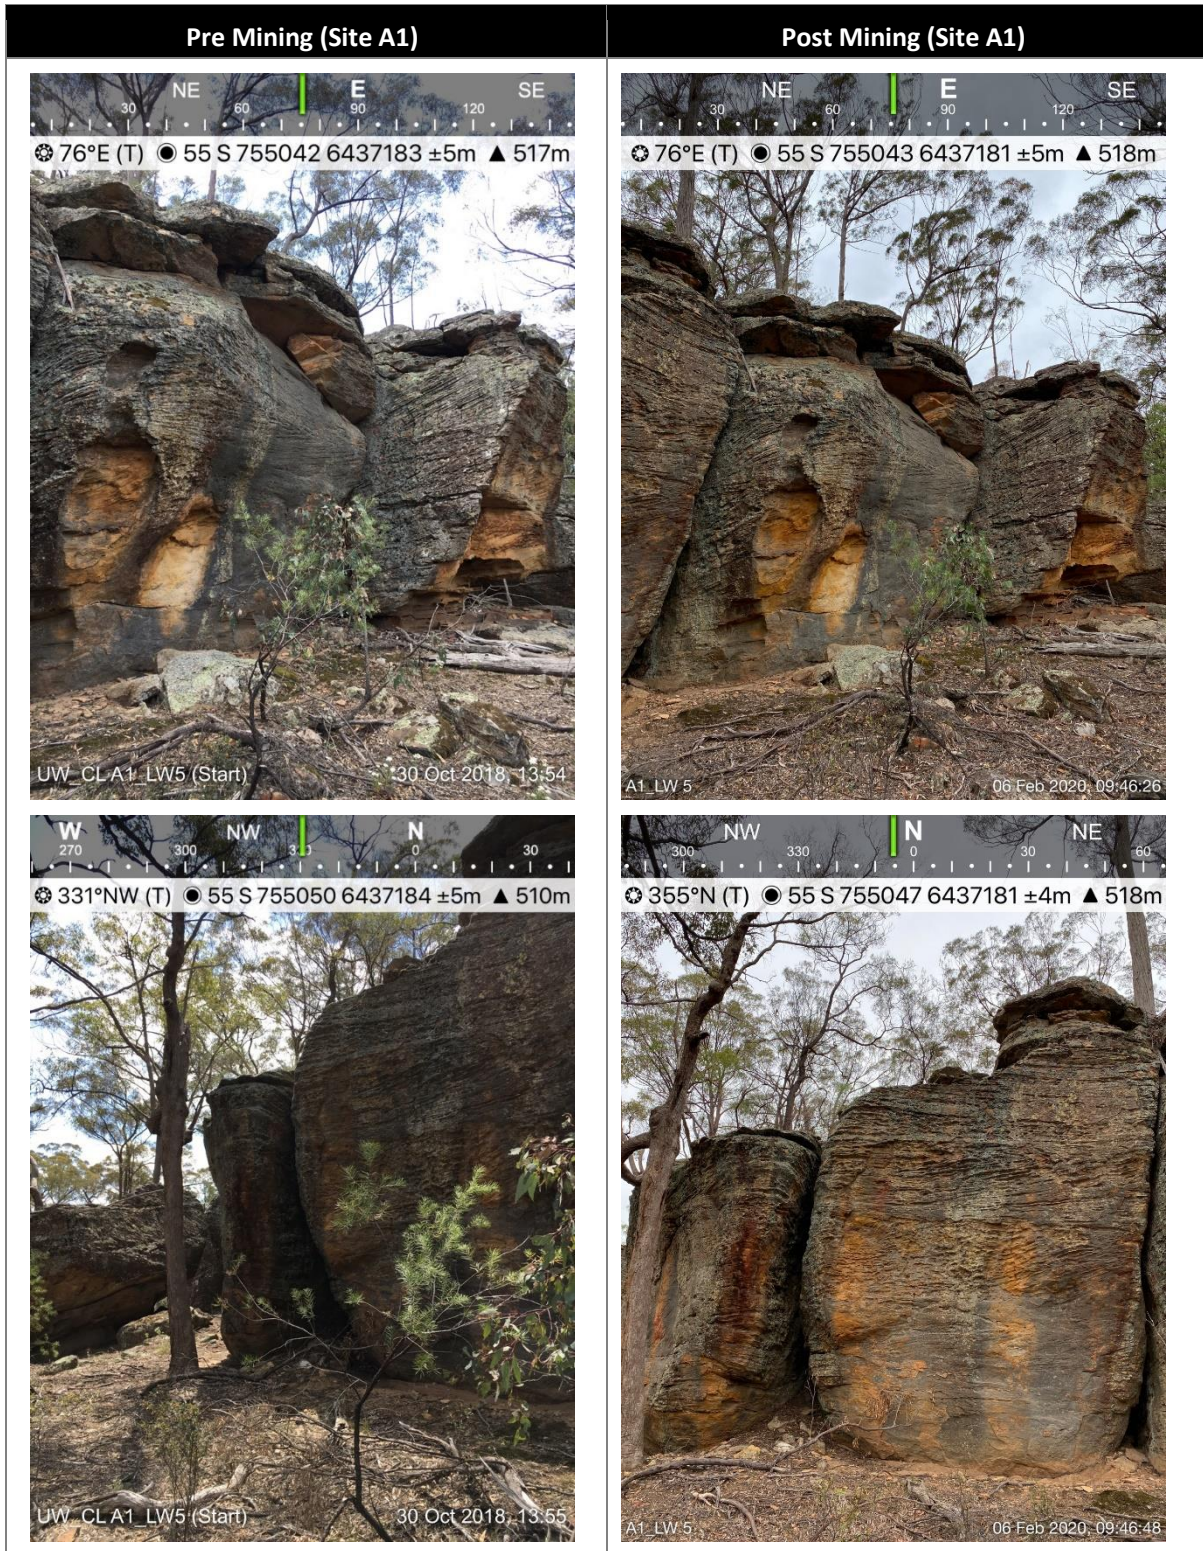
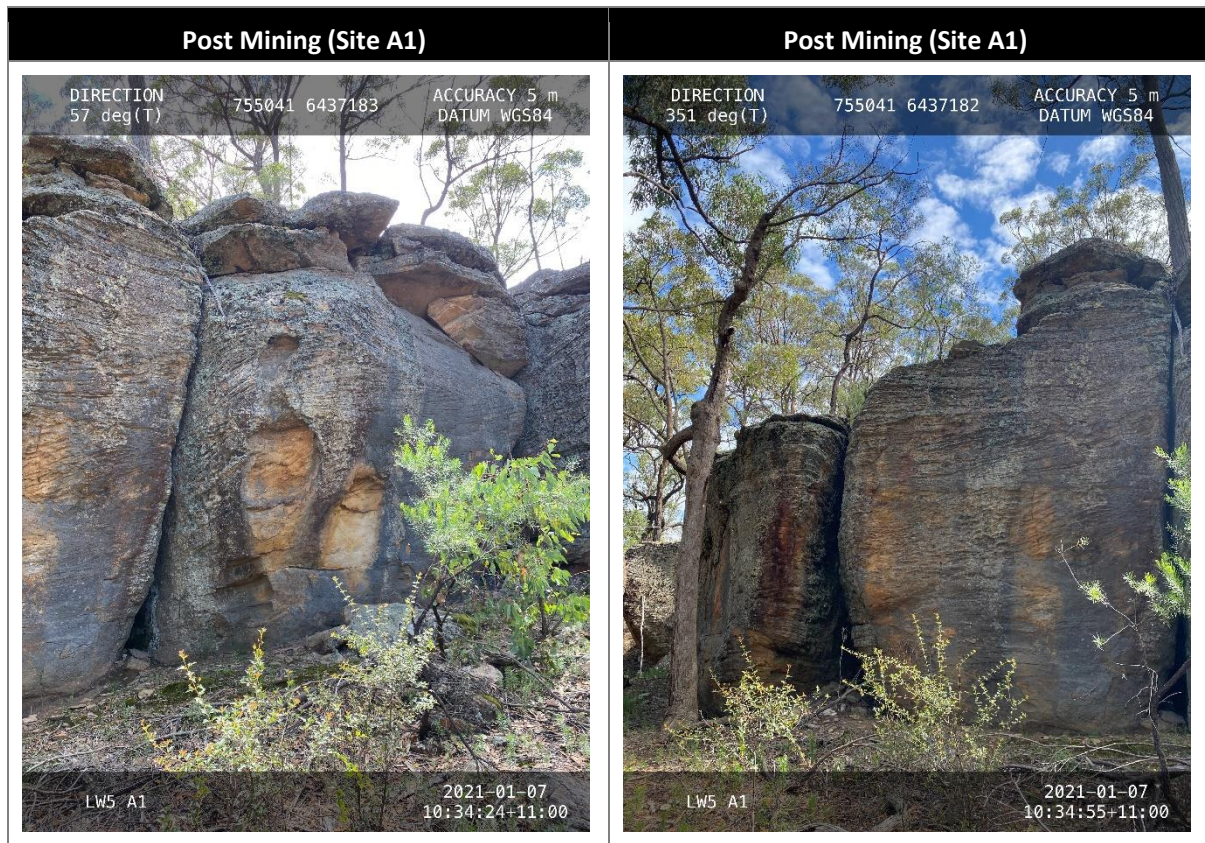
### 6.1 Cliff Lines (LW5 – Site A1)

**Notes:** No perceptible change (as a result of subsidence) from pre-mining condition noted at the time of the post mining inspections.

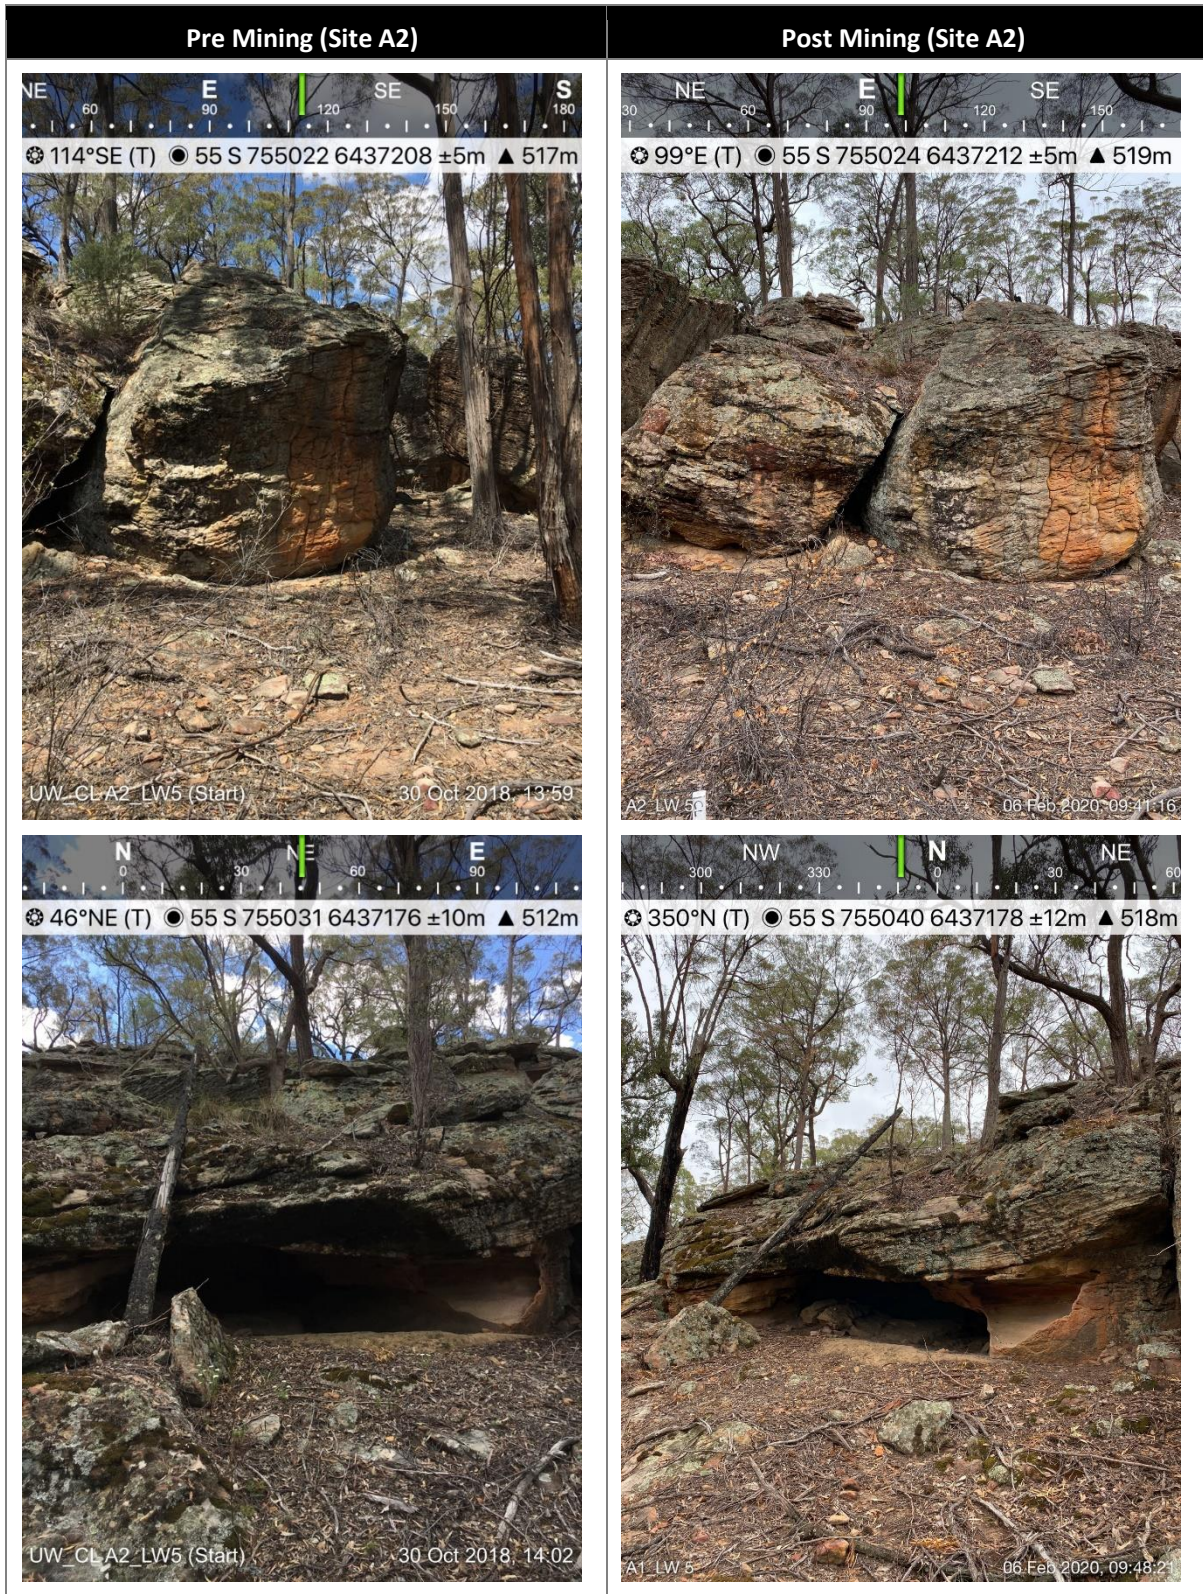
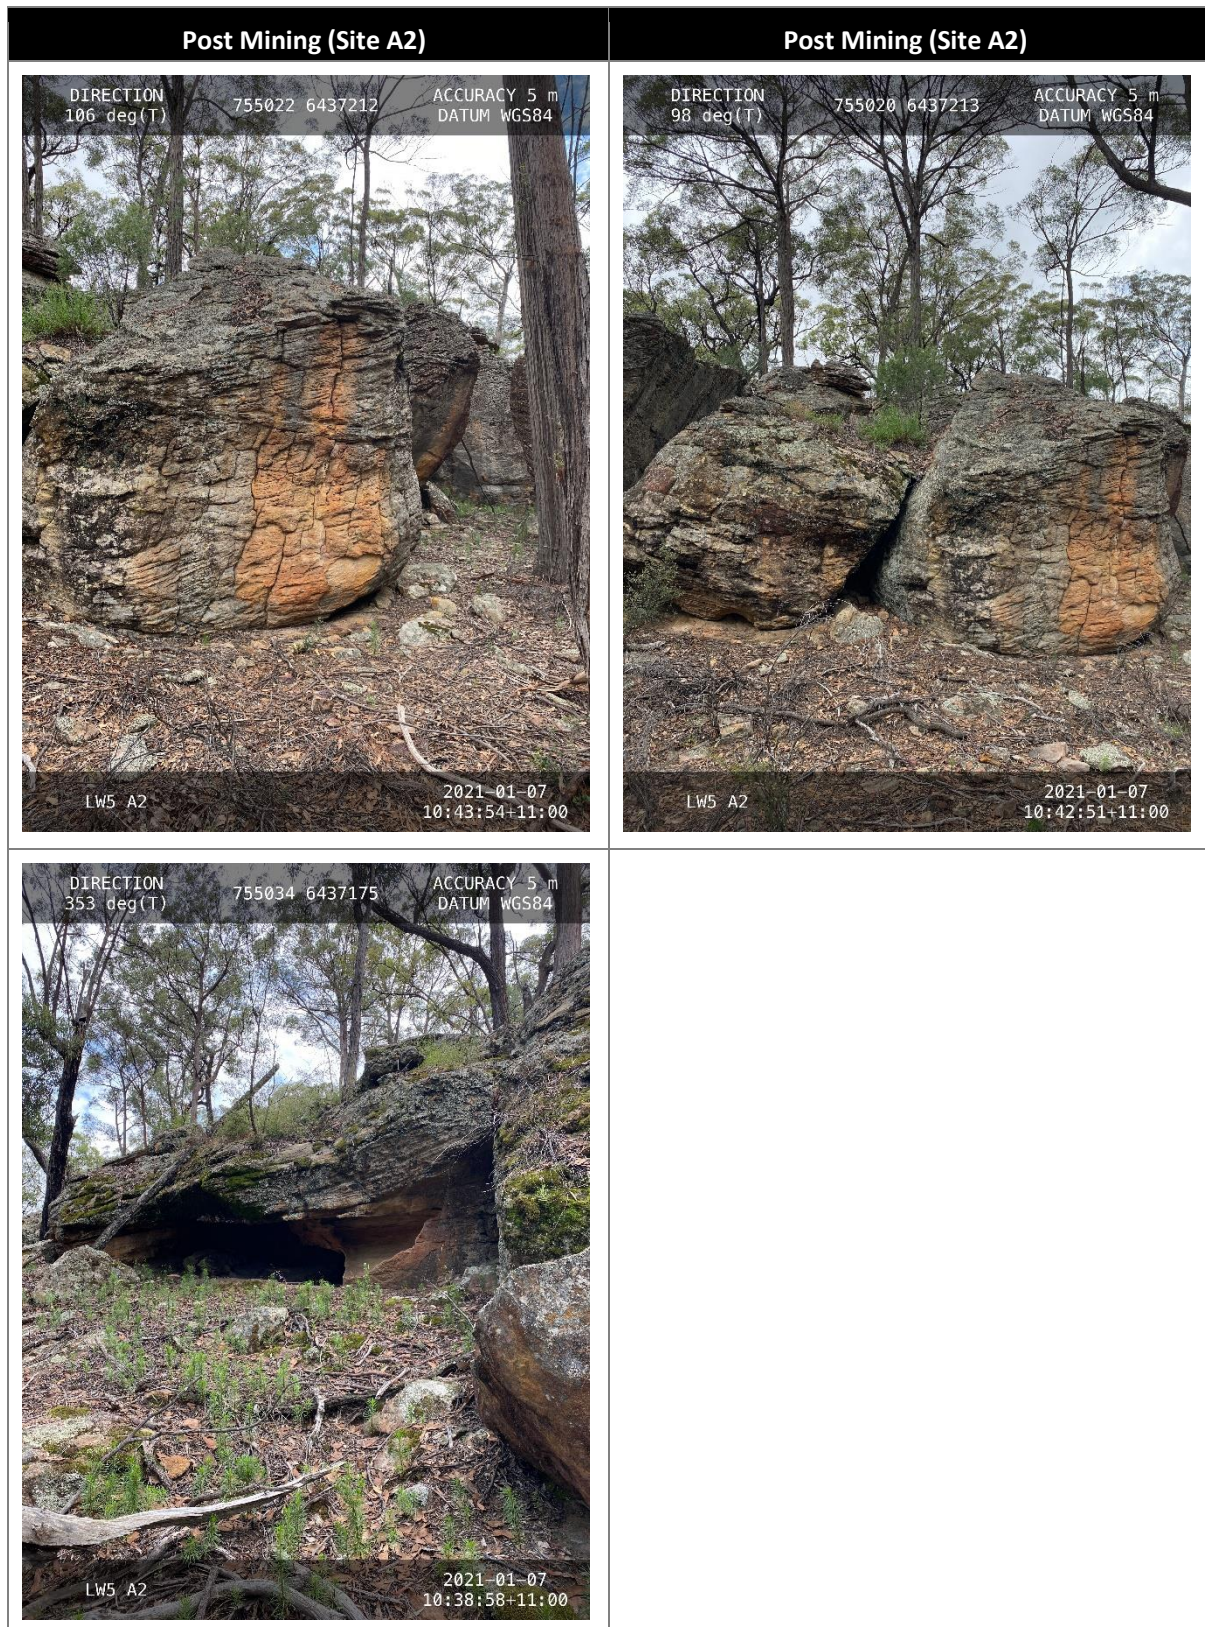
## 6.2 Cliff Lines (LW5 – Site A2)

**Notes:** No perceptible change (as a result of subsidence) from pre-mining condition noted at the time of the post mining inspections.
