ULAN  
COAL

# Condition Assessment Report for Alternate Offset Area

## Assessment of Surface Features

**Number:** ULNCX-1862890609-3

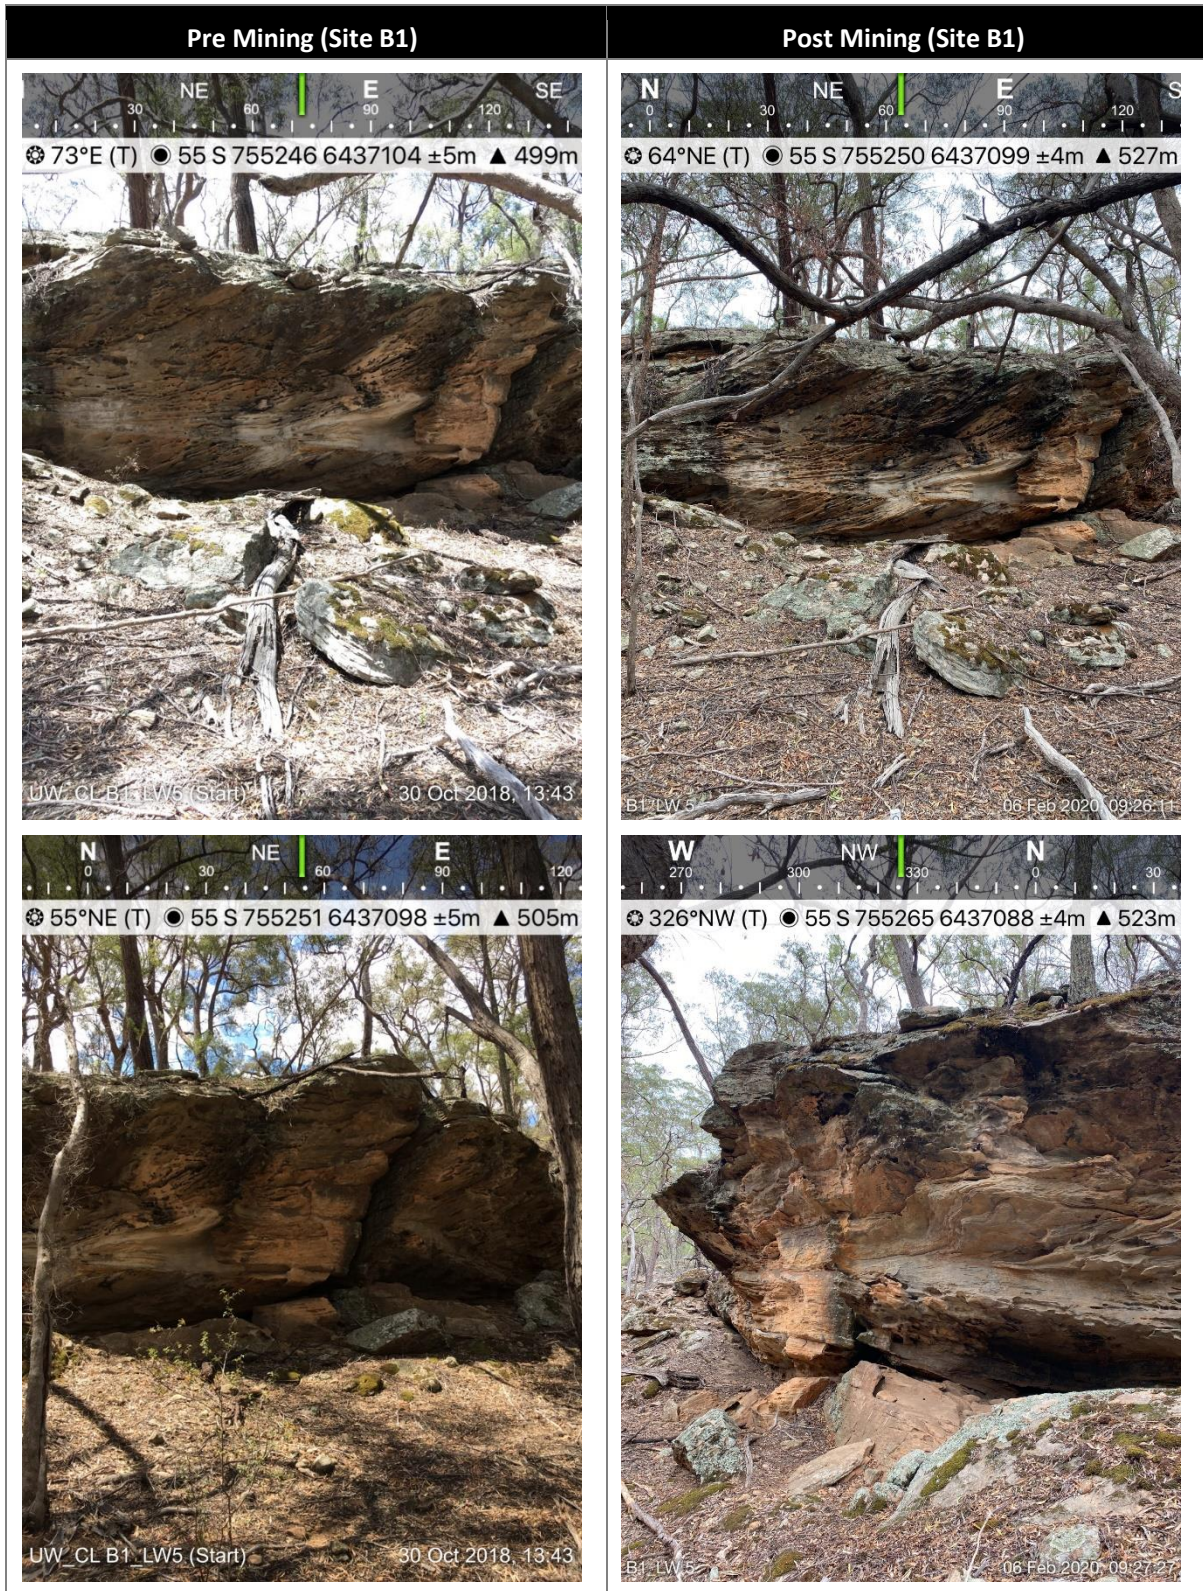
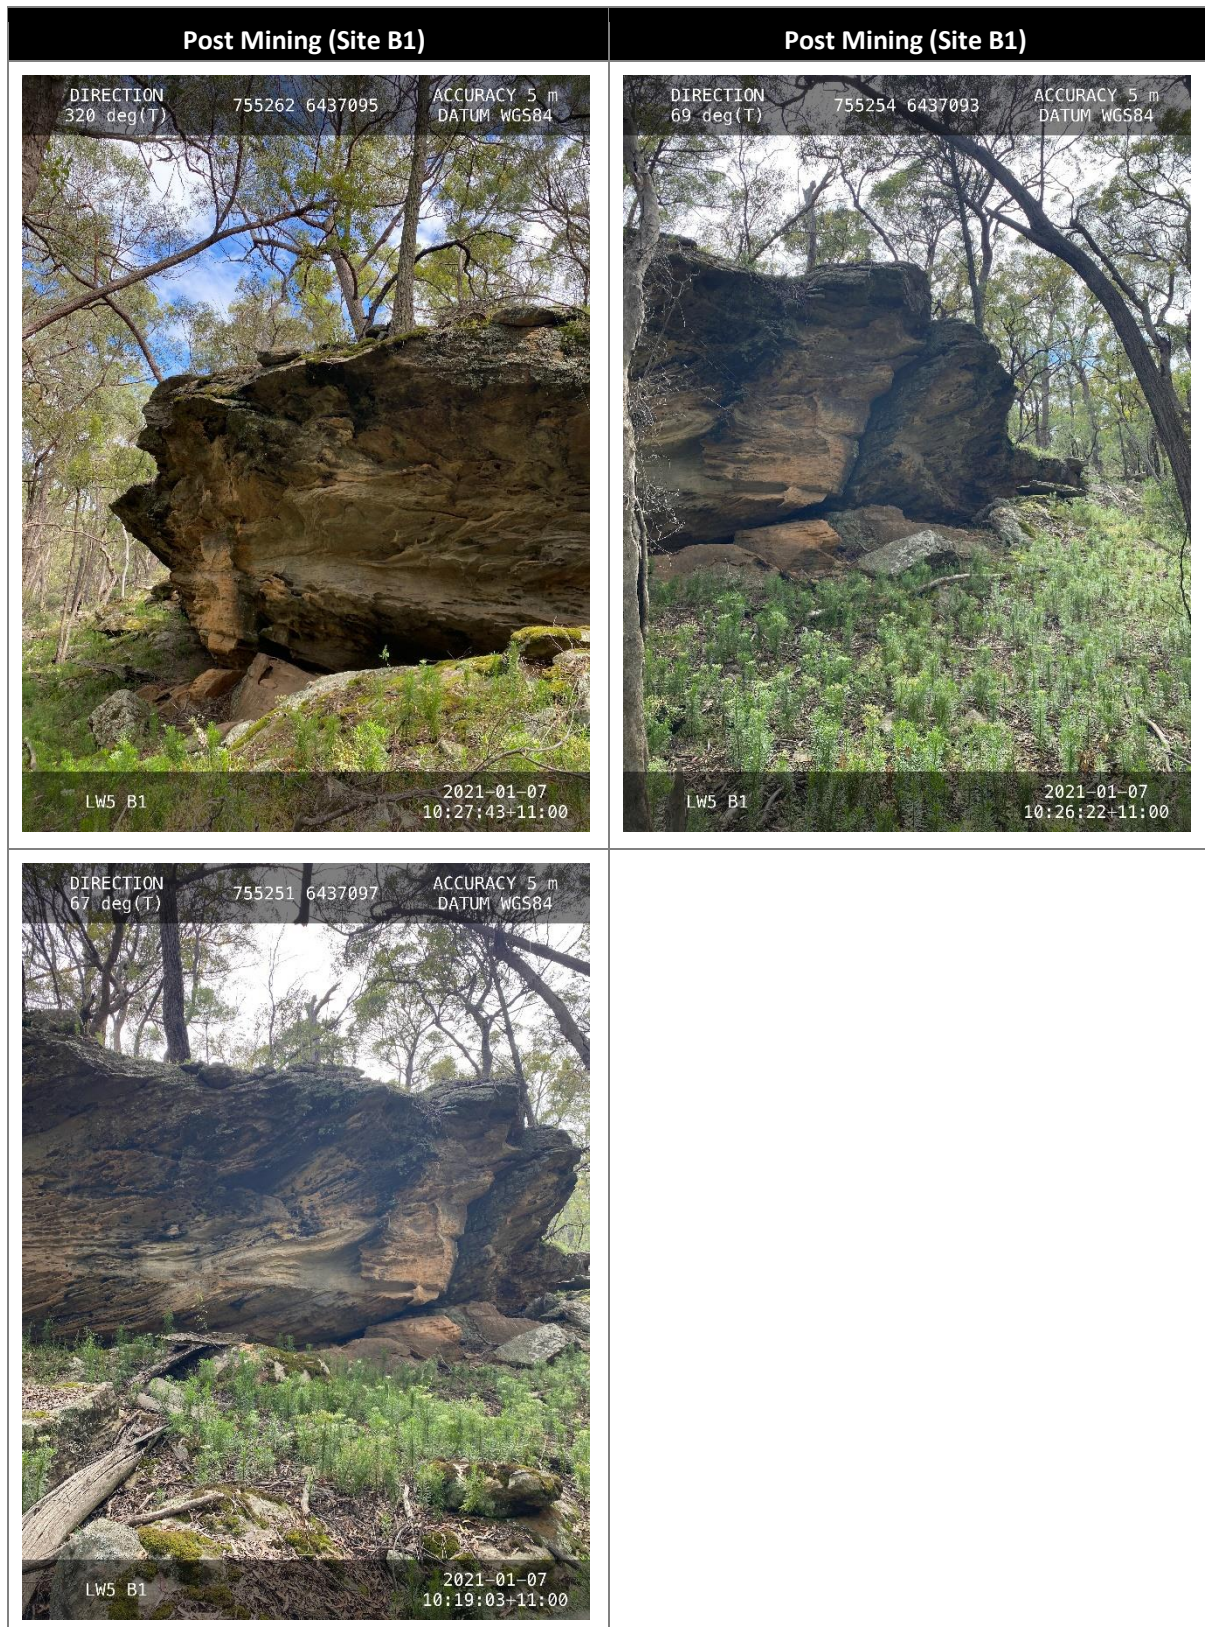
### 6.3 Cliff Lines (LW5 – Site B1)

**Notes:** No perceptible change (as a result of subsidence) from pre-mining condition noted at the time of the post mining inspections.

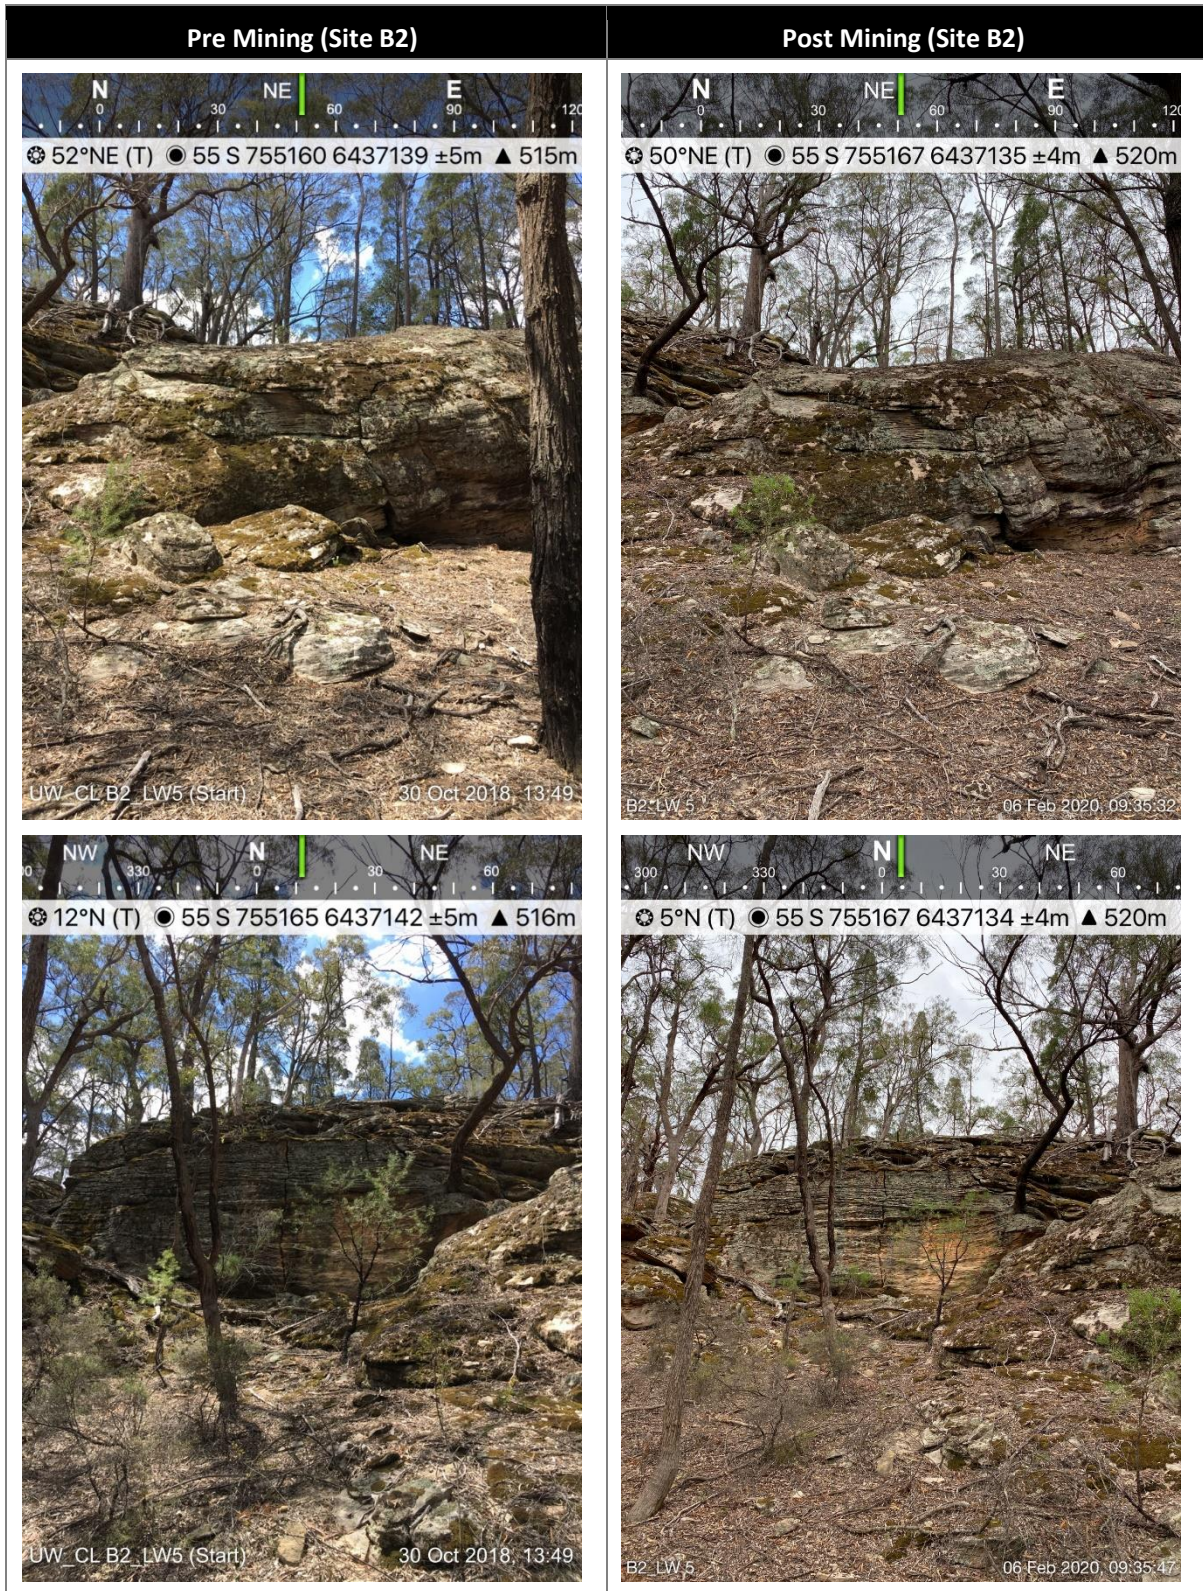
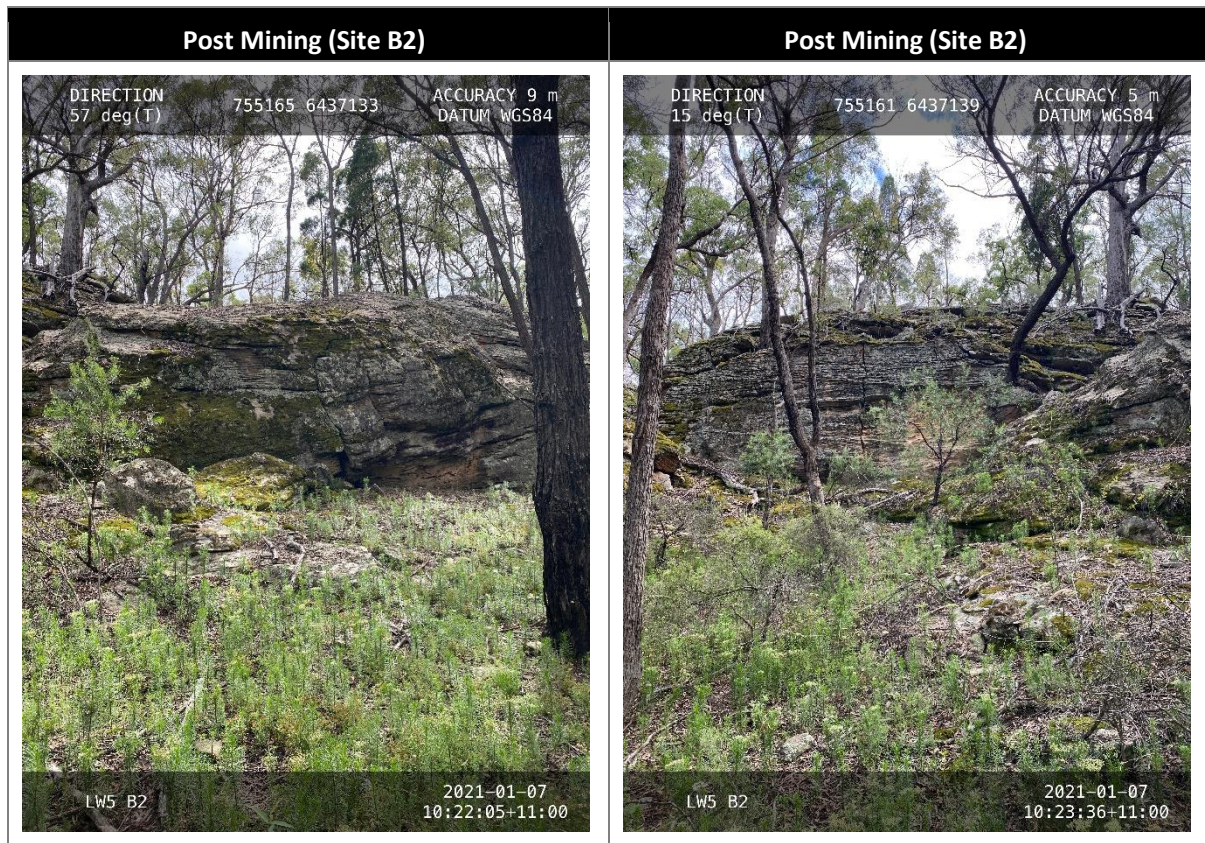
## 6.4 Cliff Lines (LW5 – Site B2)

**Notes:** No perceptible change (as a result of subsidence) from pre-mining condition noted at the time of the post mining inspections.

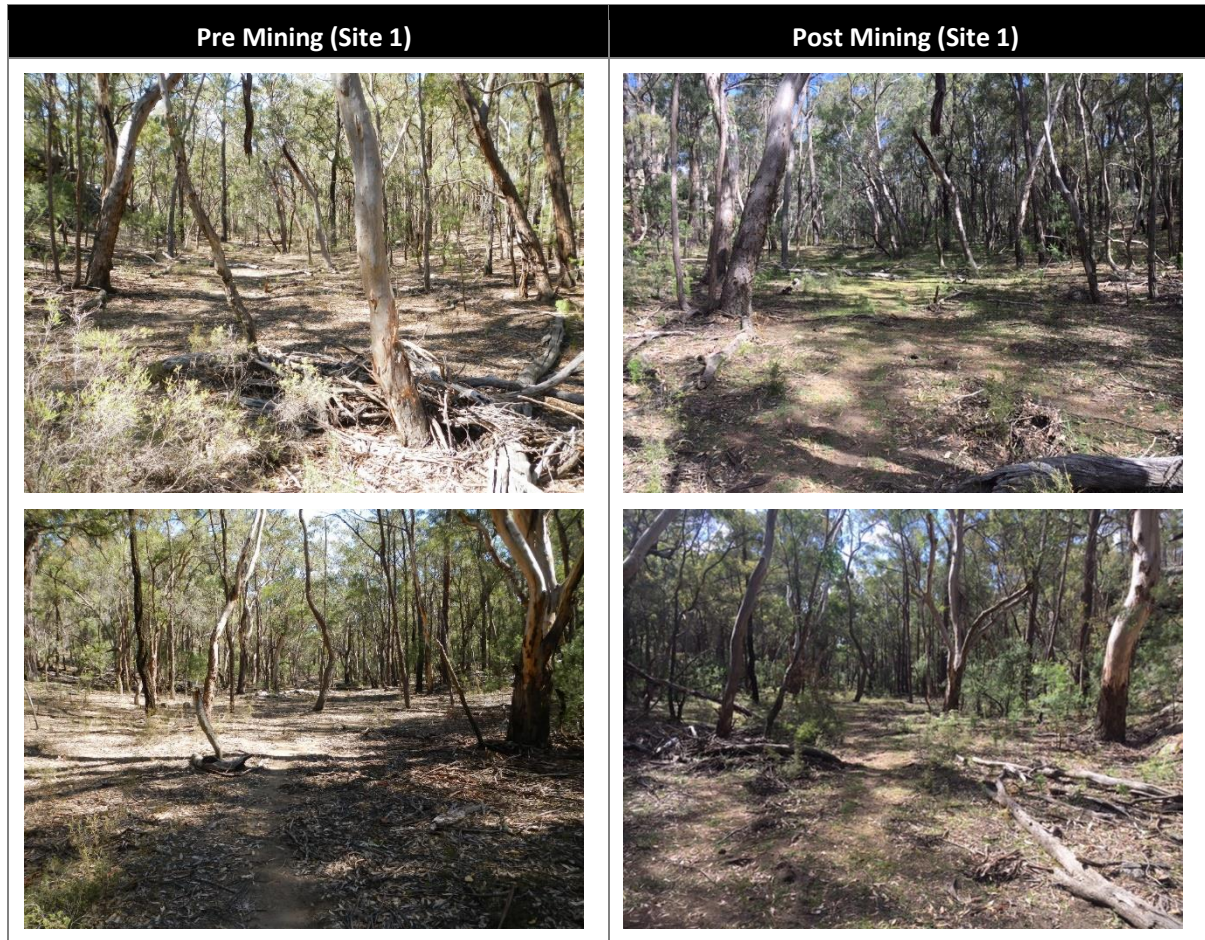
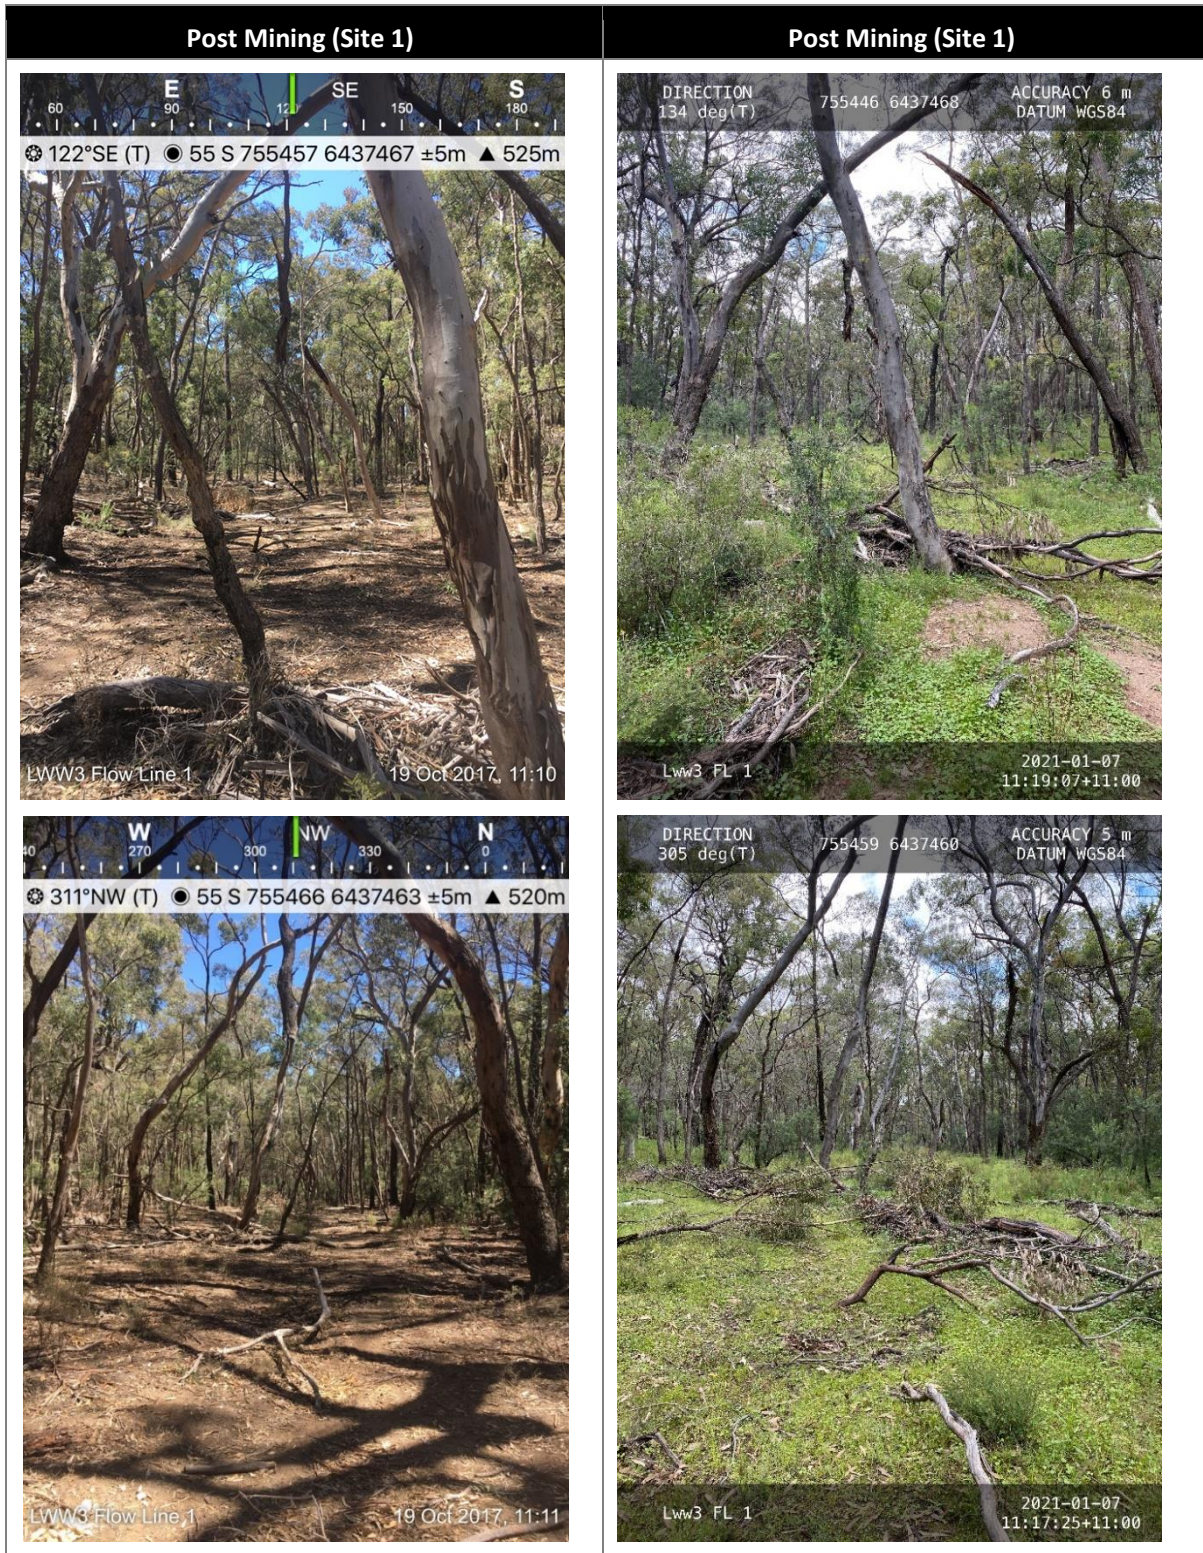
### 7.1 Flow Line (LWW3 – Site 1)

**Notes:** No perceptible change from pre-mining condition (as a result of subsidence) was noted at the time of the post mining inspections. The flow line during the most recent inspection in January 2021 exemplified the above average annual rainfall recorded for 2020 (Table 1), with an increased groundcover when compared to previous years. Several significant rainfall events were recorded during 2020 as evident by the change in flood debris throughout the flow line.

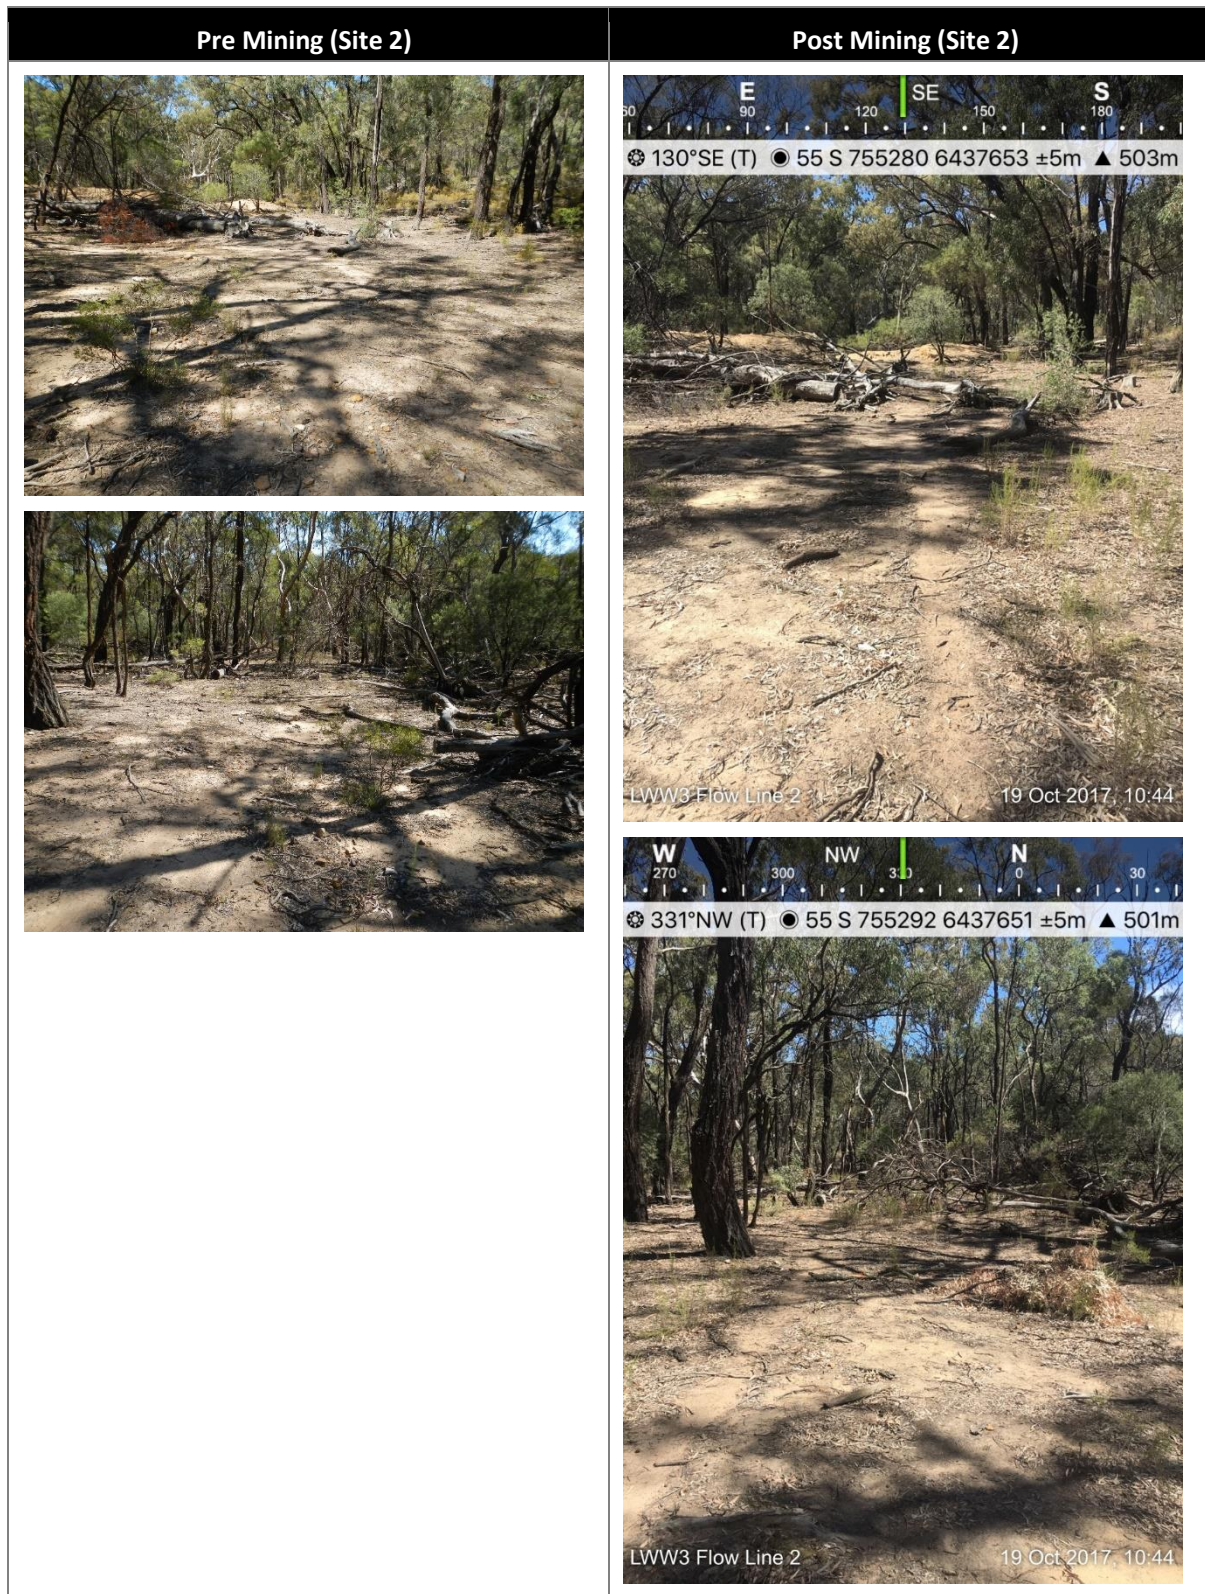
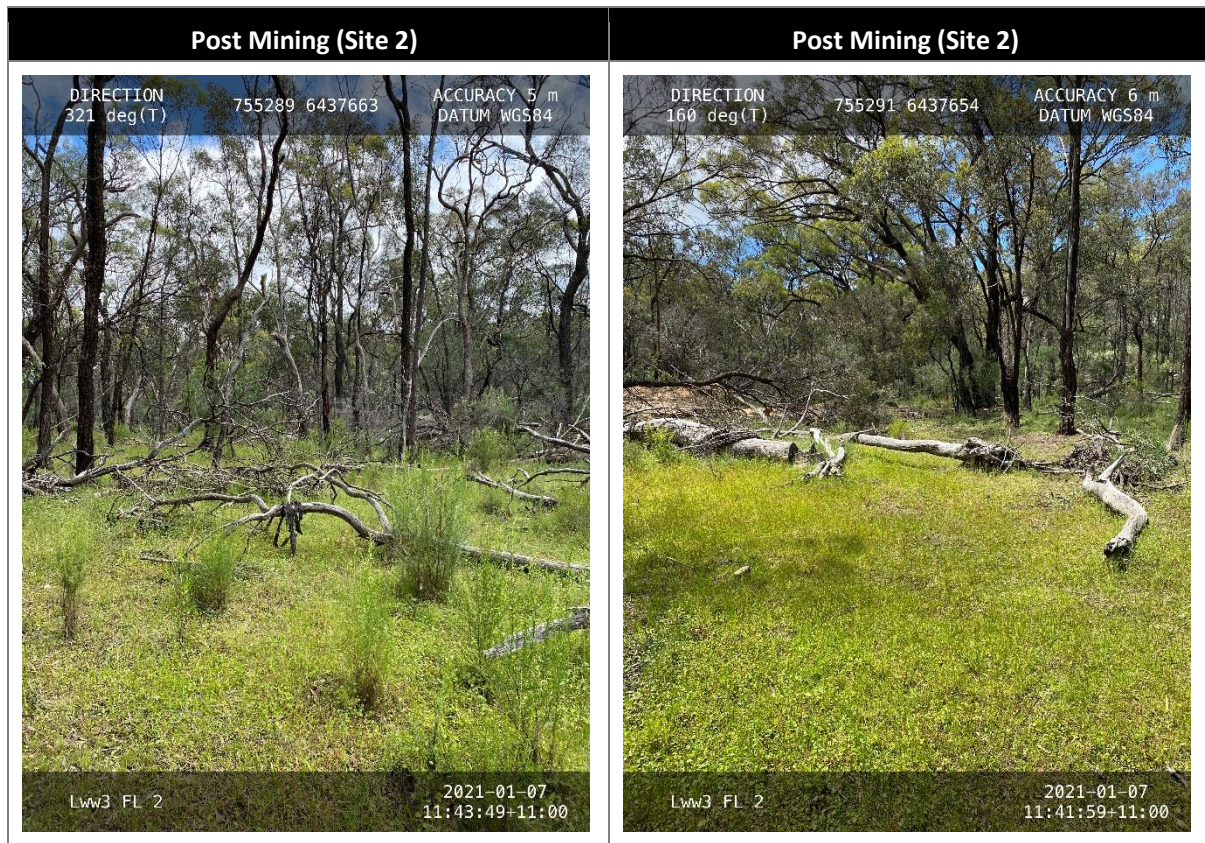
## 7.2 Flow Line (LWW3 – Site 2)

**Notes:** No perceptible change from pre-mining condition (as a result of subsidence) was noted at the time of the post mining inspections. The flow line during the most recent inspection in January 2021 exemplified the above average annual rainfall recorded for 2020 (**Table 1**), with an increased groundcover when compared to previous years. Several significant rainfall events were recorded during 2020 as evident by the change in flood debris throughout the flow line.

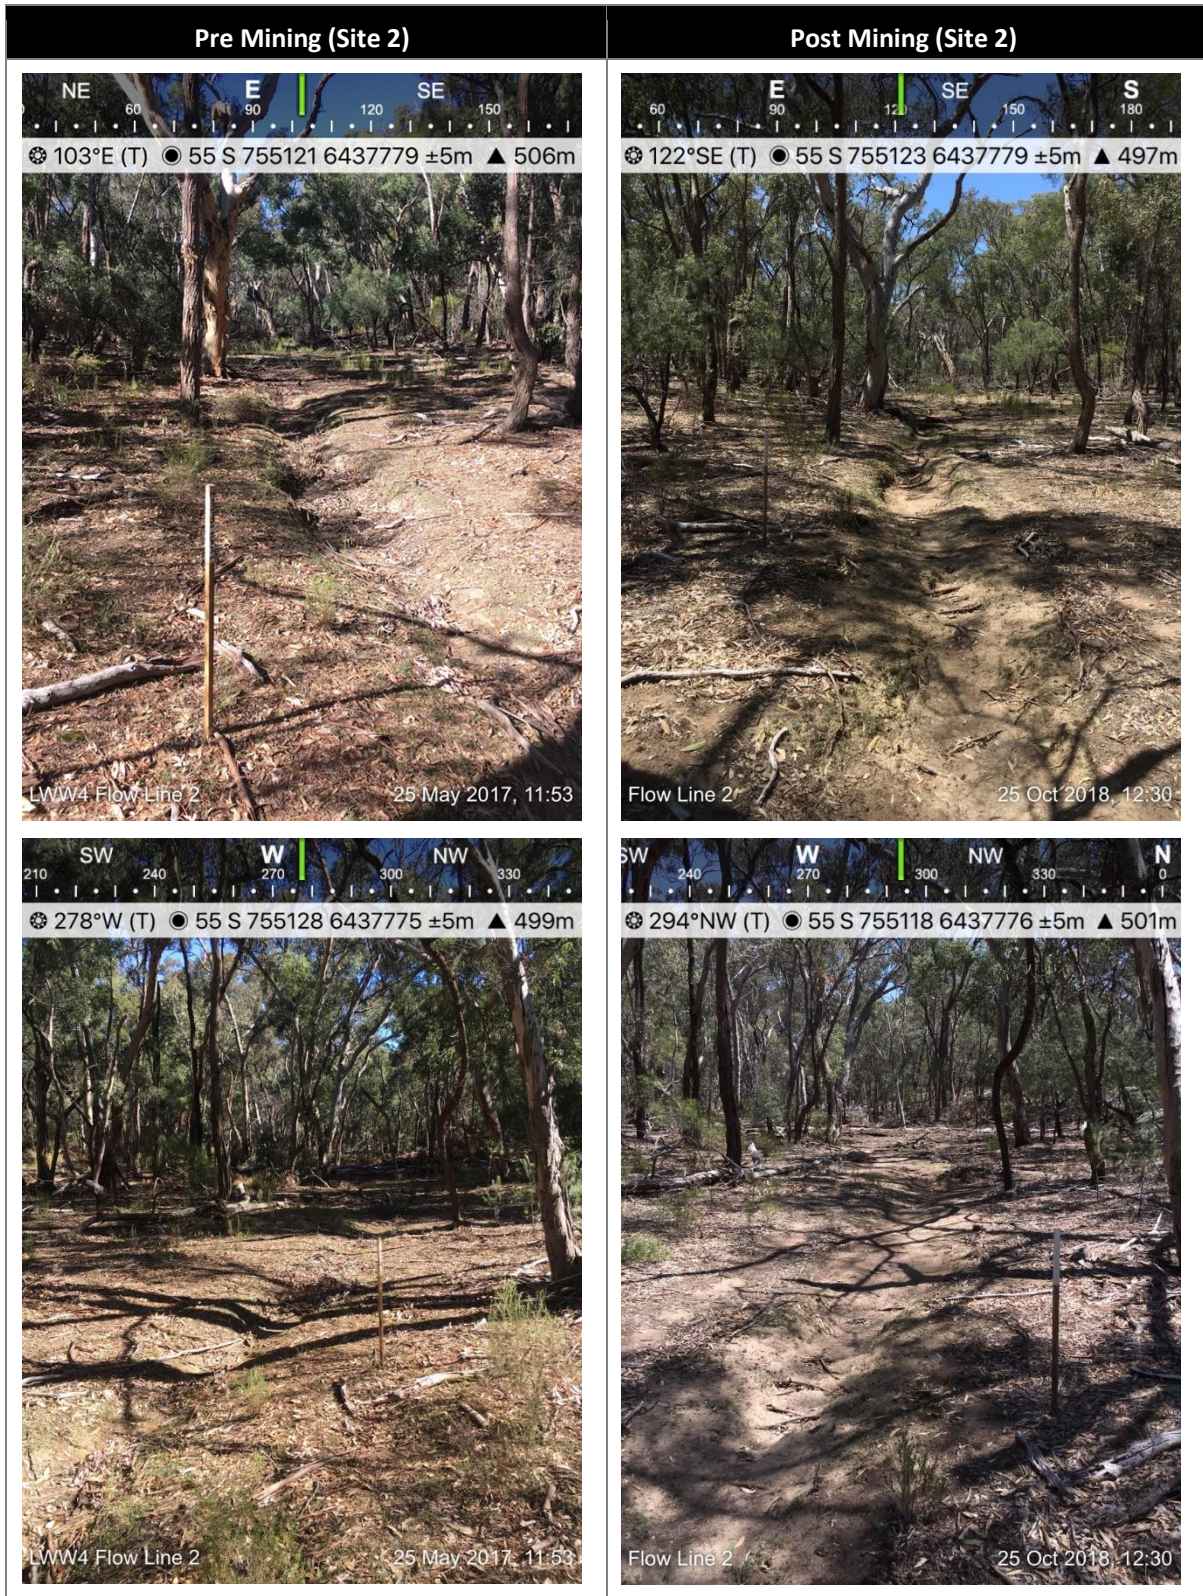
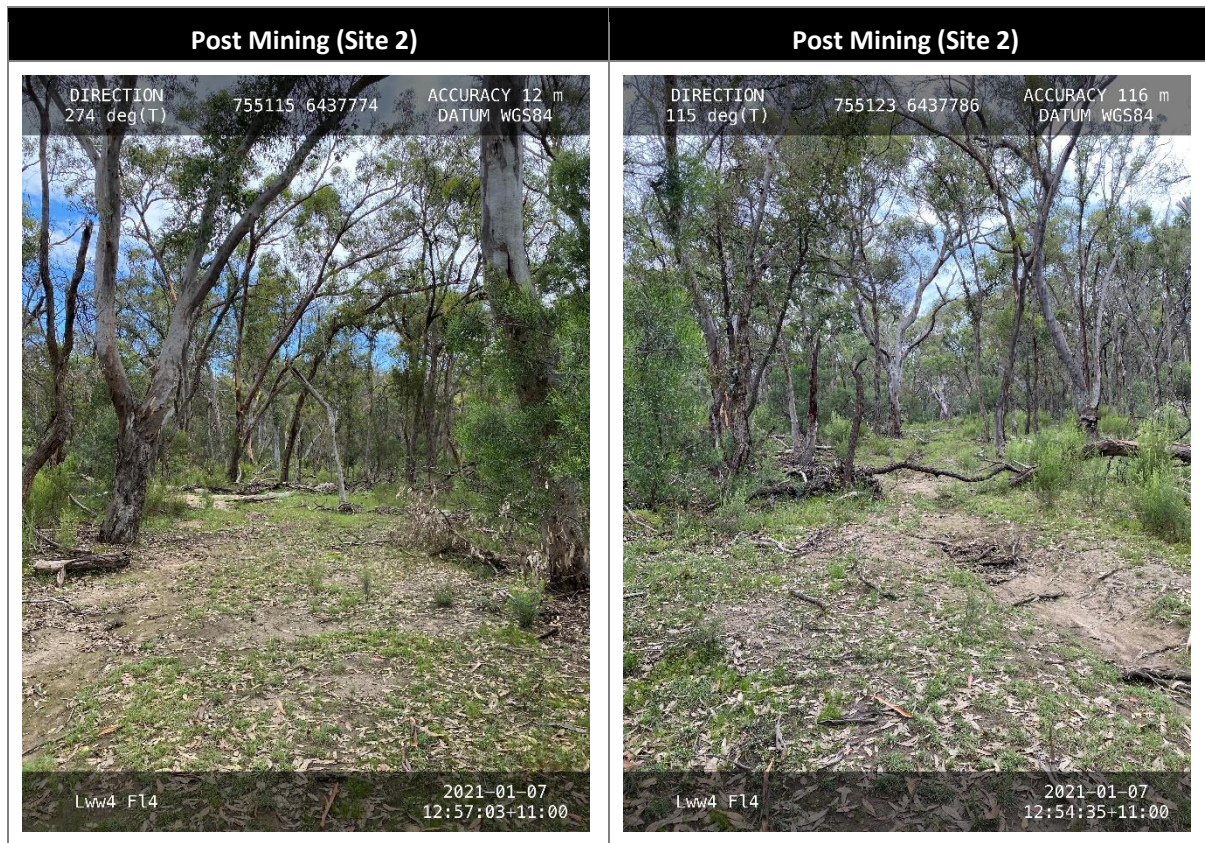
### 7.3 Flow Line (LWW4 – Site 2)

**Notes:** No perceptible change from pre-mining condition (as a result of subsidence) was noted at the time of the post mining inspections. The flow line during the most recent inspection in January 2021 exemplified the above average annual rainfall recorded for 2020 (**Table 1**), with an increased groundcover when compared to previous years. Several significant rainfall events were recorded during 2020 as evident by the change in flood debris throughout the flow line.

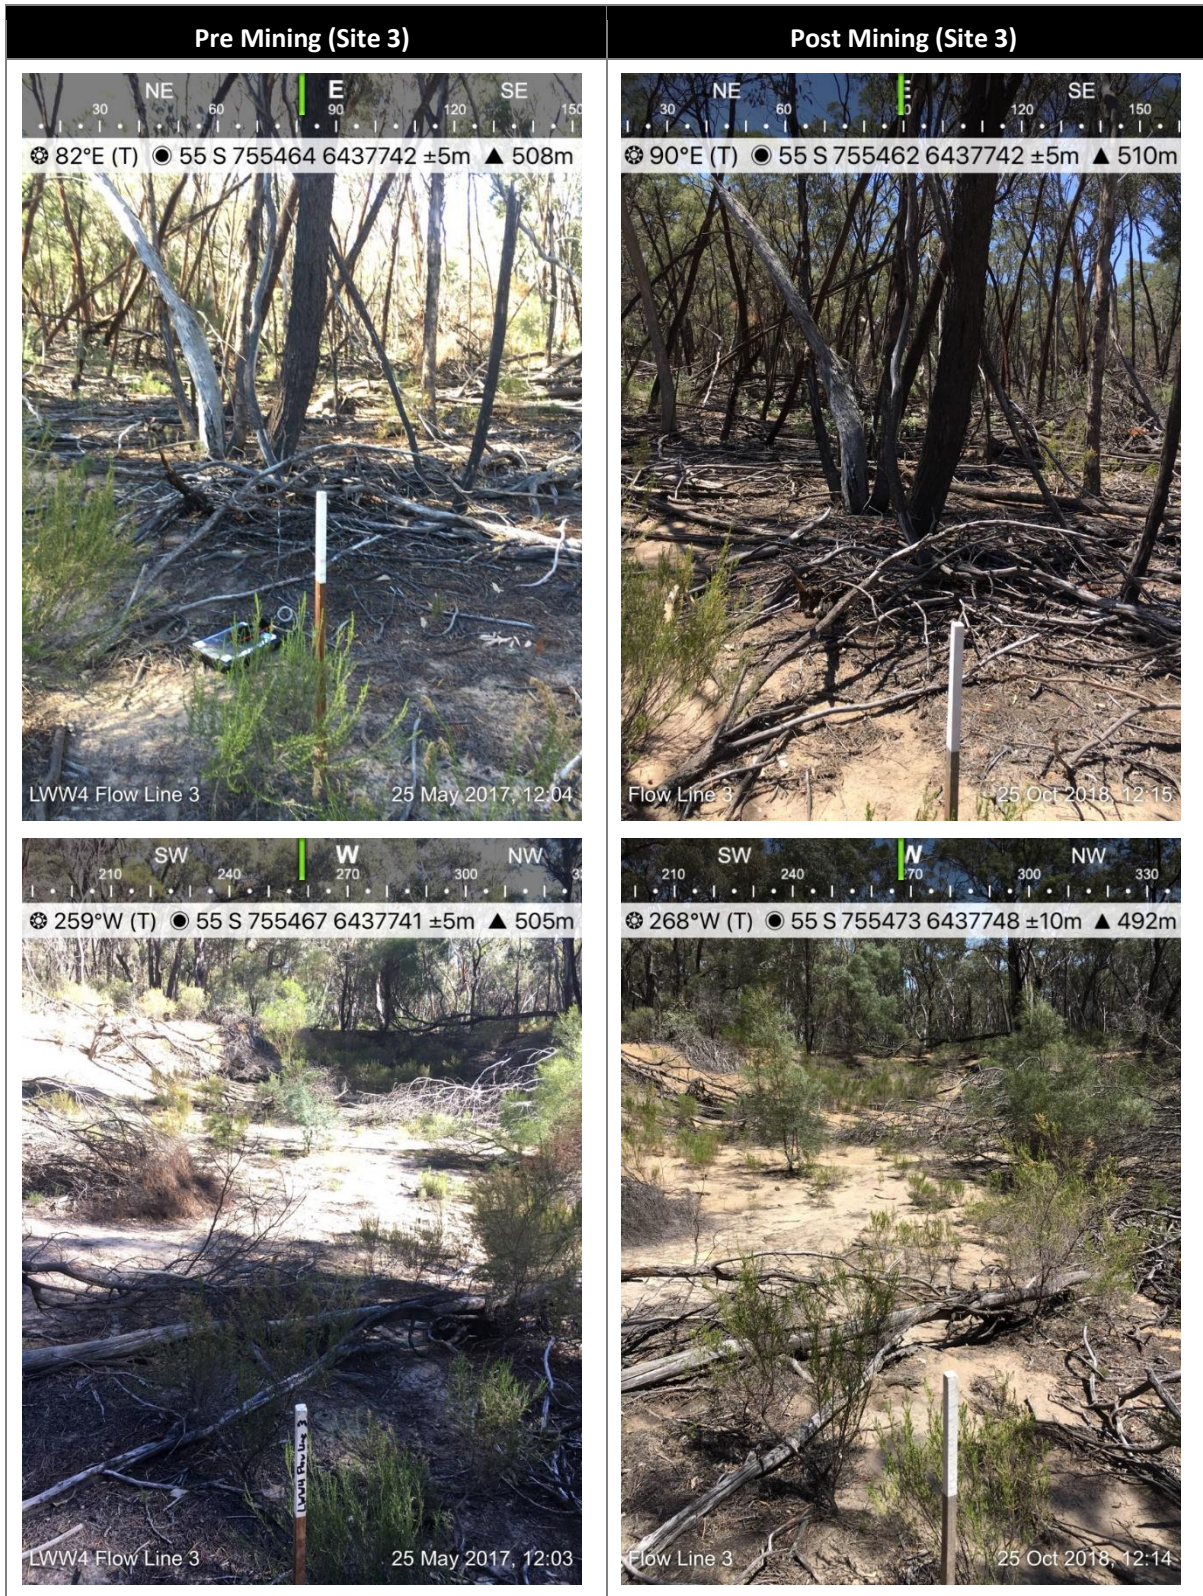
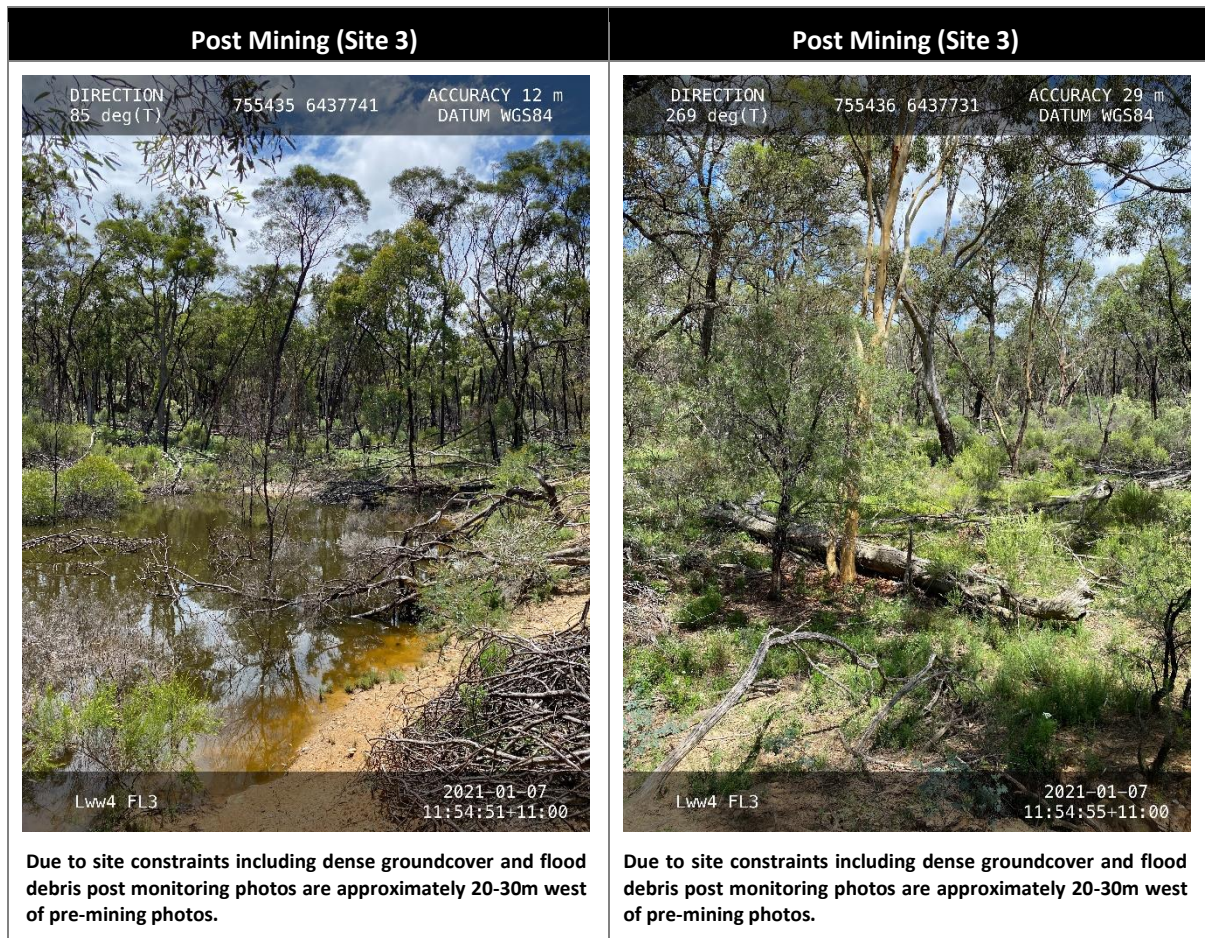
## 7.4 Flow Line (LWW4 – Site 3)

**Notes:** No perceptible change from pre-mining condition (as a result of subsidence) was noted at the time of the post mining inspections. The flow line during the most recent inspection in January 2021 exemplified the above average annual rainfall recorded for 2020 (**Table 1**), with increased groundcover and dense vegetation when compared to previous years. Several significant rainfall events were recorded during 2020 as evident by the large amount of flood debris throughout the flow line. The existing dam, although undermined, appeared to be holding water and at near capacity.
