**ULAN COAL MINES LIMITED
2023 ULAN CREEK STABILITY
MONITORING REPORT**

DOCUMENT NO. UC MPL_01_24

Document No:	UCMPL_01_24
Document Title:	2023 Ulan Creek Stability Monitoring Report
General Description:	Annual survey and stability monitoring of Ulan Creek
Report To:	Mat Croake
Prepared By:	Stephen Bragg
Date:	01 January 2024

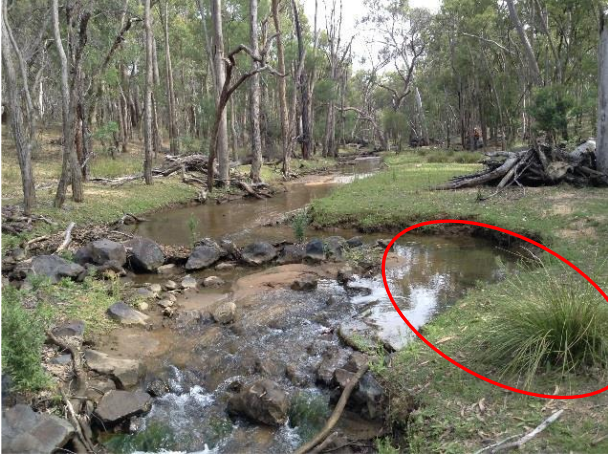
LHB in 2014

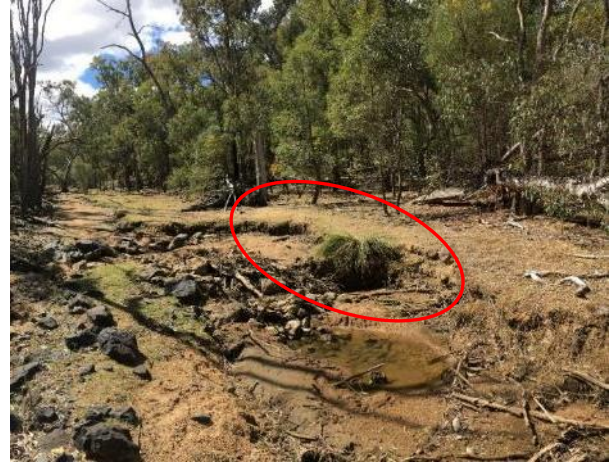
Loss of material evident from LHB in 2017

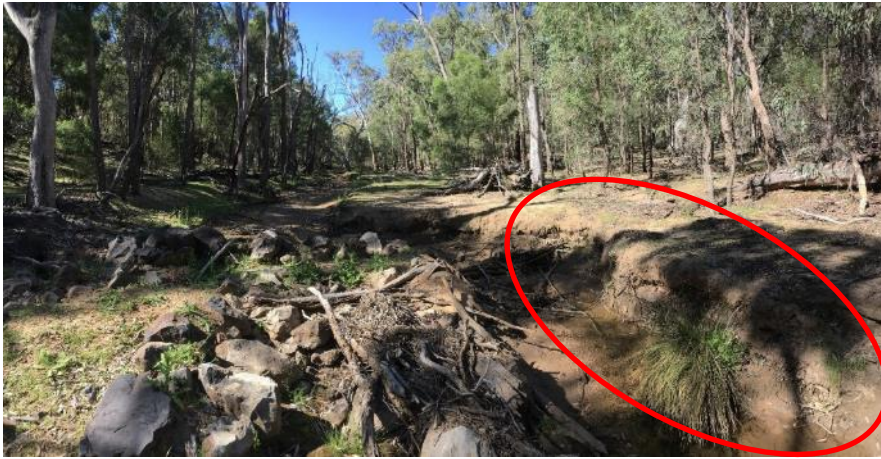
Continuation of material loss from LHB in 2018 and slumping of the creek bank.

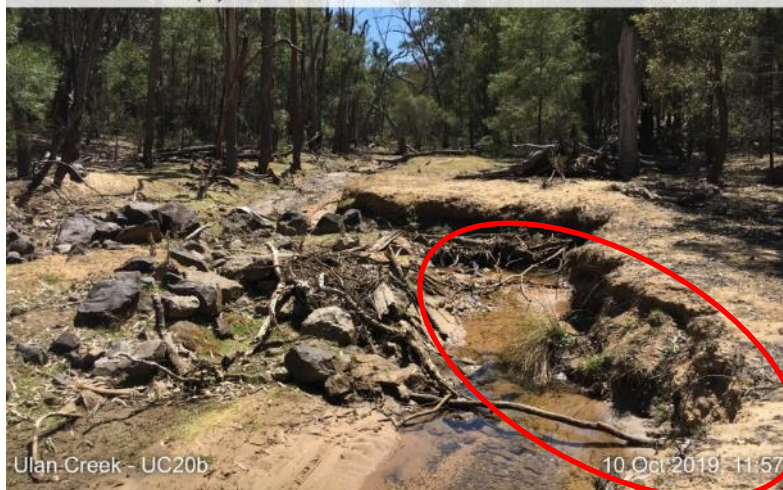
Continuation of material loss from LHB in 2019 and slumping of the creek bank.
