APPENDIX B: Ulan Creek

2023 Channel Stability Monitoring - Site Inspection Details

Creek Name: Ulan Creek

Date: 28 November 2023

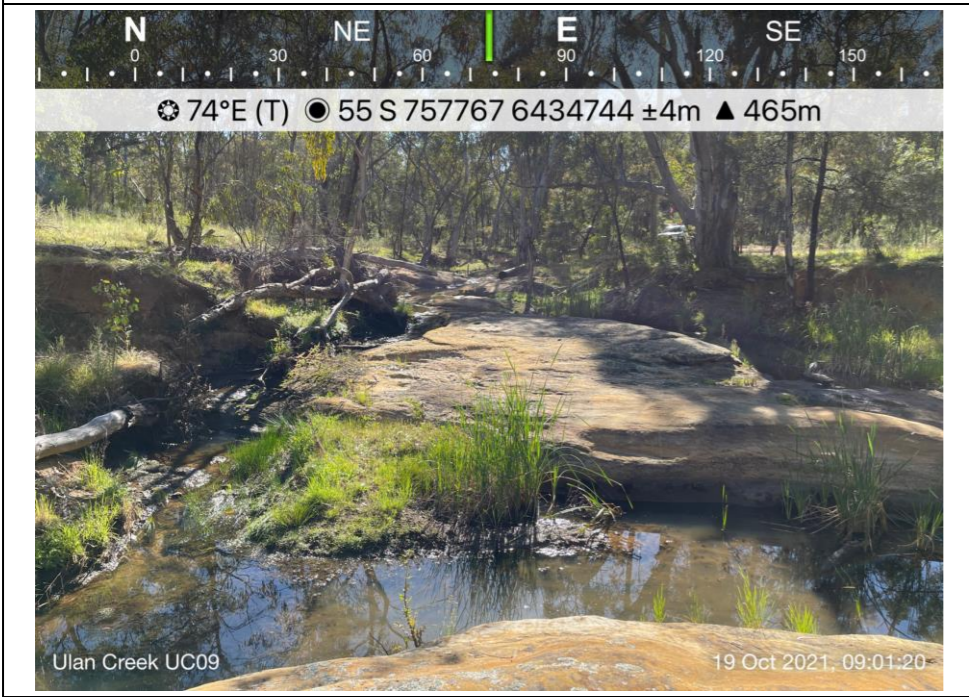
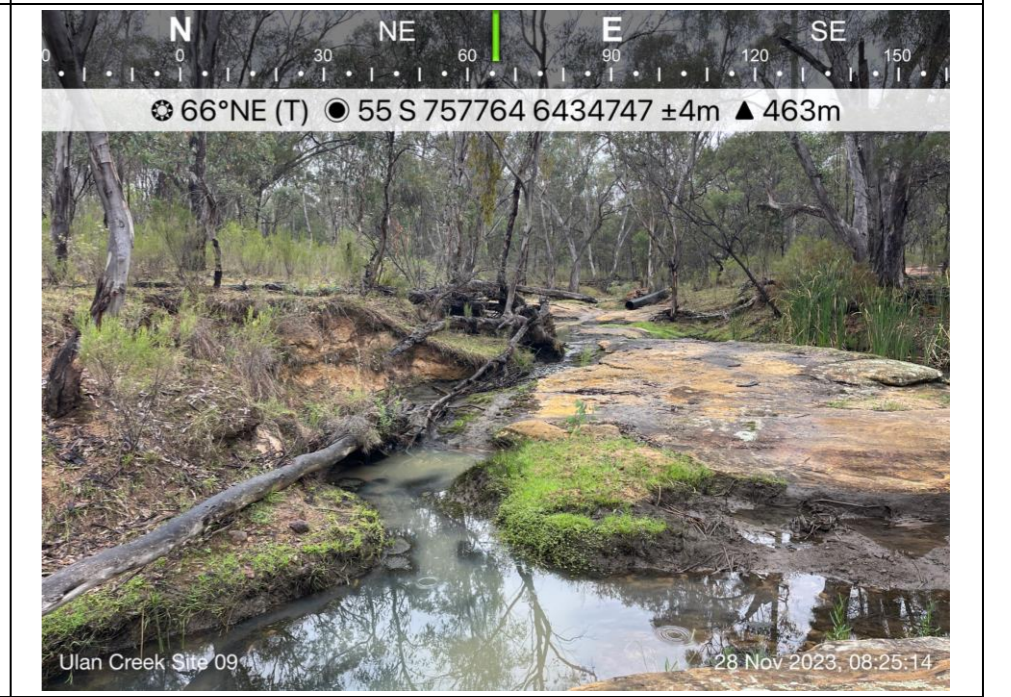
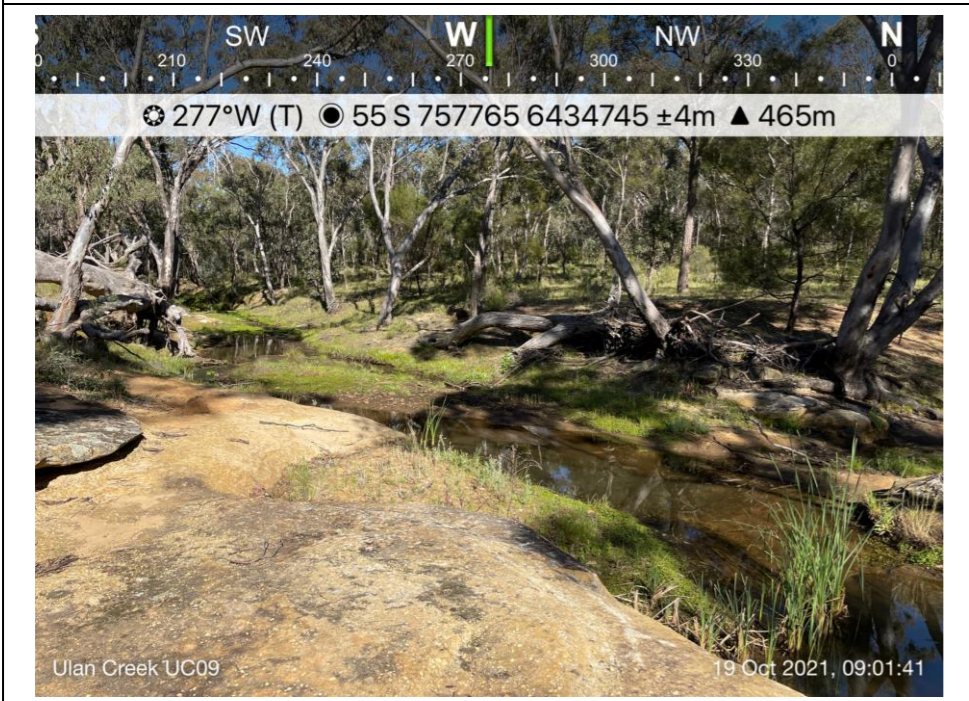
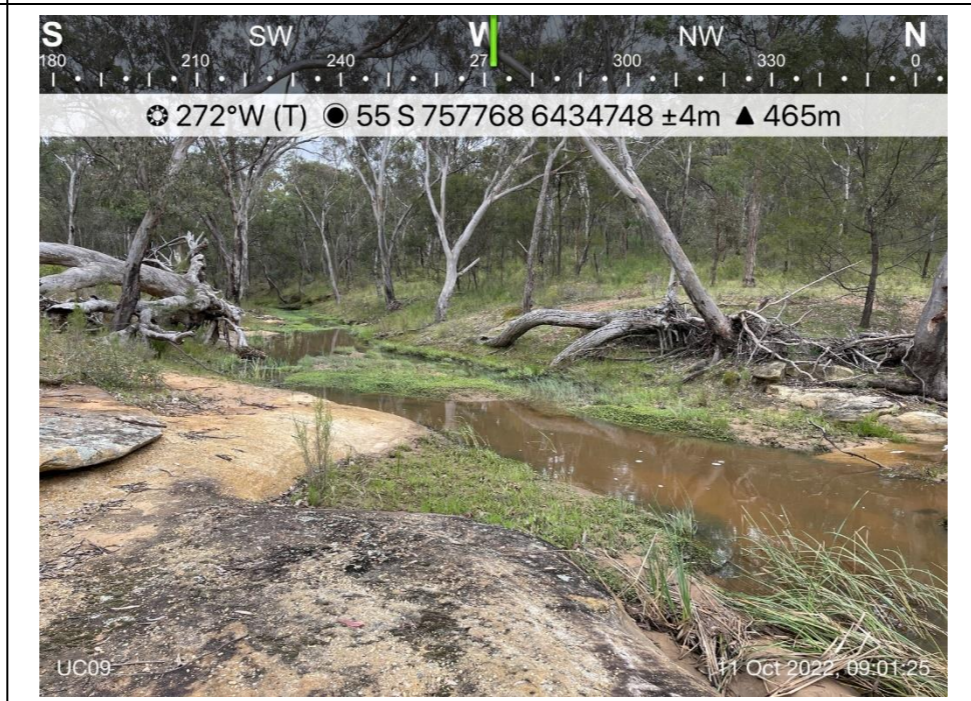
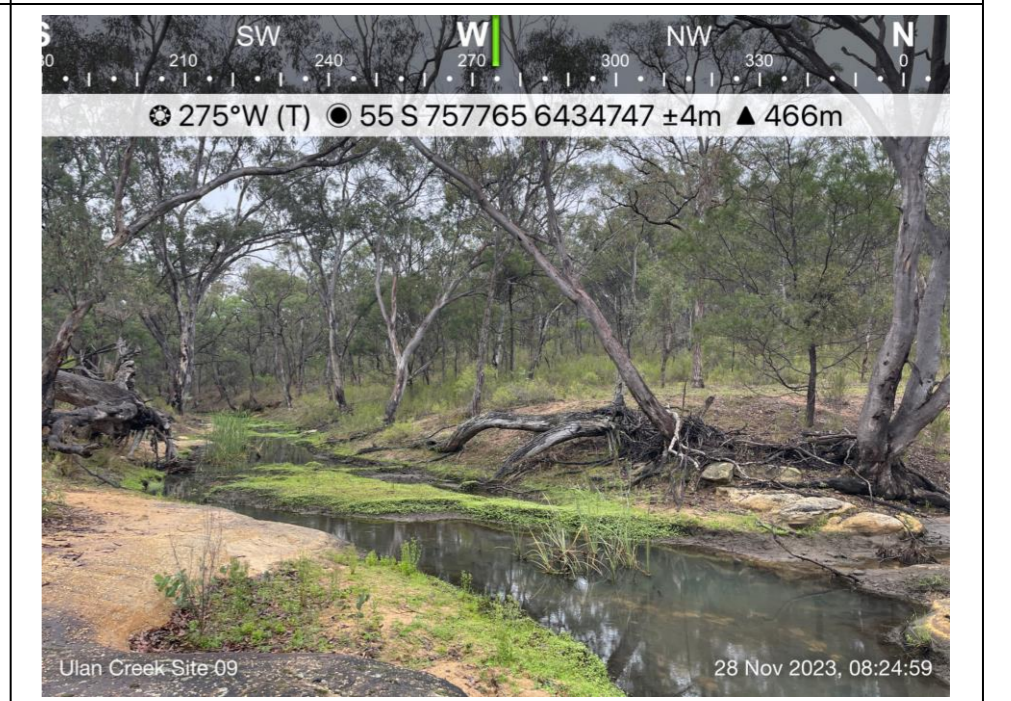
Monitoring Site: UC09

**General Observations:** Ulan Creek had water flowing at this location in 2023. Exposed bedrock is within the floor of the channel, although channel bed assessment in 2023 could not be completed due to water in the creek. A high flow event in the 2020 monitoring period moved the log that was across the channel. In 2020, flood debris was recorded above the banks. In 2022 signs of additional sand and silts deposits were noted just above the water line on the LHB. Signs of instabilities along both banks was observed in 2021 and 2022. The LHB walls are near vertical, exposed with signs of recent erosion. The RHB wall is a more moderate slope and mostly vegetated. Both banks are tree lined with fewer trees along the LHB. The tunnel erosion deep into the RHB, is comparable to previous observations since 2020. The observations in 2023 are comparable with recent years. The CSIRO *Ephemeral Stream Assessment* classification at this location as 'very active'.

**Notes:** In 2023 observations were limited to the LHB and water flowing. The creek bed could not be assessed. The water appeared slightly turbid. Decreasing vegetative ground cover noted in 2023.

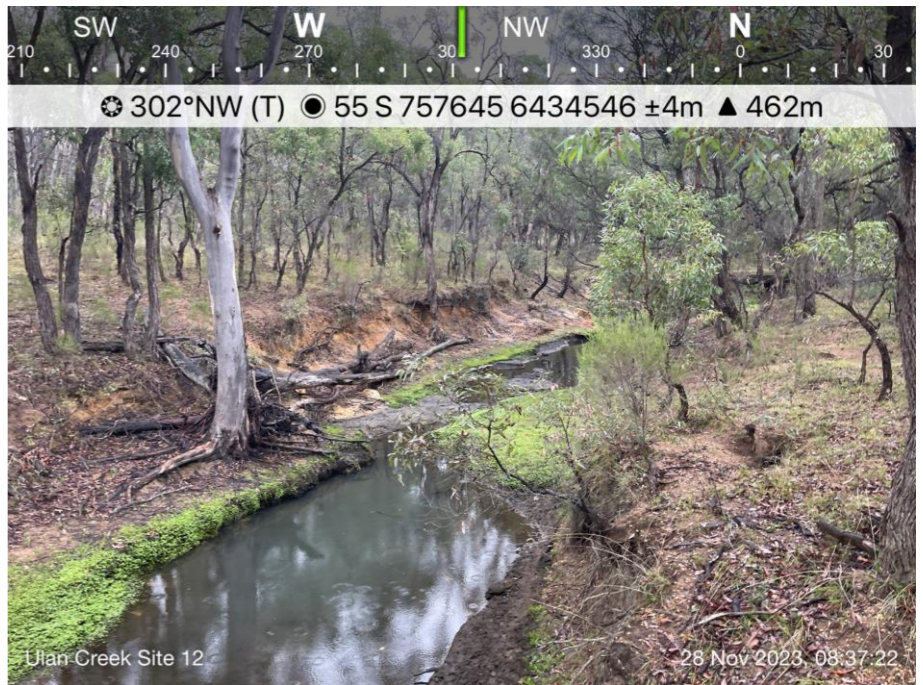
Monitoring Site: UC12

**General Observations:** Ulan Creek had water flowing at this location in 2023. The channel bed is characterised by gravel size and some larger rock, with signs of increasing vegetation along the low flow channel. Flood debris was located above the LHB in 2020. Increased erosion along the LHB was noted again in 2022. A tree had fallen into the creek from the LHB as noted back in 2020. The LHB wall is near vertical, almost entirely bare, with exposed tree roots, signs of very recent erosion and some minor undercutting. The RHB is a gentler slope, mostly with bare areas and sparse vegetation. decreased groundcover above the LHB and RHB was noted in 2023. Both sides of the creek are tree lined. An infestation of Tree of Heaven was noted between sites UC11 and UC12. Observations in 2023 are comparable to previous monitoring. The CSIRO *Ephemeral Stream Assessment* classification at this location as 'active'.

**Notes:** In 2023 observations were limited to the LHB and water flowing. Decreasing vegetative ground cover noted in 2023.

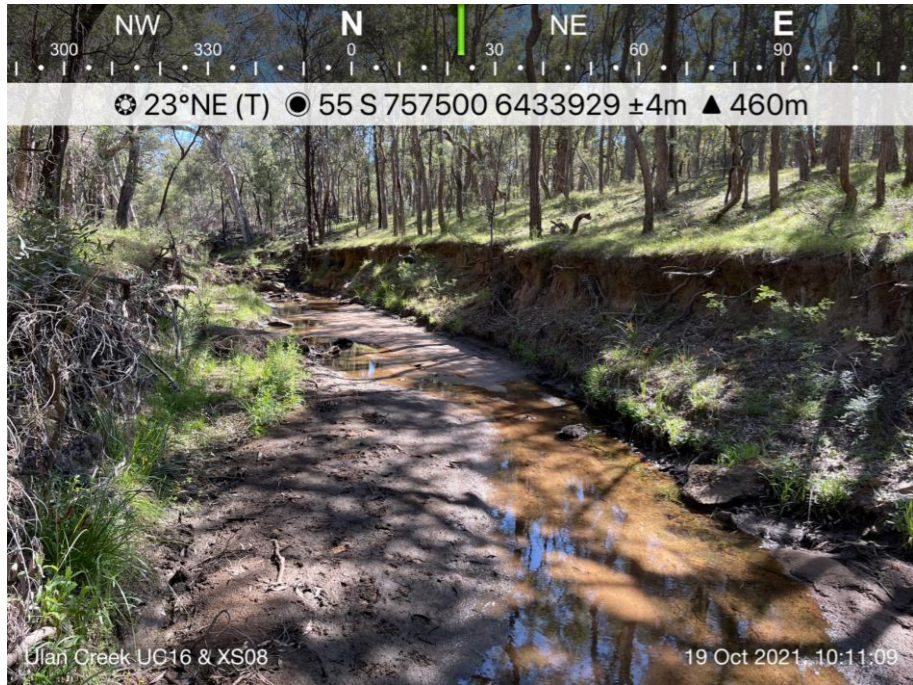
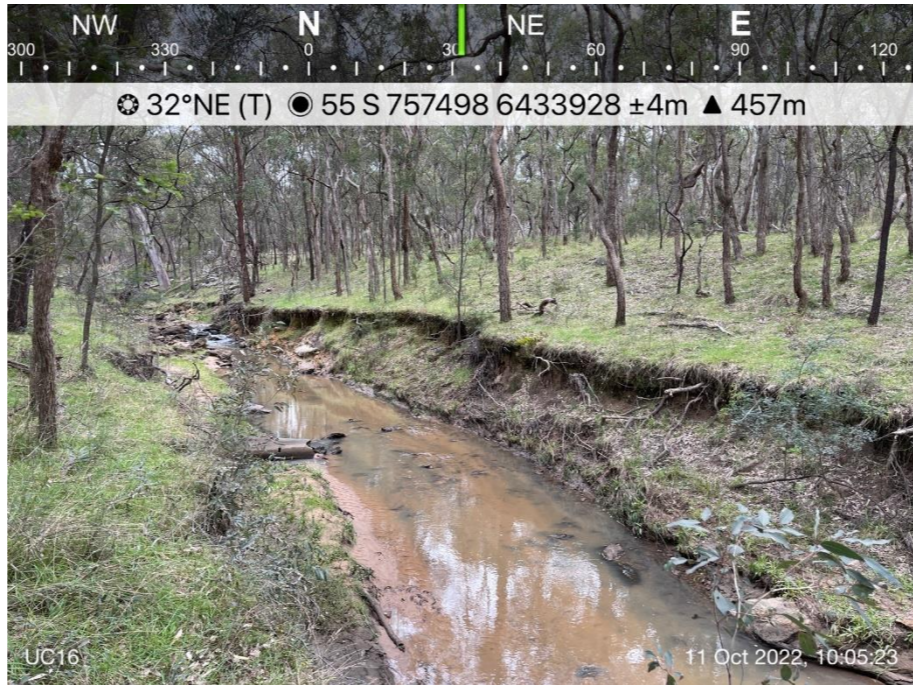
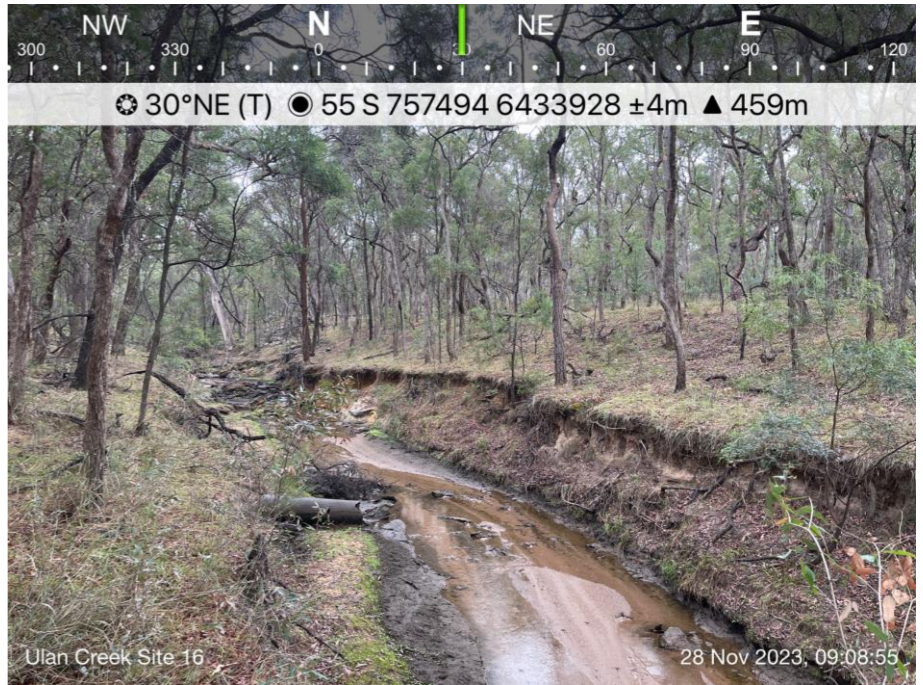
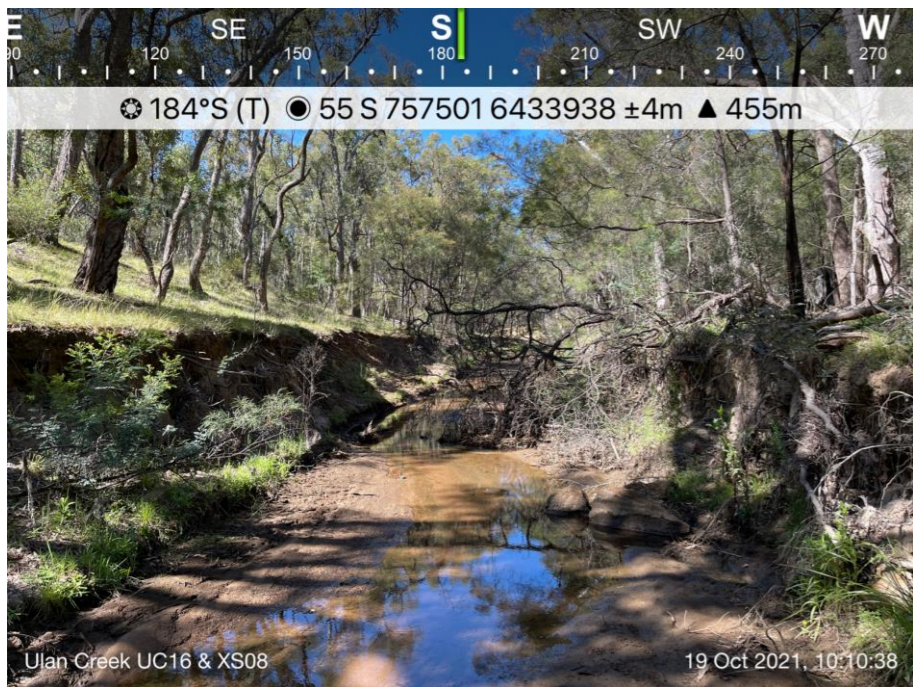
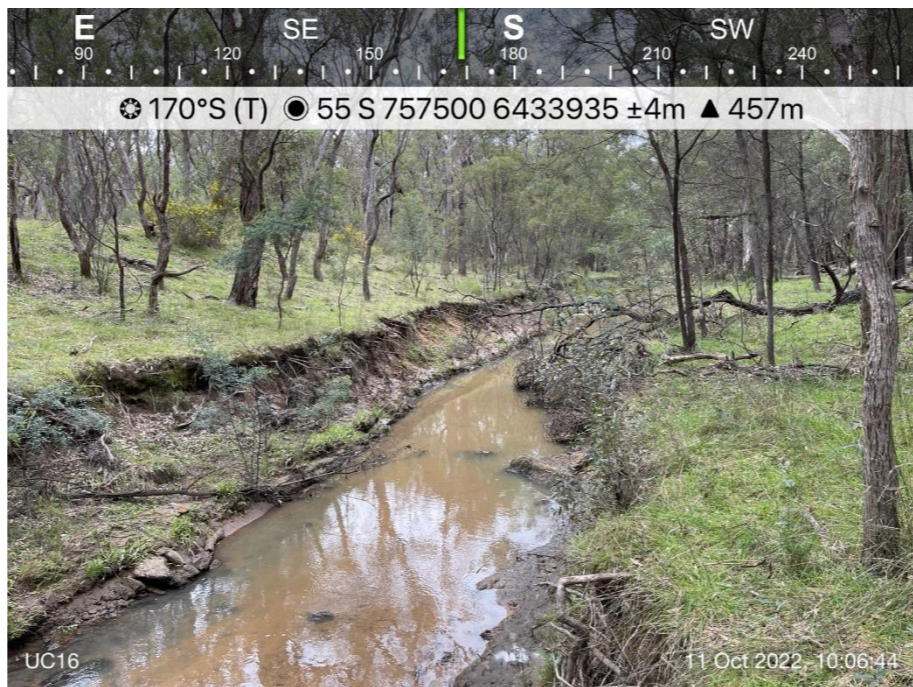
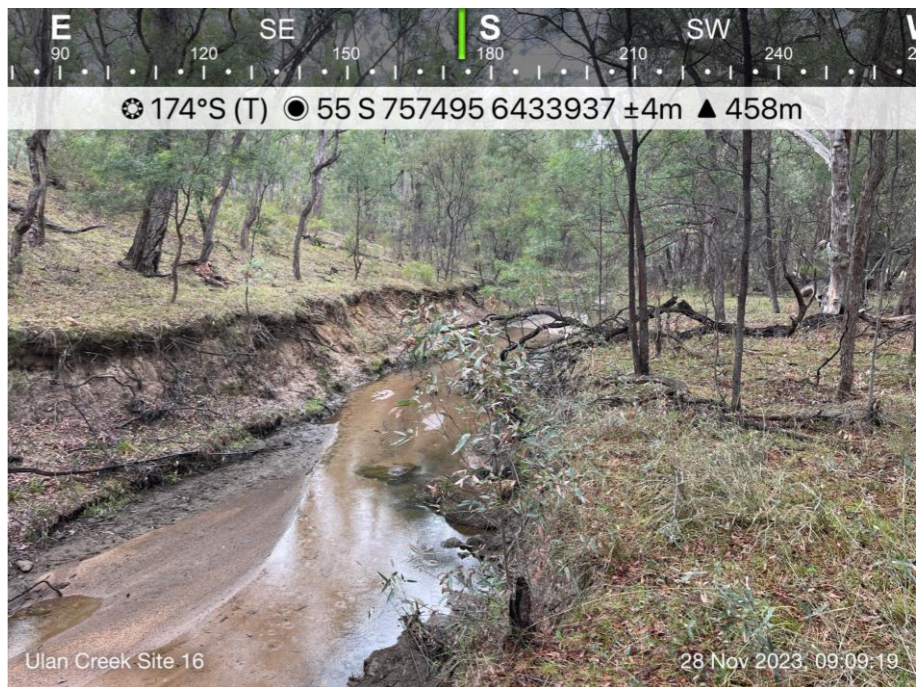
Monitoring Site: UC16

**General Observations:** Ulan Creek had water flowing at this location in 2023. Active erosion along both banks was observed again in 2022. A tree had also fallen into the creek sometime after the 2019 inspection. In 2022 additional gravel, silt and sand deposits had accumulated but less obvious than in previous years. The LHB and RHB have near vertical walls from the top of the bank, mostly bare with exposed tree roots and signs of erosion. An old concrete pipe culvert remains upstream from the site. Both sides of the creek are tree lined. Observations in 2023 are comparable to previous monitoring. The CSIRO *Ephemeral Stream Assessment* classification at this location as 'active'.

**Notes:** In 2023 observations were limited to the RHB and water flowing. Decreasing vegetative ground cover noted in 2023. Silt deposits along the edges of the channel bed noted in 2023.

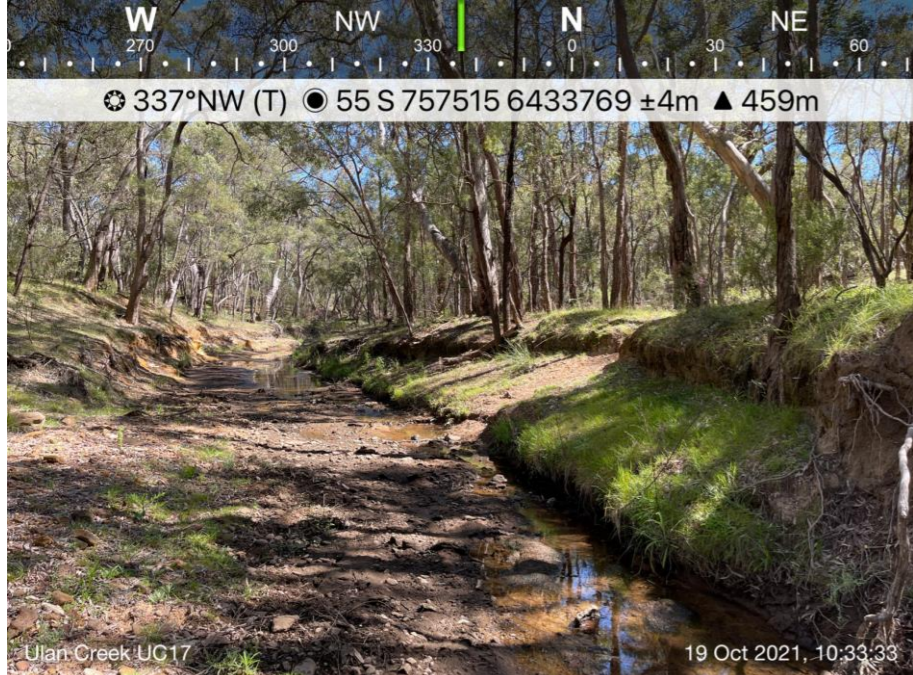
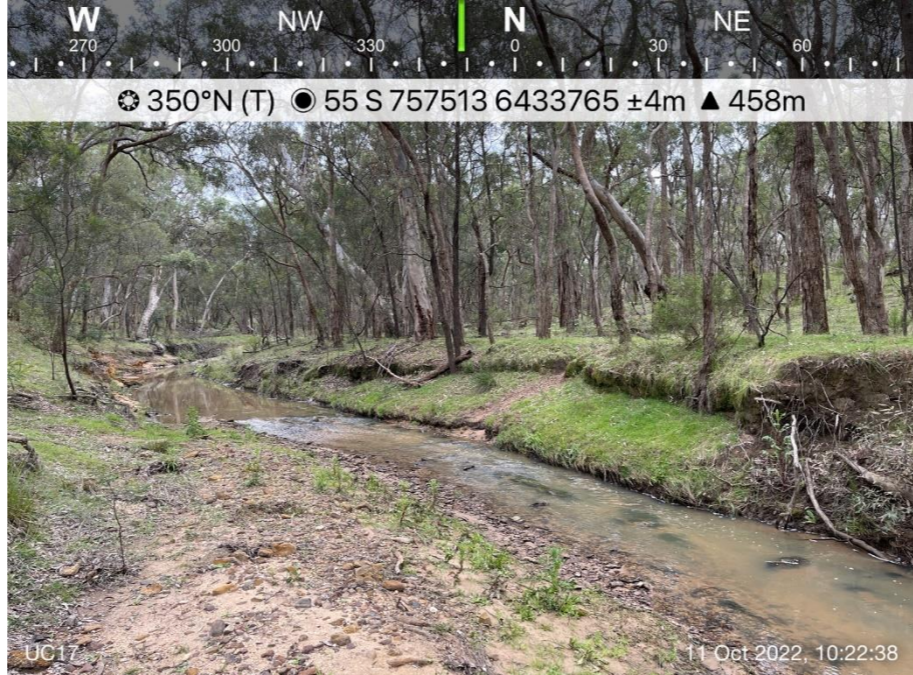
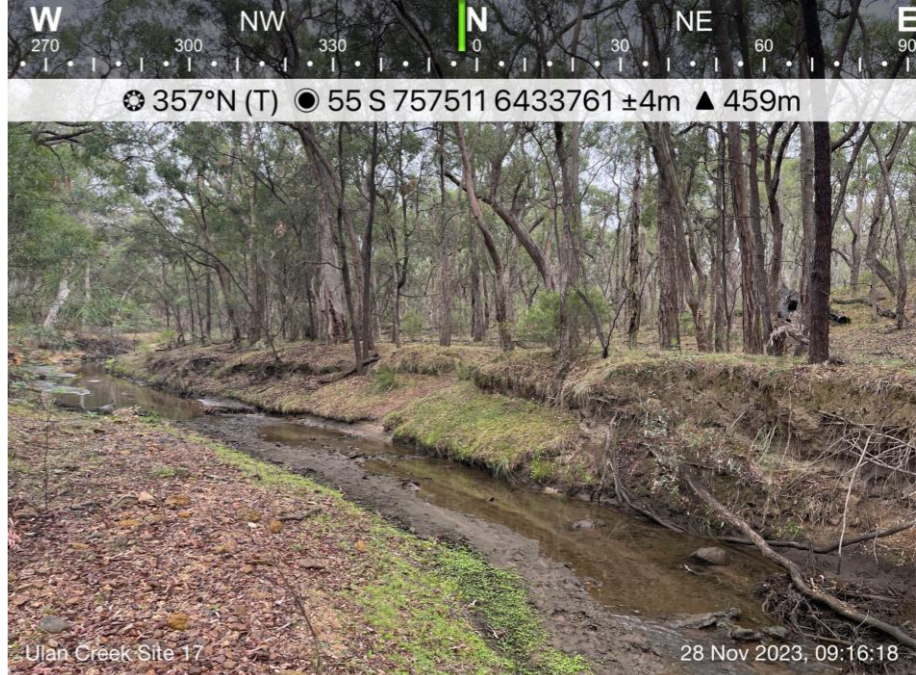
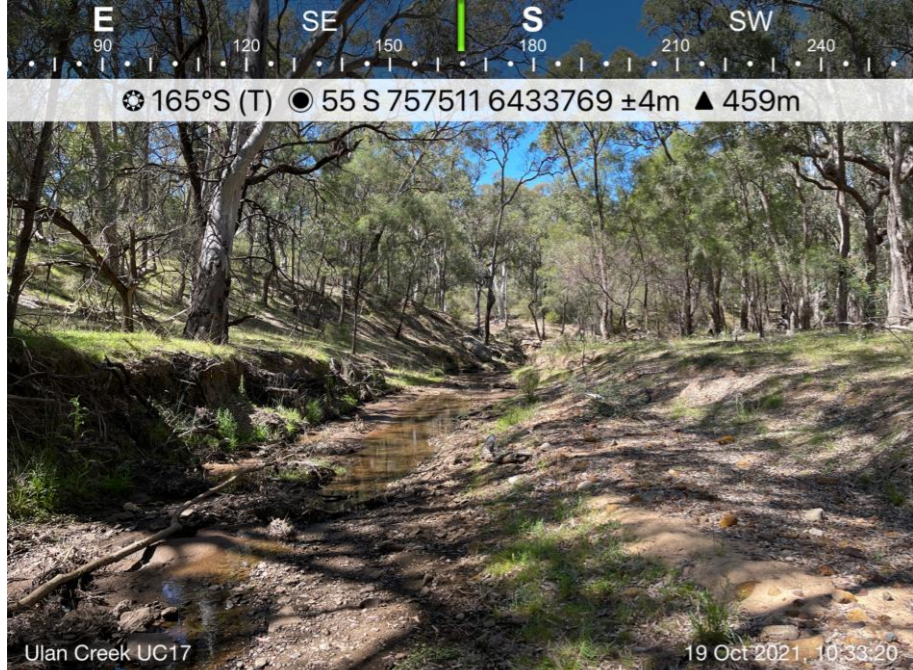
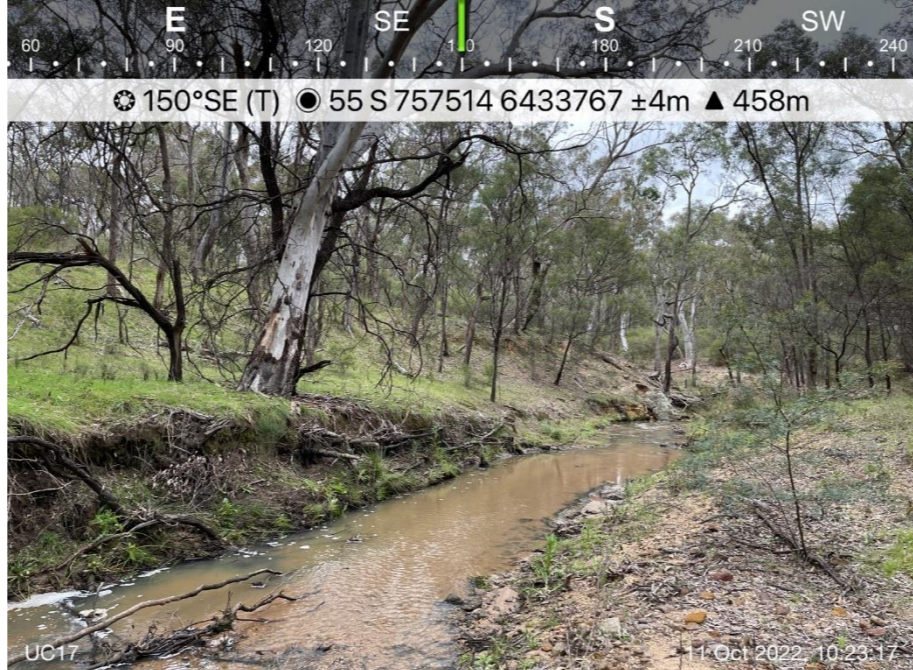
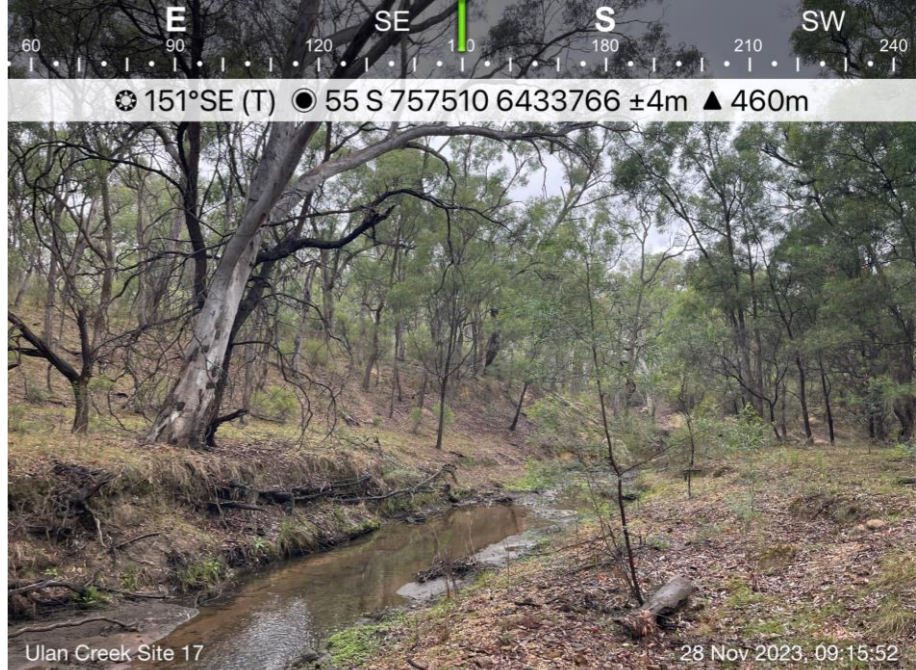
Monitoring Site: UC17

**General Observations:** Ulan Creek had water flowing at this location in 2023. Water was seeping into the creek along the LHB from an entering drainage line in 2021. The low flow channel bed had no vegetation and was a mix of silt, sand, gravel and larger rock material noted. In 2022 additional build up of sand, silt and small gravel deposits were noted. The LHB wall is near vertical, bare with exposed tree roots and signs of active slumping. Undercutting also observed along the LHB in 2022. The RHB is a gentler slope, mostly with bare areas and no vegetation. Both sides of the creek are tree lined. Observations in 2023 are comparable to previous monitoring. The CSIRO *Ephemeral Stream Assessment* classification at this location as 'active'.

**Notes:** In 2023 observations were limited to the RHB and water flowing. Decreasing vegetative ground cover noted in 2023. Silt deposits along the edges of the channel bed noted in 2023.

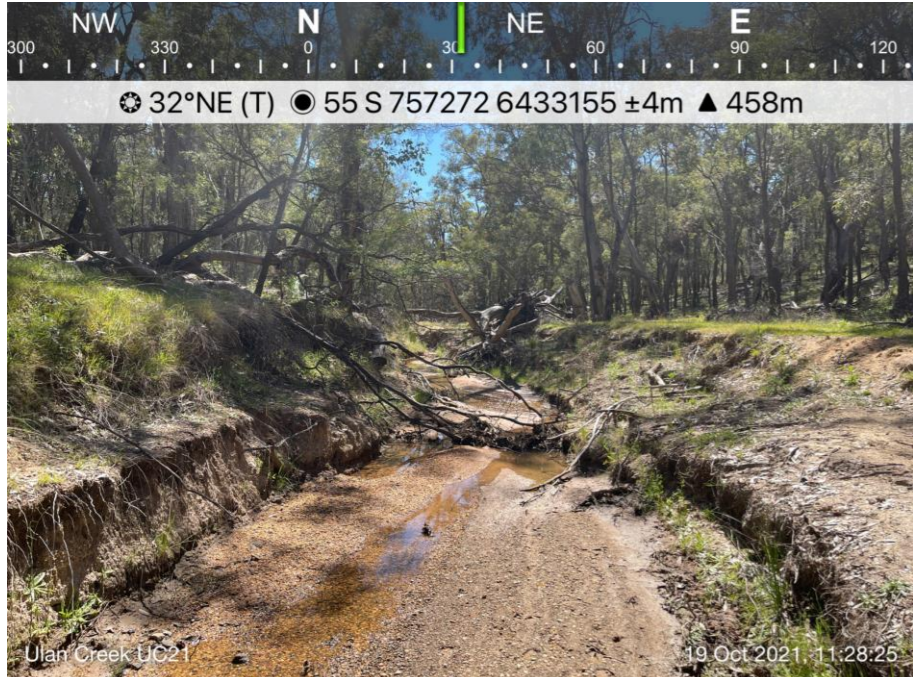
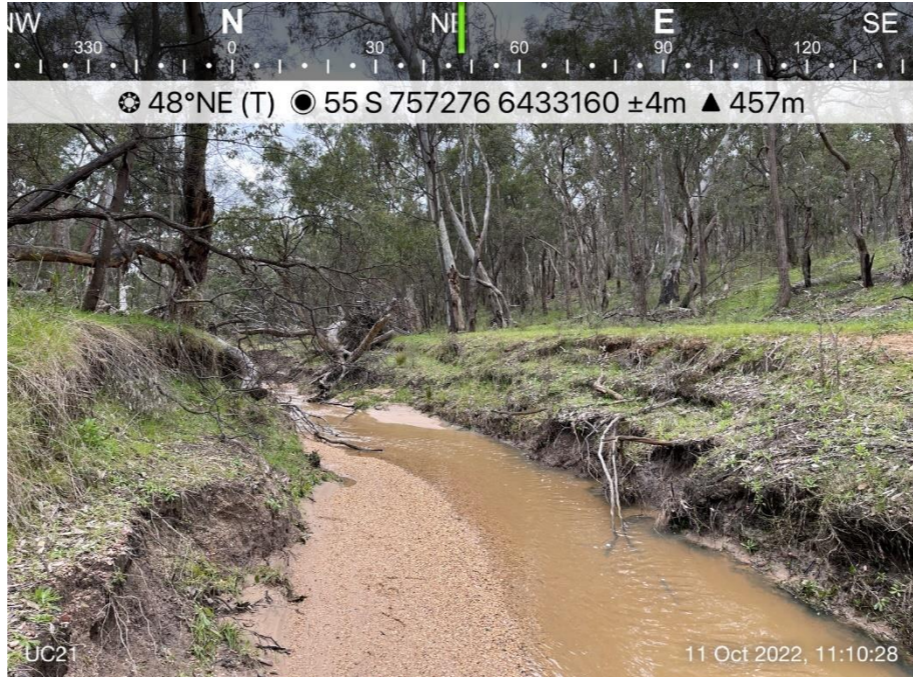
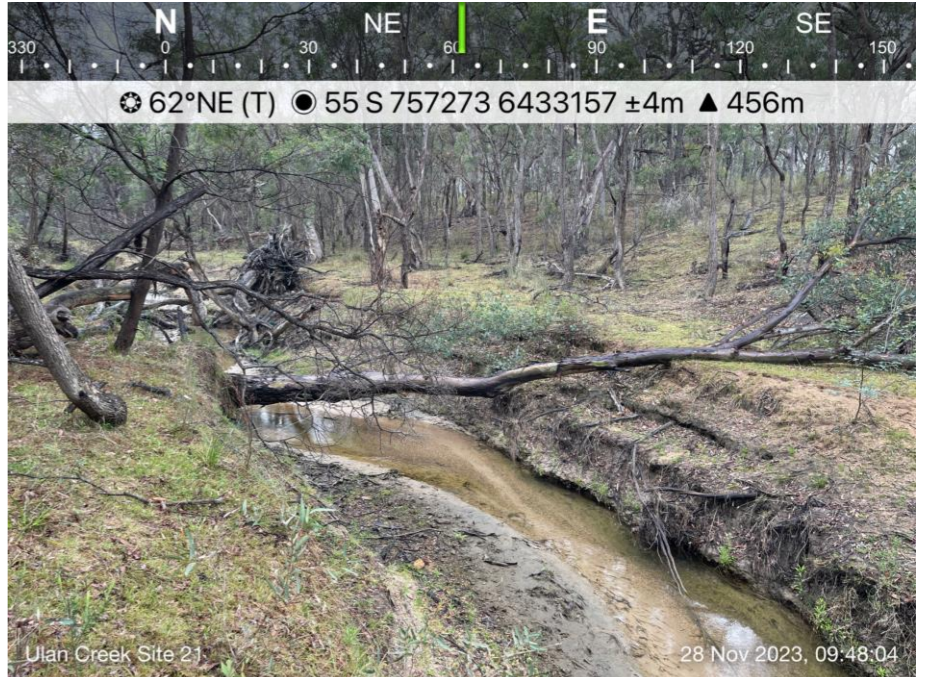
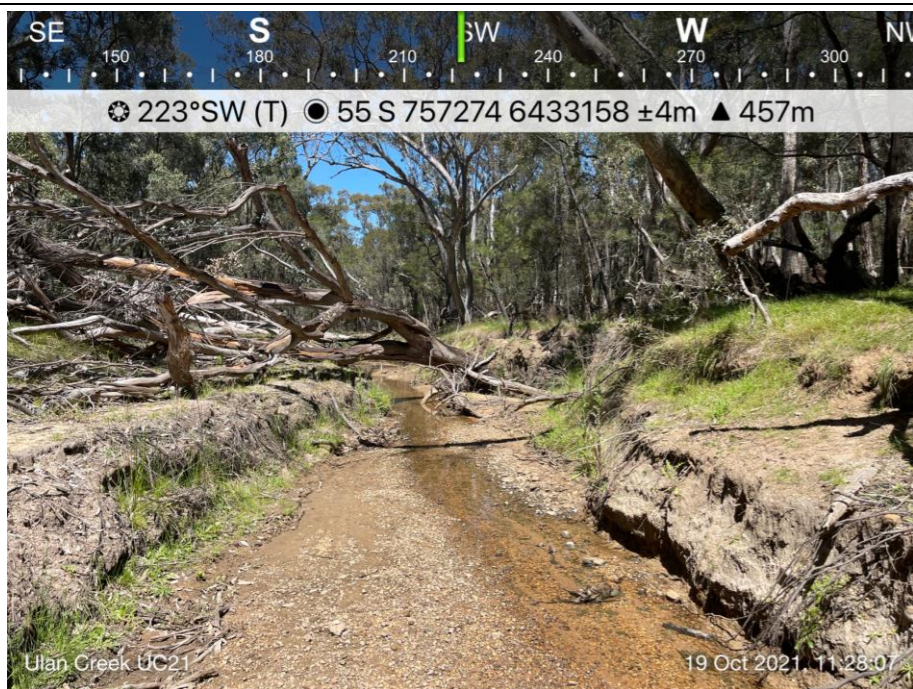
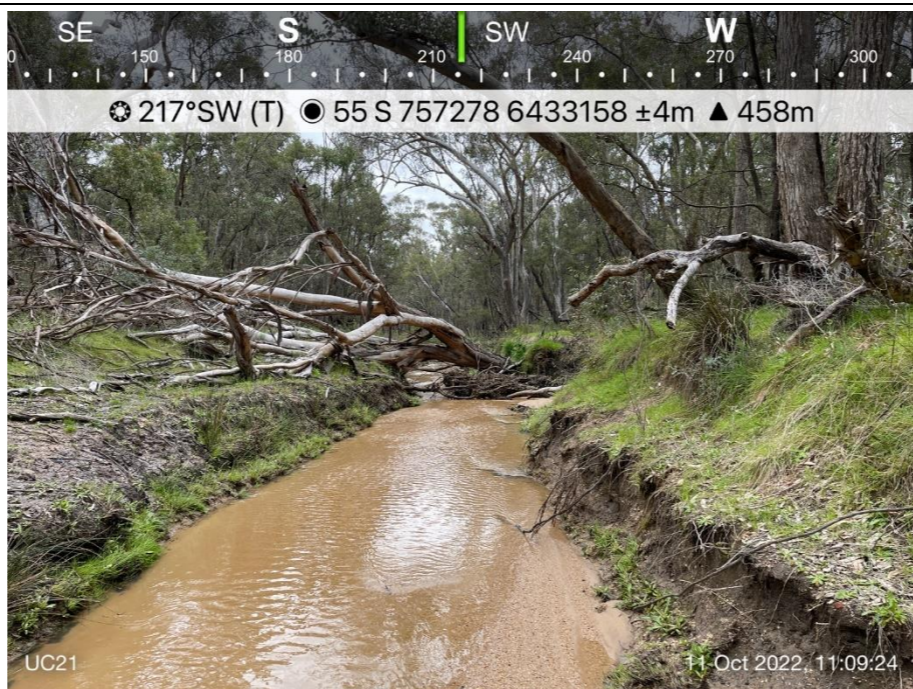
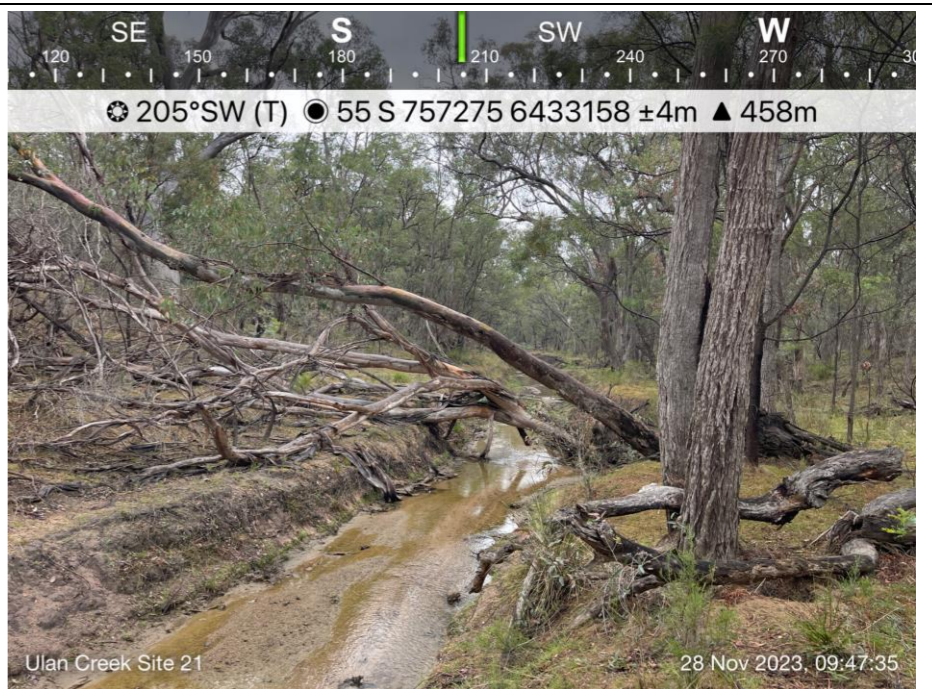
**General Observations:** Ulan Creek had water flowing at this location in 2023. Water was seeping from the LHB into the channel in 2022. Active erosion along both banks was again observed in 2022 and 2023. The flow channel bed had little to no vegetation and is a mix of sand, small size gravel and rock material. Decrease of vegetation above the banks in 2023. Both the LHB and RHB have a moderate slope. Both banks have exposed bare areas and display recent signs of erosion. The RHB has near vertical sections with bank undercutting. The LHB displayed bank undercutting in 2021 although in 2022 additional build up of sand, silt and small gravel deposits had infilled. The formation of small scour holes in 2019 appeared to have been infilled since 2020. Both sides of the creek are tree lined. Observations in 2023 are comparable to previous monitoring. The CSIRO *Ephemeral Stream Assessment* classification at this location as 'active'.

**Notes:** In 2023 observations were limited to the RHB and water flowing. Decreasing vegetative ground cover noted in 2023. Silt deposits along the edges of the channel bed noted in 2023. One tree upstream and another tree downstream had fallen across the creek from the RHB since 2022 monitoring.

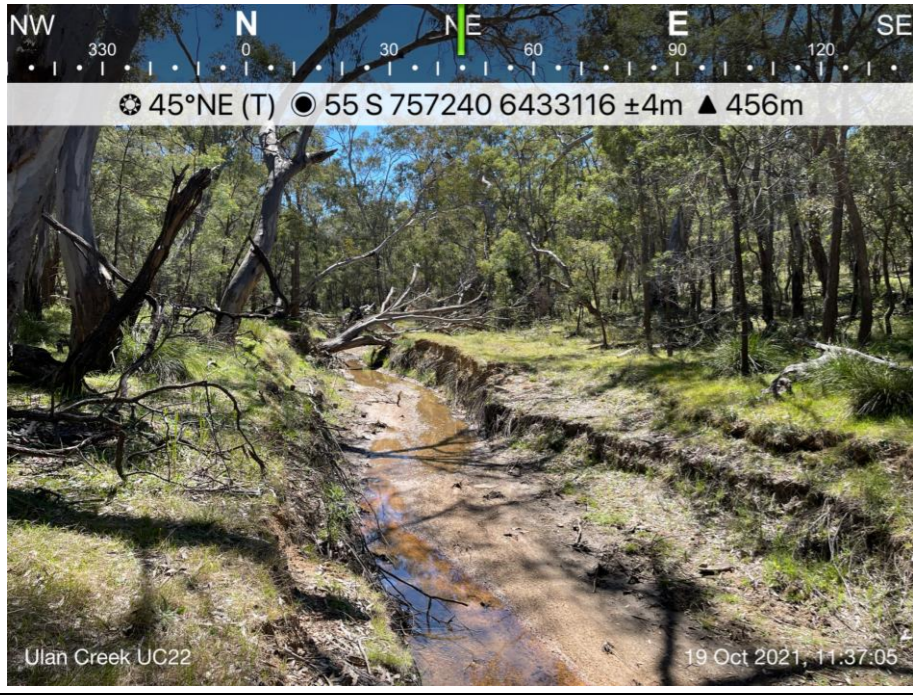
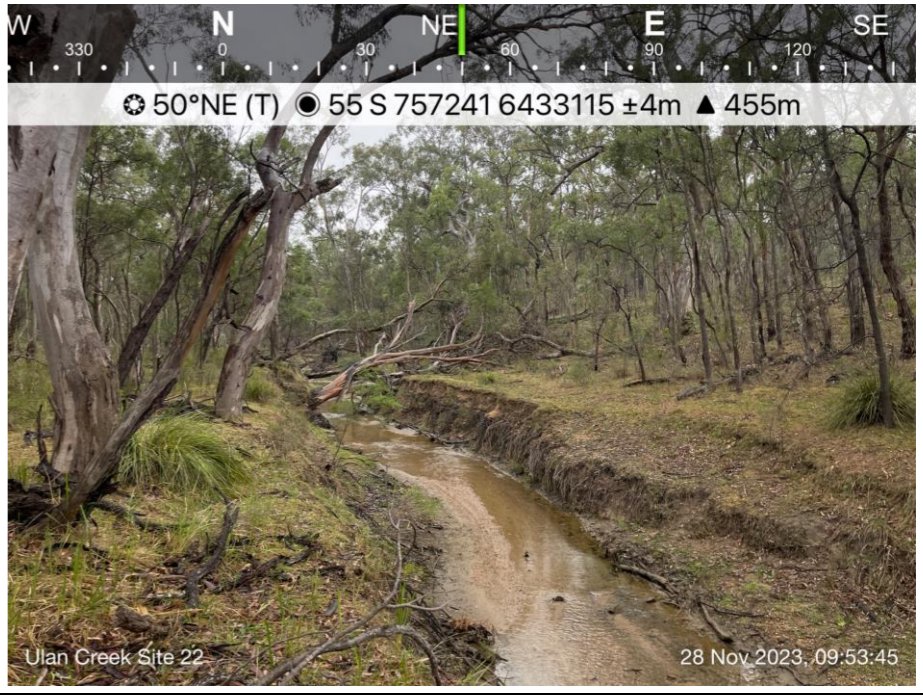
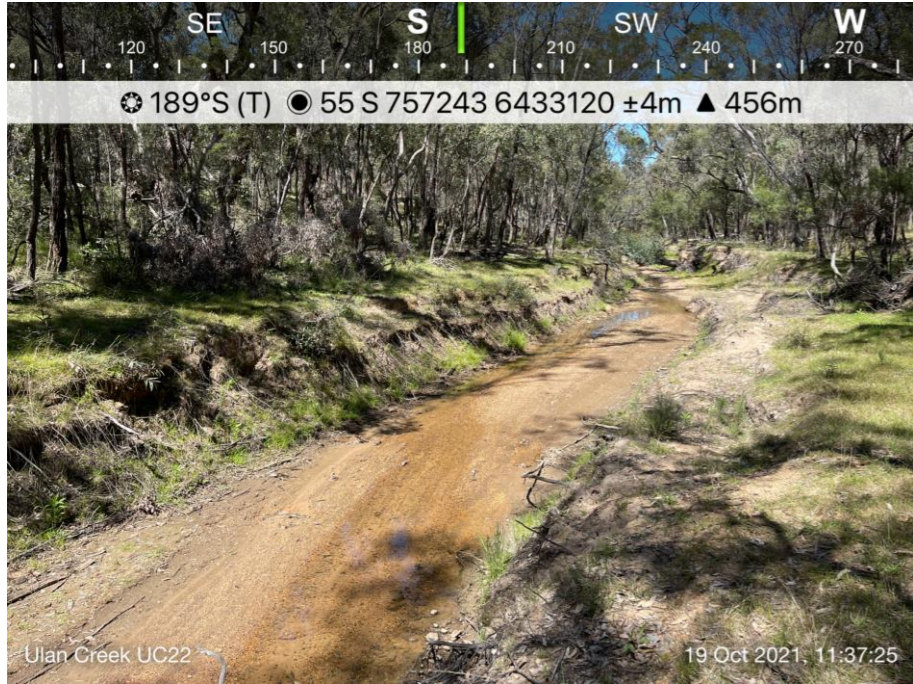
**General Observations:** Ulan Creek had water flowing at this location in 2023. Active erosion along both banks was again observed in 2022. The flow channel bed had little to no vegetation and is a mix of silt, sand, small size gravel and rock material. In 2022 additional build up of sand, silt and small gravel deposits was noted. Decrease of vegetation above the banks in 2023. A small scour in the channel bed forming in 2019 was infilled in 2020. Both the LHB and RHB have a moderate slope above the bank. Both bank walls are exposed and display recent signs of erosion. The RHB has a near vertical lower section with ongoing bank undercutting. The LHB also displays signs of bank undercutting although increased vegetation on the LHB was noted in 2022. Both sides of the creek are tree lined. Observations in 2023 are comparable to previous monitoring. The CSIRO *Ephemeral Stream Assessment* classification at this location as 'active'.

**Notes:** In 2023 observations were limited to the RHB and water flowing. Decreasing vegetative ground cover noted in 2023. Silt deposits along the edges of the channel bed noted in 2023.

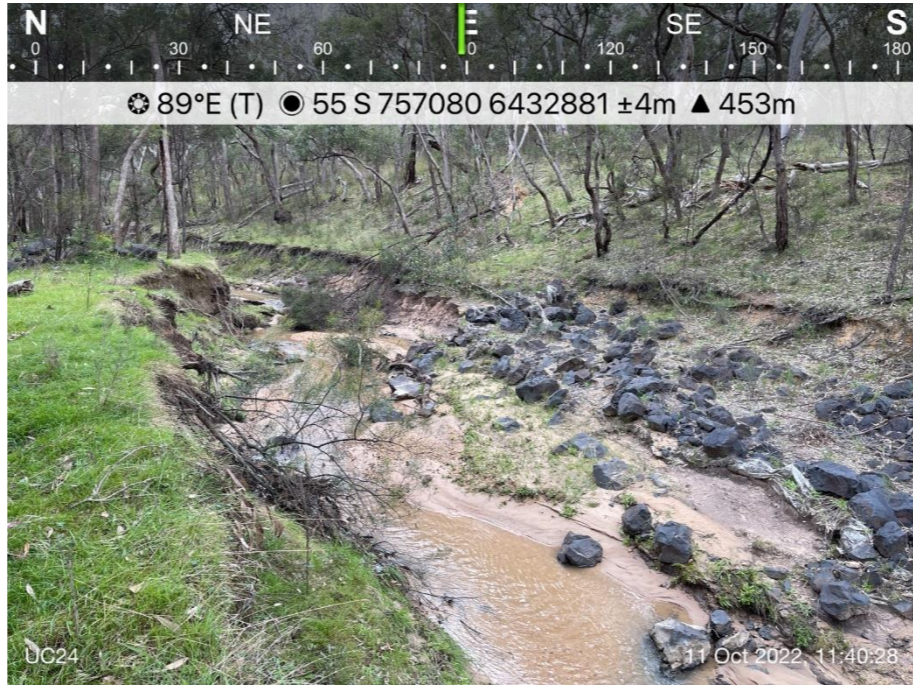
**General Observations:** Ulan Creek had water flowing at this location in 2023. Active erosion along both banks was again observed in 2022 and 2023. The low flow channel bed had little to no vegetation and is a mix of silt, sand, small size gravel and rock material. In 2022 additional build up of sand, silt and small gravel deposits were noted. The channel bed contains much larger foreign rock and geofabric material to possibly stabilise the creek, however it appears to be having a more destabilising impact. The RHB has a gentle to moderate slope above the bank, the bank wall is bare and exposed, near vertical and displays recent signs of erosion and bank undercutting. The LHB has a steeper slope above the bank and is partially stabilised by the imported rock. Both sides of the creek are tree lined. Observations in 2023 noted a similar deteriorating trend when compared to previous monitoring. The CSIRO *Ephemeral Stream Assessment* classification at this location as 'very active'.

**Notes:** In 2023 observations were limited to the RHB and water flowing. Decreasing vegetative ground cover noted in 2023. A tree had fallen across the creek from the RHB since 2022 monitoring.
