**ULAN COAL MINES PTY LIMITED
2023 MONITORING OF
CREEKS & TRIBUTARIES**

DOCUMENT NO. UCMP_L_03_24

Document No:	UCMPL_03_24
Document Title:	2023 Monitoring of Creek and Tributaries
General Description:	Post mining monitoring along selected flow lines above Ulan West for erosion and ponding sites. Now includes Mona Creek above Ulan Underground.
Report To:	Amanda Sales
Prepared By:	Stephen Bragg
Date:	29 December 2023

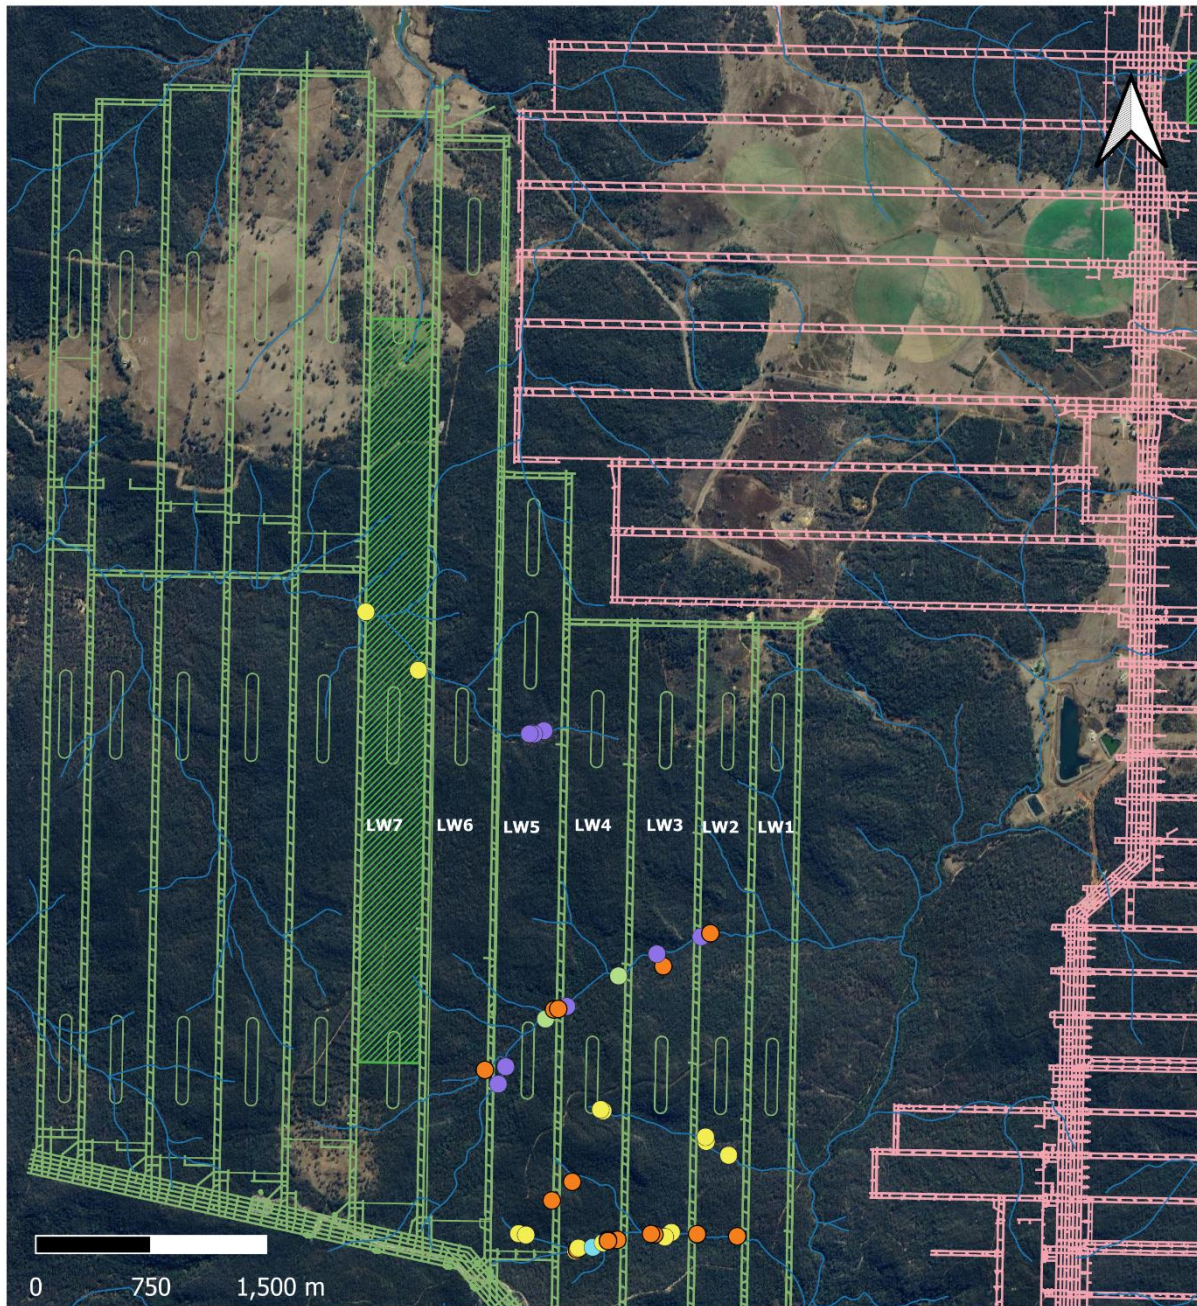
Figure 1-3 Observed Subsidence Impacts

Identified impacts at number of sites to date have included cracking of bedrock material within the channel bed, surface cracking across the channel, ponding and erosion (**Figure 1-3**). Generally, in the absence of significant flow events, these observed impacts have not perceptibly changed during re-inspections over their respective two-year post mining monitoring period.

It is recommended that UCMPL continue to record and monitor areas where subsidence impacts have likely occurred in flow lines and creeks above Ulan West and Ulan Underground as required by the relevant Extraction Plan and develop appropriate remediation measures, as required. It is also recommended to inspect recently post mined flow lines after high intensity rainfall events.
