2024 Channel Stability Monitoring - Site Inspection Details

APPENDIX B: Ulan Creek

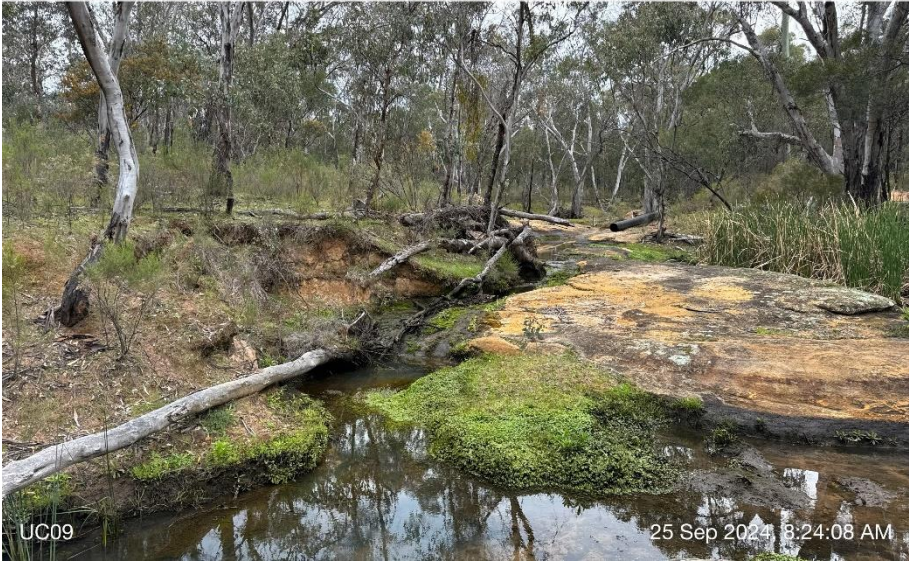
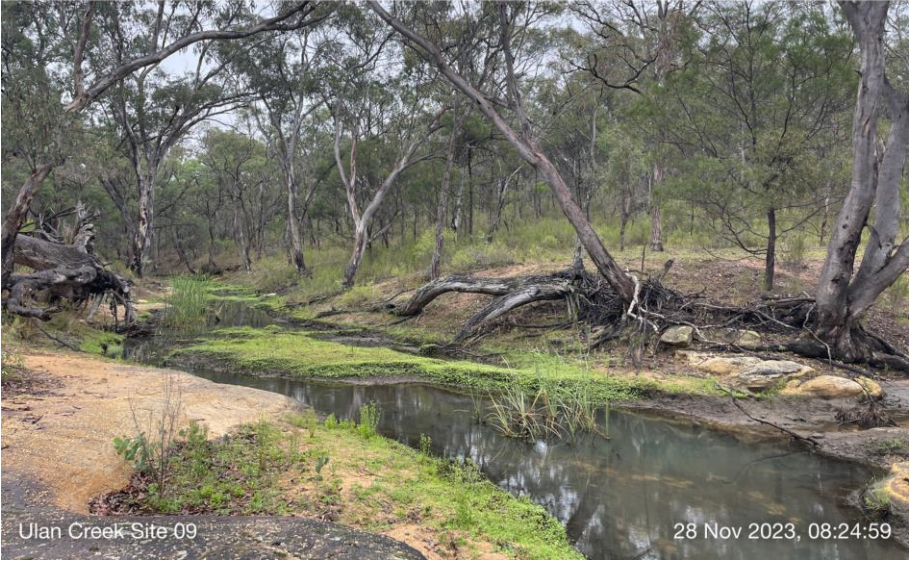
Monitoring Site: UC09

General Observations: Ulan Creek had water flowing at this location in 2024. Exposed bedrock is within the floor of the channel, although channel bed assessment in 2024 could not be completed due to water in the creek. A high flow event in the 2020 monitoring period moved the log that was across the channel. In 2020, flood debris was recorded above the banks. In 2022 signs of additional sand and silts deposits were noted just above the water line on the LHB. Signs of instabilities along both banks was observed in 2021 and 2022. The LHB walls are near vertical, exposed with signs of recent erosion. The RHB wall is a more moderate slope and mostly vegetated. Both banks are tree lined with fewer trees along the LHB. The tunnel erosion deep into the RHB, is comparable to previous observations since 2020. The observations in 2024 are comparable with recent years. The CSIRO *Ephemeral Stream Assessment* classification at this location as 'very active'.

Notes: In 2024 observations were limited to the LHB and water flowing. The creek bed could not be assessed.

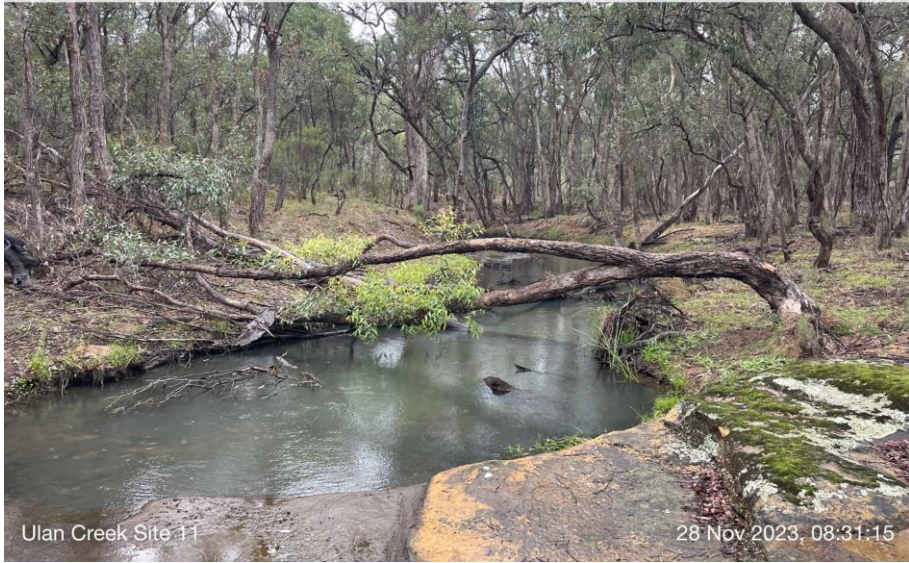
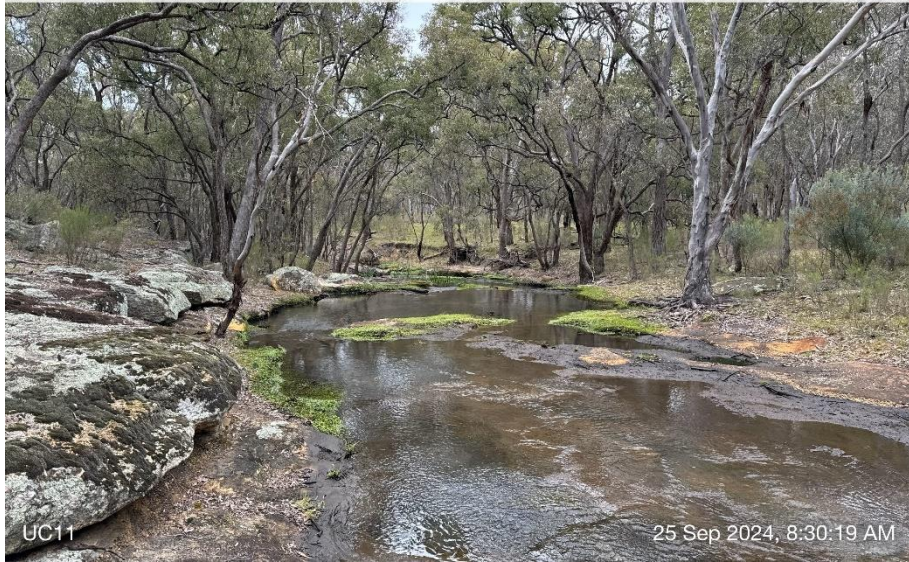
Monitoring Site: UC11

General Observations: Ulan Creek had water flowing at this location in 2024. Exposed bedrock is within the floor of the channel providing stability, although the channel bed assessment (immediately upstream) in 2024 could not be completed due to water in the creek. Flood debris was located above the LHB in 2020. Groundcover had slightly increased above the LHB and RHB in 2024. The LHB is formed from bedrock with a moderate slope. The RHB has a gentler slope partially vegetated in 2024 with some signs of minor undercutting. Both banks are tree lined. A tree had fallen into the creek from the LHB prior to monitoring in 2021. Observations in 2024 are comparable to previous monitoring. The CSIRO *Ephemeral Stream Assessment* classification at this location as 'stable'.

Notes: In 2024 observations were limited to the LHB and water flowing. This site appeared stable above the water line upstream of the bedrock.

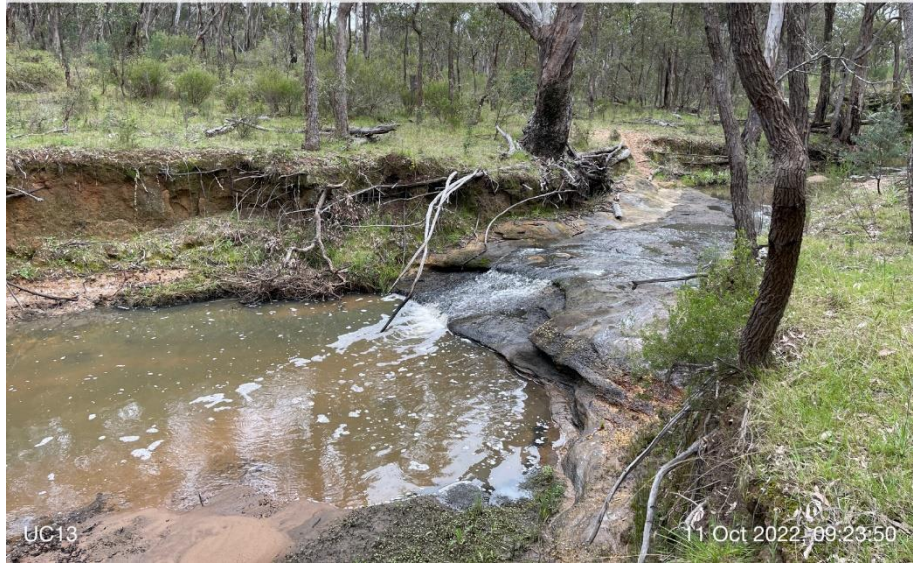
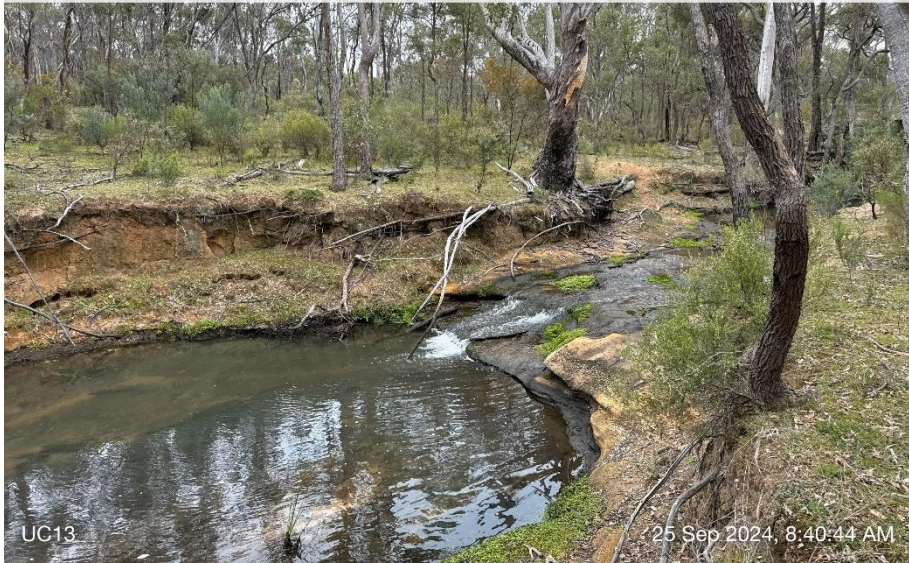
Monitoring Site: UC13

General Observations: Ulan Creek had water flowing at this location in 2024. From previous monitoring, the channel bed is a mix of silt, sand and gravel. In 2022 additional sand and sediments had deposited along the creek bed with little vegetation. Flood debris was located above the LHB in 2020. Active erosion along both banks was again observed in 2022. The LHB and RHB walls are near vertical, bare with exposed tree roots, signs of erosion and undercutting. Both sides of the creek are tree lined. A slight increase in groundcover above the LHB and RHB was noted in 2024. Observations in 2024 are comparable to previous monitoring. The CSIRO *Ephemeral Stream Assessment* classification at this location as 'active'.

Notes: In 2024 observations were limited to the LHB and water flowing. The creek bed could not be assessed.

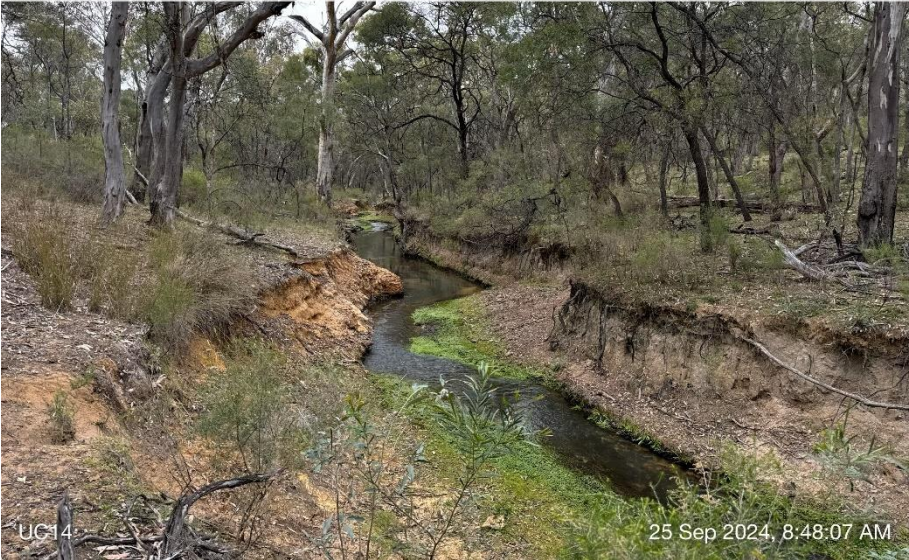
Monitoring Site: UC14

General Observations: Ulan Creek was flowing at this location in 2024. Active erosion along both banks was observed in 2022. From previous monitoring, the channel bed is a mix of silt, sand and smaller gravel. In 2022 additional build up of sand, silt and small gravel deposits were noted. Flood debris was located above the LHB in 2020. Increased erosion along both the LHB and RHB with undercutting more notable under the top edge of the banks in 2022. The LHB and RHB have near vertical walls from the top of the bank, bare with exposed tree roots and with signs of erosion. Both sides of the creek are tree lined. Observations in 2024 are comparable to previous monitoring. The CSIRO *Ephemeral Stream Assessment* classification at this location as 'active'

Notes: In 2024 observations were limited to the LHB and water flowing.

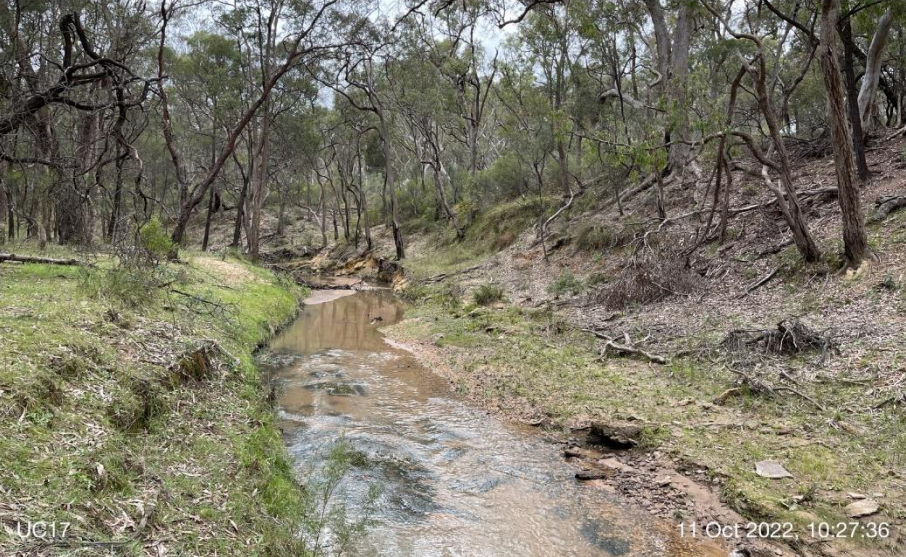
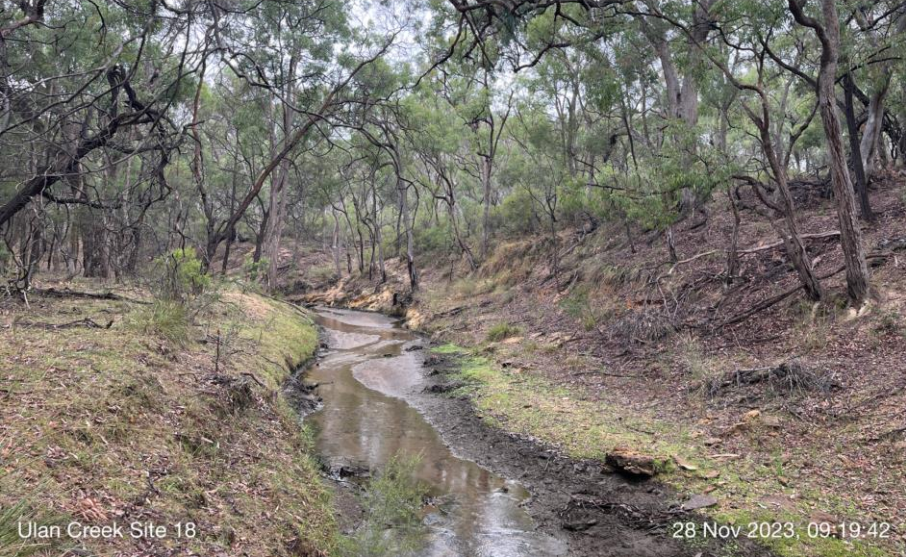
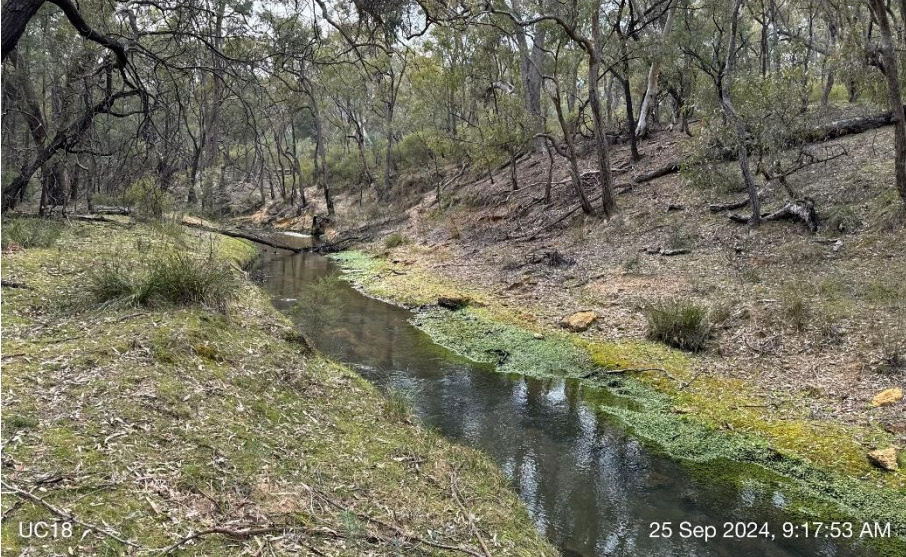
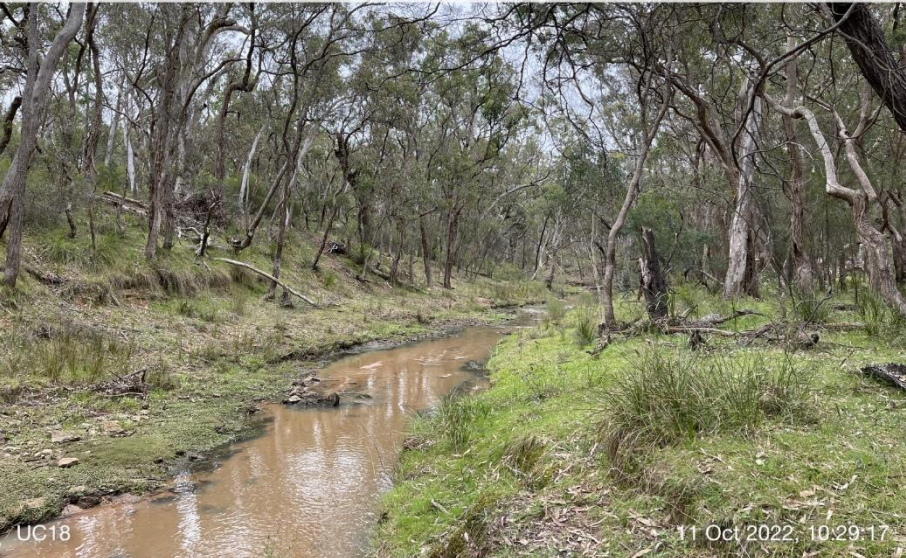
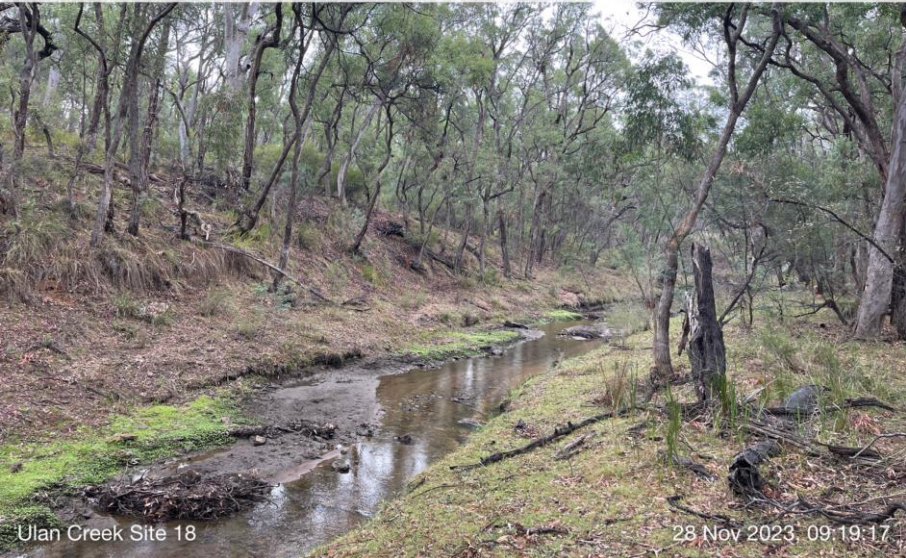
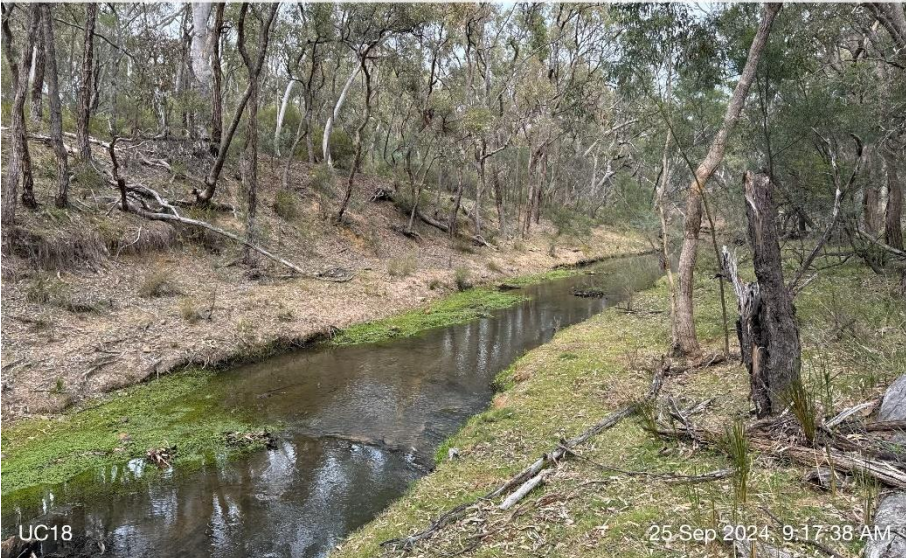
General Observations: Ulan Creek had water flowing at this location in 2024. Inflows into the creek were noted at this location in 2020. Continued undercutting (albeit minor) along the RHB was observed in 2021 and 2022. Silt, sand, small gravel and larger rocks noted in the channel bed. An increasing layer of silt sediments deposited within the low flow channel bed was noted in 2019. Flood debris and sand deposits were identified above the RHB in 2020. The RHB has a low slope with decreasing ground cover vegetation in 2024. The LHB wall is a steeper slope and partially vegetated in 2024. Both sides of the creek are tree lined. Observations in 2024 are comparable to previous monitoring. The CSIRO *Ephemeral Stream Assessment* classification at this location as 'potentially stabilising'.

Notes: In 2024 observations were limited to the RHB and water flowing.

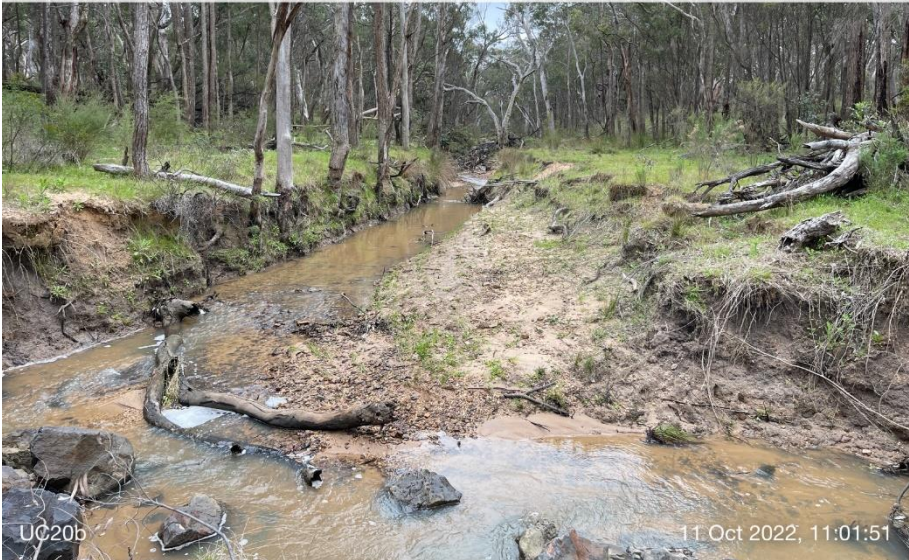
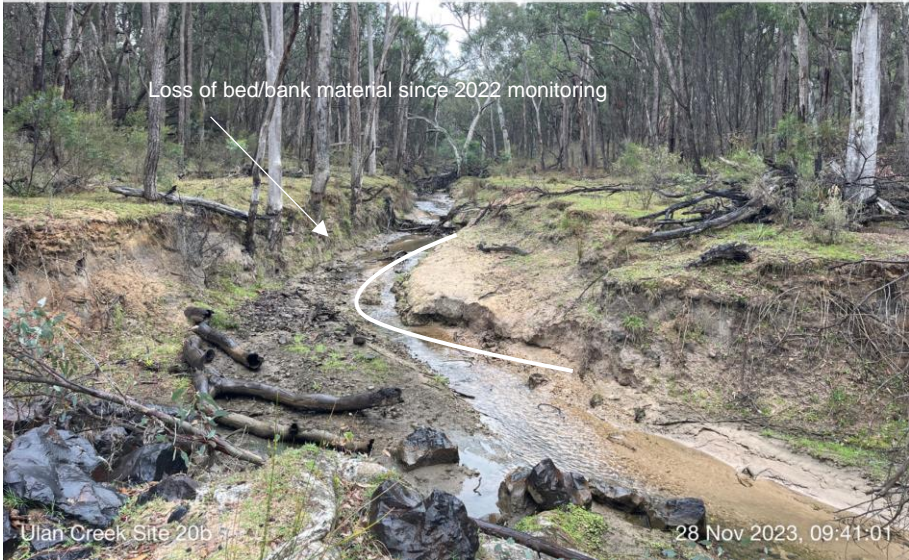
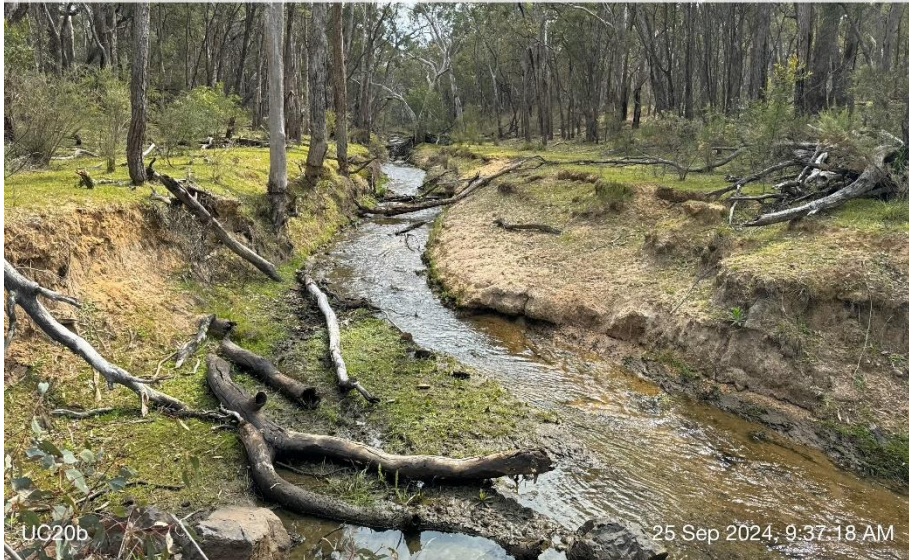
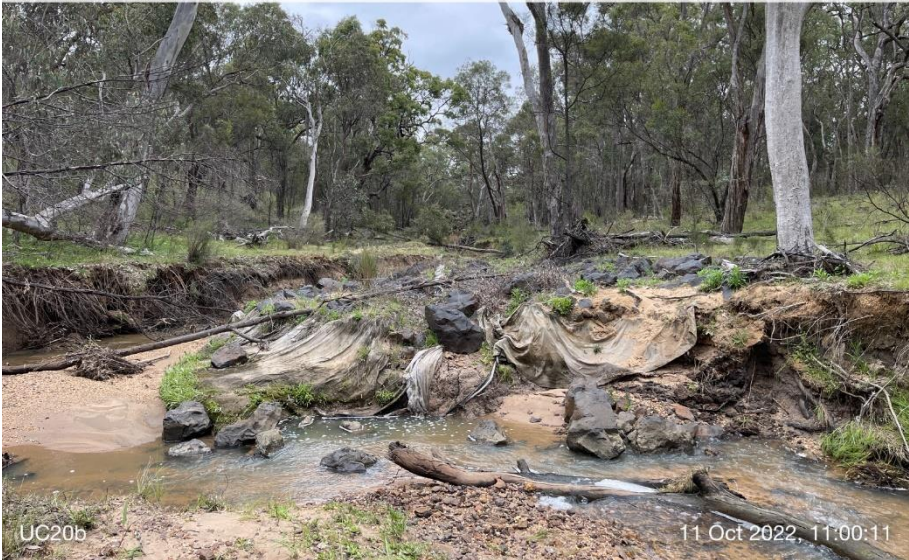
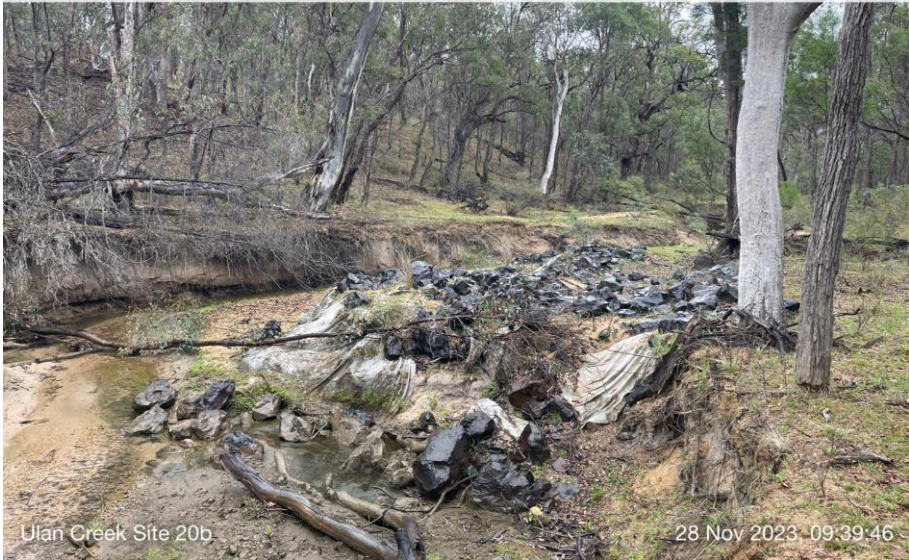
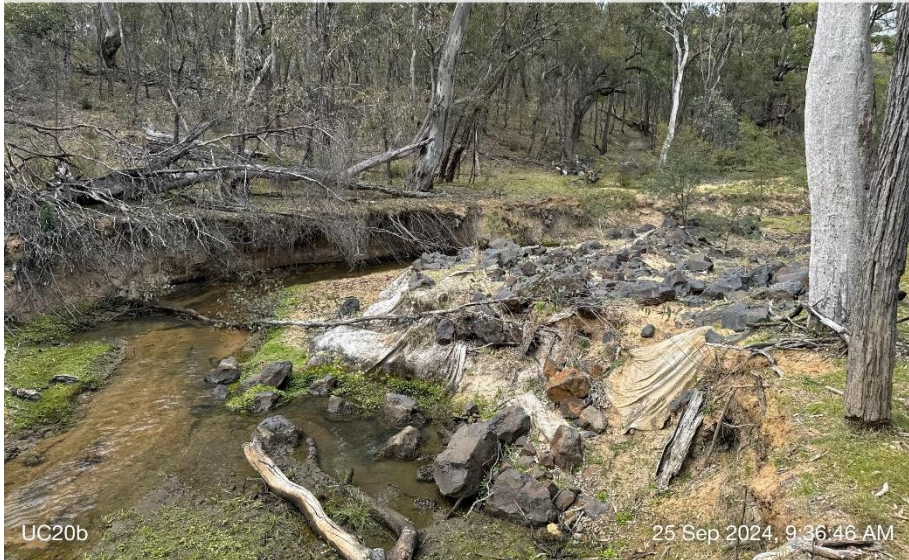
General Observations: Ulan Creek had flowing at this location in 2024. Active erosion along both banks was again observed. The flow channel bed had little to no vegetation. Silt, sand and small gravel size rock material was noted in the channel bed. Significant loss of a bank material and widening of the flow channel observed in 2020. Sand deposits above the flow line along the RHB noted in 2020. In 2022 additional build up of sand, silt and small gravel deposits were noted. The channel bed contains much larger foreign rock placed in the creek at some point, to possibly stabilise the creek (a portion of the RHB displays stability due to the rock armouring), however it appears to be having a more destabilising impact. Both the LHB and RHB have a moderate slope above the ban. The banks walls are sparsely vegetated, display recent signs of slumping, bank undercutting and causing a widening of the creek (particularly along the LHB). Both sides are tree lined. Observations in 2024 noted a similar deteriorating trend when compared to previous monitoring*. The CSIRO *Ephemeral Stream Assessment* classification at this location as 'very active'.

Notes: In 2024 observations were limited to the LHB and water flowing. *The increased erosion on the LHB exposing >1m of wall height decreased the 2022 score.Loss of bed/bank material since 2022 monitoring.

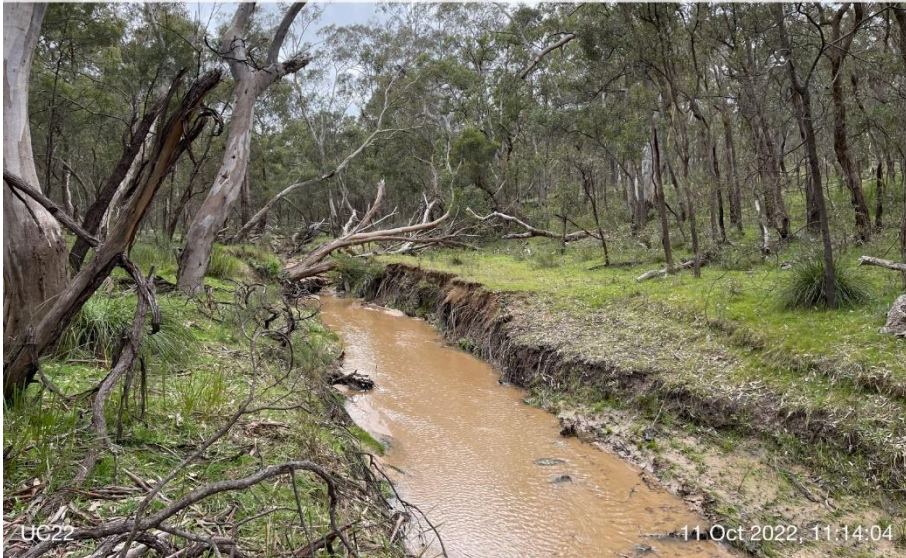
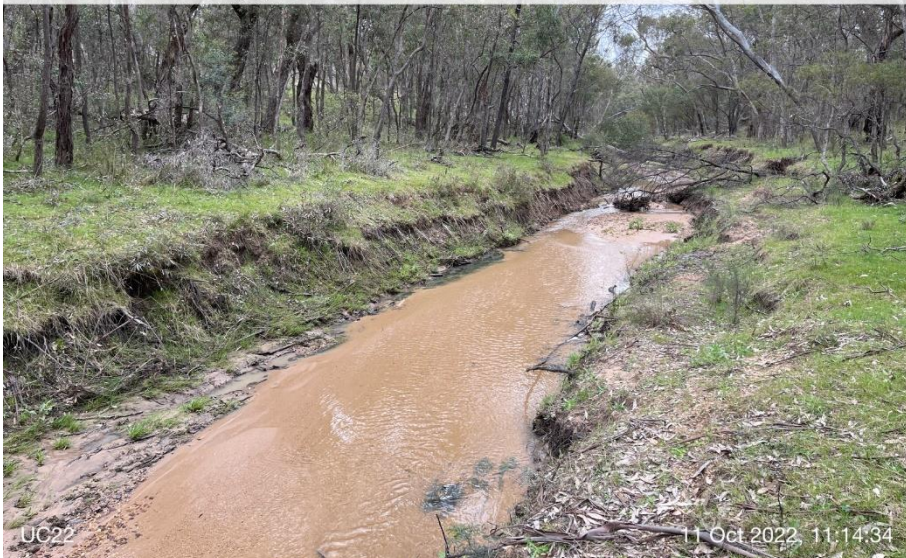
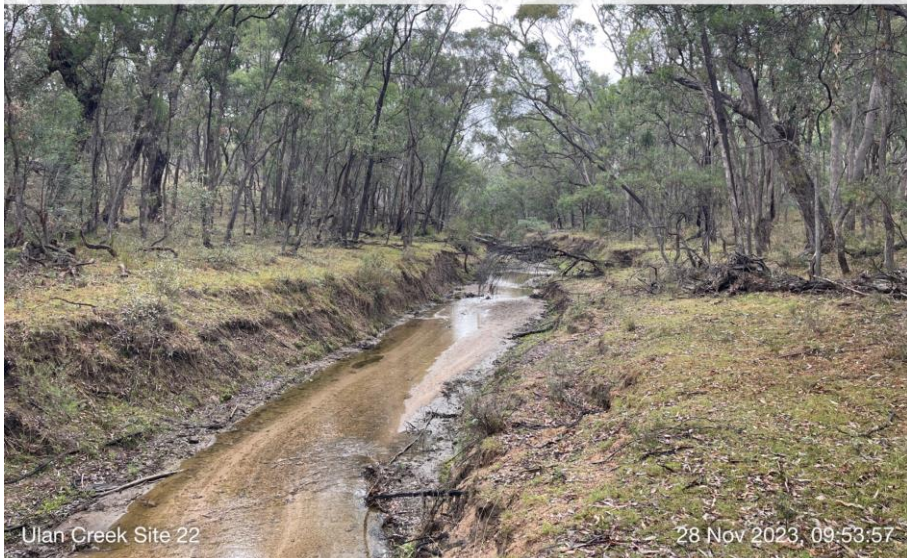
General Observations: Ulan Creek had water flowing at this location in 2024. Active erosion along both banks was again observed in 2022. The flow channel bed had little to no vegetation and is a mix of silt, sand, small size gravel and rock material. In 2022 additional build up of sand, silt and small gravel deposits was noted. Decrease of vegetation above the banks. A small scour in the channel bed forming in 2019 was infilled in 2020. Both the LHB and RHB have a moderate slope above the bank. Both bank walls are exposed and display recent signs of erosion. The RHB has a near vertical lower section with ongoing bank undercutting. The LHB also displays signs of bank undercutting. Both sides of the creek are tree lined. Observations in 2024 are comparable to previous monitoring. The CSIRO *Ephemeral Stream Assessment* classification at this location as 'active'.

Notes: In 2024 observations were limited to the RHB and water flowing.

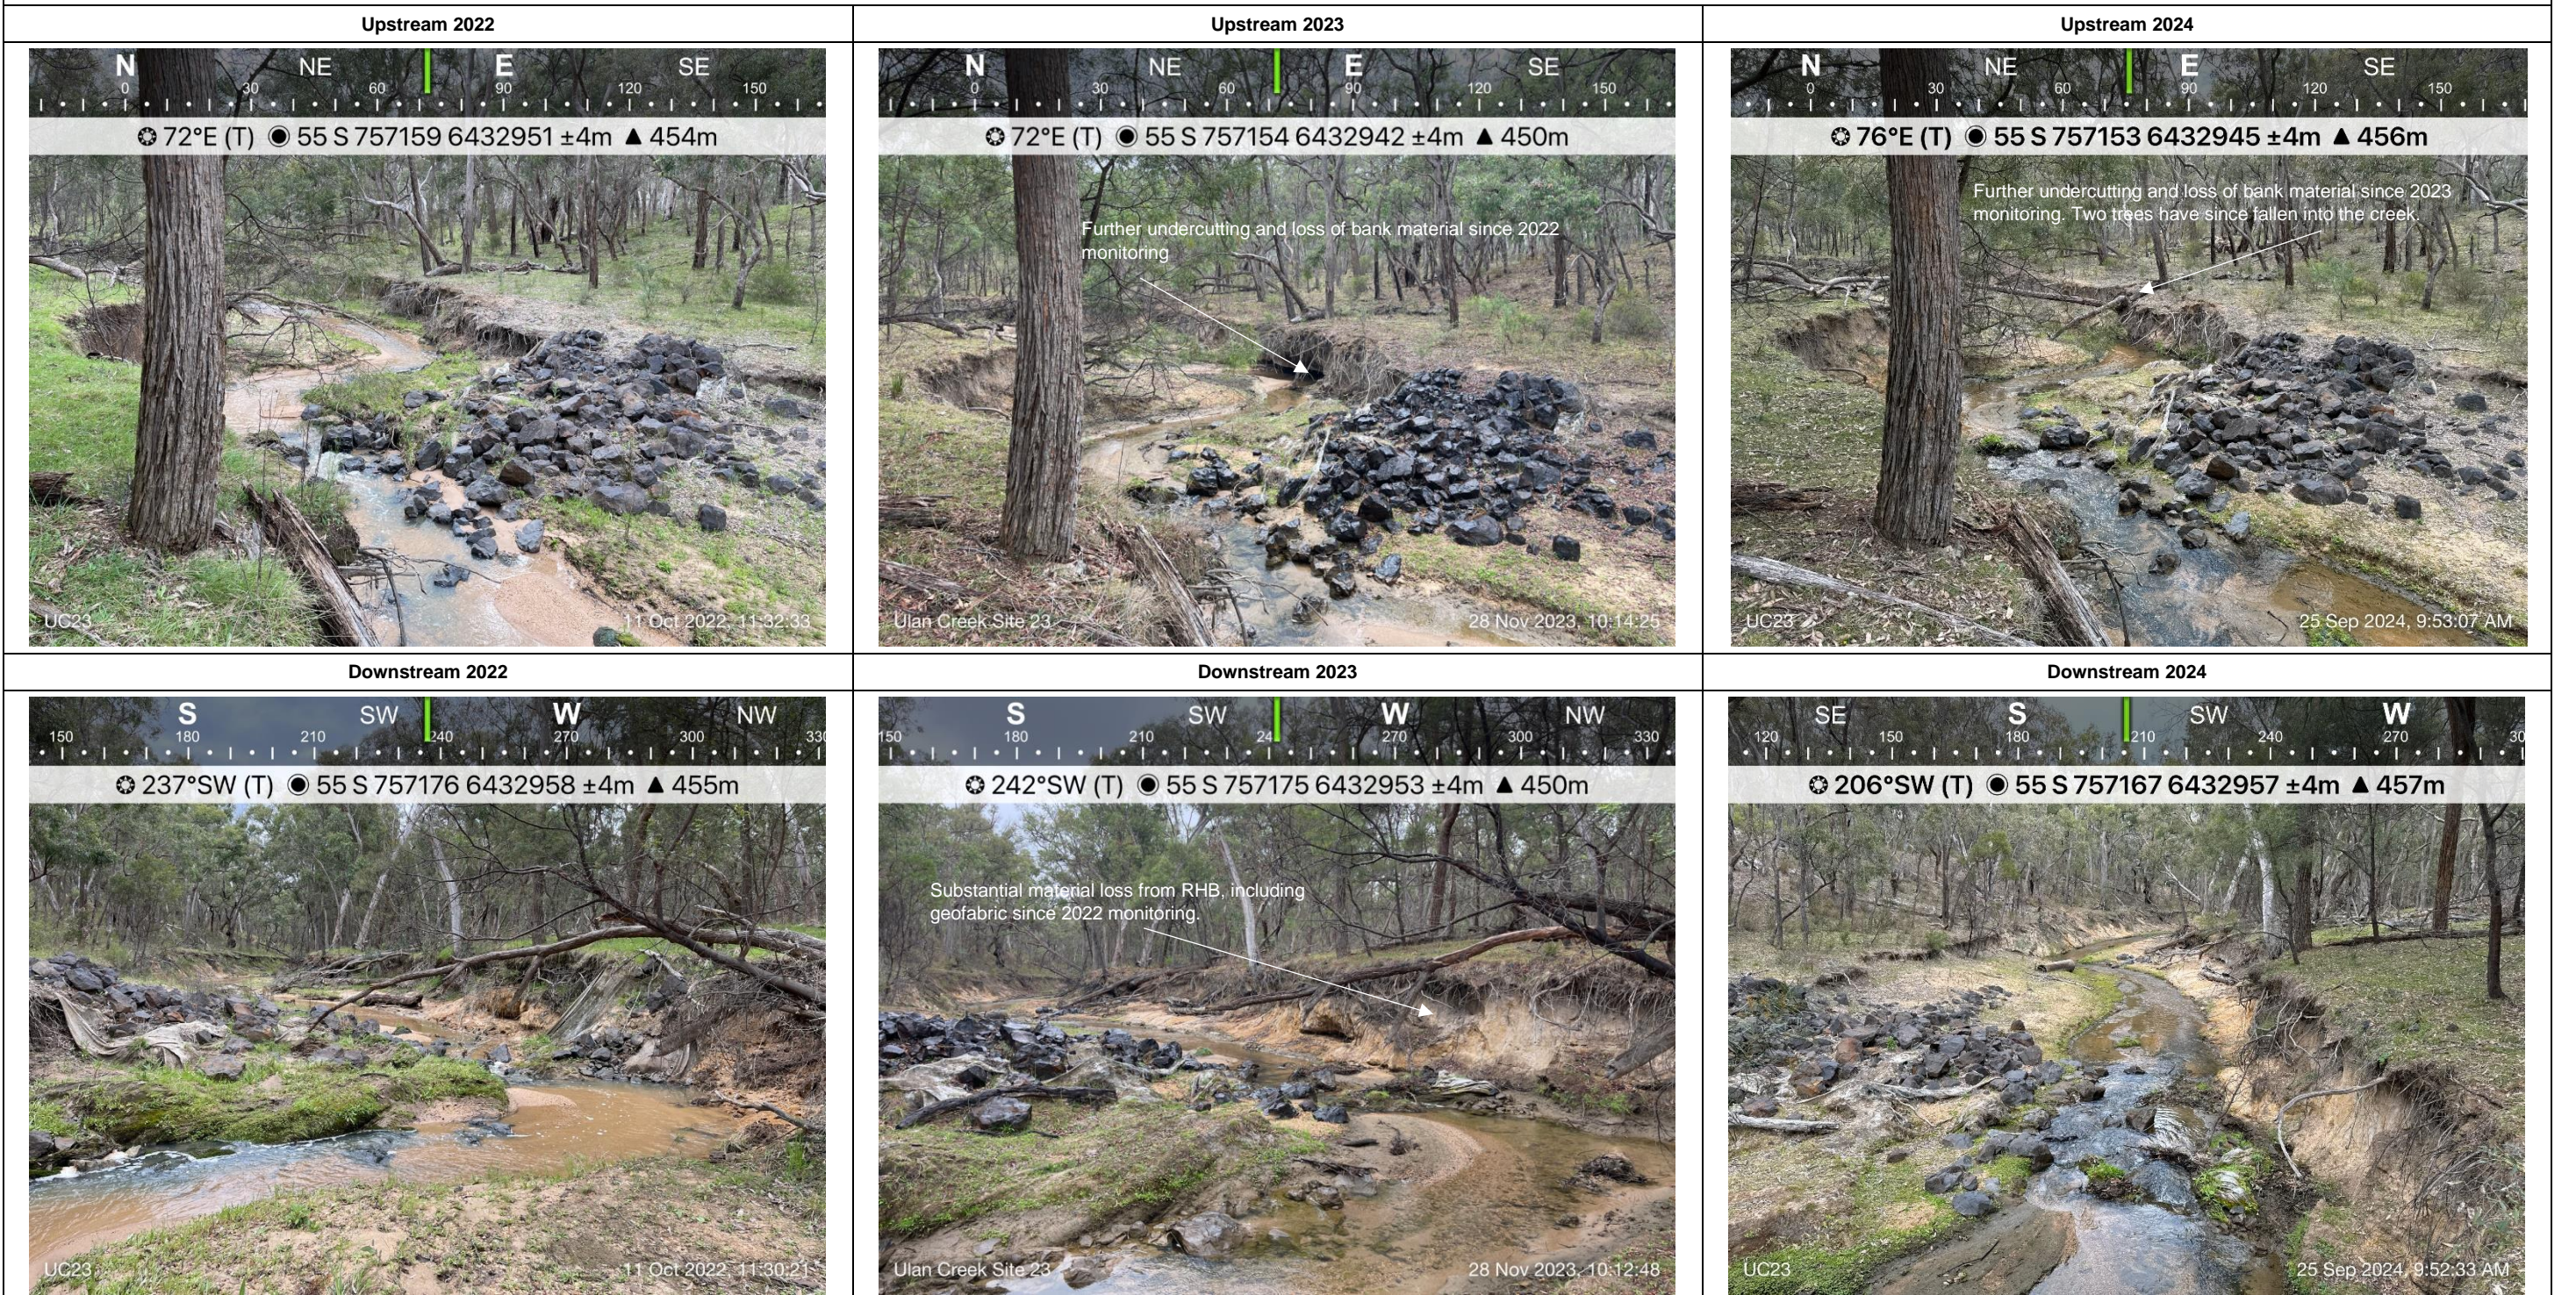
General Observations: Ulan Creek had water flowing at this location in 2024. The channel bed had little to no vegetation and is a mix of sand and small to medium size gravel. In 2022 additional build up of sand, silt and small gravel deposits were noted. The channel also has larger foreign rock and geofabric material to possibly stabilise the creek, however it appears to be having a more destabilising impact. Very active erosion along both banks was observed, particularly along the RHB causing a widening of the creek at this location. The RHB has a gentle slope above the bank. The bank wall is bare and exposed, near vertical walls and displays recent signs of erosion and undercutting. The LHB has a steeper slope above the bank and is partially stabilised by the foreign rock material. An old concrete pipe also sits downstream from this location and has been moved further downstream since 2019. Both sides of the creek are tree lined. Observations in 2024 noted a similar deteriorating trend when compared to previous monitoring*. The CSIRO *Ephemeral Stream Assessment* classification at this location as 'very active'.

Notes: In 2024 observations were limited to the RHB and water flowing. Very active undercutting and bank instabilities noted in 2024, two small tress has fallen on the creek along the LHB.

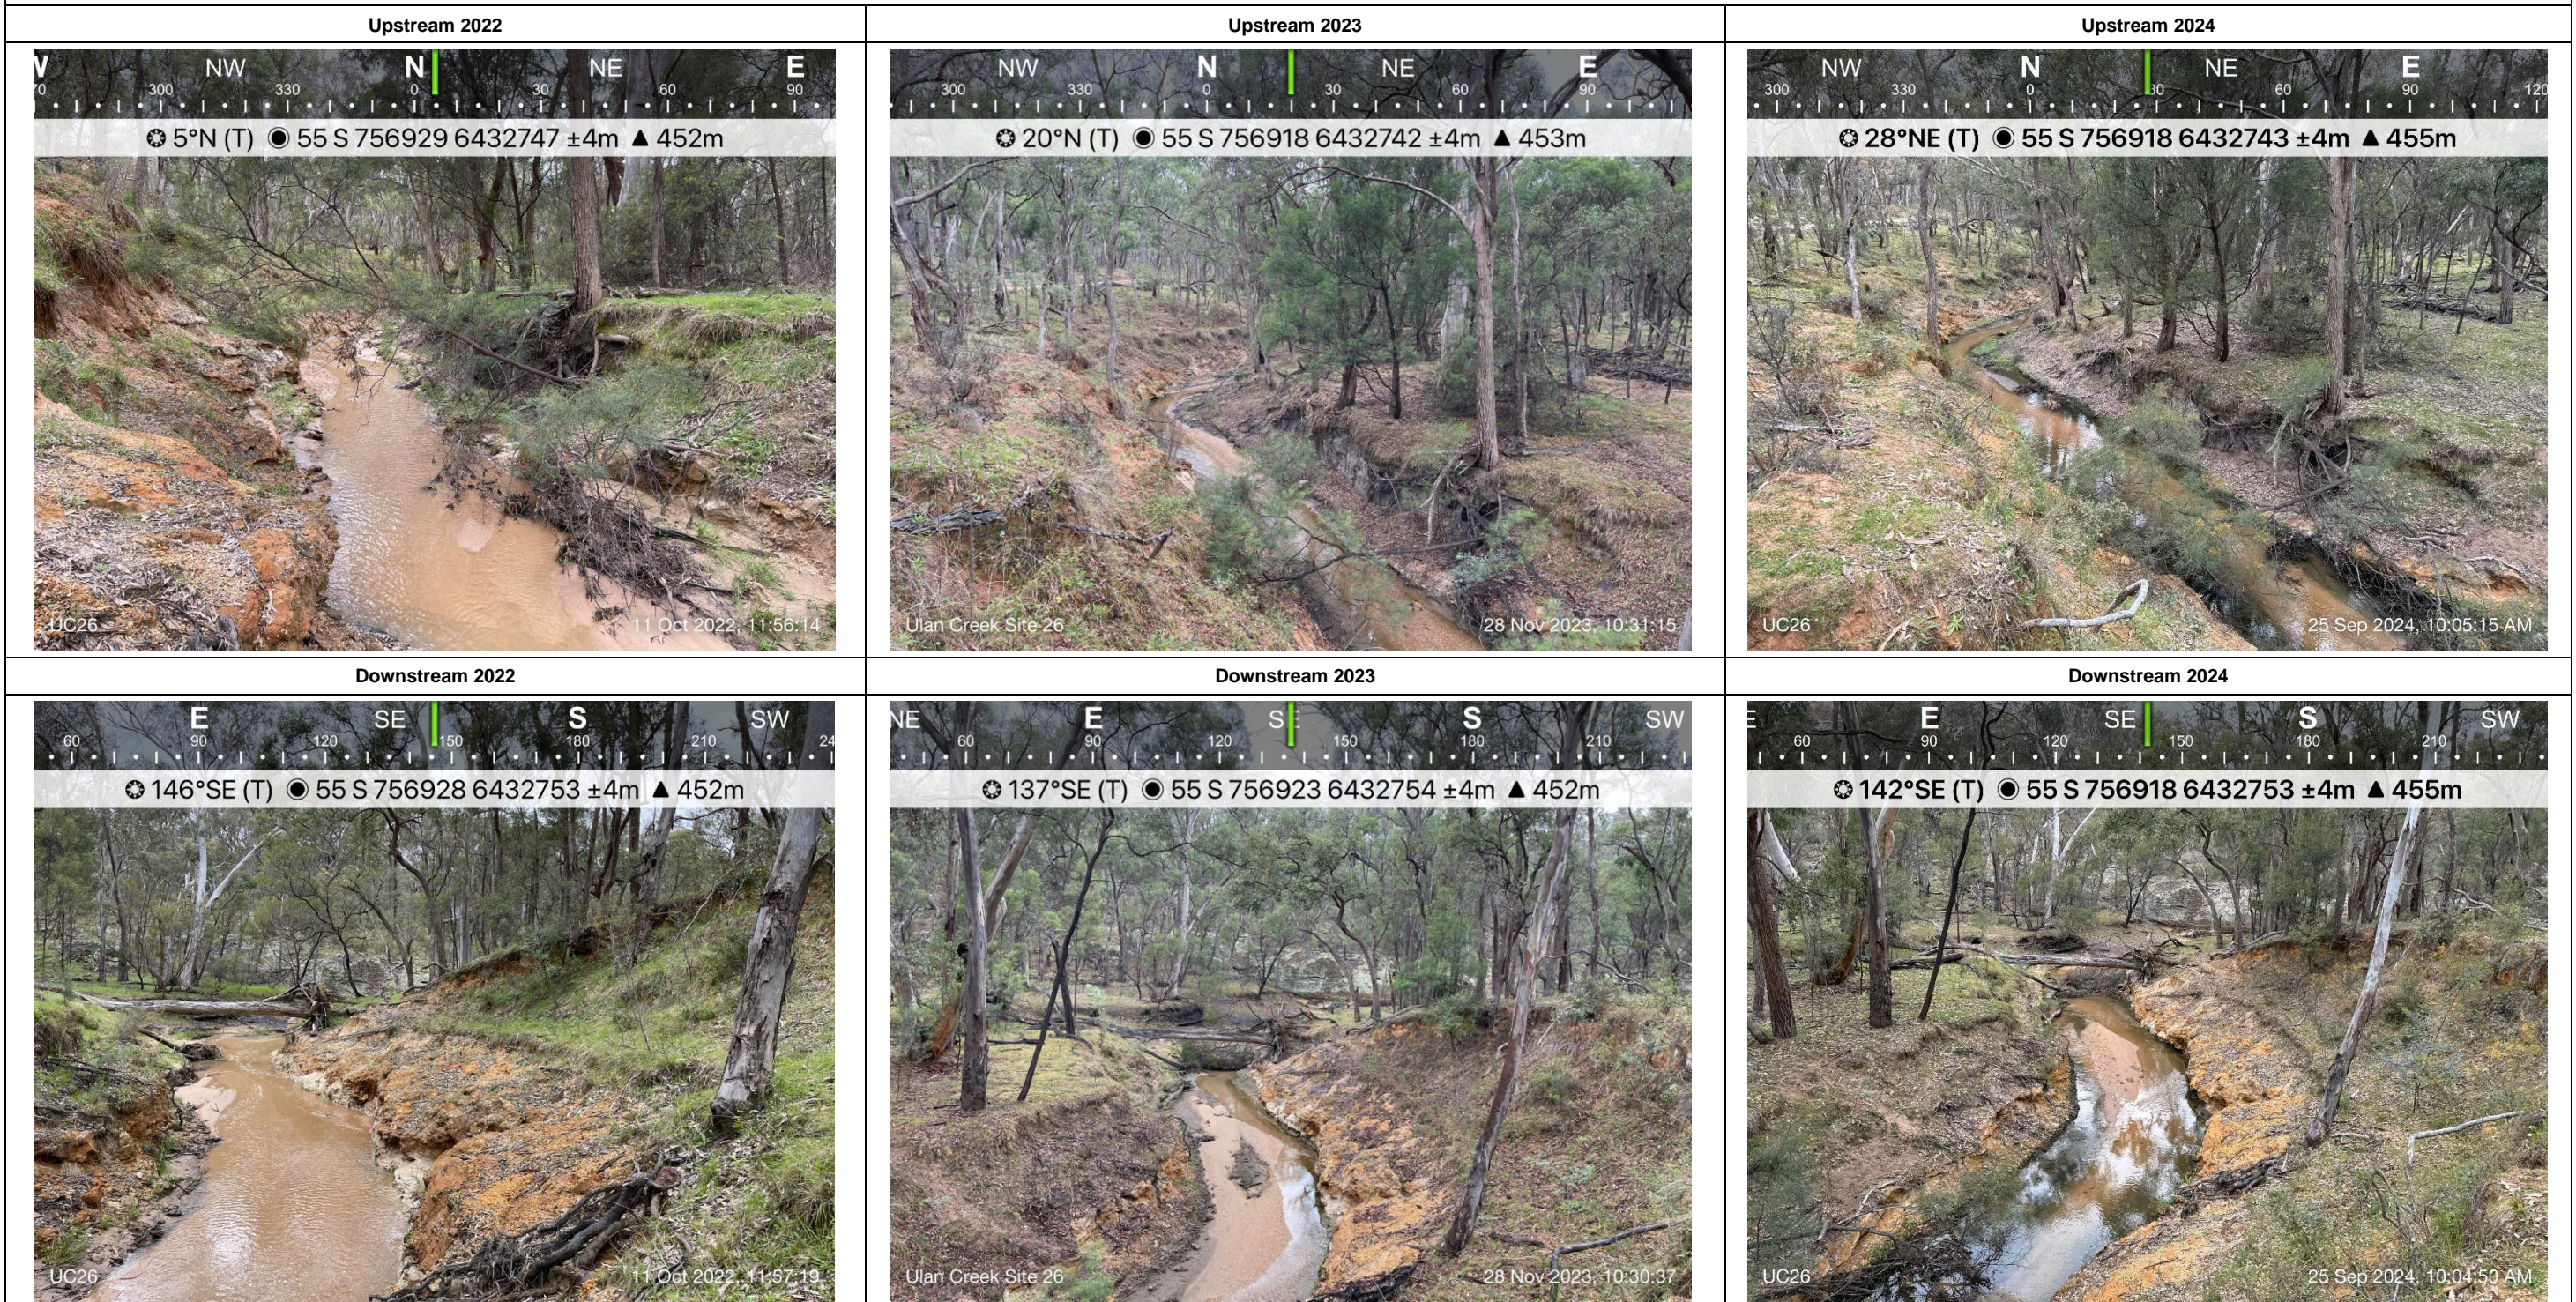
General Observations: Ulan Creek had water flowing at this location in 2024. The channel bed had little to no vegetation and is a mix of sand, silt and small size gravel. Active erosion was again noted along both banks in 2022. Both the LHB and RHB have a gentle slope above the banks. The RHB wall is near vertical, bare and exposed with signs of erosion back to bedrock. The LHB wall also has near vertical sections from the top of the bank, with bank undercutting further downstream exposing tree roots along the LHB. Both sides of the creek are tree lined. A large tree had fallen across the channel downstream since 2021. Observations in 2024 noted a similar deteriorating trend when compared to previous monitoring. The CSIRO *Ephemeral Stream Assessment* classification at this location as 'active'.

Notes: In 2024 observations were limited to the RHB and water flowing.
