2024 Channel Stability Monitoring - Site Inspection Details

APPENDIX B: Ulan Creek

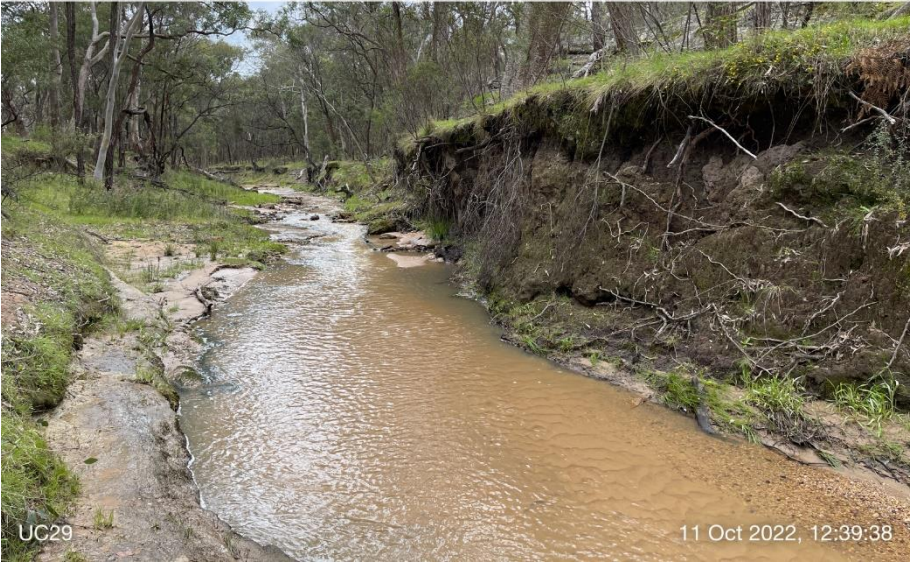
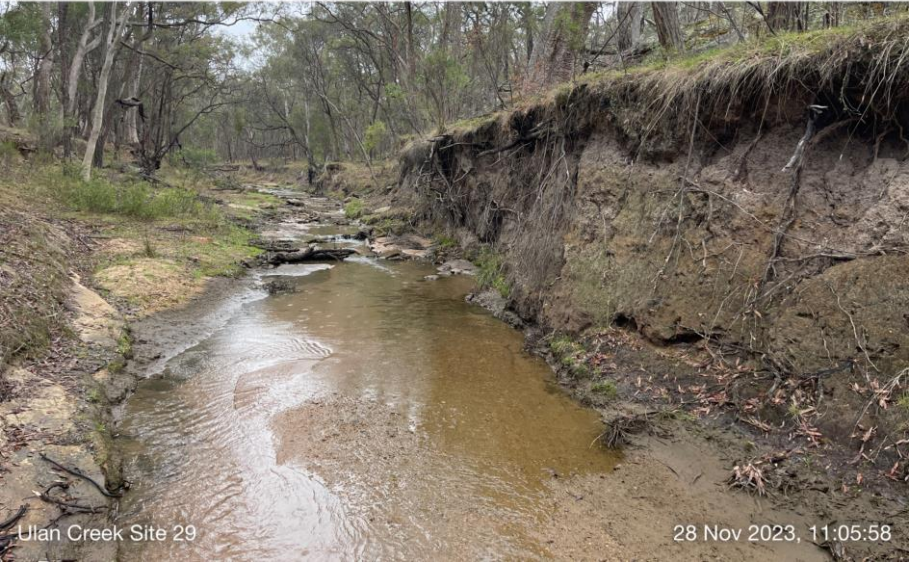
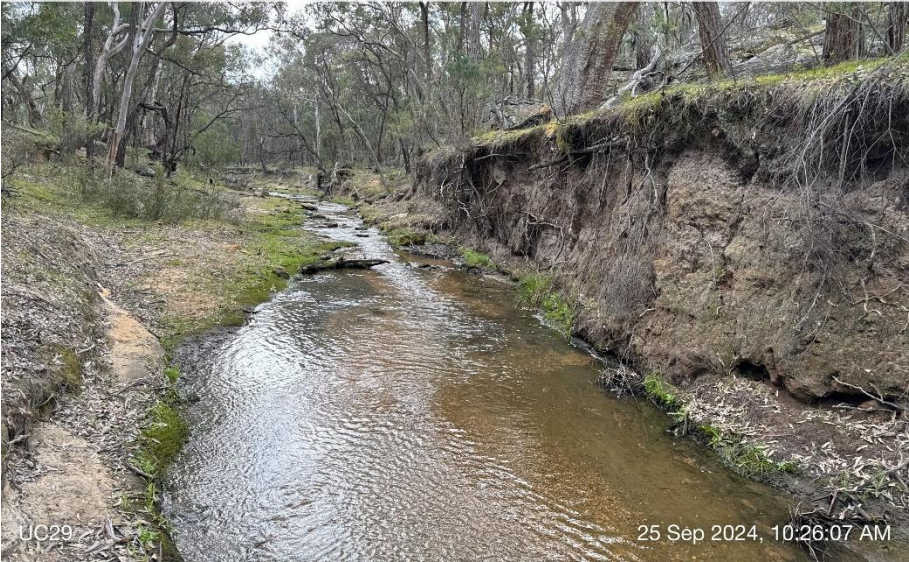
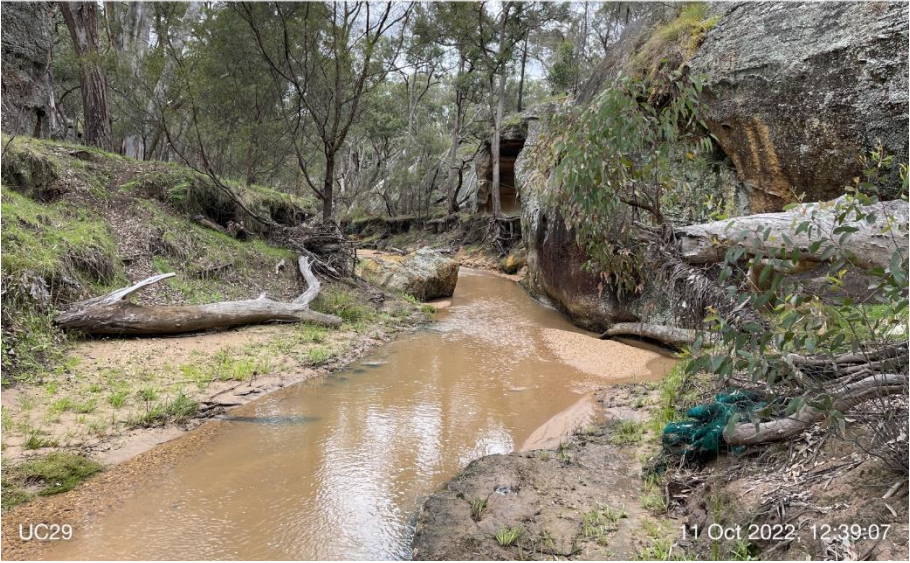
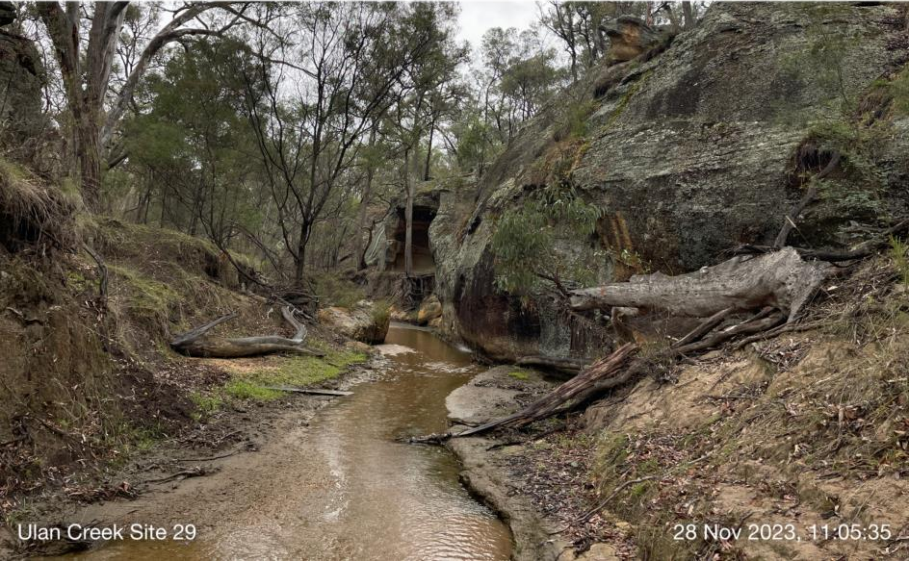
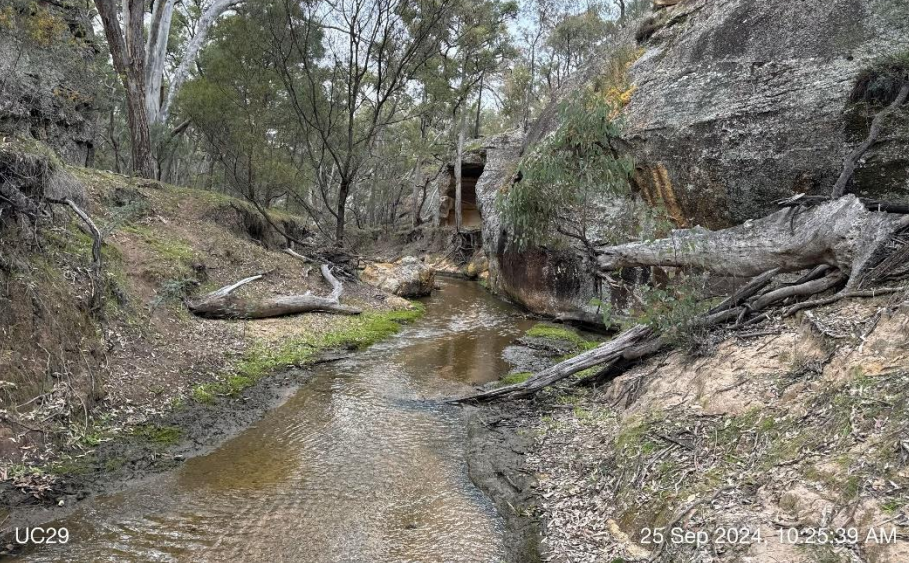
| 2024 Channel Stability Monitoring - Site Inspection Details | | |
|---|--|---|
| <p>Creek Name: Ulan Creek</p> <p>Date: 25 September 2024</p> <p>Monitoring Site: UC29</p> <p>Coordinates (MGA/Zone 55): 756821 (E) 6432374 (N)</p> <p>CISRO Ephemeral Stream Assessment: Active</p> <p>General Observations: Ulan Creek had water flowing at this location in 2024. The low flow channel bed had little to no vegetation and was a mix of sand and small to medium gravel size rock material. Deposited sediment was noted in the channel bed in 2020. Both the LHB and RHB have a steep rock/boulder slope above the bank. The RHB is near vertical formed from bedrock and is stable. The LHB wall has near vertical mid sections, sparsely vegetated with signs of active erosion in 2022. Both sides of the creek are tree lined. A piece of jute mesh that was most likely from Site UC25 was caught up on the RHB. Observations in 2024 are comparable to previous monitoring. The CSIRO <i>Ephemeral Stream Assessment</i> classification at this location as 'active'.</p> <p>Notes: In 2024 observations were limited to the LHB and water flowing. Jute mesh material from RHB transported downstream since 2022 monitoring.</p> | | |

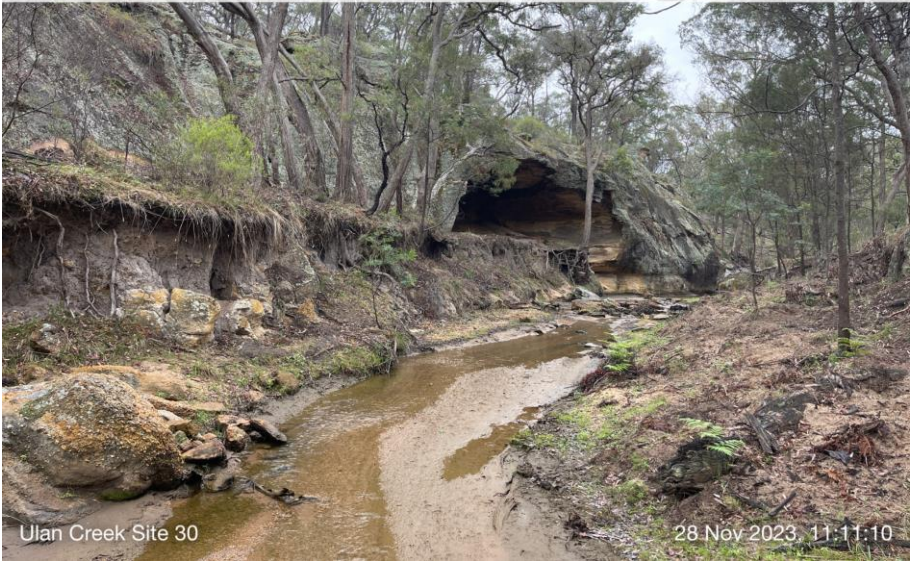
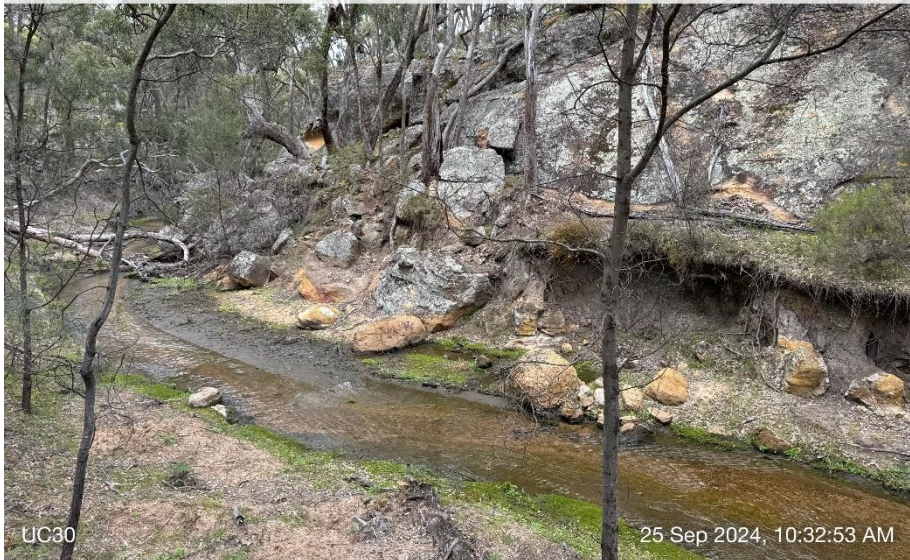
General Observations: Ulan Creek had water pooling at this location in 2023. The channel bed had little to no vegetation and is a mix of silt, sand and small gravel size rock material with several large boulders. In 2022 additional build up of sand, silt and small gravel deposits were noted. The RHB has a steep rock and boulder slope above the bank. The RHB wall is near vertical, bare and exposed, displays undercutting erosion with exposed tree roots. The LHB wall has near vertical sections from the top of the bank, a moderate to steep slope above the bank, increased vegetation in 2022 with signs of erosion. Both sides of the creek are tree lined. A large tree had fallen across the channel downstream since 2021. Observations in 2023 are comparable to previous monitoring. The CSIRO *Ephemeral Stream Assessment* classification at this location as 'active'.

Notes: In 2024 observations were limited to the LHB and water flowing. Decreasing vegetative ground cover noted in 2023. Silt deposits along the edges of the channel bed noted in 2023.

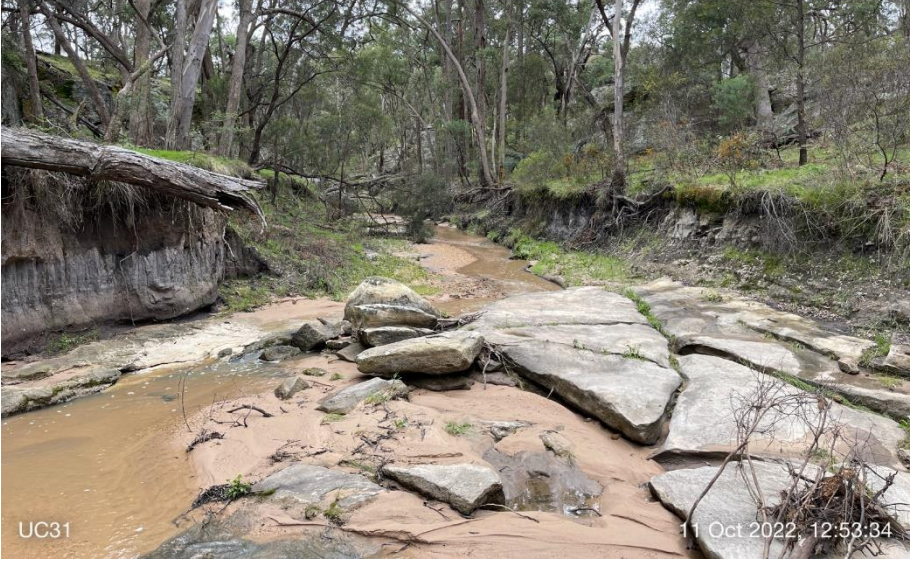
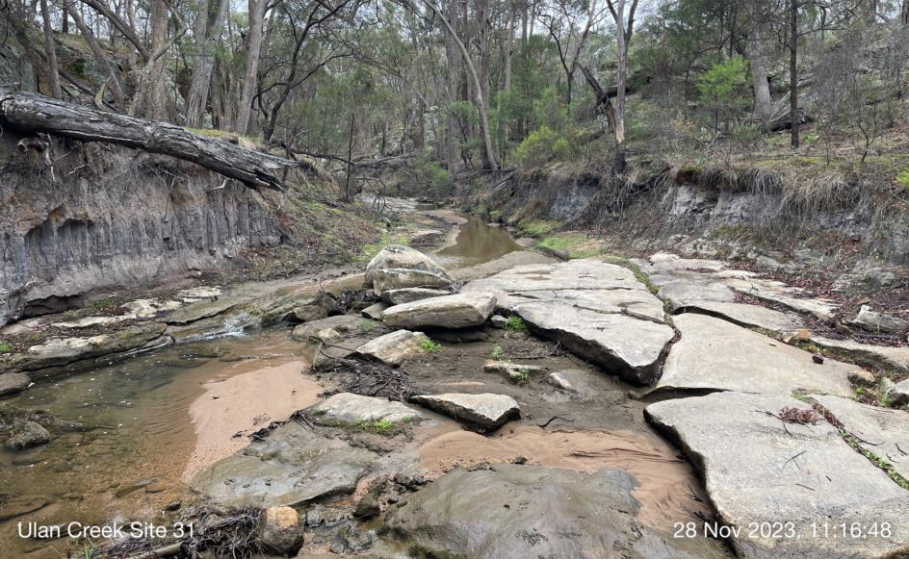
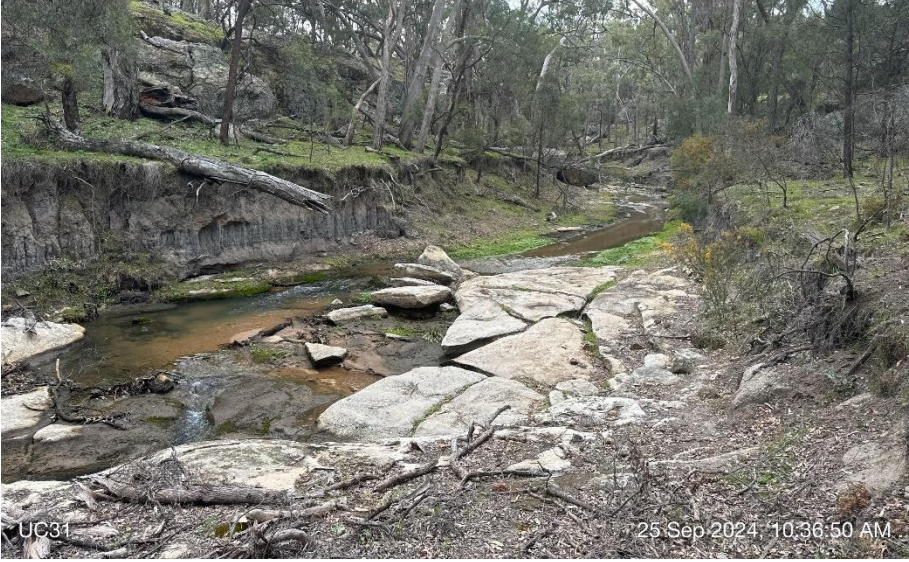
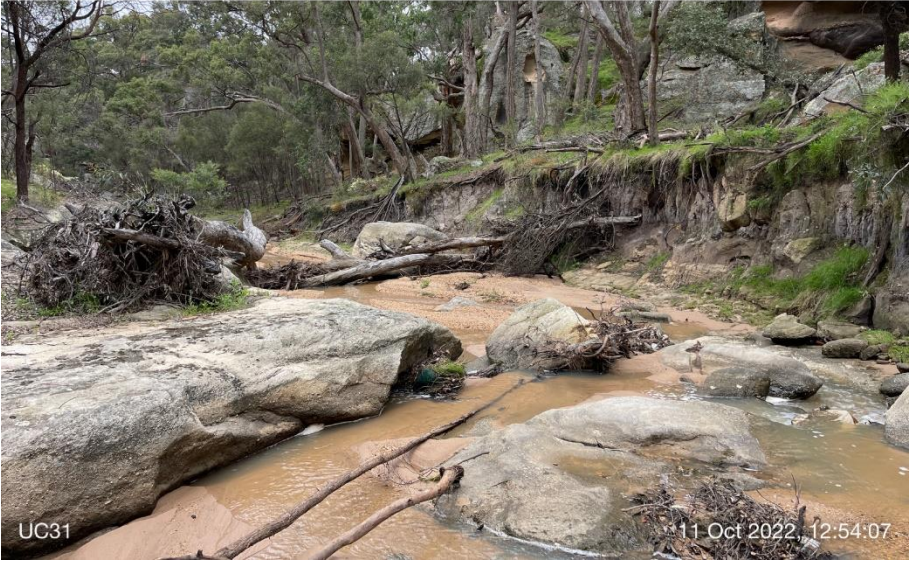
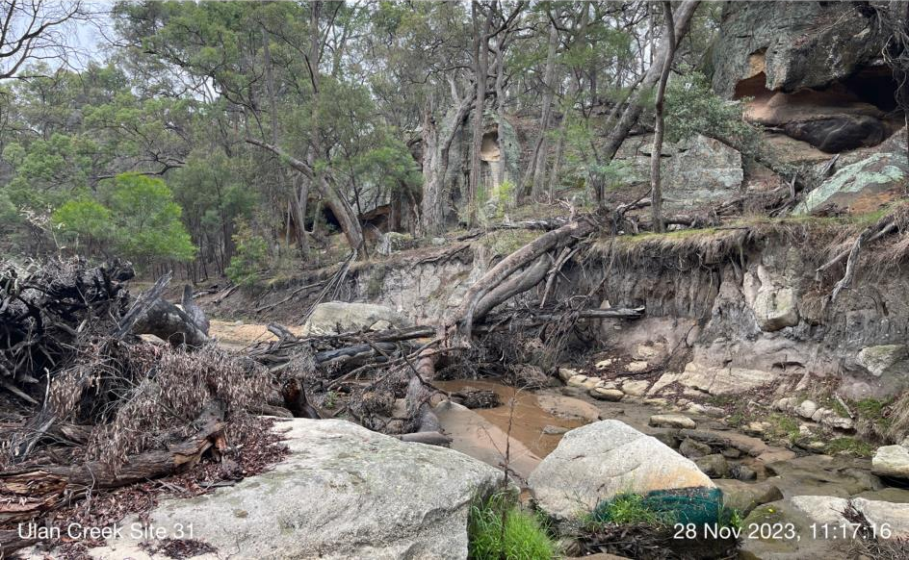
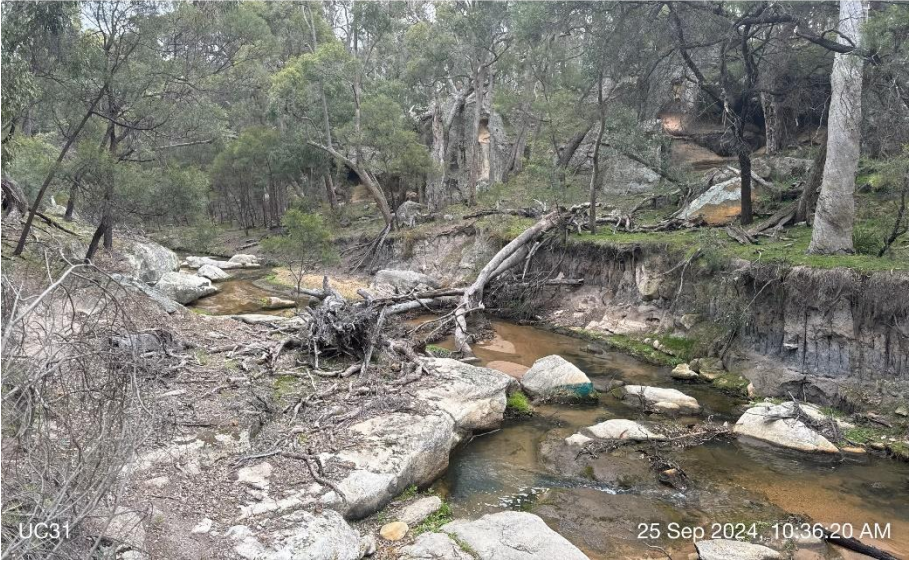
| 2024 Channel Stability Monitoring - Site Inspection Details | | |
|--|---|---|
| <p>Creek Name: Ulan Creek</p> <p>Date: 25 September 2024</p> <p>Monitoring Site: UC31 (Not visited in 2020 this site was inaccessible)</p> <p>Coordinates (MGA/Zone 55): 756840(E) 6432211(N)</p> <p>CISRO Ephemeral Stream Assessment: Active</p> <p>General Observations: Ulan Creek had water flowing at this location in 2024. The channel bed had little to no vegetation and formed from bedrock with deposited sediments and sand. Large pieces of bedrock type material were noted in the channel bed. In 2022 additional build up of sand and silt deposits were noted. The RHB has a steep rock slope above the bank. The RHB wall is near vertical, bare and exposed, displays undercutting erosion with exposed tree roots. The LHB wall has near vertical lower sections, a steep rock/boulder slope above the bank. The LHB is partially vegetated with signs of erosion. Both sides of the creek are tree lined. Observations in 2024 are comparable to previous monitoring. The CSIRO <i>Ephemeral Stream Assessment</i> classification at this location as 'active'.</p> <p>Notes: In 2024 observations were limited to the LHB and by water flowing. A tree had fallen from the RHB across the creek since 2022 monitoring.</p> | | |

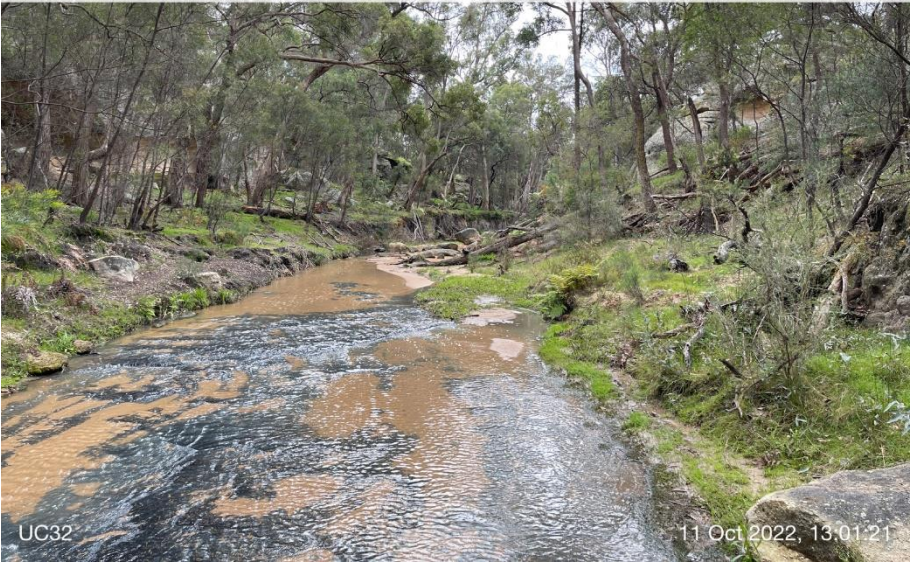
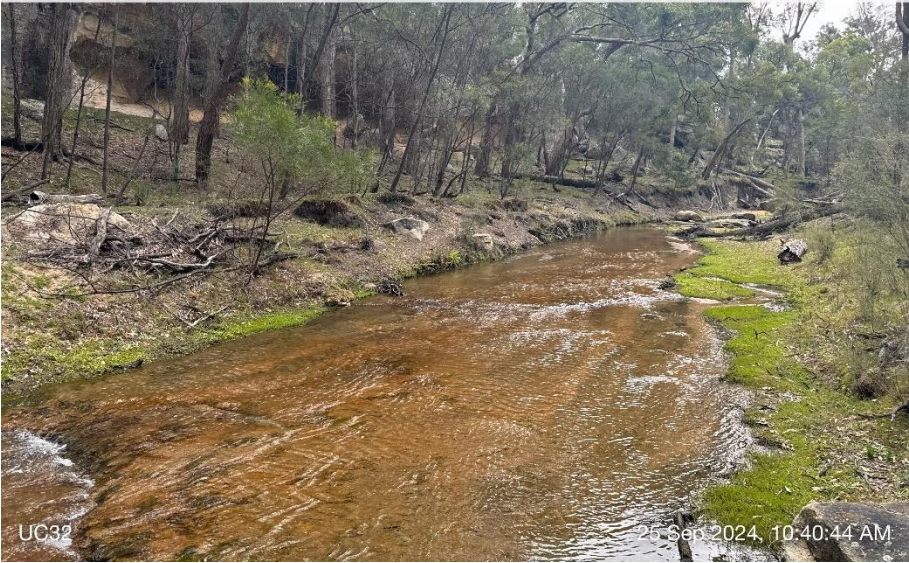
| 2024 Channel Stability Monitoring - Site Inspection Details | | | |
|--|--|---|--|
| <p>Creek Name: Ulan Creek</p> <p>Date: 25 September 2024</p> <p>Monitoring Site: UC32 (Not visited in 2020 this site was inaccessible)</p> <p>Coordinates (MGA/Zone 55): 756816 (E) 6432138 (N)</p> <p>CISRO Ephemeral Stream Assessment: Potentially Stabilising</p> <p>General Observations: Ulan Creek had water flowing at this location in 2024. The low flow channel bed has no vegetation and is formed from bedrock with sediment deposits. In 2022 additional build up of sand, silt and small gravel deposits were noted. There is a steep rock (almost cliff line in appearance) slope above the RHB bank. The RHB wall is a moderate slope and is partially vegetated with rock boulders and appears stable. The LHB is similar to the RHB. Both sides of the creek are tree lined. Observations in 2024 are comparable to previous monitoring. The CSIRO <i>Ephemeral Stream Assessment</i> classification at this location as 'potentially stabilising'.</p> <p>Notes: In 2024 observations were limited to the LHB by water flowing.</p> | | | |

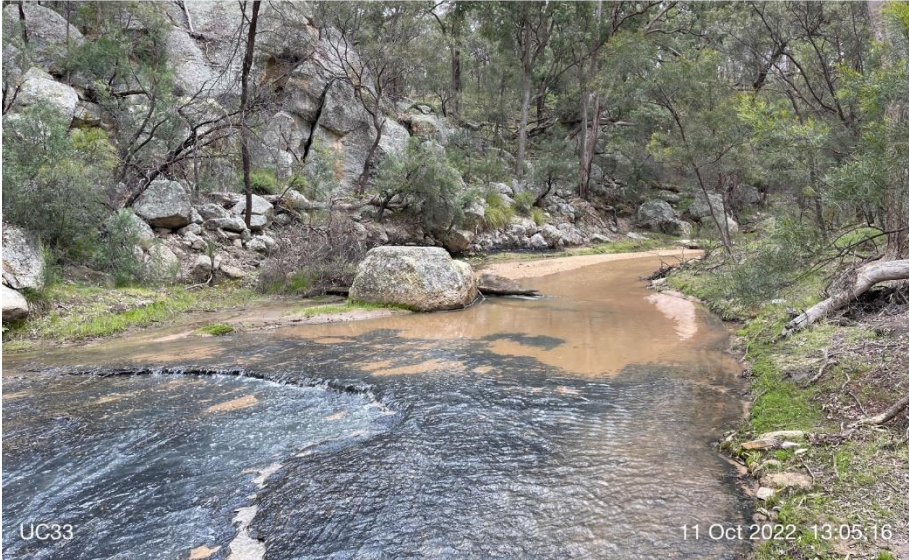
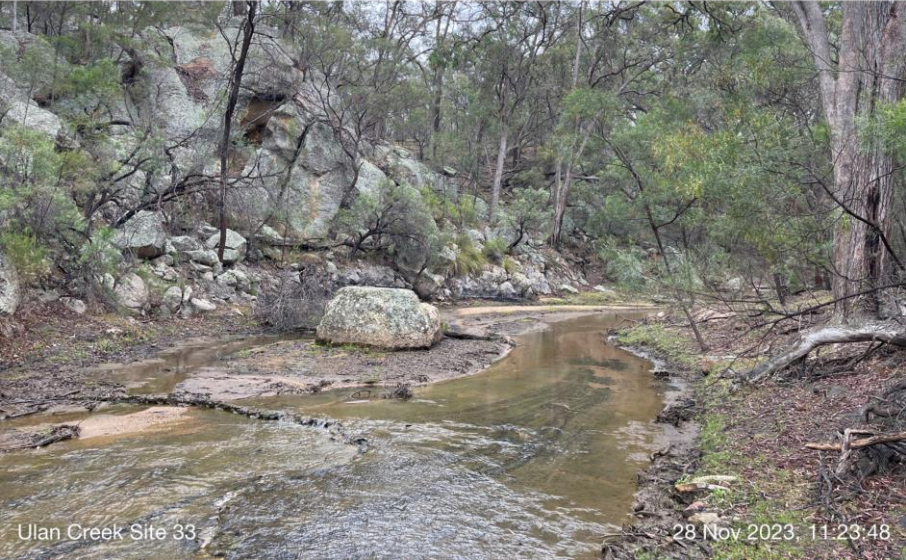
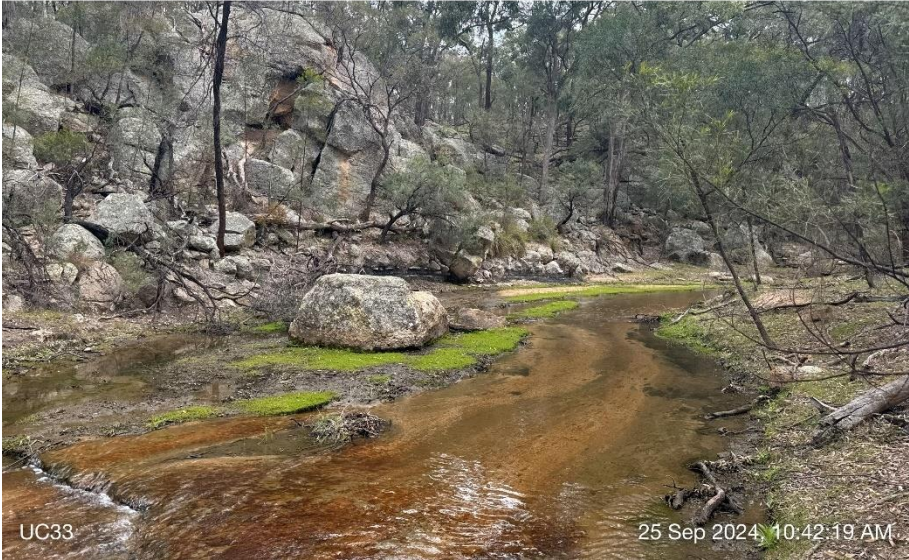
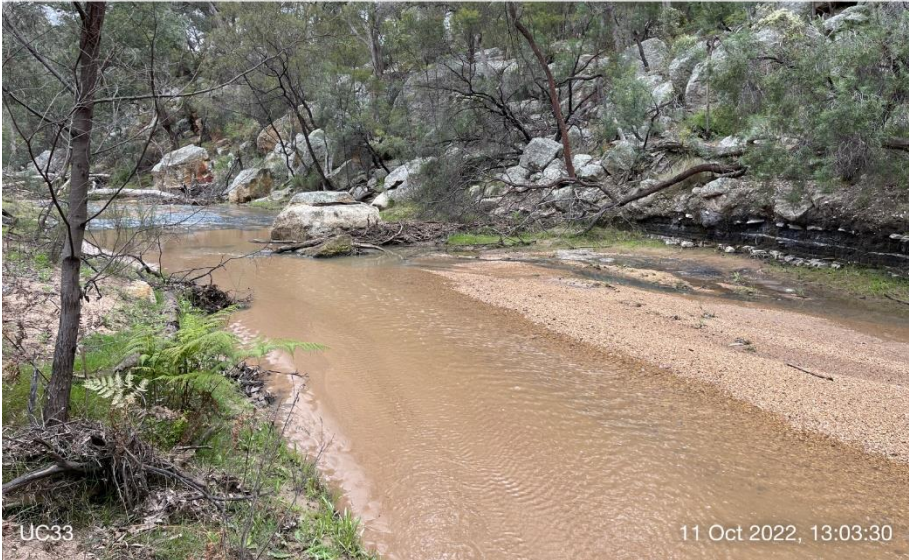
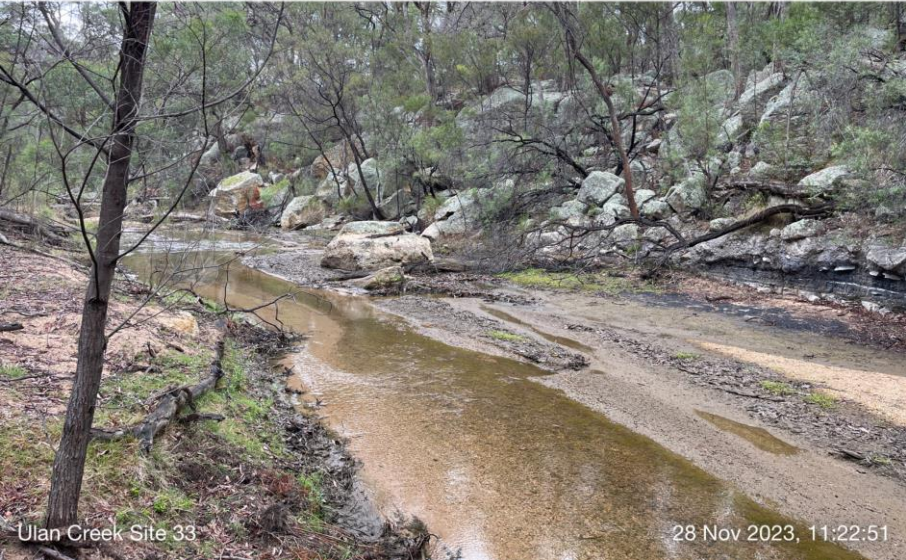
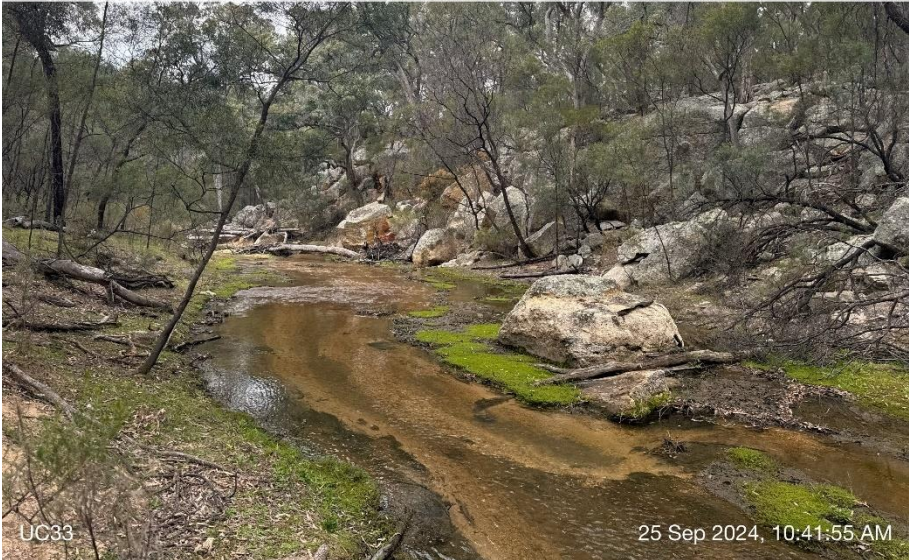
| 2024 Channel Stability Monitoring - Site Inspection Details | | | |
|--|--|---|---|
| <p>Creek Name: Ulan Creek</p> <p>Date: 25 September 2024</p> <p>Monitoring Site: UC33 (Not visited in 2020 this site was inaccessible)</p> <p>Coordinates (MGA/Zone 55): 756812 (E) 6432094 (N)</p> <p>CISRO Ephemeral Stream Assessment: Potentially Stabilising</p> <p>General Observations: Ulan Creek had water flowing at this location in 2024. The low flow channel bed had little to no vegetation, on bedrock covered with sediment deposits. In 2022 additional build up of sand, silt and small gravel deposits were noted. The RHB has a steep slope above the bank. The RHB wall is near vertical, bare and exposed and formed from bedrock and loose rocks and boulders, with signs of erosion. Carbonaceous bedrock material is also exposed along the RHB. The LHB has a moderate, partially vegetated slope, with a moderate to slope with rock boulders above the bank. Both sides of the creek are tree lined. Observations in 2024 are comparable to previous monitoring. The CSIRO <i>Ephemeral Stream Assessment</i> classification at this location as 'potentially stabilising'.</p> <p>Notes: In 2024 observations were limited to the LHB by water flowing.</p> | | | |

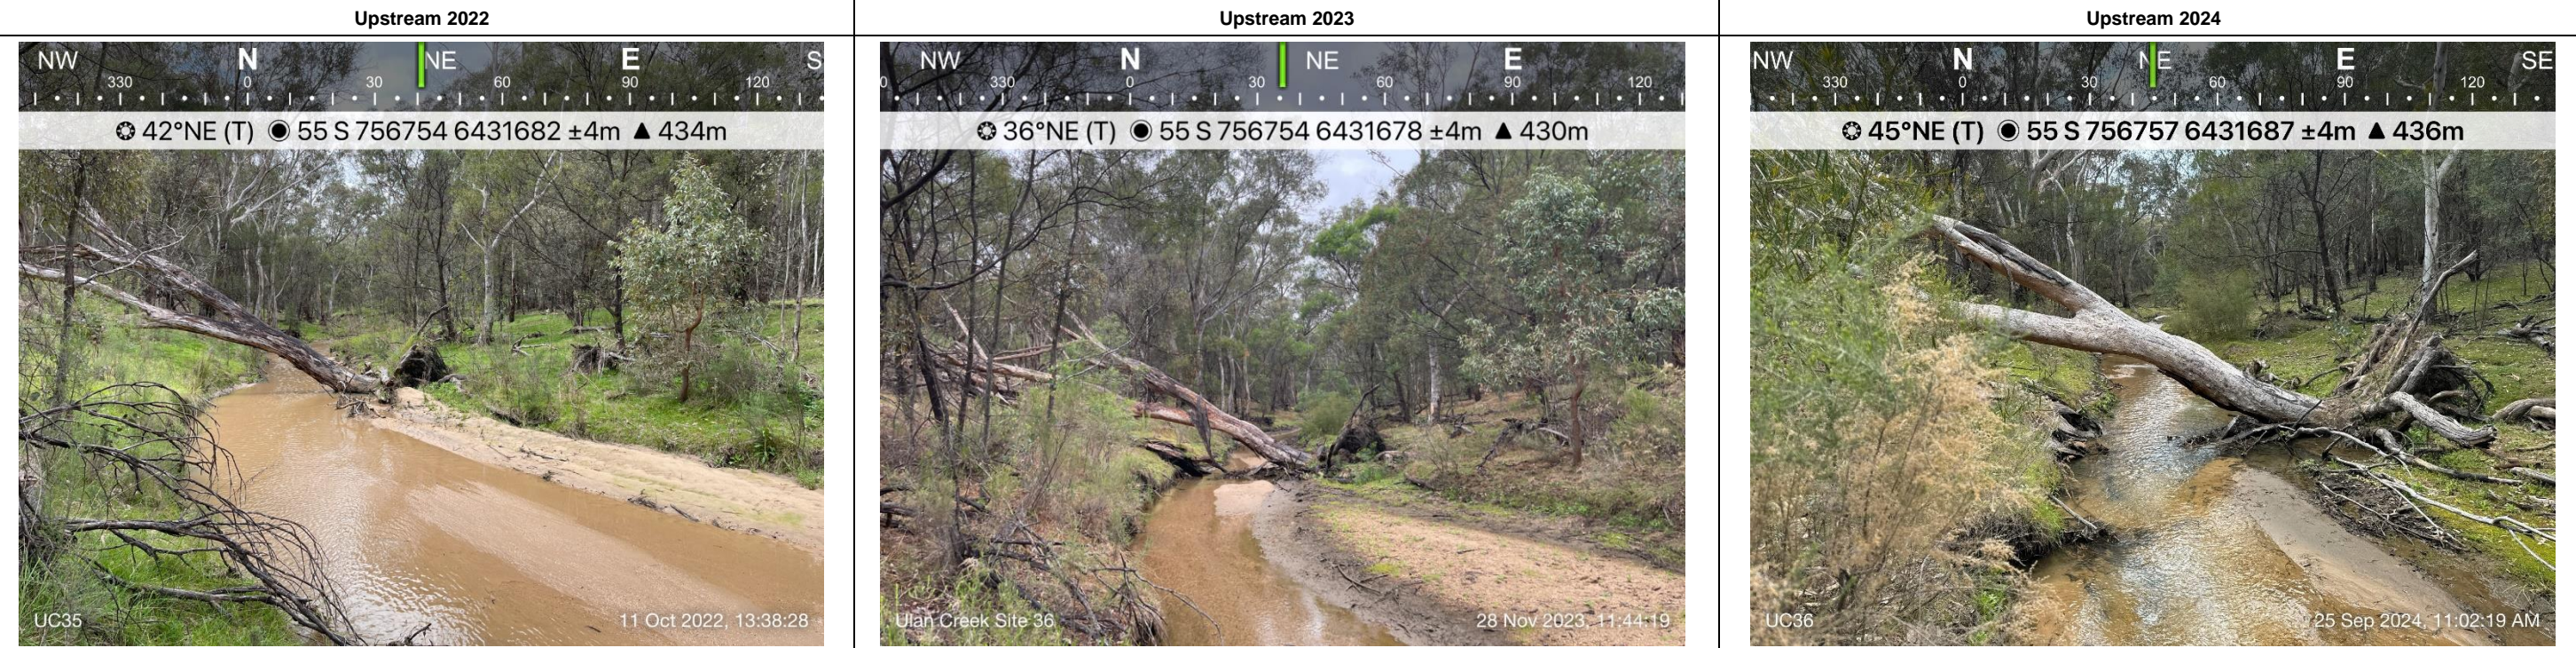
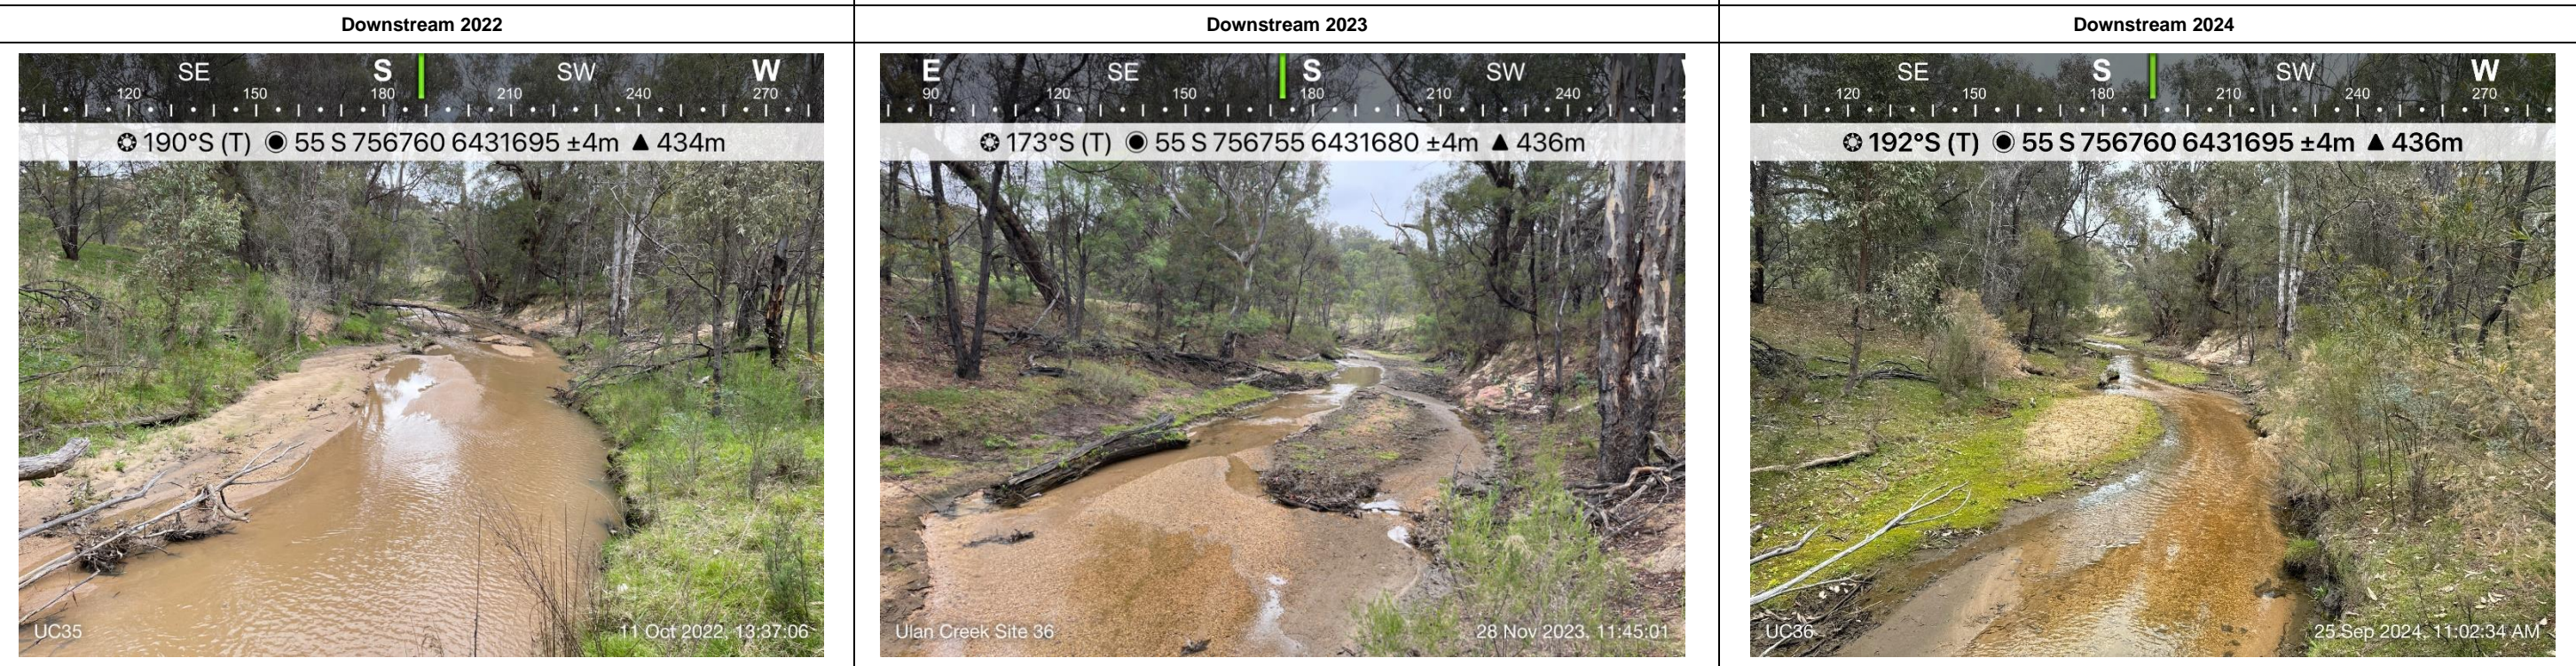
General Observations: Ulan Creek had water flowing at this location in 2024. The channel bed had little to no vegetation and is a mix of silt, sand and small to medium size gravel. In 2022 additional build up of sand, silt and small gravel deposits were noted. The LHB has a moderate slope above and was vegetated. The LHB wall displayed signs of undercutting. The RHB has a steeper slope above well vegetated. Both sides of the creek have some bare and exposed areas with evidence of past erosion although the amount. Both sides of the creek are tree lined. Observations in 2024 are comparable to previous monitoring. The CSIRO *Ephemeral Stream Assessment* classification at this location as 'potentially stabilising'.

Notes: In 2024 observations were limited to the RHB by water flowing.
