APPENDIX A – UCFL4

Site UCFL4 Site 1 (Removed from 2020 monitoring by UC MPL)

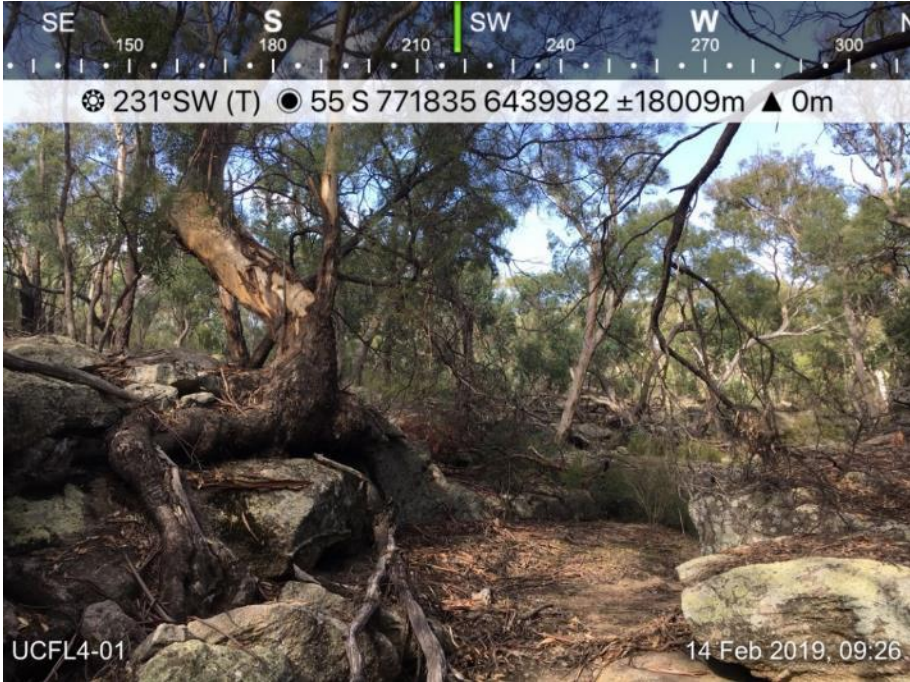
<p align="center">Notes: GPS locations incorrect on image due to loss of GPS signal</p>				
Year	March 2014	December 2015	December 2016	October 2017	February 2019
Result	Pre-mining inspection	No perceptible change	No perceptible change	No perceptible change	No perceptible change
Comments / Interpretation					
<ul style="list-style-type: none"> - UCFL4 Site 1 is approximately 600m to the east from the GOAF edge of LW1. To date no perceptible change has been identified as a result of longwall mining at this monitoring site. - This site could be considered for removal from the post mining monitoring program of Ulan Creek tributaries due to its location outside LW1 and there has been no perceptible change since the completion of LW1 in May 2015. - During the 2019 inspection, the appearance of recent flood debris in the flow channel and a fallen tree were noted.

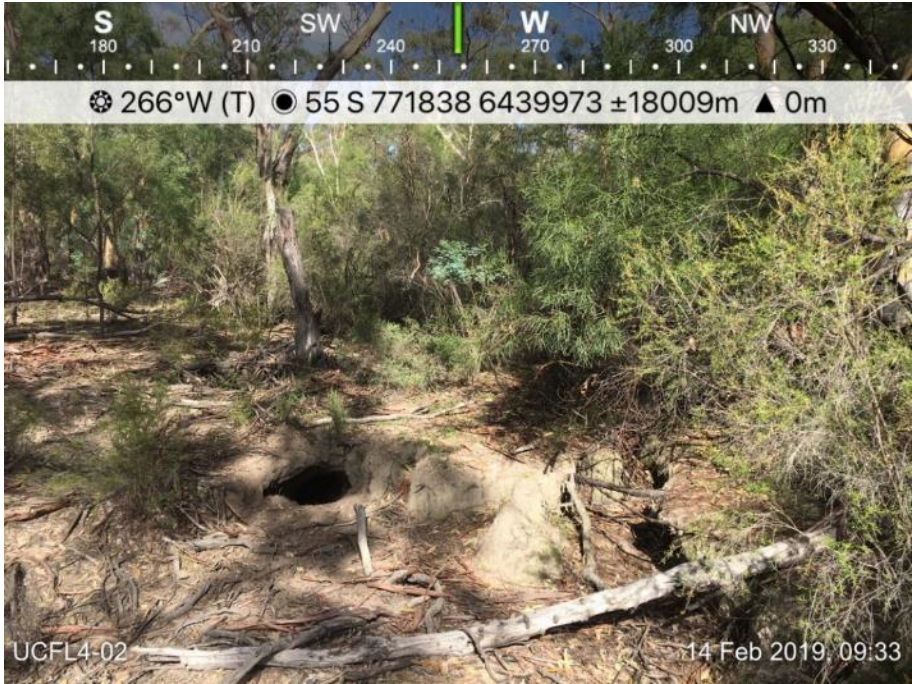
<p align="center">Notes: GPS locations incorrect on image due to loss of GPS signal</p>				
Year	March 2014	December 2015	December 2016	October 2017	February 2019
Result	Pre-mining inspection	No perceptible change	No perceptible change	No perceptible change	No perceptible change
Comments / Interpretation					
<ul style="list-style-type: none"> - UCFL4 Site 2 is approximately 500m to the east from the GOAF edge of LW1. To date no perceptible change has been identified as a result of longwall mining at this monitoring site. - This site could be considered for removal from the post mining monitoring program of Ulan Creek tributaries due to its location outside LW1 and there has been no perceptible change since the completion of LW1 in May 2015. - During the 2019 inspection, an active wombat burrow in the flow line was noted.

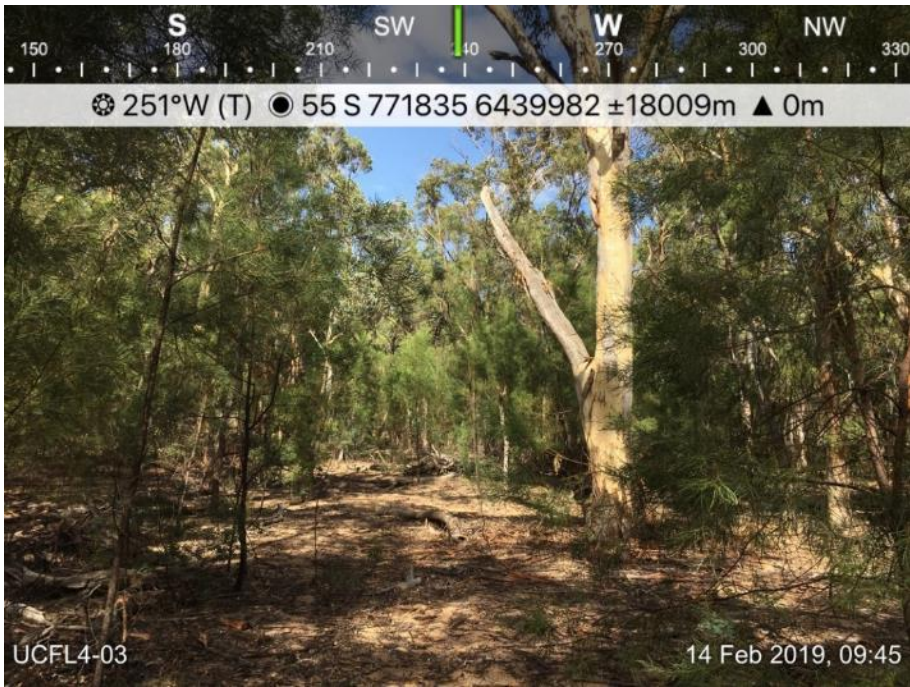
<p align="center">Notes: GPS locations incorrect on image due to loss of GPS signal</p>				
Year	March 2014	December 2015	December 2016	October 2017	February 2019
Result	Pre-mining inspection	No perceptible change	No perceptible change	No perceptible change	No perceptible change
Comments / Interpretation					
<ul style="list-style-type: none"> - UCFL4 Site 3 is approximately 300m to the east from the GOAF edge of LW1. To date no perceptible change has been identified as a result of longwall mining at this monitoring site. - This site could be considered for removal from the post mining monitoring program of Ulan Creek tributaries due to its location outside LW1 and there has been no perceptible change since the completion of LW1 in May 2015. - During the 2019 inspection, the appearance of recent flood debris in the flow channel was noted.

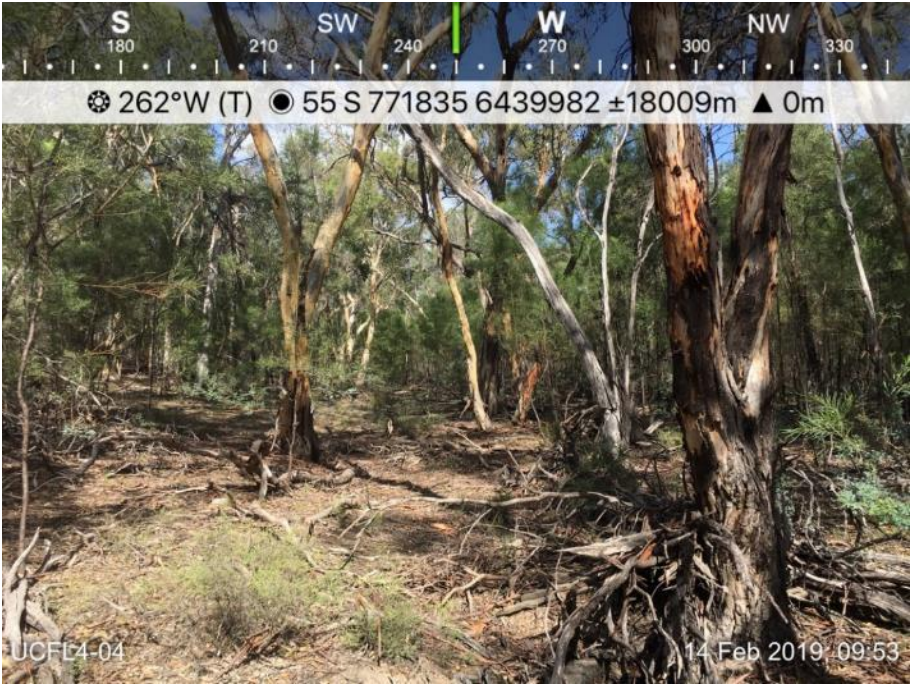
<p align="center">Notes: GPS locations incorrect on image due to loss of GPS signal</p>				
Year	March 2014	December 2015	December 2016	October 2017	February 2019
Result	Pre-mining inspection	No perceptible change	No perceptible change	No perceptible change	No perceptible change
Comments / Interpretation					
<ul style="list-style-type: none"> - UCFL4 Site 4 is approximately 100m to the east from the GOAF edge of LW1. To date no perceptible change has been identified as a result of longwall mining at this monitoring site. - This site could be considered for removal from the post mining monitoring program of Ulan Creek tributaries due to its location outside LW1 and there has been no perceptible change since the completion of LW1 in May 2015. - During the 2019 inspection, the appearance of recent flood debris in the flow channel was noted.

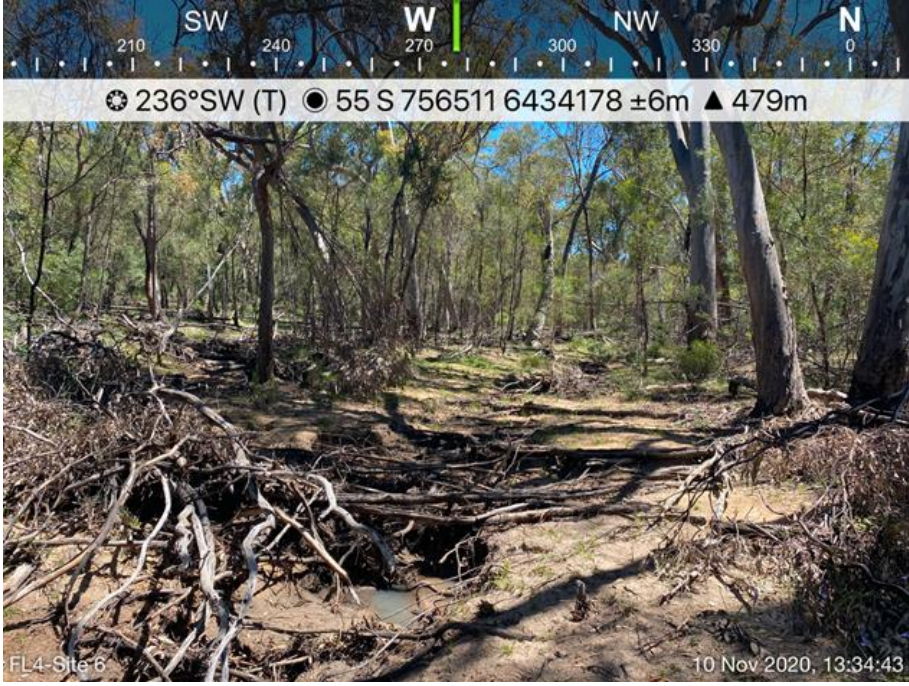
Year	March 2014	December 2015	December 2016	October 2017	February 2019	November 2020
Result	Pre-mining inspection	No perceptible change	No perceptible change	No perceptible change	No perceptible change	No perceptible change
Comments / Interpretation						
<ul style="list-style-type: none"> - UCFL4 Site 6 is centrally located above LW1 and approximately 60m to the west of Site 5. To date no perceptible change has been identified as a result of longwall mining at this monitoring site. - During the 2019 inspection, the appearance of recent flood debris in the flow channel was noted. No evidence of subsidence related impacts were identified. - During the 2020 inspection the flow line displayed signs of material movement from both banks in the form of minor undercutting and slumping (when compared to 2019), likely exacerbated by high flow event/s (refer to Section 4). The high flow event/s had cleared some of the fallen timber recorded previously. Although there were signs of erosion and instabilities, however they were minimal compared to some of the other sites. There was water pooling at this location. - This site could be considered for removal from the post mining monitoring program of Ulan Creek tributaries due to no perceptible change other than natural processes identified in 2020.

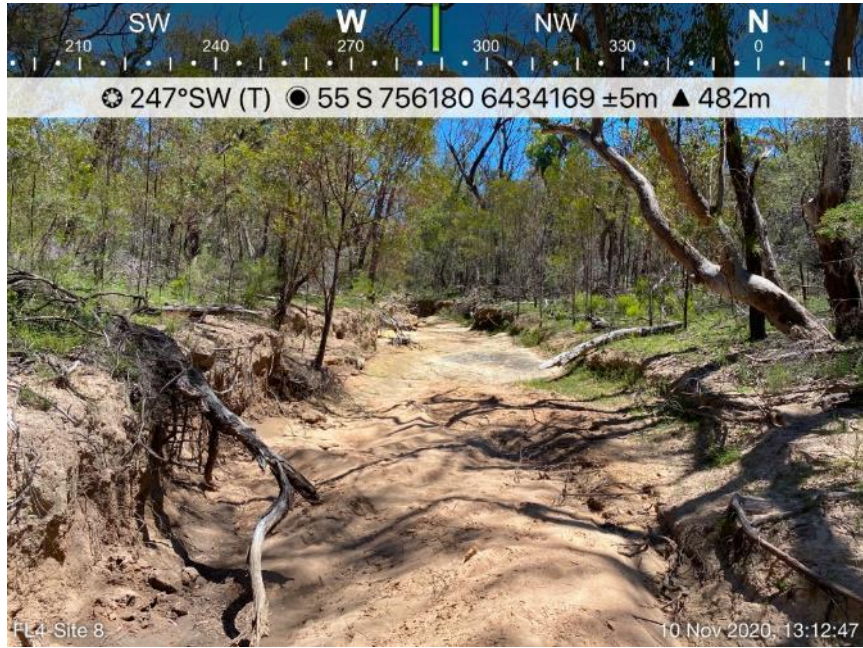
Year	March 2014	December 2015	December 2016	October 2017	February 2019	November 2020
Result	Pre-mining inspection	No perceptible change	No perceptible change	No perceptible change	No perceptible change	No perceptible change
Comments / Interpretation						
<ul style="list-style-type: none"> - UCFL4 Site 8 is located towards the western edge of LW2 and approximately 200m to the west of Site 7 and displays signs of natural instability. To date no perceptible change has been identified as a result of longwall mining at this monitoring site. - During the 2019 inspection, the appearance of recent flood debris in the flow channel was noted. No evidence of subsidence related impacts were identified. No signs of recent erosion was noted. - During the 2020 inspection the flow line displayed signs of material movement from both banks in the form of undercutting and slumping (when compared to 2019), likely exacerbated by high flow event/s (refer to Section 4). The high flow event/s had cleared fallen timber recorded previously. Although there were signs of erosion and instabilities, however they were minimal compared to some of the other sites. There was no water flowing. - This site could be considered for removal from the post mining monitoring program of Ulan Creek tributaries due to no perceptible change other than natural processes identified in 2020.

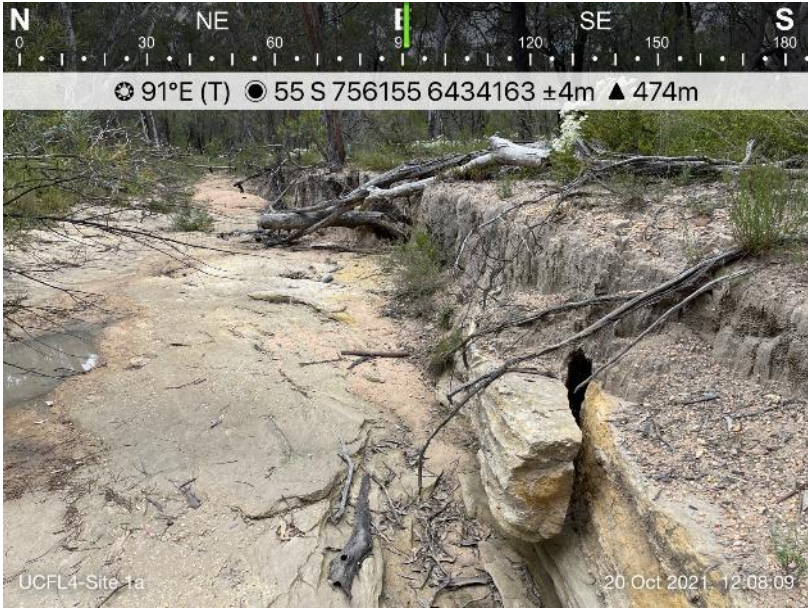
Year	October 2017	February 2019	November 2020	October 2021
Result	Perceptible impacts	Perceptible impacts (no change)	Perceptible impacts	Perceptible impacts (no change)
Comments / Interpretation				
<ul style="list-style-type: none"> - UCFL4 Site 1A is above LW2 and was identified during the 2017 monitoring program. Perceptible impacts in the form of channel bed and bank cracking was observed. Recommend continued monitoring, as this site displays signs of instability. - During the 2019 inspection, there was no observed changes since the 2017 monitoring. There were signs of recent sediment deposits and flood debris noted in the flow channel, however no active erosion was noted. - During the 2020 inspection the flow line displayed signs of material movement from both banks in the form of undercutting and slumping (when compared to 2019) as a result of high flow event/s (refer to Section 4). A piece of dislodged rock material first noted in 2017 was carried downstream. Fine sediments may have commenced infilling the cracked channel bedrock, as no cracking in the channel bed was obvious. There was no water flowing. - The erosion impacts as described from a high flow creek event may have been exacerbated by a change in the longitudinal gradients from subsidence. This potential change in grade may be exacerbating the natural eroding processes within the flowline at this location. - During the 2021 inspection the instabilities noted in 2020 appeared comparable.

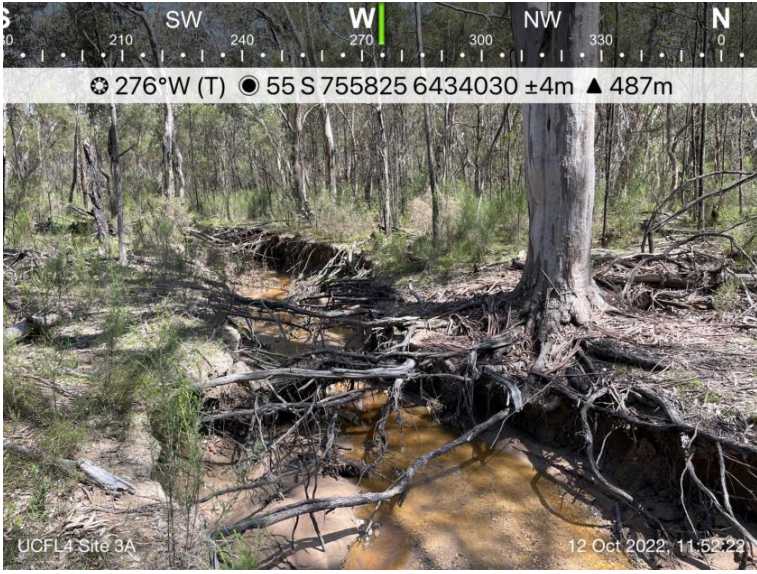
Year	October 2017	February 2019	November 2020	October 2021	October 2022
Result	Perceptible impacts	Monitor perceptible impacts	Perceptible impacts ²	Perceptible impacts ² (no change)	Perceptible impacts ² (no change)
Comments / Interpretation					
<ul style="list-style-type: none"> - UCFL4 Site 3A is above LW3 and was identified during the 2017 monitoring program. Perceptible impacts in the form of recent material deposited within existing channel bed erosion were observed. Recommend continued monitoring, as this site displays signs of instability potentially subsidence related. - During the 2019 inspection, there were signs of bank erosion along the RHB since the 2017 monitoring. - During the 2020 inspection the flow line displayed signs of mass material movement from both banks in the form of undercutting, slumping and channel widening (when compared to 2019) as a result of high flow event/s (refer to Section 4). There was water flowing and pooling and it was slightly turbid in appearance. - The erosion impacts as described from a high flow creek event may have been exacerbated by a change in the longitudinal gradients from subsidence. This potential change in grade may be exacerbating the natural eroding processes within the flowline at this location. - During the 2021 inspection the instabilities noted in 2020 appeared comparable, although monitoring to continue in 2022 to confirm no change to 2020 impacts. - During the 2022 inspection the instabilities noted in 2020 appeared comparable with previous monitoring. - Water was flowing at the time of the inspection in 2022.

² Nick point erosion begins at points of increased grade caused by subsidence and regresses upstream to erode the stream bed through the zone of less subsidence above chain pillars (SCT, 2022)

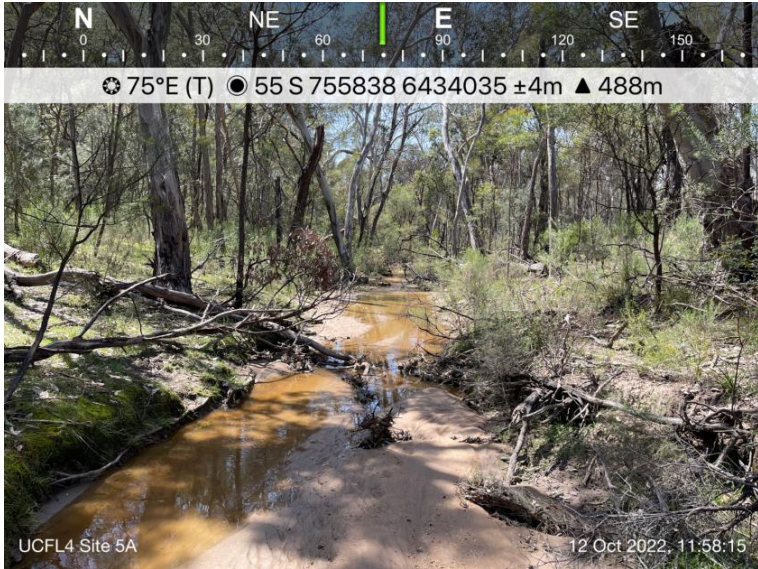
Year	October 2017	February 2019	November 2020	October 2021	October 2022
Result	Perceptible impacts	Perceptible impacts (no change)	Perceptible impacts ³ (change)	Perceptible impacts ³ (no change)	Perceptible impacts ³ (no change)
Comments / Interpretation					
<ul style="list-style-type: none"> - UCFL4 Site 5A was identified during the 2017 monitoring program. Perceptible impacts in the form of cracking along the channel bank were observed. Recommend continued monitoring, as this site may become unstable, as a result from subsidence. - During the 2019 inspection, the surface cracking noted in 2017 was not detected and site appears stable. Recent tree fall was noted in the flow lined. - During the 2020 inspection the flow line displayed signs of mass material movement from both banks in the form of undercutting, slumping and channel widening (when compared to 2019), as a result of high flow event/s (refer to Section 4). There was water flowing and pooling and it was slightly turbid in appearance. - During the 2020 inspection there were signs of a high flow event. The erosion impacts as described (Appendix A) from a high flow creek event may have been exacerbated by a change in the longitudinal gradients from subsidence. This potential change in grade may be exacerbating the natural eroding processes within the flowline at this location. - During the 2021 inspection the instabilities noted in 2020 appeared comparable, although monitoring to continue in 2022 to confirm no change to 2020 impacts. - During the 2022 inspection the instabilities noted in 2020 appeared comparable with previous monitoring. - Water was flowing at the time of the inspection in 2022.

³ Nick point erosion begins at points of increased grade caused by subsidence and regresses upstream to erode the stream bed through the zone of less subsidence above chain pillars (SCT, 2022)

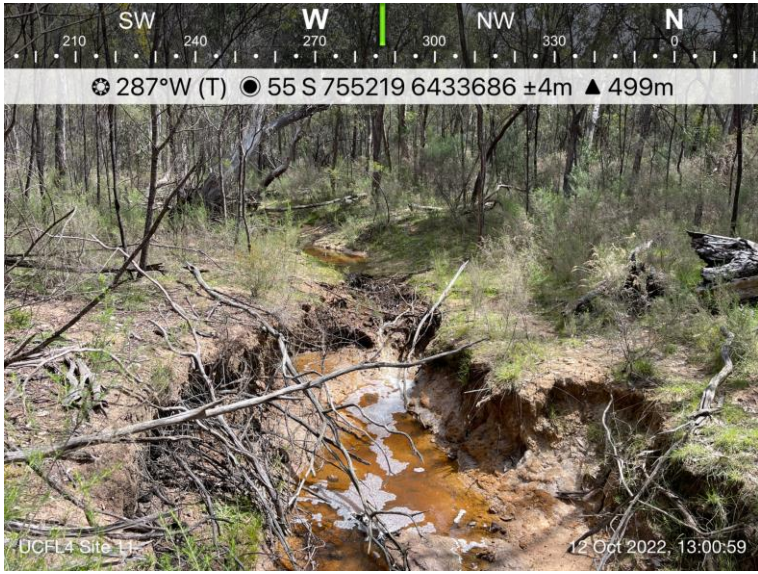
Year	February 2019	November 2020	October 2021	October 2022	
Result	Perceptible impacts	Perceptible impacts ⁴ (change)	Perceptible impacts ⁴ (no change)	Perceptible impacts ⁴ (no change)	
Comments / Interpretation					
<ul style="list-style-type: none"> - UCFL4 Site 11 is located above LW4 near the western edge of the panel and displays signs of natural instability and was added to the monitoring program in 2019. - During the 2019 inspection, there was evidence of subsidence related impacts including cracking in the creek bed and less extensive cracking noted along the LHB and RHB. - During the 2020 inspection, additional cracking and potential ponding sites were identified. - The flow line did display signs of mass material movement from both banks in the form of undercutting, slumping and channel widening (when compared to 2019) as a result of high flow event/s (refer to Section 4). There was water flowing and pooling and it was clear with a reddish/brown appearance. - The erosion impacts as described from a high flow creek event in 2020 may have been exacerbated by a change in the longitudinal gradients from subsidence (an example of nick point erosion)⁴. - This potential change in grade may be exacerbating the natural eroding processes within the flowline at this location. - During the 2021 inspection the instabilities noted in 2020 appeared comparable, although monitoring to continue in 2022 to confirm no change to 2020 impacts. - During the 2022 inspection the instabilities noted in 2020 appeared comparable with previous monitoring. - Water was flowing at the time of the inspection in 2022.

⁴ Nick point erosion begins at points of increased grade caused by subsidence and regresses upstream to erode the stream bed through the zone of less subsidence above chain pillars

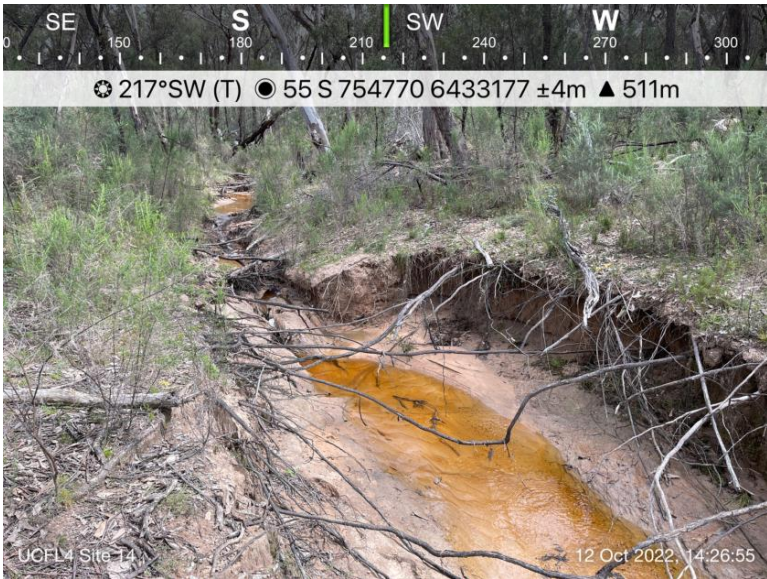
Year	November 2020	October 2021	October 2022		
Result	Perceptible impacts ⁶	Perceptible impacts ⁶ (no change)	Perceptible impacts ⁶ (no change)		
Comments / Interpretation					
<ul style="list-style-type: none"> - UCFL4 Site 14 is located above LW5 near the western edge of the panel and displays signs of natural instability (refer to 2018 pre-mining photos at Sites 12 & 13) and was added to the monitoring program in 2020. - During the 2020 inspection the flow line did display signs of mass material movement from both banks in the form of undercutting and slumping as a result of high flow event/s (refer to Section 4). At the time of the inspection water was flowing and was clear with a reddish/brown appearance. - The erosion impacts as described from a high flow creek event in 2020 may have been exacerbated by a change in the longitudinal gradients from subsidence (an example of nick point erosion)⁴. - This potential change in grade may be exacerbating the natural eroding processes within the flowline at this location. - During the 2021 inspection the instabilities noted in 2020 appeared comparable, although monitoring to continue in 2022 to confirm no change to 2020 impacts. - During the 2022 inspection the instabilities noted in 2020 appeared comparable with previous monitoring. - Water was flowing at the time of the inspection in 2022.

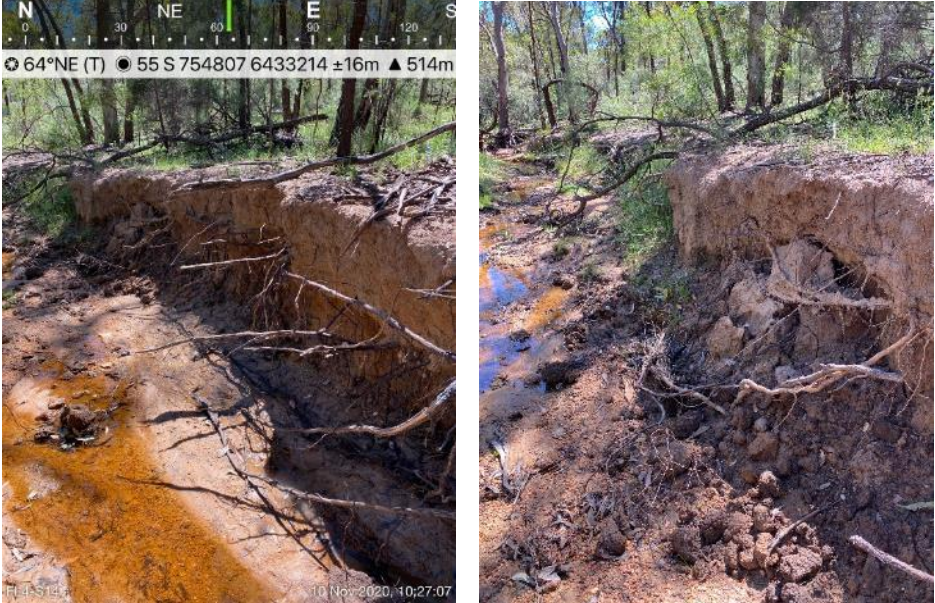
Signs of recent erosion along the banks of the flow line FL4 during the 2020 inspection at site 14 and downstream between Sites 14 and 13

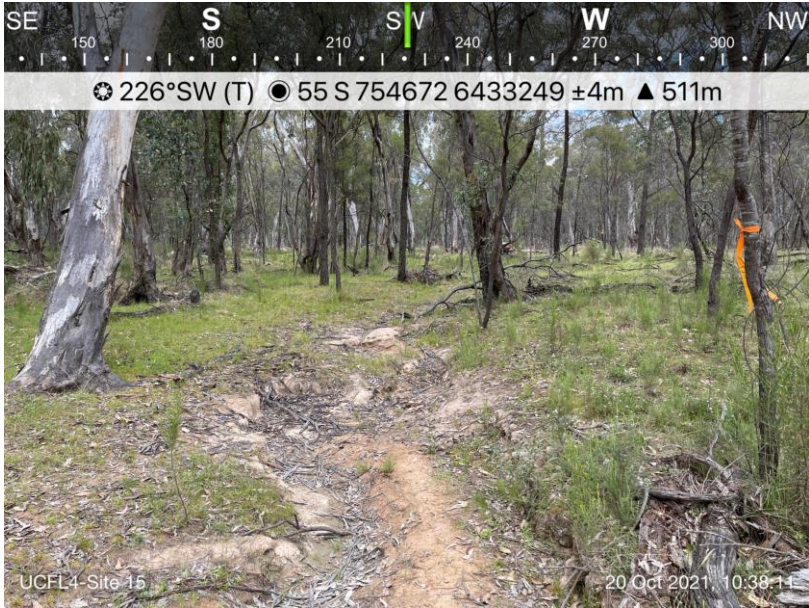
Year	October 2021	October 2022	October 2023		
Result	Pre-Mining	No Perceptible impacts	No Perceptible impacts*		
Comments / Interpretation					
<ul style="list-style-type: none"> - UCFL4 Site 15 is located above LW6 towards the eastern edge and was added to the monitoring program in 2021. - At the time of the October 2021 inspection, LW6 had 2968m of longwall retreat remaining (approximately 1.9km to the north of Site 15A). - The pre mining inspection noted the flow line was defined and the bed was partially vegetated with signs of instabilities. A scour was noted in the flow line with instabilities. Surrounding the flow line was well vegetated. - During the 2022 inspection the instabilities noted in 2021 appeared comparable with previous monitoring. - Water was flowing at the time of the inspection in 2022. - During the 2023 inspection the instabilities noted in 2021 appeared comparable with previous monitoring. - No water was observed flowing or pooling in 2023. There was decreasing groundcover. - * To the east of Site 15 extensive cracking across the creek line was identified in 2023 (see below)

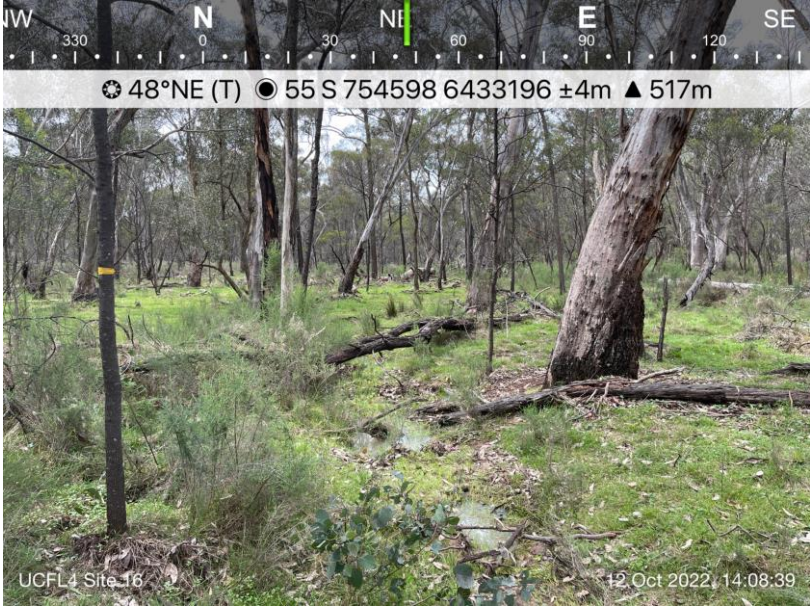
Year	October 2021	October 2022	October 2023		
Result	Pre-Mining	No Perceptible impacts	No Perceptible impacts		
Comments / Interpretation					
<ul style="list-style-type: none"> - UCFL4 Site 16 is located above LW6 towards the eastern edge and was added to the monitoring program in 2021. - At the time of the October 2021 inspection, LW6 had 2968m of longwall retreat remaining (approximately 1.9km to the north of Site 15A). - The pre mining inspection noted the flow line was defined, well vegetated and stable. A very small scour was noted in the flow line and appeared stable at this location. Further downstream a larger scour has formed. - During the 2022 inspection the instabilities noted in 2021 appeared comparable with previous monitoring. - Water was observed flowing in 2022. Partial infilling of the scour with flood debris and vegetation in 2022. - During the 2023 inspection the instabilities noted in 2021 appeared comparable with previous monitoring. - No water was observed flowing or pooling in 2023. There was decreasing groundcover.

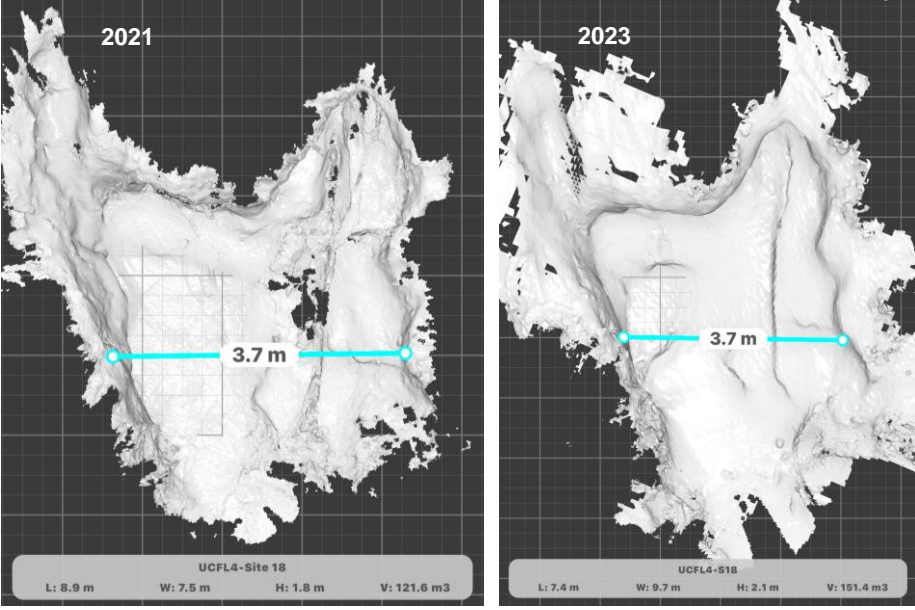
<p>UCFL4 - Site 18 L: 8.9 m W: 7.5 m H: 1.8 m V: 121.6 m3 UCFL4 - Site 18 L: 7.4 m W: 9.7 m H: 2.1 m V: 151.4 m3</p>

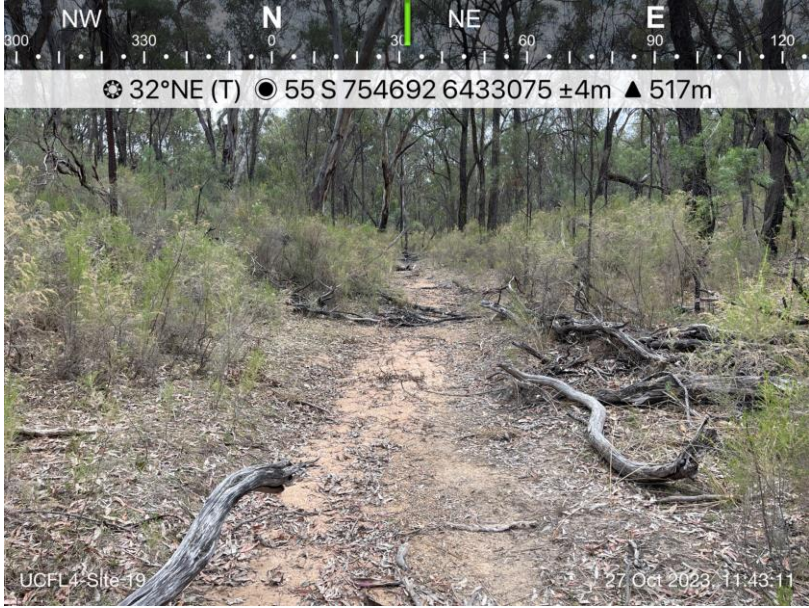
Year	October 2021	November 2022	October 2023		
Result	Pre-Mining	No Perceptible impacts	No Perceptible impacts		
Comments / Interpretation					
<ul style="list-style-type: none"> - UCFL4 Site 19 is located above LW6 towards the eastern edge and was added to the monitoring program in 2021. - At the time of the October 2021 inspection, LW6 had 2968m of longwall retreat remaining (approximately 1.9km to the north of Site 15A). - The pre mining inspection noted the flow line was well defined within a sand bed, well vegetated banks and surrounds and generally stable. - During the 2022 inspection the instabilities noted in 2021 appeared comparable with previous monitoring. - Water was observed flowing in 2022. - During the 2023 inspection the instabilities noted in 2021 appeared comparable with previous monitoring. - No water was observed flowing or pooling in 2023. There was decreasing groundcover.

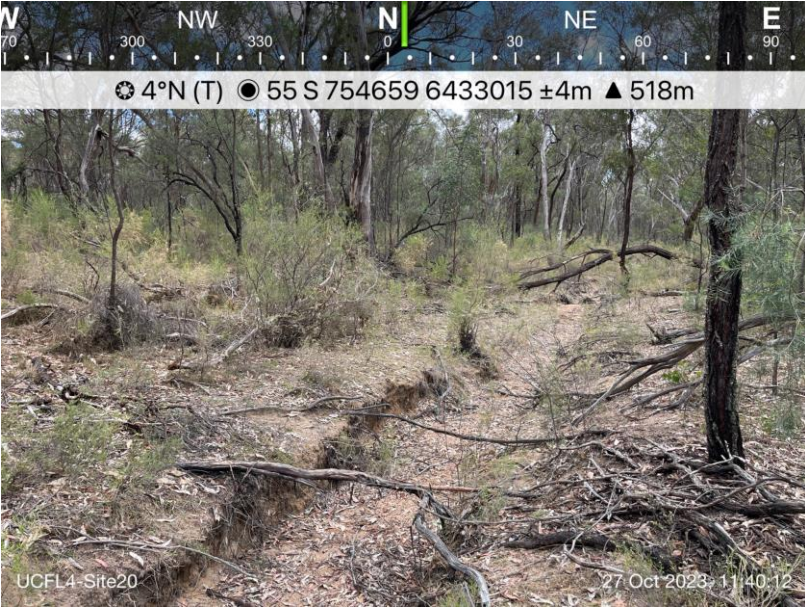
Year	October 2021	November 2022	October 2023		
Result	Pre-Mining	No Perceptible impacts	No Perceptible impacts		
Comments / Interpretation					
<ul style="list-style-type: none"> - UCFL4 Site 19 is located above LW6 towards the eastern edge and was added to the monitoring program in 2021. - At the time of the October 2021 inspection, LW6 had 2968m of longwall retreat remaining (approximately 1.9km to the north of Site 15A). - The pre mining inspection noted the flow line was well defined within an eroded channel, displaying signs of instabilities. The flow line and surrounds were well vegetated. - During the 2022 inspection the instabilities noted in 2021 appeared comparable with previous monitoring. - Water was observed flowing in 2022. - During the 2023 inspection the instabilities noted in 2021 appeared comparable with previous monitoring. - No water was observed flowing or pooling in 2023. There was decreasing groundcover.

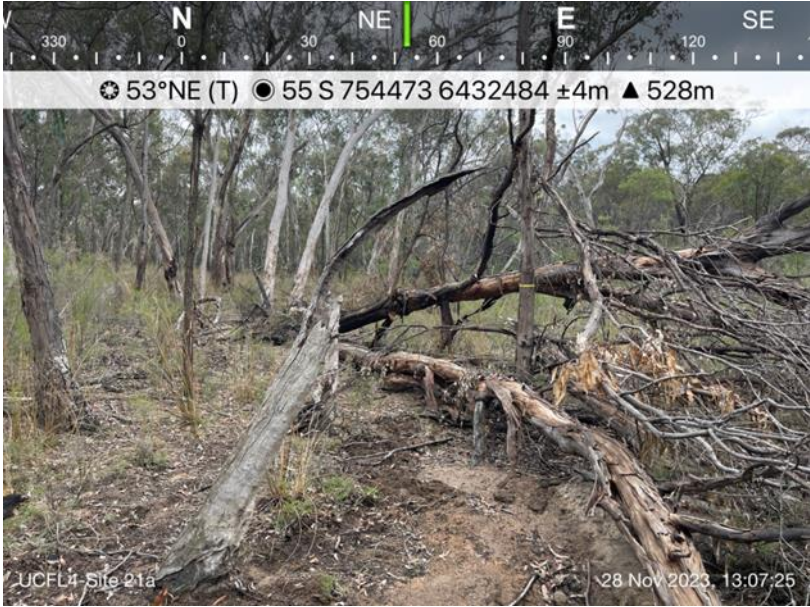
Year	October 2021	November 2022	November 2023		
Result	Pre-Mining	No Perceptible impacts	No Perceptible impacts		
Comments / Interpretation					
<ul style="list-style-type: none"> - UCFL4 Site 21a is located above LW6 near the end of panel towards the center and was added to the monitoring program in 2021. - At the time of the October 2021 inspection, LW6 had 2968m of longwall retreat remaining (approximately 1.9km to the north of Site 15A). - The pre mining inspection noted the flow line was not well defined, within a flood plain and was very well vegetated and stable. At the time of the inspection the ground was very saturated. - During the 2022 inspection the instabilities noted in 2021 appeared comparable with previous monitoring. - Water was observed flowing in 2022. The ground was saturated. A tree had fallen across the site since October 2021. - During the 2023 inspection the site appeared comparable with previous monitoring and the flow line was dry.

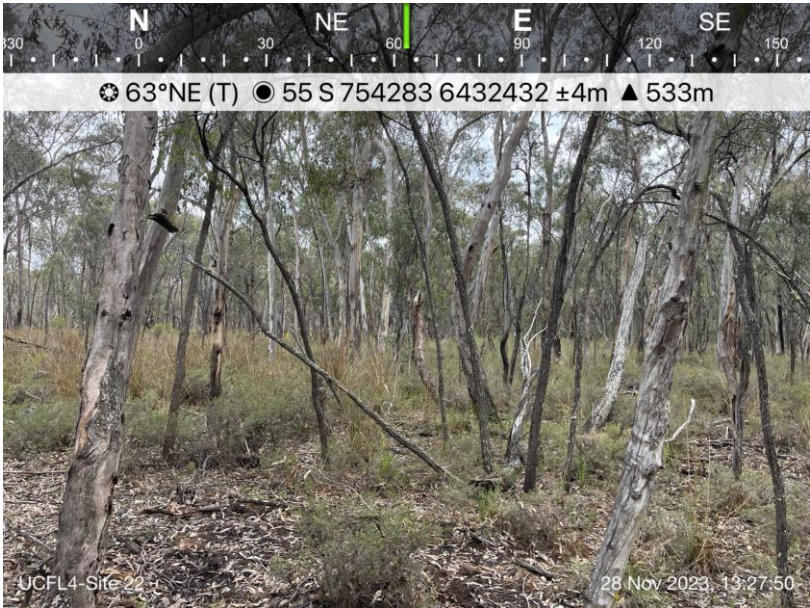
Year	October 2021	October 2022	November 2023		
Result	Pre-Mining	No Perceptible Impacts	No Perceptible Impacts		
Comments / Interpretation					
<ul style="list-style-type: none"> - UCFL4 Site 22 is located above LW6 near the end of panel on the western edge and was added to the monitoring program in 2021. - At the time of the October 2021 inspection, LW6 had 2968m of longwall retreat remaining (approximately 1.9km to the north of Site 15A). - The pre mining inspection noted the flow line was not well defined, within a flood plain and was very well vegetated and stable. At the time of the inspection the ground was very saturated. - During the 2022 inspection the instabilities noted in 2021 appeared comparable with previous monitoring. - Water was observed flowing in 2022. - During the 2023 inspection the site appeared comparable with previous monitoring and the flow line was dry with decreasing groundcover.

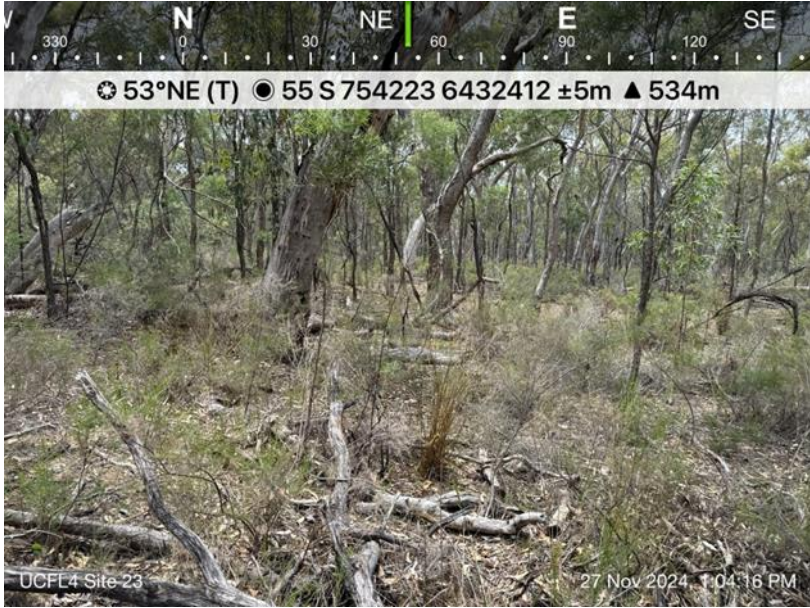
Year	November 2022	November 2024			
Result	Pre Mining	No Perceptible Impacts			
Comments / Interpretation					
<ul style="list-style-type: none"> - UCFL4 Site 23 is located above LW7 near the end of panel on the eastern edge and was added to the monitoring program in 2022. - The pre mining inspection noted the flow line was not well defined, within a flood plain and was very well vegetated and stable. At the time of the inspection the ground was very saturated. - During the 2024 inspection the site appeared comparable with previous monitoring and the flow line was dry with decreasing groundcover.

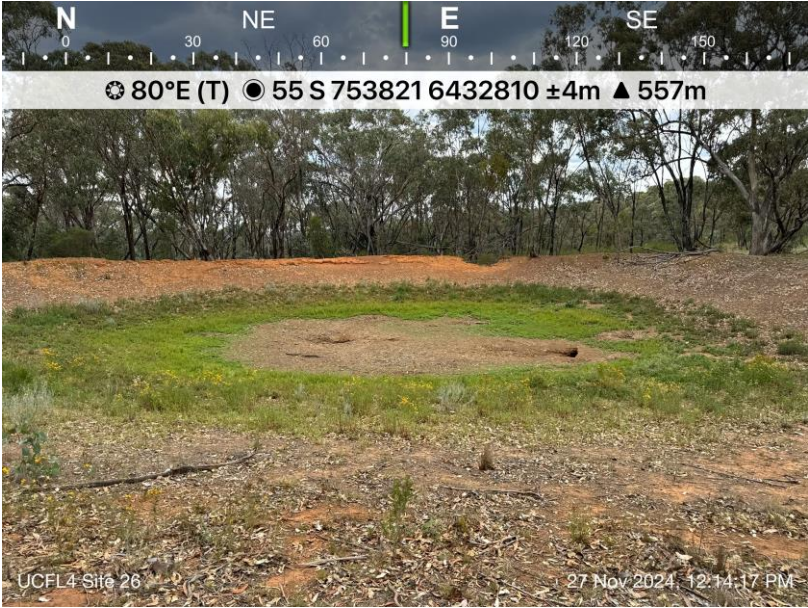
<p>UCFL4 Site 26 27 Nov 2024 12:14:17 PM</p>				
Year	November 2022	November 2024			
Result	Pre Mining	Pre Mining			
Comments / Interpretation					
<ul style="list-style-type: none"> - UCFL4 Site 26 is located above LW8B and is a UCMLPL owned farm dam near the eastern edge of the panel and was added to the monitoring program in 2022. - At the time of the November 2022 inspection, LW8B had not commenced. - The pre mining inspection noted the dam was at near capacity and the dam wall embankment at the eastern edge had been compromised, potentially many years ago, reducing the holding capacity of the dam. - During the November 2024 inspection no perceptible impacts were observed. Animal diggings were noted in the middle of the dam.

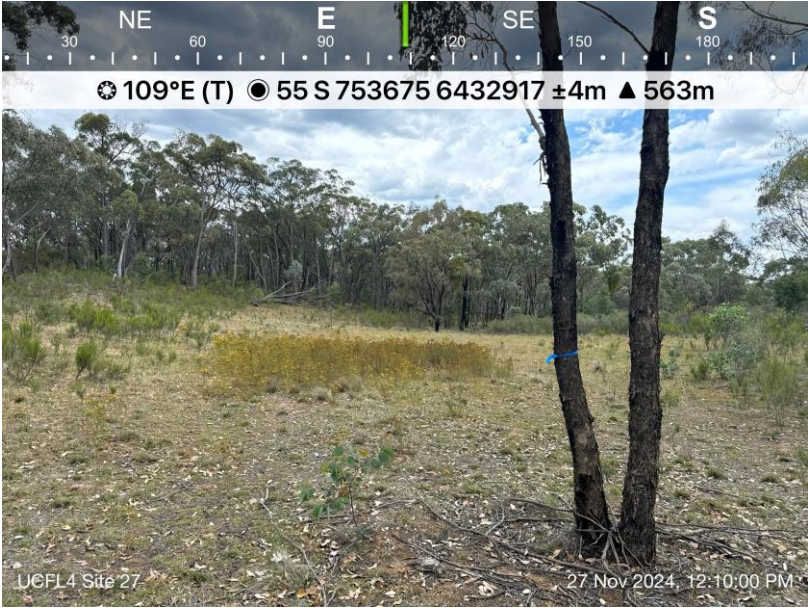
Year	November 2024				
Result	Pre Mining				
Comments / Interpretation					
<ul style="list-style-type: none"> - UCFL4 Site 27 is located above LW8B near the centre of the panel and was added to the monitoring program in 2024. - At the time of the November 2024 inspection, LW8B had not commenced. - The pre mining inspection noted there is no defined channel at this location and the groundcover was extensive. 					
Recommendations
